**TIER 3**

**ENVIRONMENTAL RISK ASSESSMENT**

**FORMER MUNICIPAL LANDFILL**

**KILRUSH,**

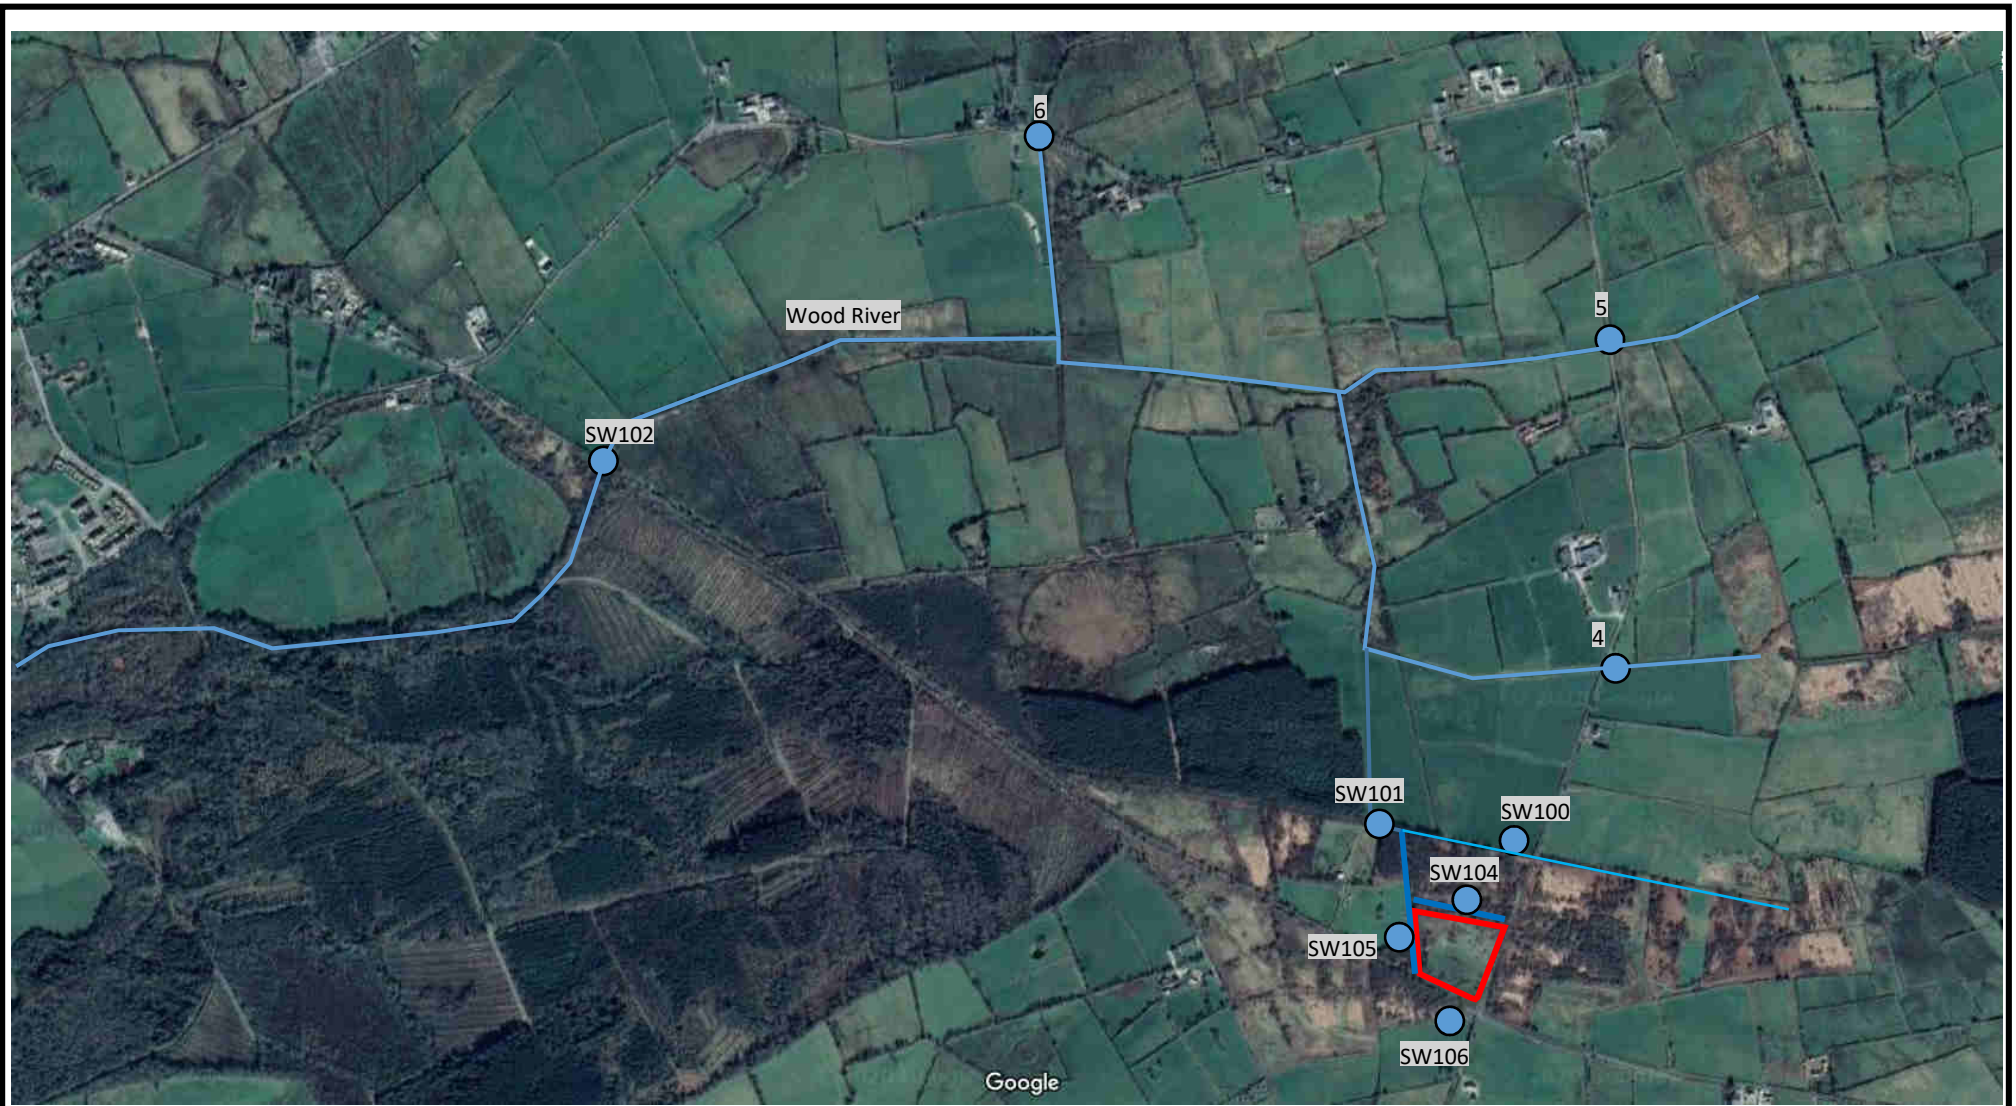
**Title:**  
Figure 3.2 Surface Water Sample Locations

Surface water sampling locations are shown on Figure 3.2. In 2010 surface water samples were collected from SW-100 is a first order stream upstream of the landfill and SW-101 a sample point in this stream downstream of the landfill. SW-102 is a sample from the Wood River downstream of the landfill beyond the point where the first order stream discharges into it.

Following a site walk over on May 28<sup>th</sup> 2020 OCM recommended the completion of an updated round of surface water sampling to include the above sampling points if and where water was present. OCM also recommend sampling surface water coming from first order streams upstream of where they enter the Wood River (sample points 4, 5 and 6). This was to establish water quality entering the Wood River upstream of the confluence with water entering the Wood River from the stream into which the landfill was draining. As was the case in 2010 sample points SW-3, 4, 5 and 6 were dry. But samples were obtained from sample points 4, 5 and 6.
