Journal of the American Institute for Conservation Summer 2008 Volume 47, Number 2

CALCIUM TARTRATE TETRAHYDRATE PRECONSOLIDATION OF SALT-CONTAMINATED LIMESTONE AT MISSION SAN JOSÉ Y SAN MIGUEL DE AGUAYO

JENNIFER CORREIA AND FRANK MATERO

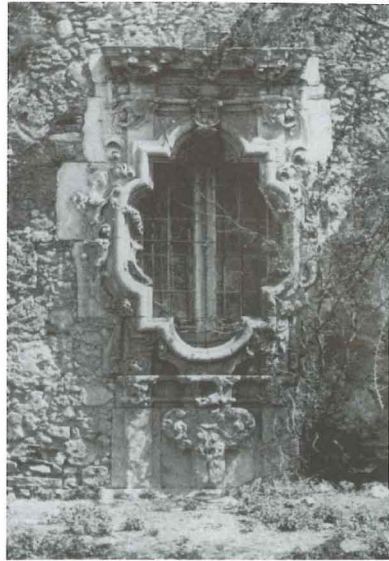
Fig. 1. The Sacristy Window before excavation of the base, Mission San Jose y San Miguel de Aguayo, San Antonio, Texas, Wister Collection, 1893, Texas State Library, copy from NPS Archives.
