FALCON SERVICE BULLETIN

FALCON 900

No 372-R1

**LIGHTING
EXTERIOR LIGHTING
ELECTRICAL BONDING OF WHELEN FIN TIP ANTI-
COLLISION LIGHT**

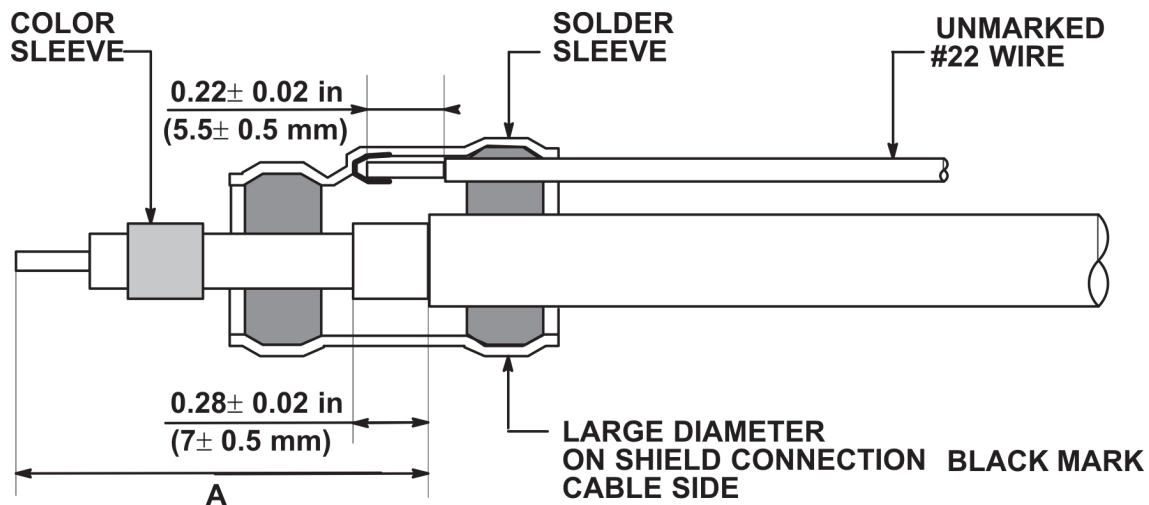
Dimension A:

- Connector with front extraction: 1.38 in (35 mm).
- Connector with rear extraction: 1.97 in (50 mm).

Modify the shield connection in accordance with instructions depicted hereafter and using **fig. 3**, **fig. 4** and **fig. 5** in accordance lights' installation on the aircraft.
