WILD TROUT TRUST

Advisory Visit

River Swale, Richmond & District Angling Society, Jan 2021

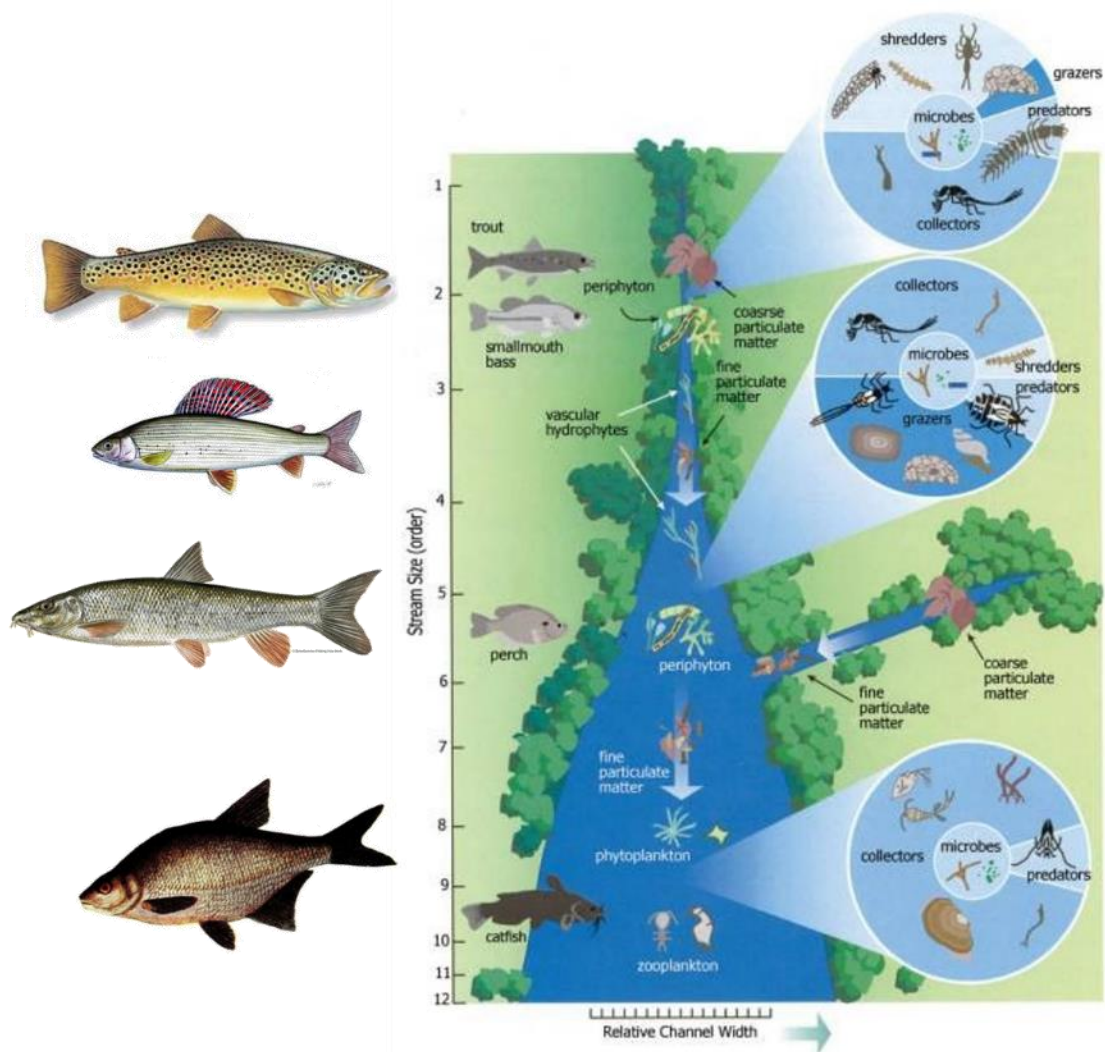
There are various ways of classifying the zonation of rivers, the simplified description of typical changes from headwaters to estuaries, using characteristics such as the basis of production (what provides the energy at the bottom of the food web) right through to the fish communities. Figure 22 is a composite schematic of the classical description of zonation as a continuum (the River Continuum Concept proposed by Vannote et al 1980) overlaid by the European fish zonation (as proposed by Aarts & Nienhuis, 2003). Human modification of river channels will impact upon these schema. Essentially, the RDAS waters lie on the cusp of what would be classified as Grayling and Barbel Zones. That is not to say brown trout (and salmon) will not be present and using those waters.

Based upon the observations made and reported here, the physical habitat within the Mercury Bridge to Red House Farm waters generally appeared more favourable for salmonids and grayling than coarse fish species like chub or barbel. While there were a few pockets of holding habitat for larger coarse fish, there was relatively little in the way of fry and juvenile habitat, and the temporal stability of gravel for spawning was questionable although probably sufficient for short periods during the late spring / early summer spawning period of these species. A detailed assessment of invertebrate life was not carried out but a cursory search by turning cobbles revealed a few small mayfly and stonefly nymphs. Food might hence be a limiting factor for some of the coarse species that typically forage on the bed (eg barbel) whereas trout and grayling feed in the drift and from the surface and can be heavily subsidised by terrestrial invertebrates. Furthermore, the slow decline in catches of coarse fish noted by the club (and elsewhere across the country) could also reflect a general trend of increasing water quality which again tends to favour salmonids over coarse species. These factors are not mutually exclusive. The Great Langton waters were more typical of the Barbel Zone but still lacked suitable habitat for fry and juvenile development. Fortunately, the Swale has relatively few man-made barriers (considering its length), and certainly fish like barbel will move considerable distances, spawning, feeding and residing in distinct reaches of a river throughout their life-cycle. Skeeby Beck offers more suitable habitat, certainly for fish like chub.

Fig 22. A schematic of the River Continuum Concept (Vannote et al 1980) with the classic European fish zonation (*sensu* Aarts & Nienhuis, 2003) added to the left panel.
