Newsletter of **Environmental, Disaster, and Crises Management Strategies**

The Mw 6.6, July 21, 2017 Kos Earthquake Scientific Report (Version 2.0)

EARTHQUAKE INFORMATION, EARTHQUAKE ENVIRONMENTAL EFFECTS AND BUILDING DAMAGE

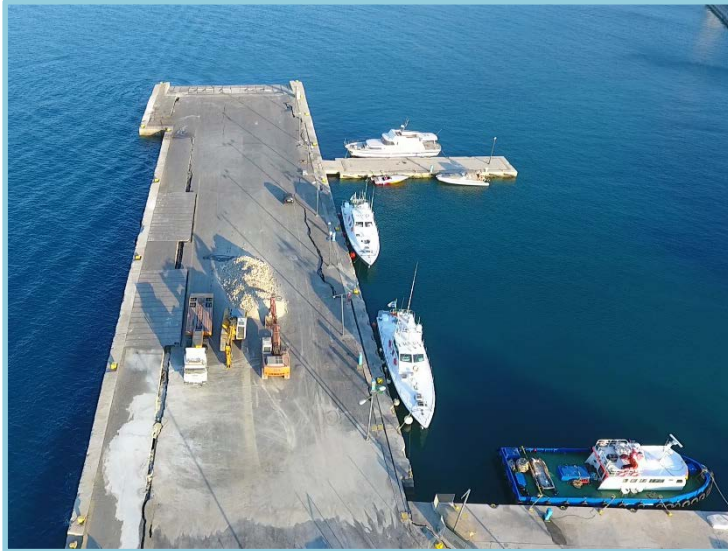
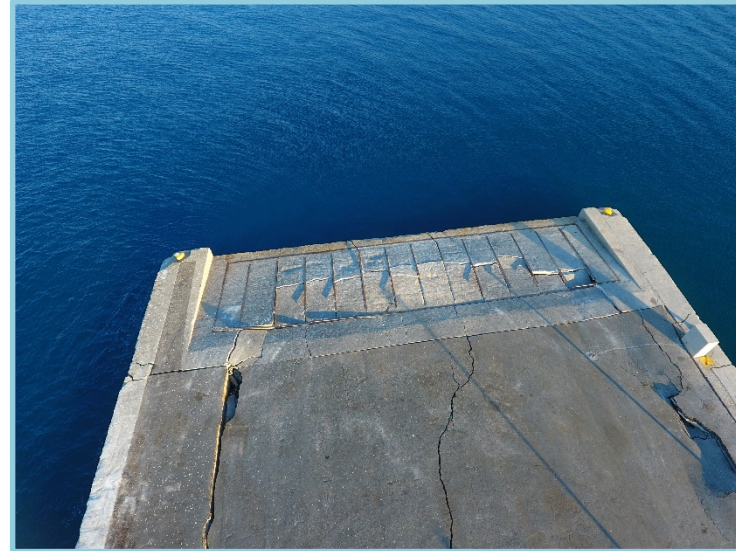
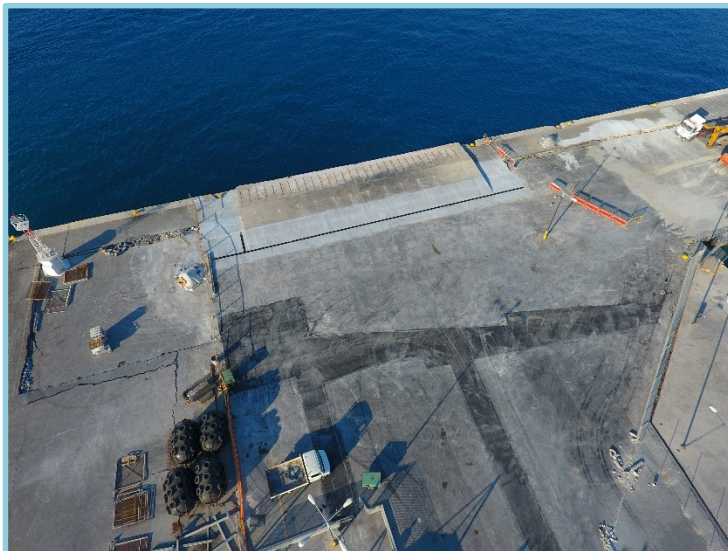
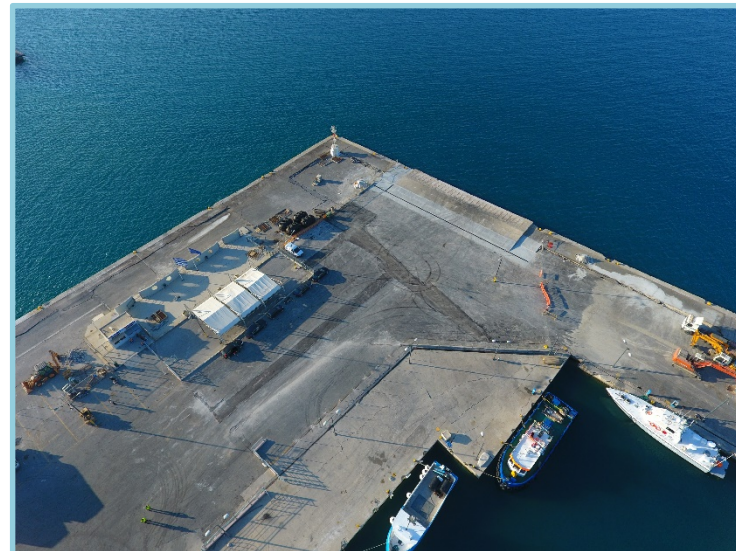
DAMAGE TO KOS PORT

Kos port and related facilities underwent failures including longitudinal cracks of the jetties parallel to the seashore, detachments and displacements of the quay seawalls as well as significant subsidence.

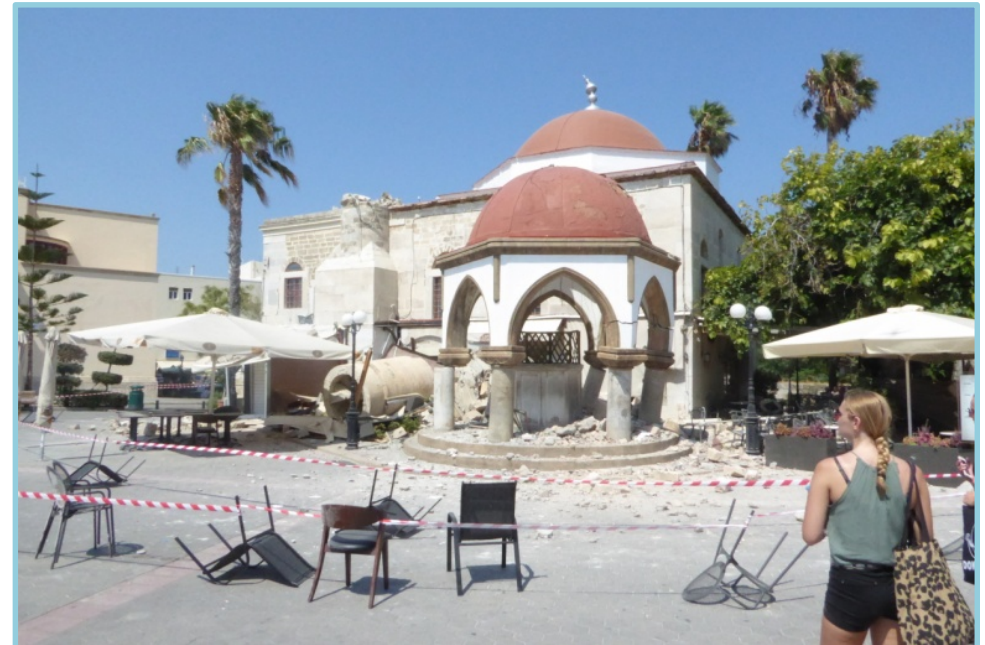
▲ The orientation of the collapse of the minaret indicates the location of the epicenter. The collapse is not attributed to the initial strong pulse, but later on, after some oscillations, to its higher flexibility. If the minaret was not fixed to the rigid structure, the collapse might be avoided.

▼ The displacement of the stiff structure is oriented towards the location of the epicenter due to the first strong pulse of the seismic motion.

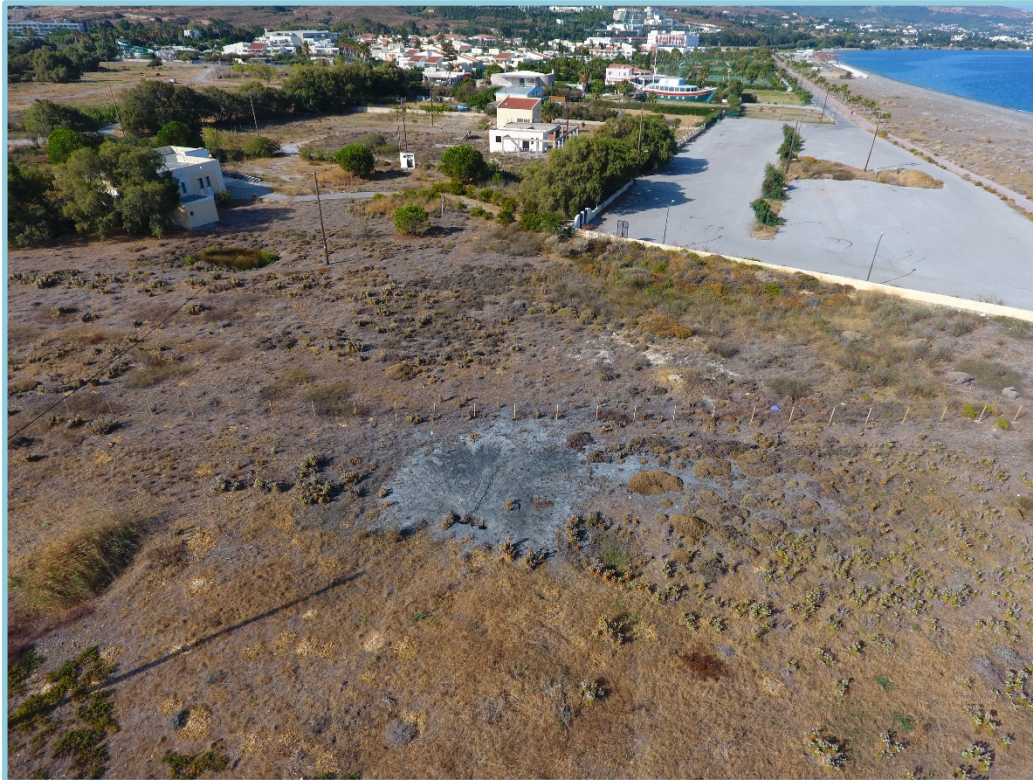
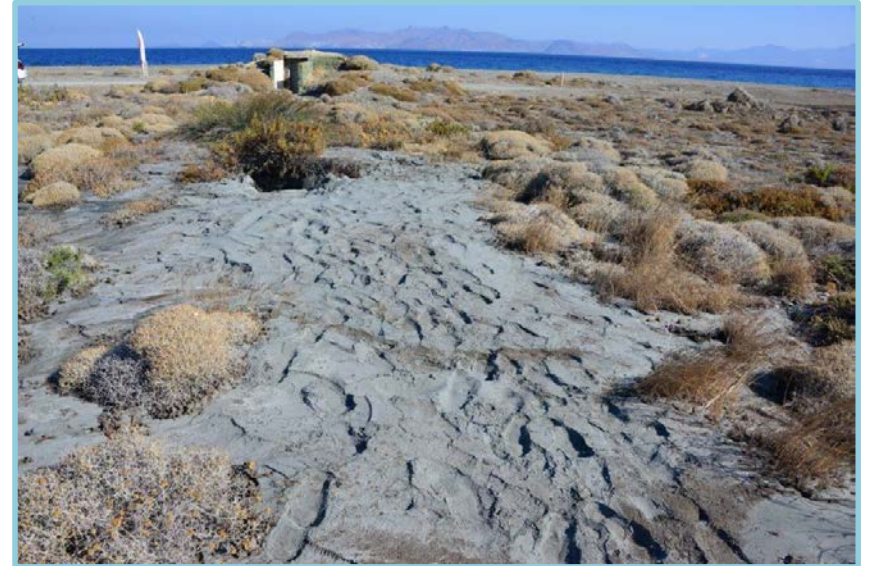
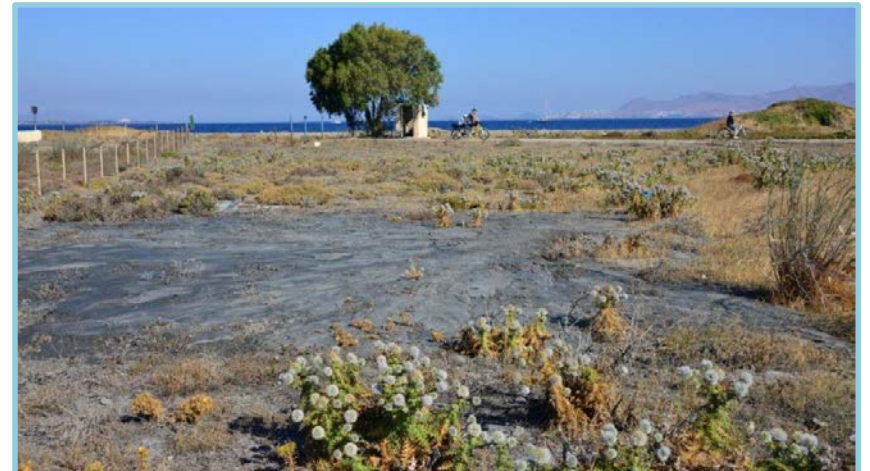
LIQUEFACTION PHENOMENA

Staff of the EPPO conducted a macroseismic survey in order to detect the earthquake impact in the meizoseismal area. More specifically, in the eastern coastal part of Kos, liquefaction phenomena were generated in the form of mud volcanoes and coastal subsidence varying from 30 to 40 cm was also detected resulting in inundation of the coast.

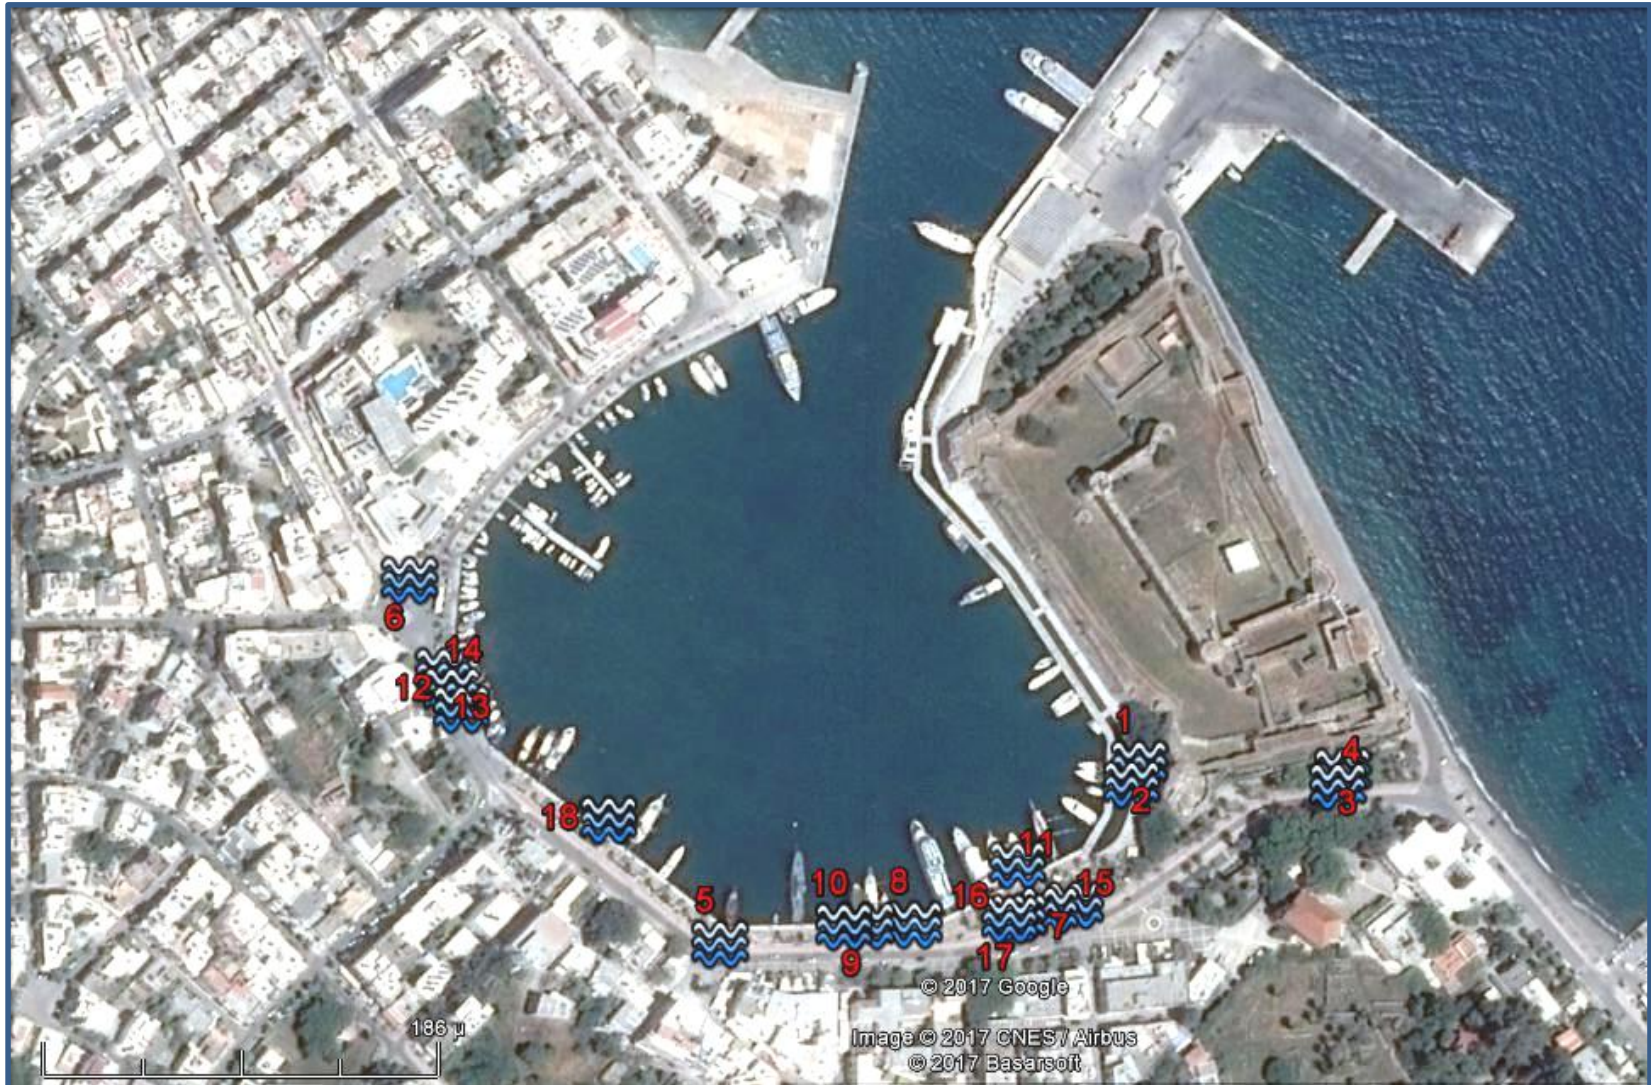
TSUNAMI-INDUCED DAMAGE DISTRIBUTION IN KOS PORT BASED ON VERBAL AND PHOTOGRAPHIC TESTIMONIES

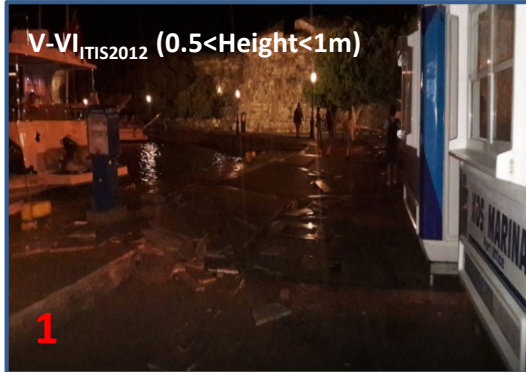
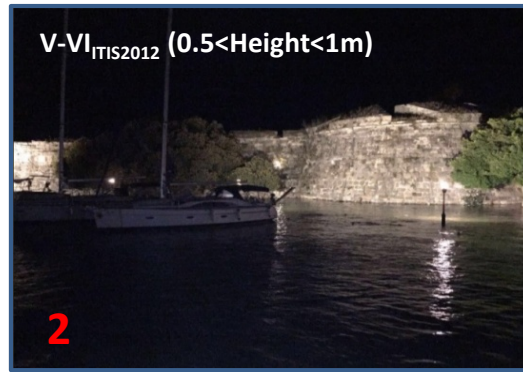
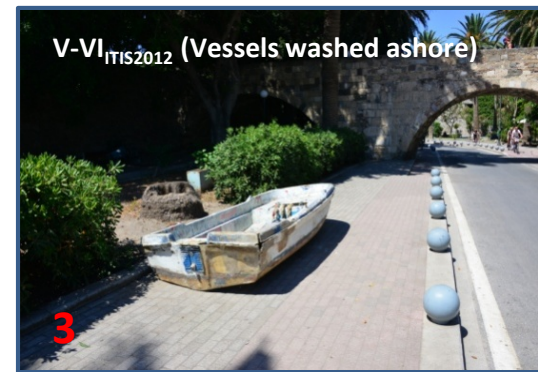
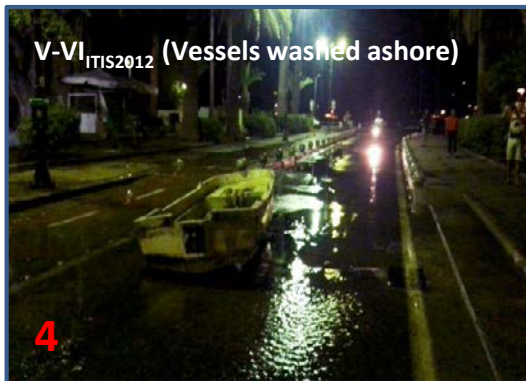
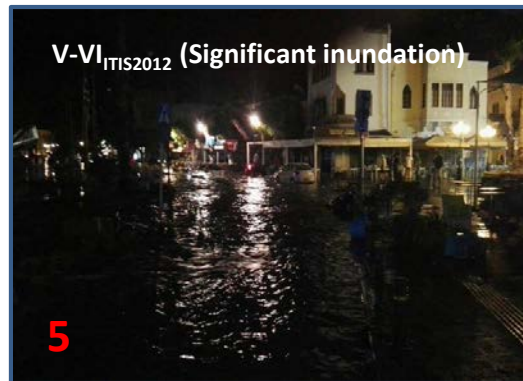
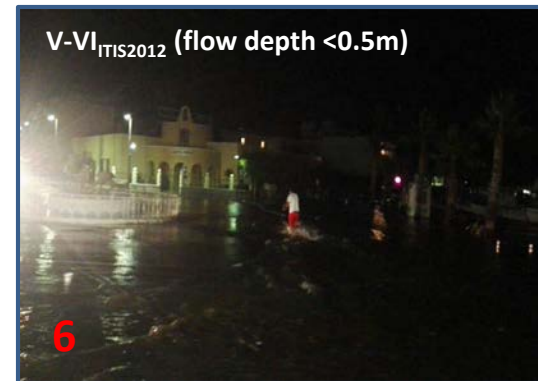
TSUNAMI EFFECTS IN THE COASTAL ZONE CLOSE TO KOS PORT

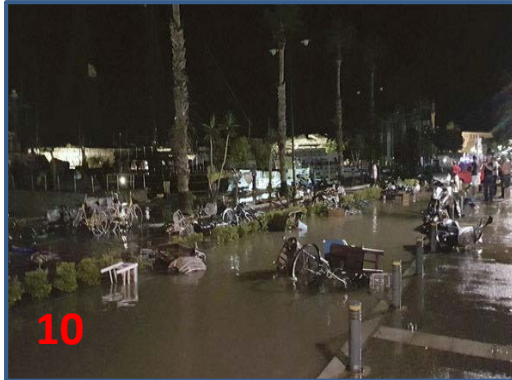
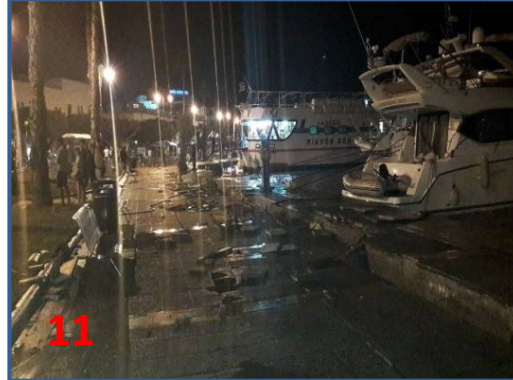
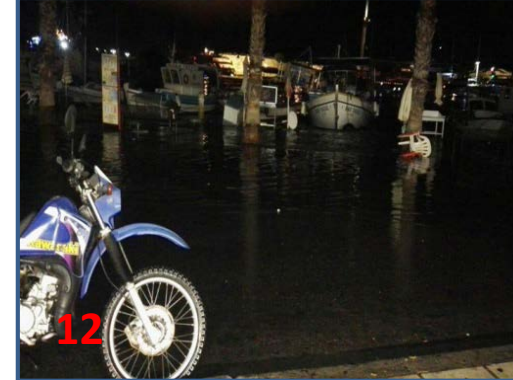
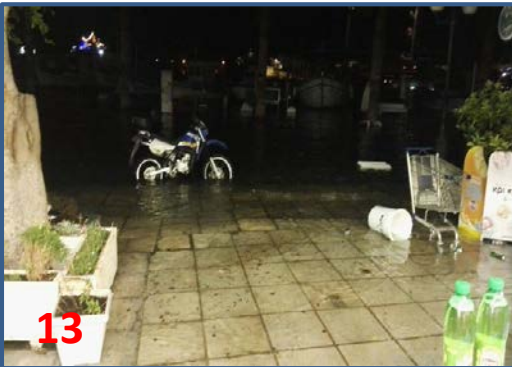
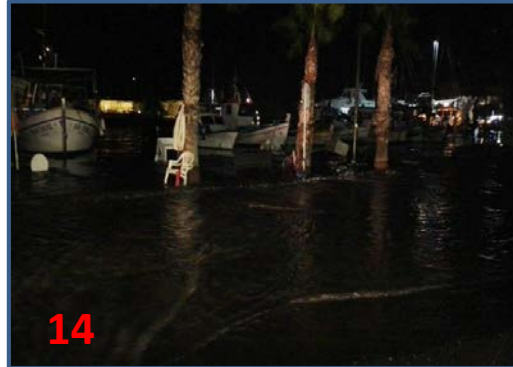
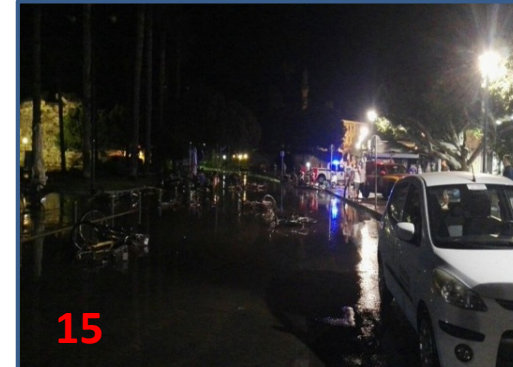
TSUNAMI EFFECTS IN THE COASTAL ZONE CLOSE TO KOS PORT
