10. A slope stability problem in Hong Kong

Introduction

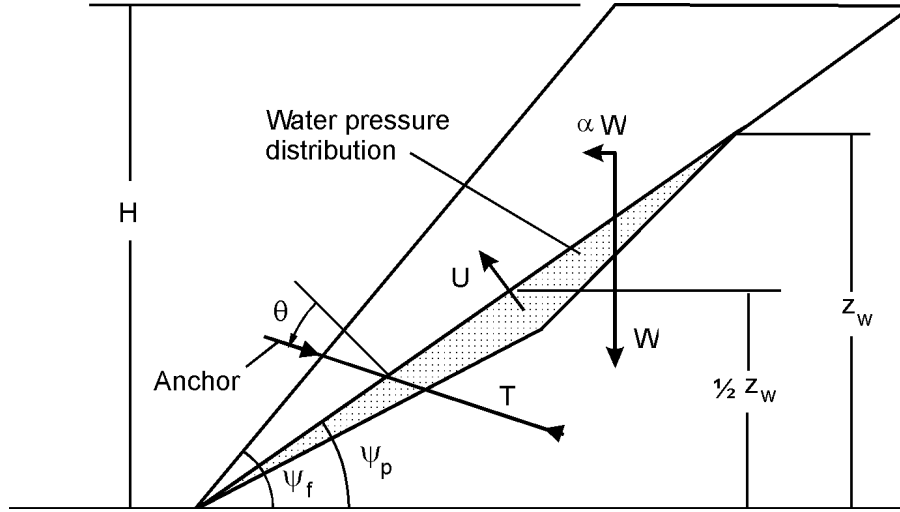
Figure 6: Factor of Safety calculation for a slope with no tension crack.

response of the slope to a range of possible conditions. The two models are defined in Figure 6 and Figure 7.

Note that this is a two-dimensional analysis, and these dimensions refer to a 1-metre-thick slice through the slope. It is also important to recognise that this analysis considers only force equilibrium and assumes that all forces pass through the centroid of the wedge. In other words, moment equilibrium is not considered in this analysis. While this is a simplification of the actual situation depicted in Figure 6 and Figure 7, the errors introduced are not considered to be significant, given the uncertainty of the other input data used in these analyses.

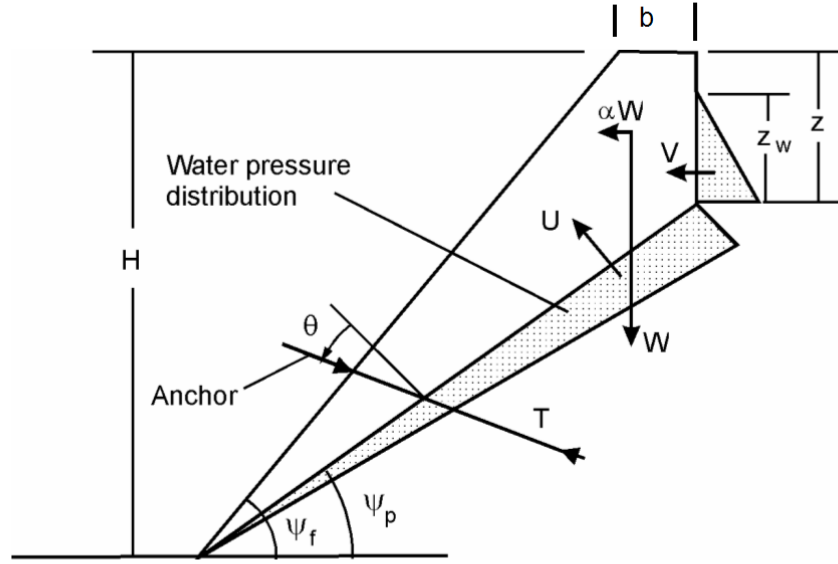
Figure 7: Factor of Safety calculation for a slope with a water-filled tension crack.

In Figure 7 the depth z of the tension crack is calculated by equation 6. This equation is obtained by minimising equation 5 with respect to the tension crack depth z (Hoek and Bray, 1974). This minimisation is carried out for a dry slope and the accuracy of equation 6 decreases as the water depth in the tension crack increases. However, for the purposes of this analysis, the estimate given by equation 6 is considered acceptable.

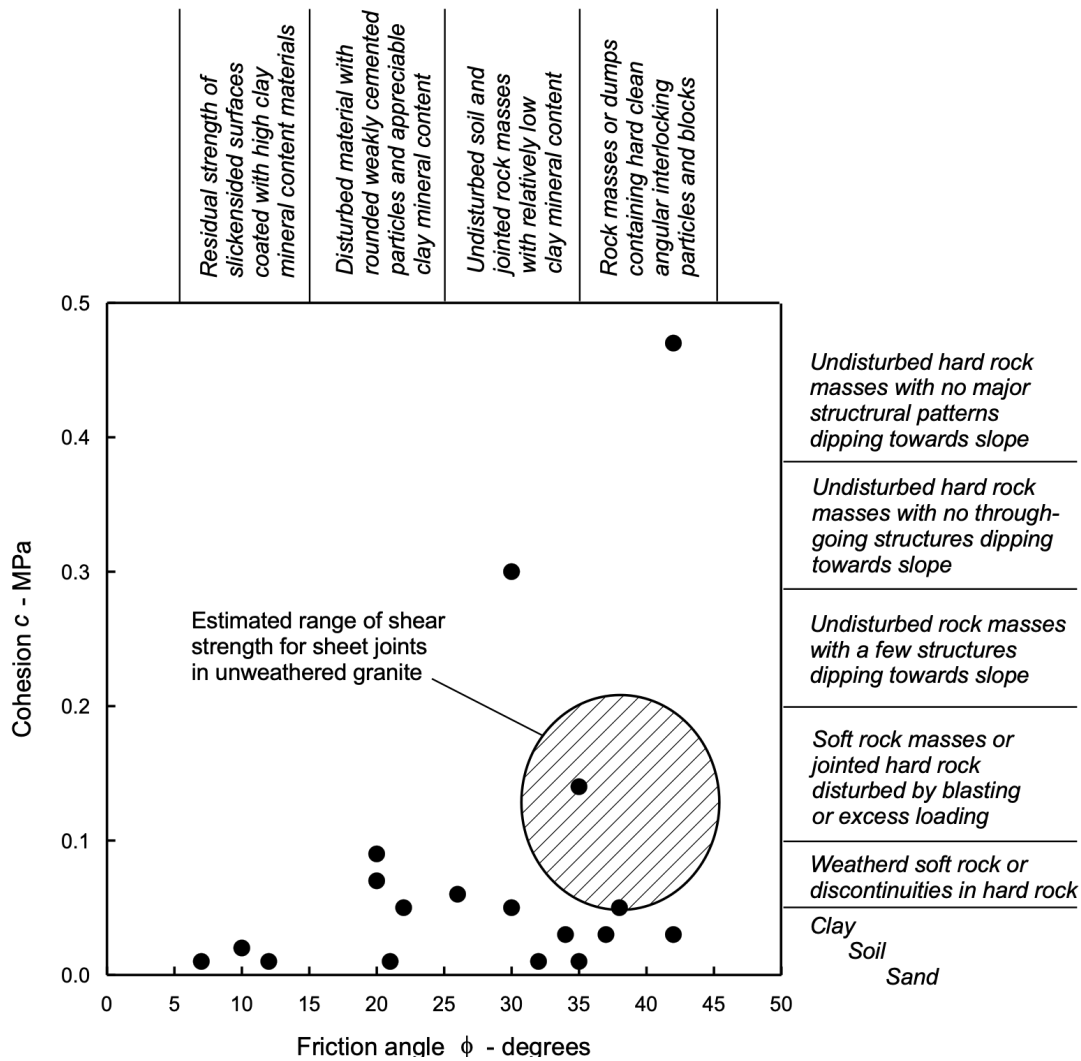
Hoek and Bray (1974) published a plot, reproduced in Figure 8, of cohesive strengths and friction angles for rocks and soils, based upon the results of published back analysis of slope failures. Super-imposed on this plot is an elliptical zone which encompasses the estimated range of shear strength for sheet joints in unweathered granite. In choosing this range it was considered that the friction angle ϕ probably ranges from 30° for very smooth planar surfaces to 45° for rough or partly cemented surfaces. The cohesive strength c is more difficult to estimate and the range of 0.05 to 0.2 MPa was chosen on the basis of the results of back-analyses of slope failures, plotted in Figure 8.

Figure 8: Relationship between friction angles and cohesive strengths mobilised at failure of slopes in various materials. The plotted points were obtained from published information from the back analysis of slope failures. (After Hoek and Bray 1974).
