Summarizing geotechnical activities after the 2011 Tohoku earthquake of Japan

I. Towhata

ABSTRACT: After the 2011 Tohoku earthquake in Japan, I as the Vice President and then as the President of the Japanese Geotechnical Society took initiatives in damage reconnaissance, developing new safety criterion for liquefaction-prone residential areas, quantitative evaluation of ageing effects on liquefaction resistance of sand, investigation on damage mechanism of river levees, recovery from the tsunami incidence of Fukushima No.1 Nuclear Power Plant and ground improvement in existing residential area. Some of them were conducted urgently within several months after the earthquake, while others encountered many difficulties from the viewpoint of public agreement. This paper summarizes the post-earthquake activities of geotechnical engineering in restoration of the community.

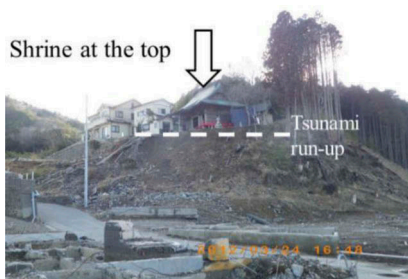
Figure 9. Shrine atop a slope in Onagawa where where tsunami stopped in its front.

The risk of catastrophic but rare disaster may be more reasonably assessed by non-engineering studies. Along the Pacific Coast of Tohoku region, there are many shrines (temples of Japanese gods). It is likely that those shrines were destroyed by past tsunamis and that local people reconstructed them at safer (higher) places. Consequently, the tsunami run-up in 2011 stopped in front of the shrine at many places (Uda et al., 2012; Matsuura, 2013). Figure 9 is

one of the examples for this. Since the tsunami height varies with the submarine topography (bathymetry), it was very low at some places. Figure 10 is an example of such a place where the shrine at low elevation survived the disaster. These facts imply the importance of historical knowledge that may not appear scientific from the modern technological viewpoints. Note, however, that Yamazaki (2013) together with Endo and Mazereeuw (2015) attributes the shrine location to other historical/political and cultural reasons.

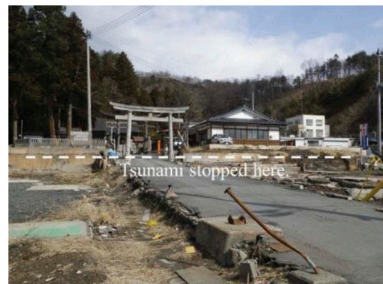
Figure 10. Shrine in Ohzuchi at very low elevation tsunami stopped in its front.

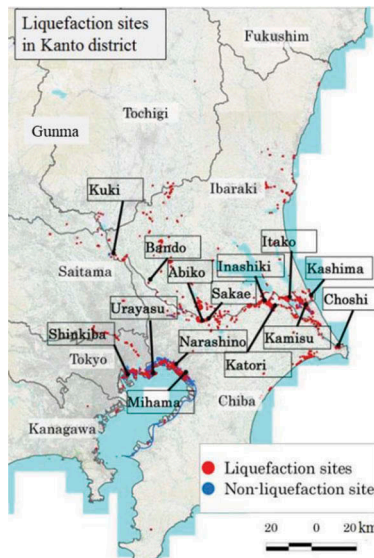
Japanese Geotechnical Society and the Kanto Regional Development Bureau of the Ministry of Land, Infrastructure, Transportation and Tourism jointly investigated the location of liquefaction in the Kanto Region and the result is shown in Figure 14 in which red dots account for the sites of liquefaction. It is evident that liquefaction occurred in two kinds of geomorphology which are young man-made islands along the coast of Tokyo Bay and abandoned river channels and former lakes along the Tone River and other big rivers.

There are many man-made islands in the Tokyo Bay. They were constructed by dumping either hill sand or dredged sea-bed sand mostly in the second half of the 20th Century. Figure 14 indicates that liquefaction was significant in those islands between Tokyo and Chiba while not much happened in the eastern coast of the Bay (south of Chiba) and between Tokyo and Kanagawa on the western side. One reason for the “good” performance in the eastern coast is the lack of information. Those “good” islands are industrial areas and factories therein do not release “negative” information nowadays. The other reason is that industries had improved soil conditions in their factories after the 1987 Chiba-ken-Toho-oki earthquake when liquefaction was significant in industrial islands (Kotoda and Wakamatsu, 1988). Consequently, liquefaction in 2011 was concentrated in young residential islands. In contrast, liquefaction hardly occurred in aged subsoil regions except young backfill soil of buried pipelines.

Figure 14. Sites of liquefaction in Kanto Region (Towhata et al., 2014).

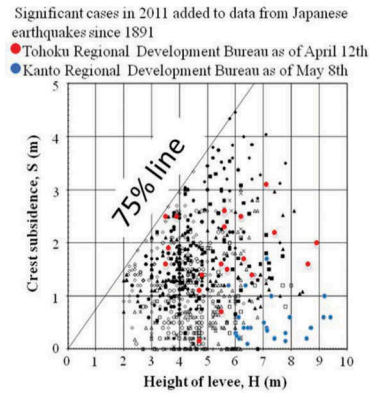
Figure 21. Relation between levee height and subsidence (Sasaki et al., 2012).

Significant subsidence occurred in many sections of river levee in both Kanto Plain around Tokyo and Sendai Plain (Figure 1). Figure 20 shows the induced subsidence and lateral spreading. According to the damage summary, the extent of subsidence (S) did not exceed 75% of the original levee height (H) (Figure 21), which is consistent with the previous summary of seismic damage of levees since the 1891 Nobi earthquake of $M=8.0$. The mechanical reason for the upper bound of 75% subsidence is schematically illustrated in Figure 22; compare the unit weight of water-saturated liquefied subsoil (typically 20 kN/m^3) and that of levee with less degree of saturation (typically 15 kN/m^3). Because of the support provided by the bearing capacity of subsoil,

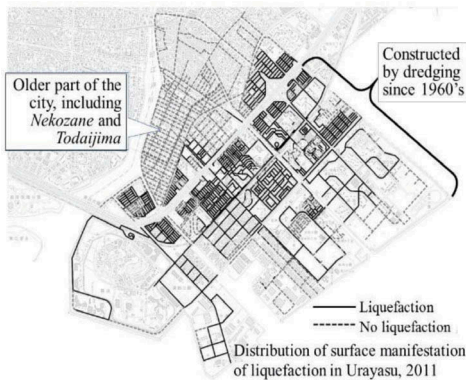
Figure 24. Distribution of liquefaction only in recent man-made island, Urayasu, Chiba.

9154 houses were affected by liquefaction in Urayasu City. Most parts of this city (Figures 14 and 24) were constructed in 1960s and 70s by dredging of marine bed and reclamation of the dredged silty sand in shallow sea water. The liquefaction resistance of this sand was obtained

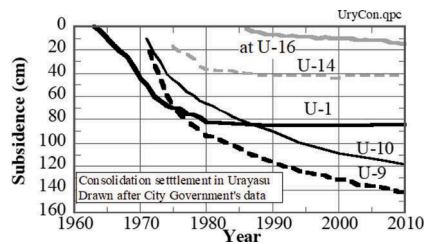
Figure 57. Consolidation settlement in recent land reclamation of Urayasu.

by using undisturbed samples collected by gel push sampling (Figure 56). Because the area is on the mouth of big Tone River, whose channel was here until new channel was constructed in late 17th Century, the man-made island in the city has been underlain by 40-meter deposit of soft alluvial clay. Hence, the man-made island in the city has been annoyed by consolidation settlement for decades (Figure 57). The memory of settlement is still vivid among people and repetition of settlement due to ground water lowering was not appreciated. Under the democratic framework, therefore, the city government could not pursue ground water lowering.

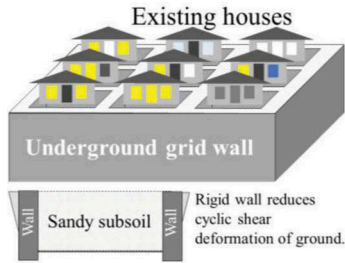
Figure 58. Conceptual illustration of the role played by underground grid wall.

The alternative technology was installation of grid-type underground walls that were constructed by mixing cement and local soil by mechanical mixing or jet grouting. Certainly, this option was more expensive than ground water lowering. Figure 58 schematically shows the grid wall that are installed in a narrow space among houses. The rigidity of the grid wall reduces the cyclic shear deformation of subsoil during earthquakes and mitigates the risk of liquefaction. This technology became popular after its success in Kobe Harbor in 1995. Nevertheless, Urayasu was its first application to subsoil under “existing” houses that are fragile and do not allow very small distortion or tilting that affect health of residents. Very narrow space for underground wall construction was another big issue (Figure 59). After discussion, it was decided to select the grid wall as the measure and design started. The goal of design was “little damage in houses under the same strong earthquake as the one in 2011”. It was not the goal to insure zero damage in any future earthquakes.

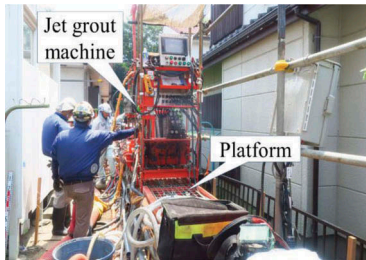
Figure 60. Jet grouting by a small machine placed on an elevated platform (August, 2018).

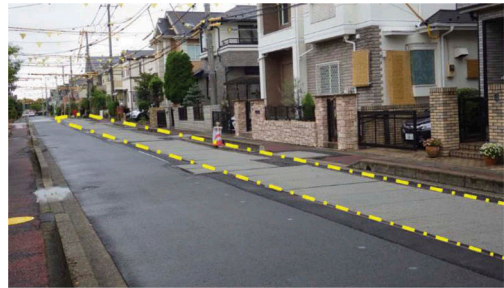
Figure 61. Construction of underground wall under street by mechanical mixing.
