**Baseline Coastal Assessment**

**Shelly Bay Road Upgrades**

**Prepared for**  
Wellington City Council

**Prepared by**  
Tonkin & Taylor Ltd

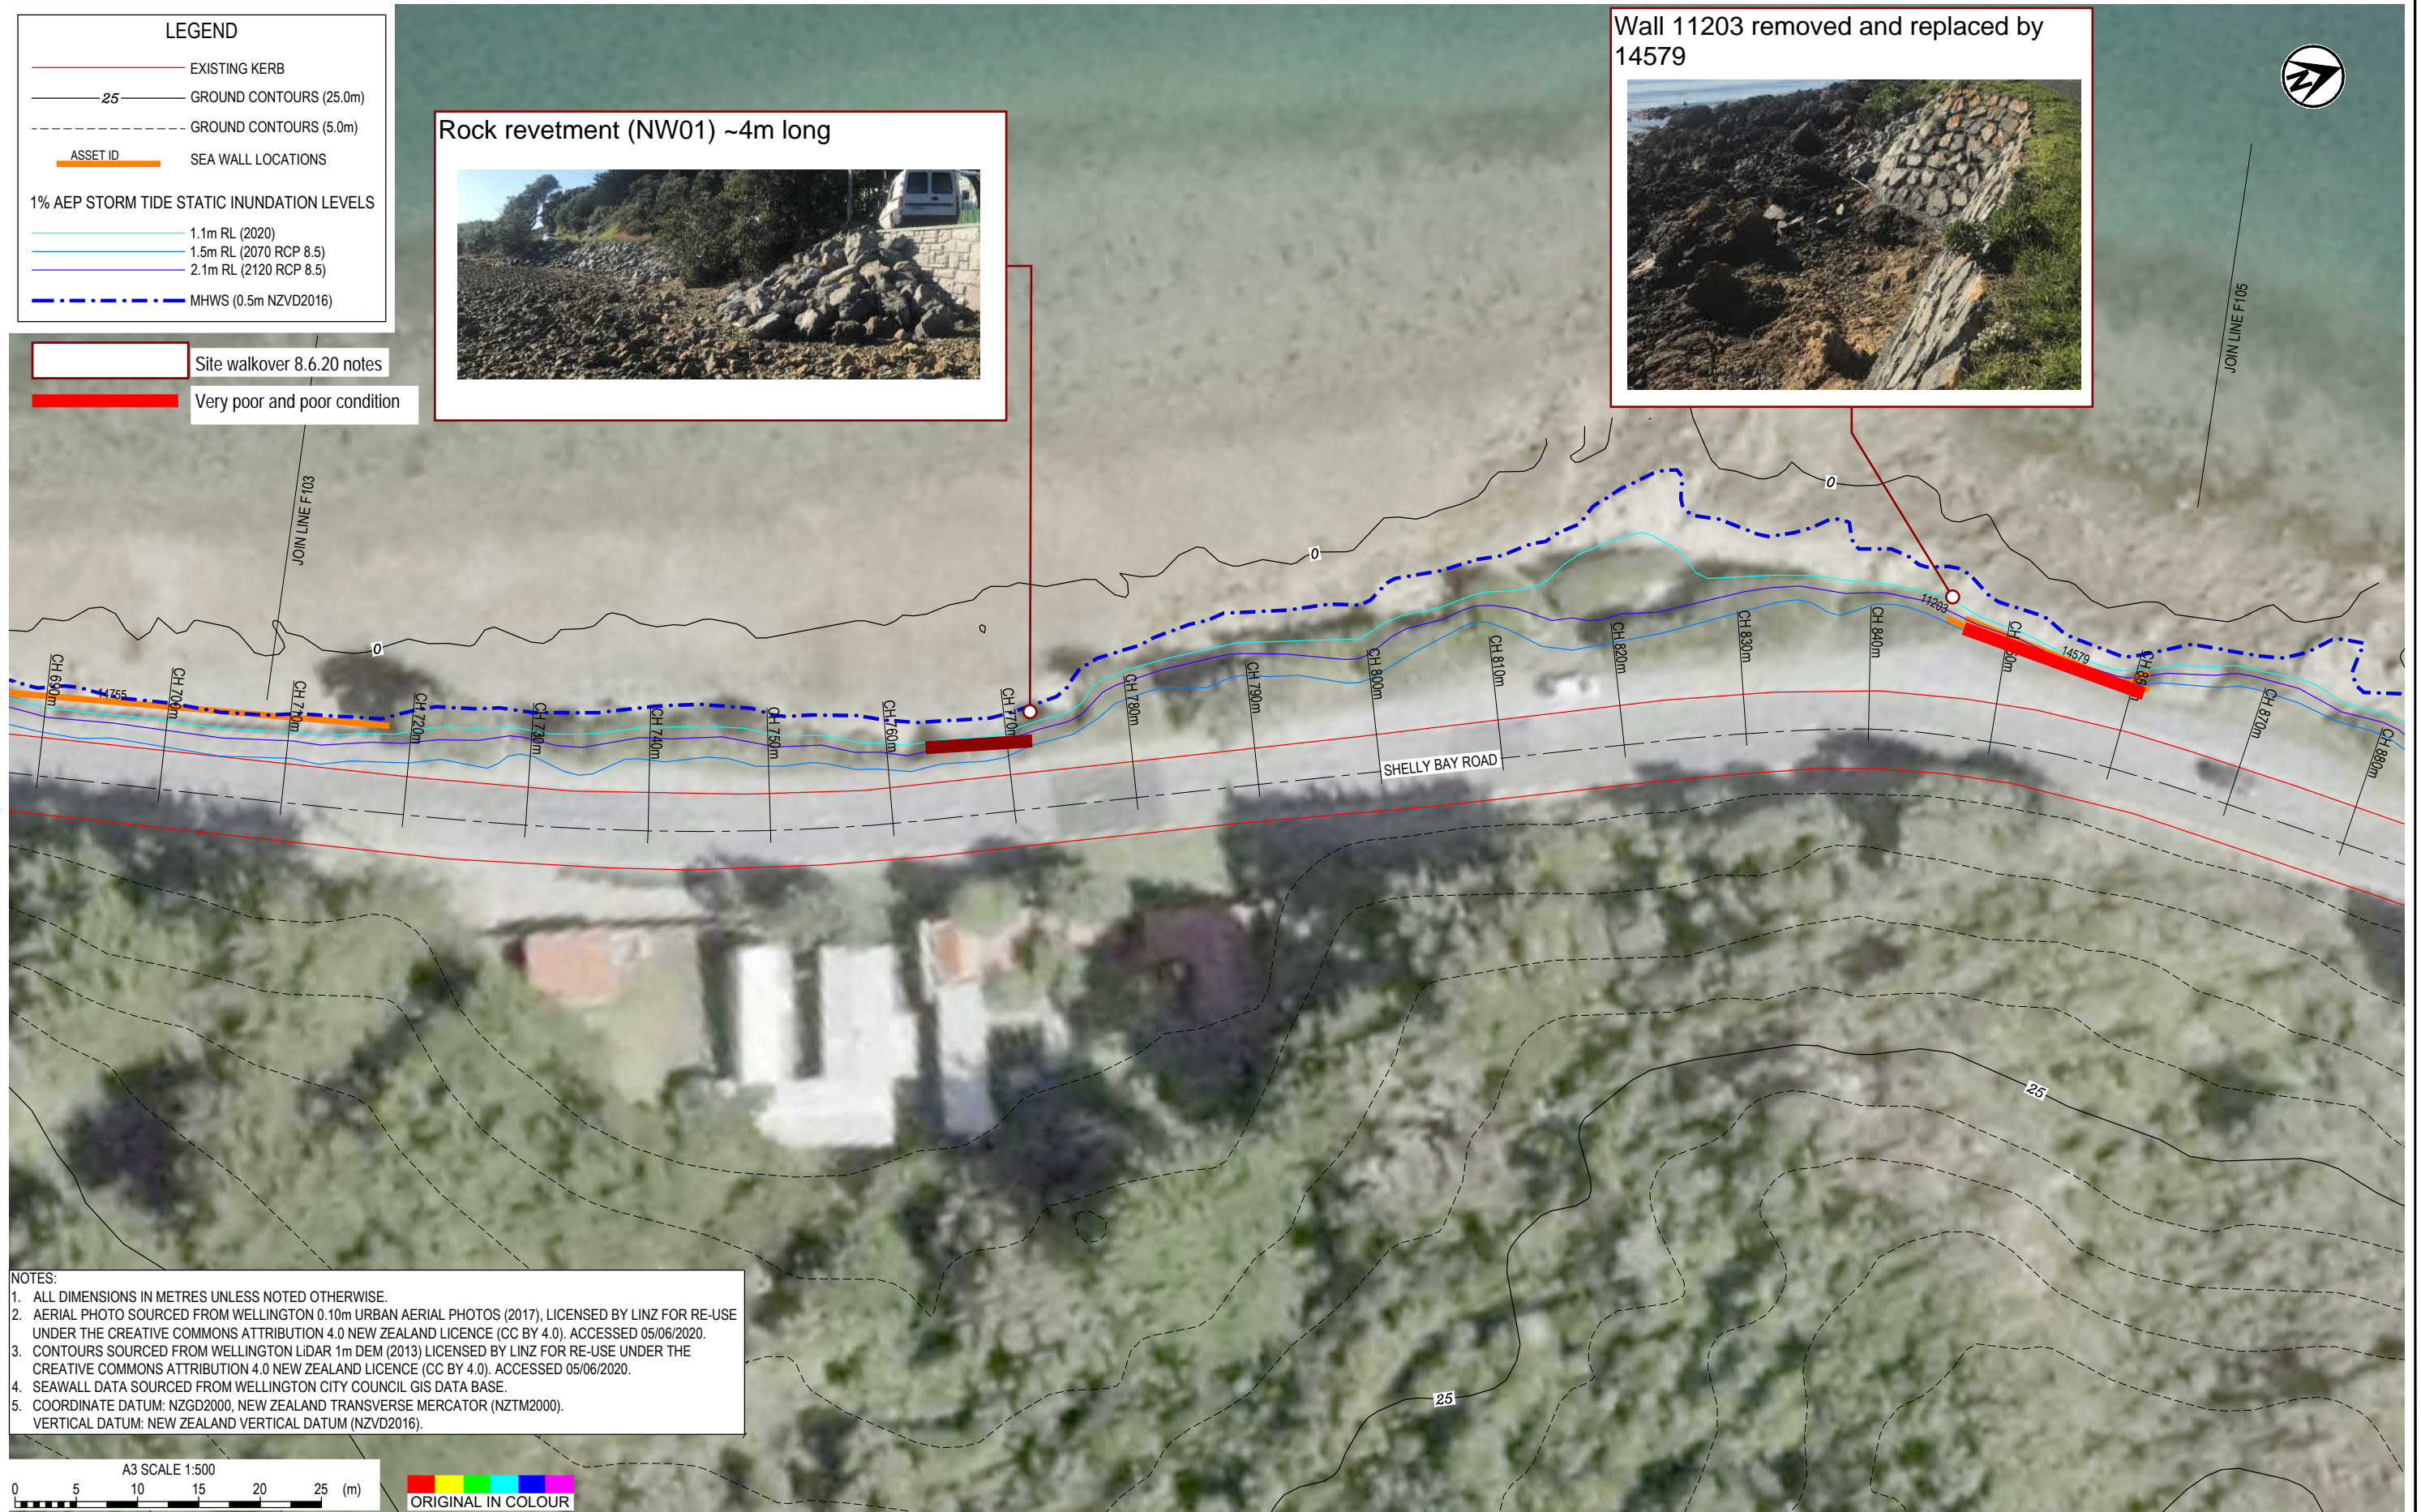
CLIENT	WELLINGTON CITY COUNCIL
PROJECT	SHELLY BAY ROAD, MAUPUIA
TITLE	COASTAL ASSESSMENT SITE PLAN - SHEET 4 OF 13
SCALE (A3)	1:500
FIG No.	1014113-F103
REV	1

**Wall 11203 removed and replaced by 14579**

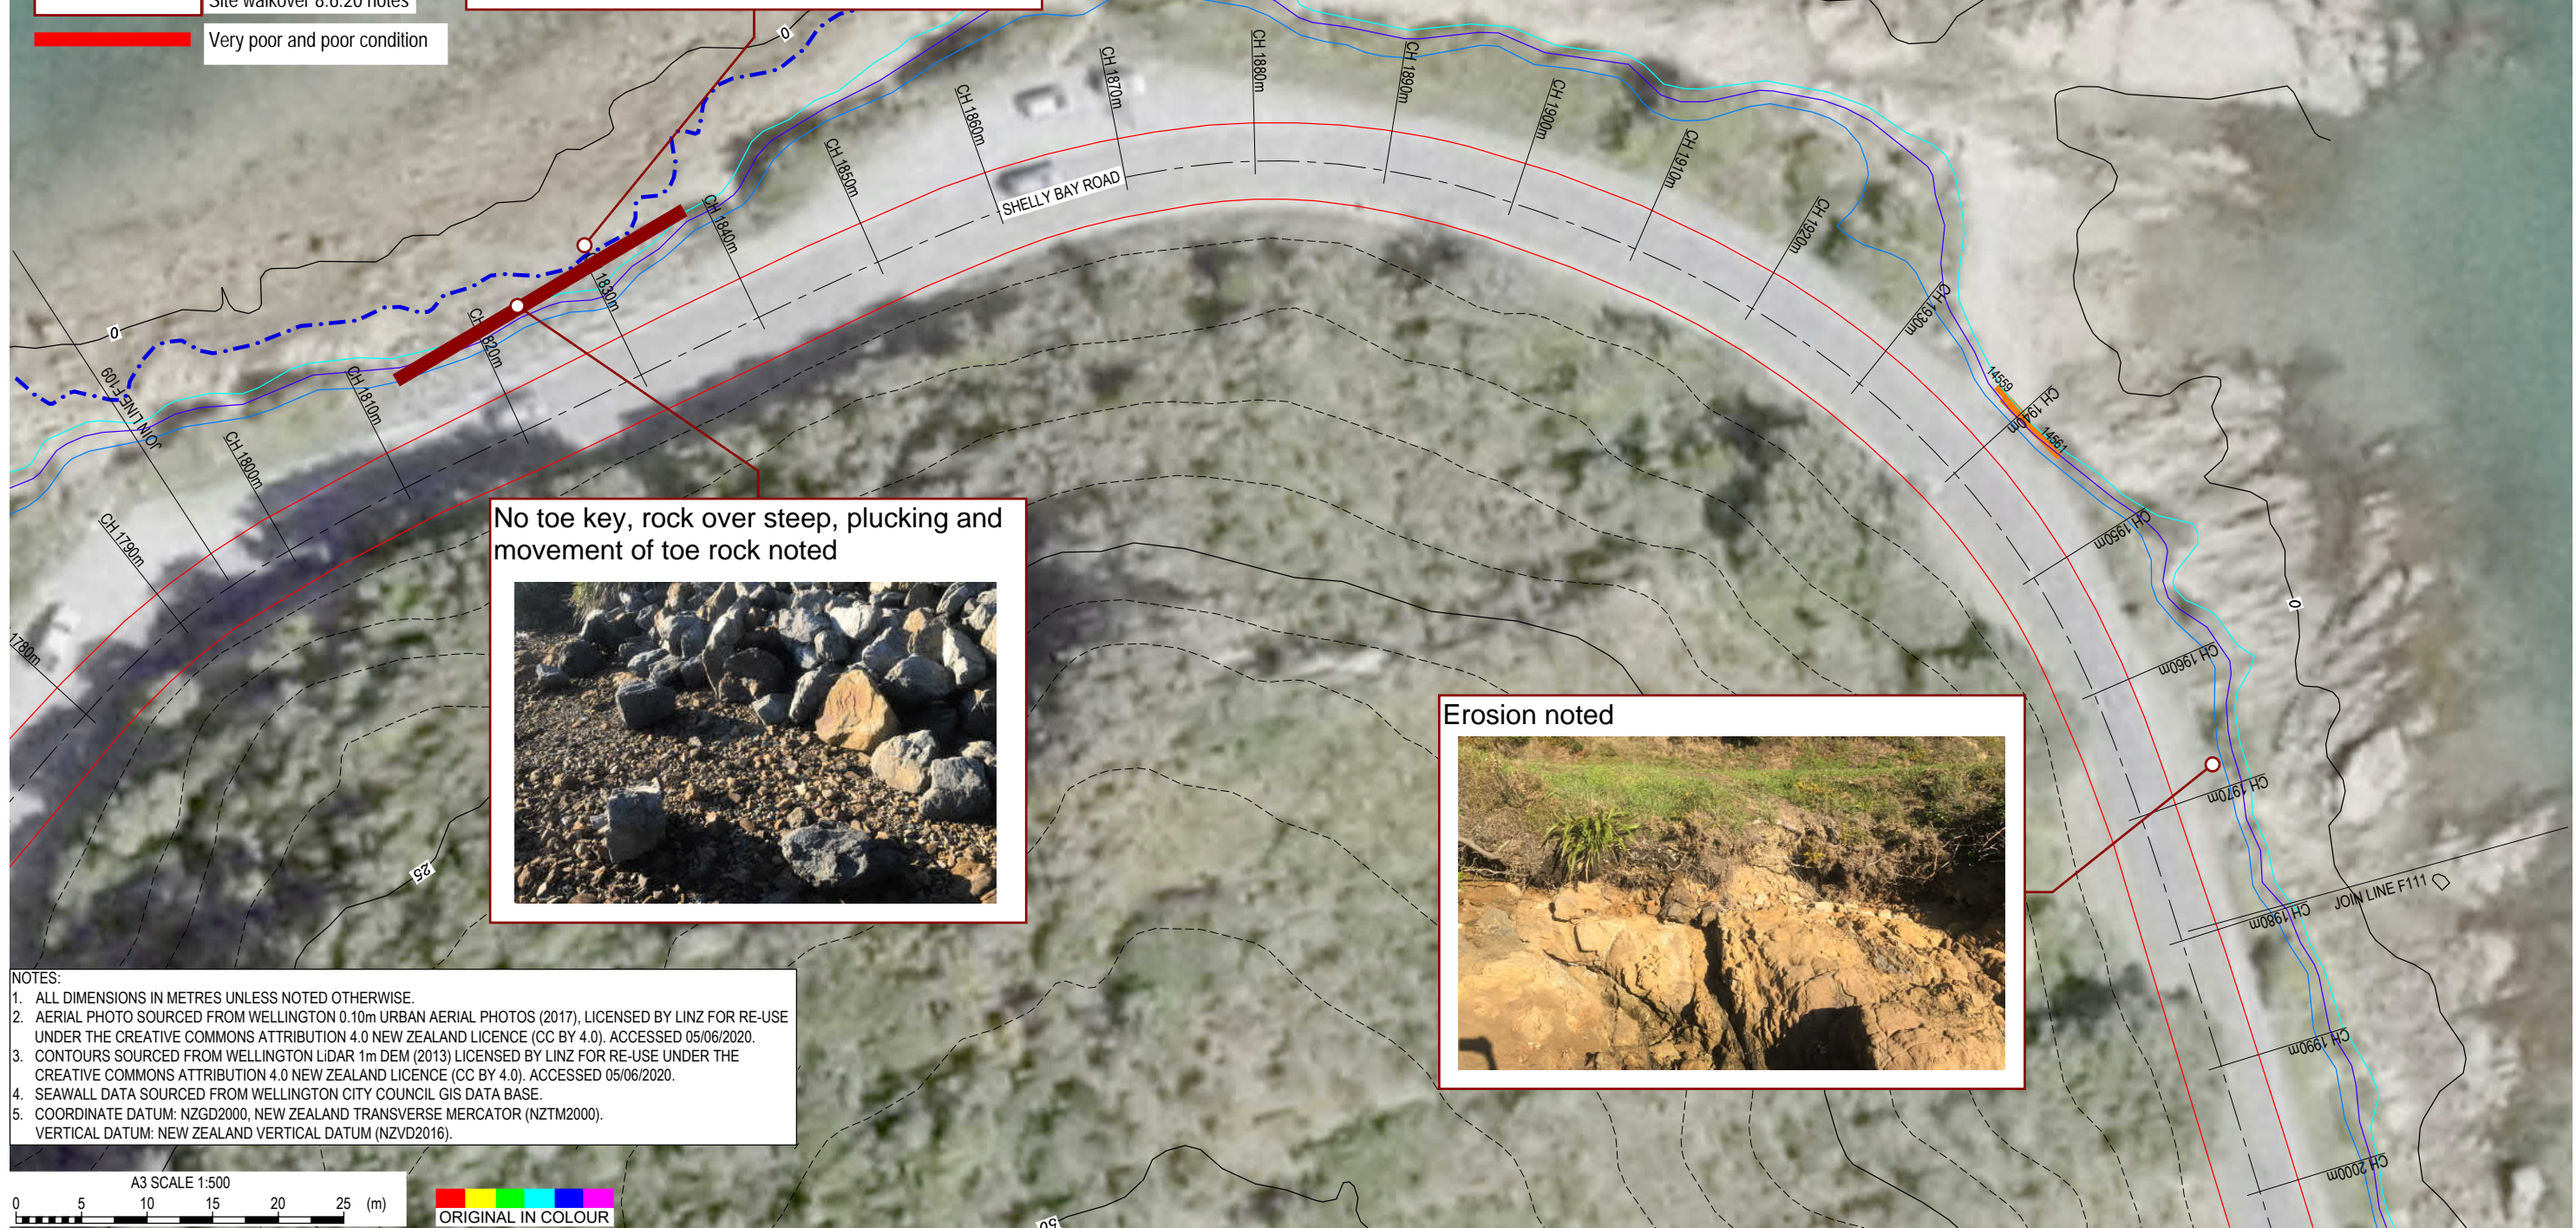
No toe key, rock over steep, plucking and movement of toe rock noted

Erosion noted
