Modified Bank Erosion Hazard Index (BEHI) Protocol

1.0 Introduction

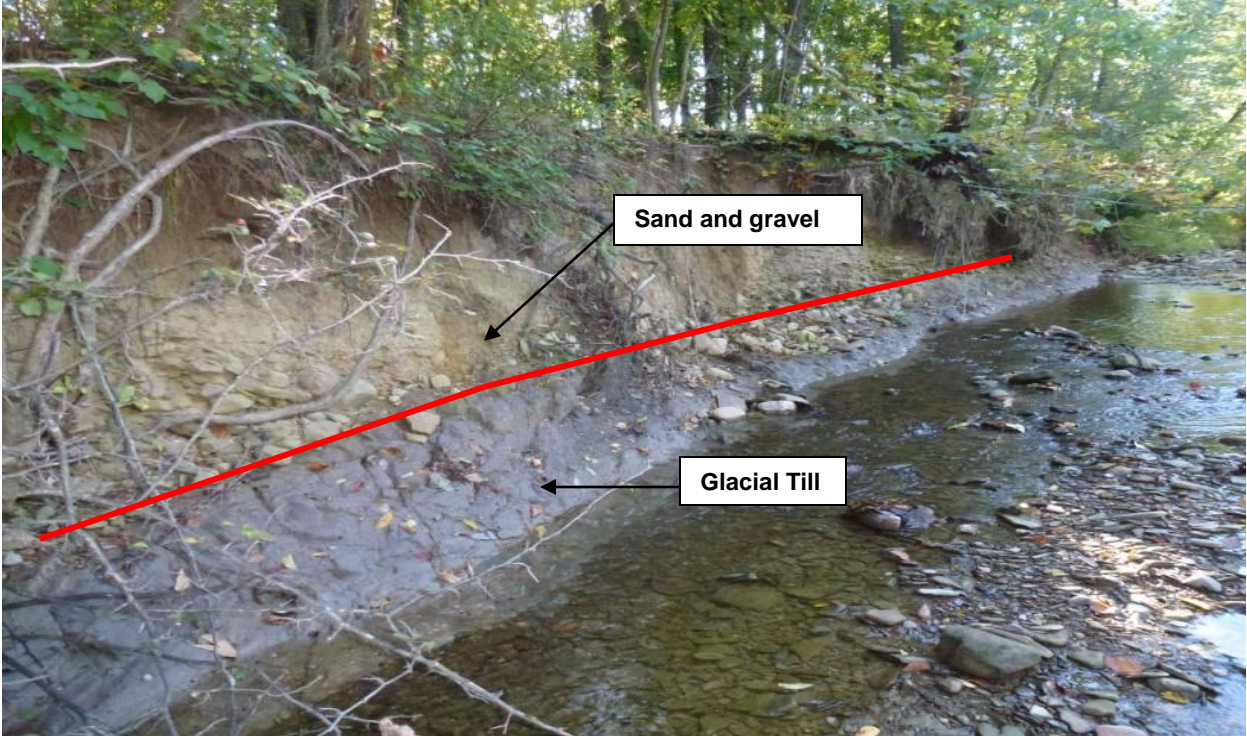
Figure 1: A clearly defined layer of stratification with glacial till at the toe and sand/gravel layer above.

Stratification adjustments, described in detail below, are made to account for zones of preferential erosion that occur within banks that have more than one strata. An example of a stratified bank can be seen in **FIGURE 1**.

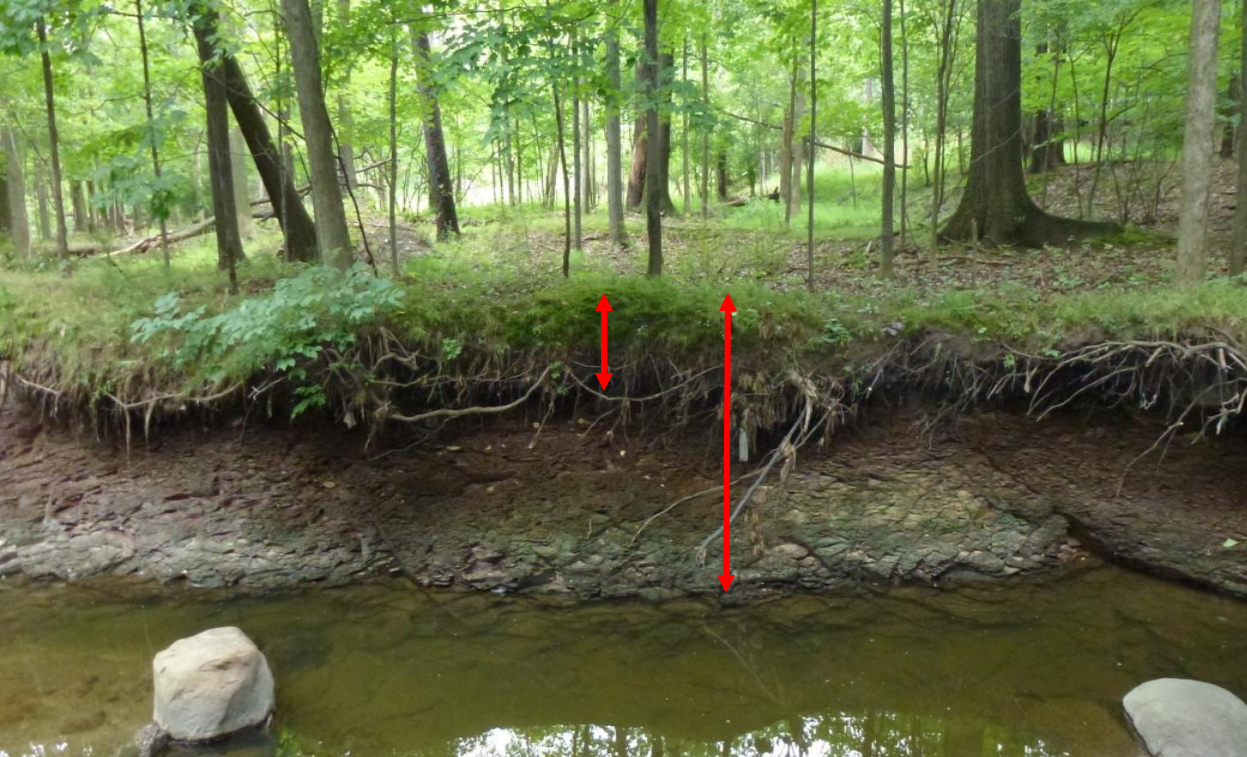
Figure 2: Root depth to bank height comparison. The roots do not extend into the shale layer beneath the top soil.

Visually estimate the root growth depth vertically from top to bottom. For example, if roots are growing in the top half of the bank, the root depth would be 50%. If there are roots growing from the top of the bank to the toe, the root depth would be 100%. Take an average percentage of the root depth along the entire section under evaluation. See **FIGURE 2** for a root depth to bank height comparison.

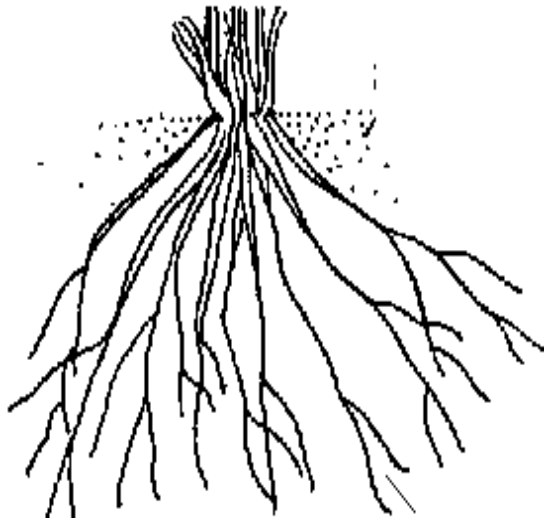
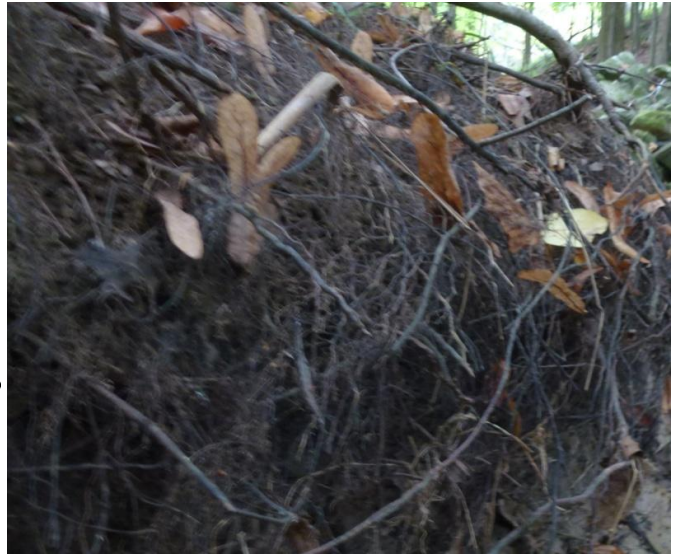
Figure 3: A fibrous root system.

A visual assessment of the amount of bank composed of root material, expressed as a percentage (i.e. density of roots within the bank). Do not consider roots that are void of bank material. Small, fibrous roots can be very dense and provide greater soil retention compared to large, tap root systems. See **FIGURES 3 and 4** for a fibrous root and tap root comparison.

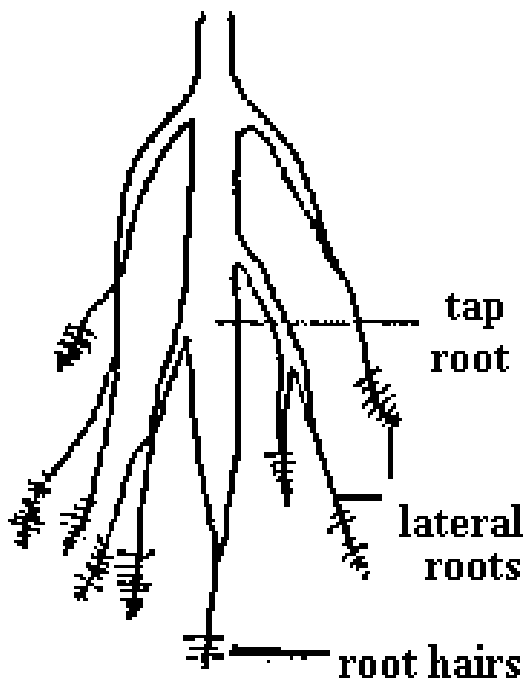
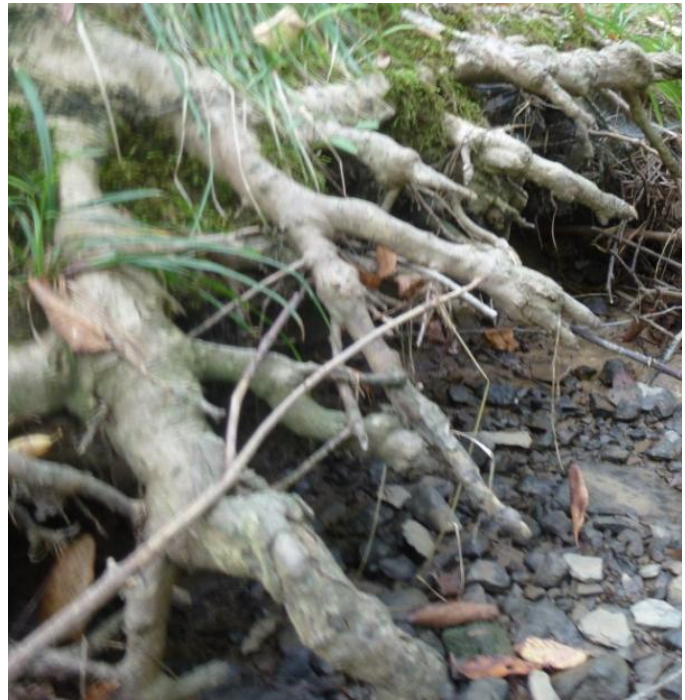
Figure 4: A tap root system.

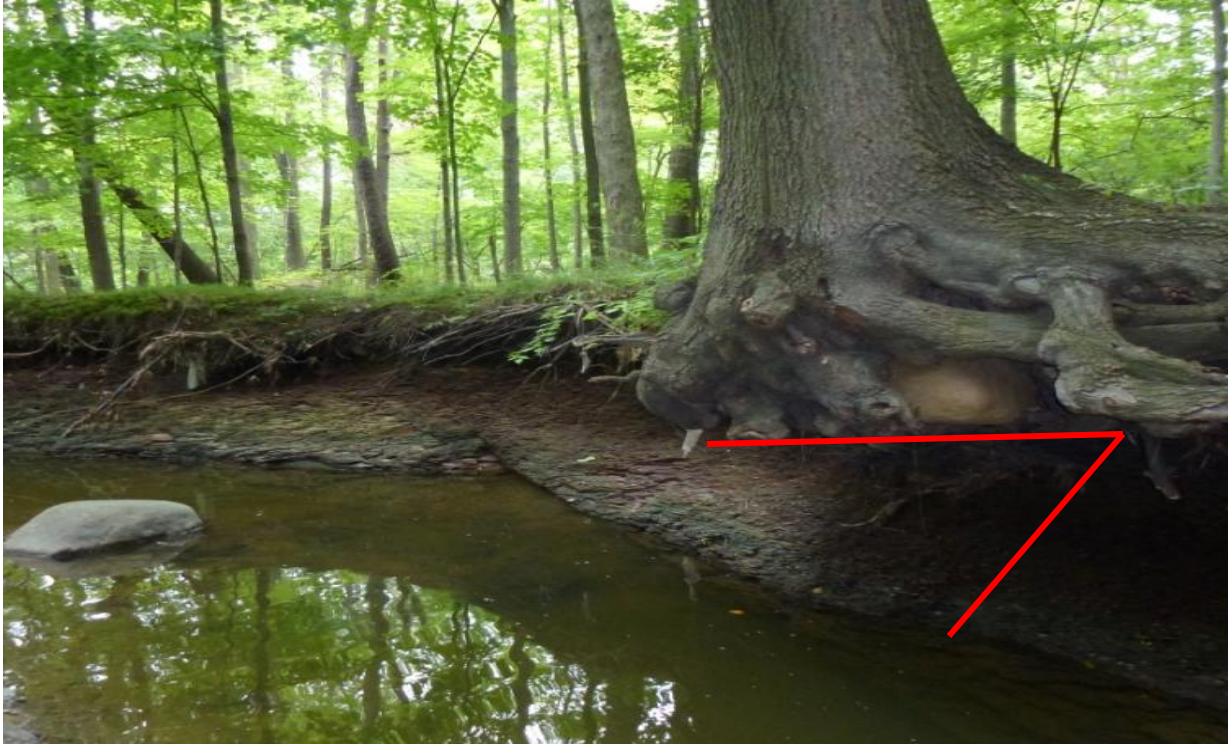
Figure 5: A bank with an extreme undercut.

An extremely undercut bank can have an angle up to 120 degrees. It helps to place a measuring stick at a 90 degree angle to the water in order to estimate angles. Take an average of the bank angle along the entire section under evaluation. For example, if the section is mostly 90 degrees with a small section that has 120 degree undercut, the recorded degree would be approximately 100 degrees. An example of an undercut bank can be seen in **FIGURE 5**.

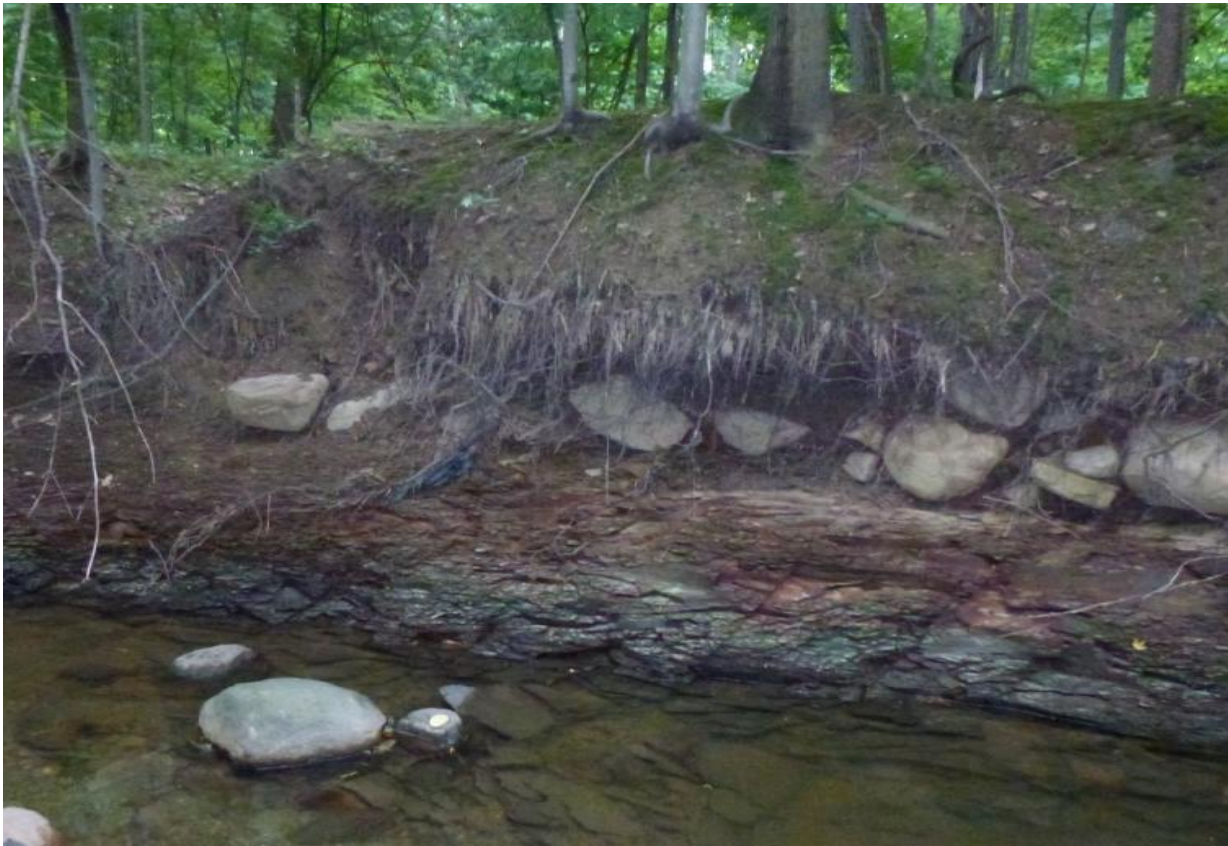
Figure 6: Boulders embedded in the stream bank, acting as surface protection.

Surface protection is the amount of stream bank covered and protected by woody debris, rooted vegetation, embedded boulders, revetment, bedrock, etc. This is measured as the percentage of streambank not exposed to erosive forces (i.e. the percentage of bank that is protected from the toe to the top of the bank). **FIGURE 6** shows a bank with embedded boulders acting as surface protection.
