Office of Oversight Environment, Safety and Health

Phase II Independent Investigation of the

Paducah Gaseous Diffusion Plant

Environment, Safety, and Health Practices 1952-1990

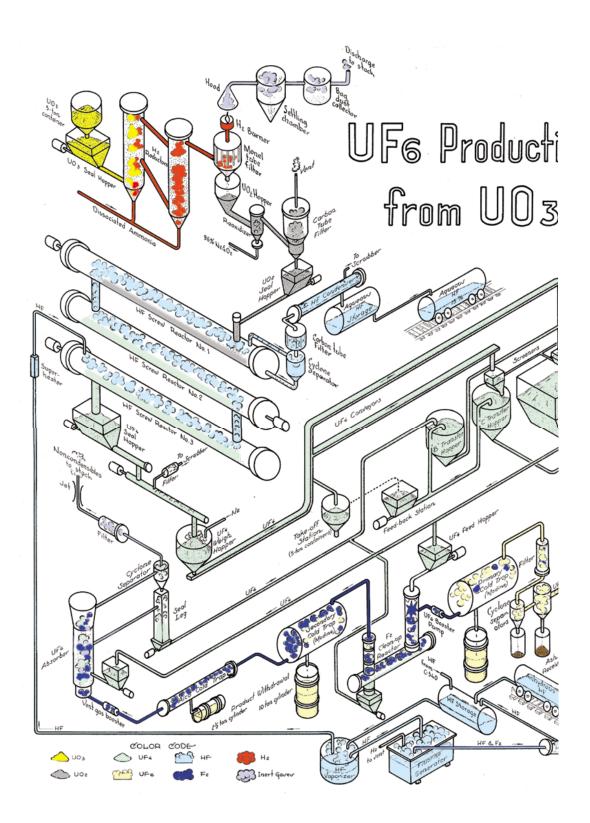
CHEMICAL REACTIONS FOR CONVERSION OF URANIUM TRIOXIDE TO URANIUM HEXAFLUORIDE

- UO₃ (yellowcake) + H₂ (gas) \rightarrow UO₂ (black powder) + H₂O (steam) (1050°F)
- $UO_2 + 4HF (gas) \longrightarrow UF_4 (green salt) + 2H_2O (steam) (500 1200°F)$
- $UF_4 + F_2(gas) \longrightarrow UF_6(gas)$ (2000°F)

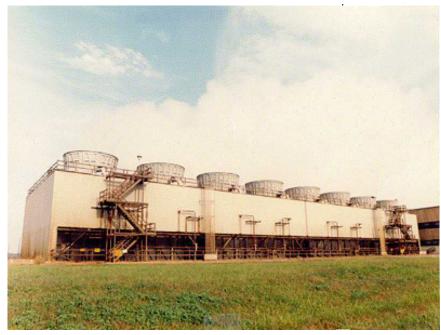
Cooling Towers

As originally practiced, fungicide spraying involved operators climbing within the cooling tower structure with ladders, work platforms, safety ropes and guidelines, and finding perches on cooling tower structural members to stand on while directing the spray. The workers wore protective clothing and breathing apparatus. This difficult task was made more hazardous by the risk of slipping and falling. At least one worker fell within the confines of the cooling tower during repair operations. In the early 1980s, a modified in-place fungicide treatment process was developed that did not require any climbing within the cooling tower, thereby significantly improving safety and reducing the difficulty of the job.
