# The Excavation of the *Machault*

## An 18th-Century French Frigate

Walter  
Zacharchuk  
and  
Peter  
J.A.  
Waddell

**National Historic Parks and Sites Branch  
Parks Canada  
Environment Canada  
1984**

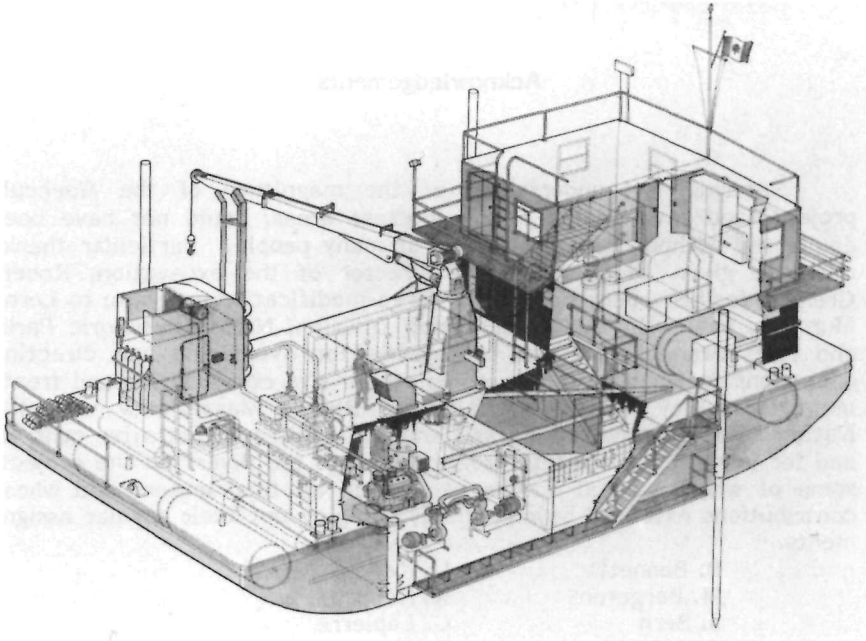
1 A steel dump scow, built in 1946, was modified for use as the excavation's main support craft. Below deck was located all of the machinery necessary for underwater excavation, such as two diesel electric generators and high- and low-pressure air compressors. The bow and stern served as storage areas for equipment, diesel-fuel tanks and compressed-air receivers. Above deck was a two-storey deckhouse in which were located office space, a galley and a head and showers. The pedestal crane, centrally located on the main deck and having an 85-foot-maximum reach, was one of the most important labour-saving devices used. The barge was held in place by four "spuds" that permitted vertical movement but arrested lateral motion during the ebb and flow of the tides.

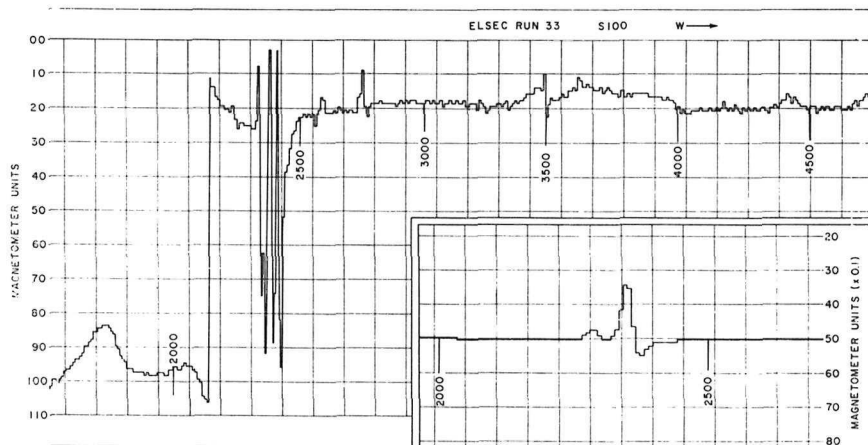
5 Facsimile of a portion of an Elsec magnetometer strip chart from the survey. The larger-scale inset is from the chart of a subsequent run on the same grid line. The anomaly of about 800 gamma at W2350 was caused by the remains of the *Machault*. (Compiled and drawn by A.E. Wilson.)

behind it the detector bottle mounted on a brass-fitted wooden toboggan. The estuary was surveyed with theodolite and a chain, and a grid was established over an area of the channel 1000 ft. wide and 10 000 ft. long. The grid was laid out on the ice with wooden pickets in 100-ft.-by-500-ft. rectangles, and magnetometer readings were taken at 25-ft. intervals running the length of the grid (Wilson 1970). A number of obvious anomalies were charted and 13 were selected for underwater investigation in May 1969. Of these 13, four were labelled because of their magnetic importance. 1M proved to be the *Bienfaisant*; 2M was tentatively identified as the *Machault* (Fig. 5); 3M was an anchor, which was raised; and 4M was determined to be a jettison site from the period of the battle, possibly the result of a ship's running aground or attempting to reduce its draught for further penetration up the Restigouche channel. Several other anomalies were briefly investigated before attention was concentrated on 2M, which seemed to be the largest and least disturbed of the wrecks. Historical maps and the process of elimination indicated that this should be the *Machault*, flagship of the convoy. The timbers that could be seen indicated that large portions of the ship were deeply buried in the deepest part of the channel, thus protecting what remained of the cargo and promising to yield valuable information on marine architecture in the mid-18th century. The site was selected for extensive excavation and four seasons of work were projected. The first three years were to concentrate on the excavation of artifacts from the wreck and the fourth on raising portions of the ship's structure.

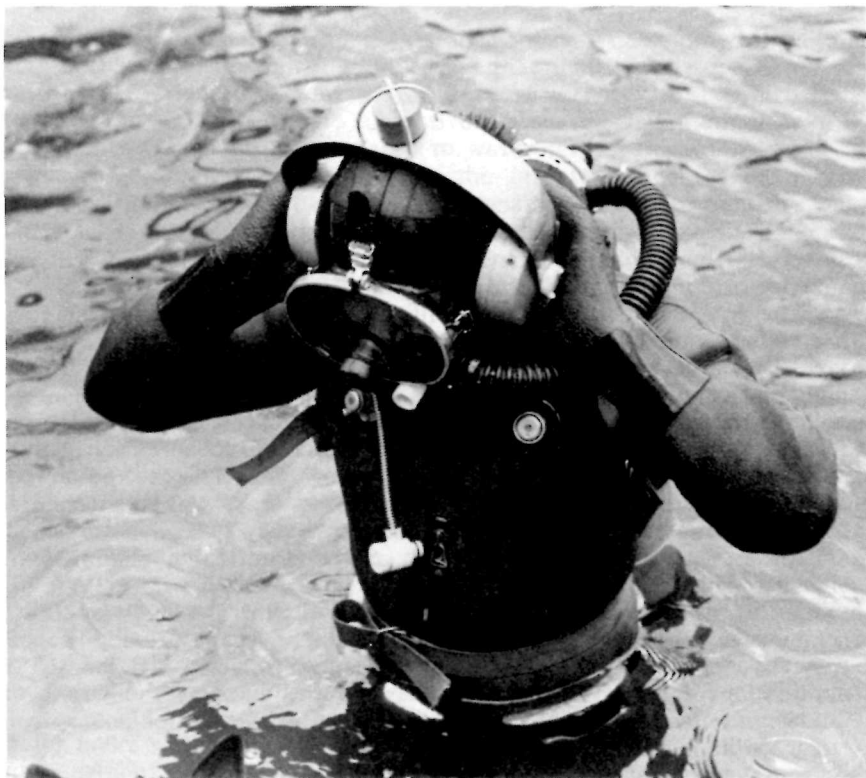
8 Variable-volume diving suits were introduced to the Restigouche excavations in 1971. Communication equipment was introduced in 1972.

The summer of 1971 saw the introduction of European variable-volume one-piece dry suits (Fig. 8) to the project. The inflatable neoprene suit had watertight zippers and seals at the wrists and neck. The nylon-fleece underwear worn with the dry suit proved to be effective in reducing chilling, thereby increasing diving time and working efficiency. This condition persisted as long as the watertight seals could be maintained. Project divers soon learned that a truly "dry" suit is nonexistent.

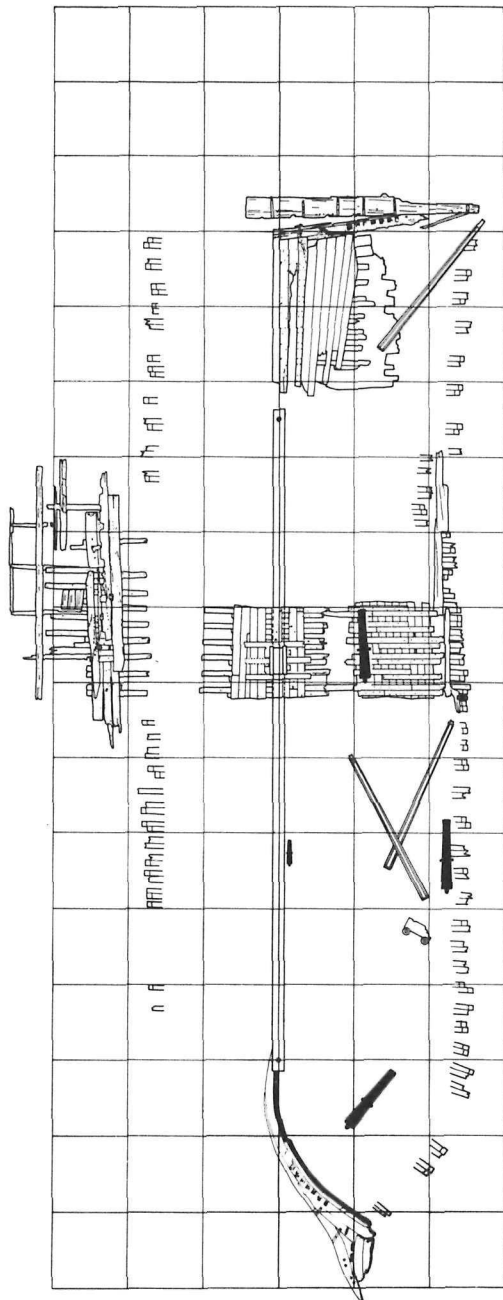
9 As-found illustration of the *Machault* based on underwater drawings and drawings of selected raised structural elements.

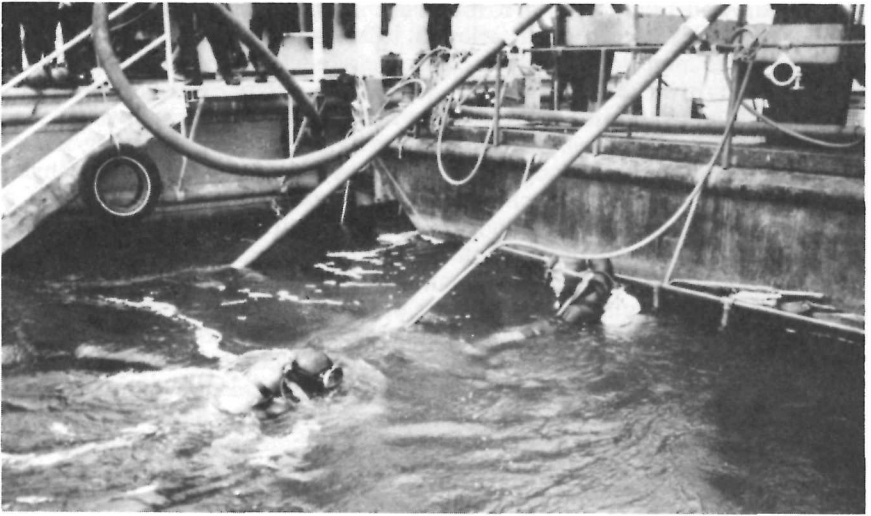
10 Airlifts were utilized as a means of transit to and from the excavation points.

A significant but often overlooked advantage of the airlifts was that they could be utilized as a means of quick, convenient access to the areas being worked. In effect they were not unlike tethered life lines. They saved considerable time as it was not unusual for a diver without an airlift to orient him to spend 15 to 20 minutes locating his assigned lot by touch. The airlift provided a guide through the darkness as well as a convenient ladder for the divers' many trips to the surface during a shift for discussion and artifact transport (Fig. 10). They also prevented a descending or ascending diver from being carried away by the current during peak tide movement. As well, prior to the use of underwater communication systems in 1972, the airlifts were used to signal divers: surface crew would shut off the air supply and use a simple knocking code on the pipe to communicate with the divers.

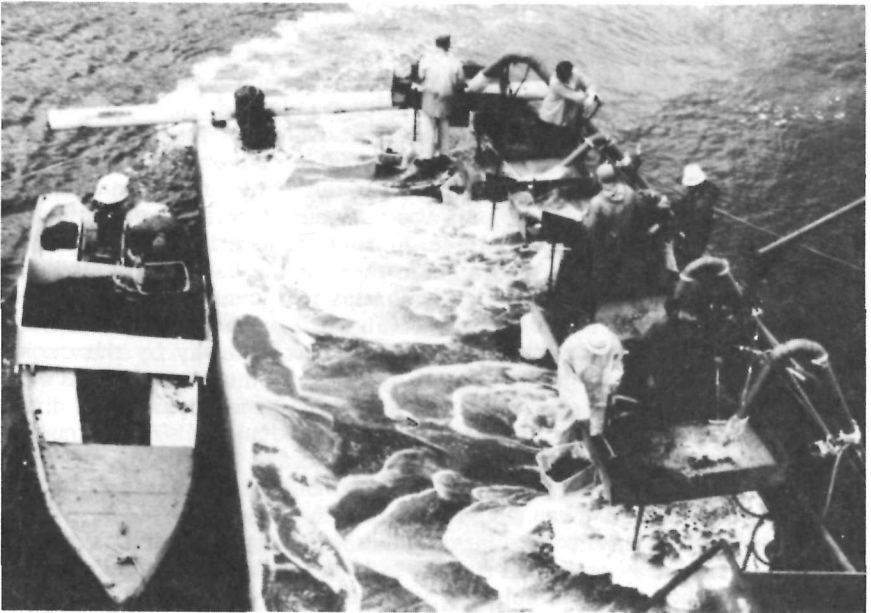
11 Airlifts discharging onto the sorting screens on an auxiliary barge. The boat-mounted hopper is alongside the barge.

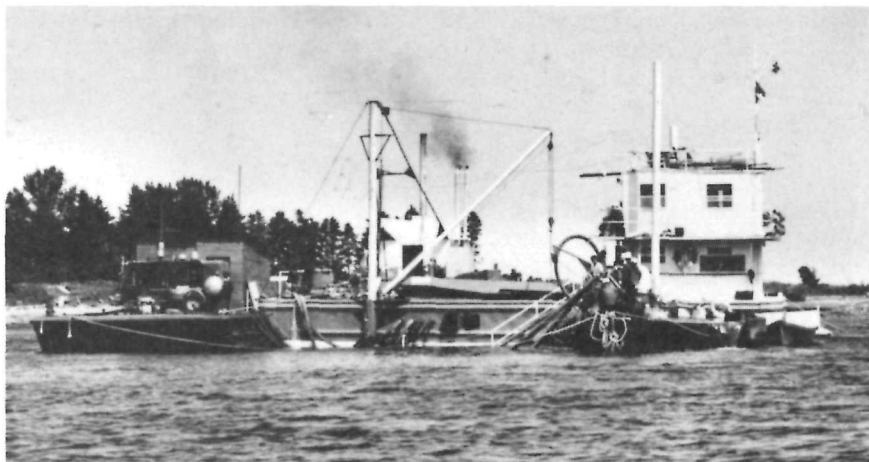
12 Auxiliary airlift and compressor barges moored alongside the main support vessel.

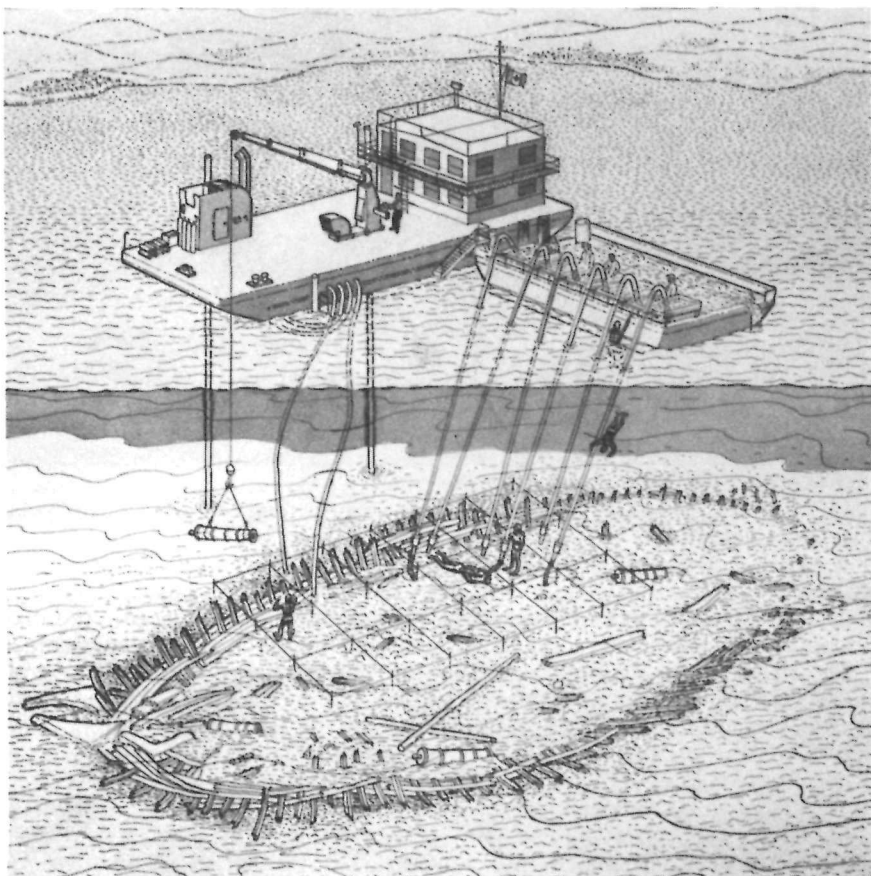
13 The final excavation set-up employed for the *Machault*.

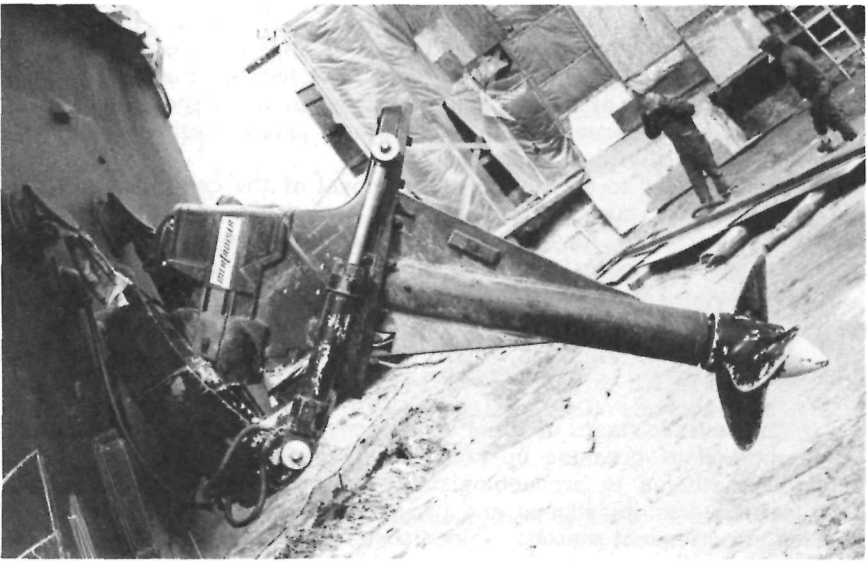
14 The modified foot of the downthrustrer.

The "downthrustrer" or "blower" (basically a propeller-driven vertical water thruster) was used primarily to investigate the boundaries of the site as well as to clear previously excavated areas that had silted in. This tool went through several evolutionary stages at Restigouche. The final version was a converted landing barge which had a 235-horsepower inboard engine with a modified foot (Fig. 14). The foot modification placed the propeller in a horizontal orientation that propelled a column of water downward. In operation, a 20-foot, 3/4-inch-diameter pipe attached to the barge close to the downthrusting unit was manoeuvred into position over the work area. The diver would then surface and signal to have the marker pipe raised and the downthrusting started. The diver remained on the surface while the downthrustrer operated, from a few minutes up to half an hour, depending on the type and amount of overburden, the depth of the water and the current. After it was shut down, the diver waited a few minutes for the disturbed sediment to clear, if any visibility was present, before descending to examine the extent of the clearing. A check was made for structural remains and artifacts, the downthrustrer was repositioned, and the operation was continued until the job was completed.

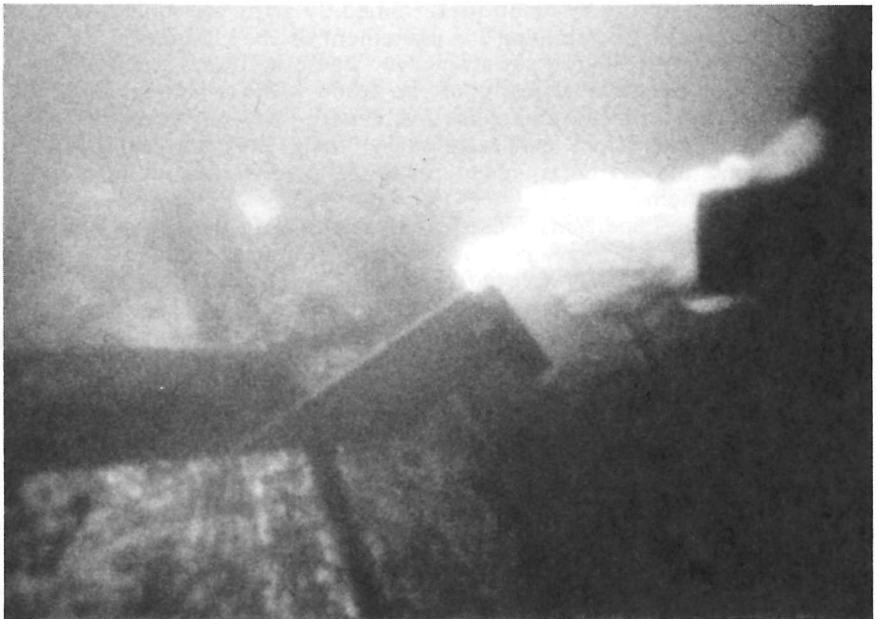
15 Cross-hull cut being made on ceiling planking.

During 1972 when work centred on raising sections of the *Ma-chault*, submersible hydraulic chain saws were employed to cut the predominately oak timbers (see Fig. 15). Reciprocating twin-blade pneumatic saws had been employed to cut intrusive logs on the site in previous years, but they were not successful in their application to continual underwater cutting of hardwood.

The majority of the cutting done consisted of cross-hull cuts made at right angles to the keelson (Fig. 15). Because of the double-skin construction, it was necessary to cut the ceiling planking the full width of the space between the frames (usually about nine inches) to get the chain saw between the frames to make the single cut required for the exterior hull planking (Fig. 15). Further, concretions, artifacts, sediment and debris had to be removed from between the inner and outer planking in order to reach the outer hull and this could only be done by removing the short length of inner planking between the frames (Fig. 16).

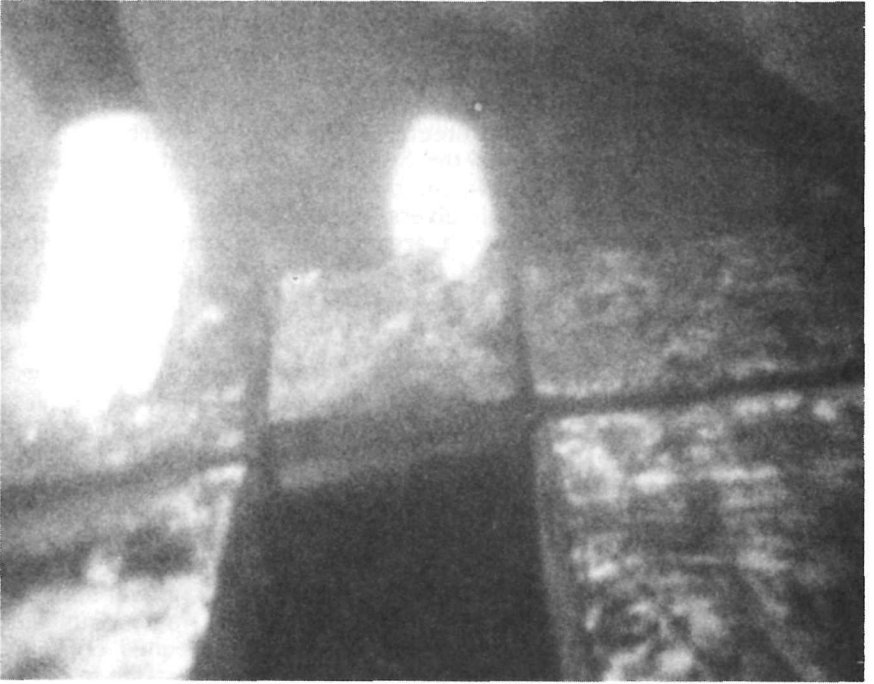
**16** Ceiling planking cut between frames to permit access to the exterior planking.

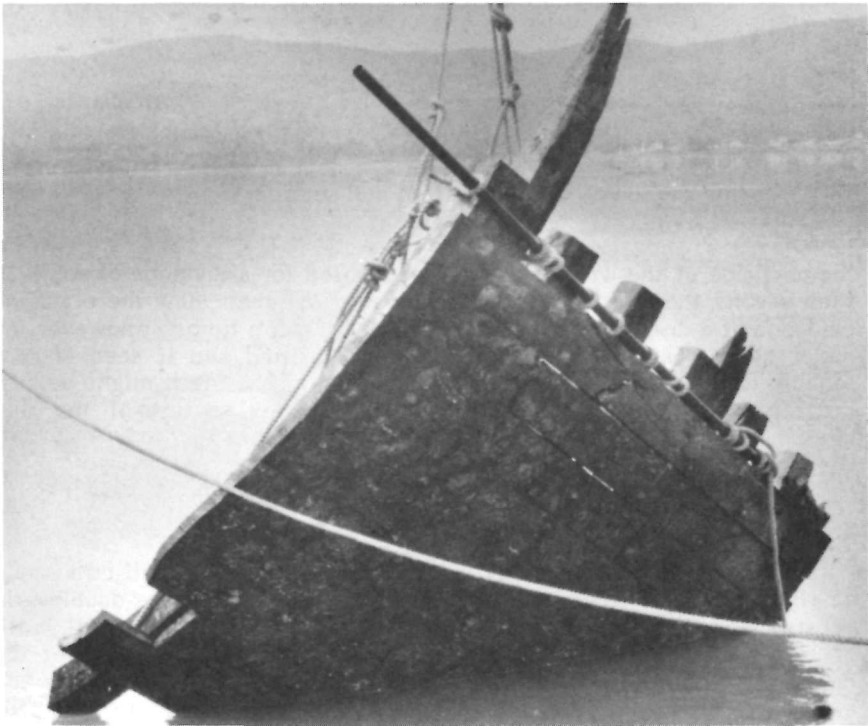
17 Raising the lower port hull portion of the midsection. Even though the iron pins, fittings and spikes had rusted away, the wooden trunnels still held and the structure was strong enough to be self-supporting.

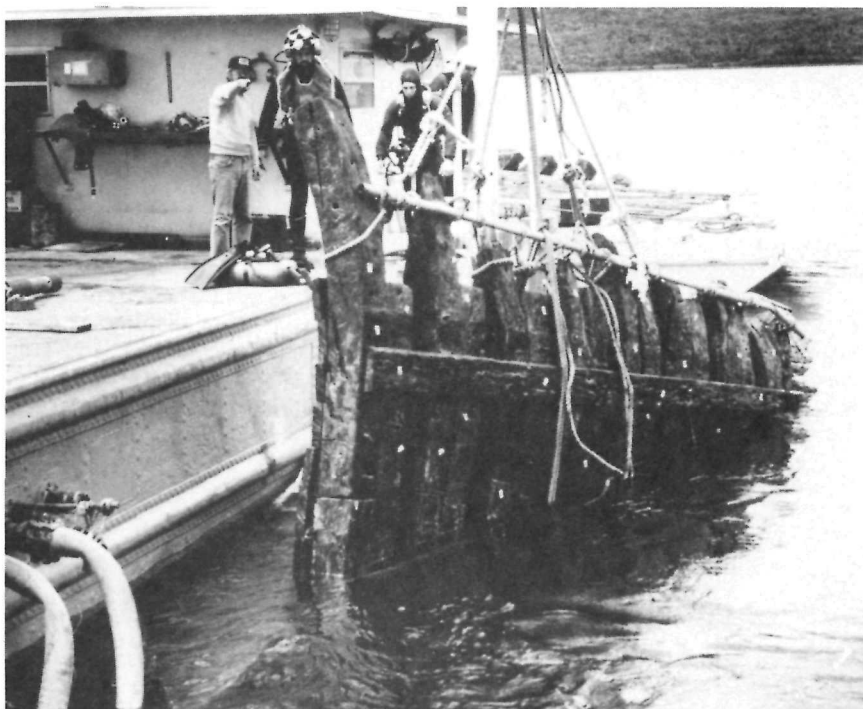
**18** Raising the lower starboard stern hull section.

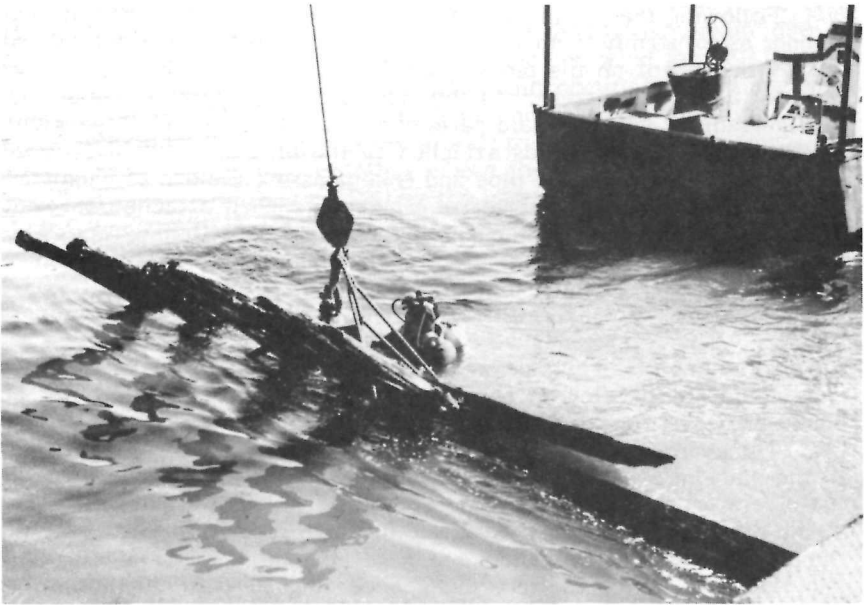
**19** Monitoring the initial lift of the starboard railing section; the downthruster is in the background.

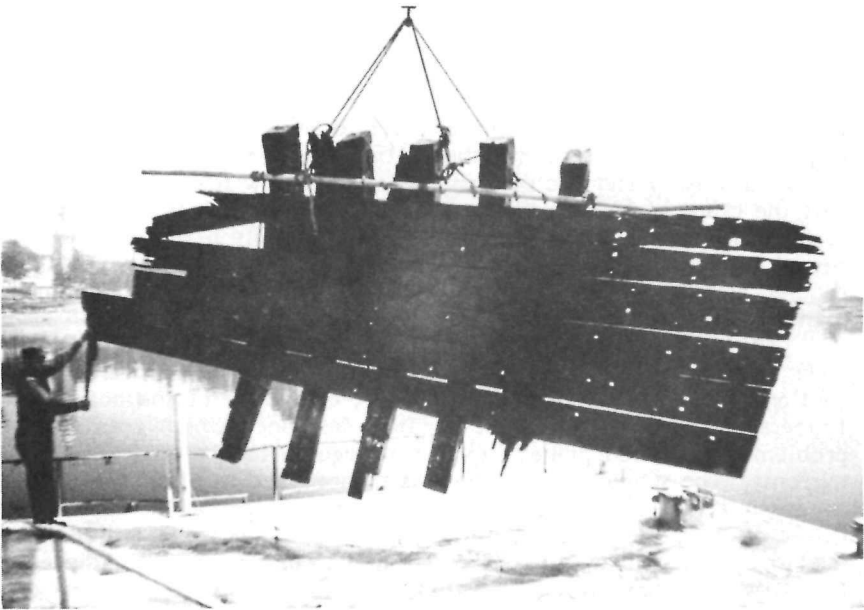
**20** The secondary support barge being manoeuvred under the port stern section.

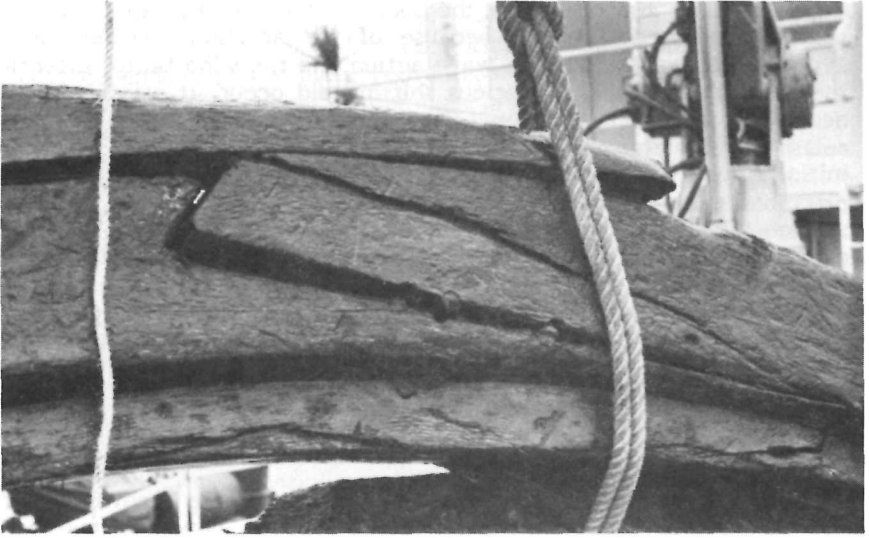
21 The stem-head section being raised.

loss of some of the remaining components of the upper bow structural unit. The section was lifted (Fig. 21) with all the components that had been attached *in situ*. Two pieces of the extreme upper structure, the timber containing the bobstay holes and the timber immediately above the one bearing the gammoning holes, were also recovered. Both pieces, as well as the extreme upper limit of the sternpost, showed significant marine growth, indicating that for the most part they had protruded above silt level. Their exposure to currents and the degenerative effects of the water accounted for the accelerated breakdown of their pinnings. This is especially well illustrated in comparing the upper extremity of the stem-head section, which has lost all its sharp lines and shows extreme signs of erosion, with the sections immediately below, which, being below silt level, retain clean, sharp edges with the ferrous pinning still relatively intact (Fig. 21).

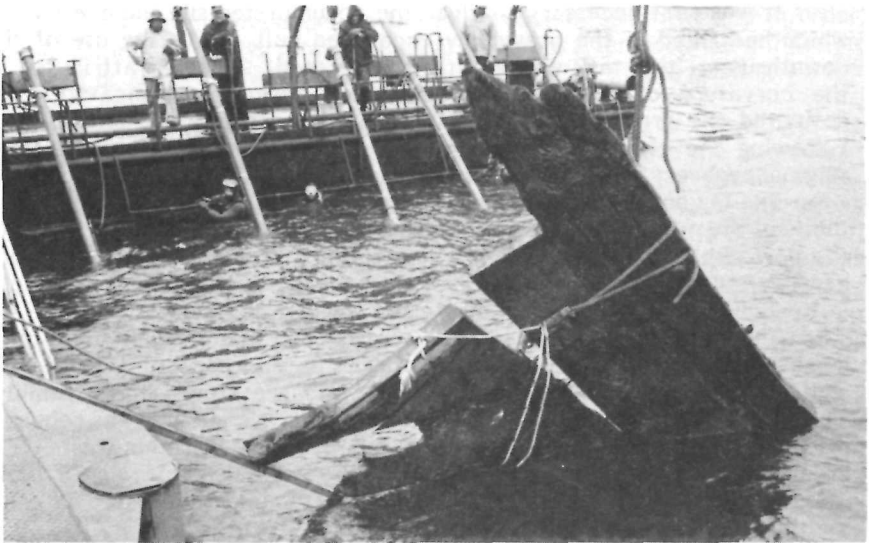
22 Rope sling around the stem-keel scarp of the stem-gripe assembly. Stopwaters in the scarp are still in place.

The lower bow section or stem-gripe assembly presented no particular difficulties. Its lower end was below the bow or south end of the keelson (see Fig. 9). Temporary ropes lifted the section clear enough of the bottom to permit the attachment of a rope sling at critical stress points, such as the lower stem-keel scarph (Fig. 22). The stem-gripe assembly was then moved northward, out from below the keelson, and up to the surface (Fig. 23). The entire lower cutwater section had been preserved several feet below silt level, consequently the structural integrity of the scarph joints was reasonably well maintained (Fig. 22) and this section was raised intact.

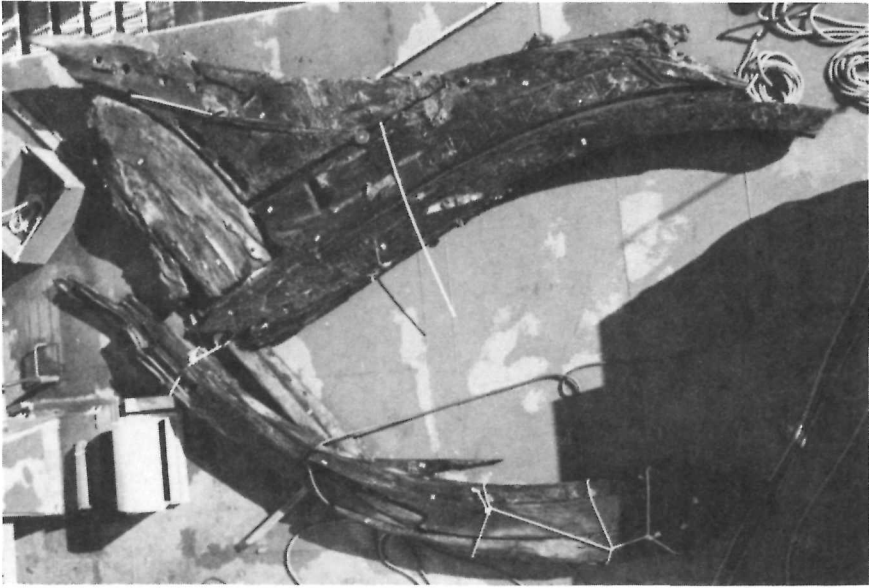
23 The stem-head and stem-gripe assemblies on the support barge.

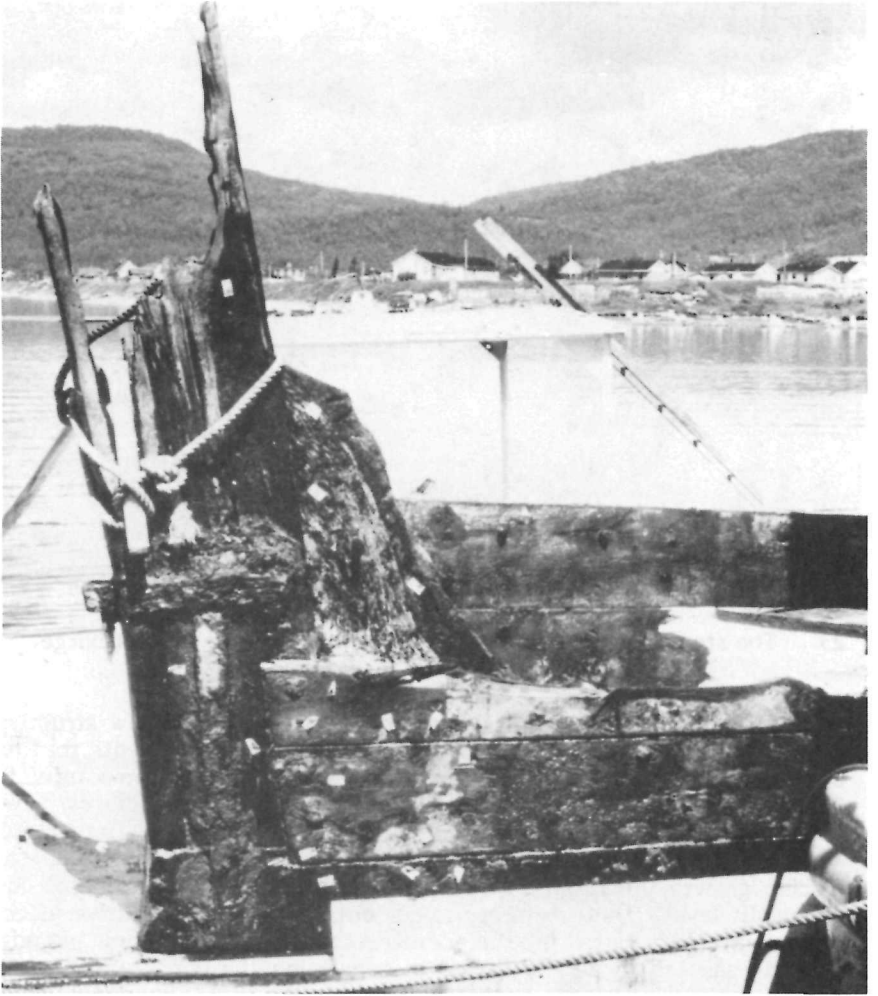
24 The heel of the *Machault*. The heel strap abutting the lowest gudgeon reinforced the mortise and tenon of the keel and sternpost.

The heel of the ship (Fig. 24), formed by the mortising of the sternpost into the keel and reinforced with a knee, had fallen approximately 60 degrees to port. The keel had borne the brunt of the fall; it had twisted and broken almost through at a point approximately 22 feet from the keel-sternpost intersection. This twisted area was under much fallen timber and it was decided to sever the keel aft of this point, giving a total cut-keel length of 20 feet. (See Figure 25 for a cross-section view of the stern keel cut.) The keel-sternpost section presented no great difficulties in either lashing it or raising it, and it was lifted intact (Fig. 24).

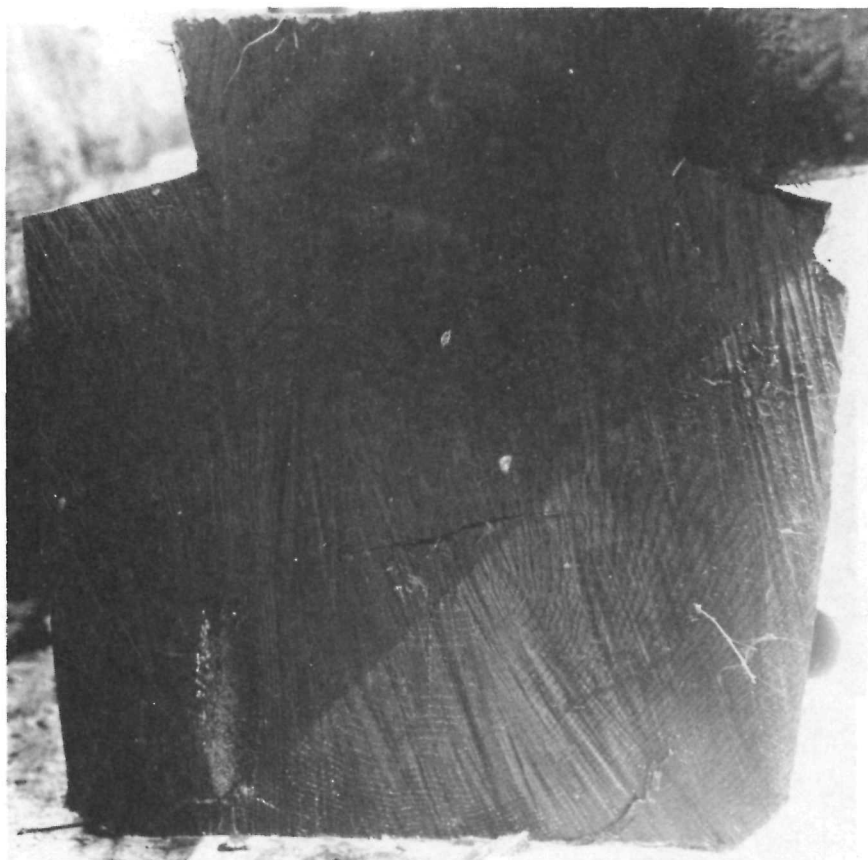
25 Cross-section of the stern keel cut. The keel is 14 inches in height. The orientation of the garboard rabbet is almost vertical.

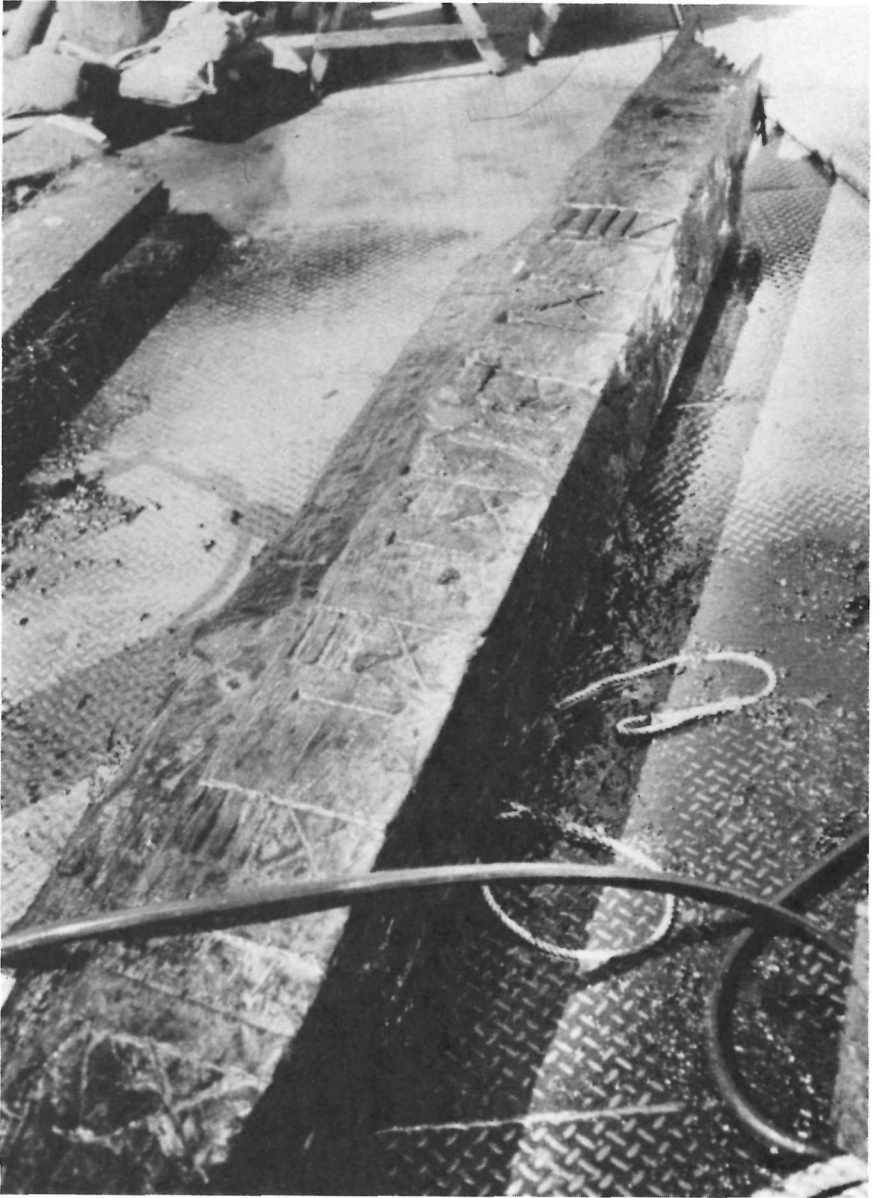
26 The upper end of the broken sternpost. The incised draught marks are similar to those on the stem.

Two major structural pieces had been recovered from the stern in 1971: the uppermost end of the broken sternpost showing the ship's draught in Roman numerals (Fig. 26) and the 31-foot-long rudder (Fig. 27). Figure 9 illustrates the locations from which the upper sternpost and rudder were originally recovered in 1971; both had been stored within the ship's hull through the winter of 1971-72.

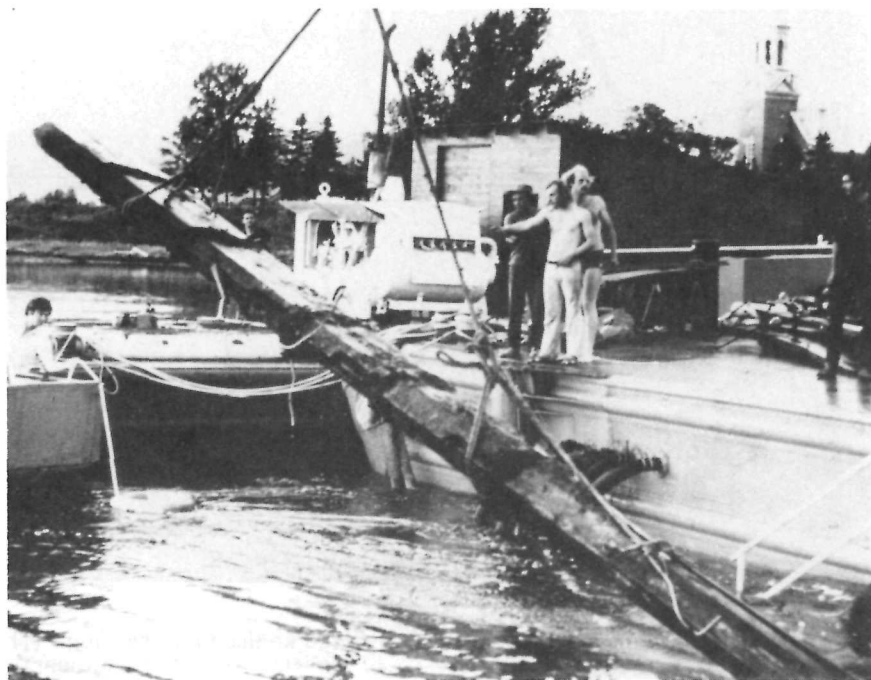
27 Raising the 31-foot-long rudder.

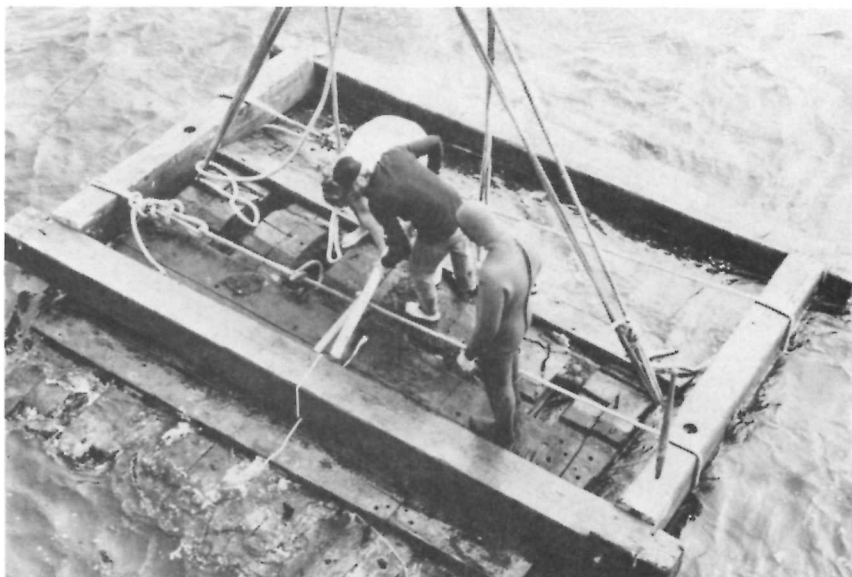
28 The cradle being secured to the inverted keelson hull section. (The keel has been removed.)

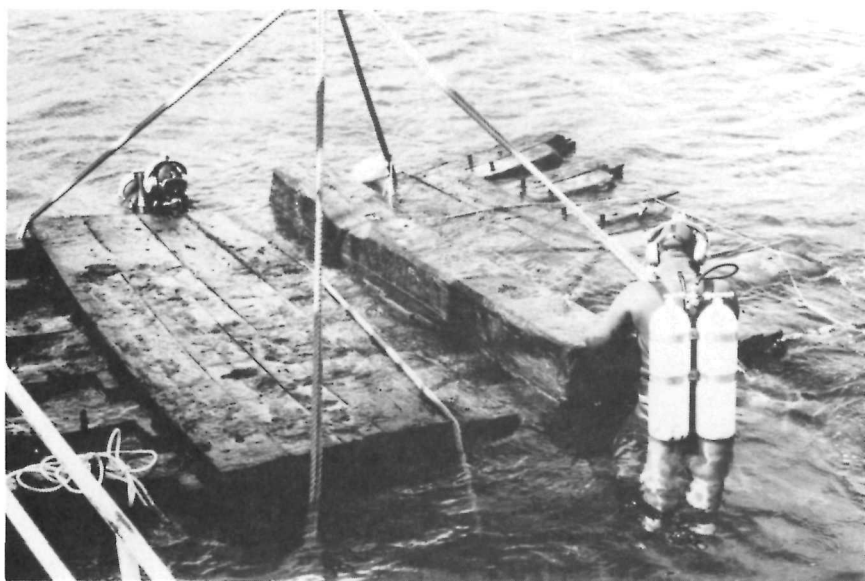
29 The keelson section of the hull with the cradle secured to its underside, ready for raising.

structurally complex. It would have to be towed underwater to larger crane facilities and a rigid cradle would have to support it when it was lifted clear of the water. The rigid cradle was the only reasonable solution to maintaining the structural integrity of the keelson section.
