Azusa River Wilderness Park

Azusa River Wilderness Park Project
Site Programming, Site Planning and
Overall Site Concept Development
for the El Encanto Property

Watershed Conservation Authority
October 22, 2007

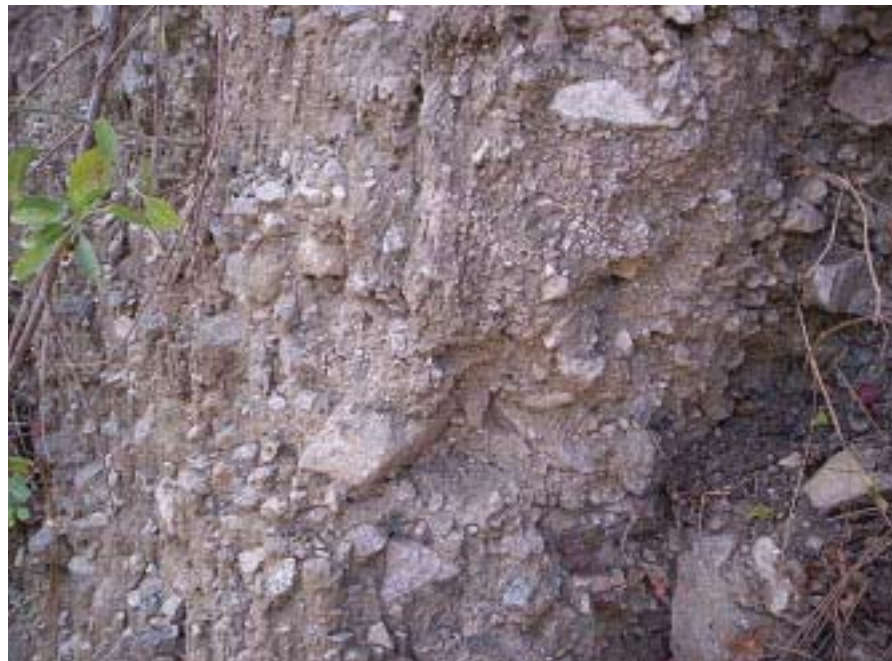
Fig. 4.7
Angular matrix-supported
landslide deposits underlying
the mobile home park and
lower slopes surrounding the
buildings.

The landslide scar on the southern slope of the property is not very visible and is heavily vegetated indicating that this landslide may have occurred many decades to centuries ago. The materials underlying today's mobile home area constitute the unaltered toe materials of the original landslide. (Fig. 4.7) Within the area of the old restaurant these slide deposits were moved to make room for the buildings and the old San Gabriel Canyon Road. It appears that the majority of the material was moved towards the stream, where it is now incorporated into the base of the parking lot and the graded southern river bank.

There are indications of ongoing mudslides and debris flows emanating from the smaller drainages and historic slide scars behind the El Encanto property. Visual field inspection suggests that the majority of these slide processes are slope wash related to erosion and down cutting of drainage channels within the depositional toe materials of the ancient slide. (Fig. 4.7)

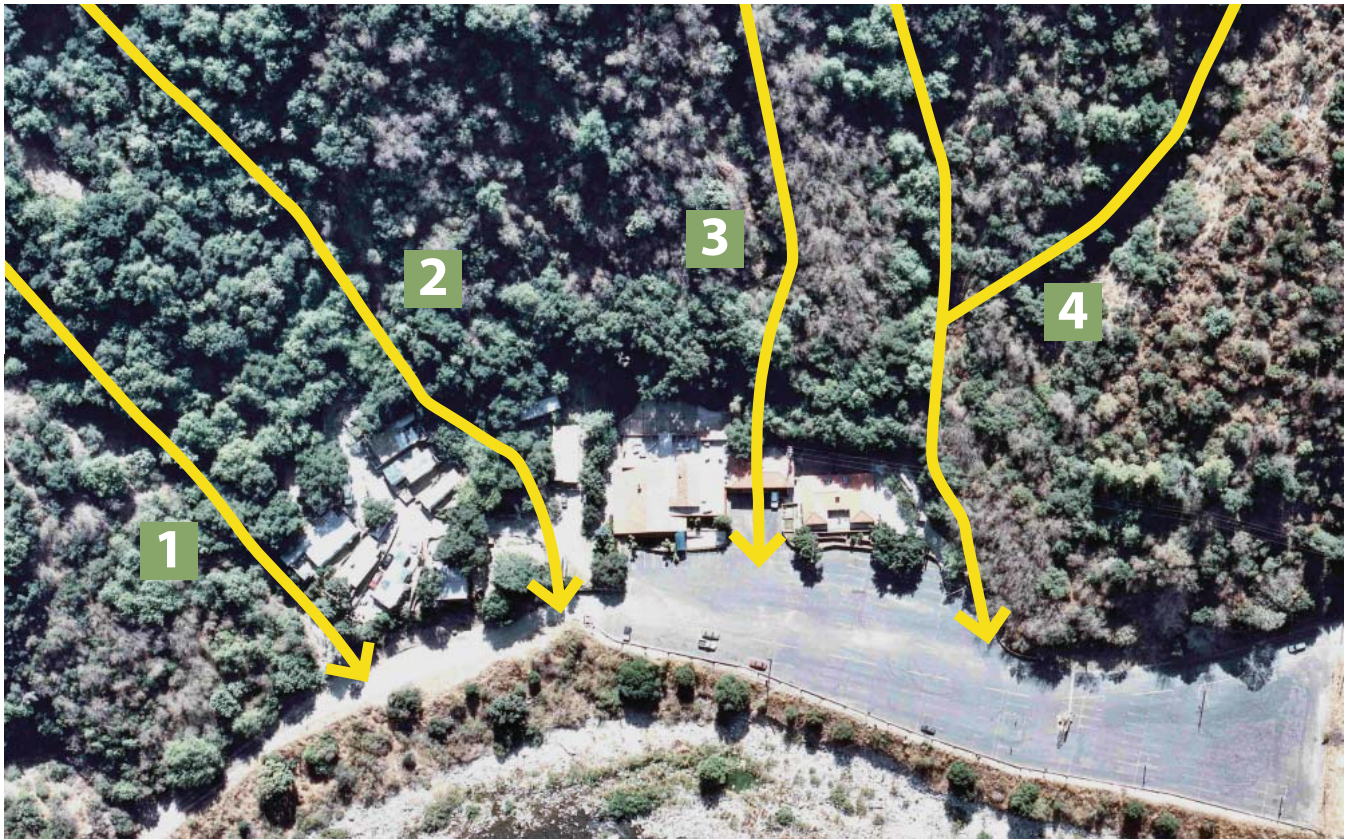
Fig. 4.8
Mapped Drainages on the El Encanto Property
Small images show the locations where sediment and water currently traverse the parking lot and road.

In detail, four separate drainage channels traverse the developed area of the southern parcel emanating from the historic slide scar. (Fig. 4.8) One channel passes the mobile home area to the east. The channel has cut down dramatically to the level of the old San Gabriel Canyon Road and the eastern set of mobile homes are perched above the western bank of the gully. The gully outlet across the road is blocked by materials that were removed from the road. A second drainage traverses the center of the mobile home park and enters into a large drain pipe under the access road to the mobile homes. This drain is filled-in with debris and does not function properly. The debris accumulates in the center of the trailer park and excess water runs down the driveway, where it exits onto the road.

The third drainage currently passes in-between the main building and the apartment through the breezeway. Finally, a fourth drainage passes the building structure on the west side and currently exits onto the parking lot. There are no structural improvements or channels to lead any of these drainages into the San Gabriel River.

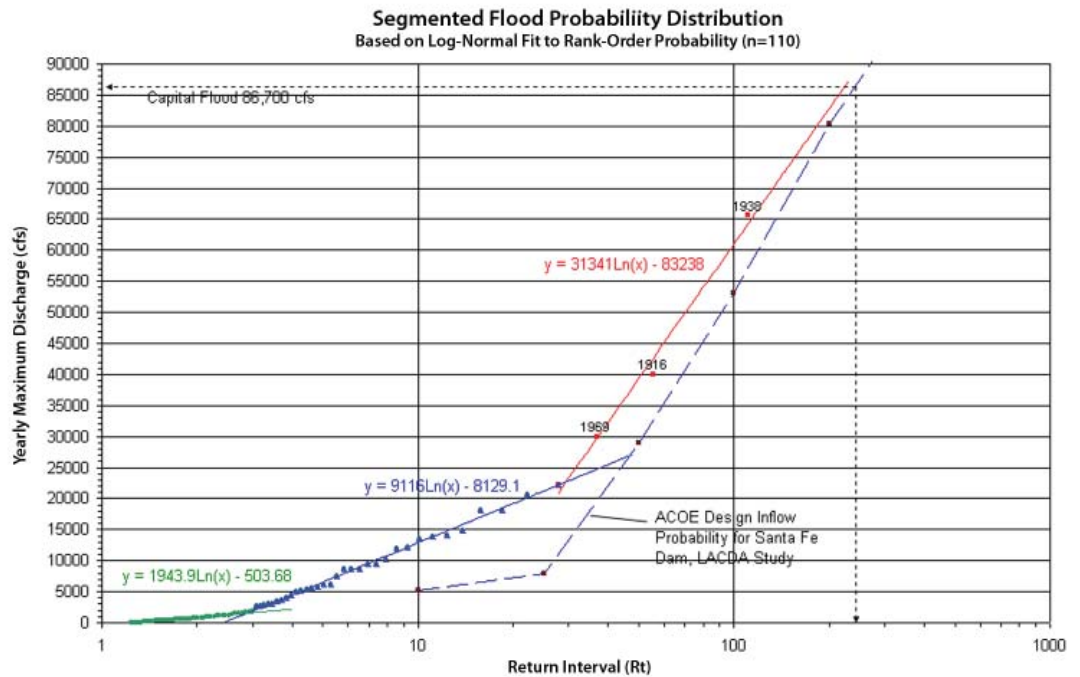
Fig. 4.10
Suggested Flood Recurrence Intervals for Planning Purposes of Plan Elements not requiring Capital Flood Protection.
 Inflow probabilities for Santa Fe Dam, approximately five miles downstream based on surface runoff models used by the Army Corps of Engineers (USACOE, 1991) are shown for comparison.

For habitat restoration activities, it is important to understand the most likely extent and probabilities of more frequent flood inundations. A preliminary analysis of flood recurrence intervals was performed to obtain a better understanding of these probabilities. Since the flood record for the site is complex, and is somewhat compromised by the closure of the dams and subsequent alterations in reservoir management, it was decided to minimize statistical inference and use a graphical fit to simplify rank-ordered probabilities to represent flood recurrence intervals. This approach is generally acceptable for habitat restoration work, but additional statistical analyses may be required for engineering work. The graphical fit is shown in Figure 4.10.

A general rule of thumb for naturally functioning streams is that they would exceed their channel capacity about every 2 years and subsequently inundate the floodplains. In semi-arid canyon environments this value is often adjusted upward to account for larger variability of discharges and more complex channel shapes and sedimentary dynamics. Using the HEC-RAS model by incrementally increasing discharge until water levels rise above the northern banks, it was determined that bankfull discharge amounts to about 22,500 cfs. Using the recurrence intervals of Figure 4.10 this would be approximately the 29-year flood.

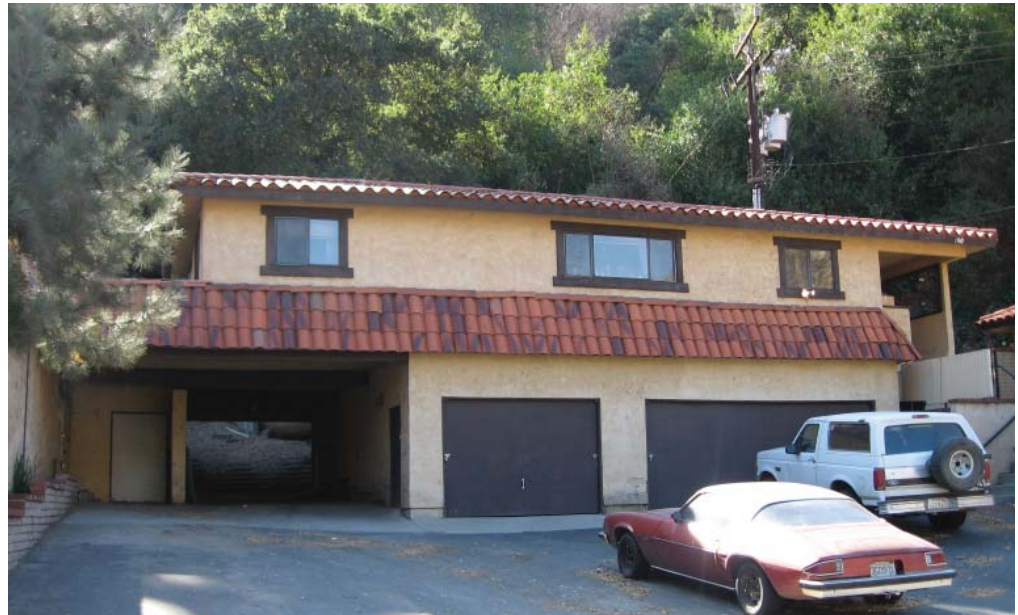
Fig. 4.24
Residential apartment

Next to the restaurant building is a small single residential apartment built on top of a garage. (Fig. 4.24) The structure is connected to the restaurant building by a covered breezeway or carport that also provides access to the back patio and storage areas of the restaurant. The breezeway also acts as drainage for the steep hill slope behind the structure.

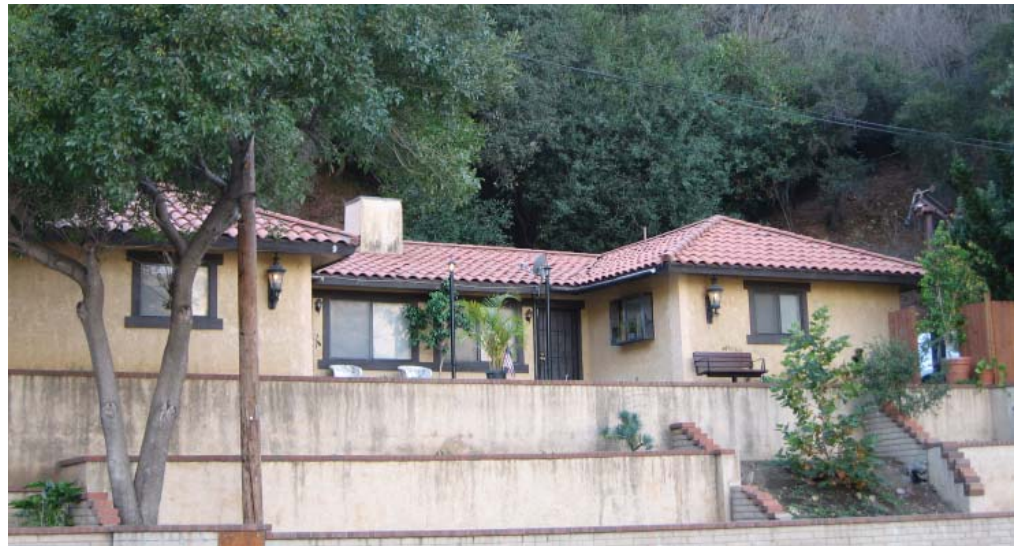
Fig. 4.25
Two-unit structure with
ranger residence

Next to the apartment is a two-unit duplex structure that was built last. One of these units is currently used as a ranger residence. The buildings have stucco exterior, fenced back yards, and slump block retaining walls and planters in the front. (Fig. 4.25)

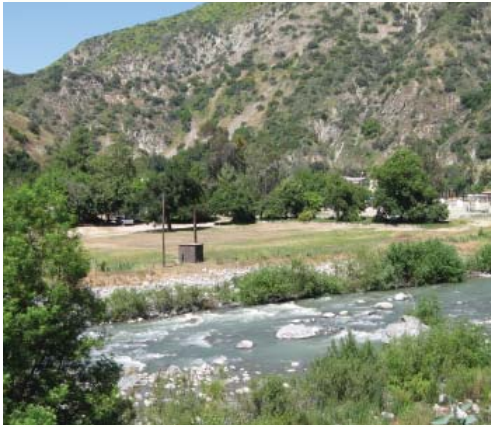
Fig. 4.31
Water well on far side of river

The Encanto property has its own water supply from a well on the northern parcel along the river bank. (Fig. 4.31) The water runs through a pipe under the river, and is pumped to a set of water tanks just above the mobile home area. In all, there are five water tanks, of which two are currently functioning. The water is chlorinated on-site and tested daily. The pipes that leave the tank to service the buildings are above ground and follow the steep slope and are vulnerable to damage from slides, rocks, and wildlife. (Fig. 4.32)

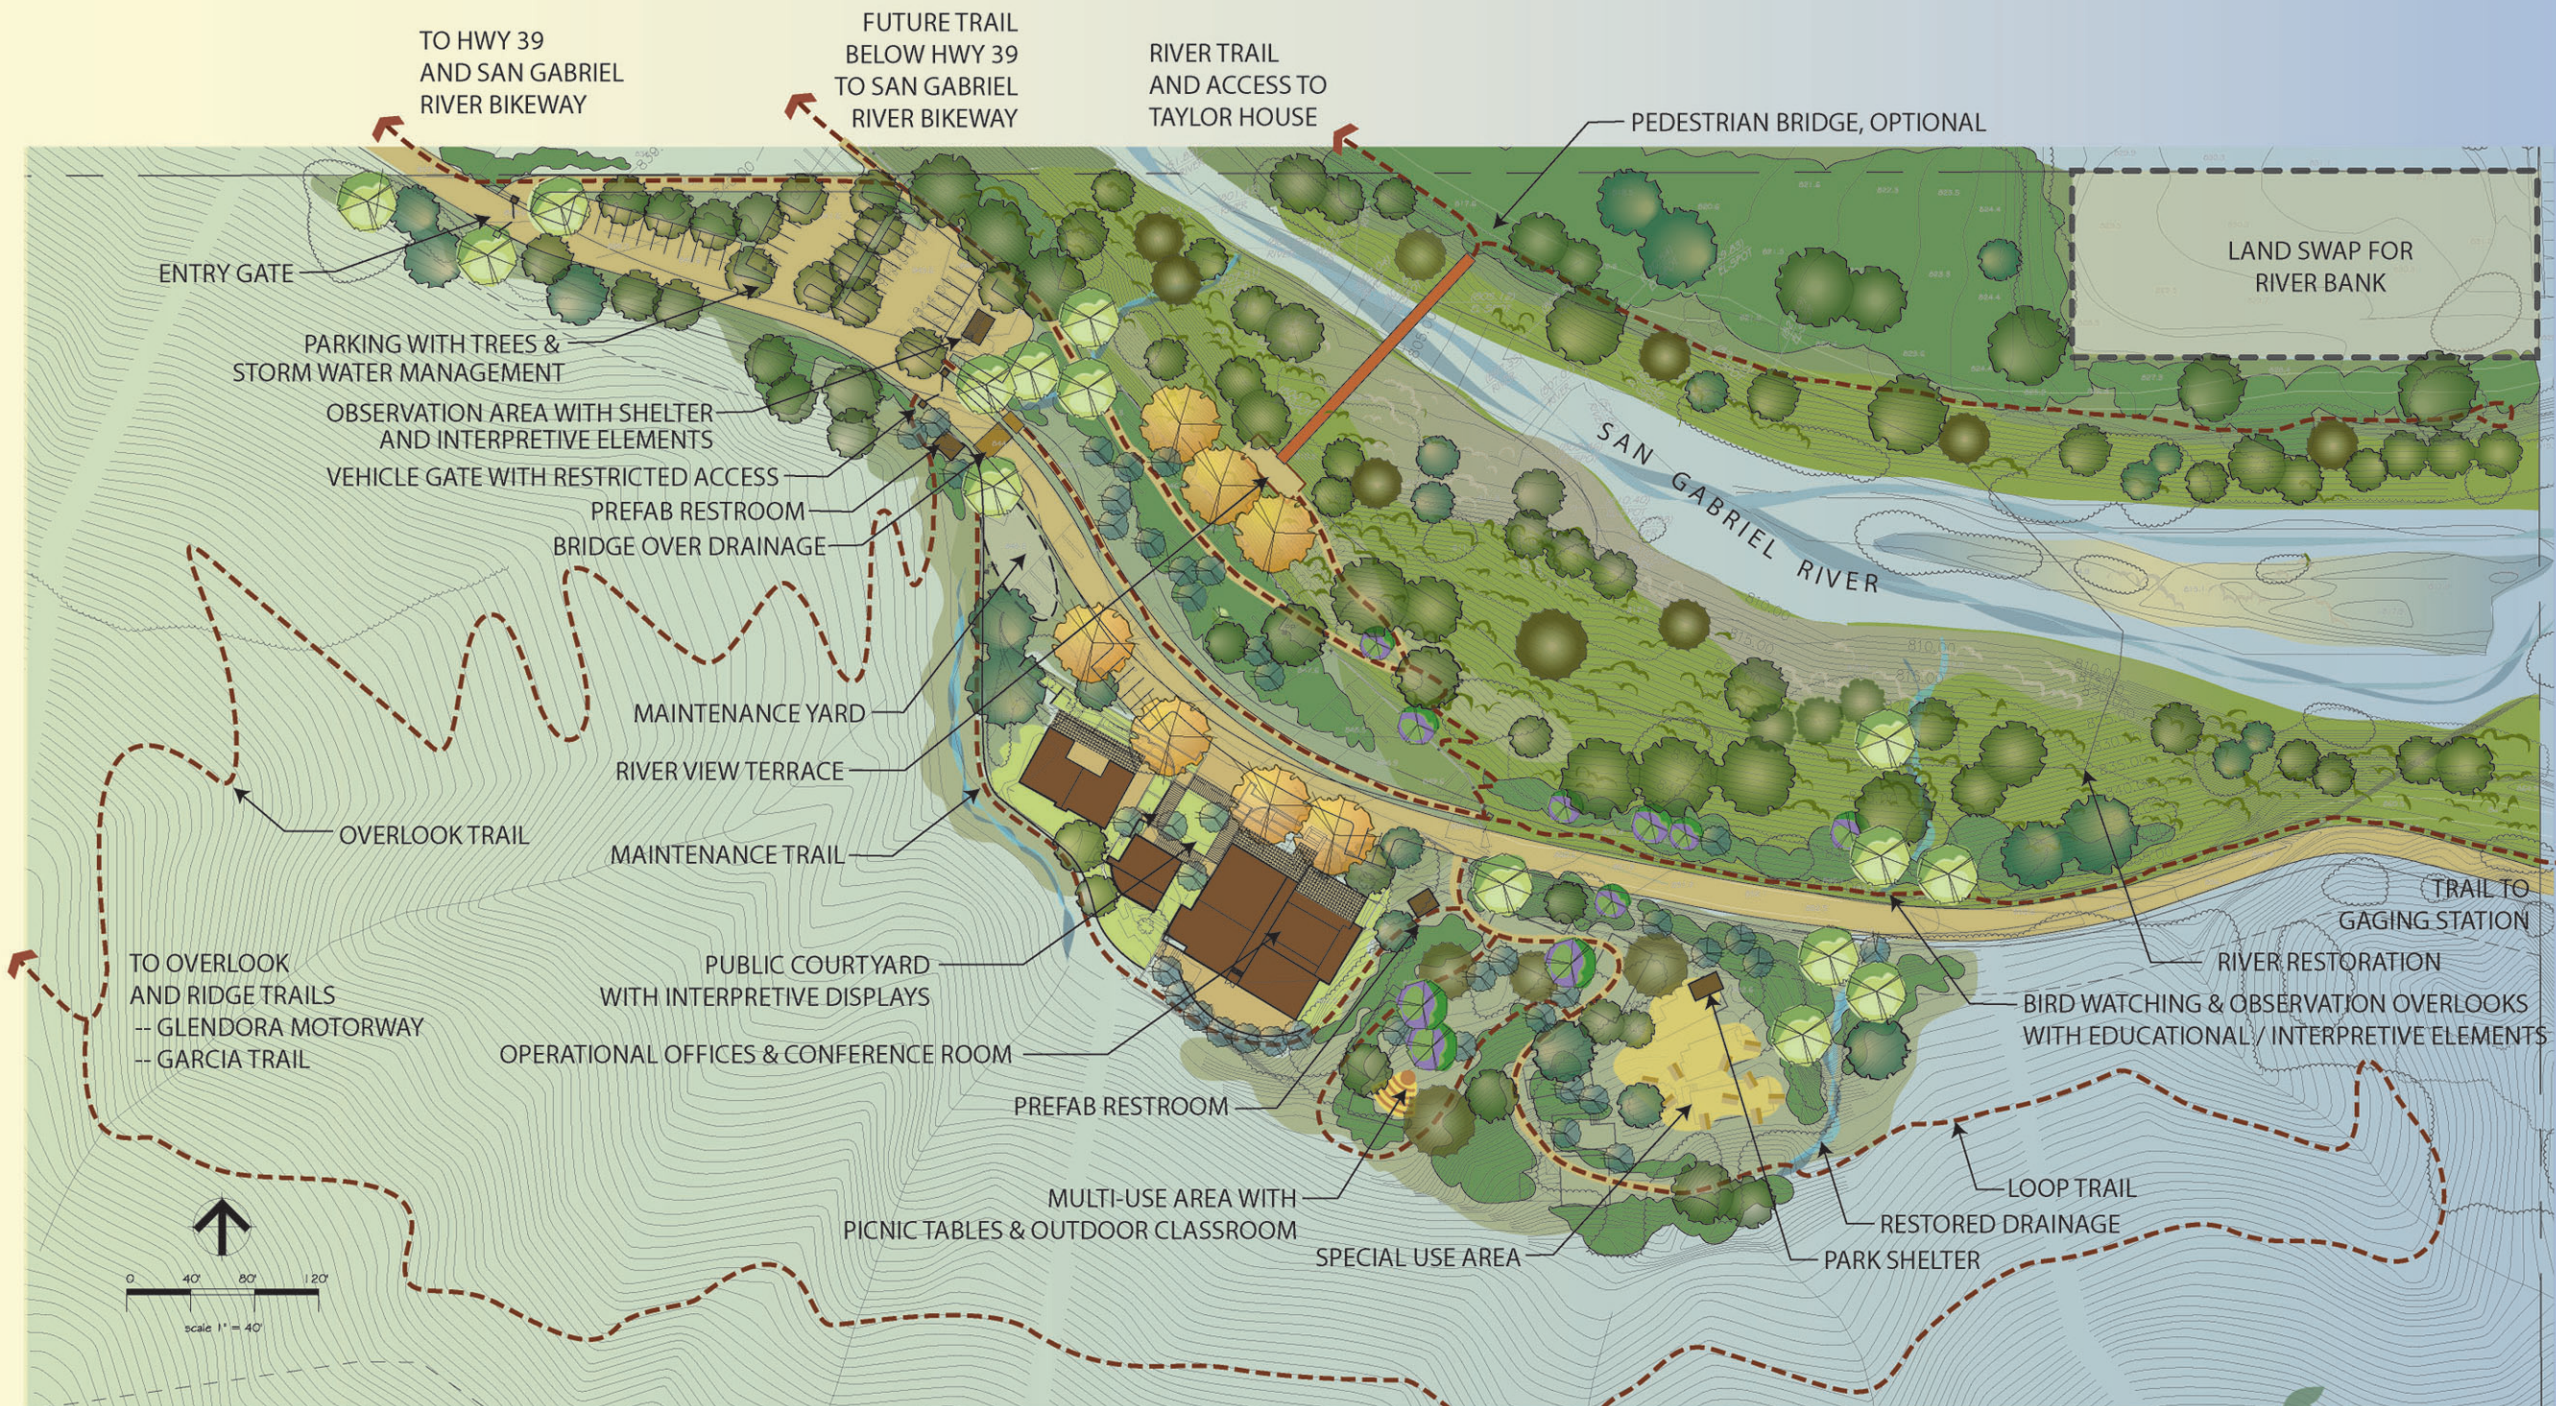
Fig. 5.3, *fold out*
The preferred alternative,
Nature Experience
Master Plan

The plan seeks to utilize existing facilities and structures for park operations featuring energy conservation and sustainable design. More extensive public use and services will not be anticipated as this would increase day-to-day traffic. With regard to the parking lot, this plan includes a dramatic reduction of parking to provide for stream bank restoration and the construction of a river bank trail with viewing terrace to provide a more intimate, non-contact experience of the riparian environment.

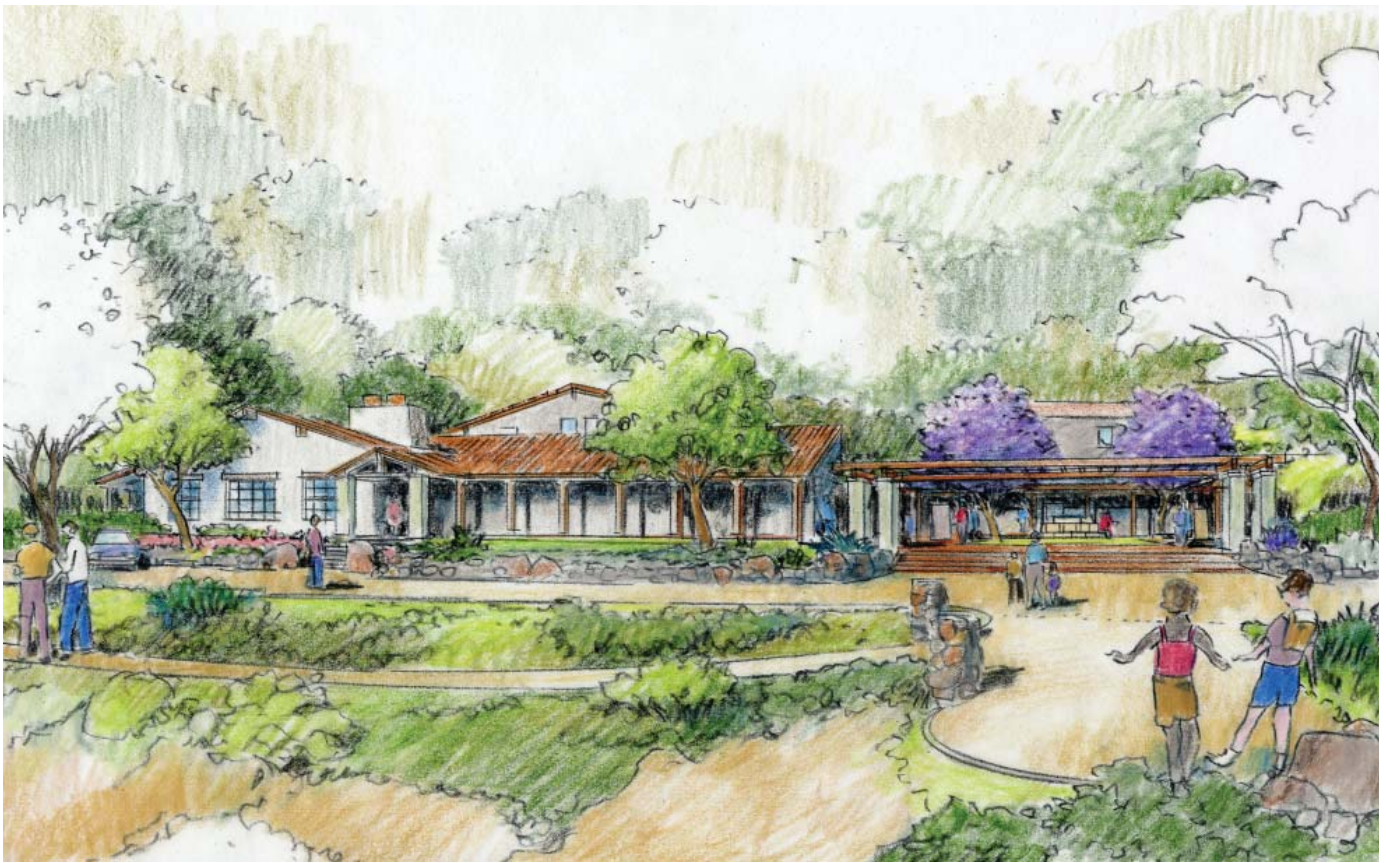
Fig. 5.4
The proposed
enhancement of
the old restaurant
structure

An upgraded façade for the structures is recommended in order to create a cohesive building complex with a unified building facade. (Fig 5.4) Integration of the three building structures will be accomplished by adding a new trellised courtyard to the area currently located in front of the garage. This will visually focus a visitor's approach to the center of the building complex, rather than to the existing restaurant entrance.

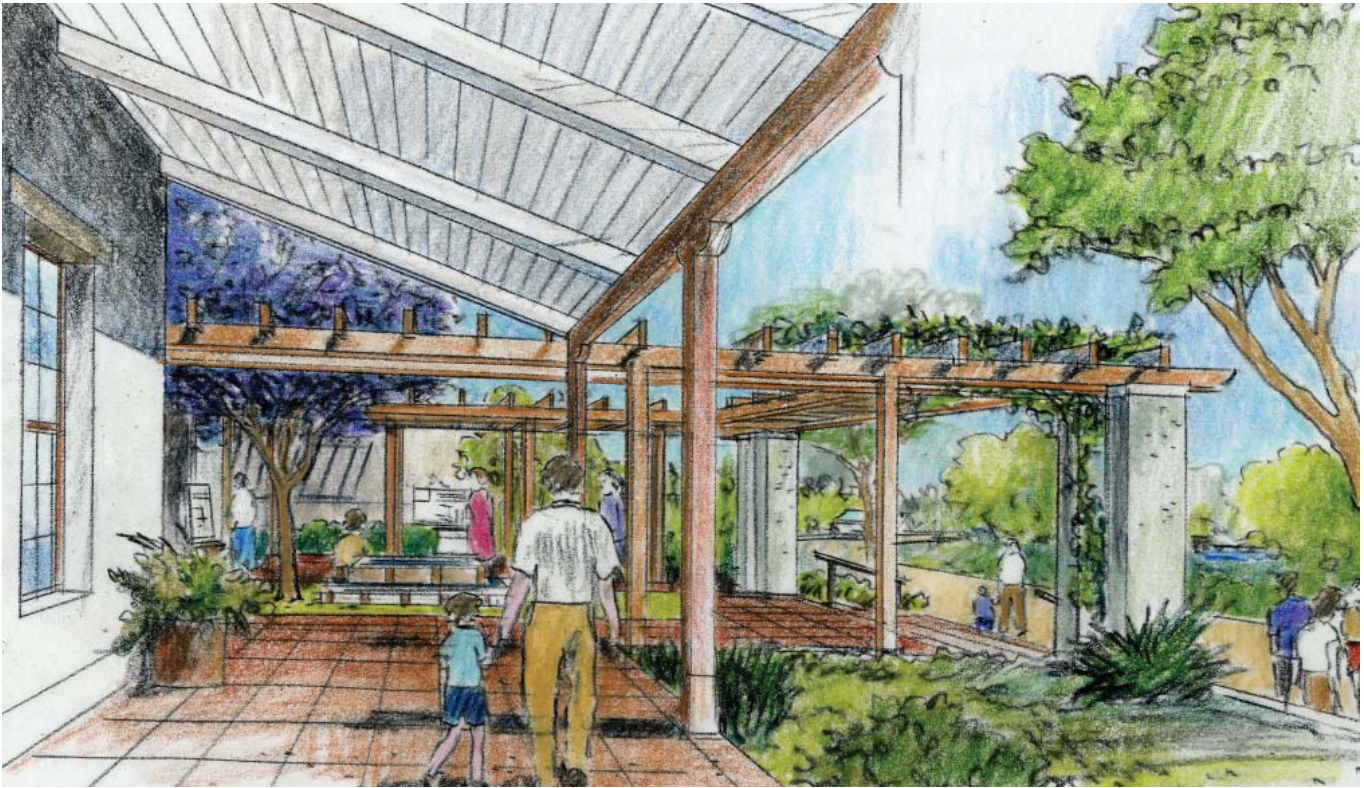
Fig. 5.8
The covered porch
and trellised courtyard

The new trellised courtyard in front of the buildings will create a new building approach, and new public space along the northern exterior of the buildings. The porches and trellis structures will give the public space to gather without entering the buildings. The courtyard will offer some relief from the sun and allow for covered interpretive displays at the same time. (Fig. 5.8)

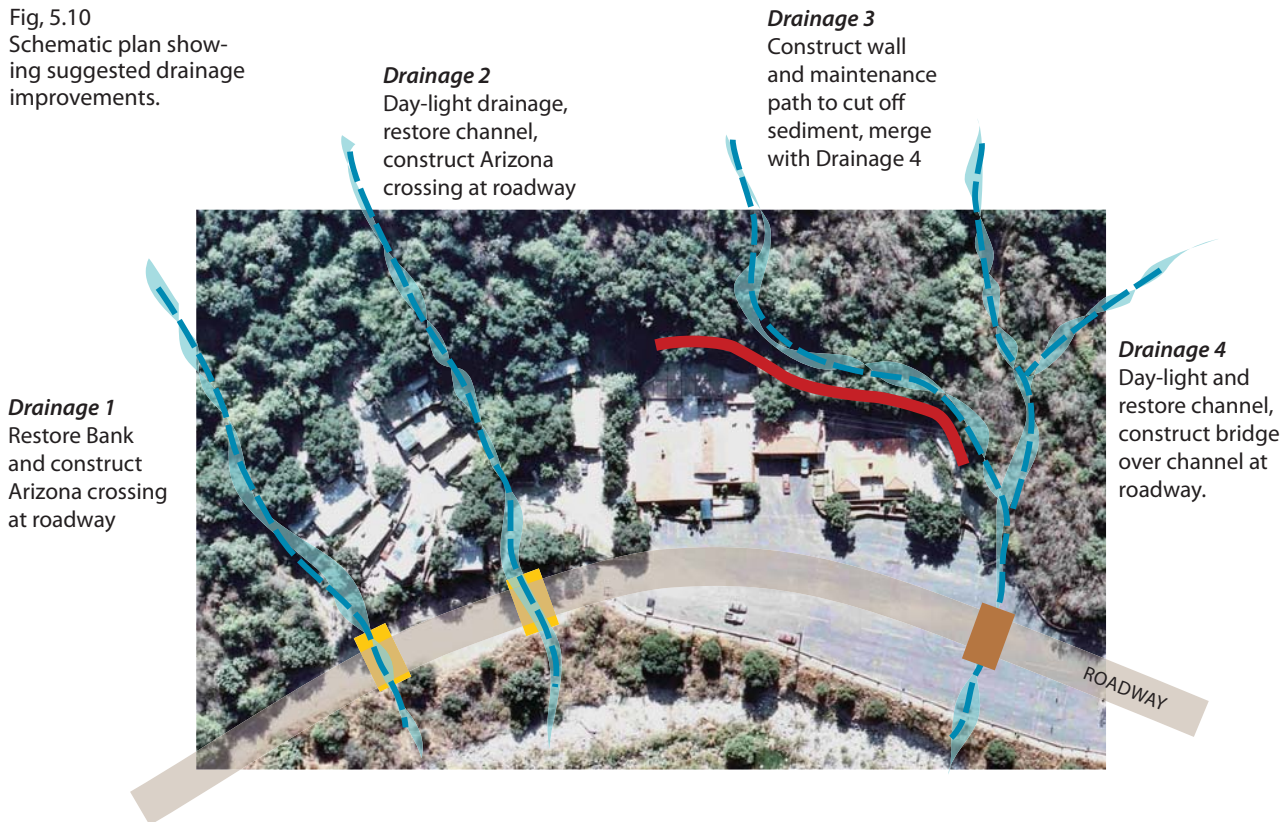
Fig. 5.10
Schematic plan showing suggested drainage improvements.

Based on a preliminary investigation of slope stability and drainage (see Appendix B1) it is highly recommended that a more detailed study of the slope area behind the buildings is performed by geotechnical experts. With regard to minor slope wash and drainage, improvements to the local drainages will be implemented to “pass” runoff and slope materials through and around the building complex, and by making improvements that facilitate management and clean-up of debris. (Fig. 5.10)

This drainage borders the mobile home area to the east. It is suggested to retain the drainage channel in the current position and to construct a road crossing that allows sediment to cross the road and enter the San Gabriel River channel. It is suggested to use what is commonly referred to as an “Arizona Crossing”, essentially, a reinforced concrete dip in the road. It is not recommended to use a culvert, because this would lower the base level of the channel and cause more sediment mobilization and down-cutting in the upper drainage. It is suggested to lay back the western gully slope and restore, and plant part of the drainage to prevent future slope collapse. Absent re-grading of the bank slope, it is recommended to install a low barrier or fence at the top of the slope to prevent visitors to the special use area from falling into the gully.

This drainage traverses the center of the mobile home park and enters into a large drain pipe under the access road within the mobile home park. It is recommended to completely re-grade and daylight this drainage. Underground culverts are likely to fill in with debris in the future. A concrete Arizona Crossing would be the most appropriate structure to allow flood waters to traverse the road.

This drainage passes the building complex on the west side and currently exits onto the parking lot. Sediment spills onto the road and parking lot. It is recommended to combine drainages 3 and 4 into one naturalized channel traversing the existing road under a small bridge. The channel would be naturalized and designed to meet the re-graded slope of the San Gabriel River. The new channel and bridge would create the planned boundary between the public parking area and the "limited access" area surrounding the buildings.

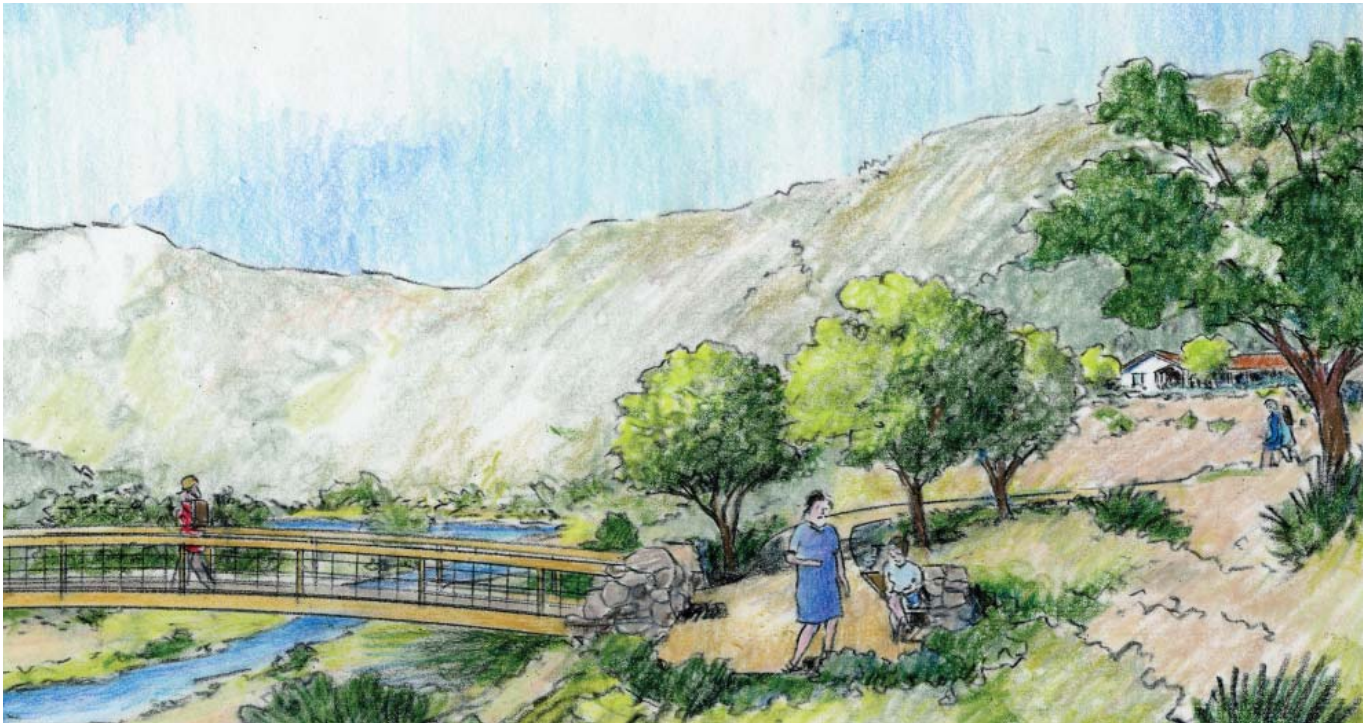
Fig. 5.15
Riverside Terrace and optional pedestrian bridge to the north river bank

However, the public also felt that stream bank restoration was appreciated and that the current parking lot was too large. The parking lot is positioned so far above the river that any closer experience of the river is currently not possible. The artificial fill constituting the base of the parking lot lies so far above the water surface, even during the largest floods, that the vegetation surrounding the parking area would have to be of an upland type. Hence, the goal of this plan is to remove a substantial amount of parking lot and artificial fill, and to re-contour a portion of the slope to a more natural profile. This will allow the planting of appropriate native vegetation that will reflect the appropriate transition from upland to riparian zones.

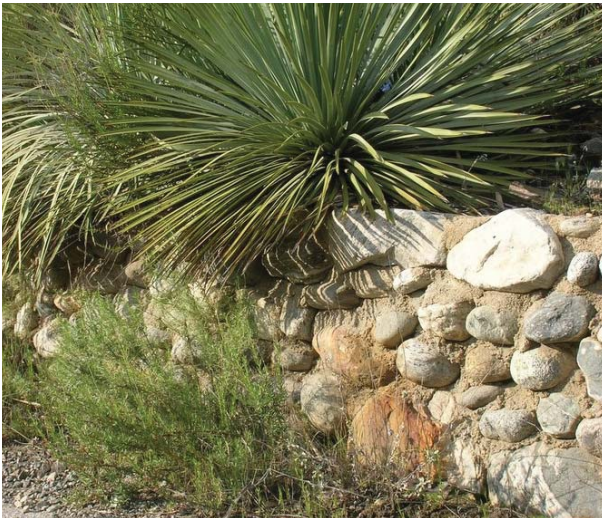
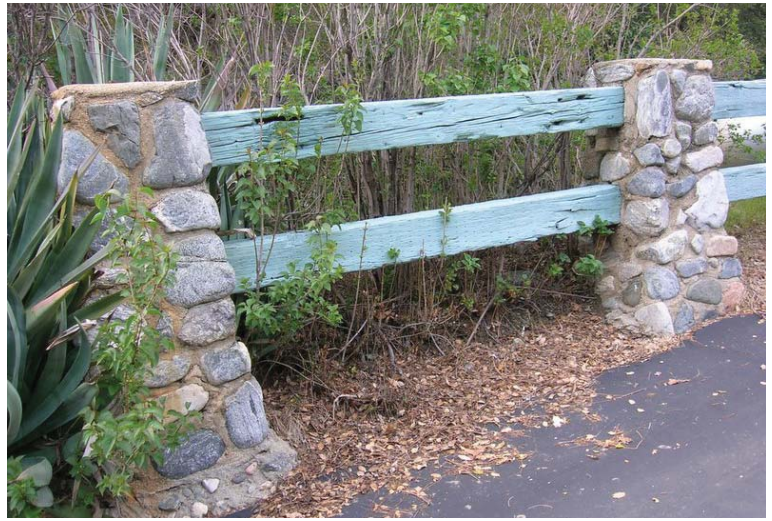
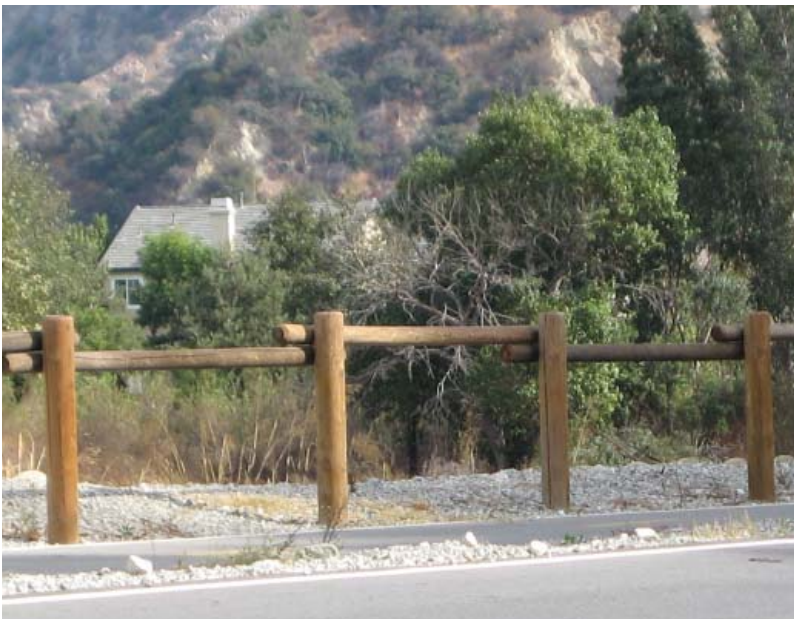
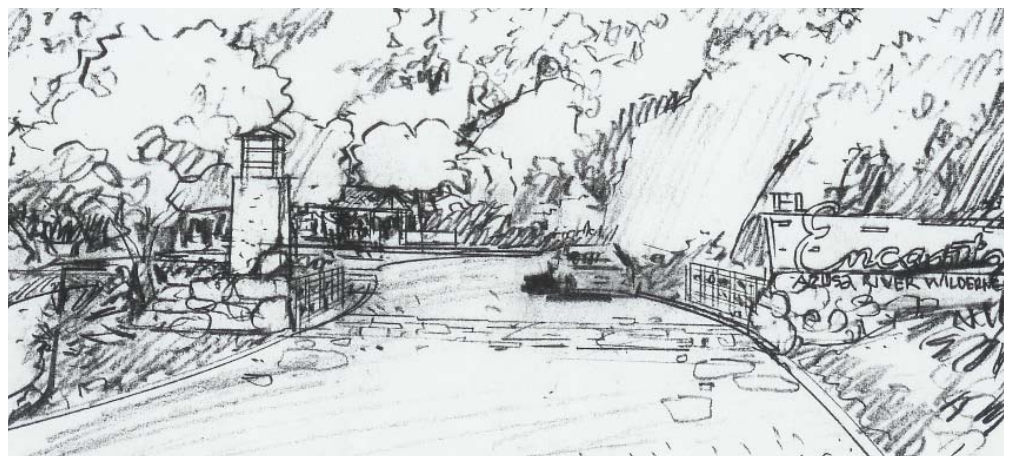
Fig. 6.1, top left
Cobble stone wall

Fig. 6.2, top right
Cobble stone piers with
heavy timber fencing

Fig. 6.3, middle left
Lodge pole fencing along
San Gabriel River Bikeway

Fig. 6.4, middle right
Example of a heavy timber
gate constructed in a simple
grid pattern

Fig. 6.5, bottom
The entry gateway with
asymmetric cobble pilasters

Walls in the landscape will reflect the natural environment with its steep, angular, granite canyon walls, and rounded river rock found along the riverbed. Round river boulders will be featured in walls supporting the river terrace and river trails. (Fig. 6.1) Elements located at higher elevation will integrate more angular granite rock. Adjacent to the buildings, Spanish/Mediterranean stucco will be used. The existing slump stone retaining walls will be waterproofed and refinished with stucco to match the new architectural facade.

Gates and fencing will be minimal, low-profile, and have an open, rustic character reflecting the mountain environment and a park service aesthetic. The entry gate will consist of rock pilasters with metal swing gates. The gates will be a framed grid design, painted dark brown and finished to resemble wood. (Fig. 6.4) Pilasters will be asymmetrical, constructed of local stone, with a rustic lantern mounted atop one, and the park entry sign atop the other. (Fig. 6.5)

In areas where access should be limited, simple wood lodge pole fencing that matches the fencing along Azusa's reach of the San Gabriel River Bikeway will be used. (Fig. 6.3)

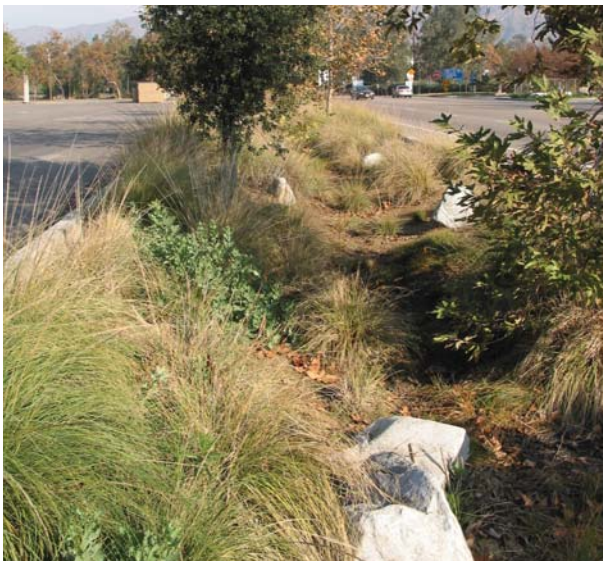
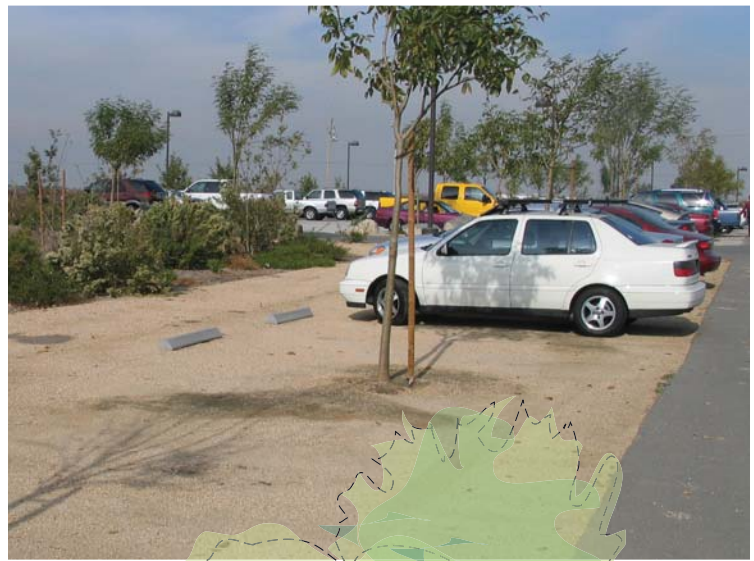
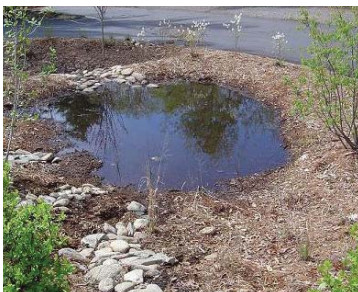
Fig. 6.7, top right
Decomposed granite parking stalls

Fig. 6.8, bottom left
Detention micro-basin allows stormwater to soak into the soil

Parking areas will consist of gravel, permeable concrete and decomposed granite surfaces. ADA parking bays will be permeable concrete with integrated color compatible with native materials. The parking area will be heavily planted and include bio-swales to accept and infiltrate site drainage. (Figs. 6.6-6.9)

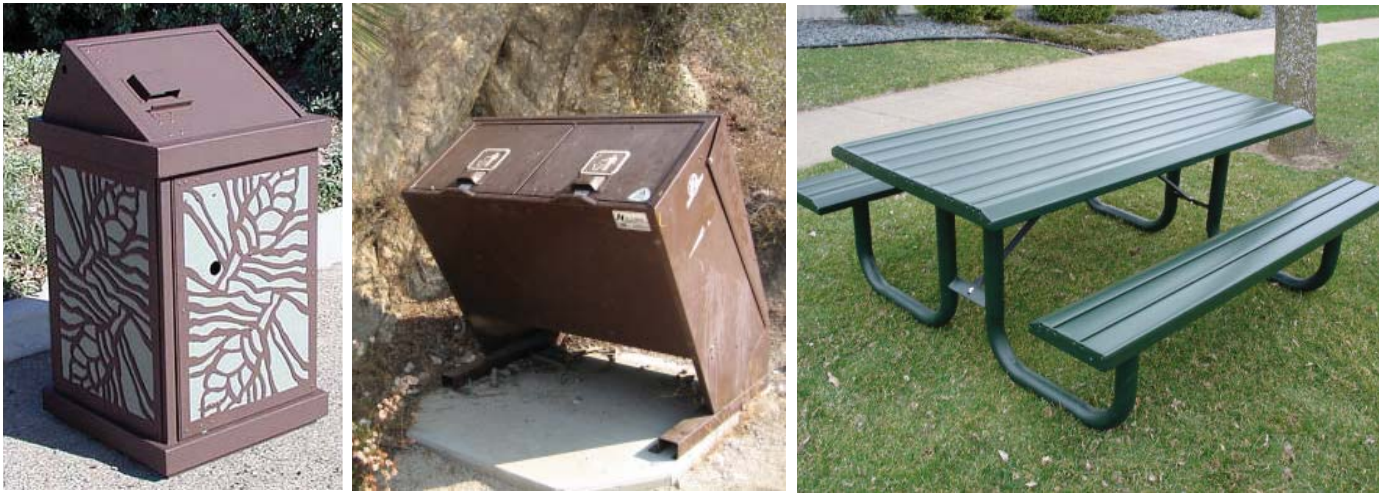
Fig. 6.10, left
Animal-proof trash receptacles
with custom graphics

Fig. 6.11, middle
Bear-proof dumpster

Fig. 6.12, right
Proposed style of metal
picnic table

Trash containers and dumpsters will be ADA compliant and bear and animal resistant. (Figs. 6.10-6.11) The trash containers can incorporate interpretive graphics and will have forest brown color. Dumpsters will be located behind enclosures (see architectural guidelines). *Bearsaver Bear Resistant Trash Container Handicap Accessible Model HA-P HA, and Bear Resistant, 2 yard, Front Load Dumpster, heavy duty handicap accessible commercial container. BearSaver, 1390 S. Milliken Ave, Ontario, California 91761 Phone 1-909-605-1697*

Located in the special use area, the picnic tables shall be metal and powder coated brown. (Fig. 6.12) ADA picnic tables should be sited in appropriate locations. *Bearsaver Standard 6' and 8' long Picnic Tables and ADA Picnic Tables 8' long.*

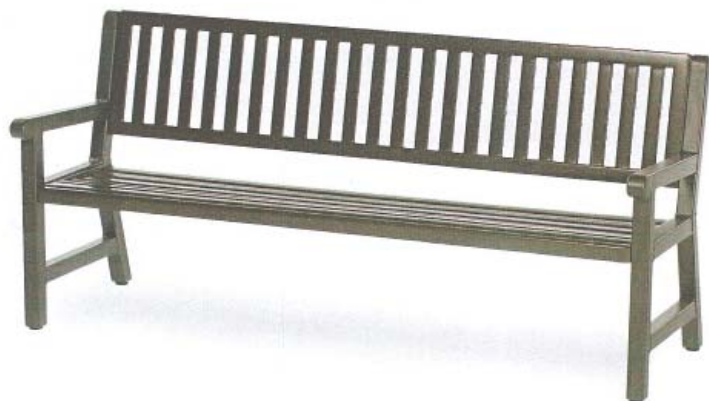
Fig. 6.13
Wabash Valley Heritage
Mission Straight Back 6'
Bench Model HR 310.

Seating will include rustic split logs, large flat boulders along trails and informal areas. Rock benches will be incorporated into the River Terrace retaining wall and into the Vista Park Shelters. Metal benches with backs will have a brown color powder coat surface and will be used within the Trellised Courtyard and near buildings.

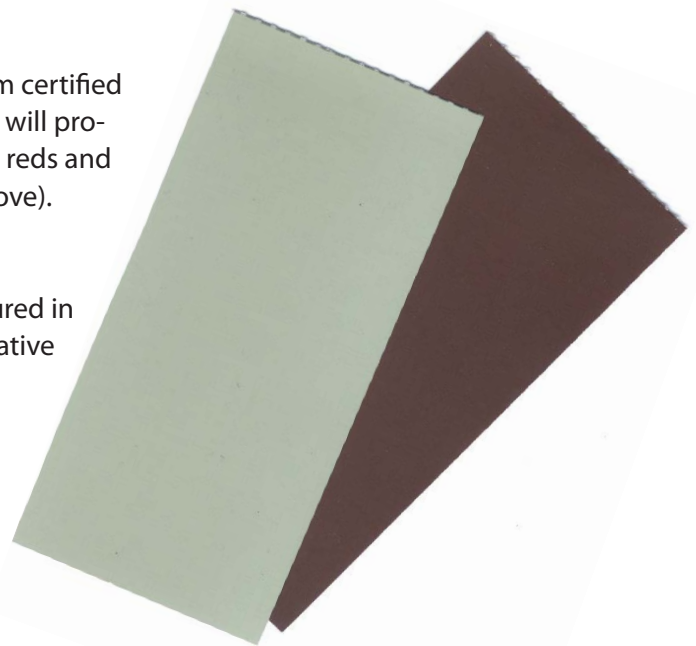
Fig. 6.16
Color samples for exterior finishes

The buildings and structures shall be painted with low-emitting materials or low VOC emissions paints and coatings. The building facades, restroom enclosures, and walls surrounding the dumpsters will have a rough stucco texture. *The stucco will be painted sage green and the trim dark rust brown. Stucco color to be Dunn-Edwards Turtle Trail – DE6256, LRV 43, trim to be Dunn-Edwards Sunken Ship – DEA148, LRV 7.* (Fig. 6.17)

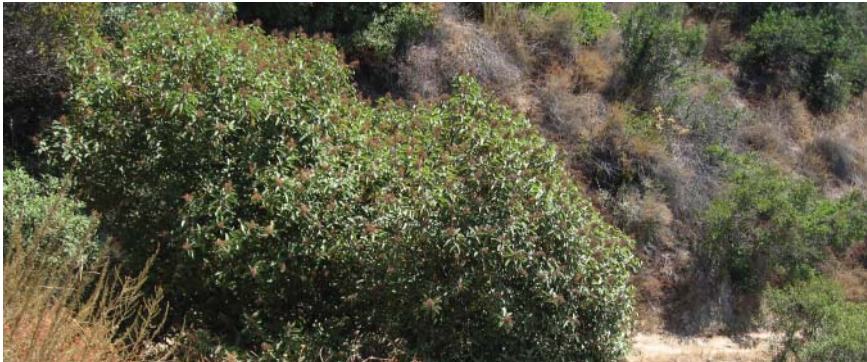
Fig. 6.17
Narrow trail along the
steeper canyon walls

Trail widths vary due to the terrain and expected use patterns. Proposed steep hill-side trails leading to overlooks, the Glendora Mountain Motorway, and Garcia trail will have a minimum two-foot tread width, minimal clearance of vegetation will not exceed four-foot overall width, height clearance will be eight feet. (Fig. 6.17) A series of steps, landings, and water bars will be necessary in the steepest sections to prevent the trail bed from eroding. The Old San Gabriel Canyon Road Trail to the gaging station shall be 10' wide; the extension to the San Gabriel River Bikeway Trail shall be 5' wide; the River Terrace Trail shall be 8'-10' wide. (Fig. 6.18)

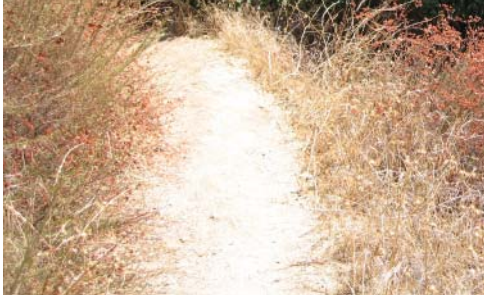
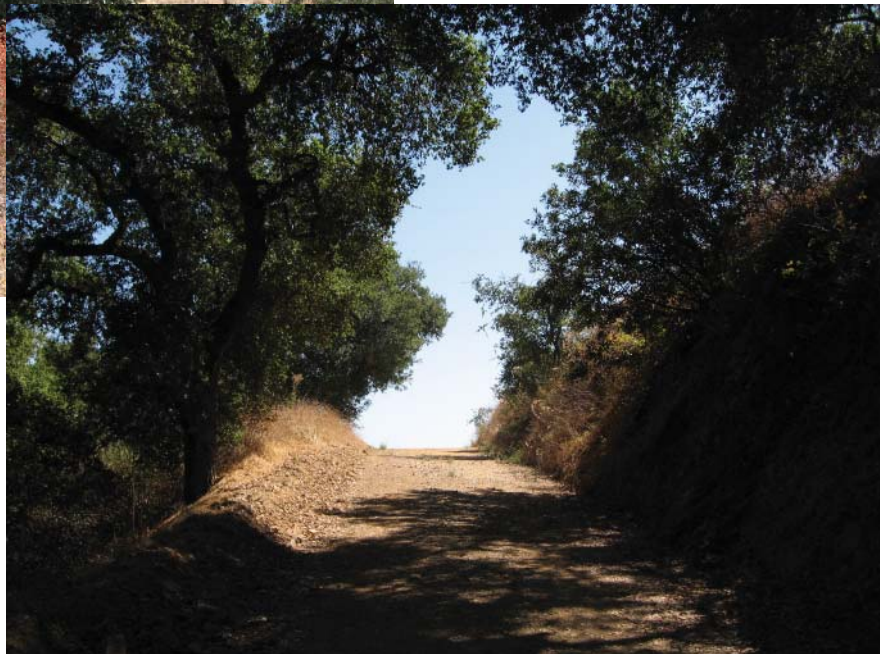
Fig. 6.18, *below*
Fire road trail

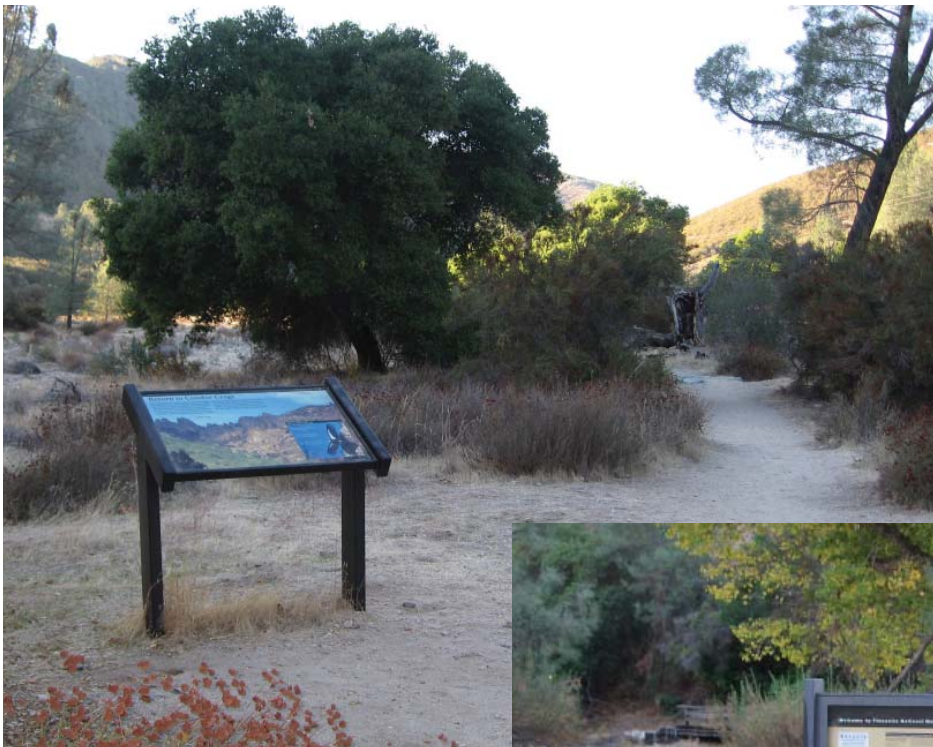
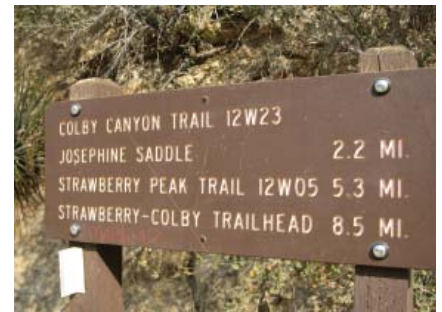
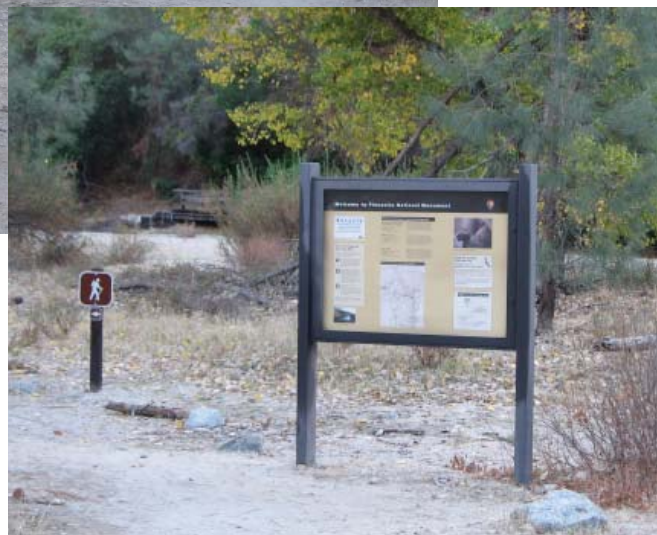
Fig. 6.20, right
Mileage signs posted
at trailheads and
intersections

Fig. 6.21, bottom right
Interpretive signage
along a trail

Secondary trailheads will be located at the restroom nearest the parking area, at the base of the Special Use Area, and the eastern most gates at the start of the Old San Gabriel Road trail to the gaging station. These secondary trailheads will mark with a trail signpost and have destination and mileage markers. (Figs. 6.20-6.22)
