Azusa River Wilderness Park

Azusa River Wilderness Park Project
Site Programming, Site Planning and
Overall Site Concept Development
for the El Encanto Property

Watershed Conservation Authority
October 22, 2007

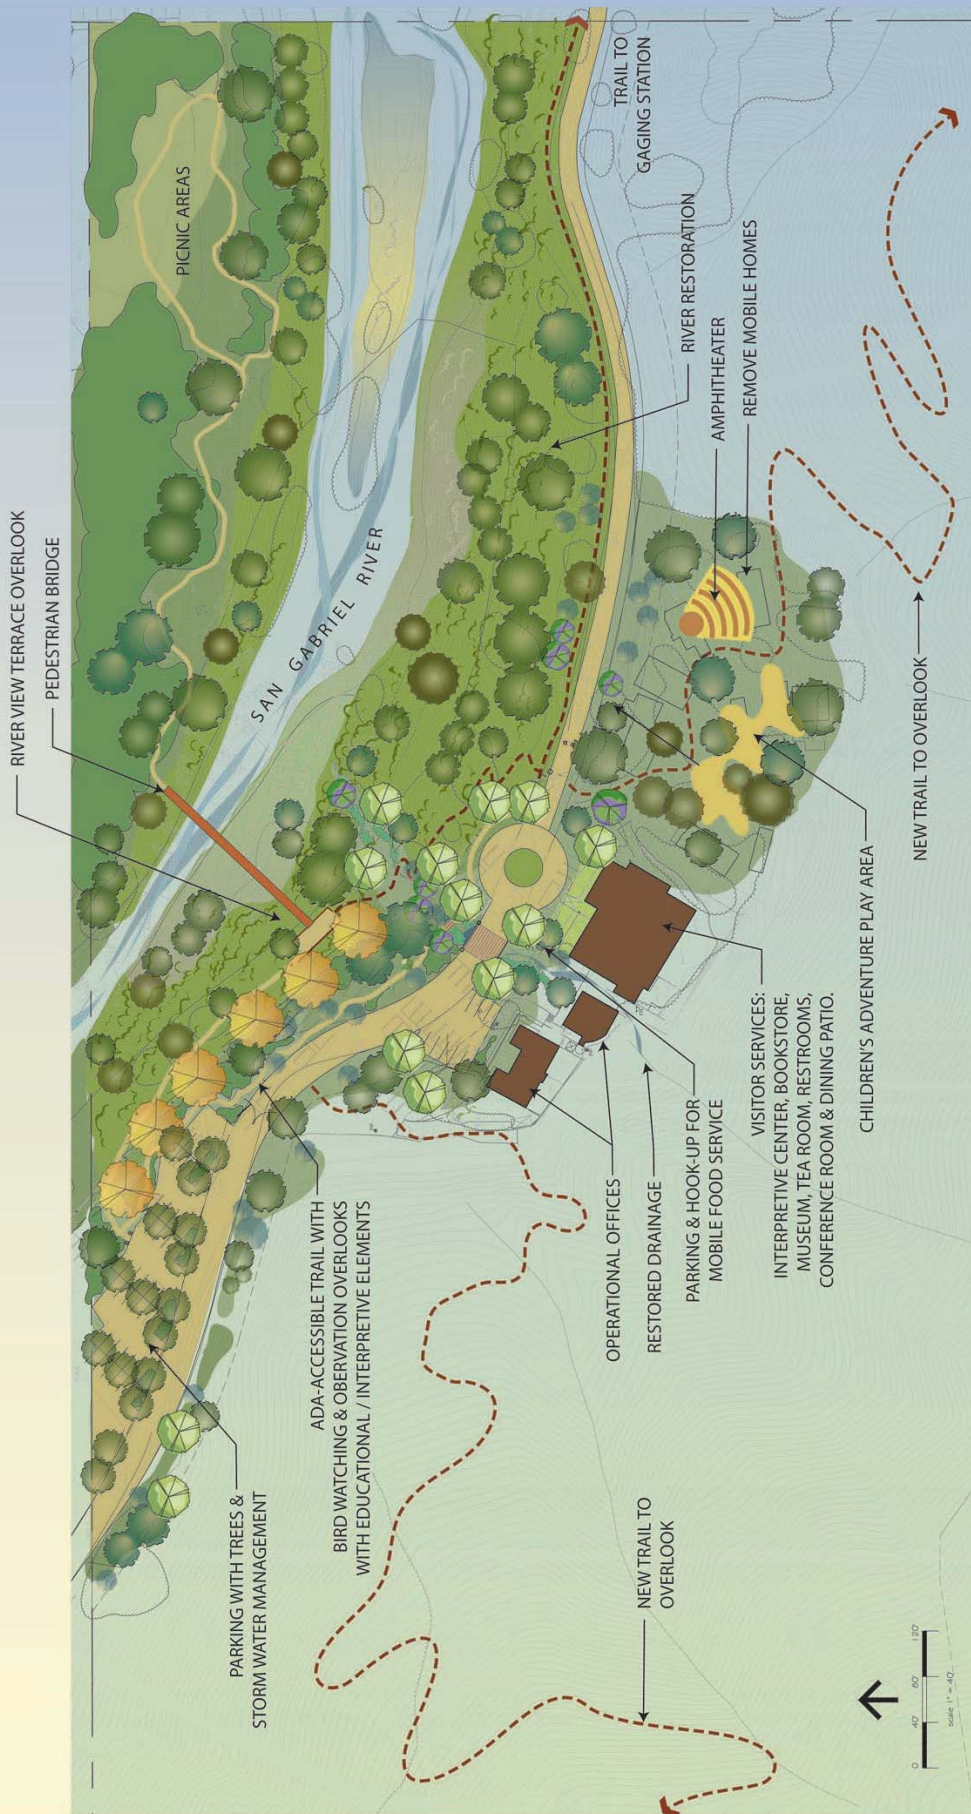
Visitor Services

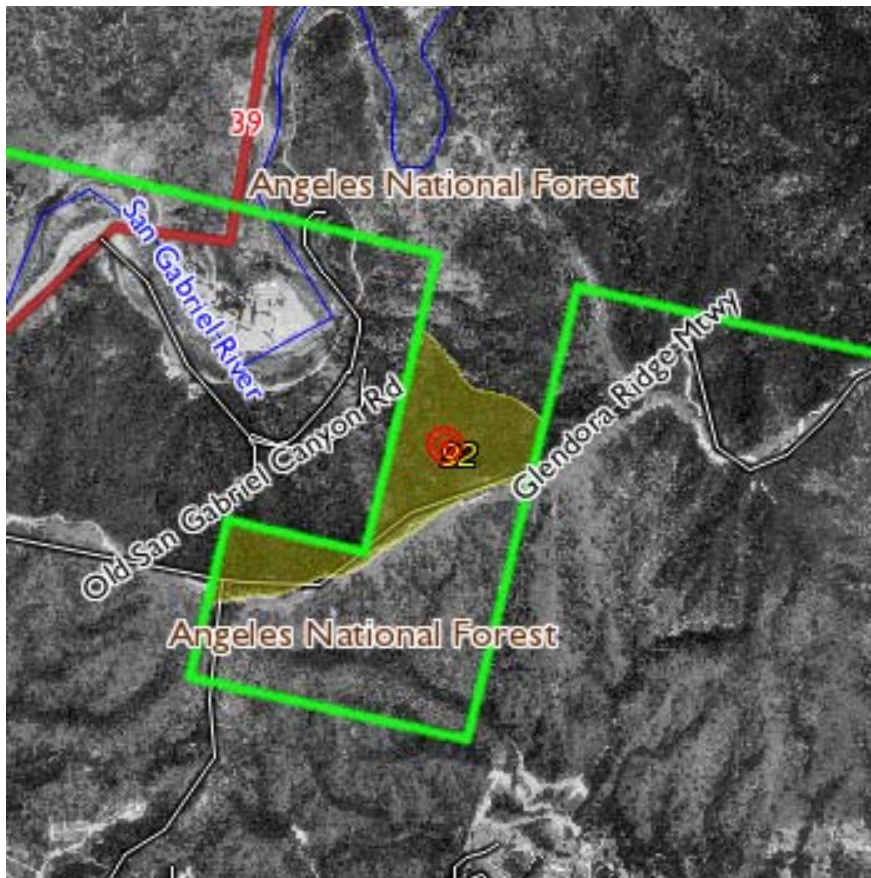
Figure 5: Soil Map showing extent of SSURGO map unit #92. Source: *University of California Davis, California Soil Resource Lab, Online Soil Survey, <http://casoilresource.lawr.ucdavis.edu/drupal/>*

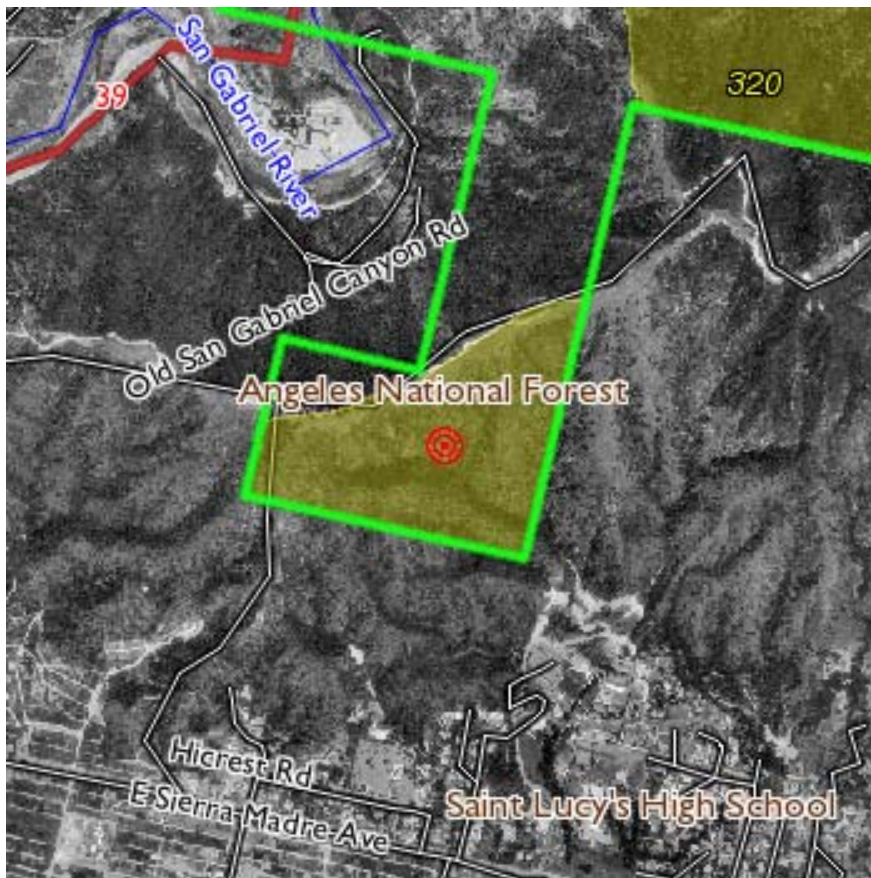
Figure 6: Map of the extent of SSURGO map unit #320. Source: *University of California Davis, California Soil Resource Lab, Online Soil Survey, <http://casoilresource.lawr.ucdavis.edu/drupal/>*

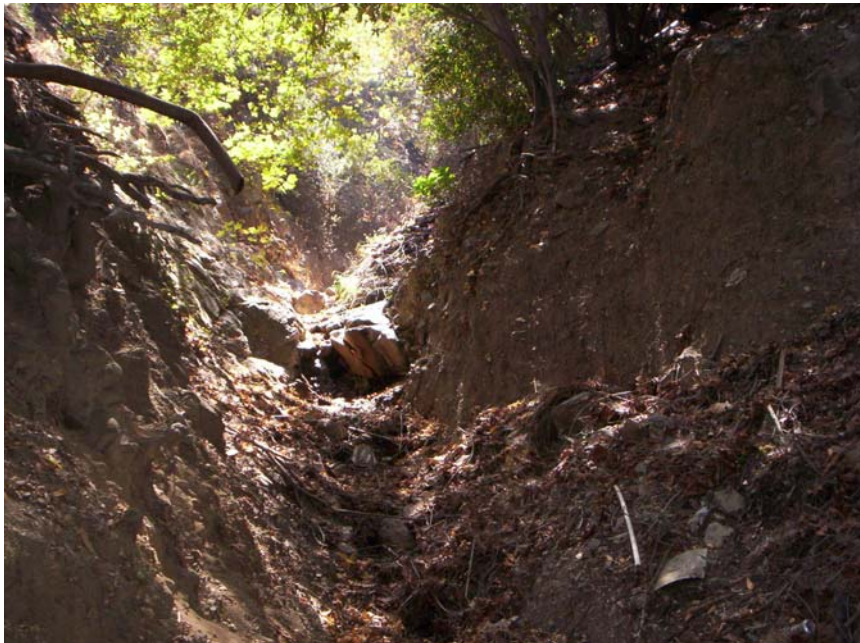
Figure 8: Steep drainage channels behind buildings are cutting deeply into the local historic landslide sediments. Remobilization of these deposits is the primary origin of mud and debris flows surrounding the buildings.

There are indications of ongoing mudslides and debris flows emanating from the smaller drainages and historic slide scars behind the El Encanto Property. Visual field inspection suggests that the majority of these slide processes are slope wash related to erosion and down

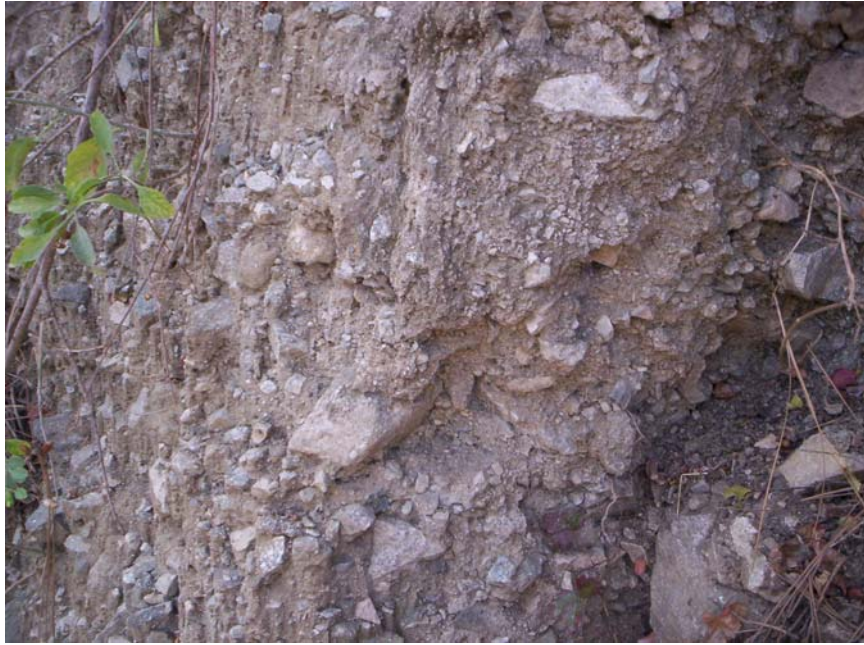
Figure 9: Angular matrix-supported landslide deposits underlying the mobile home park and lower slopes surrounding the buildings.

cutting of drainage channels within the depositional toe materials of the ancient slide. Figure 9 shows one of these channels that are deeply incised into the slide material.

Visual inspection of the material indicates that the lower slopes, behind and immediately adjacent to the buildings, and underlying the trailer park, are an angular, matrix-supported conglomerate, characteristic of a slide deposit.

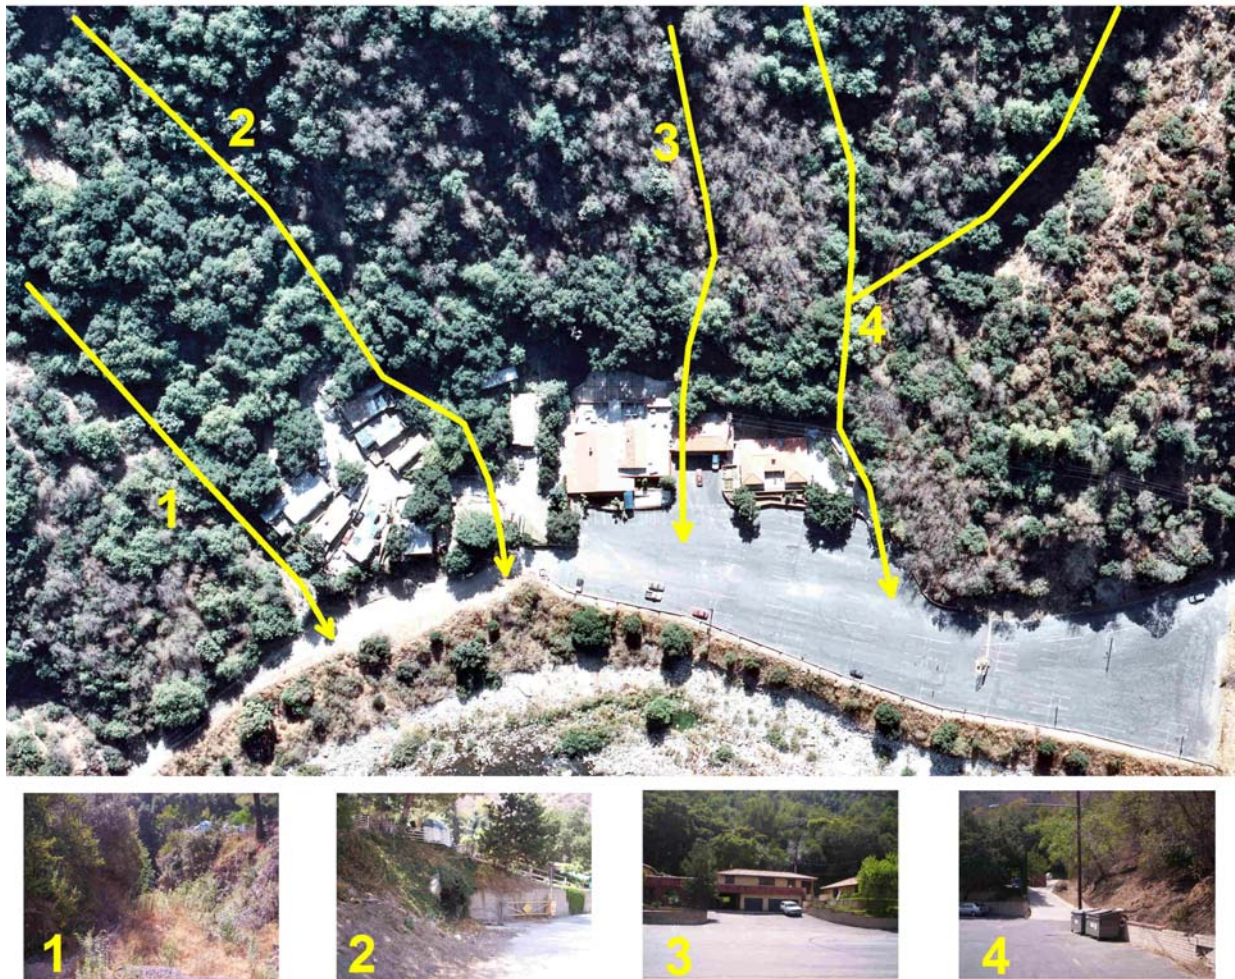
Figure 10: Mapped Drainages that cross the El Encanto Property. Small images show the locations where sediment and water currently traverses the parking lot and road.

With regard to the more surficial processes of slope wash and drainage, it appears that general improvements to the local drainages can be designed in order to “pass” larger amounts of slope materials through the site, and by making smaller improvements that facilitate management and clean-up of debris. The following section will characterize the 4 sub-drainages and make suggestions with regard to future management.

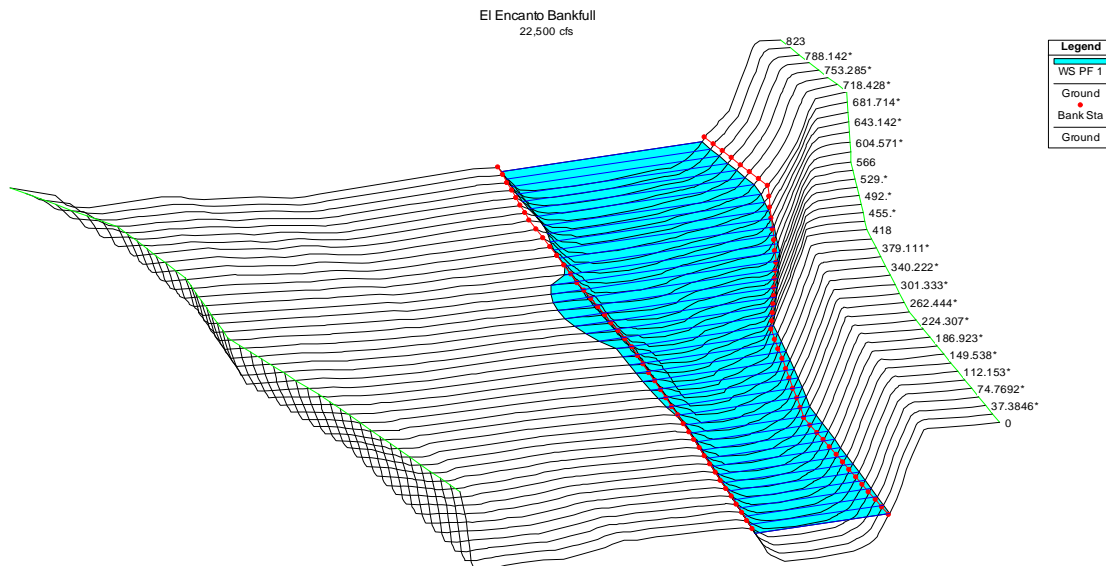
Figure 4: Onset of floodplain inundation in the center of the reach at 22,500cfs with an estimated recurrence interval of 29 years.

Using the HEC-RAS model by incrementally increasing discharge until water levels rise above the northern banks it was determined that bankfull discharge amounts to about 22,500 cfs. Using the above recurrence interval estimates this would be approximately the 29-year flood. This value is far greater than one would see in a natural system. Generally, one would expect that in a natural canyon type environment, even a large and complex point bar would be at least partially inundated every 5-10 years.

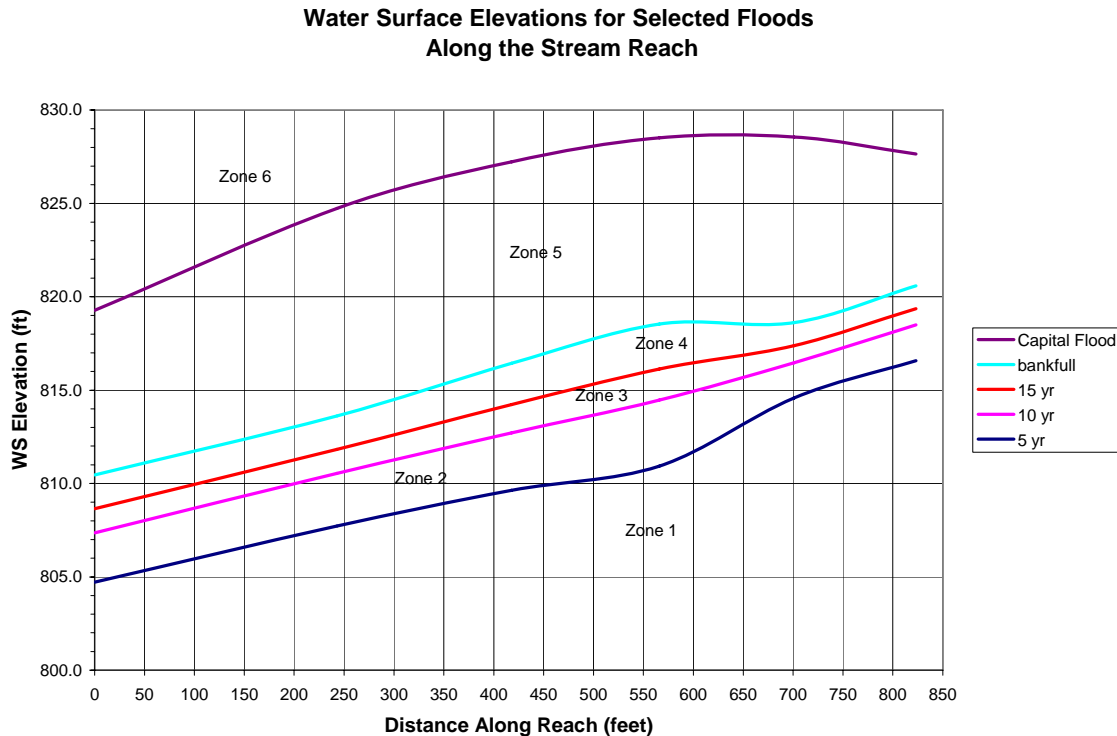
Figure 8: Recommended Flood Zones along the Banks.

The above hydraulic analysis ultimately leads to a set of recommended bank zones that are determined by certain frequencies of inundation that are relevant to either flood safety or associated physical conditions along the river reach that will dictate restoration strategy. The zones are summarized in figure 8.

This is the actual active stream channel comprised of boulders and cobbles. No physical alterations should be done within this zone except for limited planting of very flood-resistant riparian plants that thrive under conditions of frequent inundation and erosion.

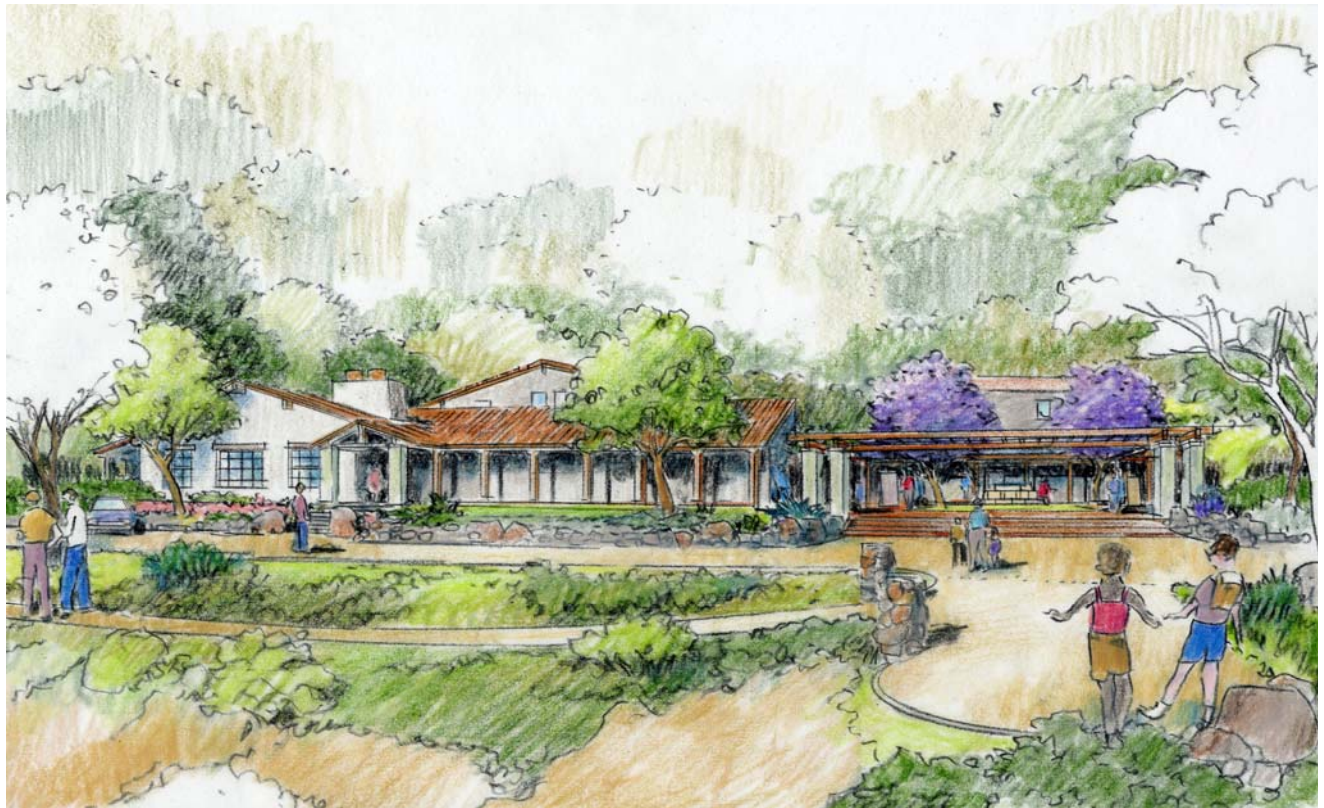
Figure: Proposed Overall Building

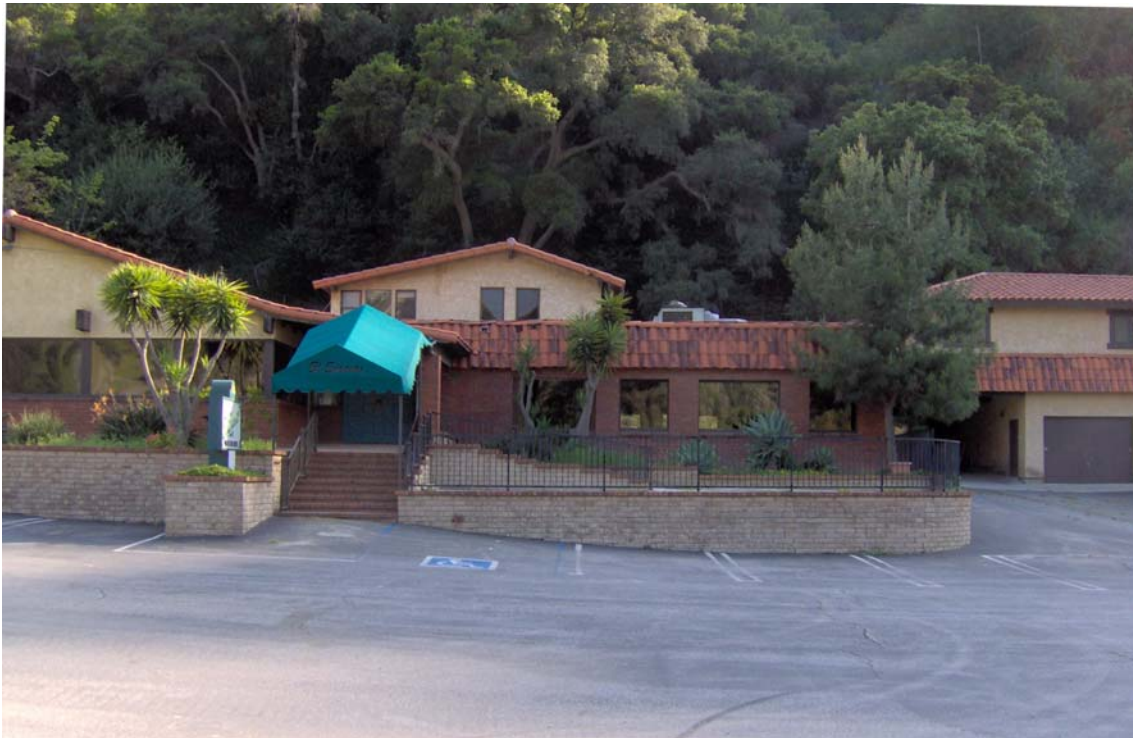
As a restaurant in the 1960's, additions appear to be made on all sides of the original house at different times. Till we arrive at today's building, which is broken up into four major rooms plus service spaces. In the rear of the building is a patio that is shaded by the verdant growth of trees on the steep hillside. Retaining walls keep water from the hillside from flowing on to the patio and into the building.

Figure: Existing Restaurant

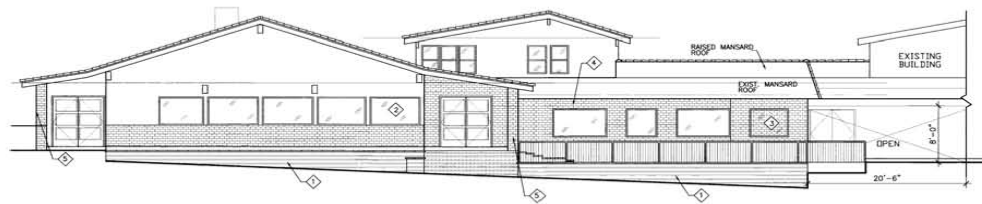
Figure: Existing Front Elevations

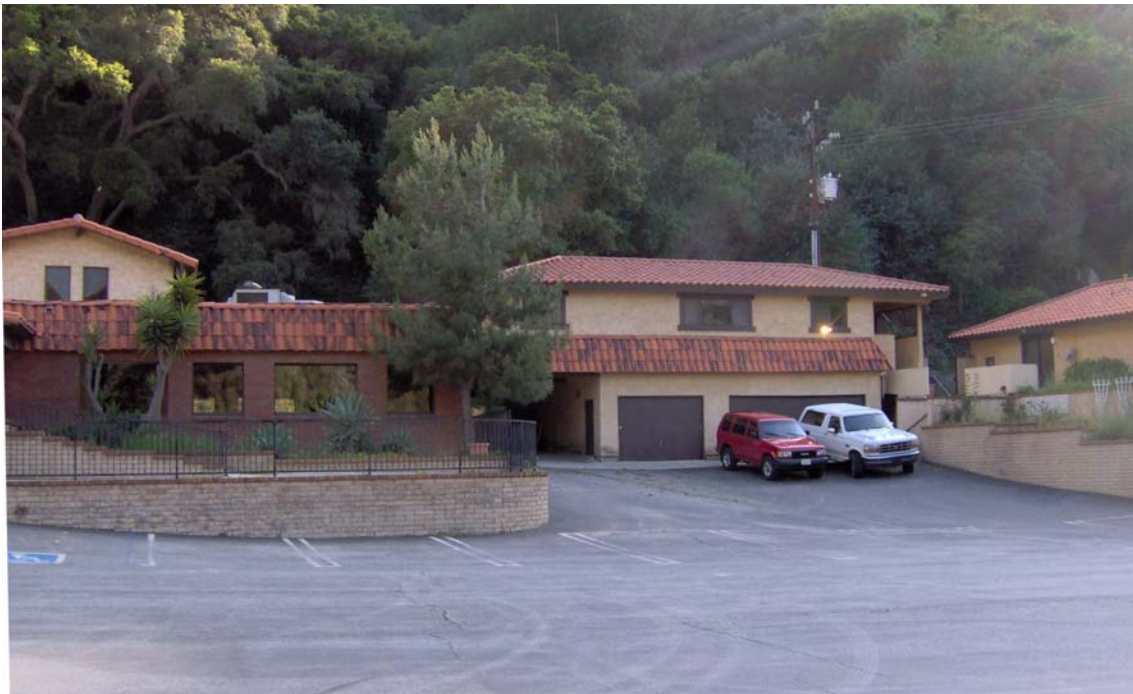
To the northwest or left of the restaurant is a carport and garages with a small single residential unit above. The buildings are also stucco built at a latter time as the restaurant expanded. Between these buildings water drains down from the slope above through the carport.

Figure: Existing Garage and Apartment

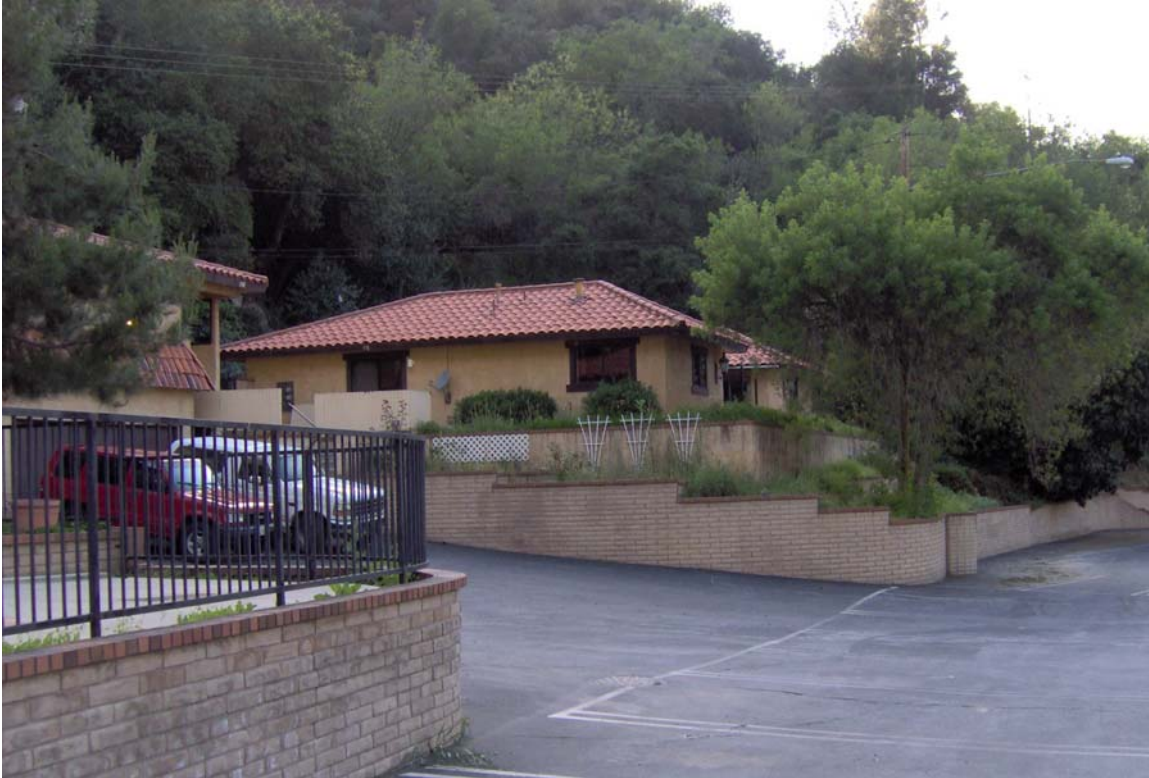
Further to the left of the main building is a two-unit apartment structure. It appears this structure was built after the structures because of the slump block retaining walls in front of the structure. One unit is currently the Rangers residence.

Figure: Existing Two-Unit Apartment

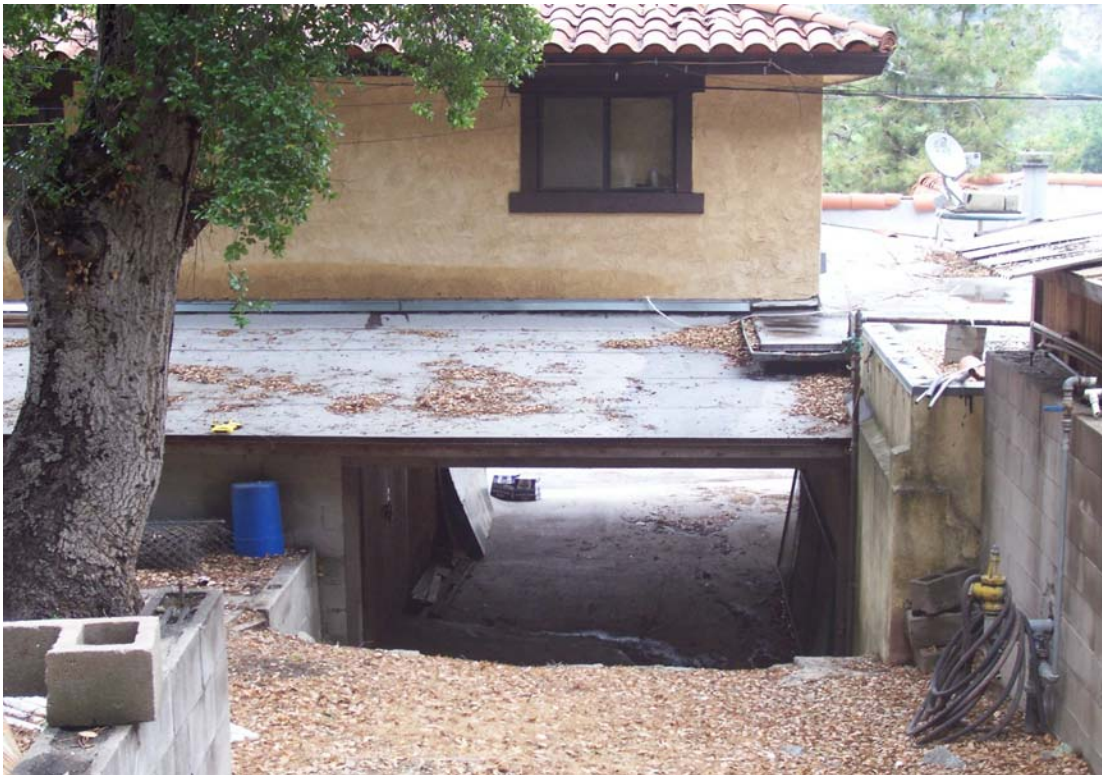
Drainage: Surface runoff from the slope behind the structure is probably the largest risk. Walls on the patio; the channel between the structures; and the constant running water indicated the drainage will be an on going issue. With the assistance of a Civil Engineer, the drainage can be attractive feature of the site. The drainage maybe expressed by different government agencies, as something other than drainage, such as a creek or environmentally sensitive habitat area. If so, any new structure would need to be set back away from this zone, or require zoning modifications and variances from many different agencies.

Figure: Drainage Looking Through Carport

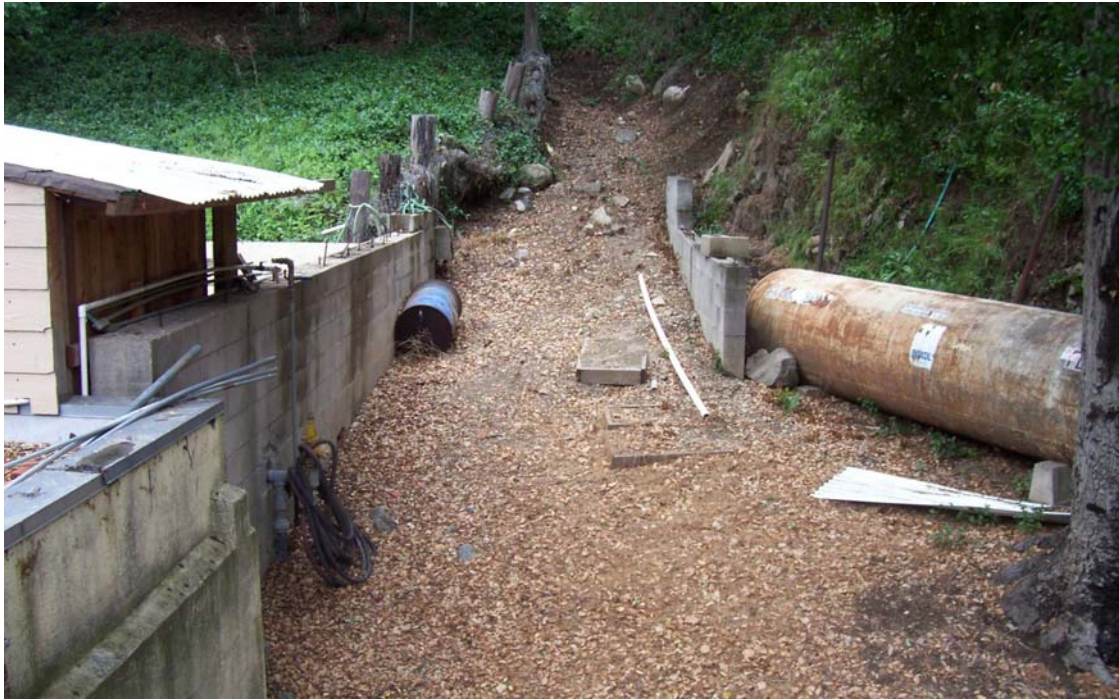
Figure: Drainage Looking Up The Hill

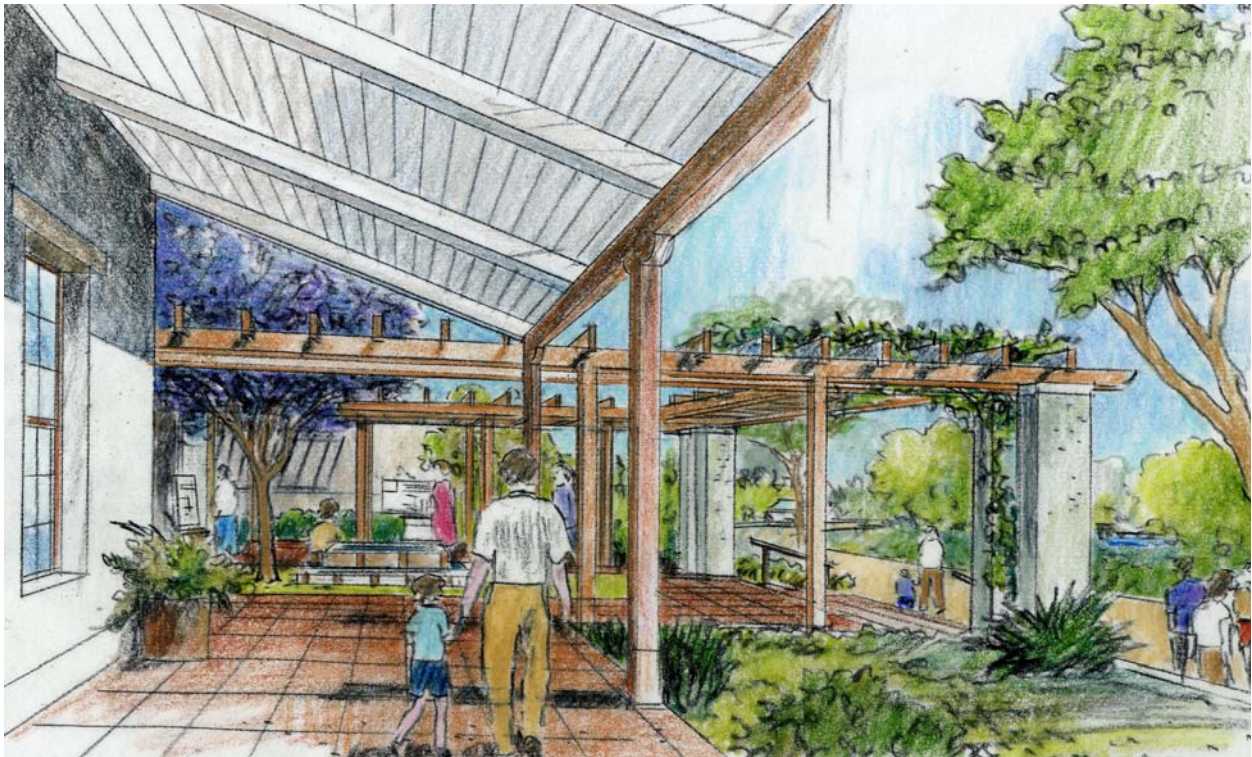
Figure: Trellis Detail

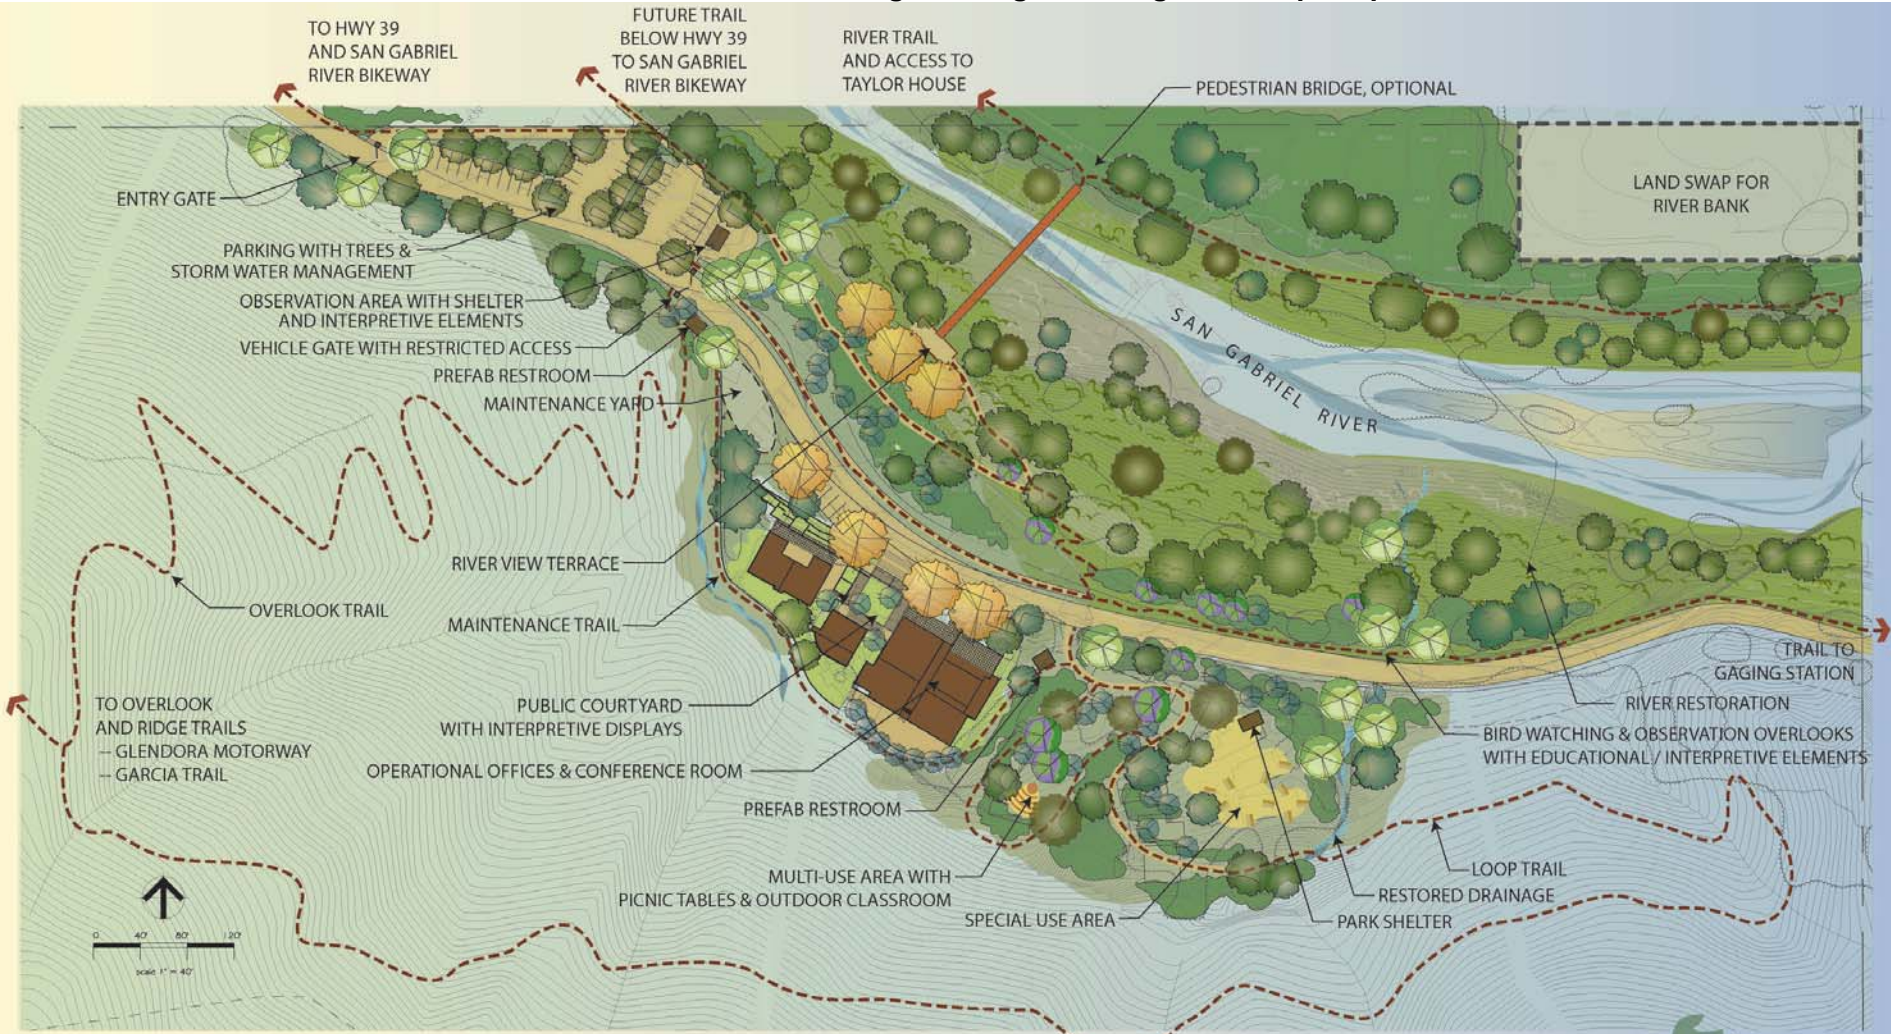
Figure 2

Nature Experience

PREFERRED CONCEPT
Presented May 2007

Nature Experience
PREFERRED CONCEPT
Presented May 2007

The proposed project includes several master-planned components that together would create a nature- and community-oriented public park. The San Gabriel River is the dominant natural feature of the project site and one of the objectives of the project is to create connectivity between the project site and the river, including terraced riverbank surfaces and improved native habitats. The Azusa River Wilderness Park components would be constructed in phases over a 10 to 15 year horizon. The proposed project includes the following activities, which are shown in Figures 2 through 5:

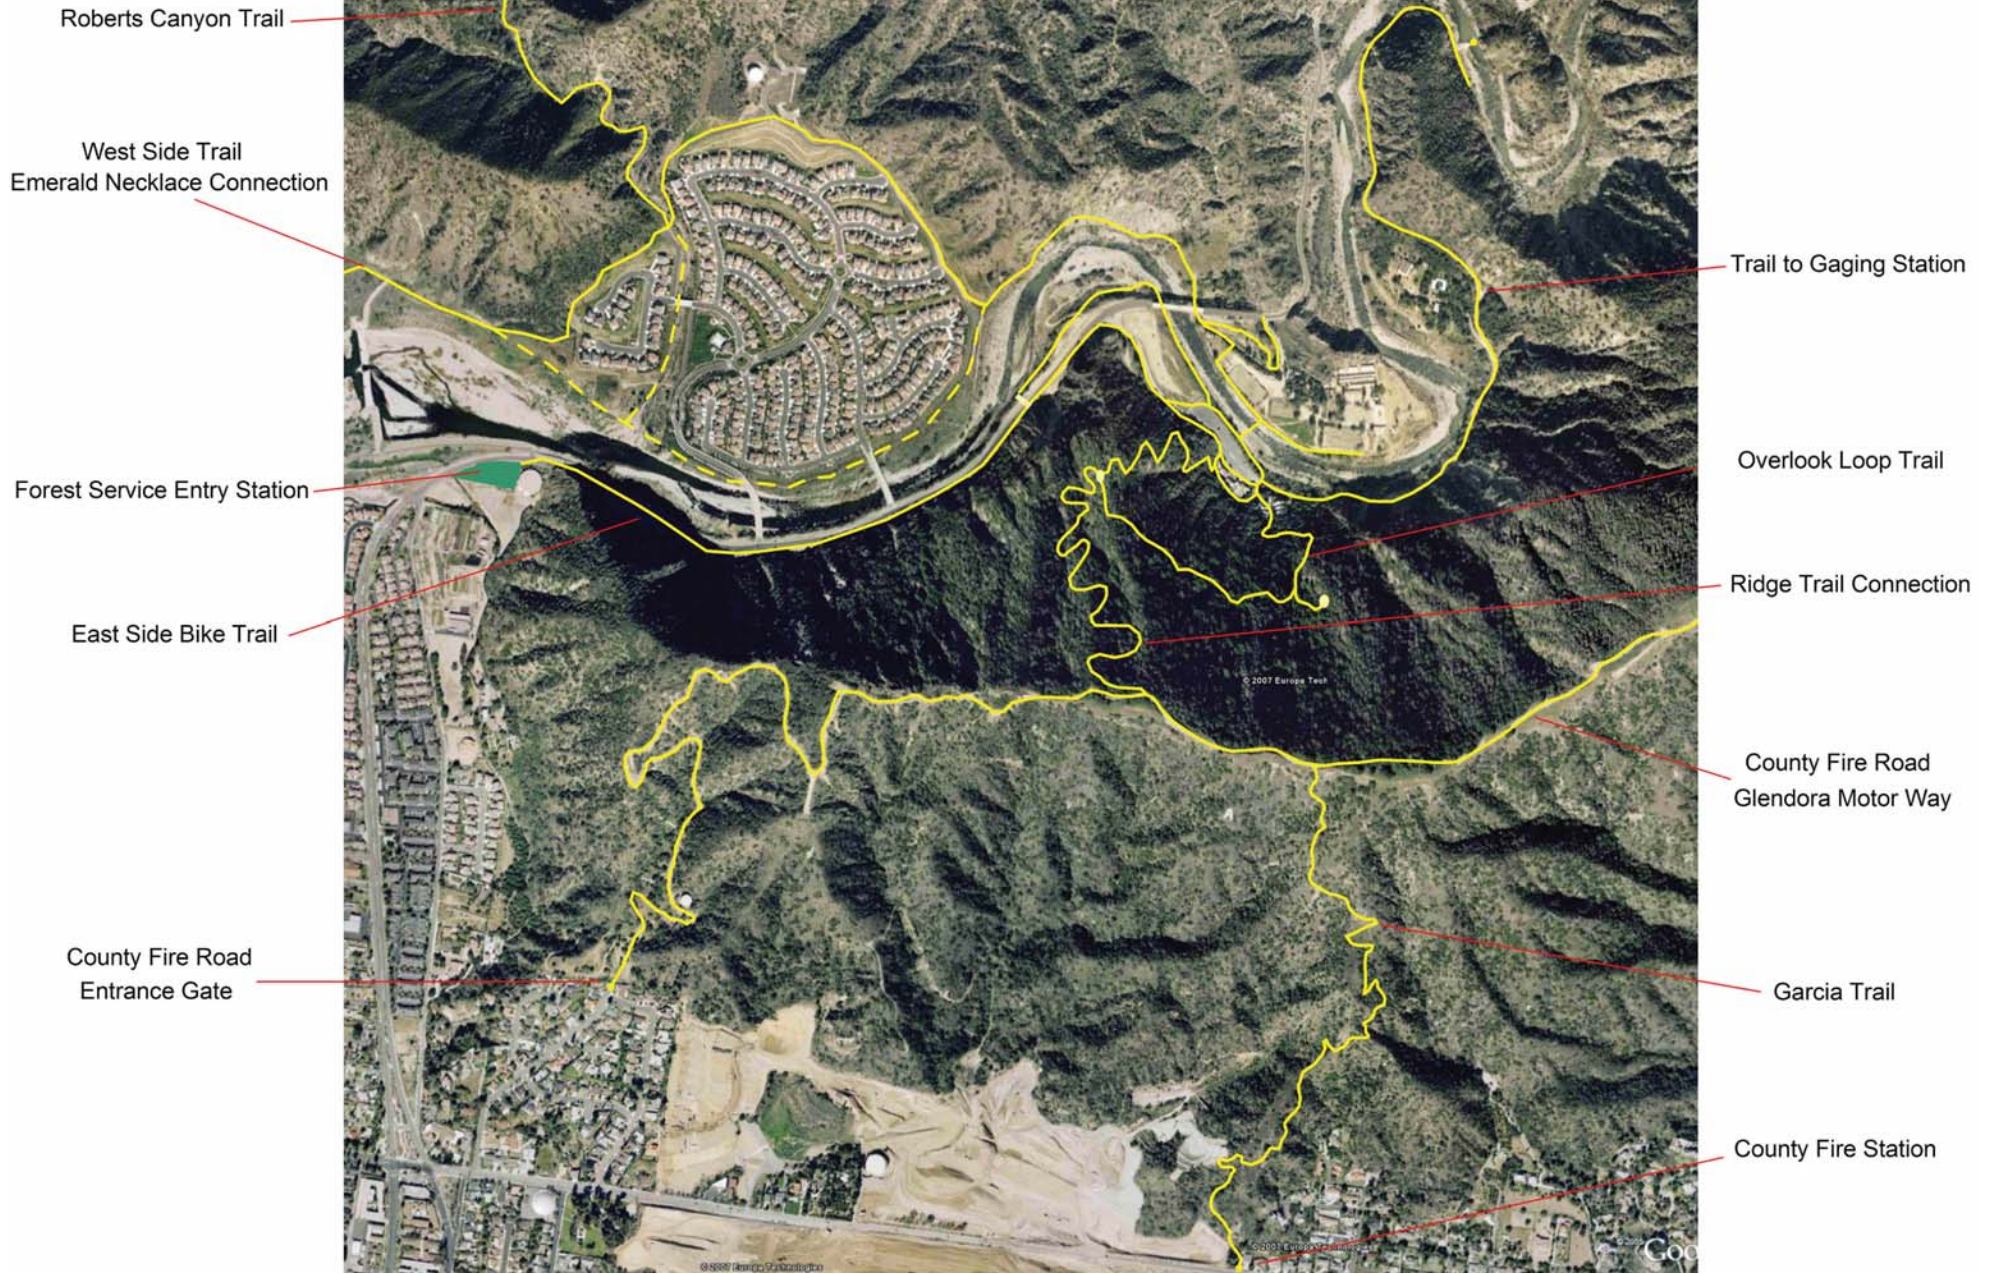
Potential Trail Connections
