KAMAN Rotor Tips

KAMAN AIRCRAFT CORPORATION

JUNE-JULY, 1966

In This Issue

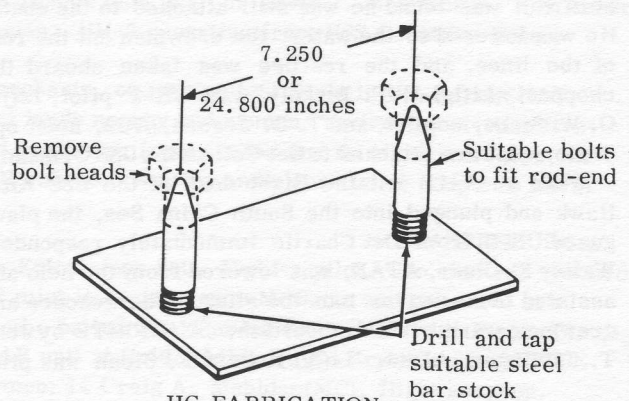
Dimensioning jigs can be easily fabricated by drilling and tapping a suitable steel bar to accept bolts of correct diameter. Cut off the heads of the bolts and maintain the dimensions called out in steps above. See sketch for jig example.

Whenever the main rotor control rod (shoe-string rod), P/N K659108, or the tracking turnbuckle, P/N K659270, rods or rodends are replaced, or during the re-rigging of the control system, the following nominal rodend lengths are recommended:

1. Adjust all 4 tracking turnbuckles, P/N K659270, to a 7.25-inch dimension between rodend centers. (Bench rig.)
2. Adjust all 4 main rotor control rods (shoe-string rods), P/N K659108, to a 24.80-inch dimension between rodend centers. (Bench rig.)

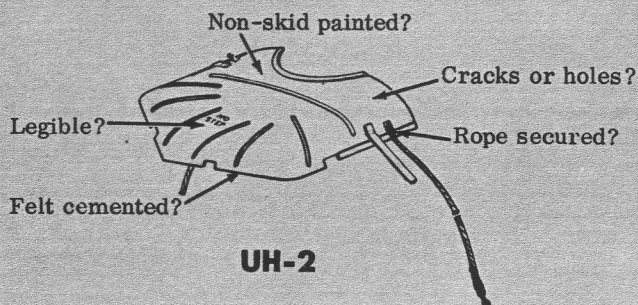
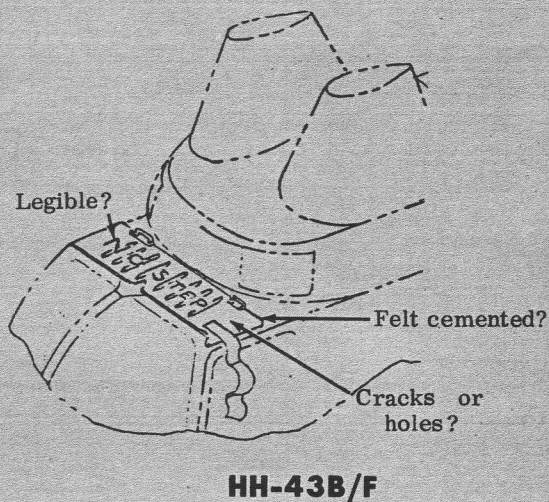
Protective Shields

1. Check fiberglass protective shield for cracks or holes and repair with standard fiberglass procedures. Install all doublers or reinforced patches on the exterior side.
2. Ensure that protective felt binding is free of abrasive particles and properly secured to the shield.
3. Repaint non-skid area as necessary to eliminate possible safety hazard while in use.
4. Store in protected areas where shield will not be subjected to "hangar rash."

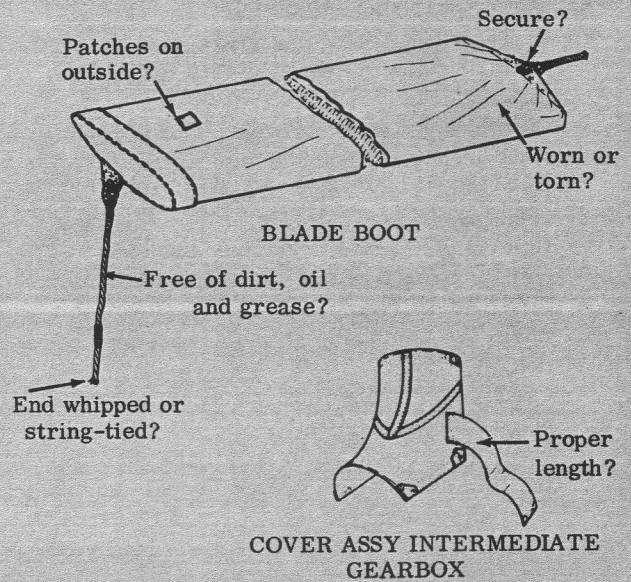
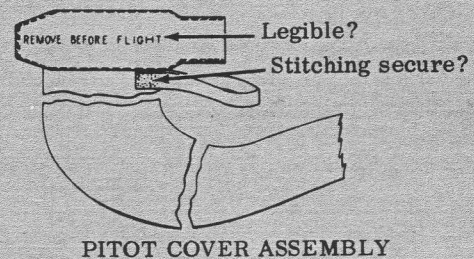
Protective Covers

1. Check canvas materials for worn spots, tears in canvas and loose or broken stitching in seams. Make sure grommets and streamers are secure. Streamers less than their original length (36 inches) should be replaced.
2. Remove oil and grease from protective covers with safety solvent, P/N P-D-680.
3. Clean rope and guide lines with soap and water or replace if worn.
4. Ensure that splice areas of rope are tight and that rope ends are whipped or taped to prevent unraveling.
5. Fold, or roll up loosely, canvas covers prior to storage in a well ventilated rack or bin. To prevent mildew, whenever possible, do not store in a damp area.
6. After cleaning, and before folding for storage, hang up to "air dry" naturally in a clean dry, and preferably sunlit, area.
7. When canvas repairs are necessary — sew canvas patches on exterior surfaces only.

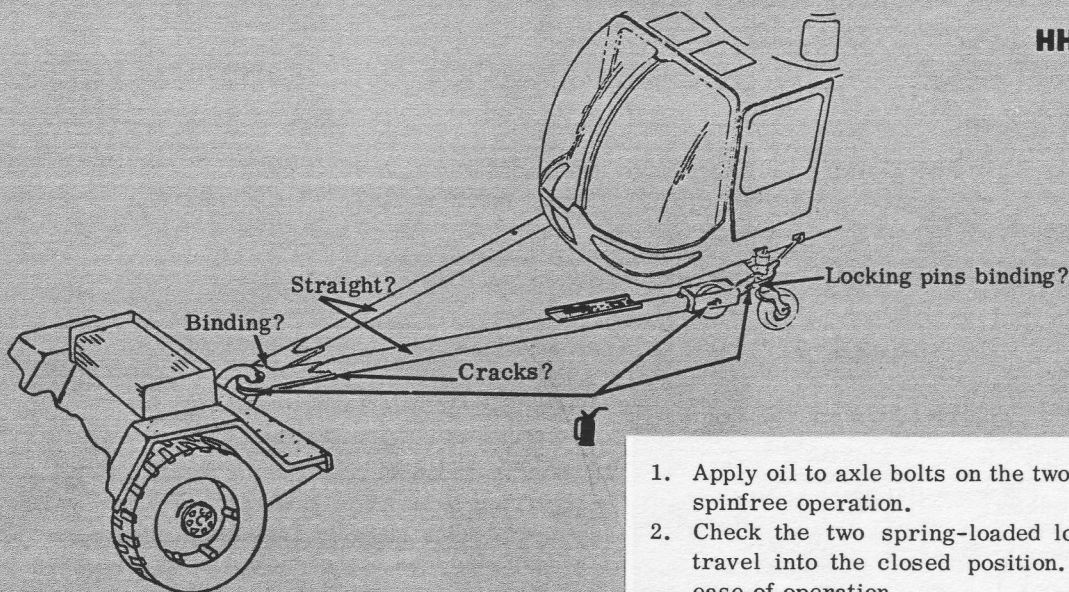
Tow Bar

1. Apply oil to axle bolts on the two trailing wheels for spinfree operation.
2. Check the two spring-loaded locking pins for full travel into the closed position. Oil sparingly for ease of operation.
3. Ensure parallel alignment of the two draw tubes. Straighten if bent out of alignment.
4. Check for binding of the scissor feature and apply oil to pivot bushing.
5. Remove all sharp objects embedded in rubber-tired wheels and clean oil and grease from wheels.
6. Paint bars if necessary.
7. Check for cracks and weld if necessary.

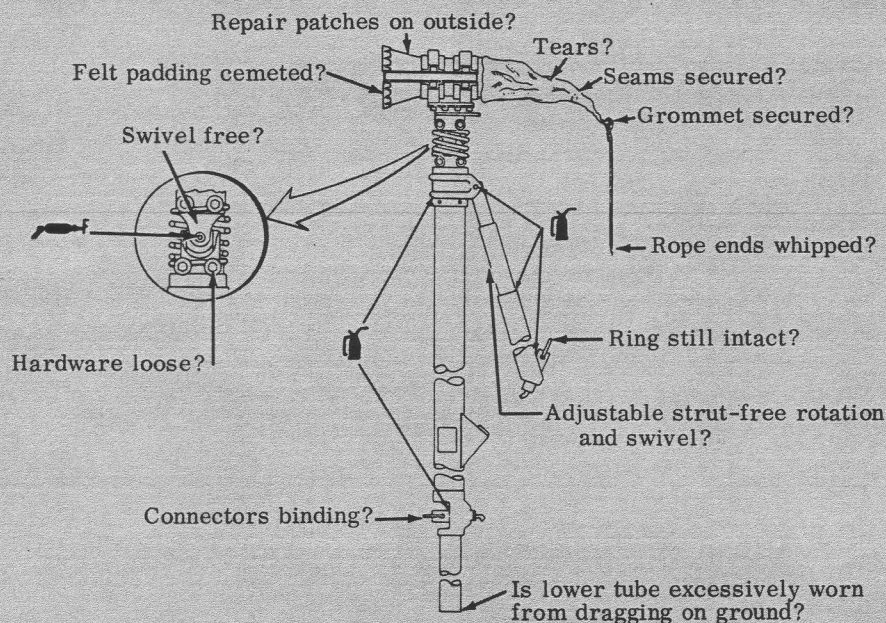
UH-2

Rotor Blade Folding Retaining Assemblies

1. Lubricate in accordance with HMI NAVWEPS 01-260HCA-2-1 lubrication chart.
2. If repairing of the fiberglass boot is necessary, install reinforcement doublers or patches on exterior side only.

3. Clean and oil connectors on strut assembly to ensure proper engagement into aircraft receptacles. Make sure steel rings are still intact and replace as necessary.

4. Ensure that universal joint, enclosed within the coil spring, is free to swivel easily in all directions. Lubricate as required.
5. Check the adjustable strut for operation and condition.

6. Check lower end of tube for excessive wear and replace if necessary.
7. Apply a light coat of oil to all the pivot points and rotating components. Wipe excess lubricant from retaining assembly.

14. Check attaching hardware for security within the fiberglass boot and tighten if necessary.

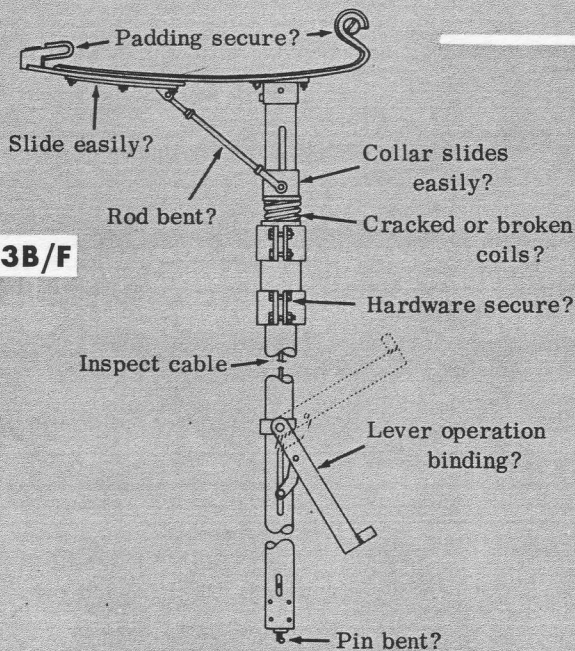
HH-43B/F

(HH-43B/F maintenance checks in addition to the ones above)

1. Ensure rodends are free to rotate and apply oil sparingly to attaching hardware.
2. Check sliding plate for freedom of operation. Ensure plate is not bent or sprung out of original shape. Straighten if necessary.
3. Inspect cable for broken strands and kinks; replace cable if necessary. Check swaging at both ends.
4. Clean oil and grease from rubber collar.
5. Inspect spring for broken or cracked coils.
6. Cycle the locking handle a few times to ensure bind-free operation of the attaching hardware. Correct any binding by replacement of parts or lubrication.

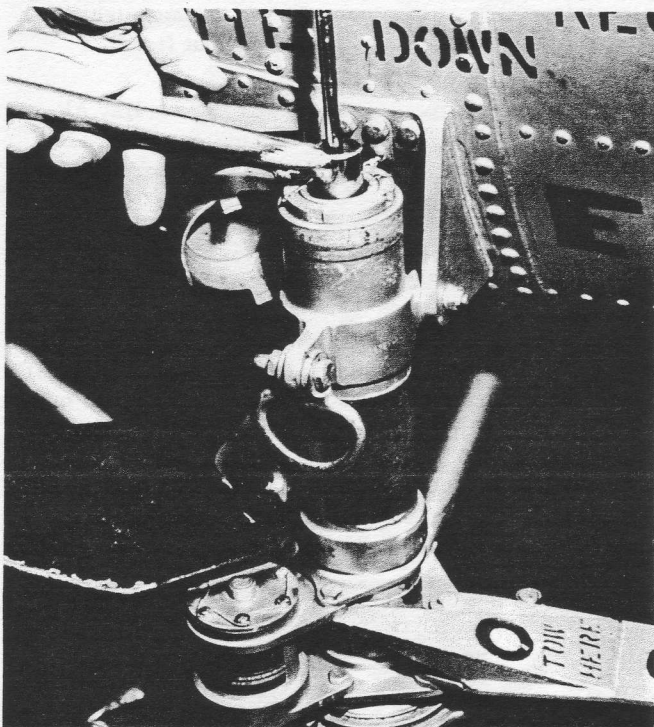
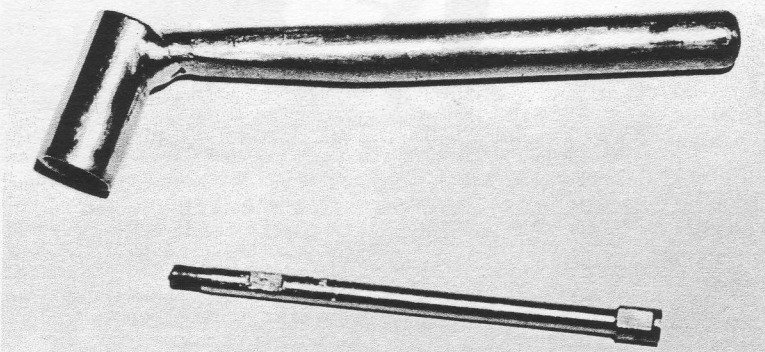
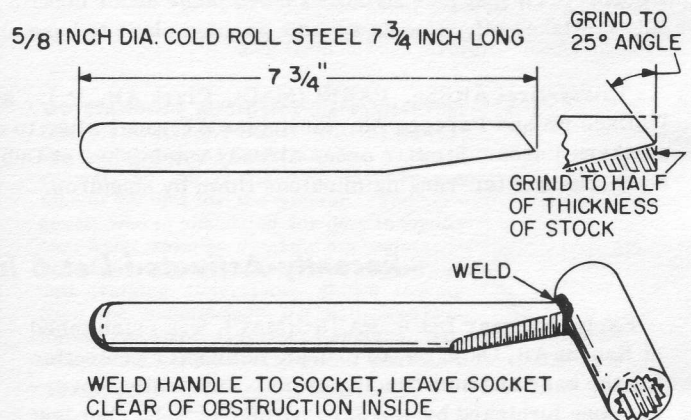
The strut servicing tool consists of a 3/4-inch, 12-point deep-well socket (FSN 5120-242-3349) which is cut to dimension and a handle of 5/8-inch diameter cold rolled steel. The handle is welded to the top of the socket in a fashion that permits the stem of the valve (high-pressure strut inflation valve P/N MS20813-1) to protrude through the top. This tool allows the mechanic to install the valve extension and air hose at one time and eliminates the need for two or three separate operations.

DEEP WELL SOCKET FSN 5120-242-3349
CUT SOCKET 2 INCHES LONG

VIEW OF FINISHED PRODUCT

SSgt Cary W. Walton of Det 9, EARRC (MAC), Shaw AFB, S. C., devised this servicing tool to save time and lessen the possibility of "knuckle scraping" while inflating and deflating the auxiliary landing gear struts on HH-43B/F helicopters. It is estimated that the device, which can be manufactured locally, will cut labor time in half and contribute to the USAF Cost Reduction Program with a first-year savings of more than \$1423 if utilized with all the HH-43's in the MAC Command.

Under the present method of strut servicing, the deep-well socket is inserted over the pressure control nut and a pair of vice grip pliers is then locked on the socket and used to loosen the nut. A valve stem is inserted through the square socket opening and the strut is serviced to the proper height. The nut is then tightened with the vice grip/socket combination and the valve stem removed. An alternate method is to grind two flats on the socket to accommodate an open end or adjustable wrench. Both methods involve using the socket in a manner different from its design purpose.

PROCEDURAL USE OF TOOL

4. Attach the pressure hose to the valve stem extension and pressurize. This will preclude the possibility of hydraulic fluid entering the pressure hose when the pressure control nut is loosened.

5. Slowly loosen the pressure control nut and inflate the shock strut to the proper height. Continue servicing the shock strut as outlined in T.O. 1H-43(H)B-2.

- NOTE: Although the primary design of the tool is for the auxiliary landing gear strut, it may be also used to service the main landing gear struts.
