NRL Report No. R-2093  
BuShips Prob. X71S

TESTS OF THE MODEL SF RADAR

Contractor - The Submarine Signal Co.

NAVAL RESEARCH LABORATORY  
ANACOSTIA STATION  
WASHINGTON, D. C.

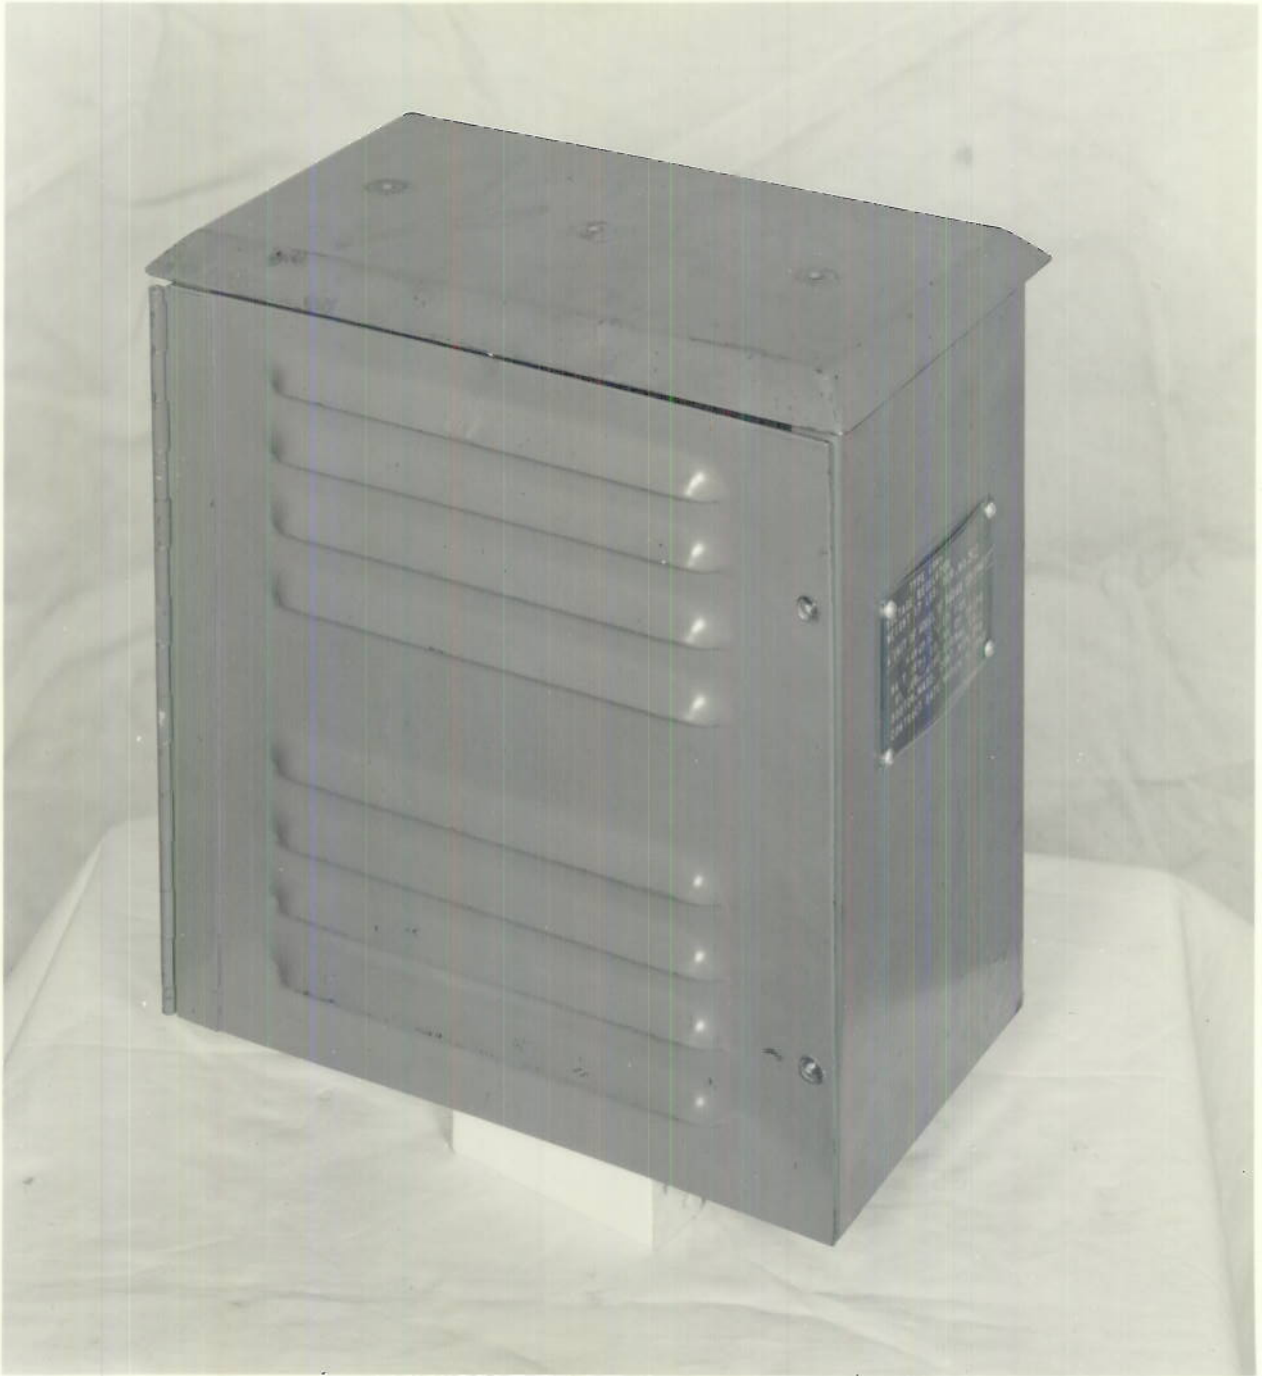
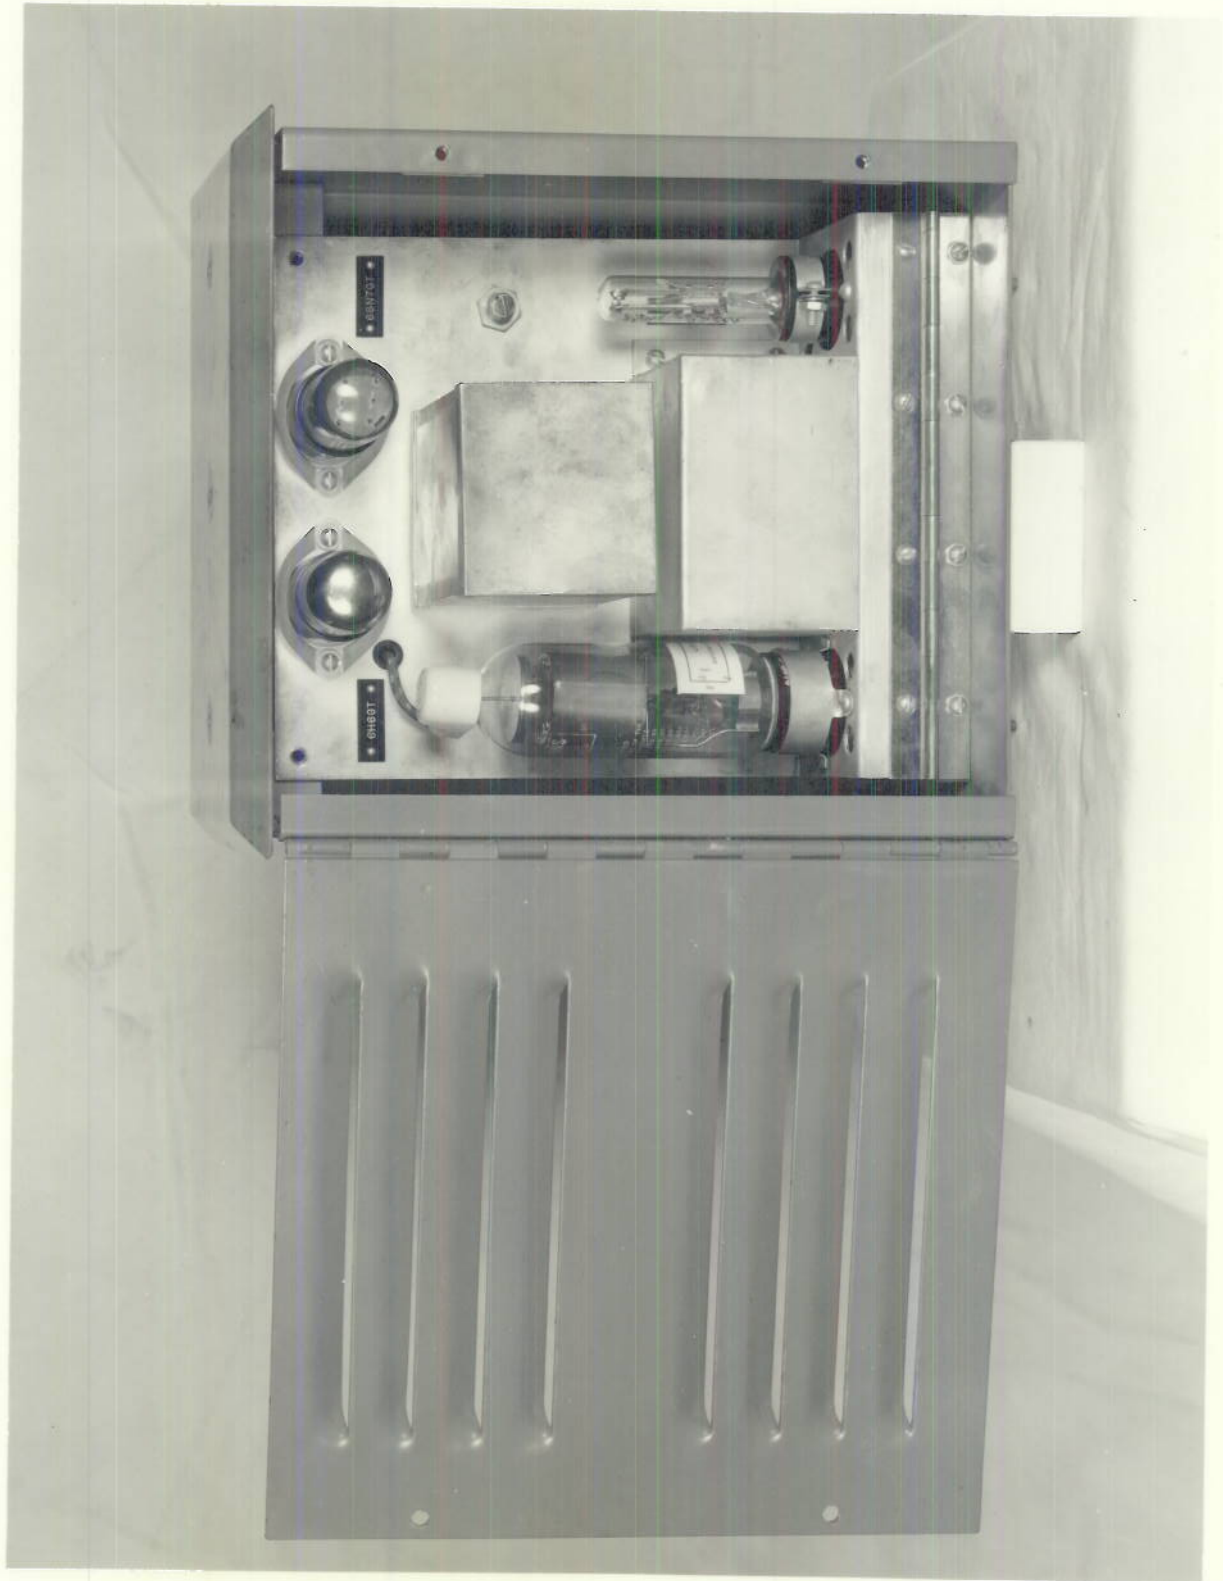
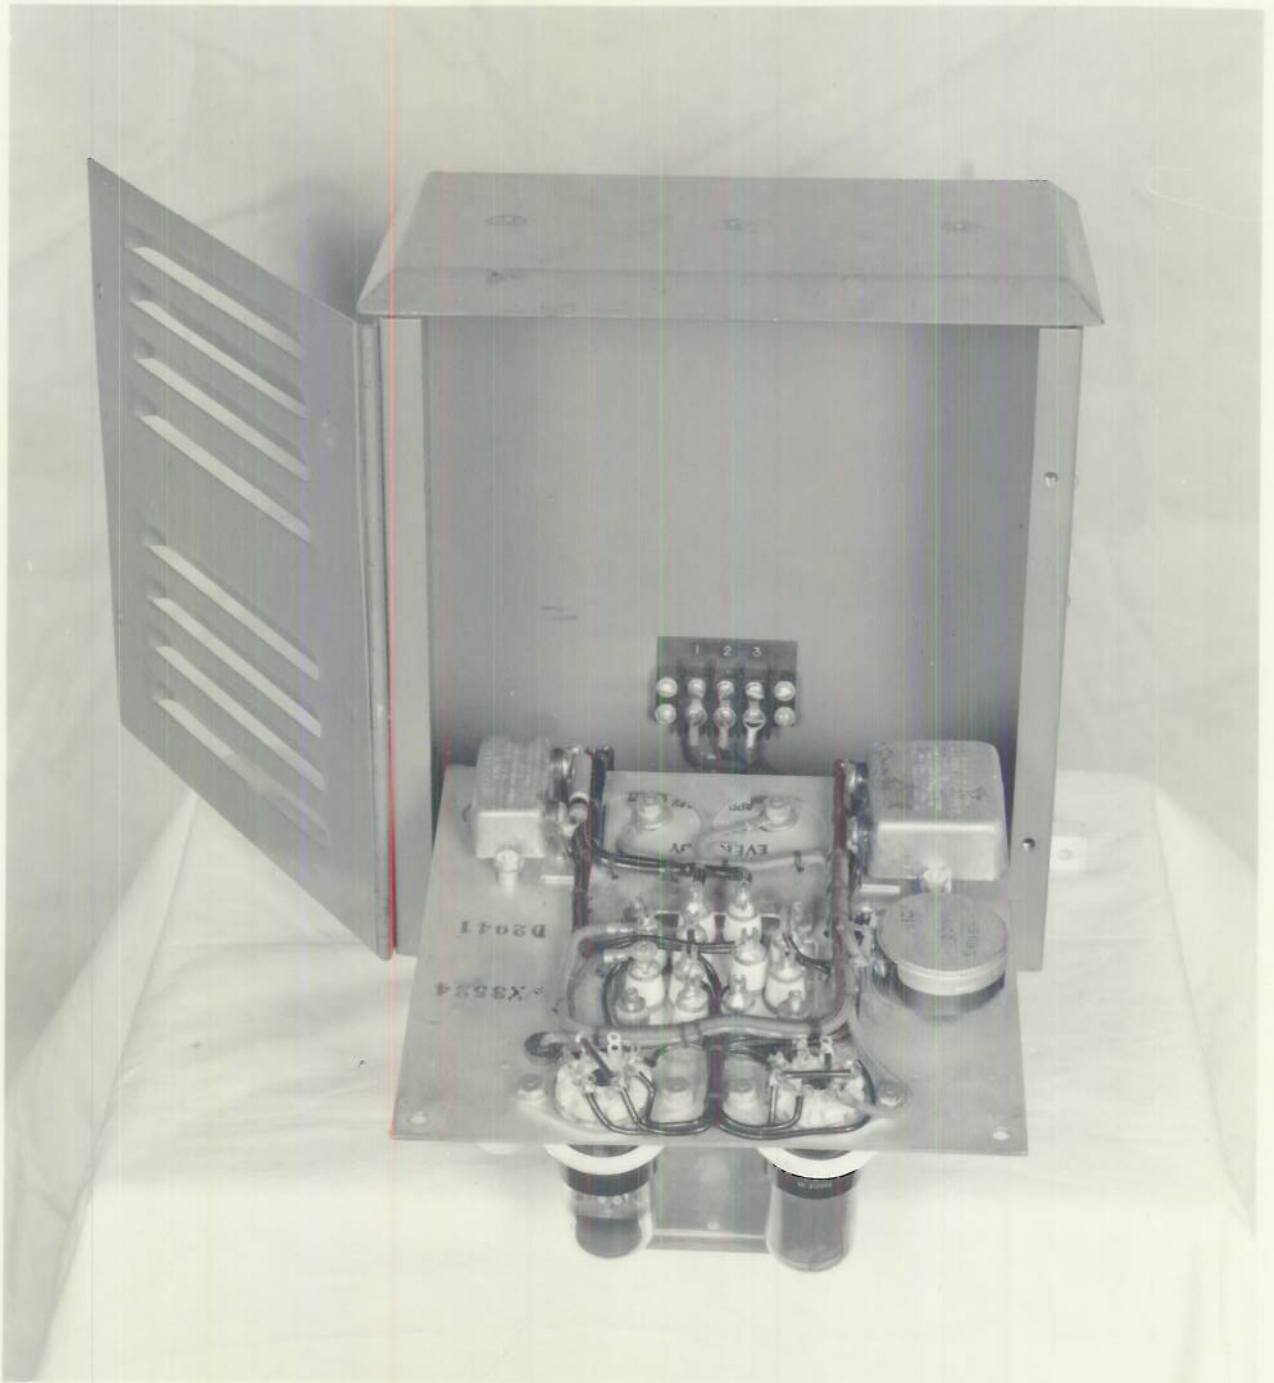
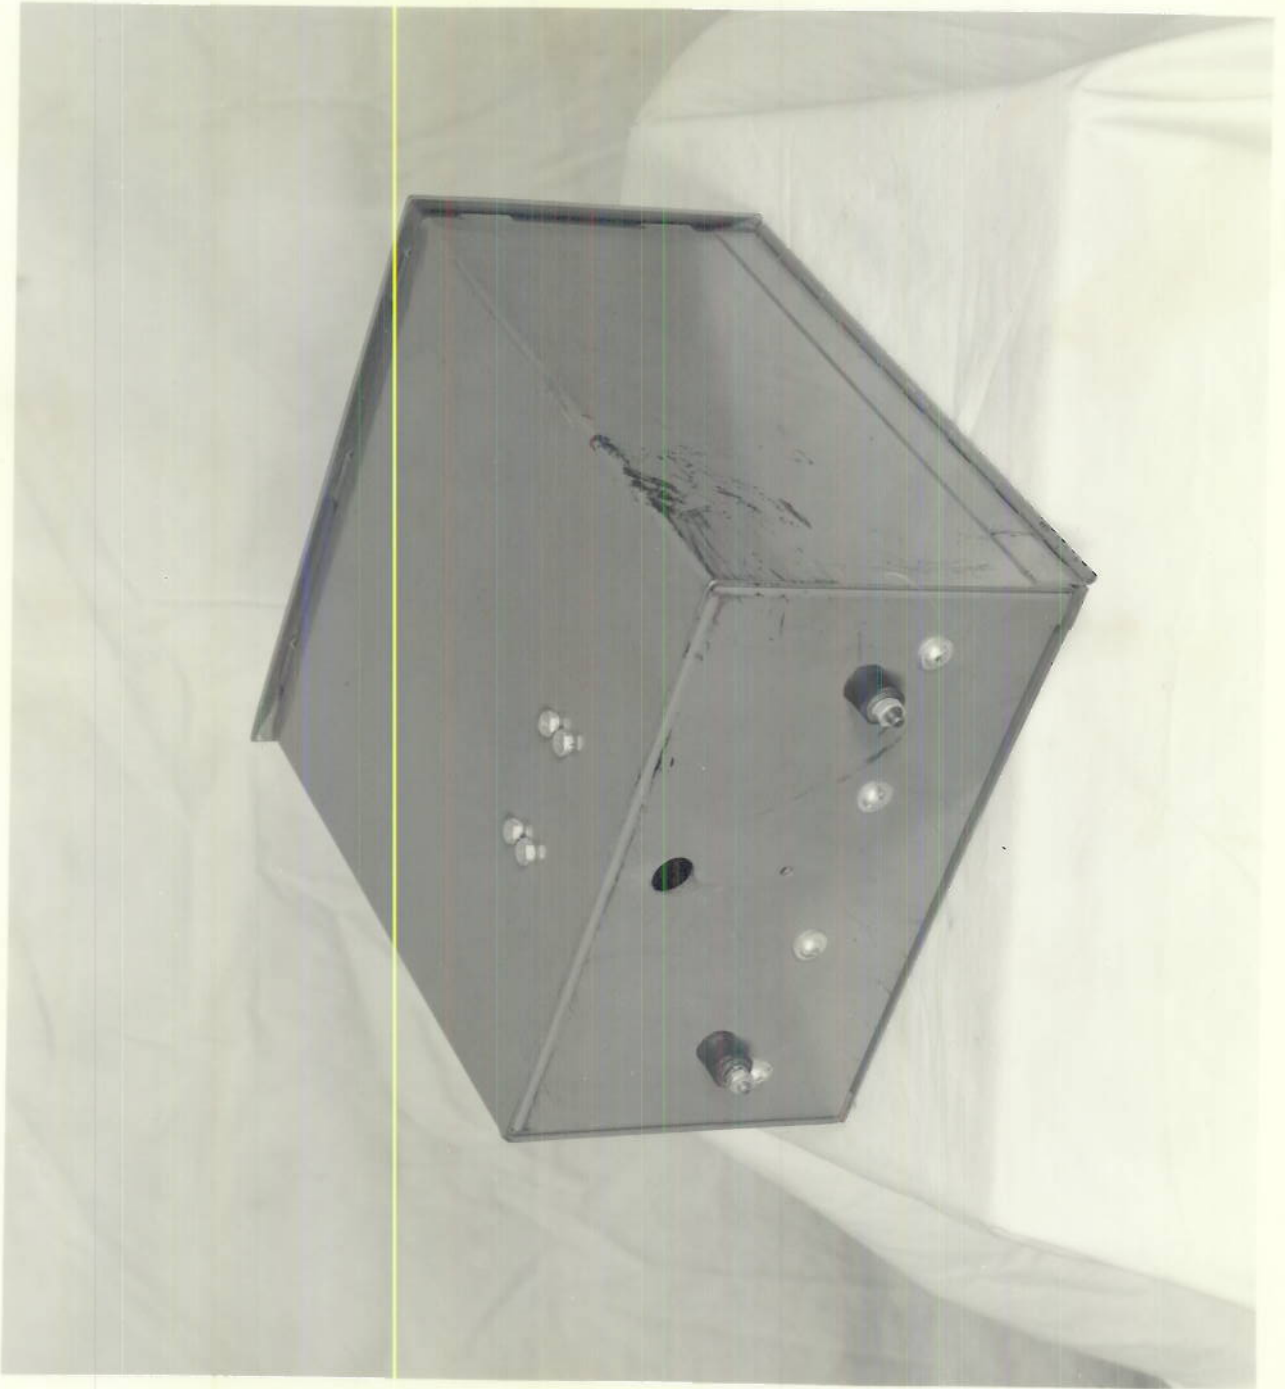
The subject equipment operates with a line voltage of 115 volts at 400 cycles which is supplied by a motor generator set designed for operation on 110 volt d-c supply. The output is maintained constant by a thyatron voltage regulator. See plates 19 to 22, Section 2. A vacuum-sealed thermal time delay is used to allow the thyatron cathode to reach operating temperature before applying the plate voltage.

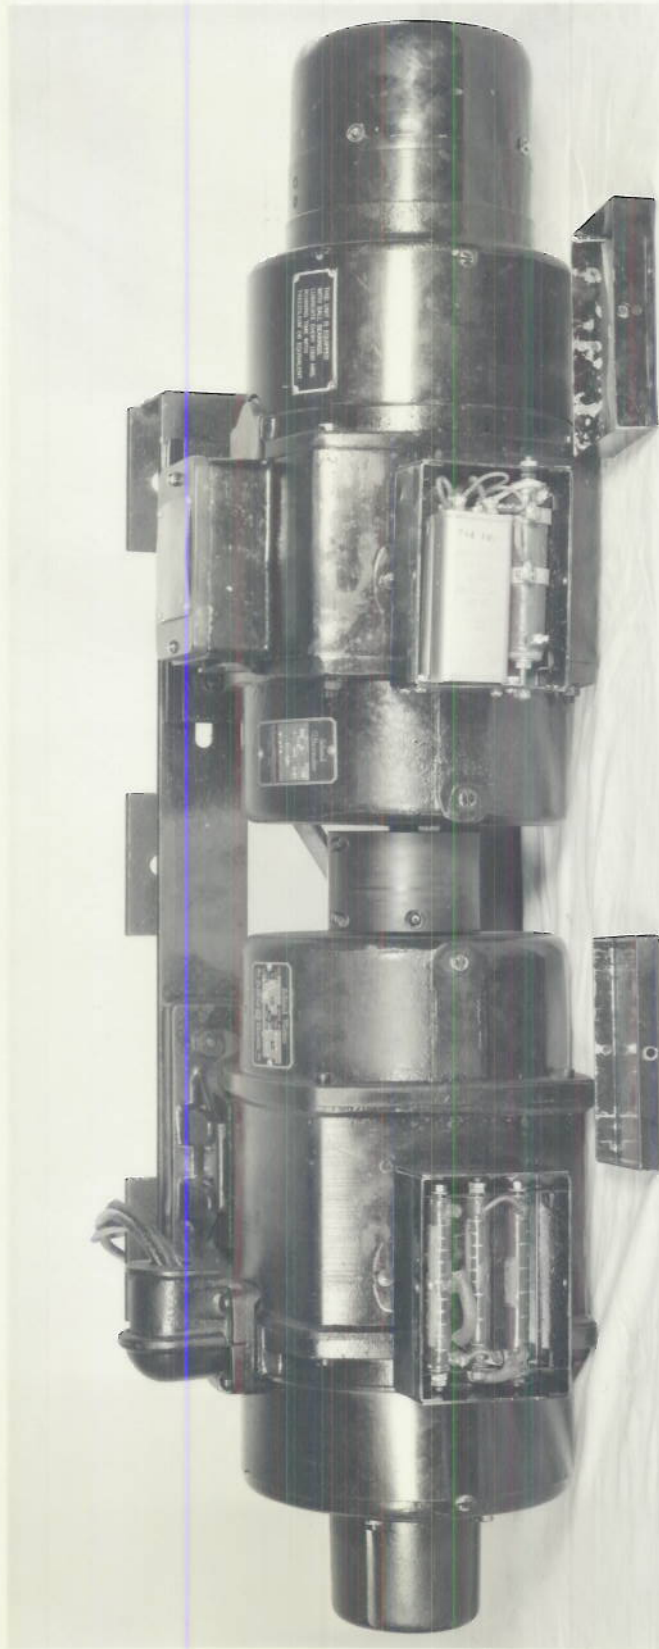
PLATE 30 SEC.2

mounted on an unplated brass rod (Plate 30). This rod should be nickel or cadmium plated.

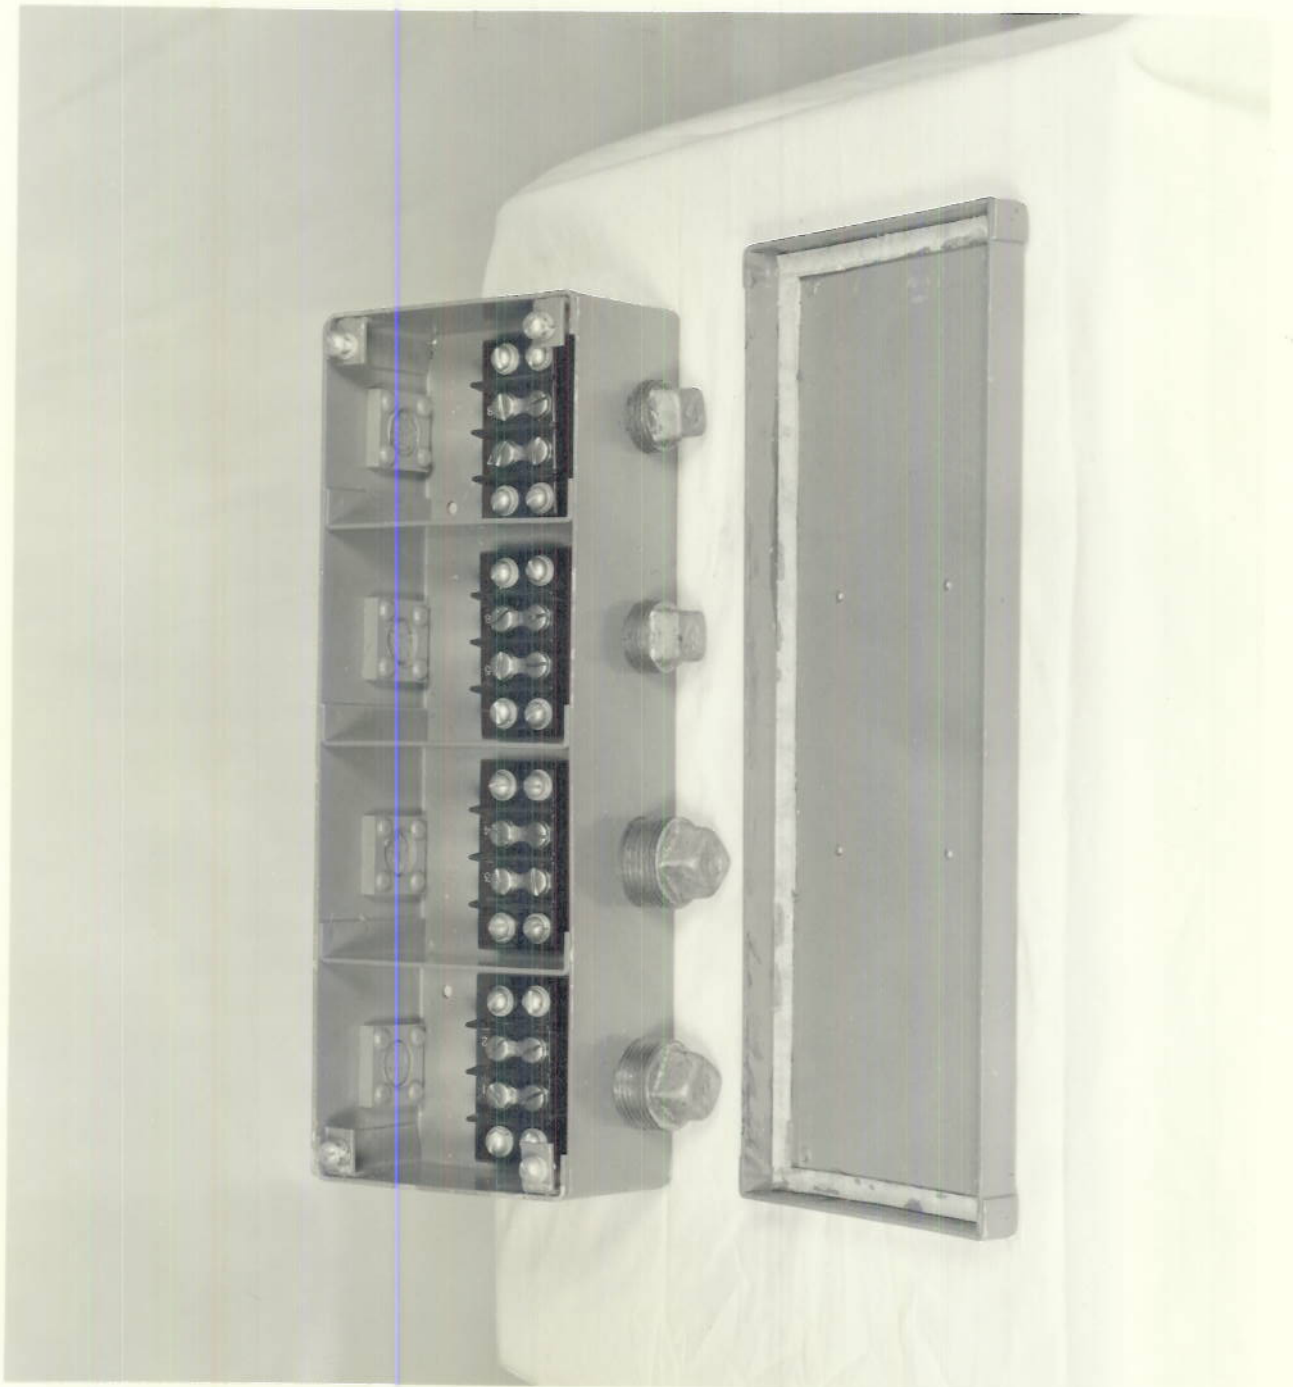
PLATE 32 SEC.2

2-15-30. The terminal box supplied with the equipment is not moisture proof. (Plate 32)

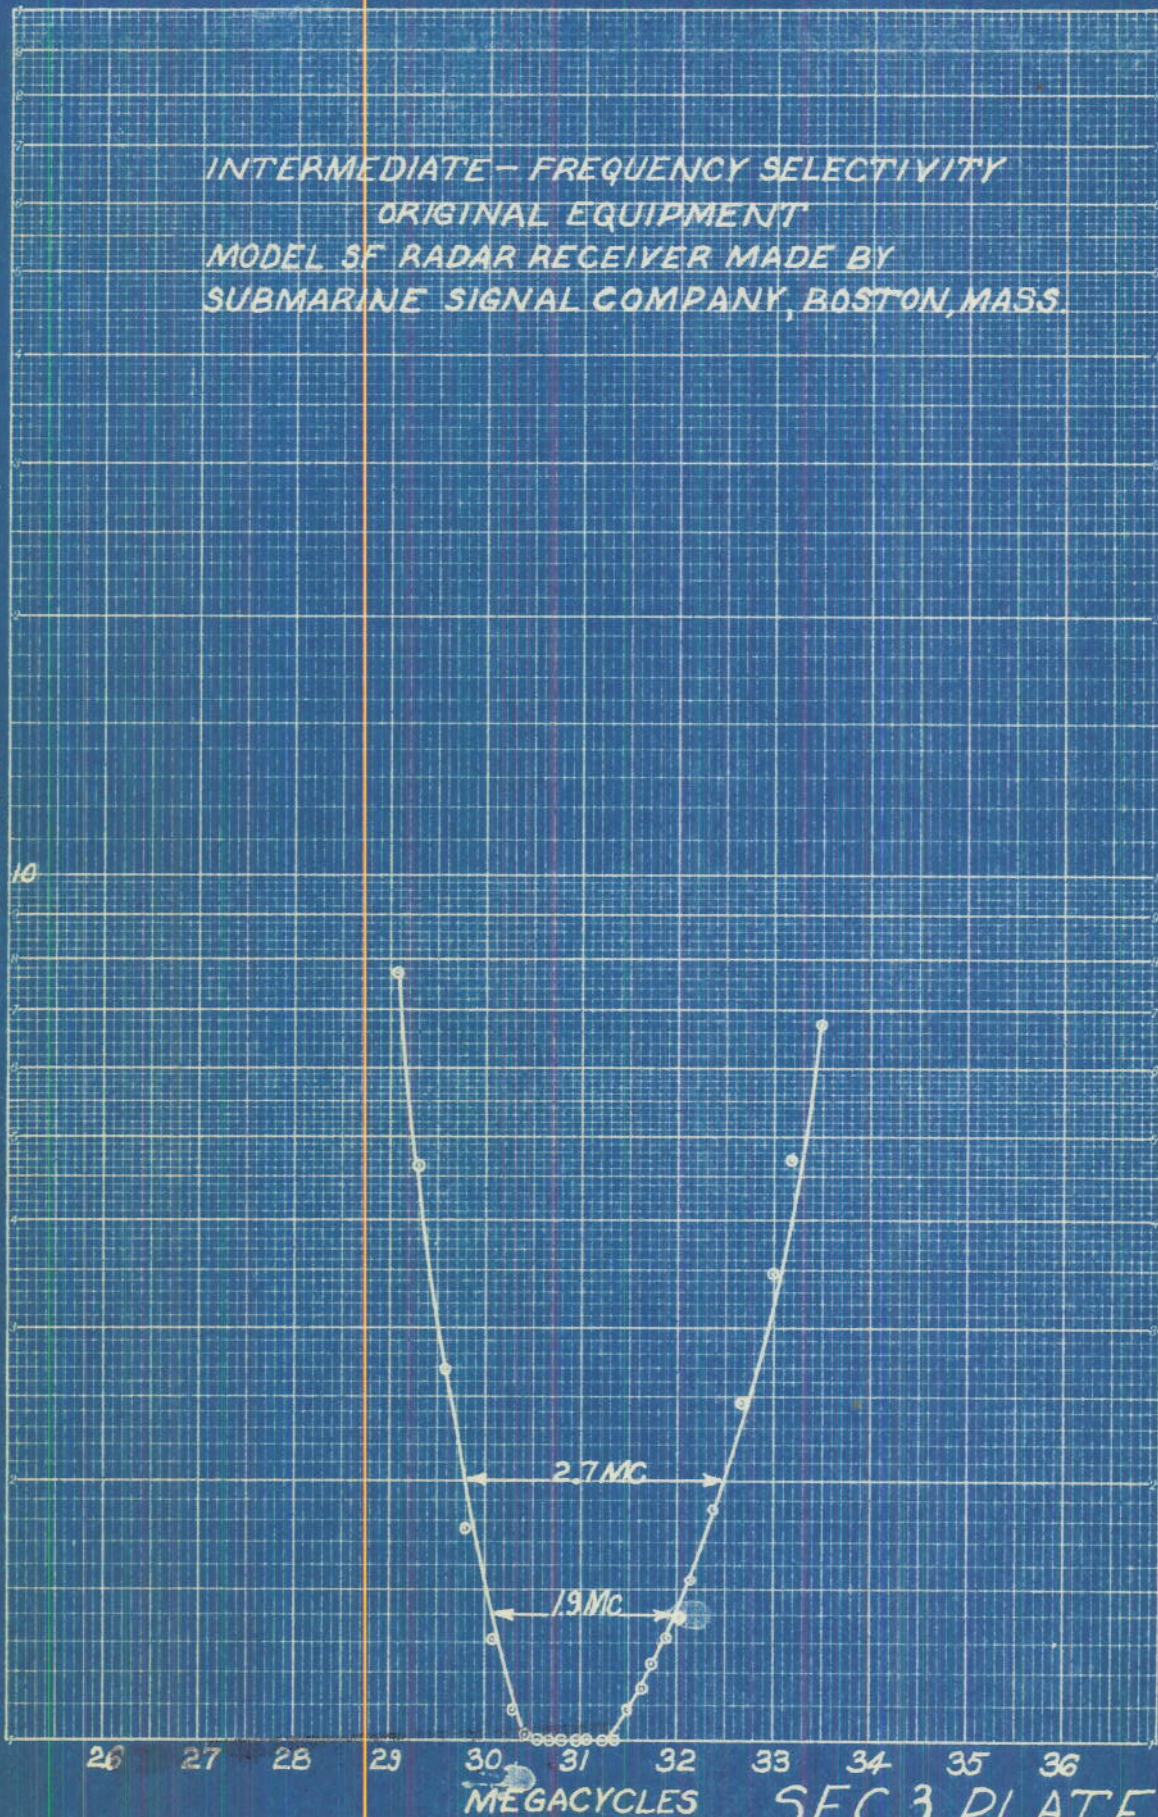
SEC. 3 PLATE 1

INTERMEDIATE-FREQUENCY SELECTIVITY  
ORIGINAL EQUIPMENT  
MODEL SF RADAR RECEIVER MADE BY  
SUBMARINE SIGNAL COMPANY, BOSTON, MASS.

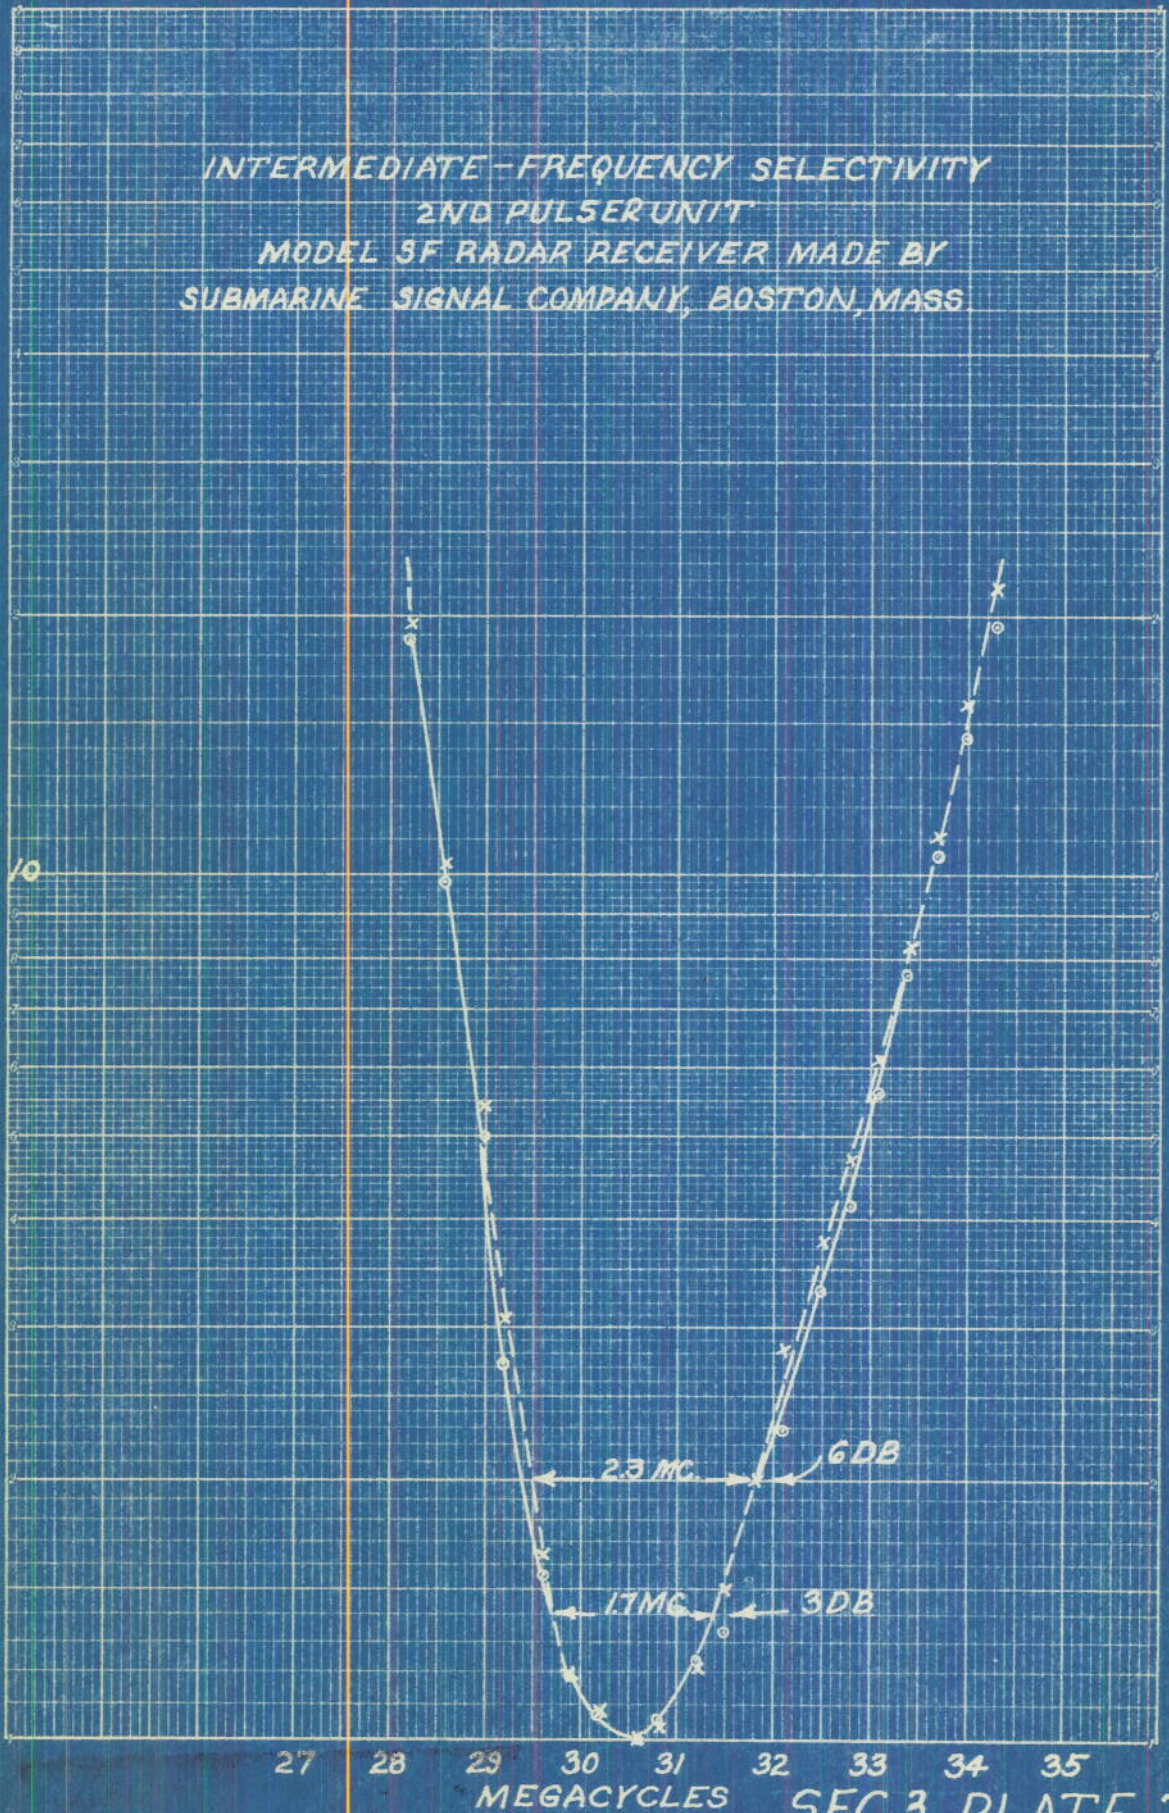
SEC. 3 PLATE 2

INTERMEDIATE-FREQUENCY SELECTIVITY  
2ND PULSER UNIT  
MODEL 3F RADAR RECEIVER MADE BY  
SUBMARINE SIGNAL COMPANY, BOSTON, MASS.

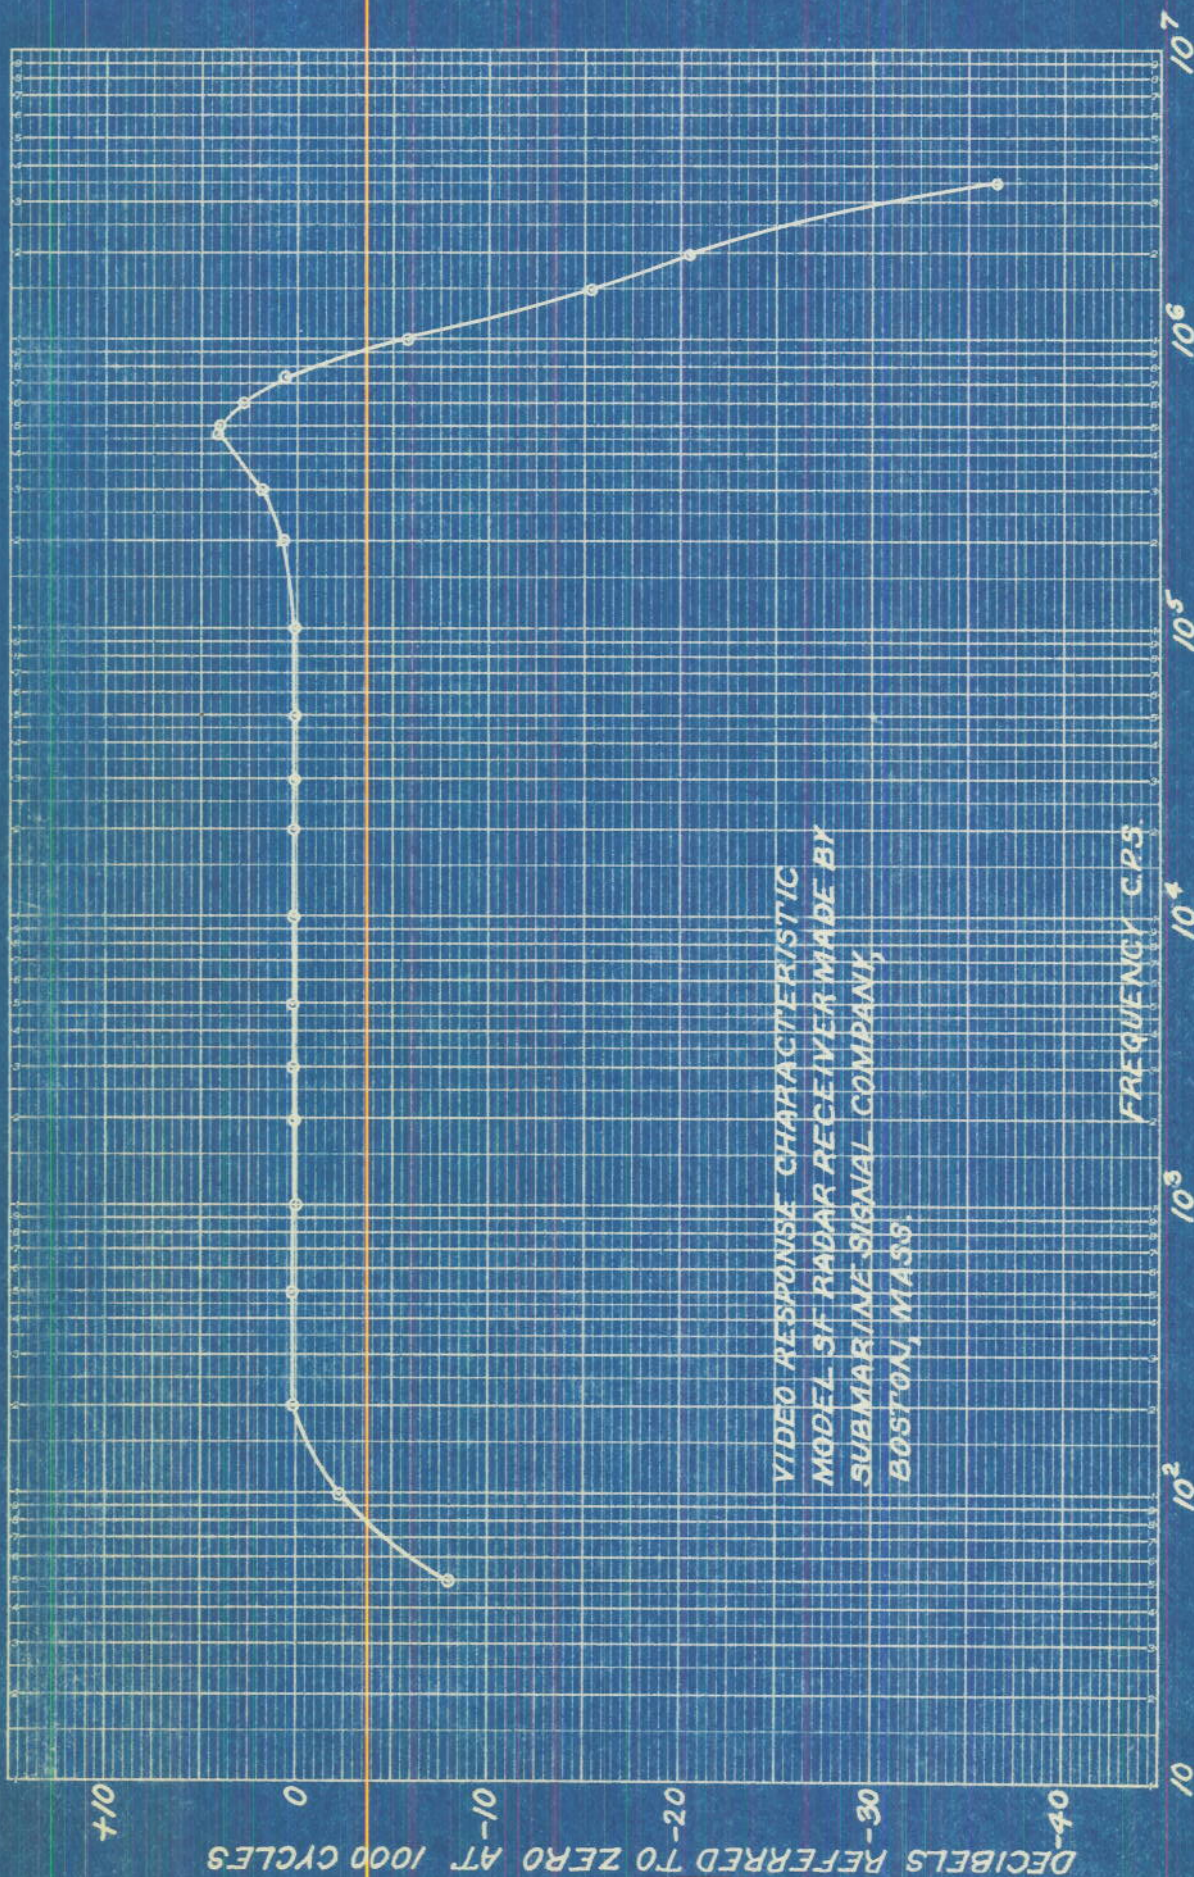
VIDEO RESPONSE CHARACTERISTIC  
 MODEL SF RADAR RECEIVER MADE BY  
 SUBMARINE SIGNAL COMPANY,  
 BOSTON, MASS.

DECIBELS REFERRED TO ZERO AT 1000 CYCLES

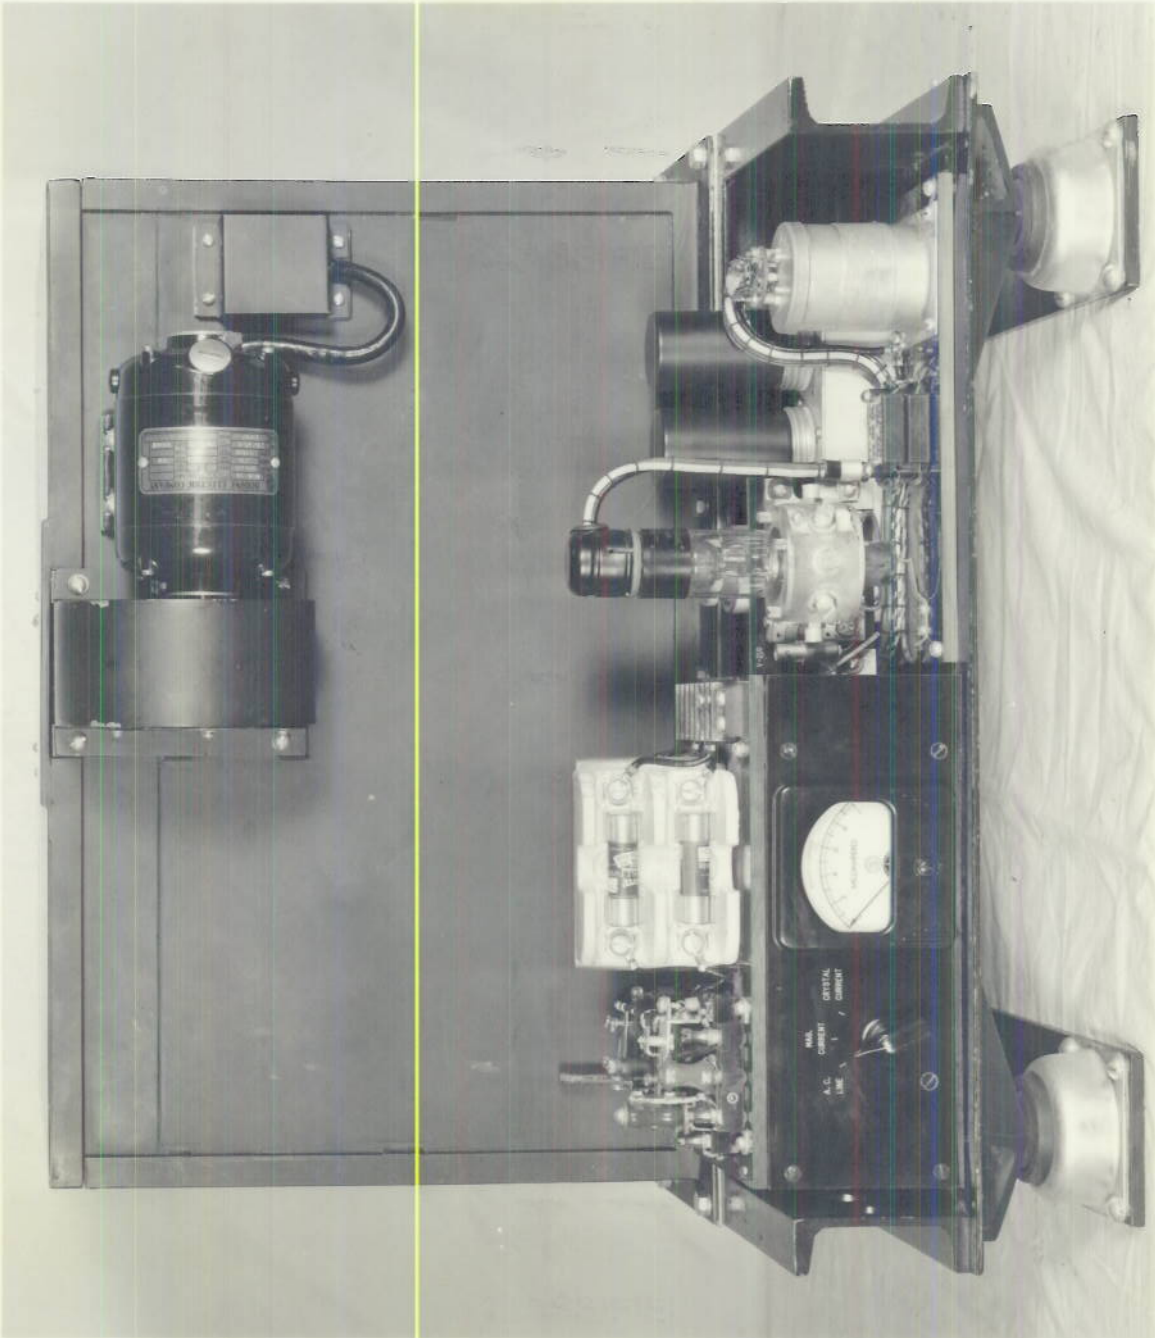
PLATE 109

Front View of Pulser Unit - Cover Removed		Plate 109
Top View of Pulser Unit - Showing Oscillator, Crystal Mixer, TR Box, and Meter Assembly		Plate 110
Close-Up of Receiver Units in Pulser		Plate 111

- 3-11-1. The single meter supplied with this equipment is mounted on the pulser unit. See plates 109 and 111. This instrument, upon the manipulation of the meter switch can be made to read the crystal current of the mixer, the magnetron current, or the a-c voltage supplied to the equipment.
