Aquatic Ecosystem Restoration in the Texas Western Gulf Coast Plain / Lower Rio Grande Alluvial Floodplain Ecoregion

Resaca Boulevard Resaca Section 206—Vegetation Community Adaptive Management

August 2023

Final report

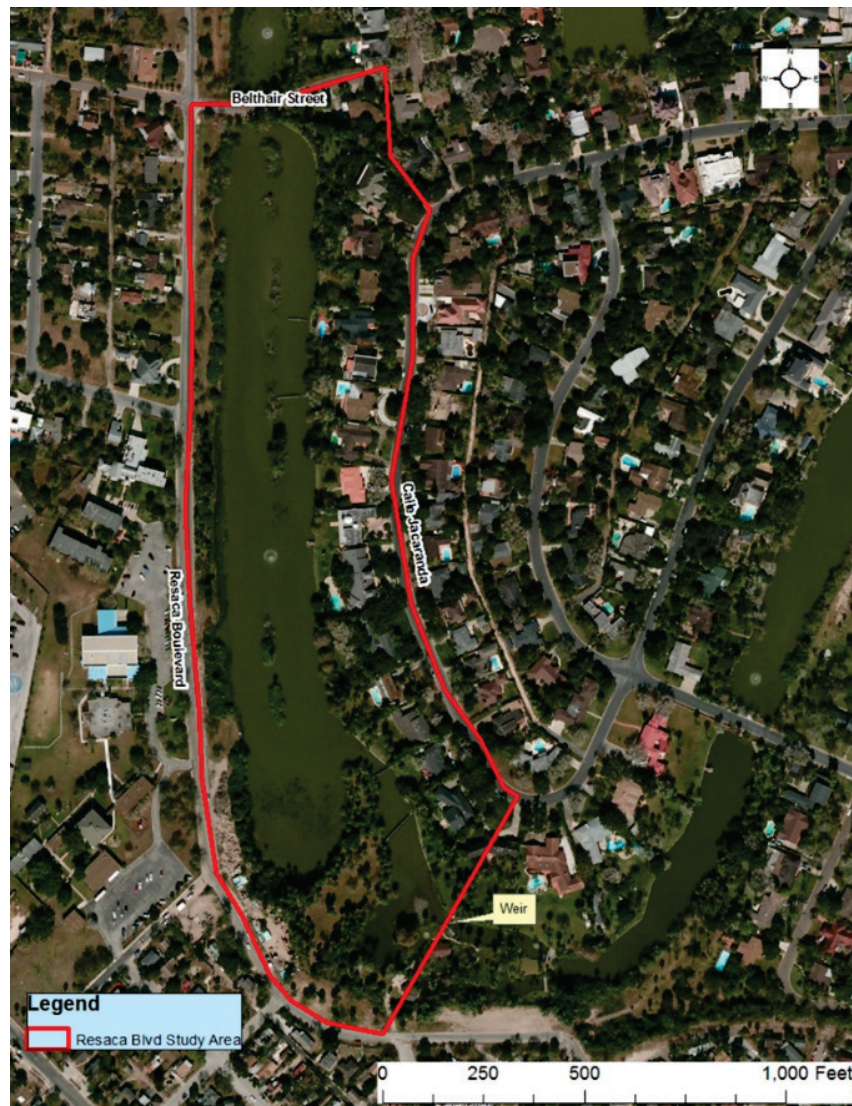
Figure 2. Resaca Boulevard Resaca study area includes the resaca and adjacent lands.

The project location was in the City of Brownsville in Cameron County, Texas (SWG 2016). The study area included the RBR and surrounding lands between Belthair Street and a downstream weir located at the southern end of the resaca. The total project area encompassed approximately 2.16 ha (5.35 acres), which was composed of 0.75 acres of aquatic and emergent wetland habitat and 4.6 acres of riparian habitat (Figure 2). The RBR was part of the Town Resaca system that flows west to east across the southern section of Brownsville. The area had subtropical climate with warm maritime influence from the Gulf of Mexico. The RBR study area had a relatively flat topography associated with a large river delta at elevations of 25 ft above mean sea level.

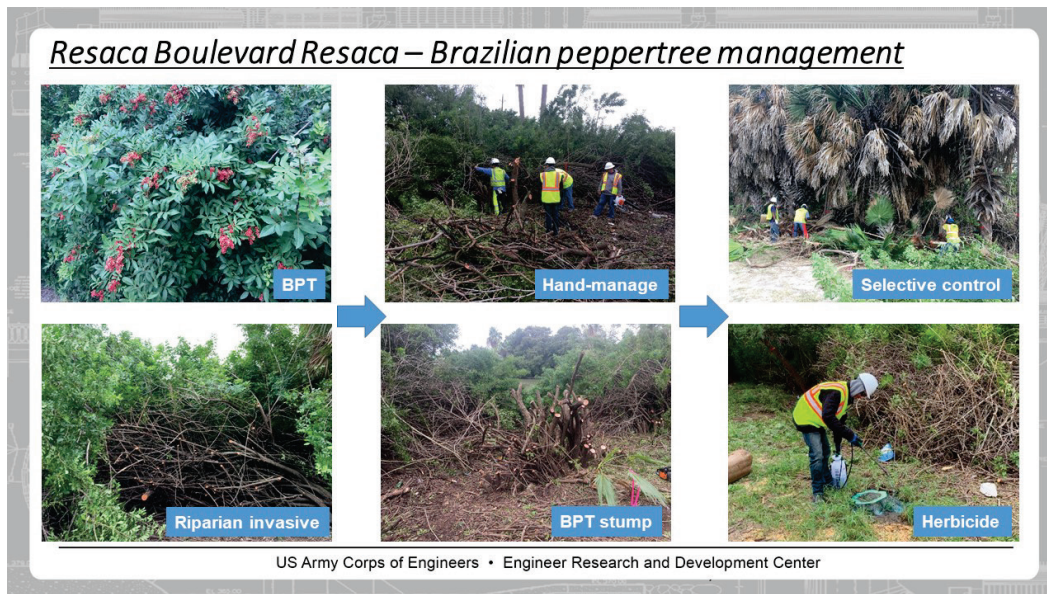
Figure 3. Brazilian peppertree removal process at RBR project site.

maturity of seeds. In addition to Brazilian peppertrees, several other tree species were treated or removed where necessary and possible (Figure 3). Scattered Chinaberry and Chinese tallow trees were cut and stump-treated in the same manner as Brazilian peppertree. Additionally, a large stand of Australian pines was removed from near the center of the site.

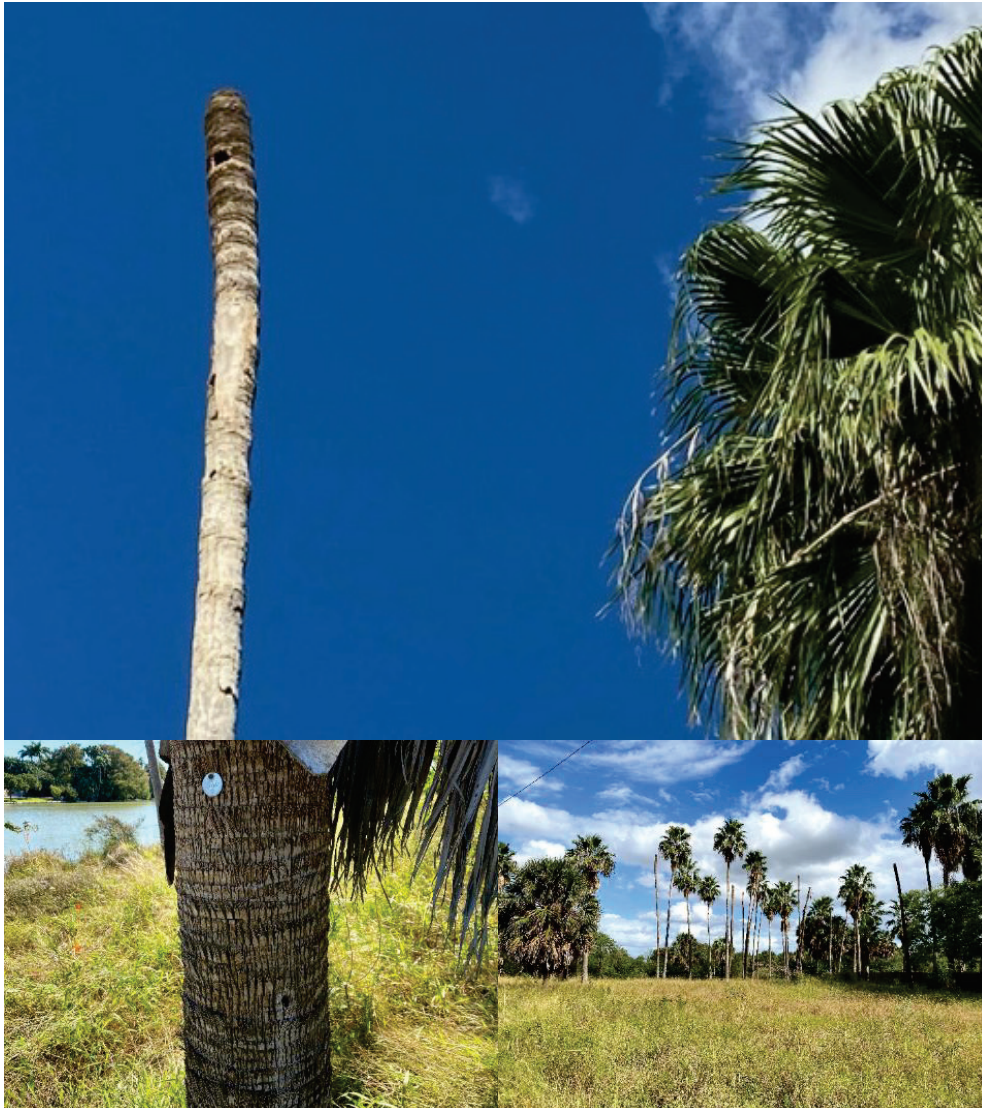
Figure 4. Nonnative palm snags at RBR for the purposes of red-crowned parrot and woodpecker habitat.

Working maps were continuously created to show the next treatment dates for each area and document the fate of invasive trees in the project area. This identified the six-week windows (to confirm invasive plant mortality from herbicide before grubbing) for the separate segments of Brazilian peppertree and other nuisance tree treatment areas. The last treatment and the earliest grubbing dates were marked for each segment. They also identified the fate of targeted trees and the species of trees that remain, non-native palms that were treated and killed, those that will be treated in 5 yr, and those that will be treated in 10 yr. Non-native palm trees were thinned, and a subset of the palms were treated with glyphosate to create standing snags to serve as nesting habitat for golden-fronted woodpeckers and red-crowned parrots (Figure 4).

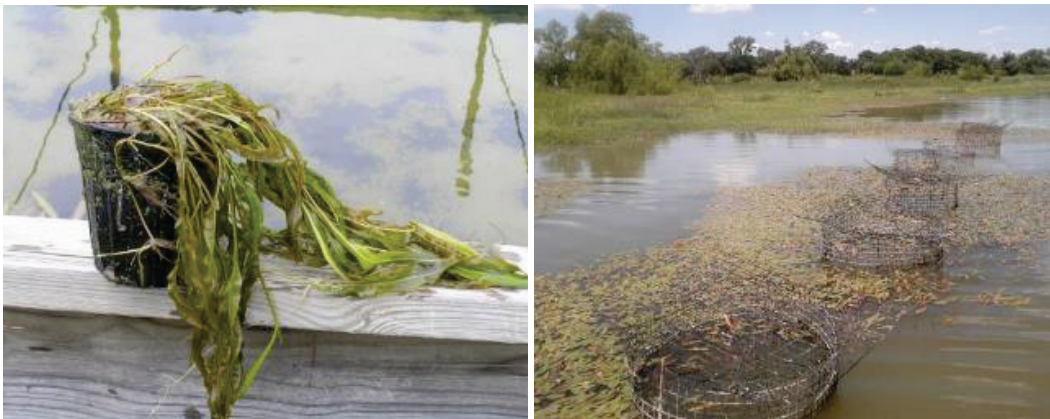
Figure 5. Field-ready containerized longleaf pondweed (*Potamogeton nodosus*) and other species were used to establish aquatic and emergent species at RBR.

Aquatic (submerged aquatic vegetation or SAV, emergent, and floating-leaved) plants were mature transplants (Figure 5) with well-developed root balls, grown in appropriately sized 4 in. (quart) to 6 in. (gallon) plastic containers to facilitate recovery and growth after planting. Propagules (seeds, apical tips, and/or bareroot plants) were collected from appropriate ecoregions. Herbaceous plant species (grasses and forbs) were mature transplants with well-developed root balls with most species grown in 2 in. diameter x 6 in. deep plastic containers. In some cases, variations in container size were needed to facilitate growth. Propagules (seeds or bareroot plants) from appropriate ecoregions were collected and grown to specifications at LAERF. Deep root producing woody plant species were grown in appropriately sized containers designed to direct roots downward and self-prune at bottom air holes to induce branching and reduced root curling. Most seedlings and cuttings were grown in 2 in. x 6 in. deep “conainers” and 4 in. x 8 in. to 12 in. tall (1/4+ gal) ridged, deep plastic containers. Variations in container size were dependent upon species and modified as needed; Appendix A provides detailed photographs of the production of containerized herbaceous and woody plants.

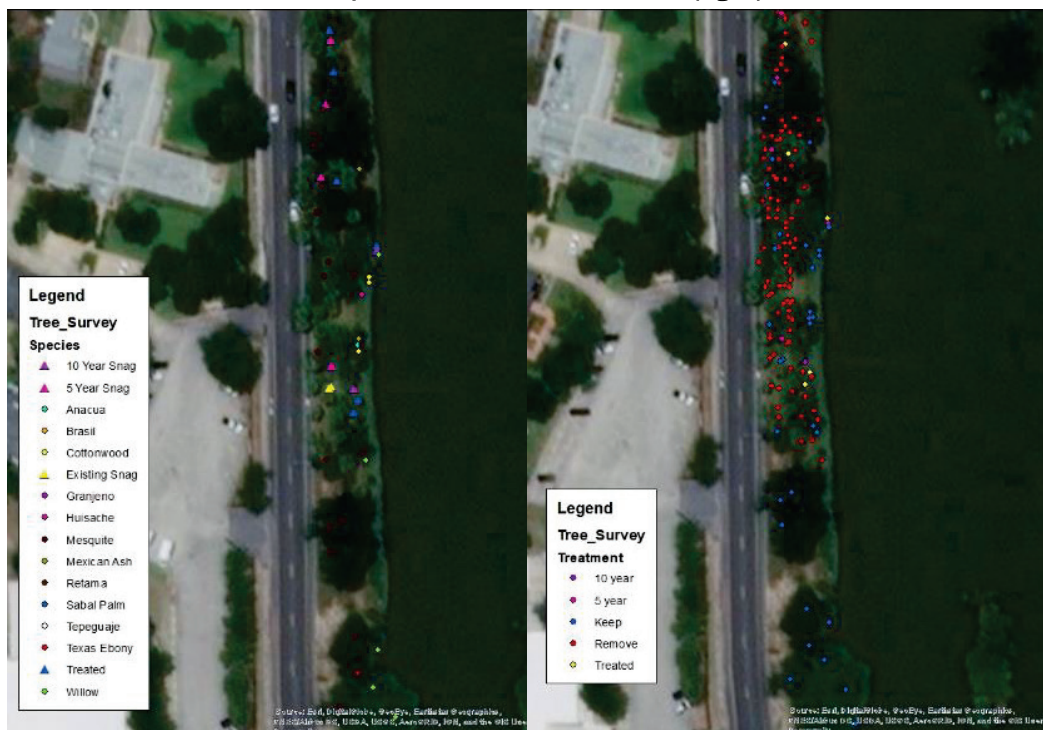
Figure 7. Paired maps that identify fate of trees to keep, remove, and treat (*left*) and the species of trees that remain (*right*).

ERDC-EL-LAERF assisted with onsite biological monitoring of invasive species removal, native plant avoidance, improvements in installations, and other contractor activities throughout construction to ensure project success. Figure 7 illustrates an example of native plants to stay during invasive species removal phase (USACE RPEC).

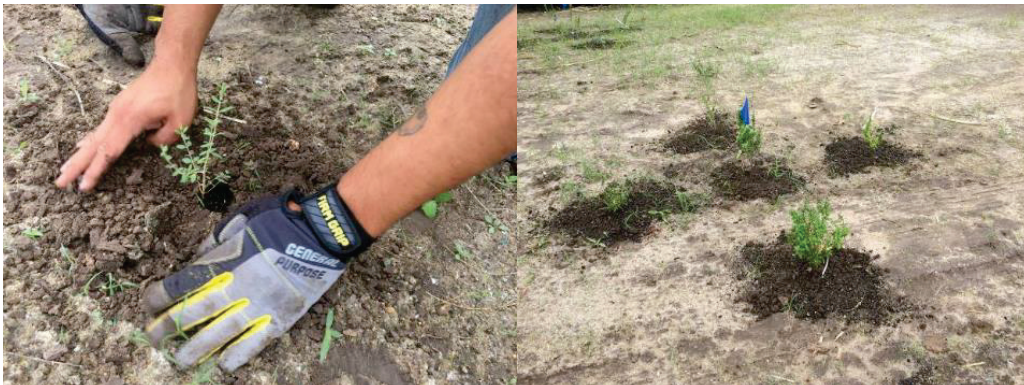
Figure 9. Woody and herbaceous vegetation planting in riparian areas at RBR in April 2019.

The first planting effort consisted of woody and herbaceous containerized plants (riparian or shoreline and upland) to promote the RBR ecosystem restoration goals of native plant establishment. Plantings occurred in two general areas, south and north sites from a species selected list (Table 4). Plants were placed in clusters leaving 7–10 ft between to enable mowing over herbaceous cover when necessary. Holes were dug using small gas-powered augers and plantings were backfilled with on-site sediment. Most of the plants were planted on the landside of the existing silt fence, while 26 Montezuma cypress and 9 ash trees were planted 4 ft away from the silt fence towards the water (lower elevation, saturated soils). On the south site, a total of 330 plants were planted including five Rio Grande palmettos and ten Montezuma cypress. On the north site, 231 plants were transplanted, including three clusters of sabal palms (approximately 25 each) along with 16 Montezuma cypress plants. The north end also included a one 10 ft x 30 ft flag marked woody seeding location containing native plants (Rio Grande palmetto, sweet acacia, ebony, blackbrush acacia, cedar elm, crucillo, tenaza, hog plum, and anacua). Starting monthly on 15 April 2019, ERDC-EL-LAERF assessed plant and vegetation site conditions (see Results). Figure 9 illustrates planting method results of first plantings efforts, April 2019.

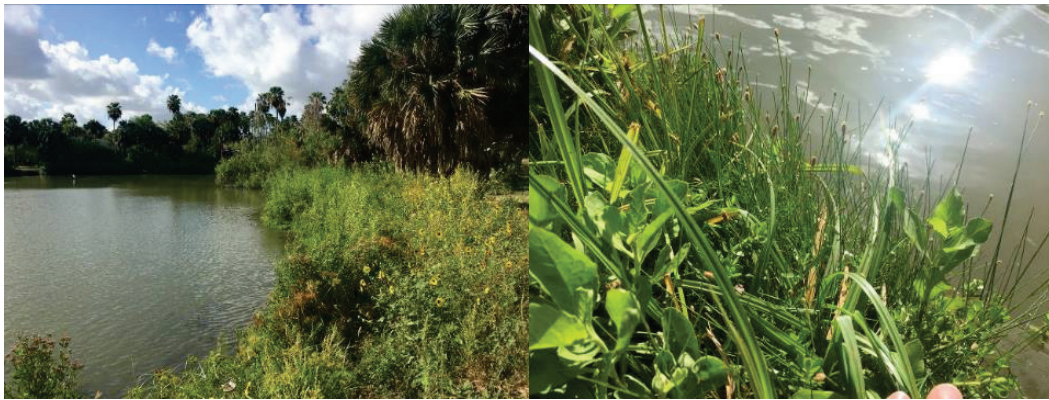
Figure 10. Wetland fringe developing with native plants: *left*—within silt fence in no-mow designated area; *right*—waterhyssop and spikerushes.

Wetland fringe vegetation naturally develop following invasive species removals (Figure 10); dominated by native emergent volunteer species. To increase diversity of the wetland fringe and ensure establishment of floating-leaved and SAV, a planting was undertaken by ERDC-EL-LAERF the week of 9 September 2019 from an approved species list decided by the team (Table 5).

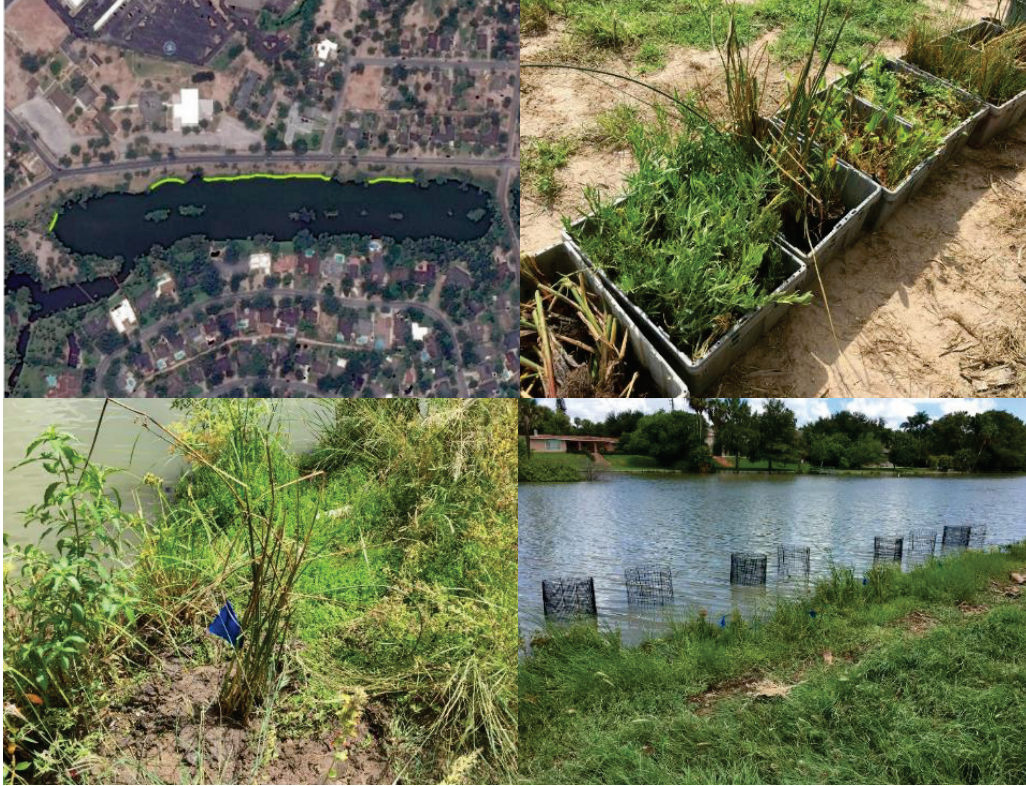
Figure 11. Planting 10 September 2019: *top left* – highlighted areas show planting locations; *top right* – containerized aquatic plants; *bottom left* – planted, flagged emergent vegetation; *bottom right* – submerged and floating leaf plants were caged for herbivore protection.

Emergent species were planted along the length of the shoreline at the water's edge at 5 ft centers. Submerged and floating-leaved plants were planted in herbivore exclosures or PVC welded-wire ring-cages at three different "founder-colony" locations. These sites would serve as a propagule source to spread aquatic vegetation throughout the resaca wetland. The caged protection was also constructed to determine whether herbivore protection would be needed to prevent plant disturbance of native submerged and floating-leaved aquatic plants throughout the project. At each SAV site, four species were planted (American pondweed, water stargrass, Mexican waterlily, and American white waterlily). Each species was planted in each of the three levels of protection: unprotected, protected by 1 in. × 1 in. mesh, and protected by 2 in. × 2 in. mesh. All SAV was planted at 1.5 ft depths (Figure 11). One transplant of each species at each site was also planted at 0.5 ft depth unprotected within the wetland vegetated fringe to determine if the natural-vegetation protection served as adequate herbivore masking/protection. After woody and aquatic first-year plantings, monitoring and adaptive management began, which included supplemental plantings as needed (see Results, Monitoring and Adaptive Management).

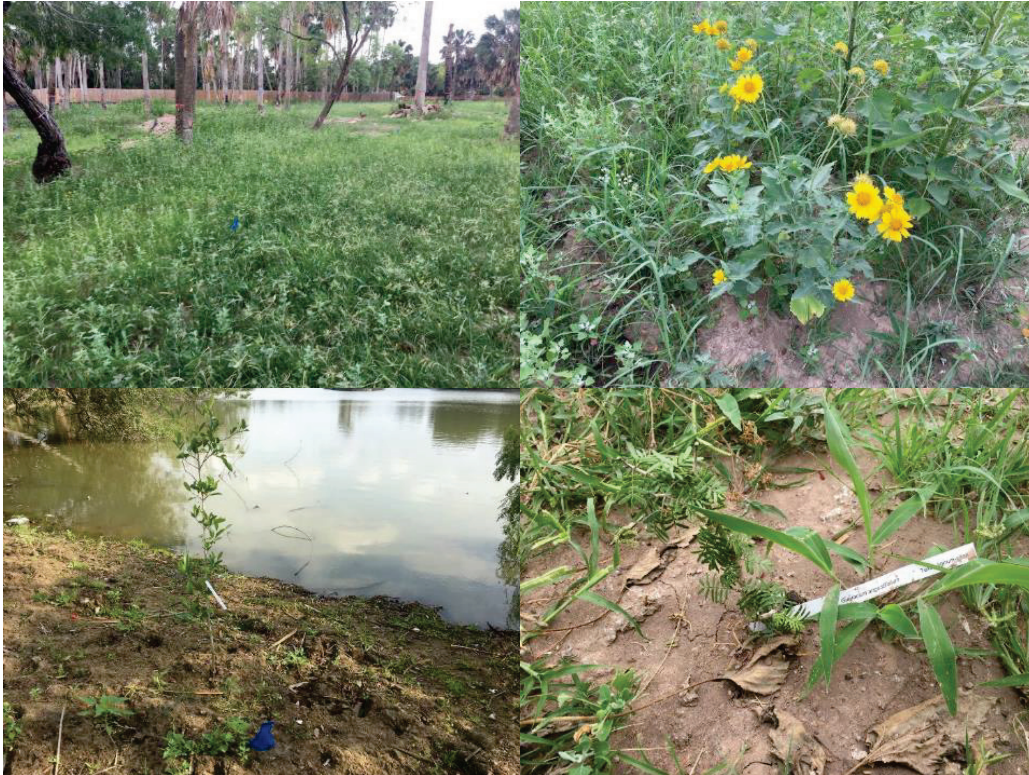
Figure 13. First site assessment (1 May 2019); *top left* – successful seeding; *top right* – cowpen daisy; *bottom left*–woody species planted, Mexican Ash; *bottom right* – Texas lignum-vitae.

The first site assessment occurred 01 May 2019, following the January 2019 seeding and April 2019 woody planting. Six of the seeded native species were observed along with some desirable volunteer vegetation (e.g., cowpen daisy) (Figure 13) and some less than desirable vegetation (goosefoots and annual sunflowers). Minimal herbivory (estimated at 1% or less) was observed on woody transplants throughout the site (Figure 13). Appendix E provides detailed photograph examples of woody plantings. Due to this and the short duration since planting, survival was near 100%. Mowing was prohibited in several areas at that time because some native vegetation was flowering and needed to go to seed before mowing. Annual sunflowers were also culled by hand to allow for better establishment of desirable species. In addition to grasses and forbs, Chinese tallow seedlings were observed and designated for treatment during this assessment.

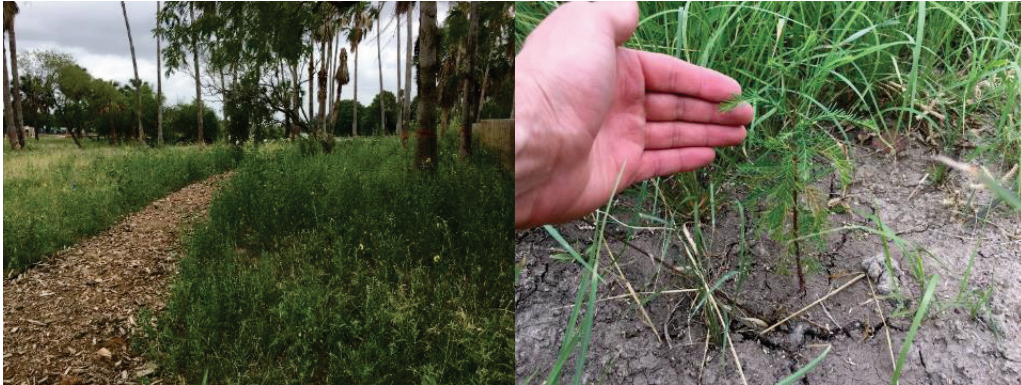
Figure 14. *Left* – showing growth of seeding, and *right* – planted Montezuma cypress, 28 May 2019.

Smaller transplants appeared more successful than larger transplants. Most previously seeded native herbaceous vegetation had gone to seed (Figure 14), whereas remaining aggressive annual sunflowers had just begun flowering. Therefore, the project-site first mow was scheduled for late June at an appropriate height to minimize damage to shorter, desirable species, reduce annual sunflower seed production, and promote native grass spread in the following growing season. Other native volunteer wildflowers were observed in the seeded area, including Mexican hat and plains coreopsis. A volunteer wetland vegetation fringe dominated by native volunteers was observed to be developing between the silt fence and shoreline (Figure 15) and was designated as a no-mow area.

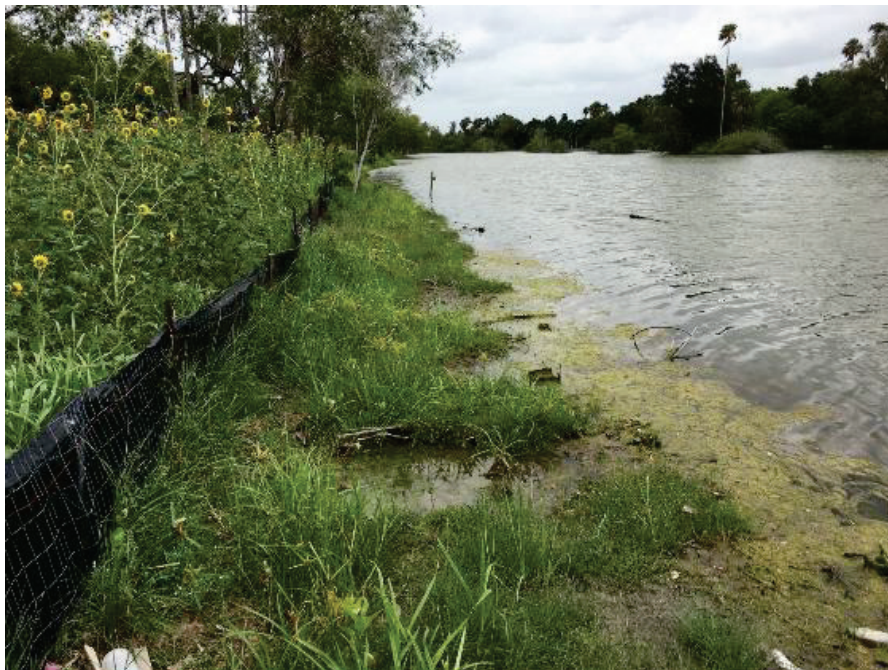
Figure 15. Wetland fringe developing within silt fence in no-mow designated area.

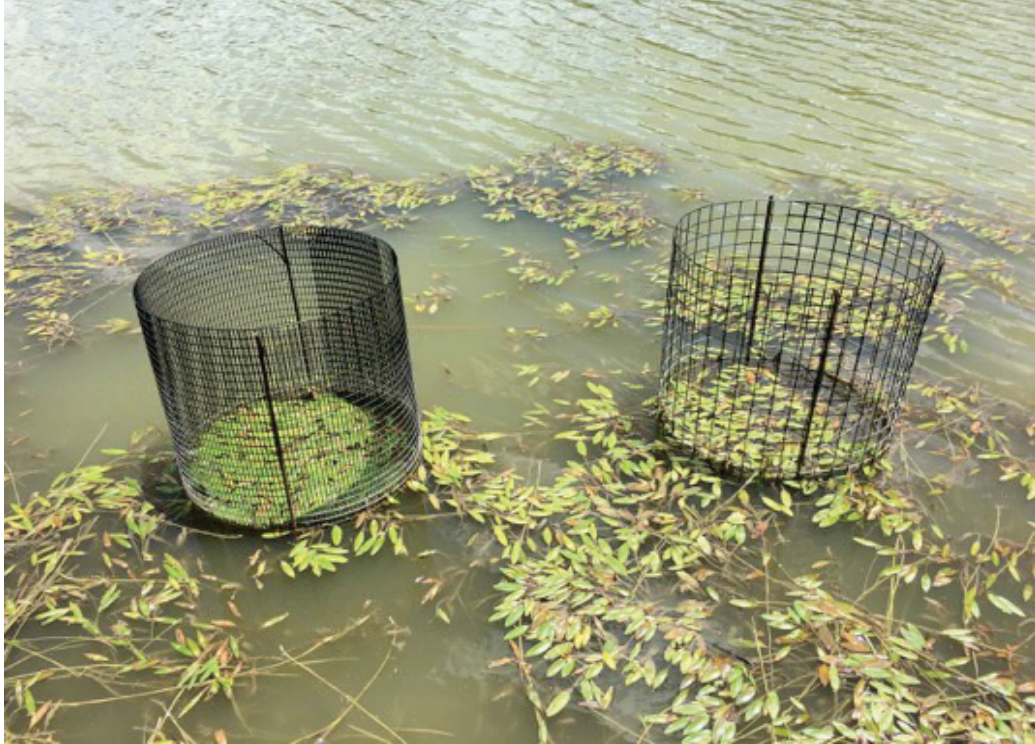
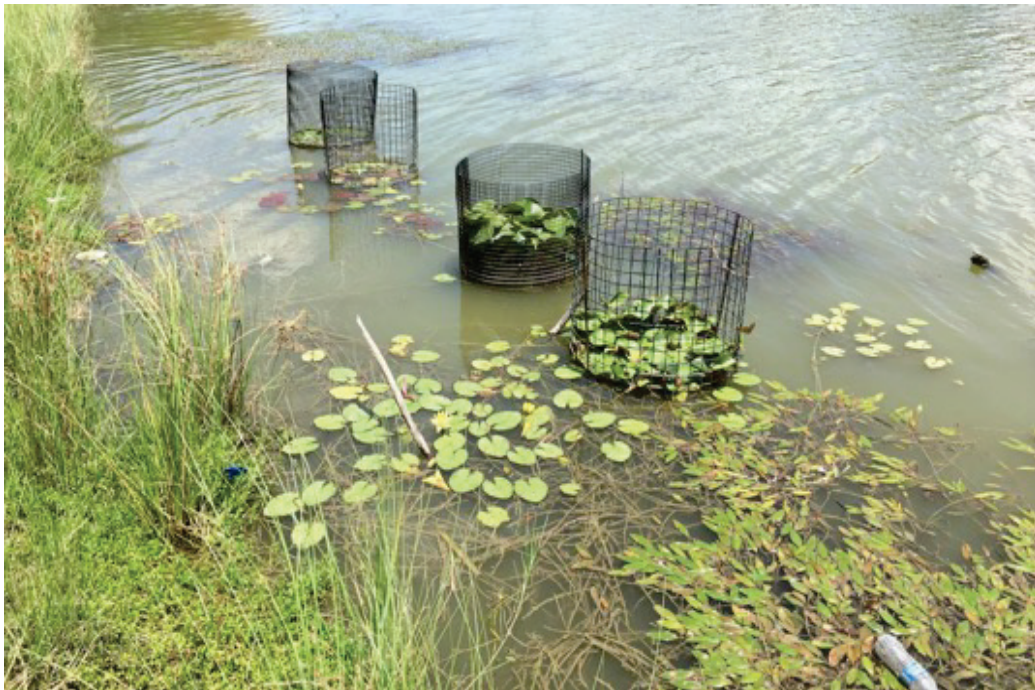
Figure D-1. Native submerged aquatic vegetation established at project site.

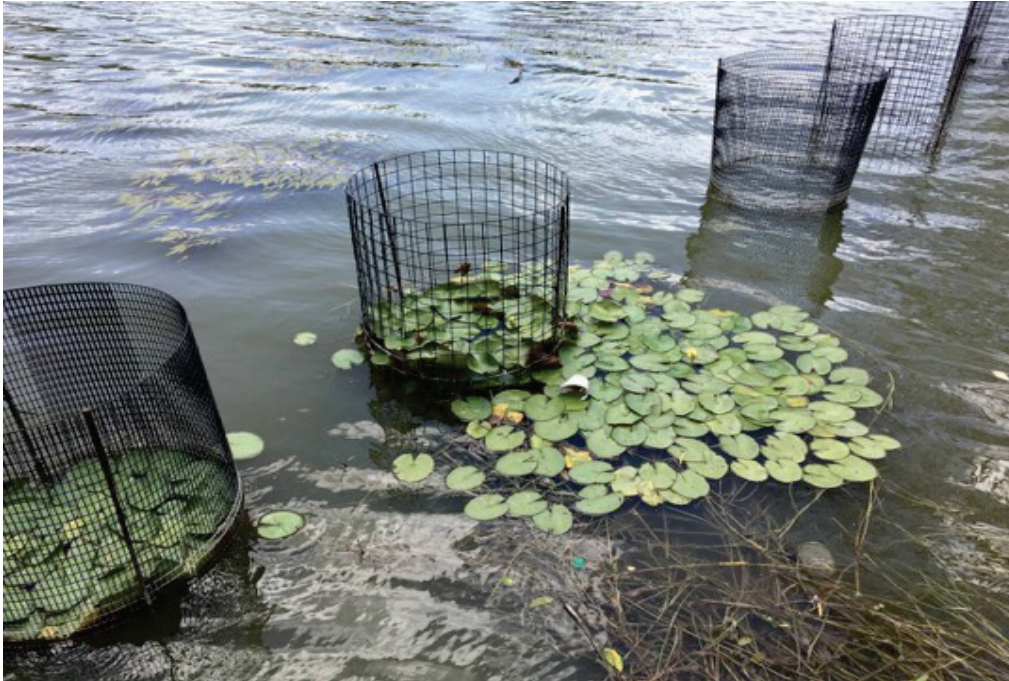
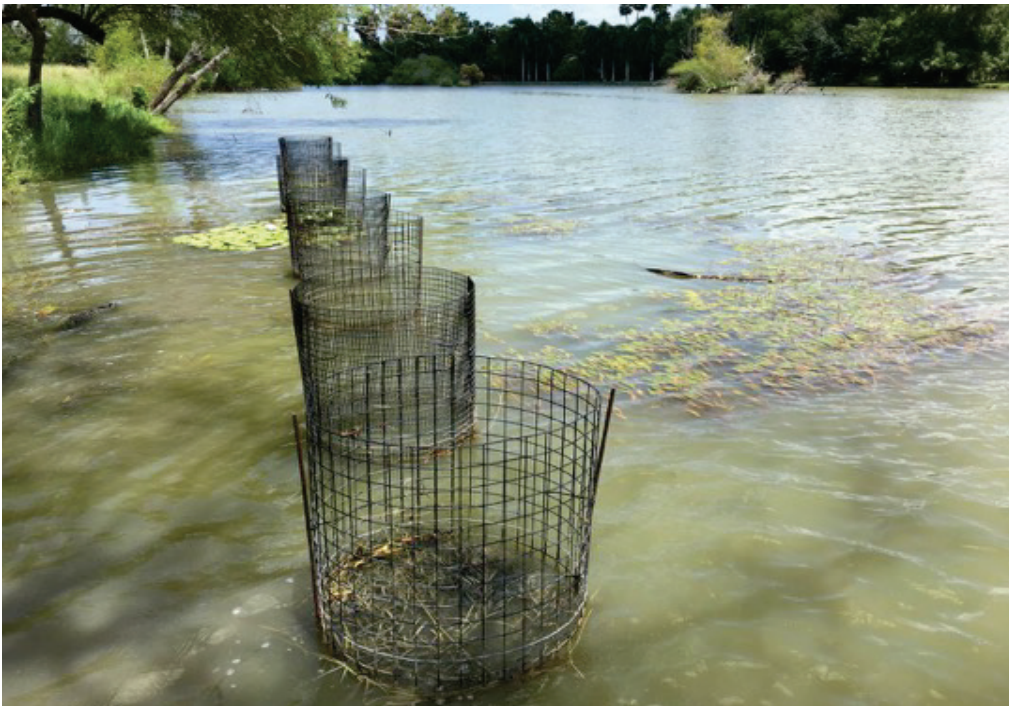
Figure D-2. Native submerged aquatic vegetation established at project site.

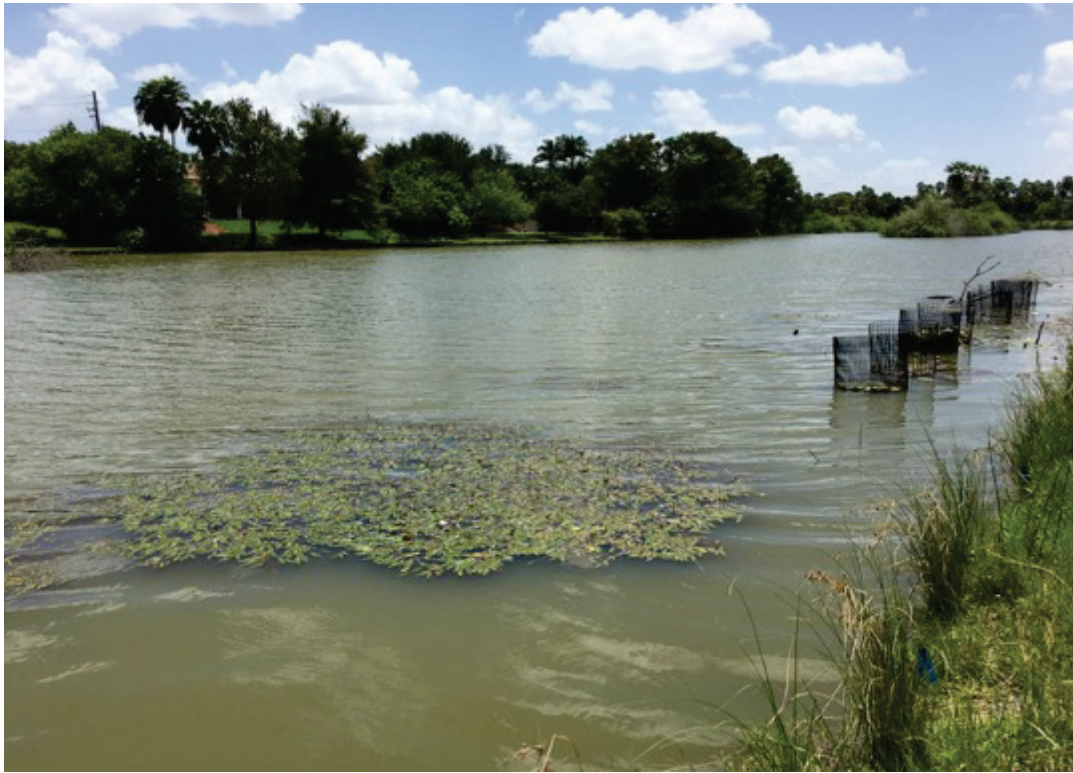
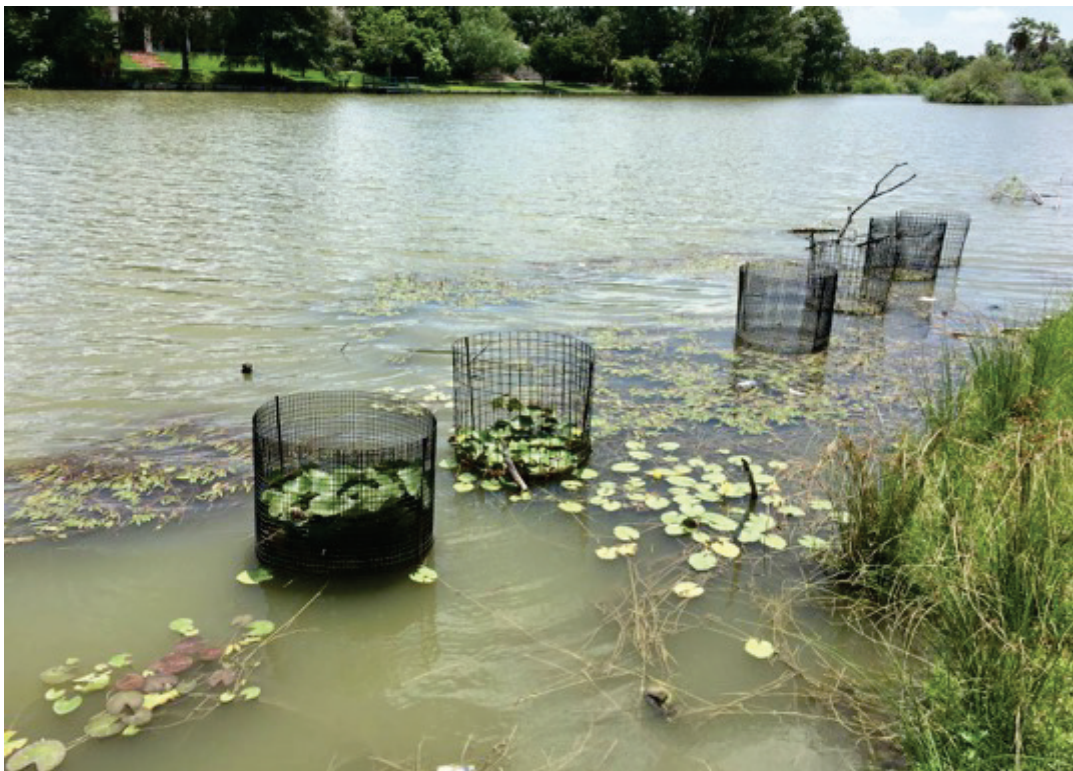
Figure D-3. Native submerged aquatic vegetation established at project site, showing extensive spread from herbivore cages.

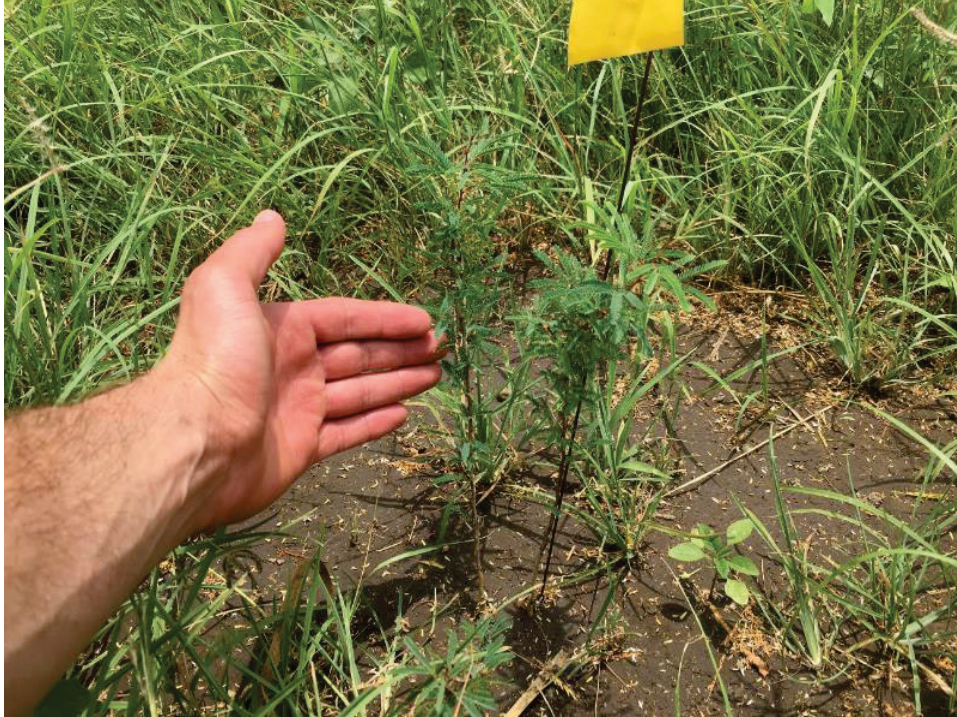
Figure E-1. Planted twisted acacia (*Acacia schaffneri*).

The final ERDC-EL-LAERF planting occurred in November 2020 and involved a site-wide supplemental / adaptive management planting that included installation of 17 plant species totaling 700 plants. Species planted included anacua, Texas lignum-vitae, catclaw acacia, sabal palm, Mexican holdback, milkweeds, whitebrush, lotebush, Mexican olive, blackbrush acacia, spiny hackberry, Texas ebony, Brazilian bluewood, Texas persimmon, Montezuma cypress, and guajillo (Figure 25). During this time, site conditions were also assessed. SAV founder colony sites were functioning as planned and the most successful woody vegetation remained was anacua, Mexican holdback, Montezuma cypress, Mexican olive, Mexican ash, acacias, sabal palms, hackberries, cedar elms, Texas persimmons, and whitebrush (Appendices D and E).

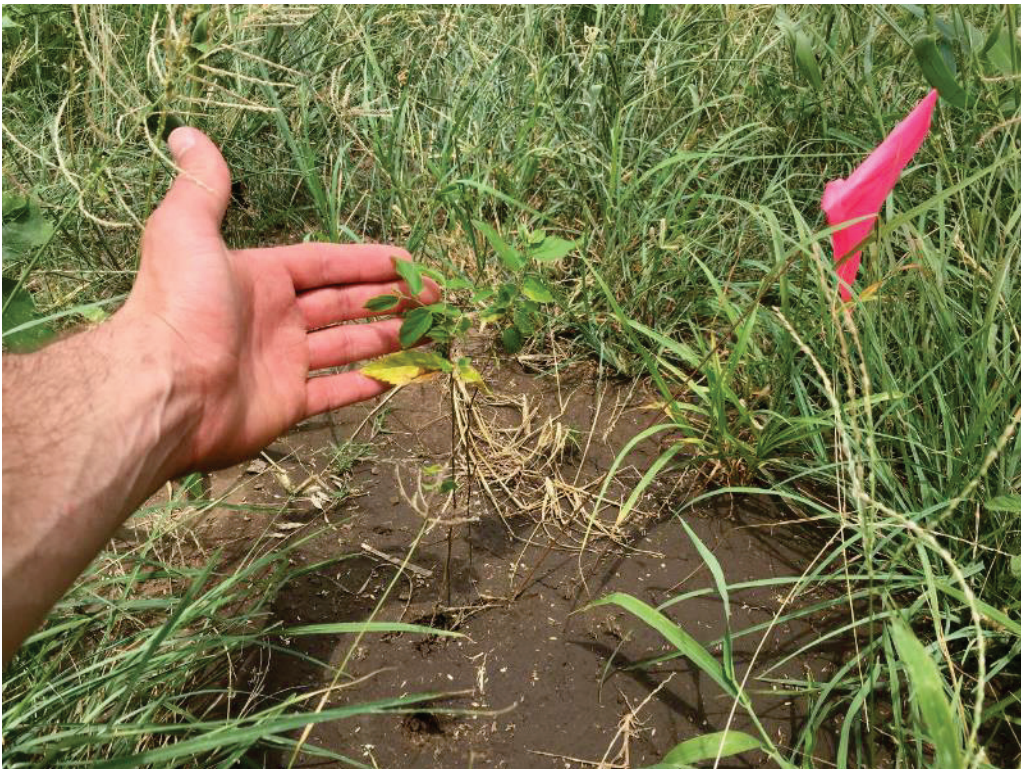
Figure E-4. Planted sugarberry (*Celtis laevigata*).

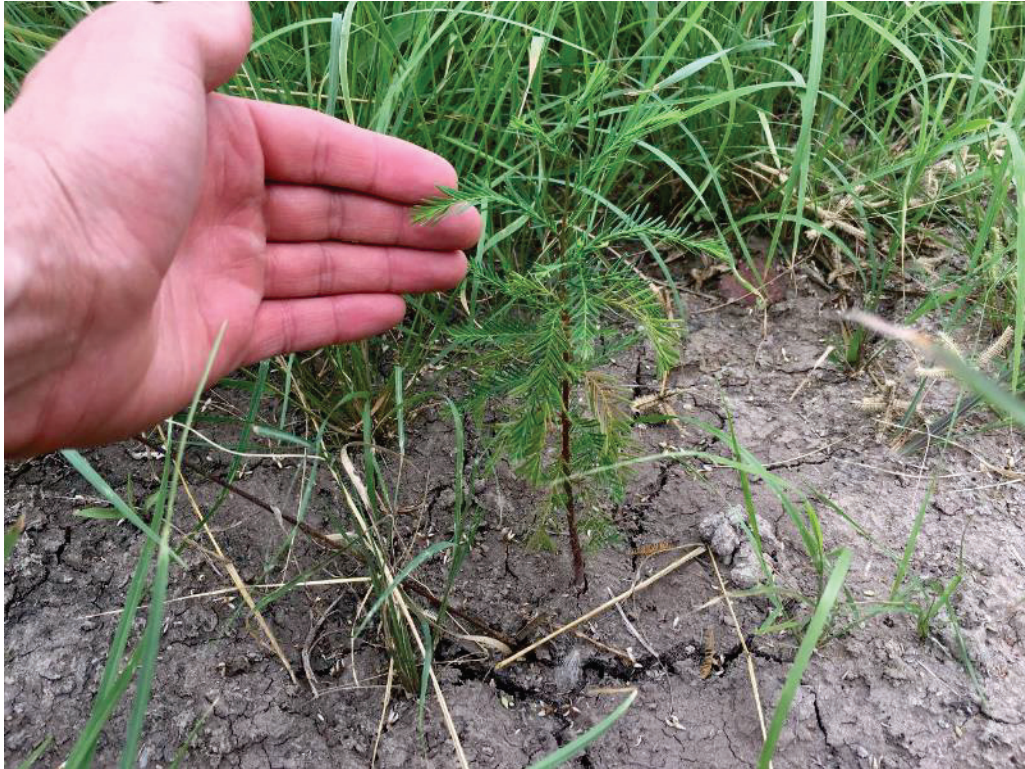
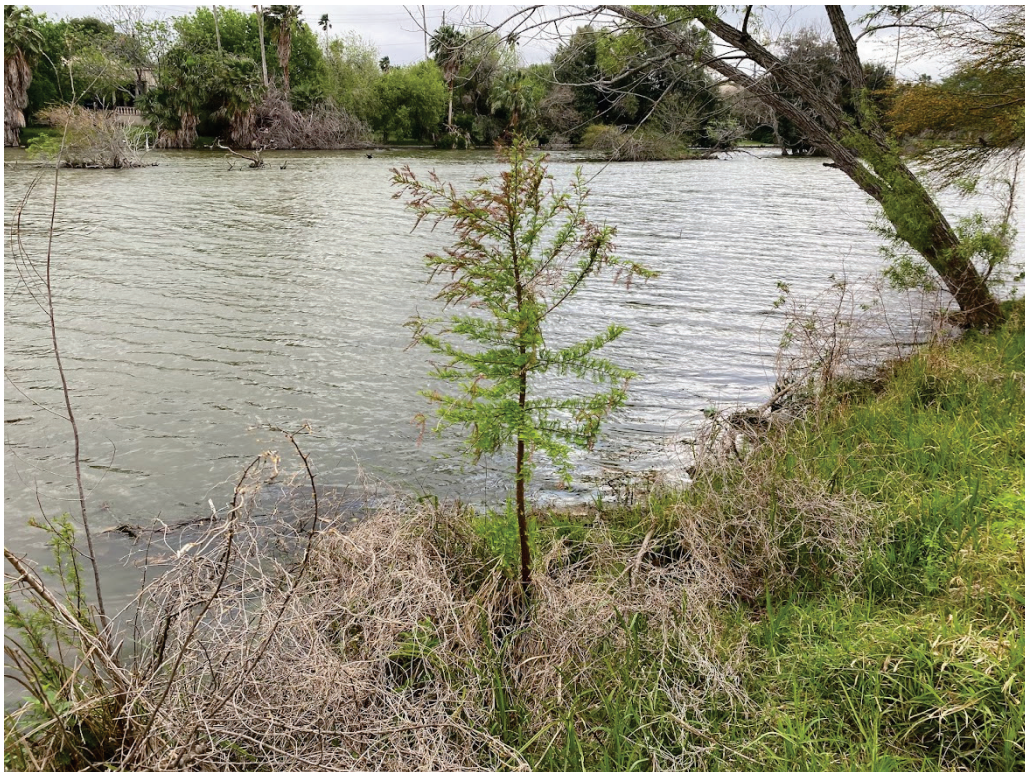
Figure E-5. Planted Montezuma cypress (*Taxodium mucronatum*).

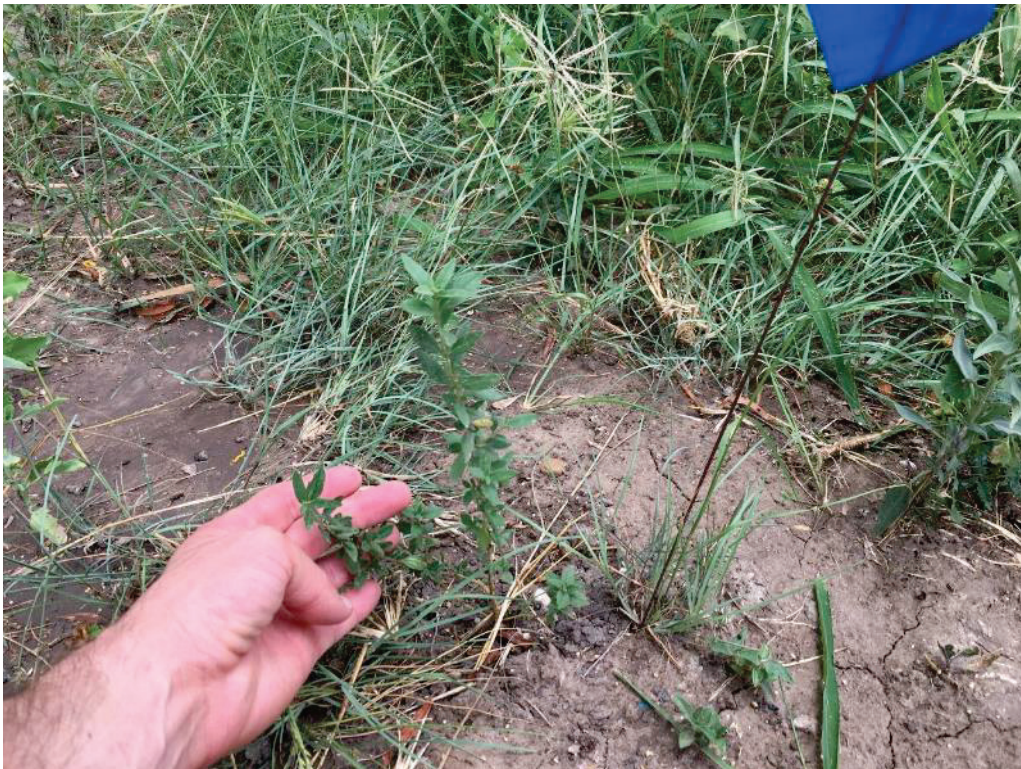
Figure E-9. Planted whitebrush (*Aloysia gratissima*).
