# **Lower Duwamish Waterway Source Control Status Report January 2014 through December 2016**

June 2018

Publication No. 17-09-266

Toxics Cleanup Program  
Northwest Regional Office  
Washington State Department of Ecology  
Bellevue, Washington

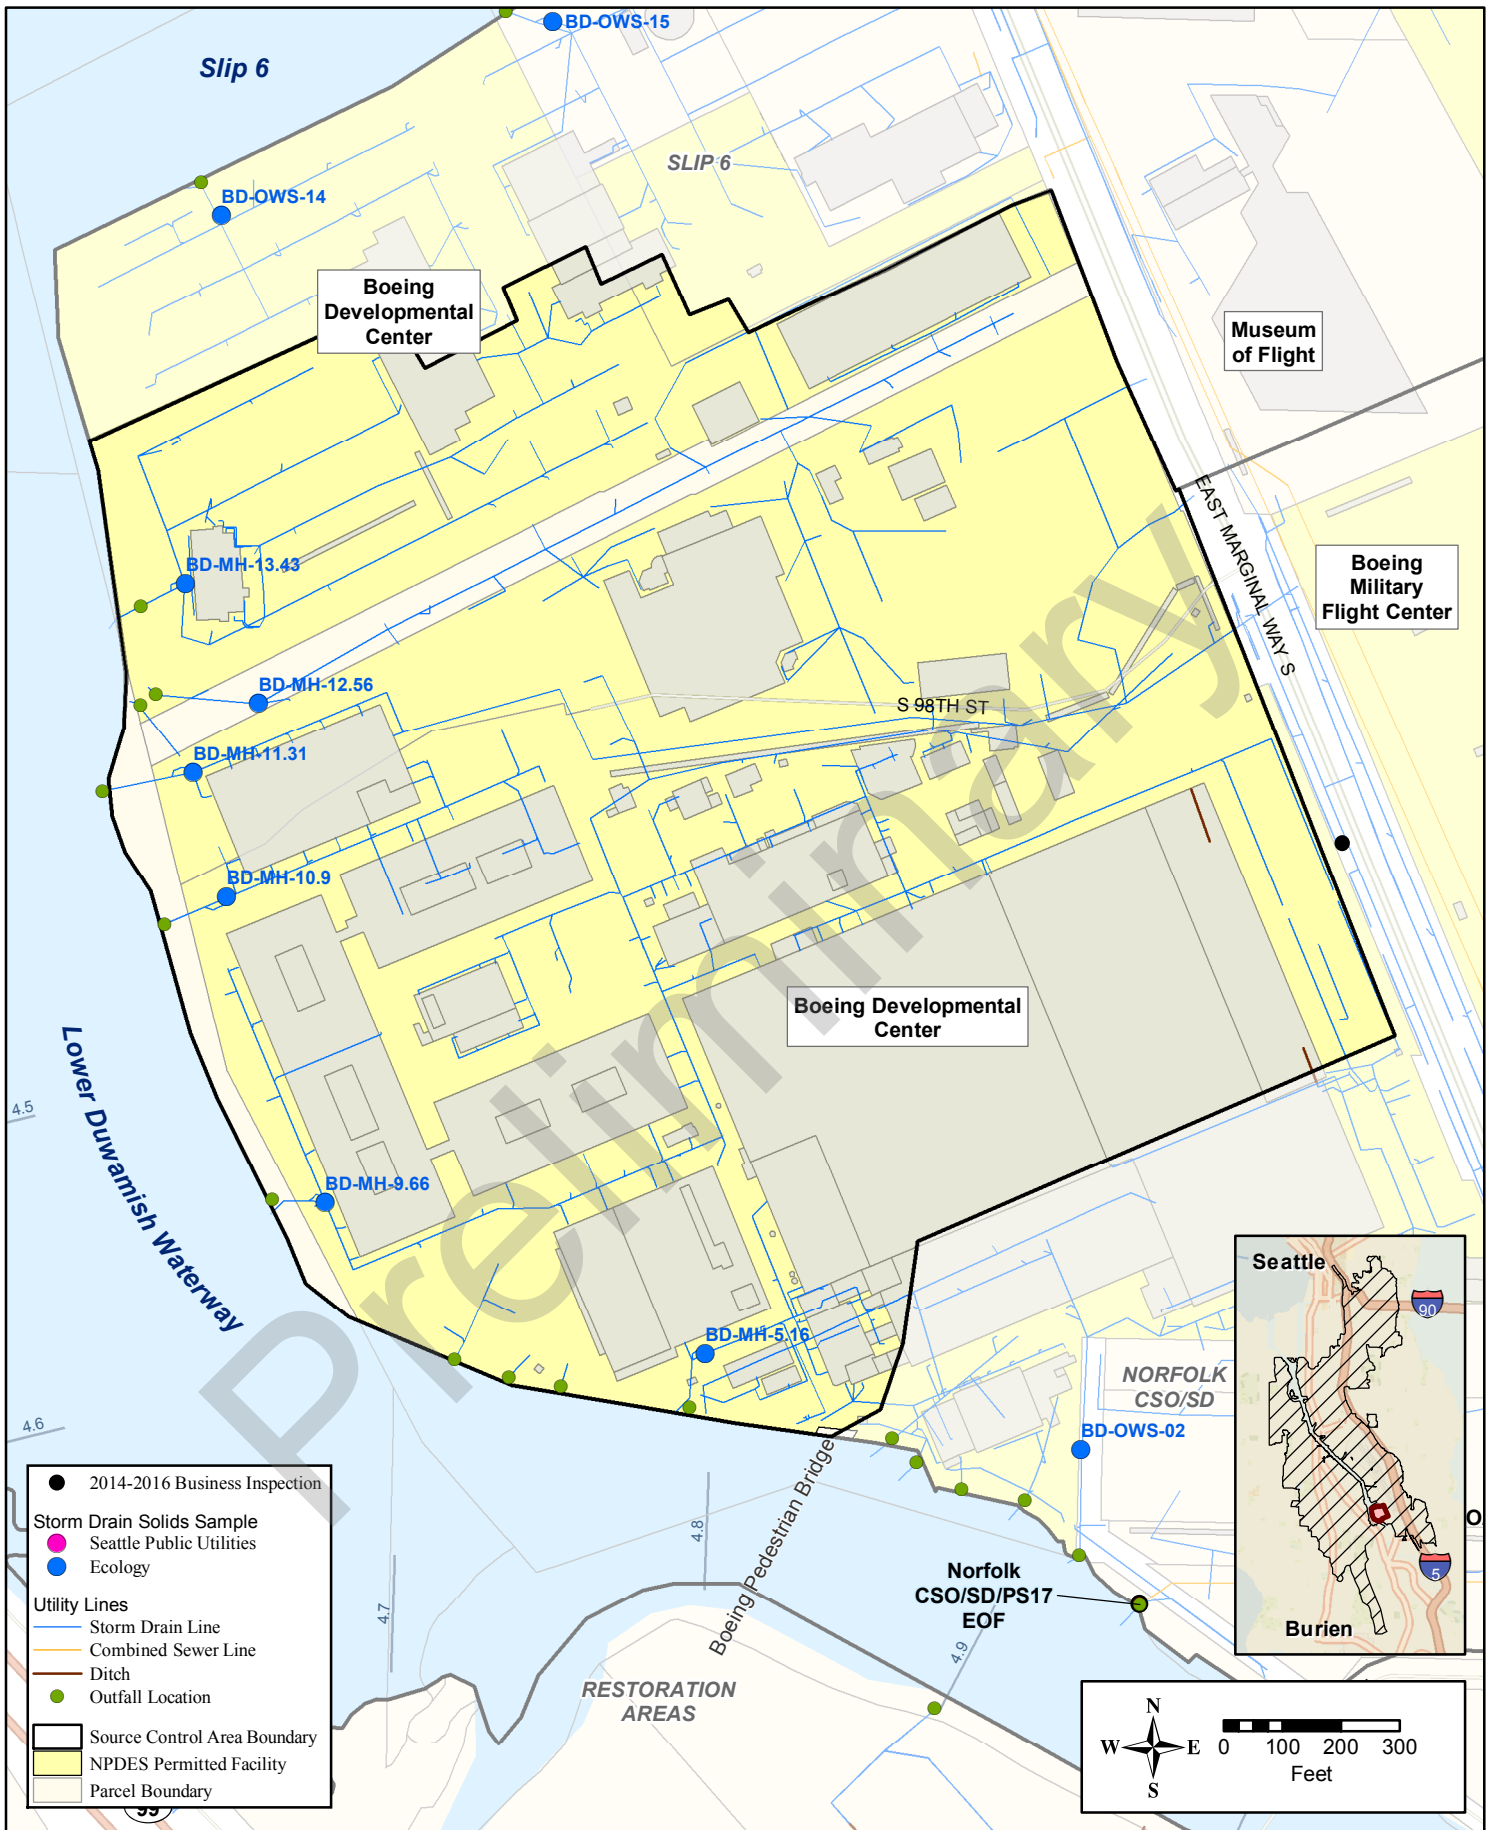
**Figure 2. RM 4.3-4.9 East  
(Boeing Developmental Center)  
Source Control Area**

- 2014-2016 Business Inspection
- Storm Drain Solids Sample
- Seattle Public Utilities
- Ecology
- Utility Lines
  - Storm Drain Line
  - Combined Sewer Line
  - Ditch
  - Outfall Location
- Source Control Area Boundary
- NPDES Permitted Facility
- Parcel Boundary

<b>Property Name</b>	<b>Boeing Developmental Center</b>
	RM 4.9. Outfalls DC1, DC2, DC3, DC4, DC16, DC17, and the associated drainage areas, are included in this portion of the BDC property (Figure 3).
<b>Historical Activities</b>	<p>The Monsanto Fund purchased the northern 38 acres of the BDC property at an unknown time and leased portions of the property. The area included warehouse and office buildings, winery buildings, a granary, and a trucking company. The Port of Seattle purchased the property and took over the leases in 1976; the northeastern five acres (two separate parcels) were leased by the Port to Kenworth Truck Company and Transport Pool Granary for storage (Ecology 2008 [0080]).</p> <p>The Port sold the property to The Boeing Company in 1985. Boeing has operated on portions of this property since 1956. Historical activities include manufacturing of airplanes and missiles, including metal machining, electroplating, chemical milling, conversion coating, painting, parts cleaning, and assembly activities (Ecology 2008 [0080]).</p>

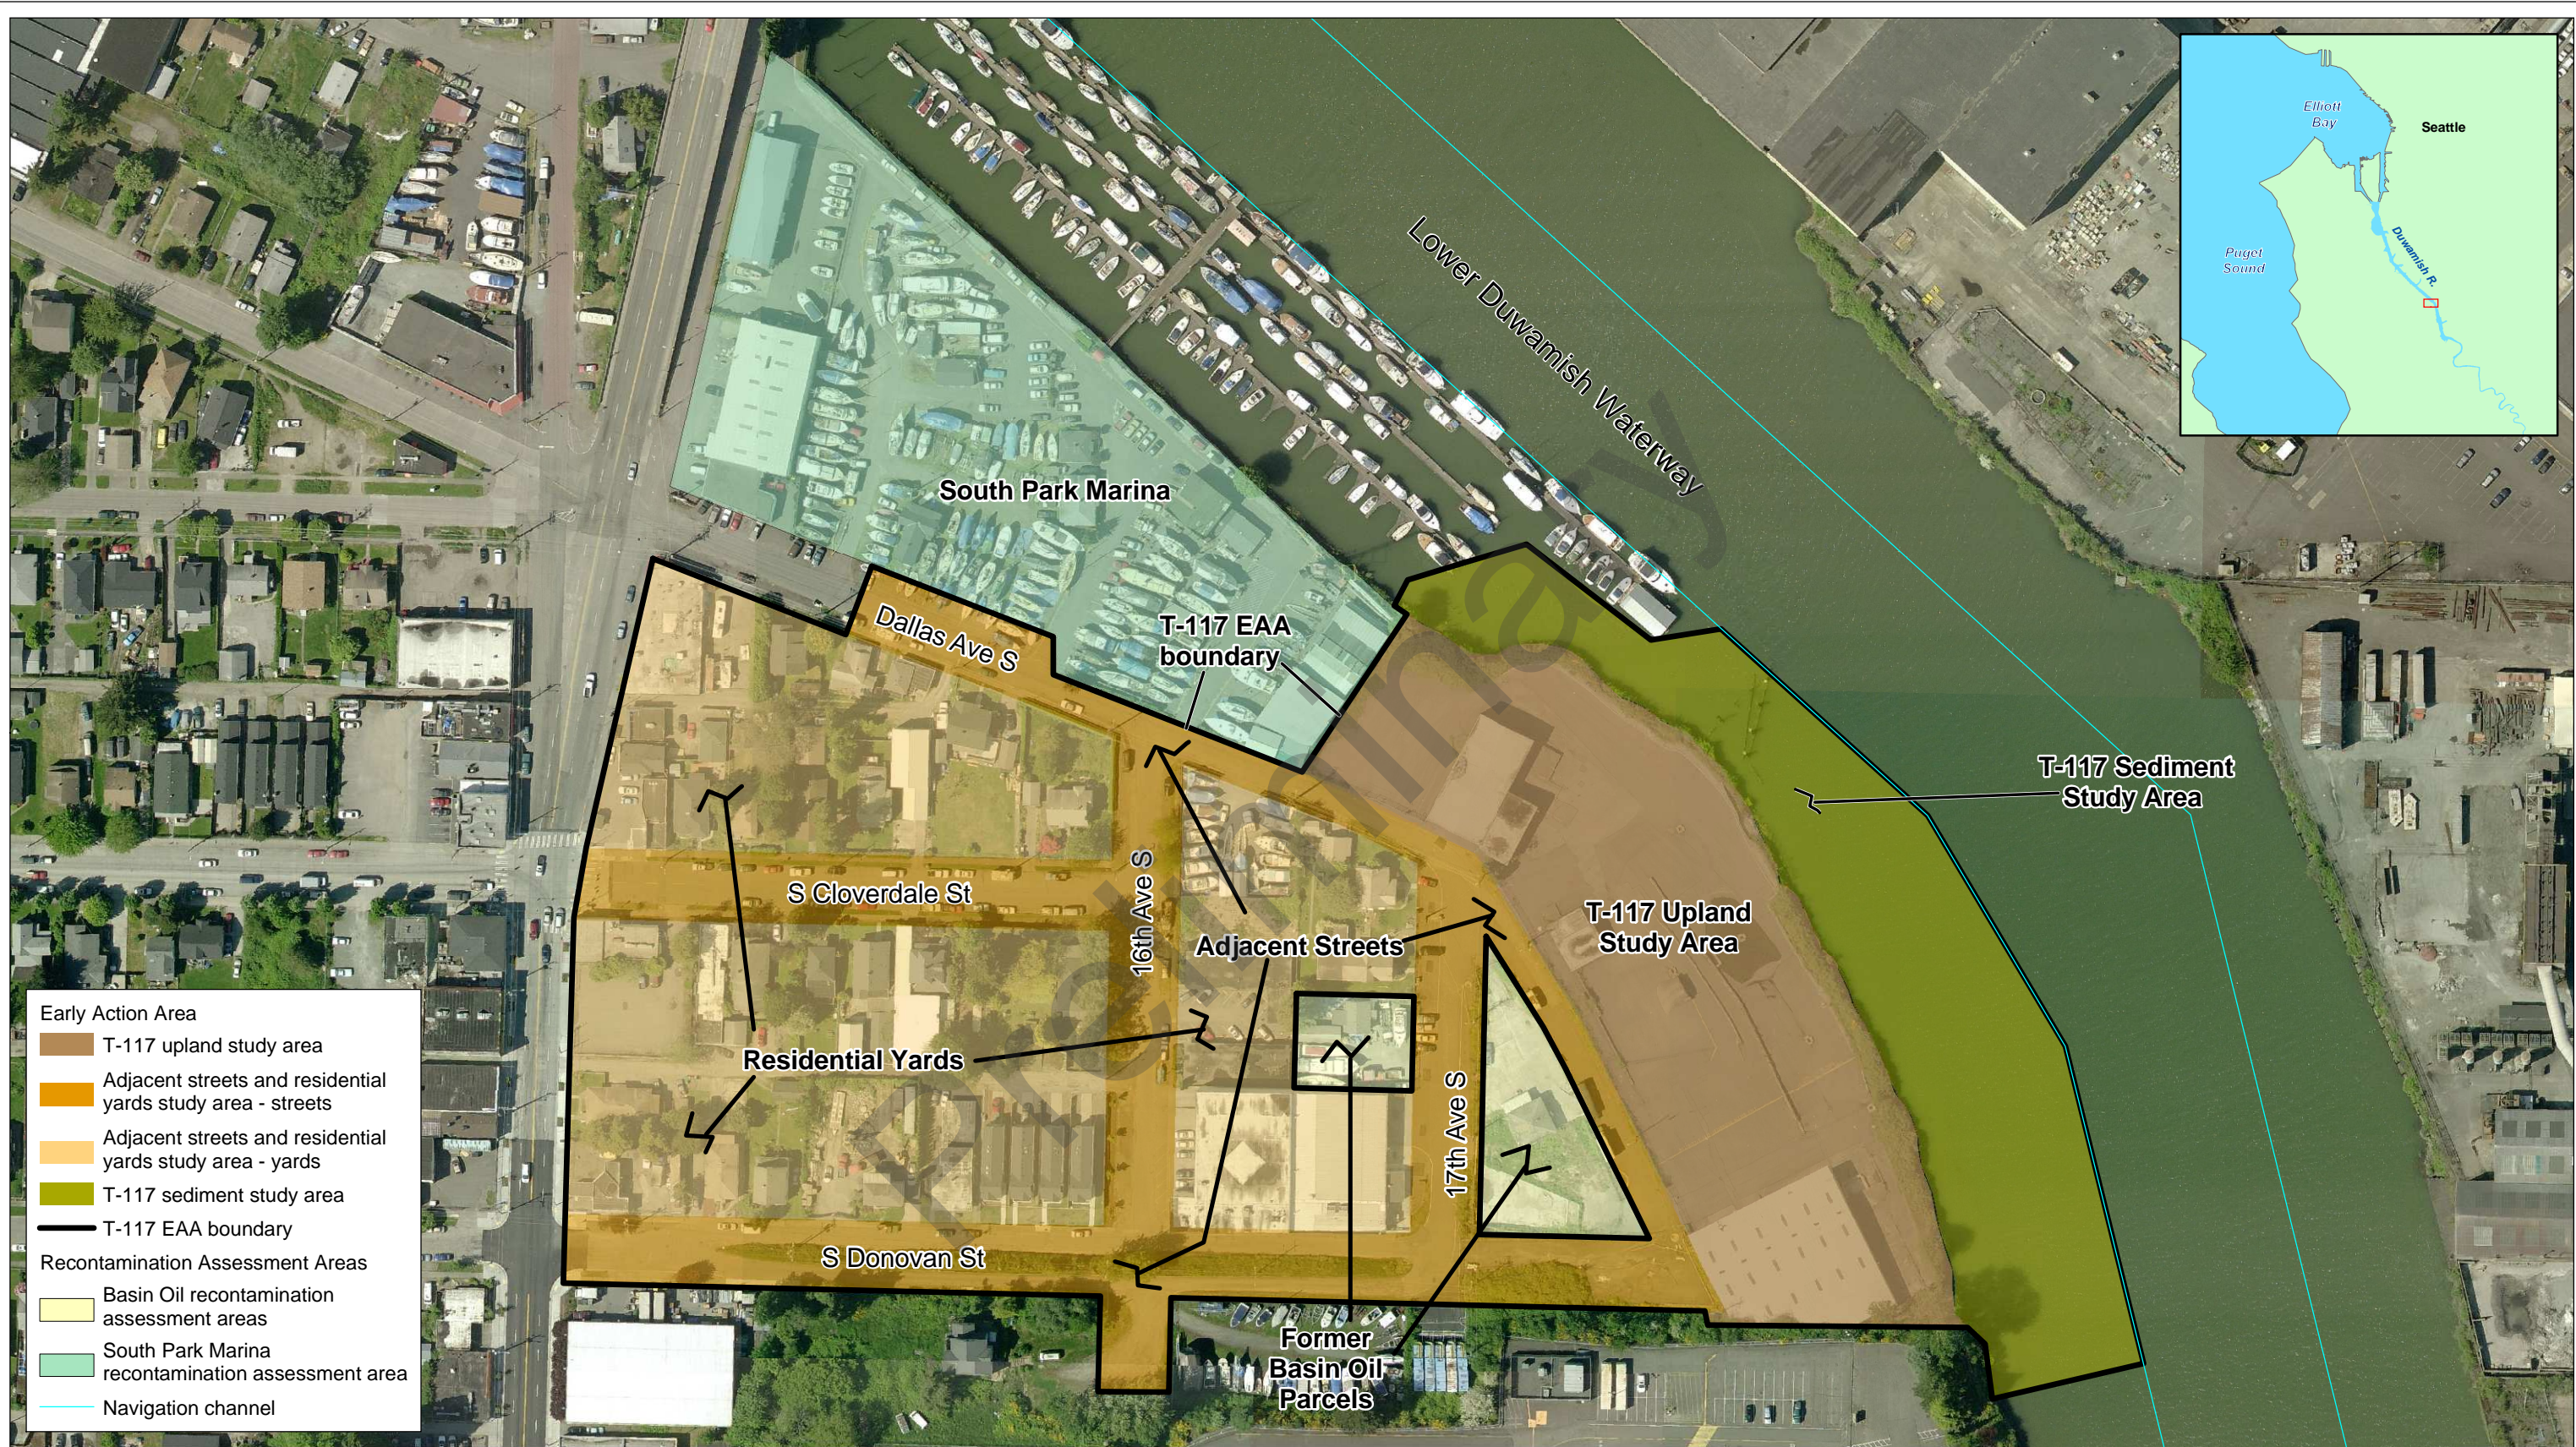
Map 1-1. T-117 EAA site overview

Figure 2. Terminal 117 Upland Study Area and Adjacent Streets
