**ENVIRONMENTAL ASSESSMENT REPORT
FLAMINGO BAY ECO RESORT
ST. THOMAS, U.S. VIRGIN ISLANDS**

**ENVIRONMENTAL
ASSESSMENT
REPORT A MAJOR
LAND PERMIT
FLAMINGO BAY ECO RESORT**

BBK Development LLC proposes to develop Plot 19 on Water Island to create a small Eco Resort. Within the 3.97-acre plot, 14 units – including eight (8) studio units, two (2) one-bedroom units, and four (4) two-bedroom units – will be constructed. The resort will also include a swimming pool, an open-air restaurant and bar and 30 parking spaces. Plot 19 contains what was once part of the Fort Segarra military complex and contains the remains of four buildings, including three barracks buildings and a mess hall. The ruins of these old buildings are being incorporated into the project. The project is incorporating solar energy to help meet its power requirements and will install a wastewater treatment plant and utilize the gray water for irrigation.

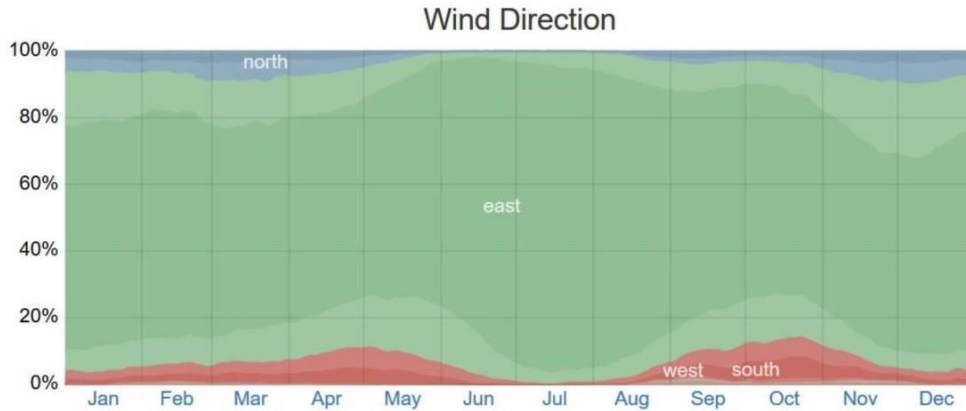
Figure 6.01.2 Wind averages from Weatherspark

The percentage of hours in which the mean wind direction is from each of the four cardinal wind directions (north, east, south, and west), excluding hours in which the mean wind speed is less than 1 mph. The lightly tinted areas at the boundaries are the percentage of hours spent in the implied intermediate directions (northeast, southeast, southwest, and northwest).

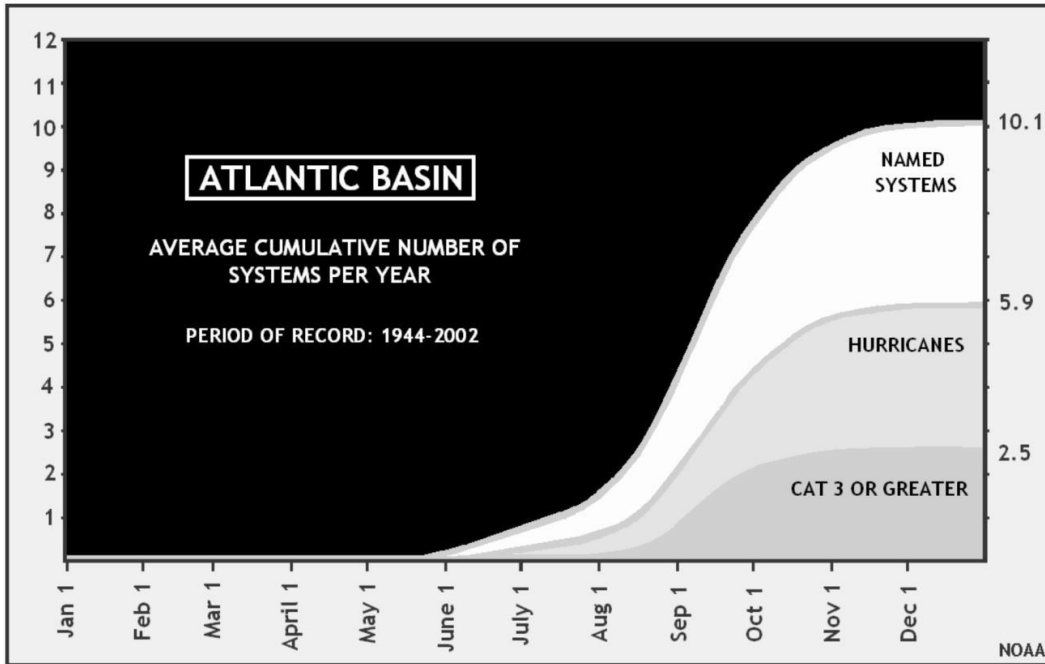
Figure 6.01.4 Tropical cyclone frequencies in the Atlantic
 Source: NOAA via the National Weather Service

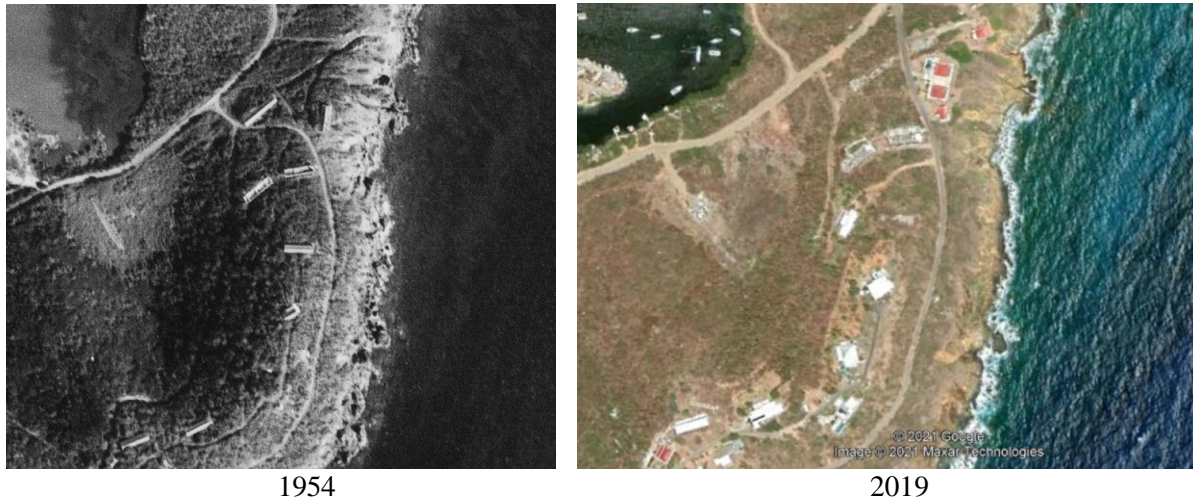
The proposed project site was previously used by the U.S. Navy for barracks in relationship with the Segarra Military Reservation. The ruins of the barracks remain on site.

Figure 6.02.1 The proposed project site on Water Island in 1954 and 2019

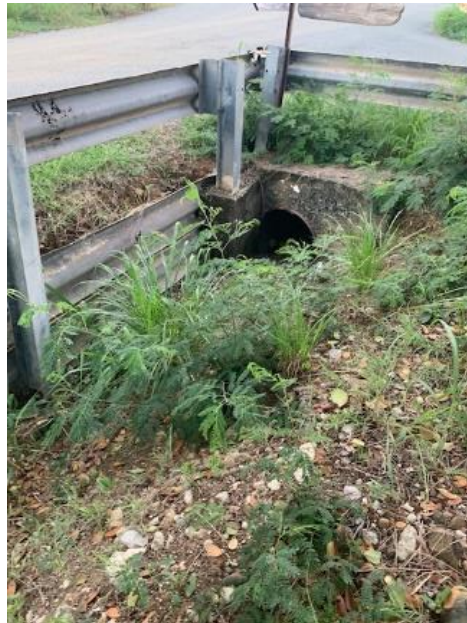
Figure 6.03.2 Existing culvert on proposed project site

There is an existing culvert under the roadway which moves stormwater through the site under the road. The water then sheet flows across the dirt roadway.

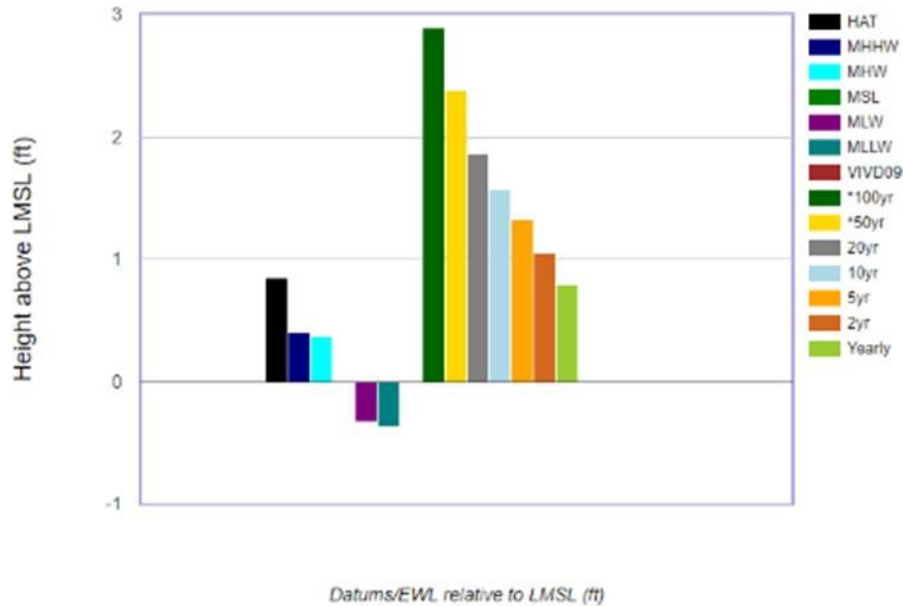
Figure 6.05.2 Tidal Datums and extreme water levels Station relative to VIVD09 - Station 9751639

The following figures shows the extreme water levels at the Charlotte Amalie station that were evaluated using the USACE calculator (version 5/17/2017) based on local tide gauge data – 32 years of record.

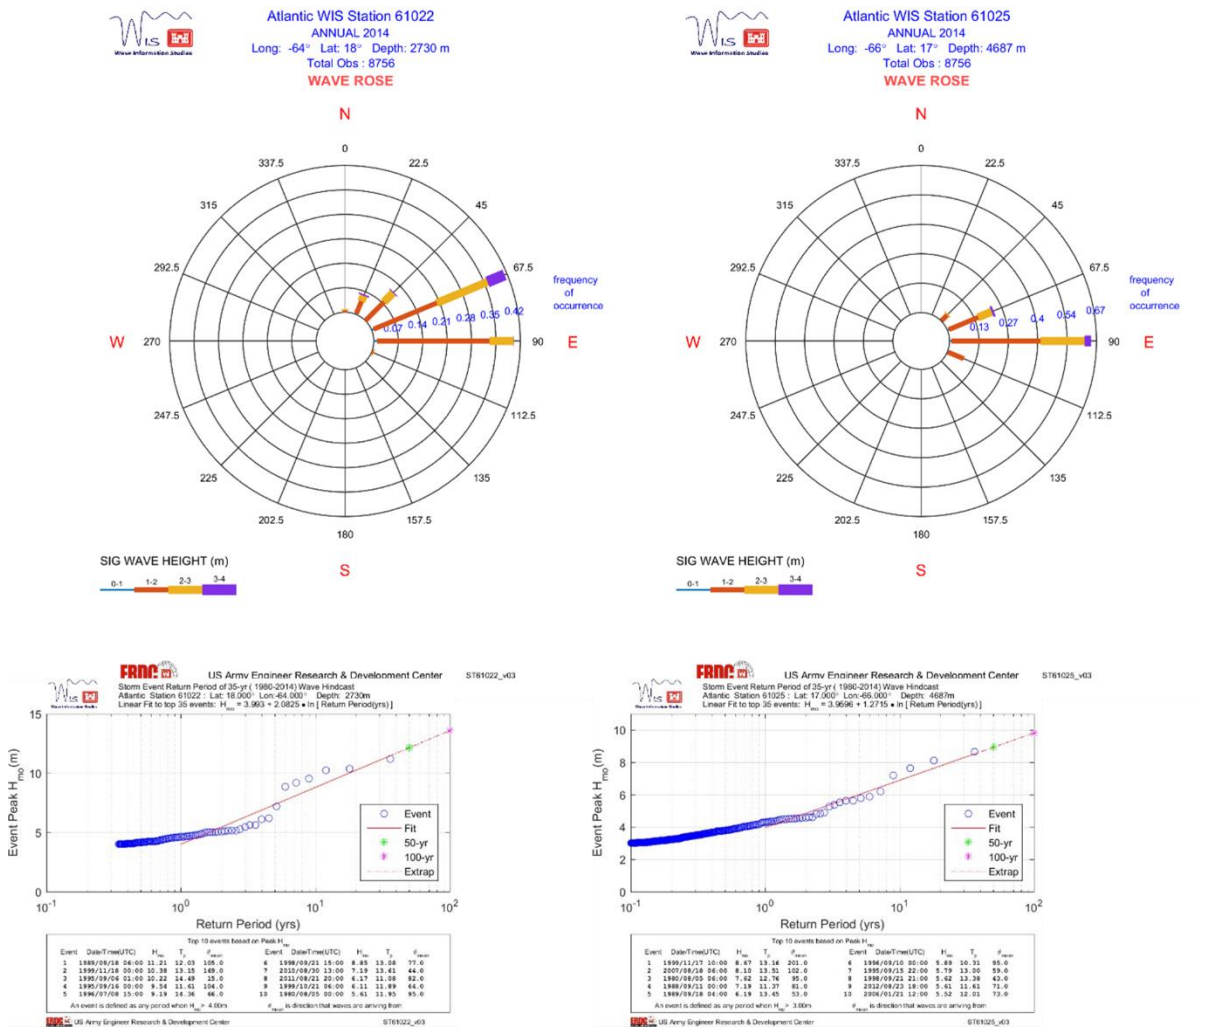
Figure 6.05.6 Wave Information for Station 61022 and 61025
 Source: <http://wis.usace.army.mil/hindcasts.html?dmn=atlantic>

The deep-water waves off St. Thomas are primarily driven by the northeast trade winds that blow most of the year (Figure 6.05.6). Waves average from one to three feet from the east, 42% of the time throughout the year (IRF, 1977). For 0.6% of the time, easterly waves reach 12 ft. in height. The southeasterly swell with waves one to twelve feet high become significant in late summer and fall when the trade winds blow from the east or when tropical storms and hurricanes pass the islands at a distance to the south. During the winter months, long length, long period northern swells develop to a height of one to 5 feet. Waves have negligible impact on the Flamingo Bay Pond.

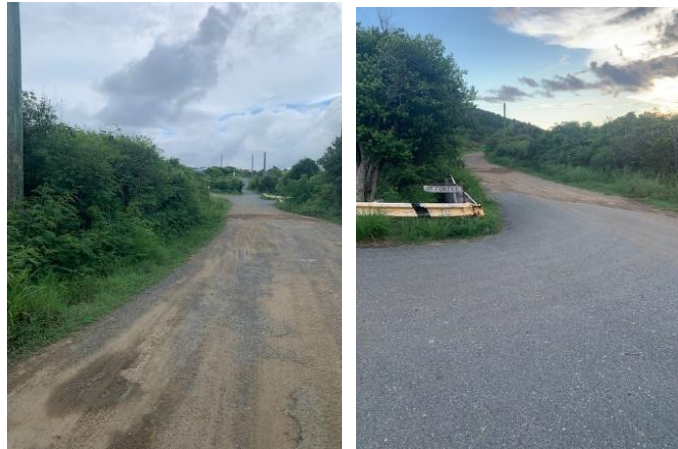
Figure 7.03.1 Photographs of the roadways

Construction will result in an increase of vehicles and materials brought to Water Island by ferry. The vehicles and supplies will be carried to the proposed project site which is approximately 0.3 miles down a compacted dirt roadway from the barge landing. The roadway is in poor condition and has minimal traffic.

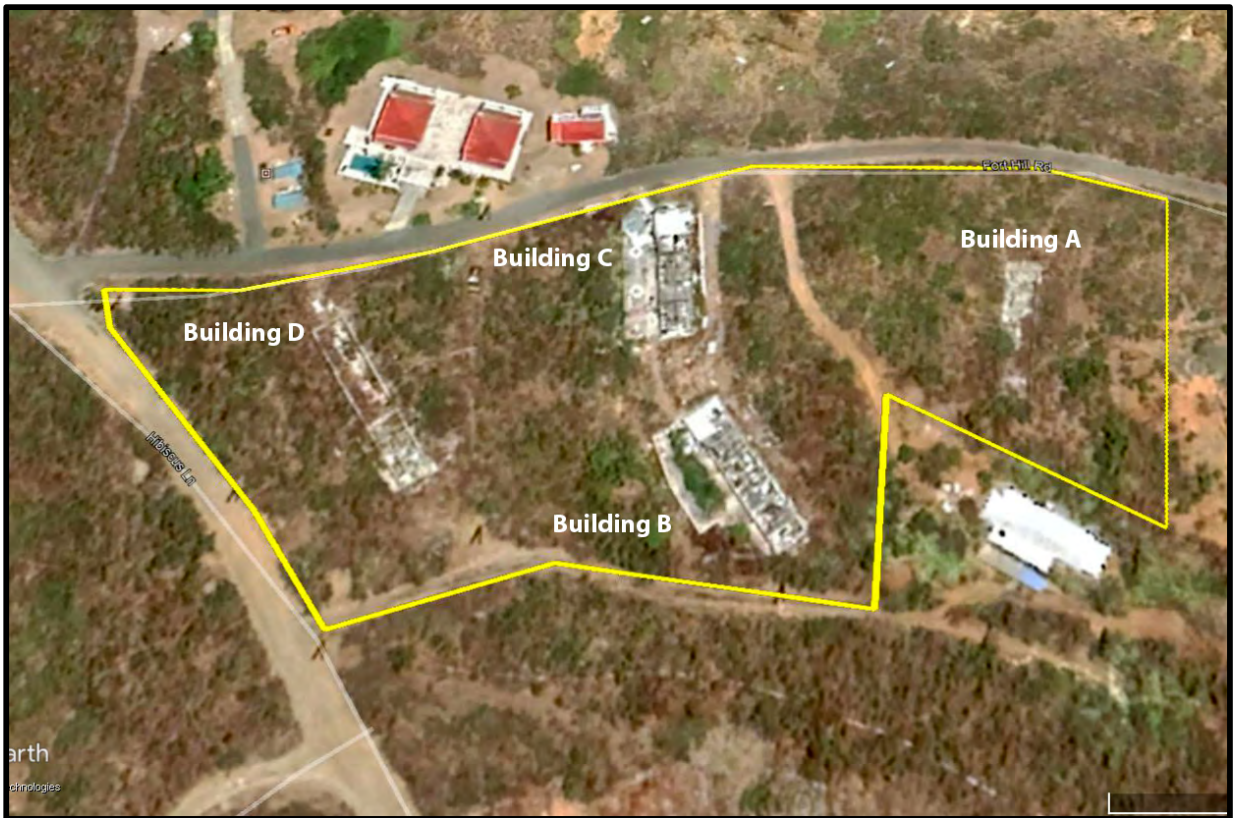
The field survey resulted in the identification of four concrete structures, three of which were once U.S. Army barracks and herein designated as Buildings A, B and C. Building D was a mess hall. Locations of the buildings are shown on Figure 9 below. Descriptions of each of the structures are provided below.

Figure 9: Google Earth image depicting the location of Buildings A – D)

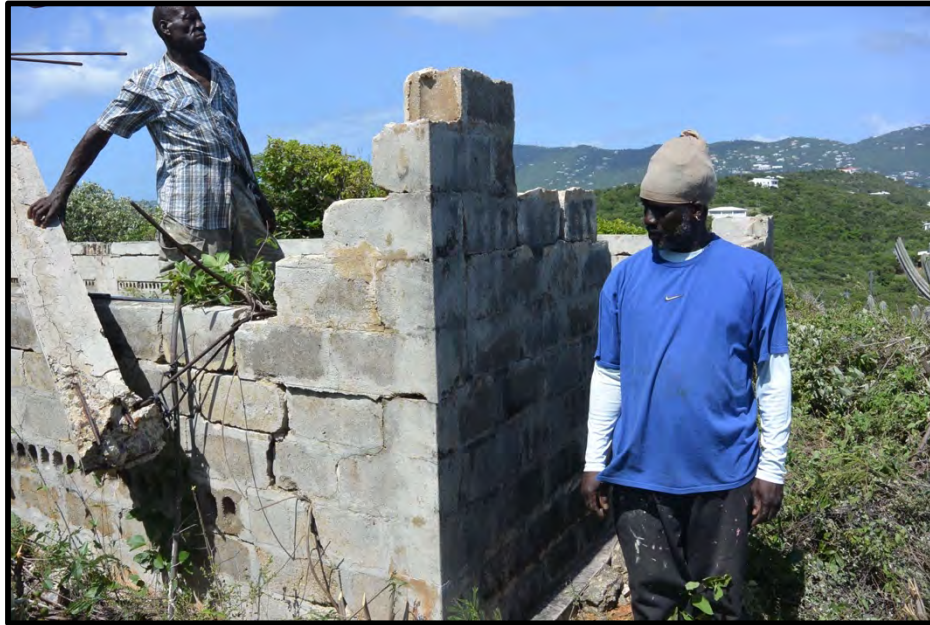
Building A is an open bay rectangular building located in the southernmost part of the subject property and at the highest elevation. The building measures approximately 29 meters (m) along its east to west axis by approximately 7 m along its east to west axis. An entrance door is discernable on the east end of the building, the west end of the building may have contained another entrance or a set of windows. This section of the building is largely collapsed and would require removal of rubble to discern the use. The highest preserved walls are on the south side of the building and extend approximately 2.7 m high from the interior concrete floor (Figure 11). The top of the horizontal column for this wall contains a few remaining rafter holders for a hipped roof that was likely covered with galvanized steel sheets. The building contains six large windows on its north and south elevations (Figure 12). Each of the long walls contain concrete blocks that were laid so that the block openings are open to the interior and exterior for what we interpret to have provided additional ventilation.

The structure is poorly preserved, with the north, east and west elevations largely collapsed. The south elevation is better preserved but does contain collapsed sections and a multitude of diagonal fissures. We did not note interior plumbing in the building but did note wall plugs for electricity.

Figure 10: Photograph of the southeastern corner of Building A

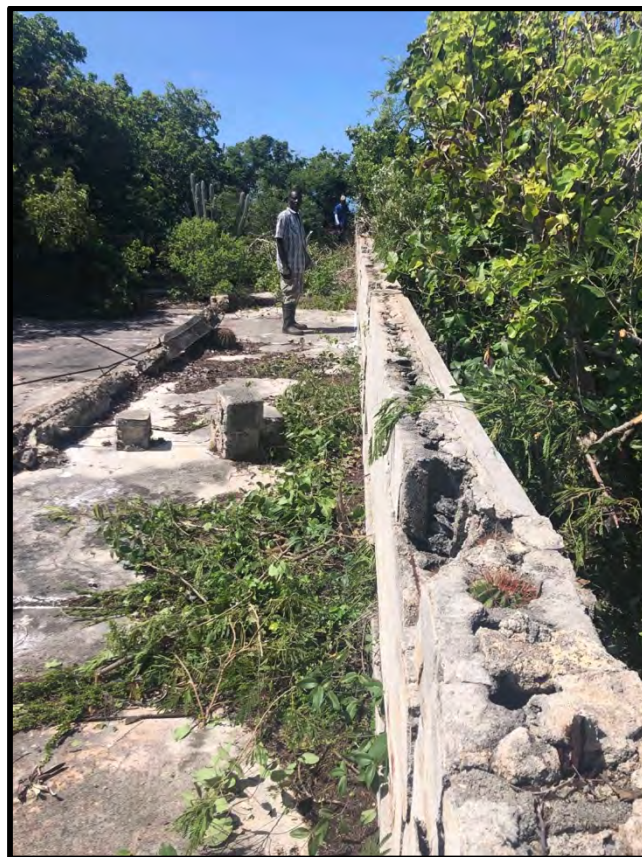
Figure 11: Photograph of the north wall axis, view to the west

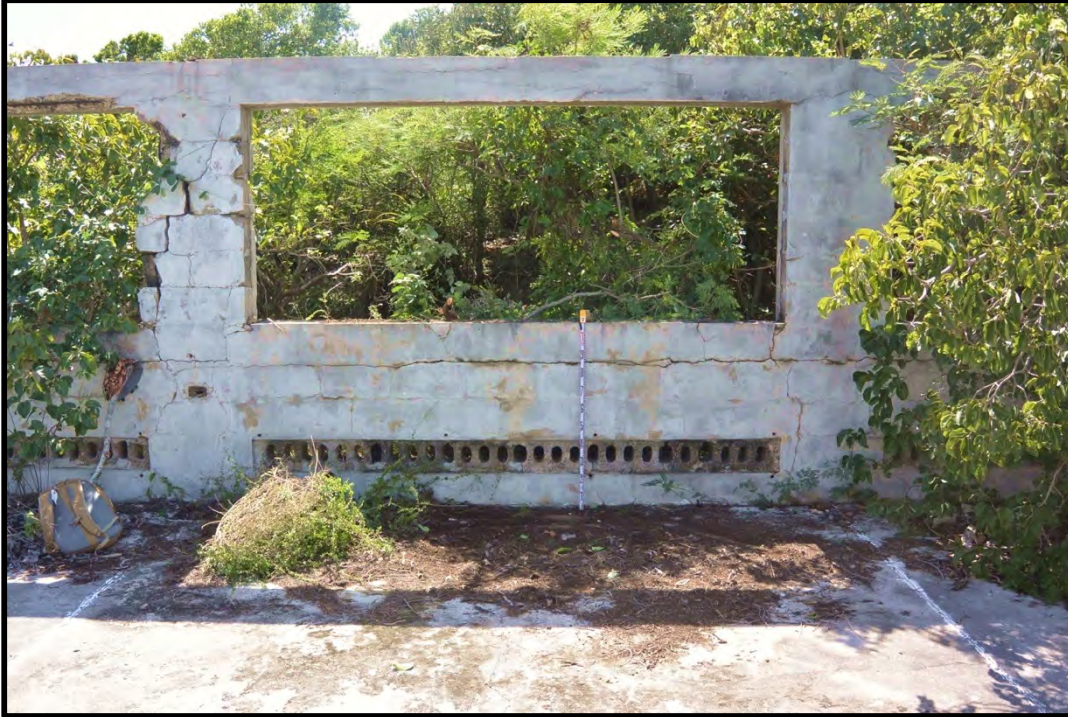
Figure 12: Photograph of south wall details, note the large window openings and ventilation features near the base of the wall

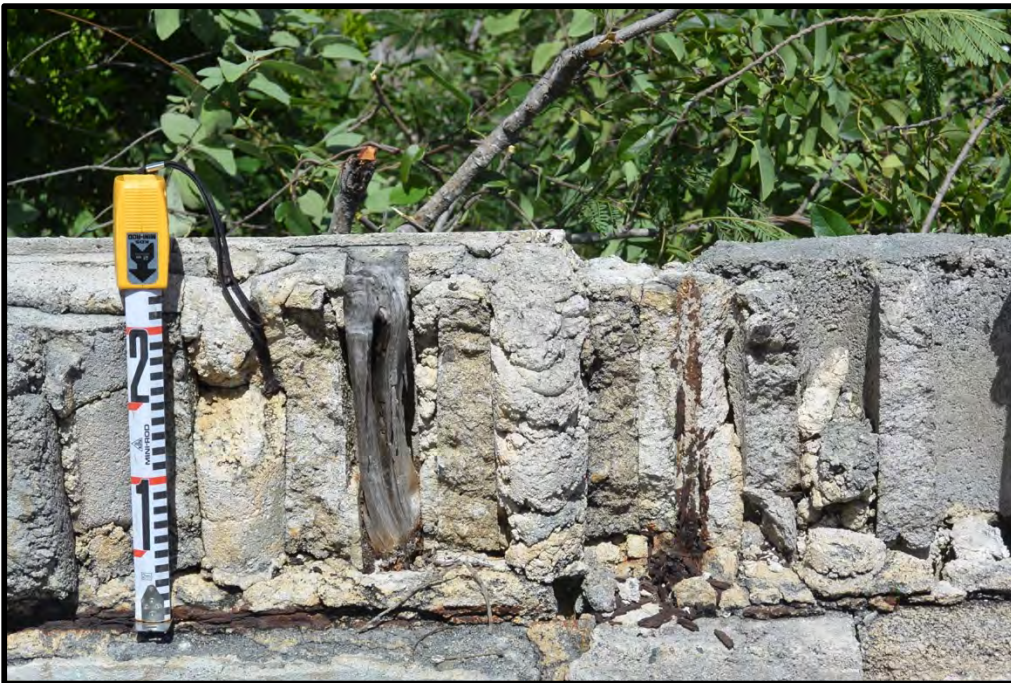
Figure 13: Window casing detail

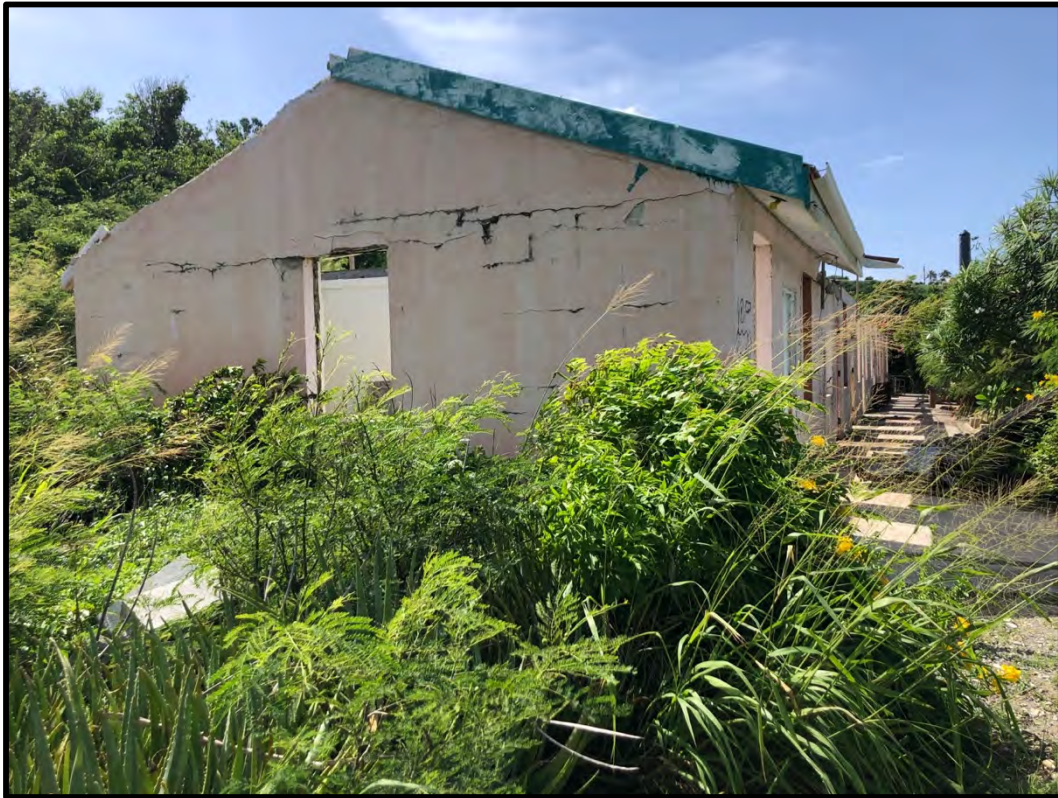
Figure 14: East elevation of Building B

Buildings B and C were barracks buildings likely of similar plan and construction as Building A. These buildings were converted for use as a hotel in the past and have been extensively damaged by hurricanes. Our Clients propose to rehabilitate the buildings. The existing modifications to the buildings primarily consist of the subdivision of the open bays into 6 hotel rooms per building, each room appears to have had a kitchenette and bathroom. The large window casings were partially sealed to make individual entrances and windows. Both buildings contain terraces on top of large cisterns that may have been added for the hotel's purposes. The east elevation of Building C (Figure 18) appears to have had a rock façade added, as no evidence of such facing was observed on the other buildings. A plywood workshop was recently built on the terrace of Building C.

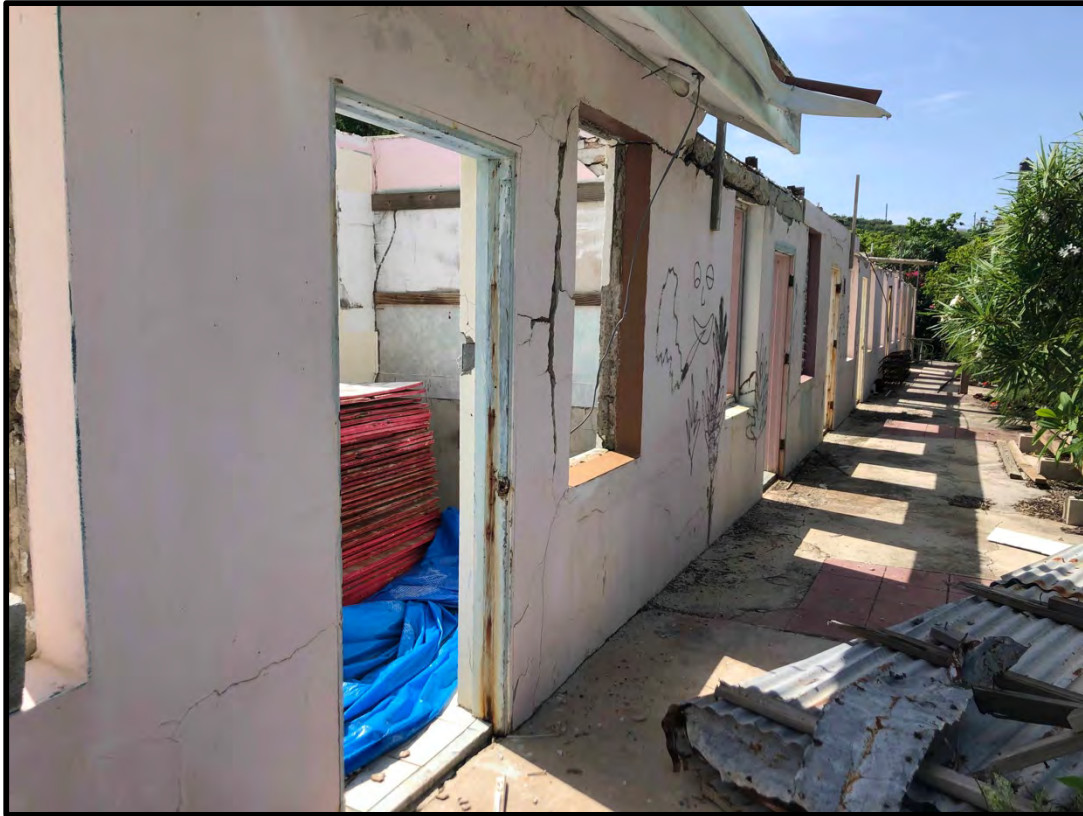
Figure 15: North elevation of Building B

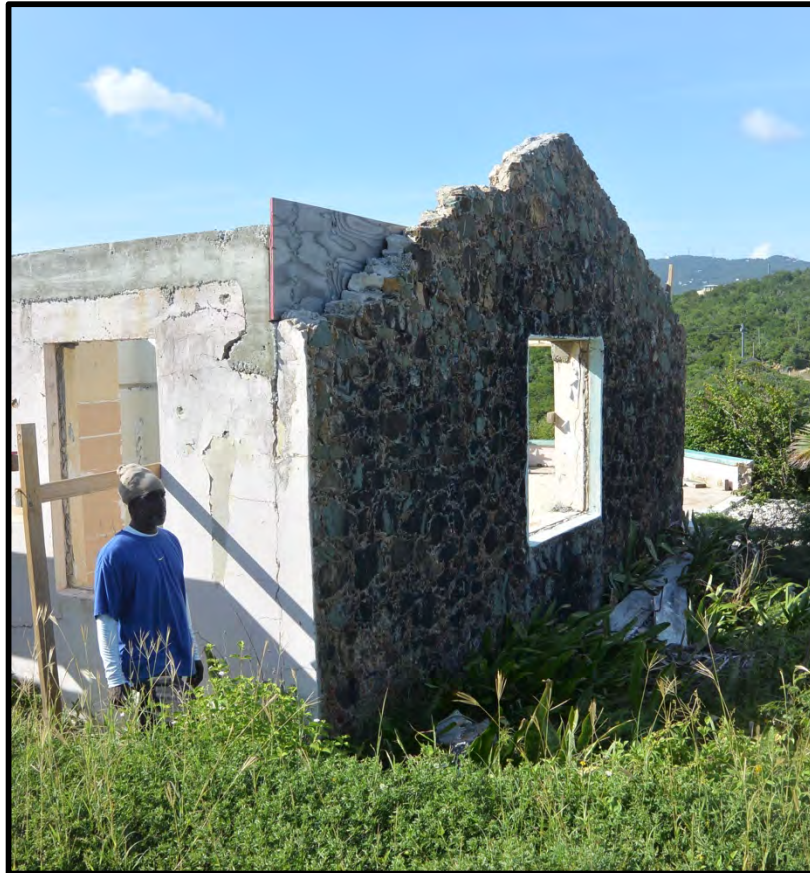
Figure 18: Rock faced east elevation of Building C

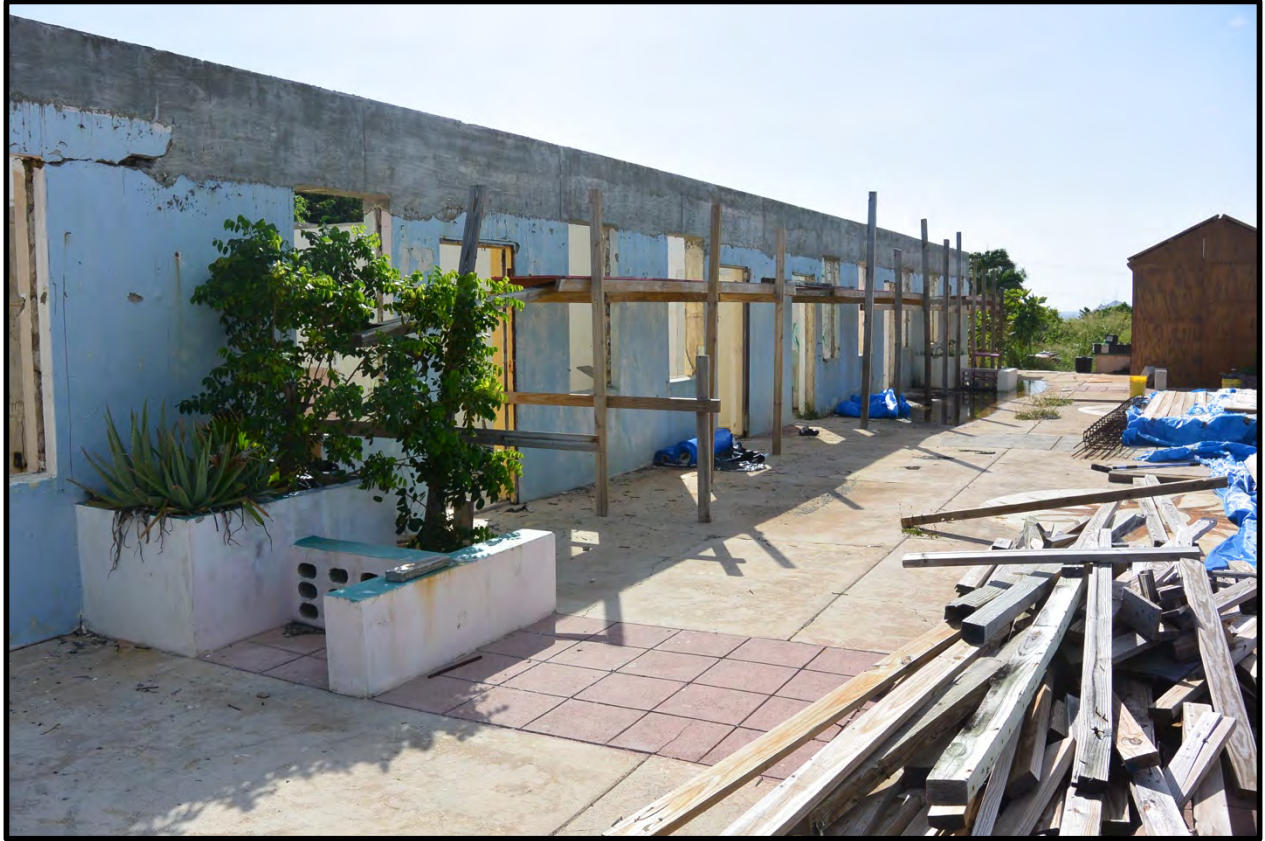
Figure 18: Partial view of the north elevation of Building C

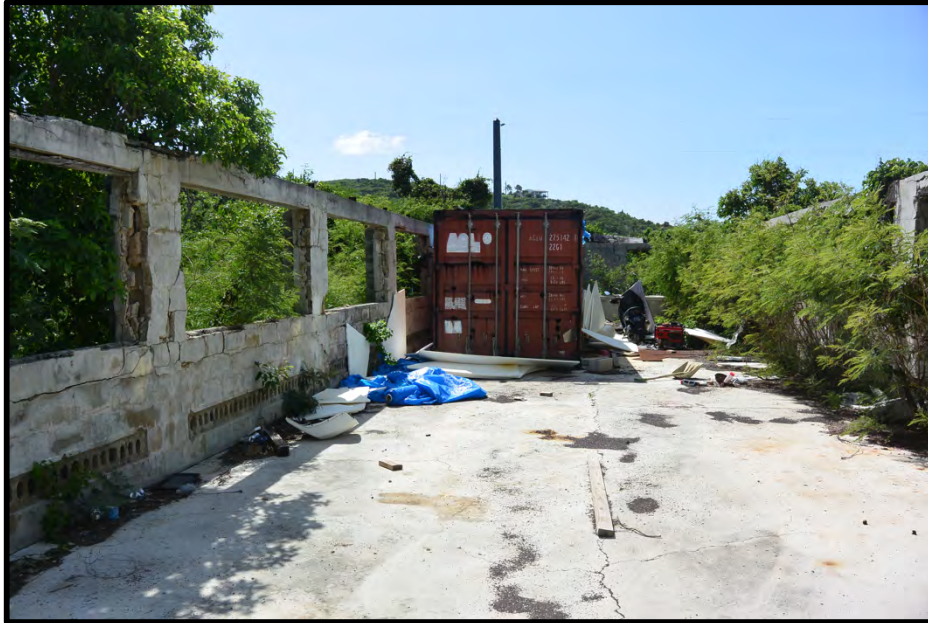
Building D is the northern most building located on the subject property. Building D is scheduled for demolition and its footprint will serve as a parking area. The building is generally of the same open bay plan (Figure 19) and construction as Building A, except that it contains attached spaces on the west and northwest ends, and a constructed bar or large counter top (Figure 20). The open bay and attached room on the west end measure approximately 42 m along its east to west axis by approximately 7m in width. An attached room on the northwest corner of the building extends from the exterior northwest wall of the open bay for approximately 7.5 m along its east to west axis, its width is estimated to be 3.5 m. At the time of our *Survey*, Building D contained a metal container that appears to have been used for domestic purposes and large amount of recent trash throughout the building interior and exterior.

Figure 19: Building D interior, view to west

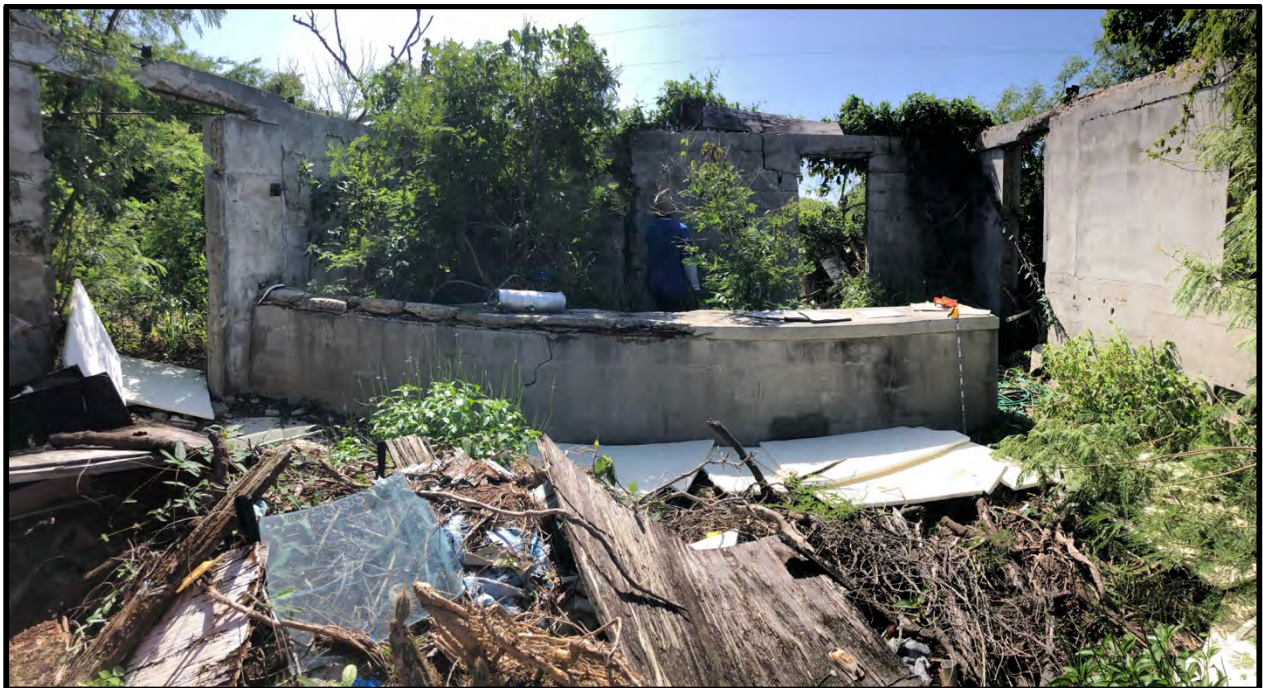
Figure 20: Photograph of the west end of Building D

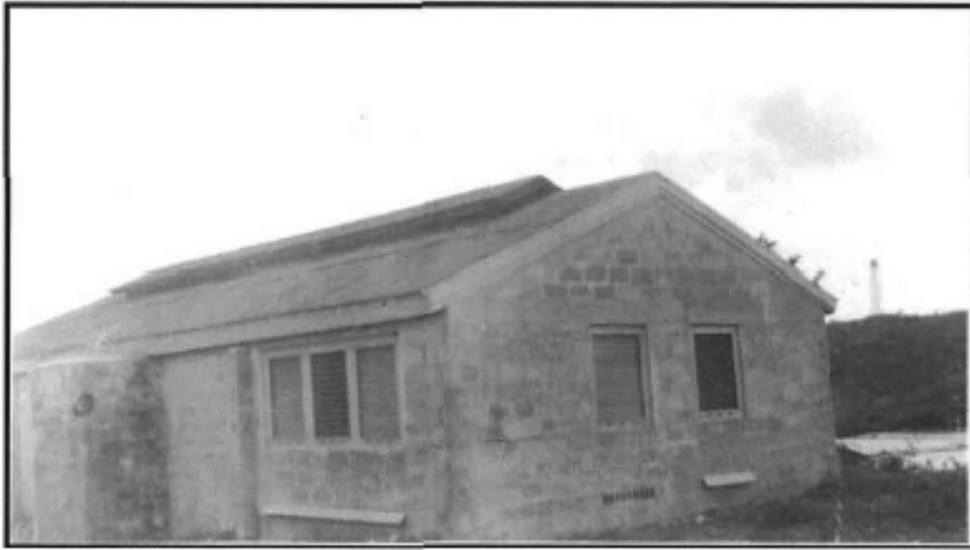
Figure 21: Photograph of similar barracks, Building 33 “rear view.” Source: US Army Forces Antilles, Signal Corps Photos, 1948

Signal Corps photographs of similar buildings located on Water Island are shown below and provide other construction details such as that the large window openings framed three individual jalousie windows (Figures 22 and 23).

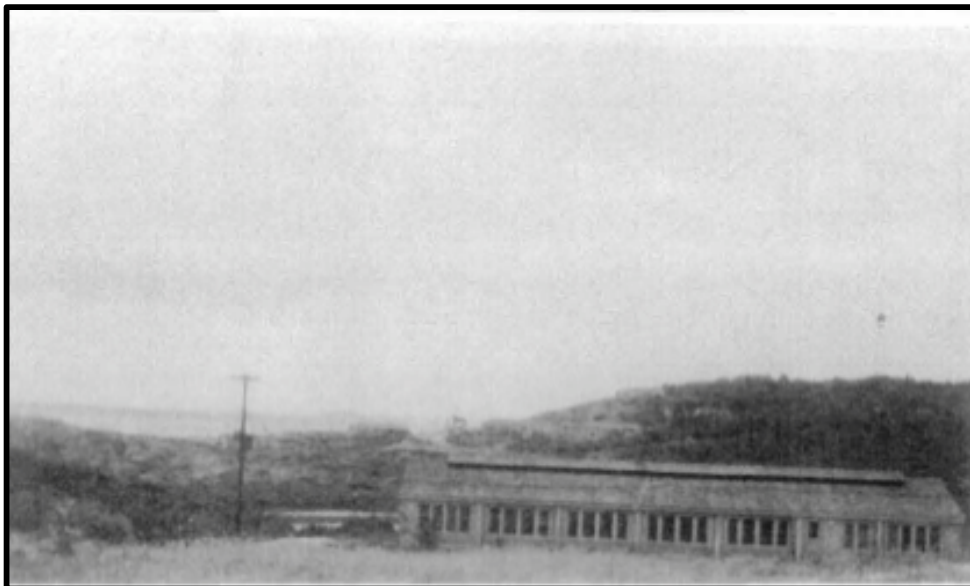
Figure 22: Photograph of similar barracks building. Source: US Army Forces Antilles, Signal Corps Photos, 1948
