# SÄ DENA HES OPERATING CORPORATION

## SÄ DENA HES MINE

### DETAILED DECOMMISSIONING & RECLAMATION PLAN

### JANUARY 2010 UPDATE

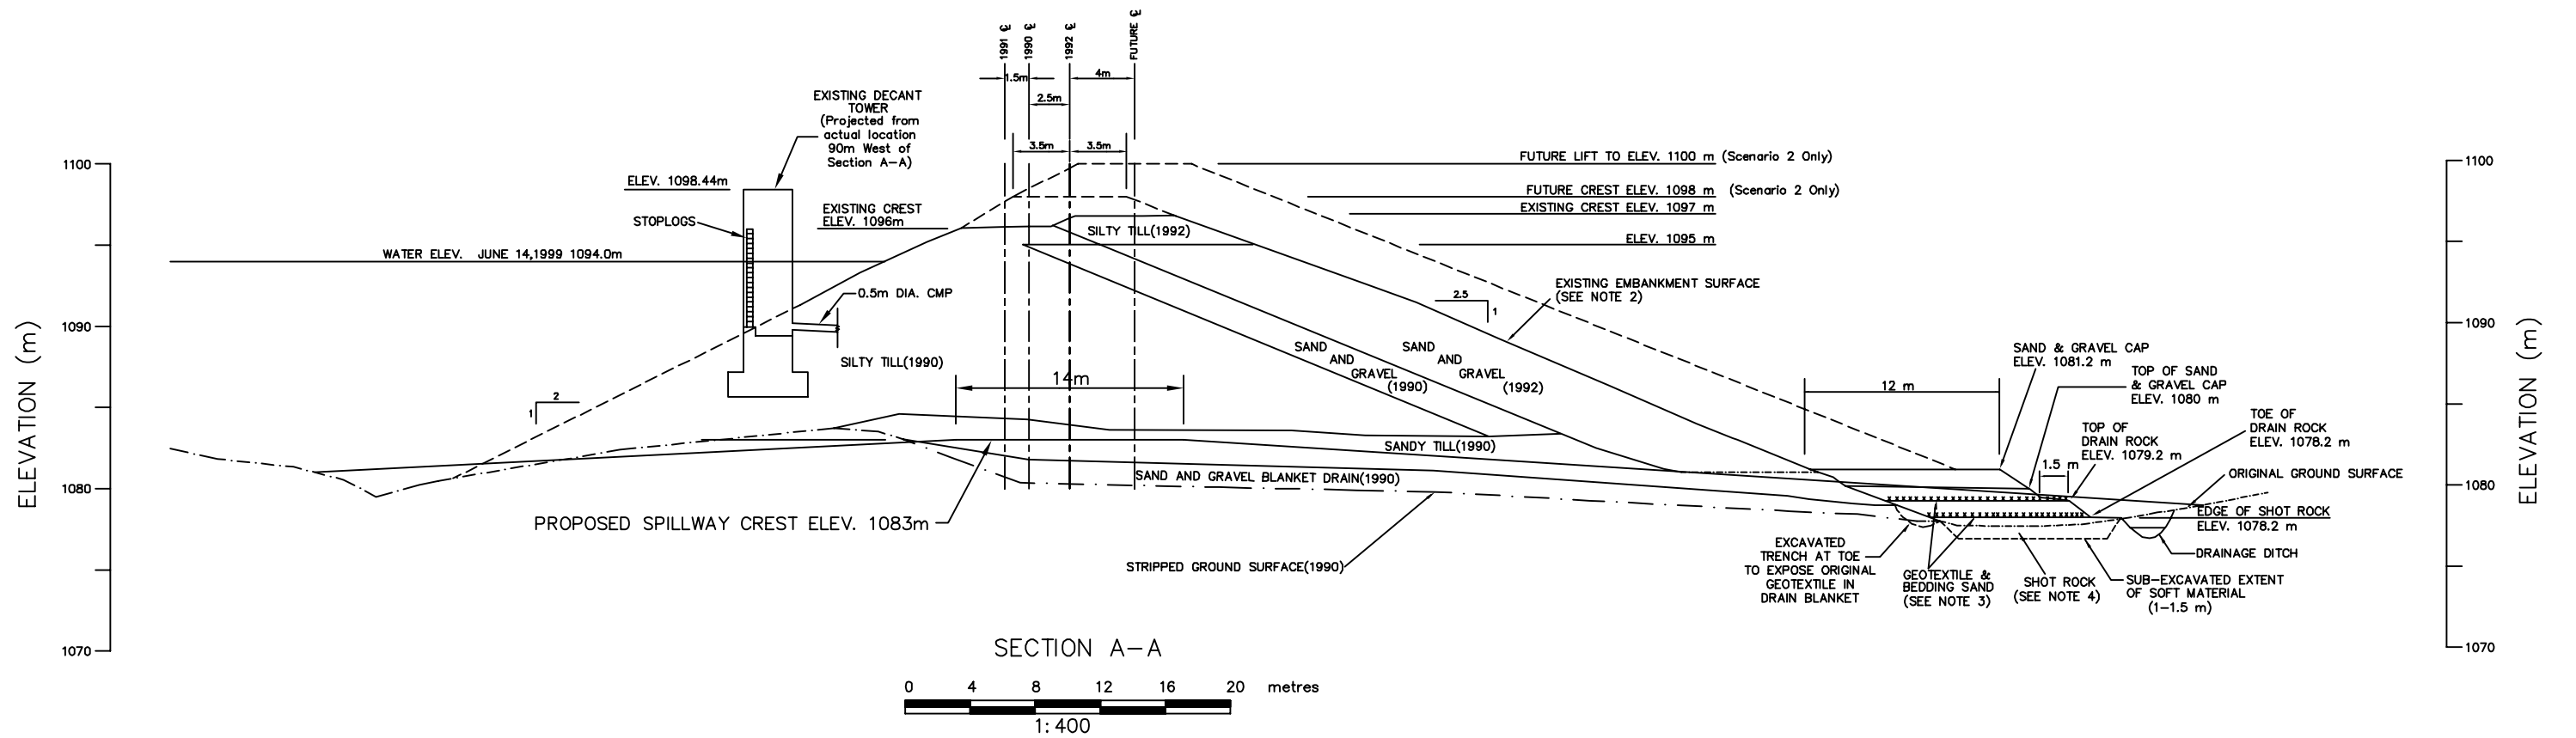
RECLAIM DAM BREACH CHANNEL	SOUTH DAM SPILLWAY
Q (m <sup>3</sup> /s)	15.6	5.4
B (Crest width)	4m	4m
D (Depth of flow)	0.88m ?	0.75m
D <sub>50</sub> (Riprap)	0.3m	0.3m
Sideslopes	2:1	2:1
Depth of Riprap	0.45m	0.45m
Crest Elevation	N/A	1083m
Channel Slope	0.013	N/A

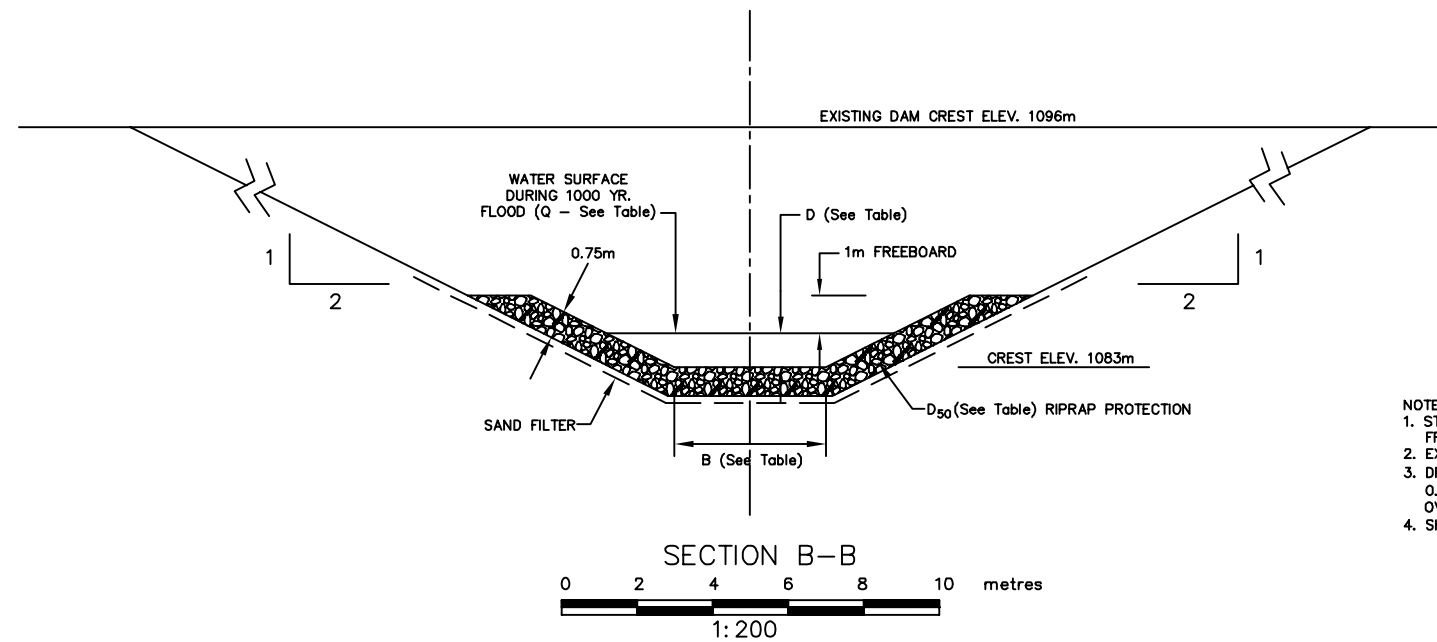
DRAWN BY: MH	CHECKED BY: PMH	FIGURE NO. 3-6	REV.
DATE: January 2010	PROJ. NO. 1CC005.05

- NOTES
1. STRIPPED GROUND SURFACE AND EXISTING DAM ZONES FROM Y.E.S. AS-BUILT DRAWINGS, JULY 1991.
  2. EXISTING DAM SURFACE FROM SURVEY COMPLETED AUGUST 1997.
  3. DRAIN ROCK FILTER CRITERIA -  $5\text{mm} < D_{15} < 25\text{mm}$   
0.3m THICK BEDDING LAYER OF PIT RUN SAND AND GRAVEL OVER SHOT ROCK PLATFORM.
  4. SHOT ROCK CONSISTS OF BLASTED LIMESTONE FROM JEWELBOX PIT.

TMF CLOSURE MEASURES – SCENARIO 1  
SECTIONS A-A AND B-B

In addition to the North and South Dams, a Reclaim Dam was built to retain supernatant water decanted from the tailings pond for reuse in the mill. The Reclaim Dam is about 15 metres high at the maximum section. The mine plan involved recycling of the reclaimed water to the mill with a controlled discharge into Camp Creek from April to October each year. During operations and when the pond water level becomes too high, water is decanted from the tailings pond to the Reclaim Pond through a concrete decant tower located adjacent to the upstream crest of the South Dam as shown Figure 3-6. Details of the decant tower are shown on Figure 3-7.

An emergency spillway, consisting of two 900 mm dia. CSP culverts, is located at the west abutment of the South Dam as shown on Figure 3-6. The spillway has the capacity to discharge flow from a 200-year flood event into the Reclaim pond. An emergency spillway is also located on the west flank of the Reclaim pond which would discharge into the Camp Creek Diversion.

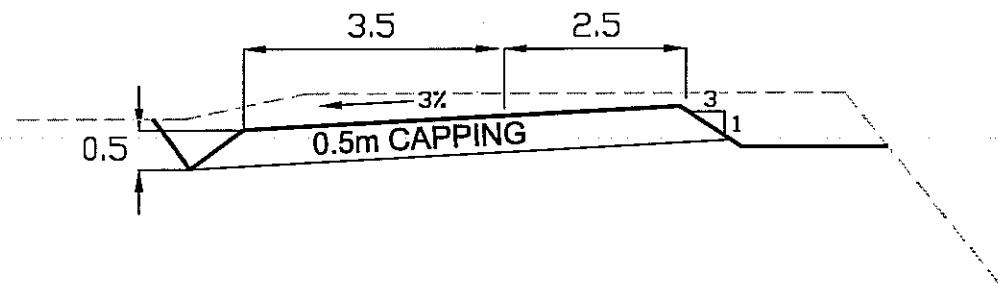
Sta. 0+000 to 2+413

**TYPICAL SECTION  
SINGLE LANE WITHOUT BERM**

ALL SIDE SLOPES 1.5:1 EXCEPT WHERE NOTED  
AND DITCH SLOPE OF 3:1

H= 1:200 V= 1:100

The main access road to the property was constructed in 1990. Figure 1-2 illustrates the overall routing for this road. This road was constructed to facilitate traffic from 26 ton ore concentrate trucks. The road was constructed by cut and fill methods with a road width of 8 m and associated ditch drainage and culvert installations. A typical cross section for the main site access road appears in Figure 3-16 (Typical Road Cross Section).

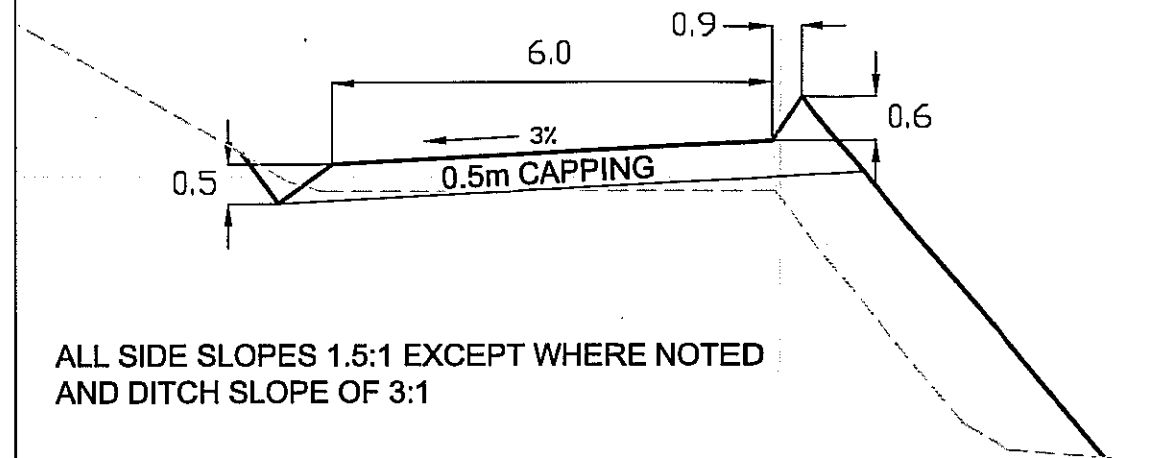
Sta. 0+000 to 1+400

**TYPICAL SECTION  
SINGLE LANE WITH BERM**

ALL SIDE SLOPES 1.5:1 EXCEPT WHERE NOTED  
AND DITCH SLOPE OF 3:1

H= 1:200 V= 1:100

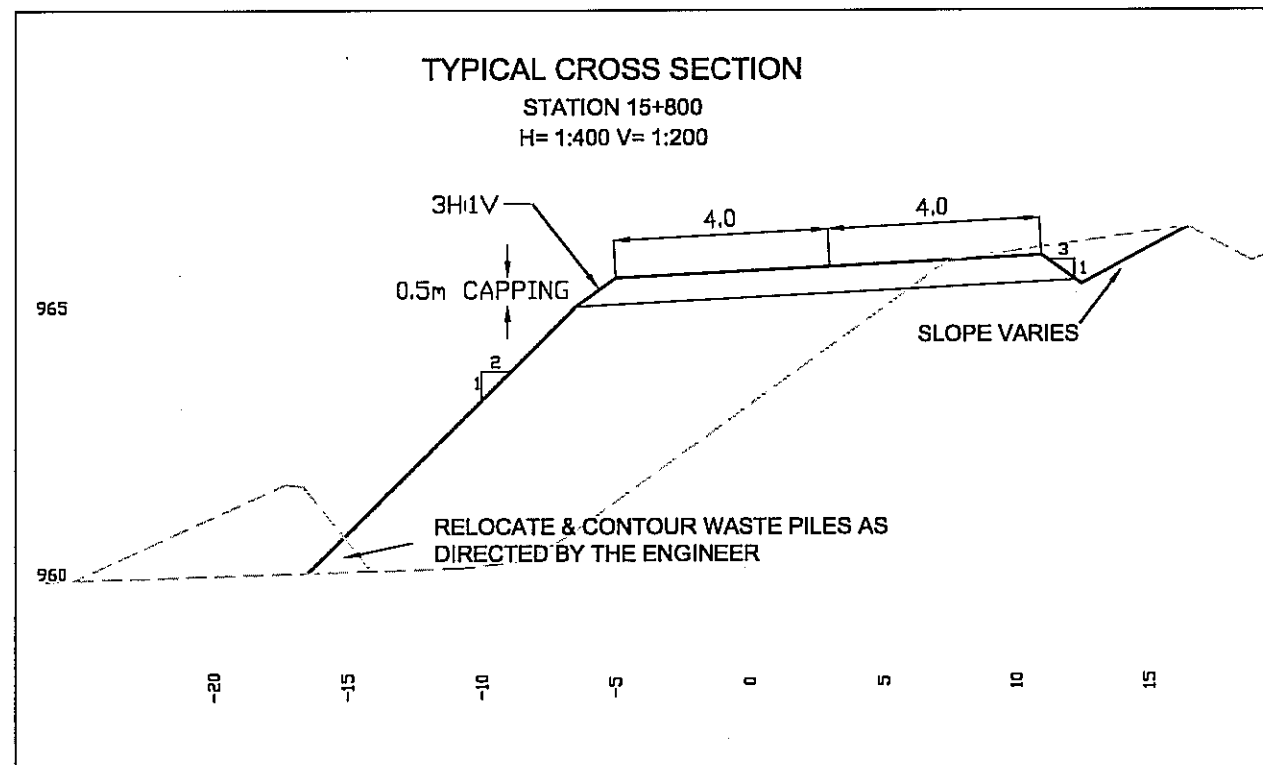
STATION 15+800  
H= 1:400 V= 1:200

**TYPICAL CROSS SECTION**

**ACCESS ROAD - TYPICAL**

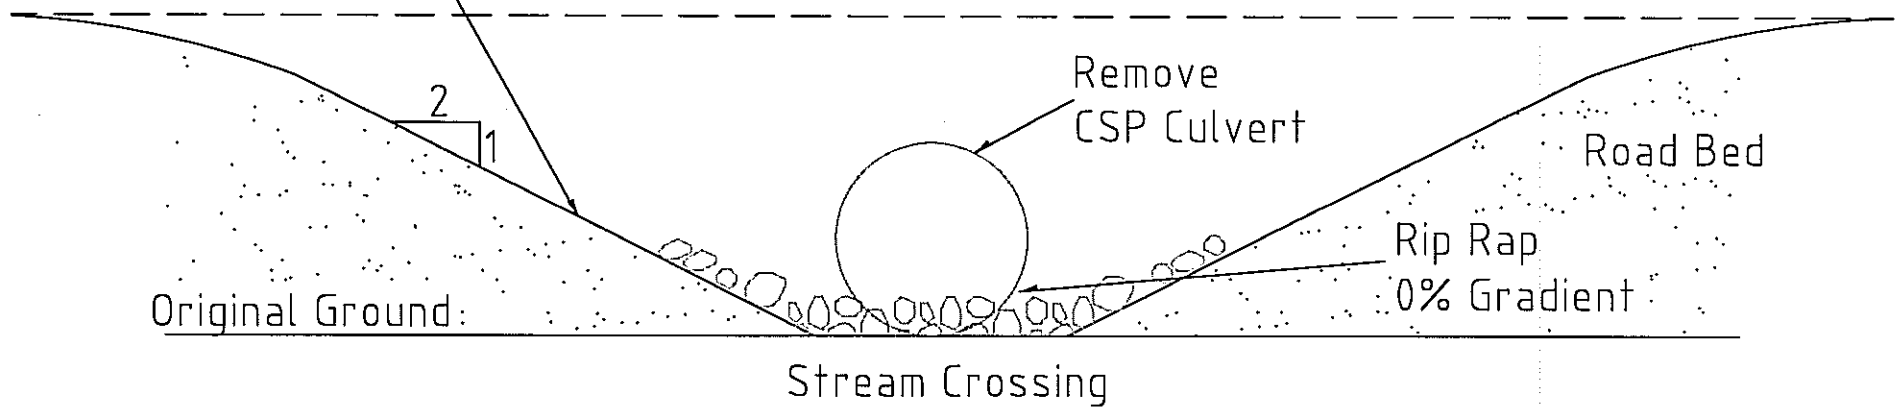
Sand & Gravel

Revegetate & Dress Slope with  
Erosion Protection Blanket (Soil/Gravel/Cobbles)

Existing Access Road Surface

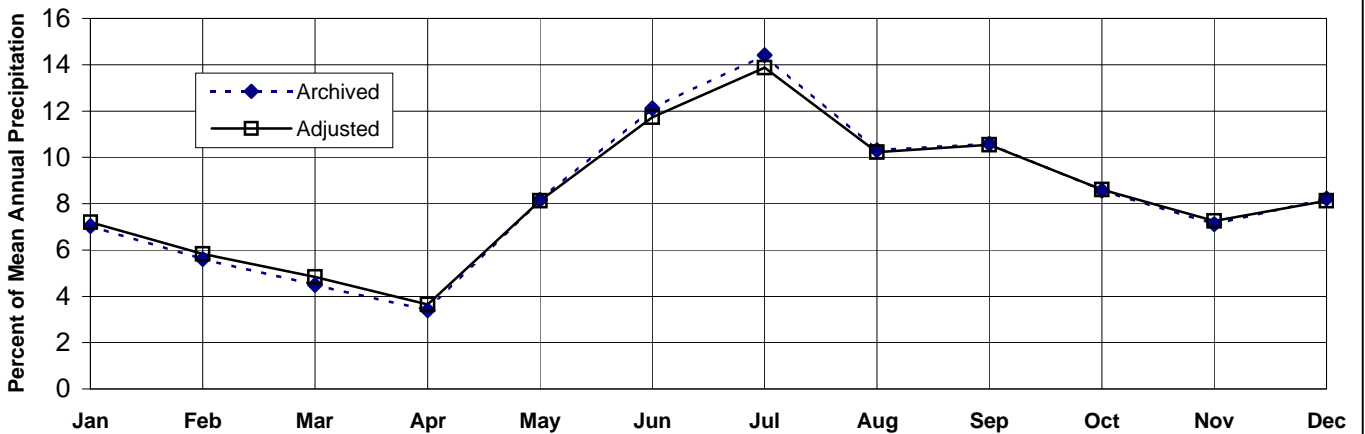
Comparison of Archived and Corrected Precipitation Records for Watson Lake A. - (1953-1993)

SA DENA HES DETAILED  
DECOMMISSIONING AND RECLAMATION PLAN  
MEAN MONTHLY PRECIPITATION  
DISTRIBUTIONS AT REGIONAL CLIMATE  
STATIONS

Therefore, the corrected MAP for Watson Lake of 490mm will be used in the analysis. The previous archived value from the 1961 – 1990 normals was 413 mm. For all other stations, the archived MAP value will be used. The correction of the archived records for these other stations is the focus of on-going research at the AES.

The seasonal precipitation distribution at the tailings impoundment was approximated using normalized monthly average distributions of regional AES stations. The two upper graphs in Figure 2-2 graphically present the monthly rainfall and snowfall distributions for two high altitudes (Cassiar and Swift River) and two low altitude (Tuchitua and Watson Lake A) AES stations. The rainfall and snowfall (as water equivalent) distributions are expressed as percentages of the MAP. The high altitude stations exhibit fairly different distribution patterns than the low altitude stations. It is assumed that the difference is primarily a result of an elevation dependency; however, it may also be related to spatial variations. The two low altitude stations are located along the valley floors of the Frances and Liard Rivers in fairly close proximity to the mine site whereas the two high altitude stations are sited further to the west within the Cassiar Mountains. The normalized distributions for the two high altitude stations coincide remarkably well despite the fact that the stations have an elevation difference of about 170 m. The one difference is the anomalously high, and probably erroneous, average snowfall at Swift River during March. Based on the similarities between the distributions at the two high altitude stations, the Cassiar distribution was adopted, without any adjustments, to represent the precipitation pattern at the tailings impoundment. This distribution was used to reflect the fact that a higher proportion of precipitation falls as snow at elevations as high as the proposed tailings impoundment than at the valley floor. It should be noted that the snowfall at Cassiar is converted to a water equivalent by applying a factor of 0.1.

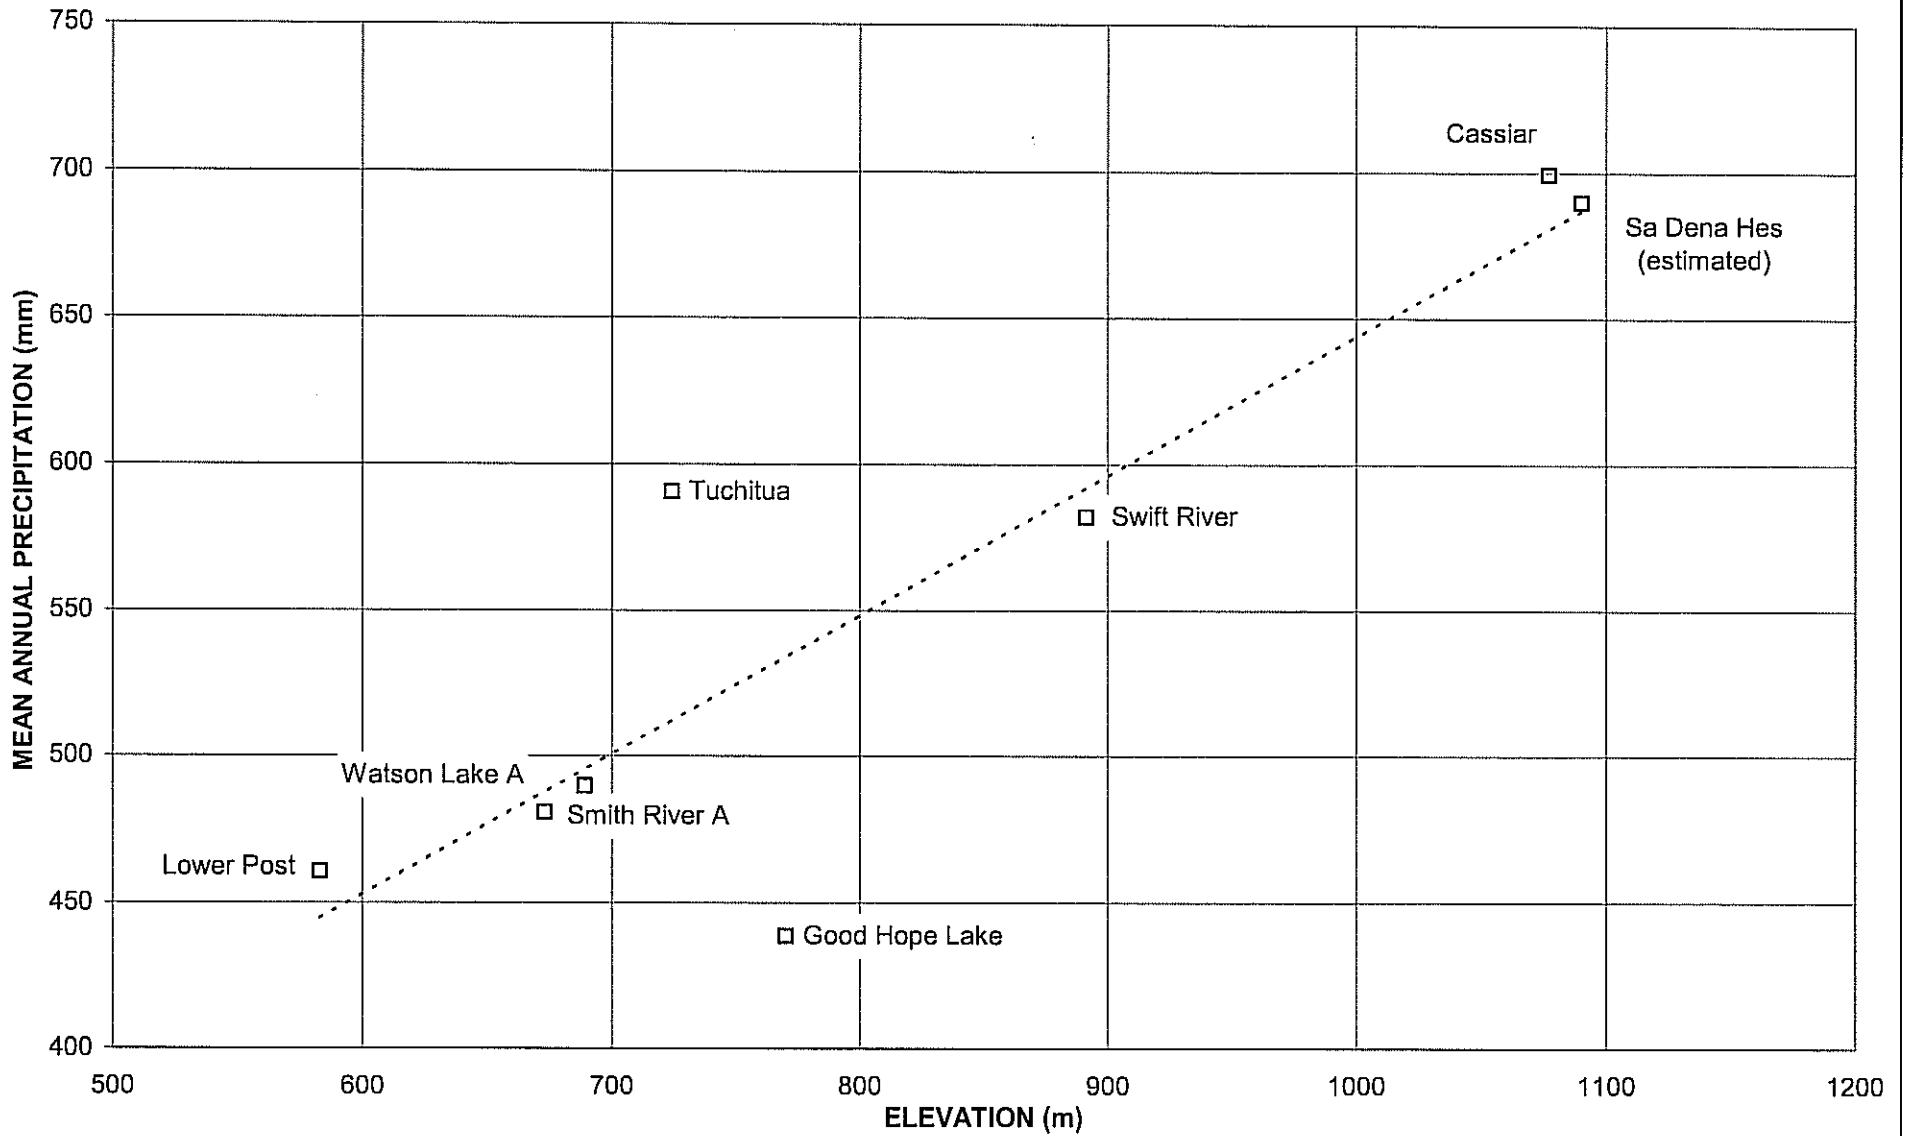
REGIONAL RELATIONSHIP BETWEEN MEAN  
ANNUAL PRECIPITATION AND ELEVATION

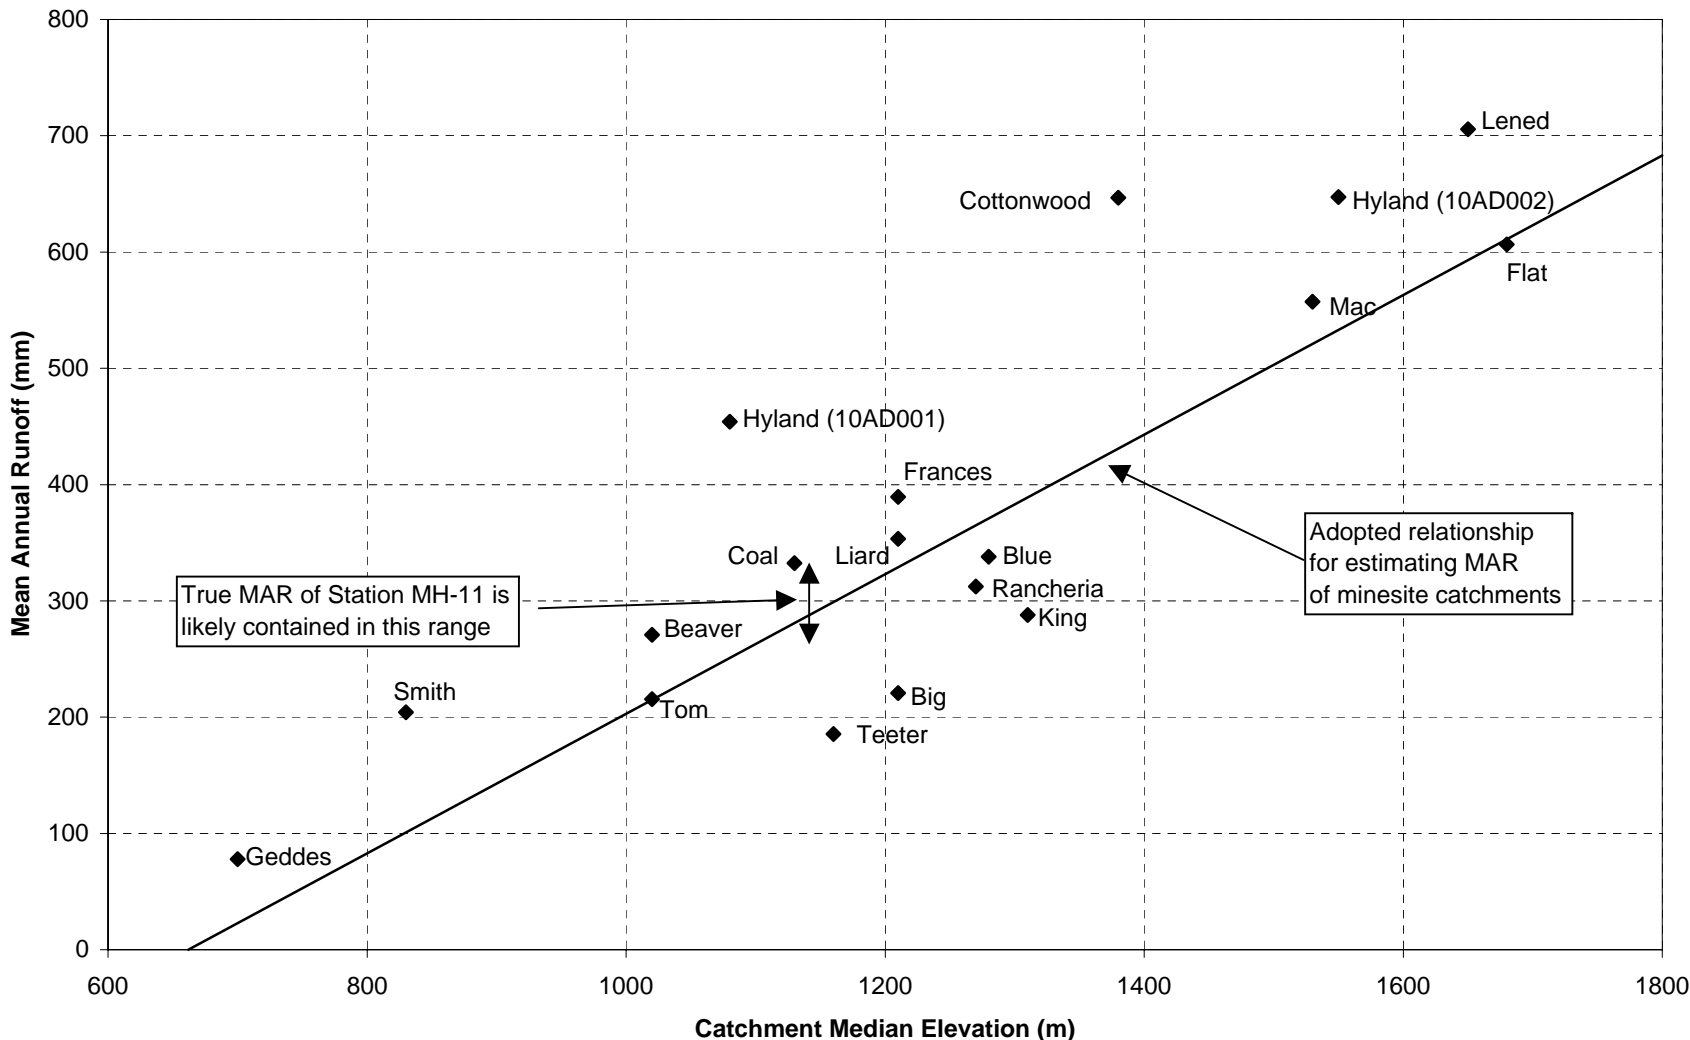
PROJECT 1CC005.05	DATE AUG. 1999	APPROVED	FIGURE <b>3-3</b>
----------------------	-------------------	----------	----------------------

SA DENA HES DETAILED  
 DECOMMISSIONING AND RECLAMATION PLAN  
 REGIONAL RELATIONSHIP BETWEEN MEAN  
 ANNUAL RUNOFF AND CATCHMENT MEDIAN  
 ELEVATION

As indicated in Section 2.4 in Appendix B, elevation generally accounts for a large proportion of the variation in mean annual precipitation within a mountainous region. It follows, therefore, that mean annual runoff (MAR) would also be a function of elevation. Figure 3-3 shows how this observation was exploited to estimate the average flows of the minesite streams. The vertical axis of this figure displays values of MAR expressed as equivalent depths of water. The horizontal axis shows values of median elevation, which is the variable adopted to quantify the elevation characteristics of the regional and minesite catchments. The 18 pairs of MAR and median elevation values assembled in Table 3-2 for the WSC stations were plotted on this figure. These data demonstrate a reasonably strong relationship between the two variables.

The data plotted on Figure 3-3 were used to develop a relationship that was believed to represent the conditions at the minesite. Two steps were undertaken to develop the relationship. Firstly, a linear regression was fitted to all 18 data points. This defined a straight line with a slope of 0.60 mm per m. Secondly, the intercept of this straight line was adjusted to force the line through the data point for Tom Creek. This adjustment was based on the premise that, of all the WSC catchments, the one for Tom Creek is probably the most representative of the conditions within the False Canyon Creek catchment. These two catchments share a significant portion of their respective drainage divides and also possess similar elevational characteristics.

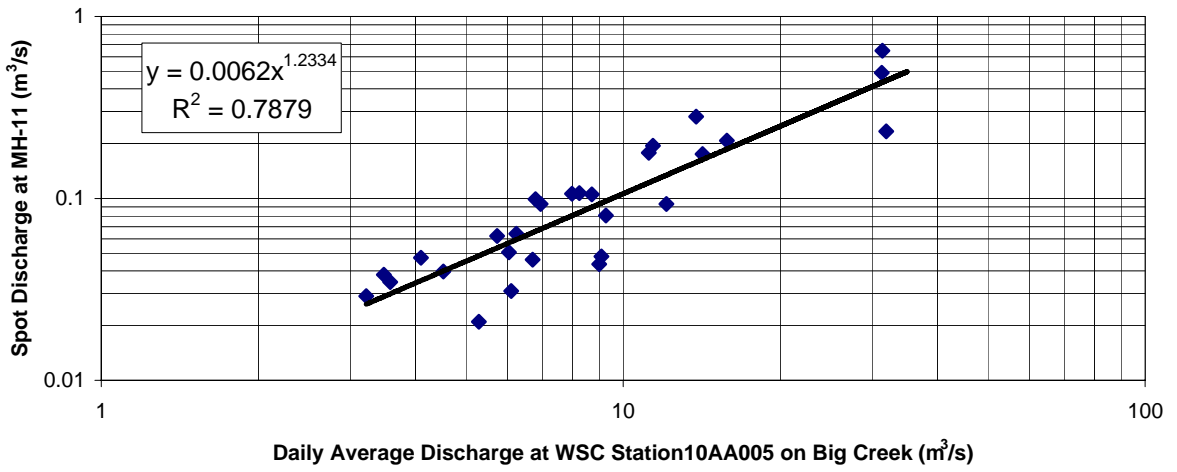
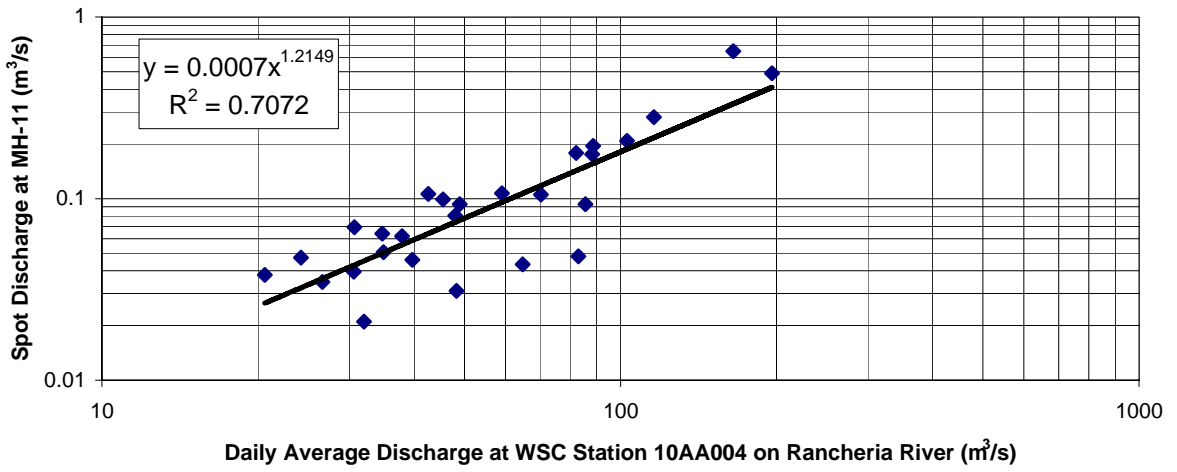
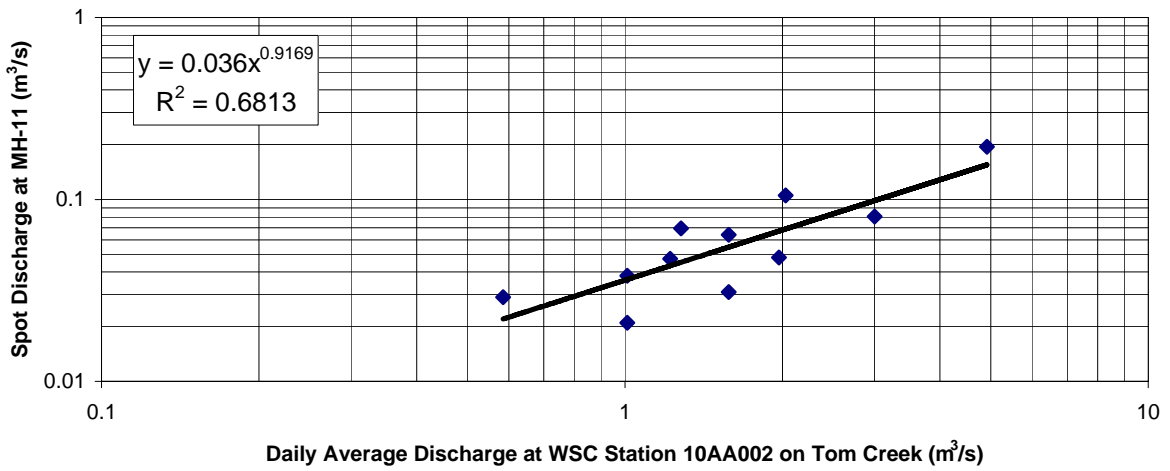
PROJECT 1CC005.05	DATE AUG. 1999	APPROVED	FIGURE <b>3-4</b>
----------------------	-------------------	----------	----------------------

**CORRELATION BETWEEN SITE AND REGIONAL  
STREAMFLOW DATA**

To provide a greater degree of confidence in the estimate, the observed flows at Station MH-11 were correlated with the coincidental flows of neighbouring WSC Stations. Three stations were selected for this purpose, Station 10AA005 on Big Creek, Station 10AA004 on Rancheria River and Station 10AA002 on Tom Creek. Figure 3-4 is a graphical presentation of the correlations. These correlations were performed on log-log graphs in recognition of the differences between the flow regimes of small and large catchments. Station MH-11 commands a much smaller catchment than the three WSC Stations and, accordingly, is expected to experience a more erratic flow regime (i.e., the ratio between the highest and lowest flow for Station MH-11 should be greater than the corresponding ratios for the other three stations).

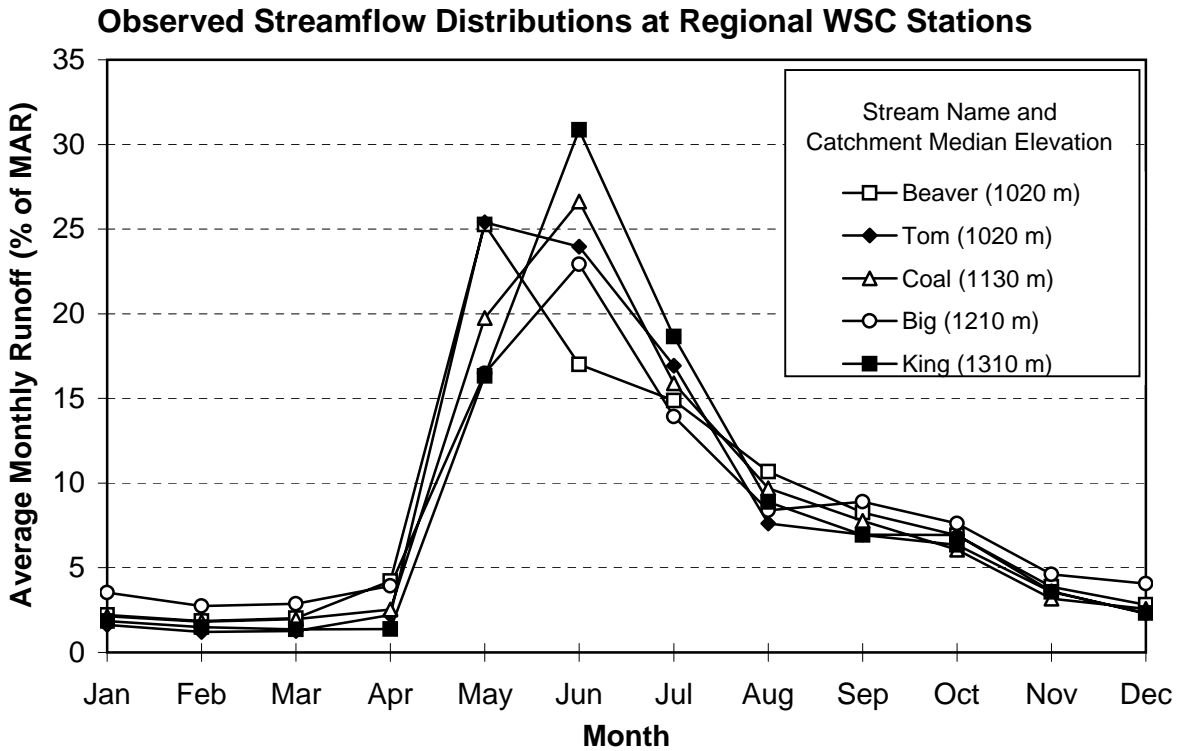
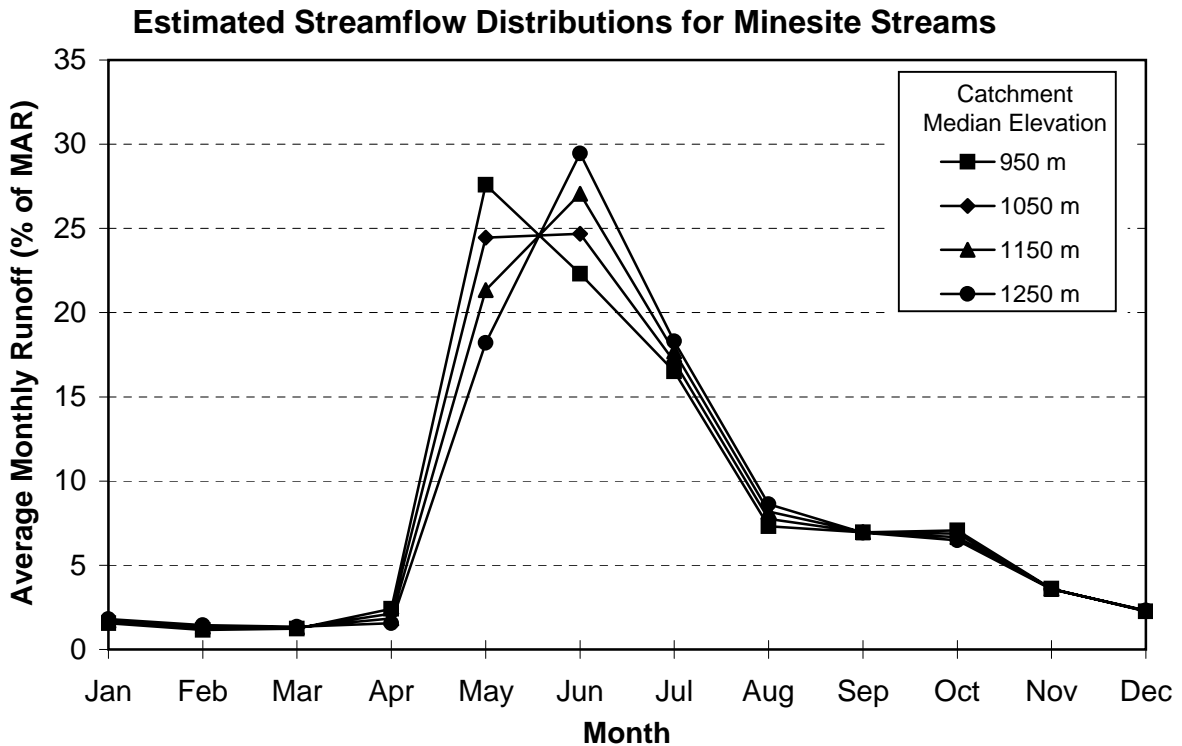
AVERAGE MONTHLY STREAMFLOW  
DISTRIBUTIONS

The distributions for the five selected stations are characterized by high spring flows during snowmelt and low winter flows during prolonged freezing conditions. All five distributions are remarkably similar over the period August to April, especially considering they represent runoff from significantly different catchment areas ranging from 13.7 km<sup>2</sup> to 9190 km<sup>2</sup>. The major difference that exists amongst the five distributions is the proportion of runoff that occurs during the months of May, June and July. Examination of these distributions and the characteristics of their associated catchments revealed that median elevation is a reasonably good predictor of the shape of the average monthly hydrograph. As expected, low-elevation catchments generally experience earlier peaks than high-elevation catchments. The median elevations for the catchments of the five stations are shown in the legend of the top plot.

The observed relationship between hydrograph shape and catchment median elevation was used to estimate the shape of the average monthly hydrograph at ungauged locations around the minesite. The bottom plot on Figure 3-5 shows how this was implemented. The normalized distributions for Tom Creek and King Creek were used to establish the hydrograph shape at median elevations of 1020 m and 1310 m, respectively. Interpolation between the shapes of these two hydrographs was used to estimate the distribution for intermediate median elevations. Figure 3-5 shows the estimated shapes of the hydrographs for four distinct elevations.

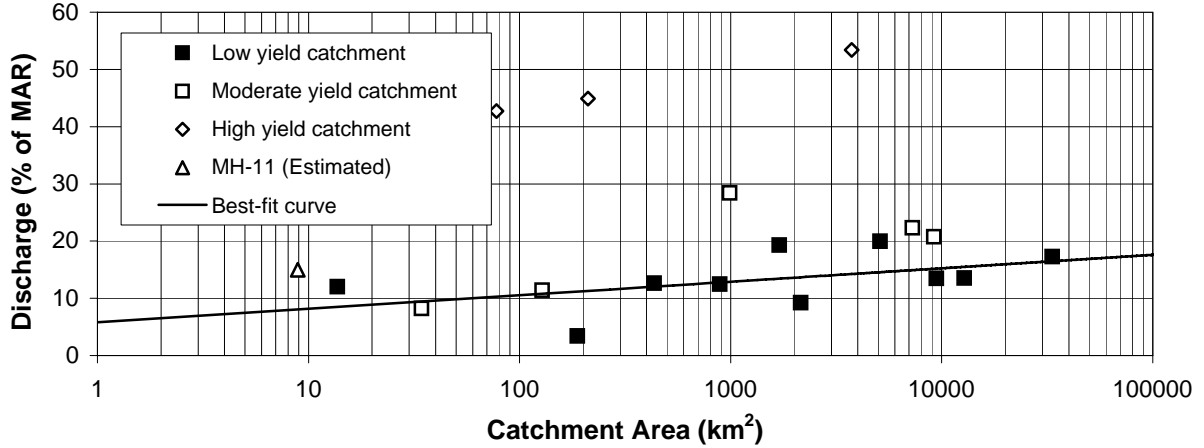
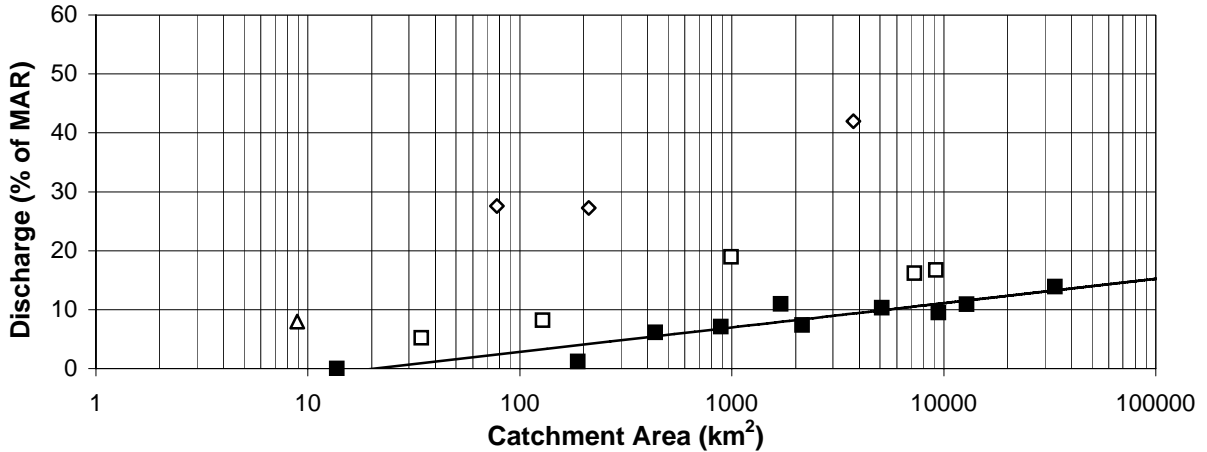
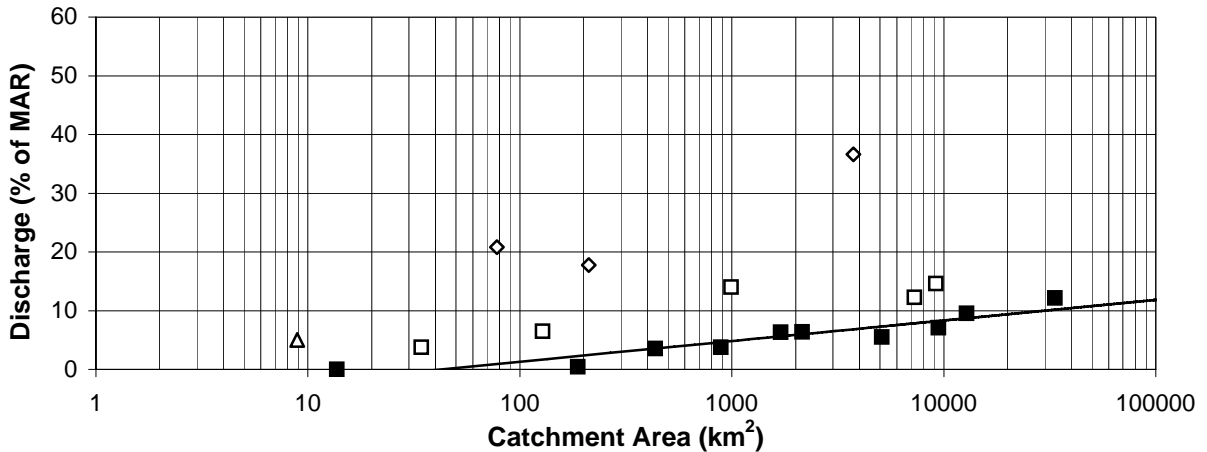
### 7-Day Low Flow with 2-Year Return Period

### 7-Day Low Flow with 10-Year Return Period

### 7-Day Low Flow with 50-Year Return Period

REGIONAL RELATIONSHIPS BETWEEN 7-DAY  
LOW FLOW AND CATCHMENT AREA

The magnitude of low flows at the minesite was estimated using Regional Analysis. To apply this technique, three steps were undertaken. Firstly, the annual series of 7-day low flows was extracted from each of the 18 WSC streamflow records assembled for this hydrology study. For the purpose of selecting the annual low-flow values, the year was defined as the period June 1 to May 31. Use of a calendar year was rejected for this purpose to avoid missing any low-flow periods that might span the period from late December to early January. It is interesting to note that the annual low flows for durations of 1, 3, 10 and 30 consecutive days have values very close to the 7-day low flow. This is a consequence of the low flows occurring in the winter rather than the late summer. The winter flows originate from storage releases (lake and groundwater) and, accordingly, vary only slightly over lengthy periods of time.

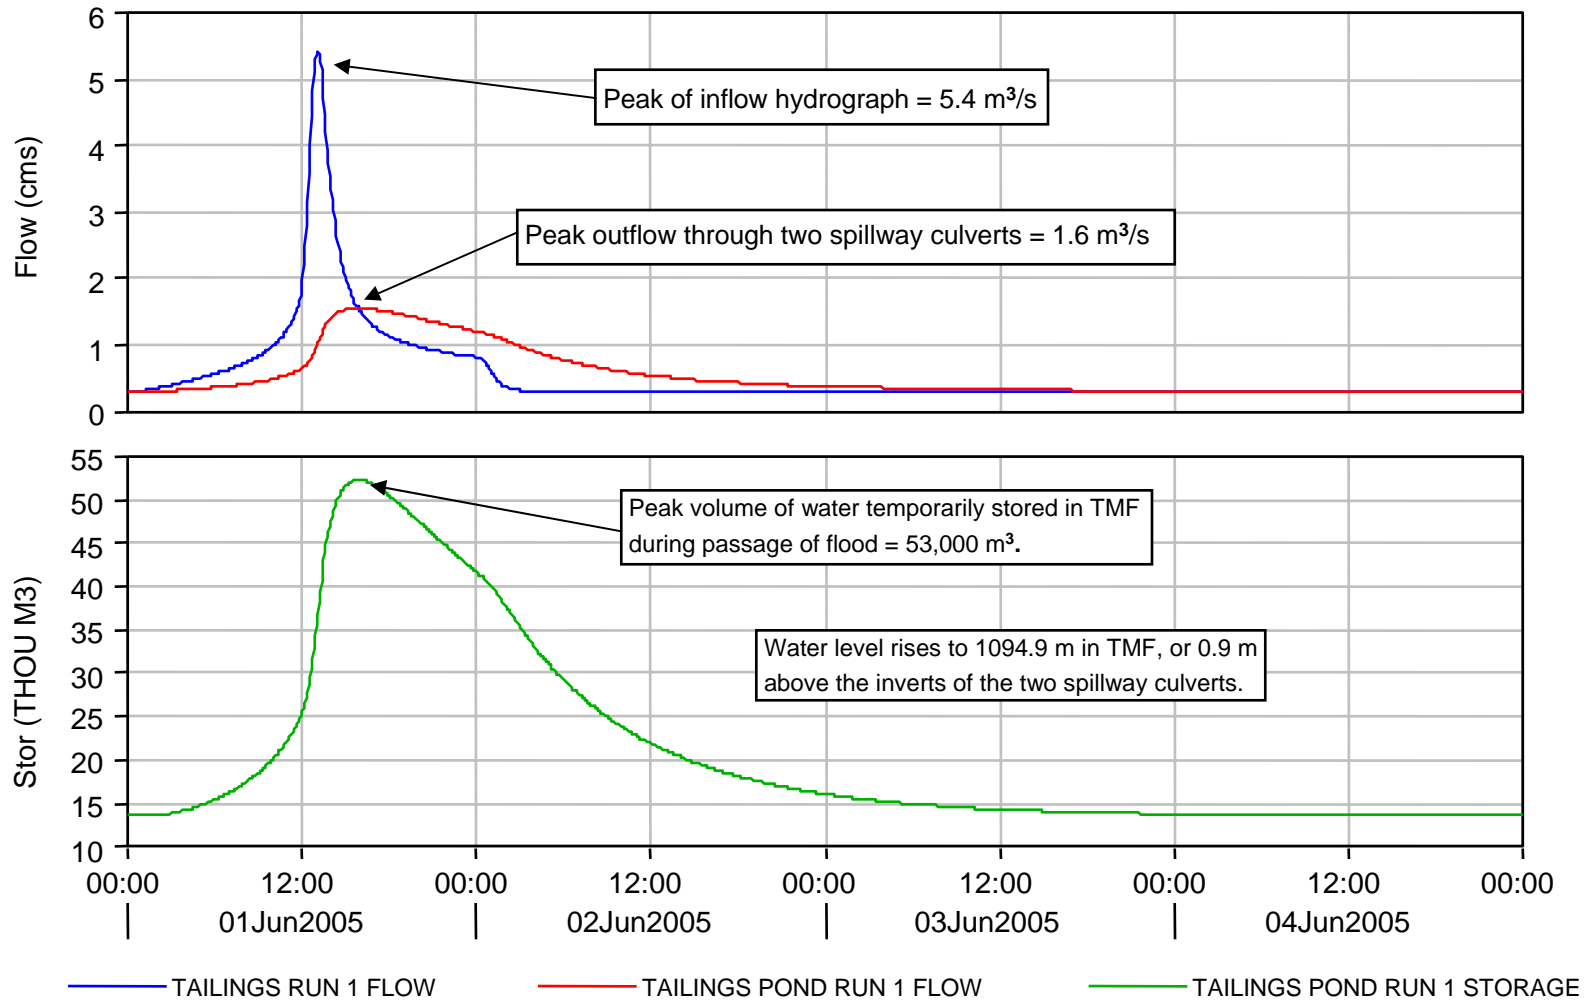
**Simulated 1000-Year Flood in Tailings Management Facility-Temporary Closure Status**

Figure 5 shows the results of applying the HEC-HMS model to the TMF. Key assumptions of the modeling are:

- The 1000-year flood would be generated by an intense thunderstorm (1000-year, 24-hour total rainfall = 81 mm) falling on a ripe snowpack that, in the days preceding the storm, was melting at a high rate (20 mm/d);
- The spillway would be comprised of the existing two 900 mm culverts;
- All interceptor ditches around the TMF would fail, allowing the full catchment runoff to enter the impoundment; and
- The culverts would be flowing prior to the arrival of the storm, so that storage below the invert level of the culverts would not be available to store a portion of the incoming flood hydrograph.

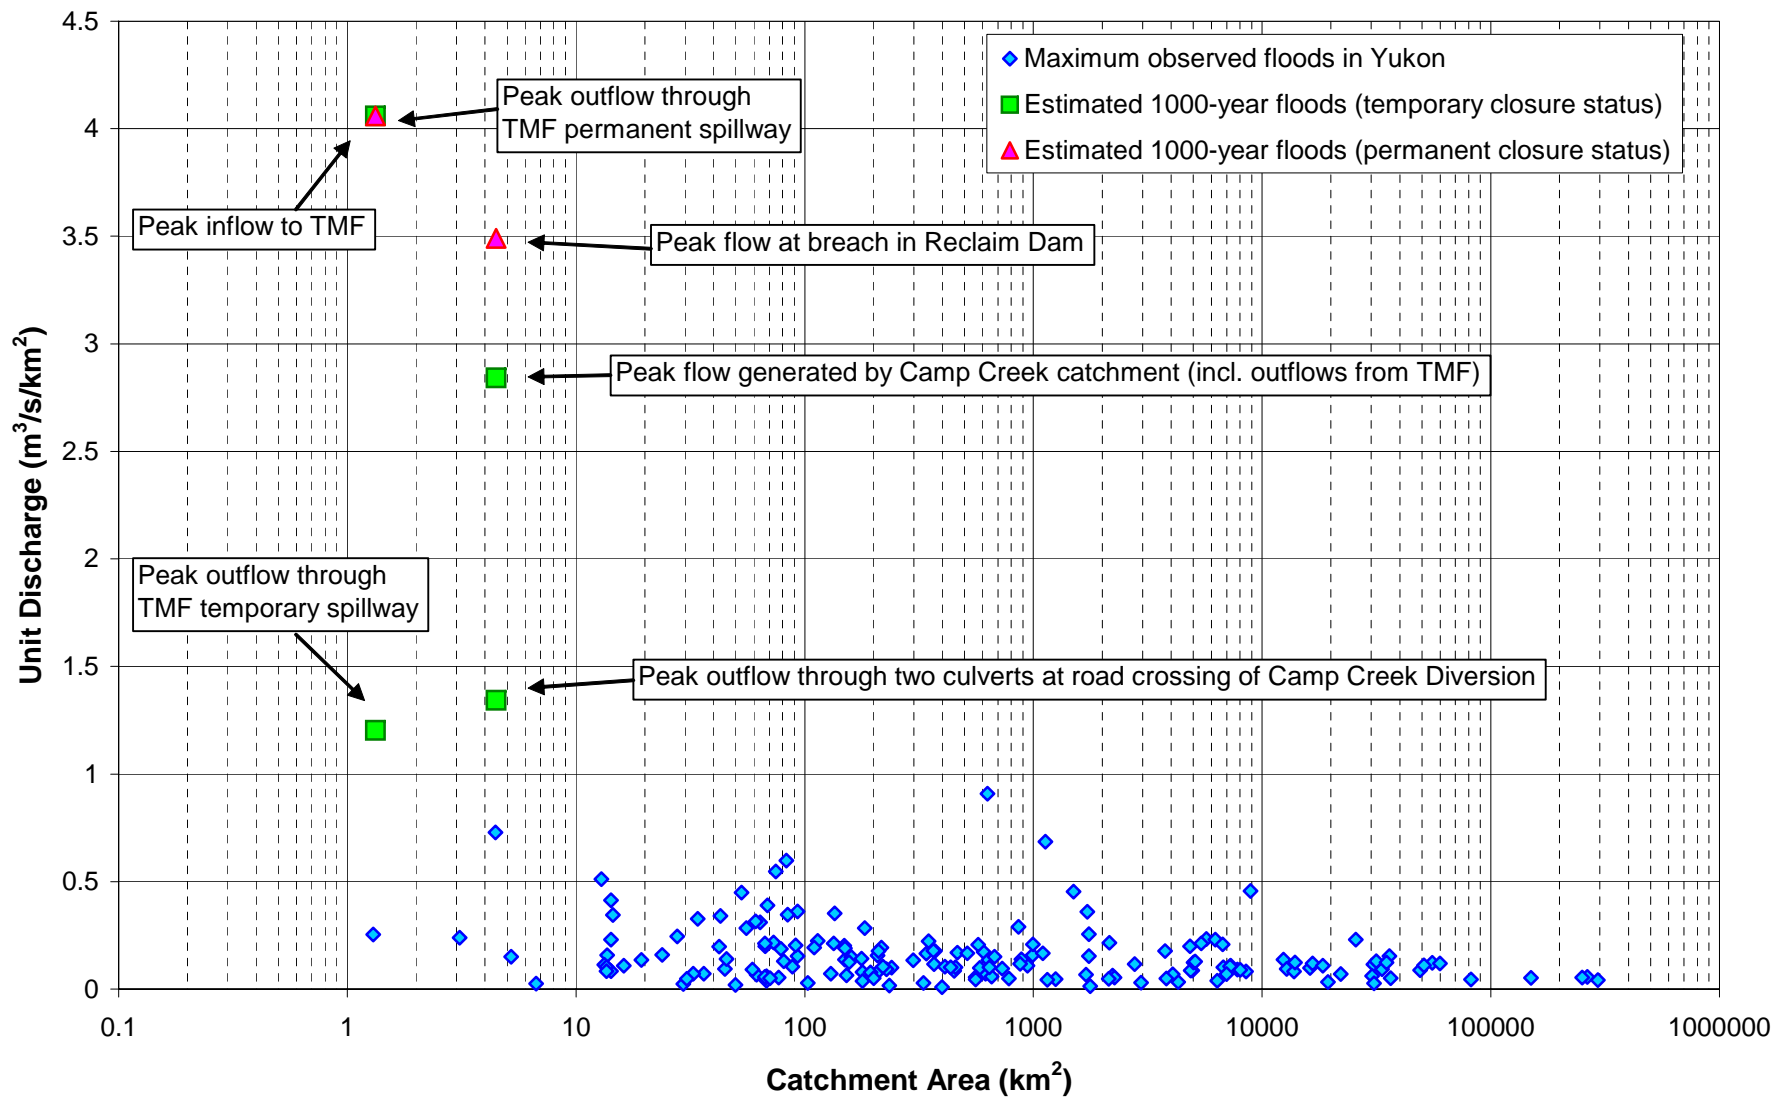
**Comparison of Estimated 1000-Year Floods with Maximum Observed Floods in Yukon**

The simulated flood peaks in Figures 5 to 8 were checked for reasonableness by comparing them against maximum observed floods in the Yukon. Figure 9 presents the maximum observed floods at all government-operated streamflow gauging stations within the territory (87 operated by the Water Survey of Canada and 97 by Environment Yukon.) To facilitate comparison of the flood values from the widely different drainage areas, the flood magnitudes have been normalized (i.e., the absolute flood value has been divided by the contributing drainage area). Examination of

Figure 9 reveals that none of the floods in the Yukon have attained a unit discharge greater than  $1.0 \text{ m}^3/\text{s}/\text{km}^2$ .
