# SÄ DENA HES OPERATING CORPORATION

## SÄ DENA HES MINE

### DETAILED DECOMMISSIONING & RECLAMATION PLAN

### JANUARY 2010 UPDATE

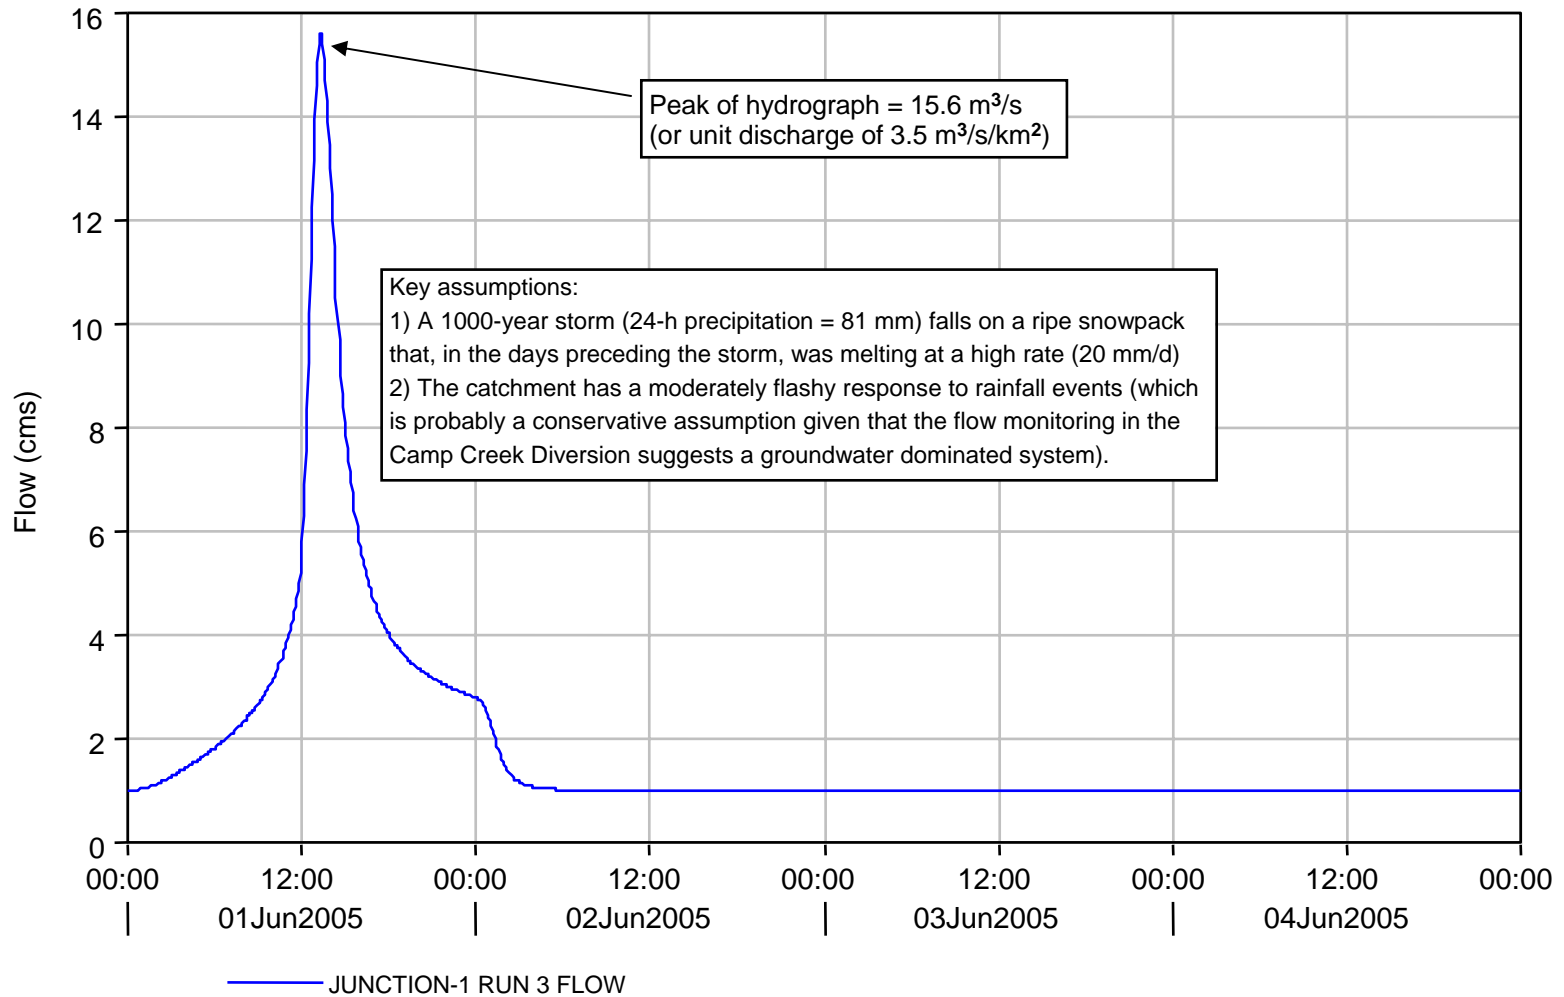
**Simulated 1000-Year Flood at Breach in Reclaim Dam - Permanent Closure Status**

Figure 8 shows the estimated 1000-year flood for the proposed breach in the Reclaim Dam. Without the benefit of storage within either the Reclaim Pond or the TMF, the flood peaks at an estimated 15.6 m<sup>3</sup>/s.

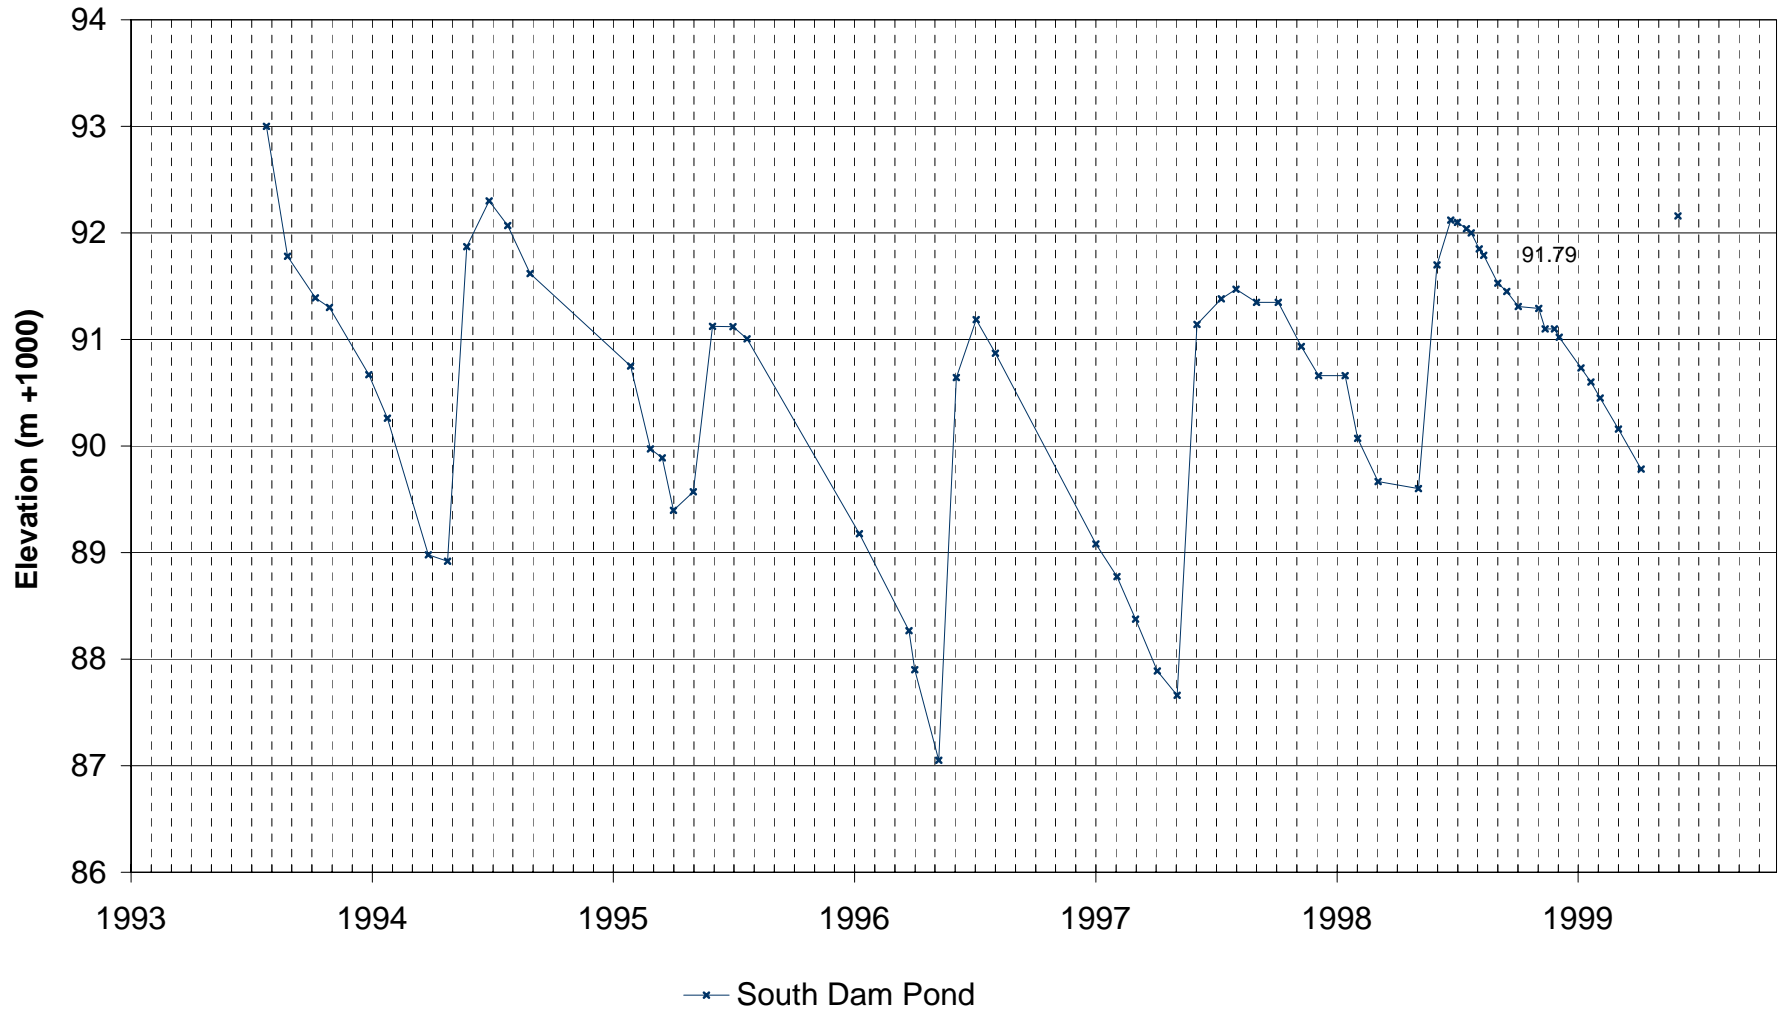
<b>SA DENA HES DETAILED DECOMMISSIONING AND RECLAMATION PLAN</b>			
	 	<b>South Dam Pond Levels</b>			
	PROJECT 1CC005.05	DATE AUG. 1999	APPROVED	FIGURE <b>3-7</b>

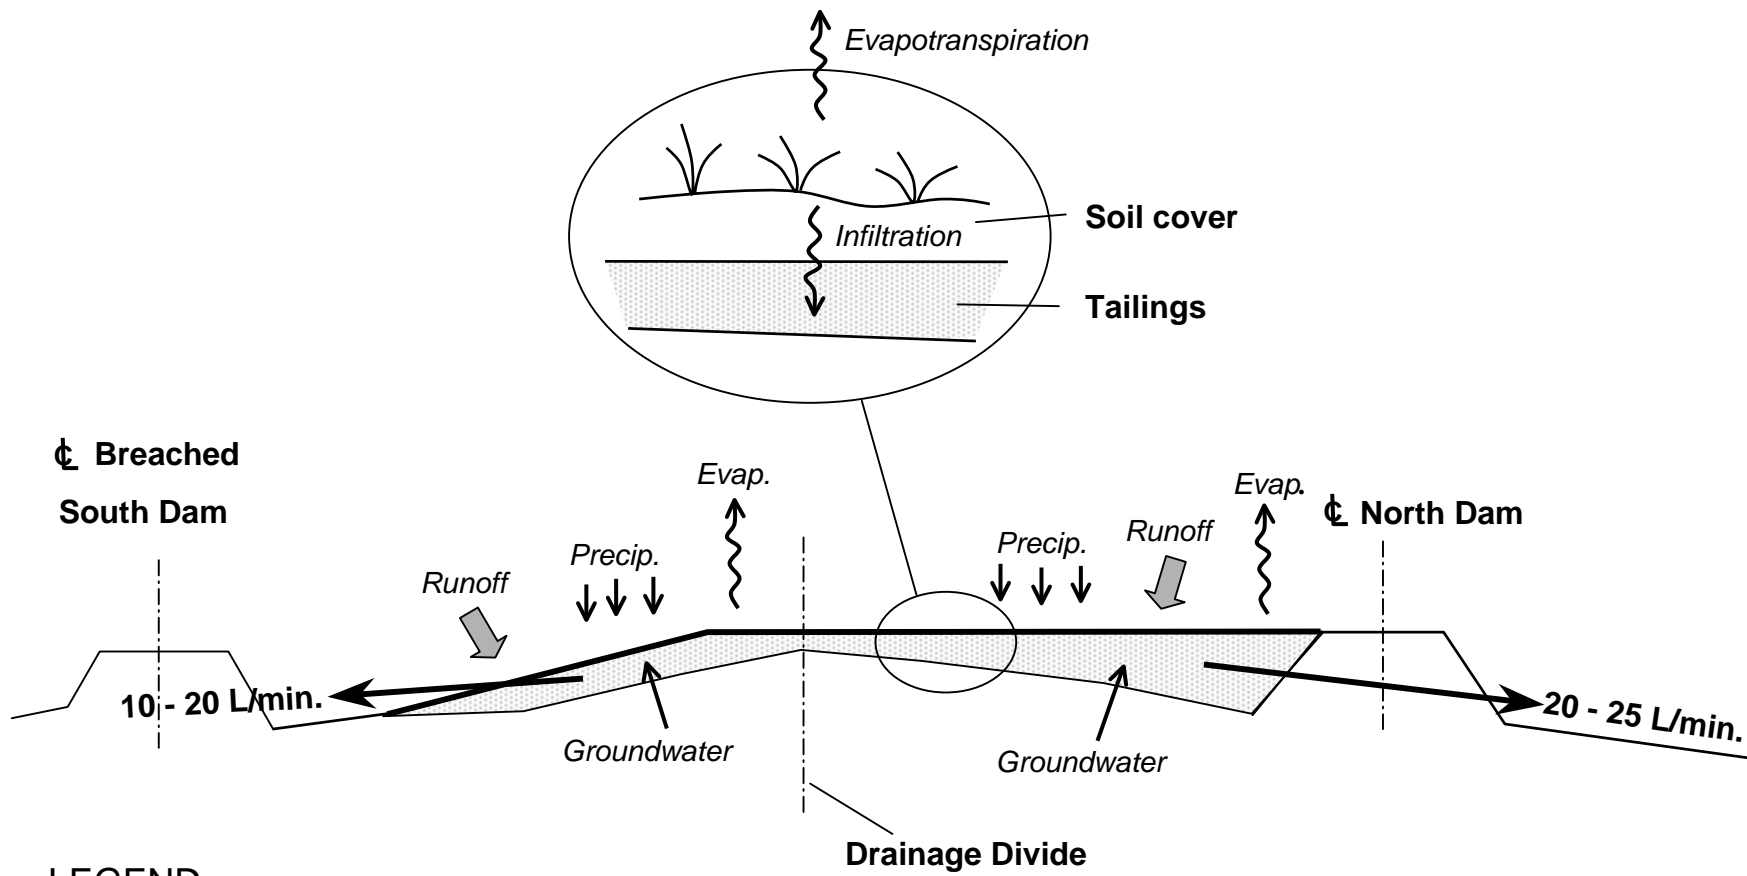
**LEGEND**  
 Seepage Flux through Tailings

<b>SRK Consulting</b> <small>Engineers and Scientists</small>	SA DENA HES DRAFT DETAILED DECOMMISSIONING AND RECLAMATION		
	<b>ACCESS MINING CONSULTANTS LTD.</b>	Conceptual Movement of Water through Tailings - Scenario 1		
	PROJECT: 1CC005.05	DATE: Aug. 1999	APPROVED:	FIGURE:: <b>3-9</b>

As shown in Figure 3-8, flow into the tailings will come from groundwater recharge and infiltration through the cover. However, it is also thought that the vegetation cover will reduce the flow.

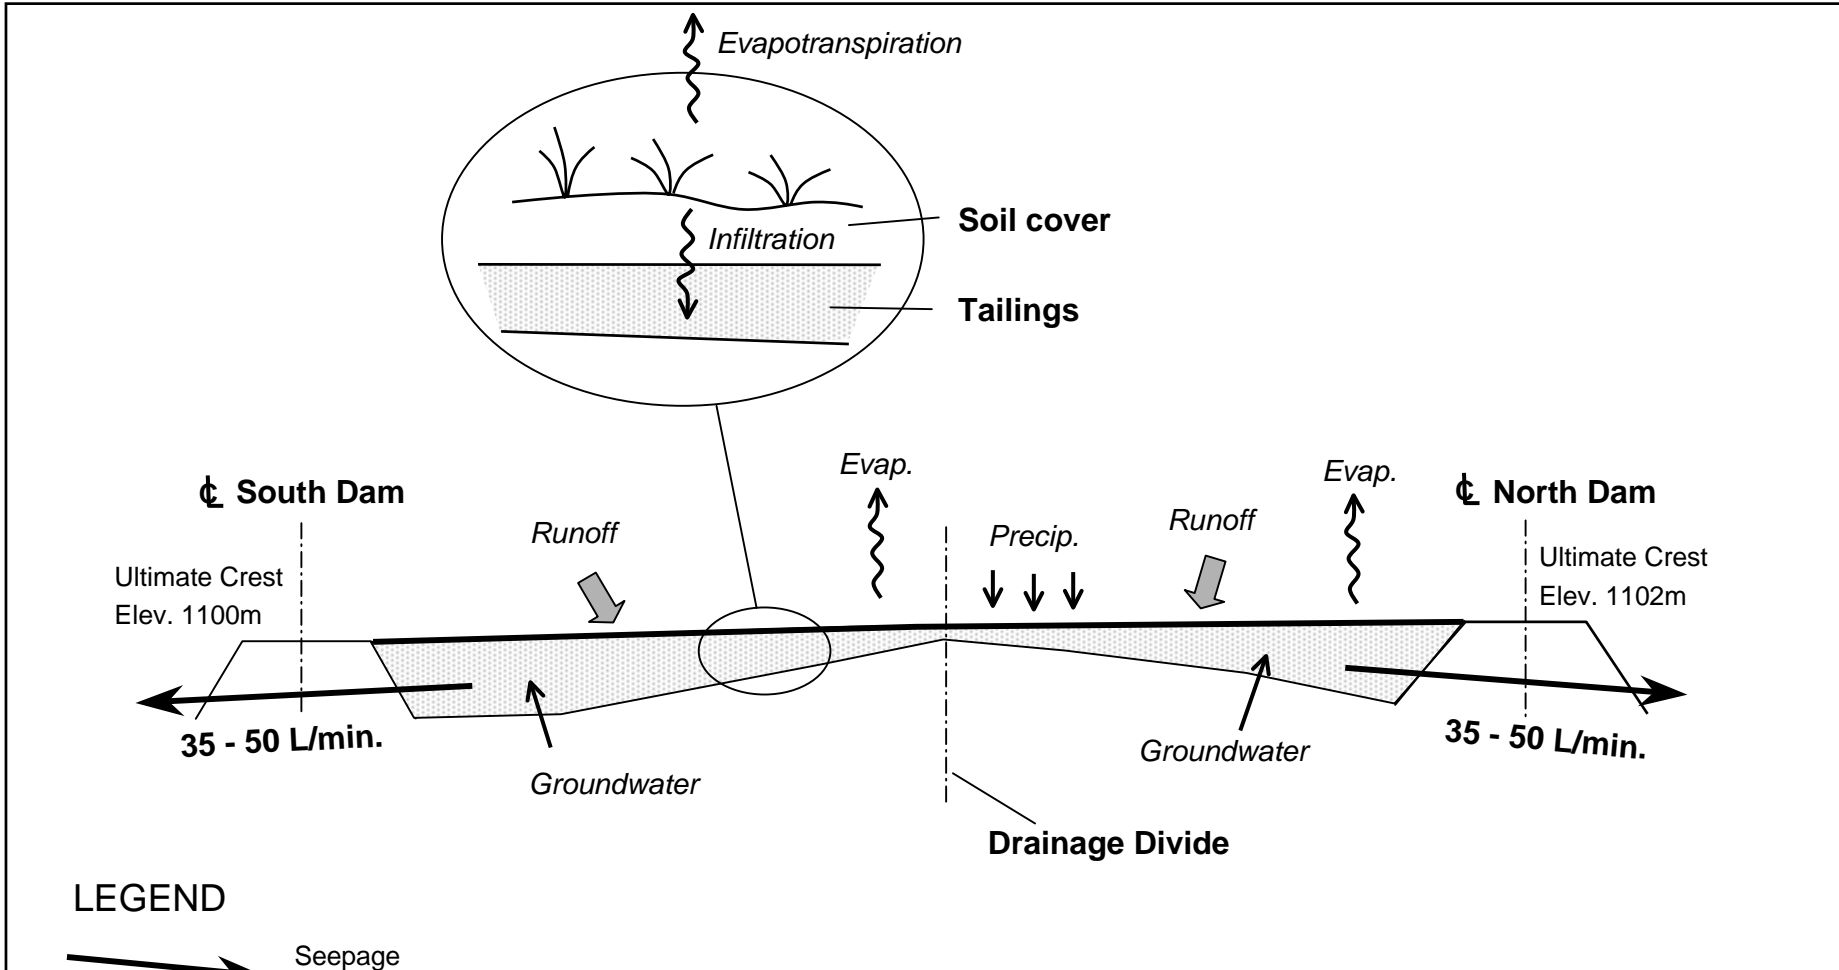
Seepage Flux through Tailings

SA DENA HES DRAFT DETAILED DECOMMISSIONING AND RECLAMATION			
Conceptual Movement of Water through Tailings - Scenario 2			
PROJECT: 1CC005.05	DATE: Aug. 1999	APPROVED:	FIGURE:: <b>3-10</b>

Given the smaller area and volume of tailings present at the south end, the seepage rate after application of a cover will likely be lower than that of the existing south end. Although the volume and areal extent of tailings at the South end are not known, they are thought to be approximately half that of the North Dam. Therefore a steady seepage rate, in the range of 10 to 20 L/min, is expected from the tailings at the south end after closure.

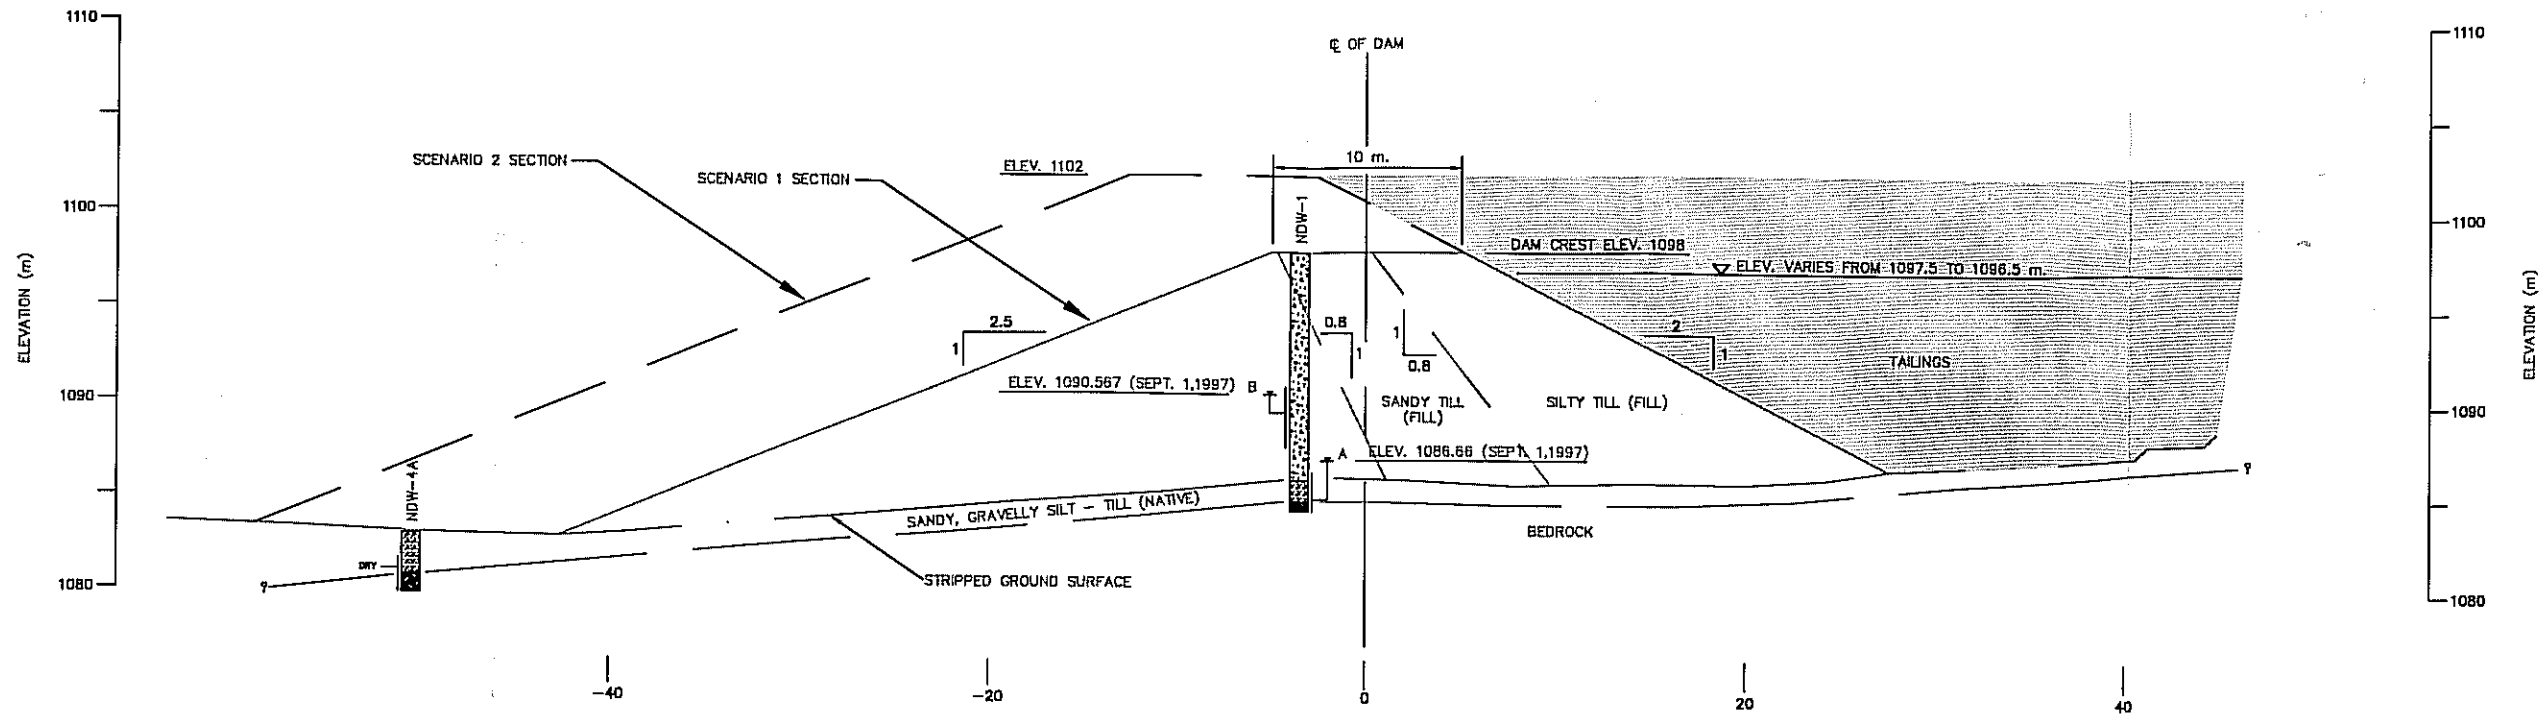
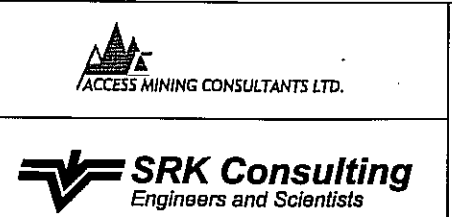
NDW-1B			
DATE	T.O.P.	READING	ELEV.
SEPT. 1, 1997	1098.572	8.005	1090.567

PIEZOMETRIC HEAD FOR FILTER ZONE INDICATED

NORTH DAM - SECTION 0+400

The North Dam was constructed during October and November 1990. Sand boils were observed emanating from the area immediately downstream of the dam in 1991, as water was stored behind the dam in preparation for plant startup. However, tailings were subsequently deposited against the North Dam and the sand boil activity gradually diminished, with no recent evidence of any fines in the seepage.

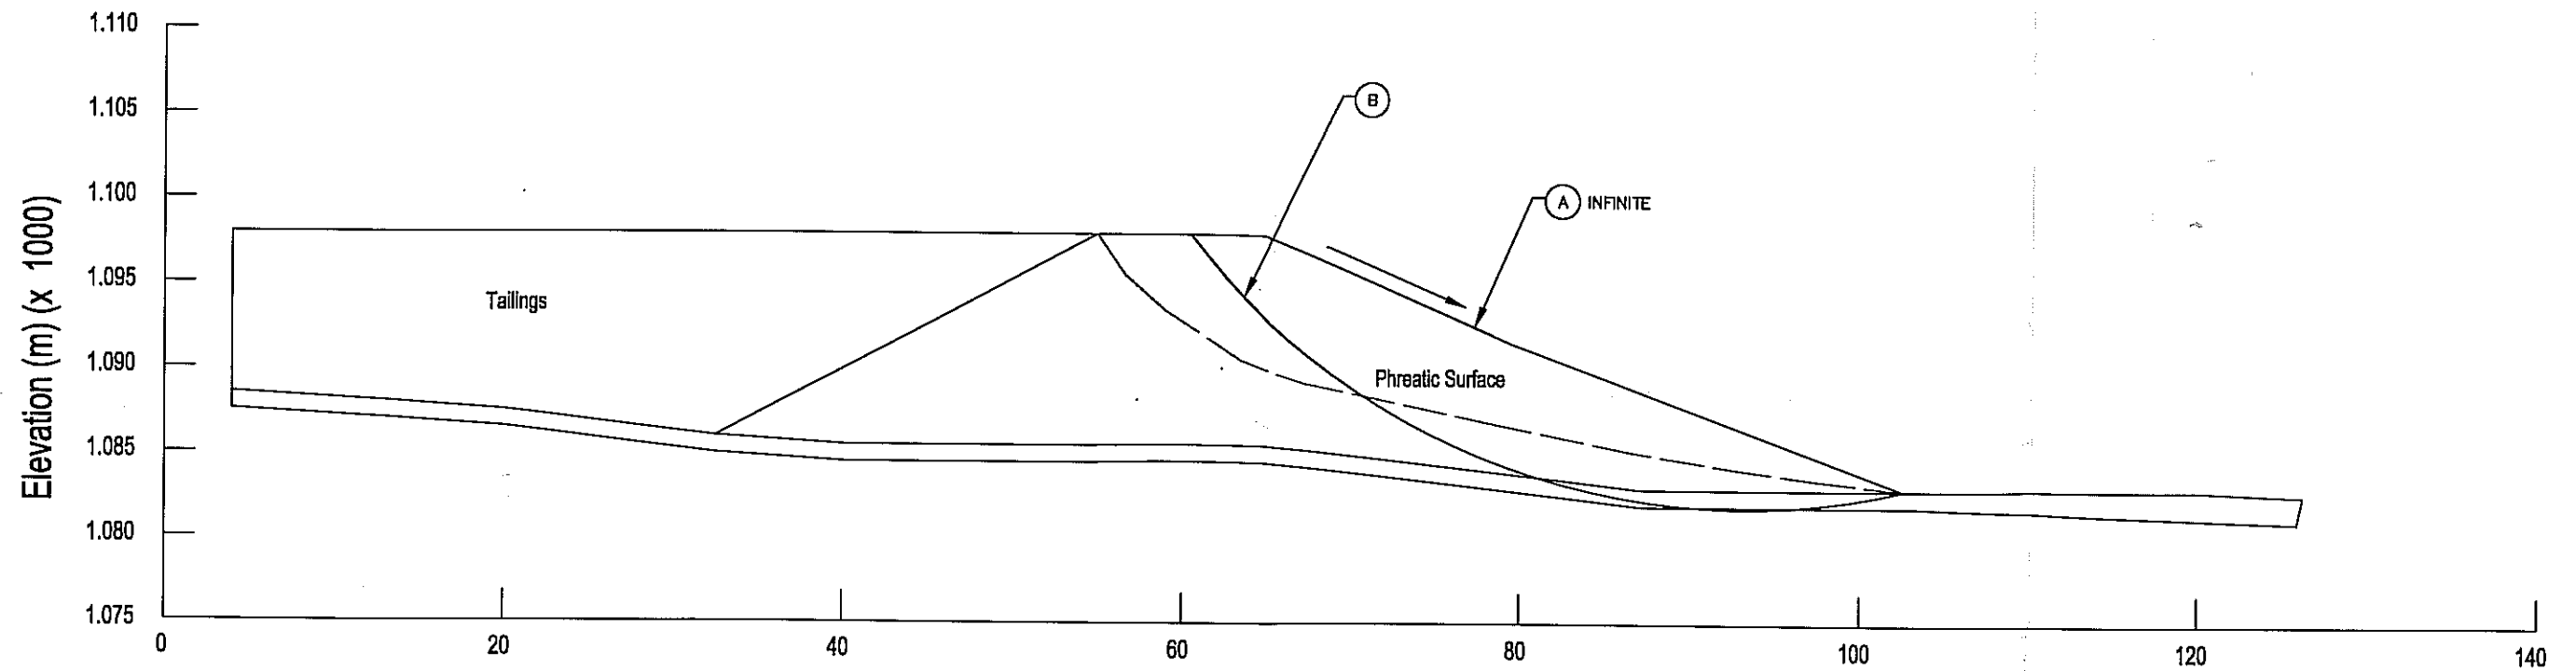
Material Properties Assumed in Stability Analysis				
Layer	Description	Unit Weight (kN/m <sup>3</sup> )	Effective Angle of Friction (?)	Effective Cohesion C' (kPa)
A	Tailings	18.0	25	0
B	Sand & Gravel	20.6	33	0
C	Sandy, Gravelly Silt - Till	20.6	35	0
D	Bedrock	19.5	45	0

Failure Surface	Description	Factors of Safety	
		Static	Pseudo-Static (a <sub>max</sub> =0.089g)
1	Slope Face	1.63	1.28
2	Deep	1.83	1.43

In the long term, the phreatic level in the tailings that abut the North Dam will be at or below the cofferdam that separates the drainage catchments for the North and South Dams (i.e. elevation 1098, or less). Piezometric conditions are not likely to be as severe as they have been previously and may well be similar to what they are presently. The safety factors shown in Table 10-2 and Figure 10-5 are, therefore, conservative representations of the long-term conditions at the North Dam.

The peak acceleration used in the analysis was 0.089 g, which corresponds to the 1:1000 year seismic event 0.071g, times as amplification factor of 1.25 to account for the foundation sediments. As failure of the tailings dams does not pose a significant risk to public health and safety after closure, the minimum return period of 1000 years as specified in the water license was adopted in calculating the factors of safety. This is based on the following factors:

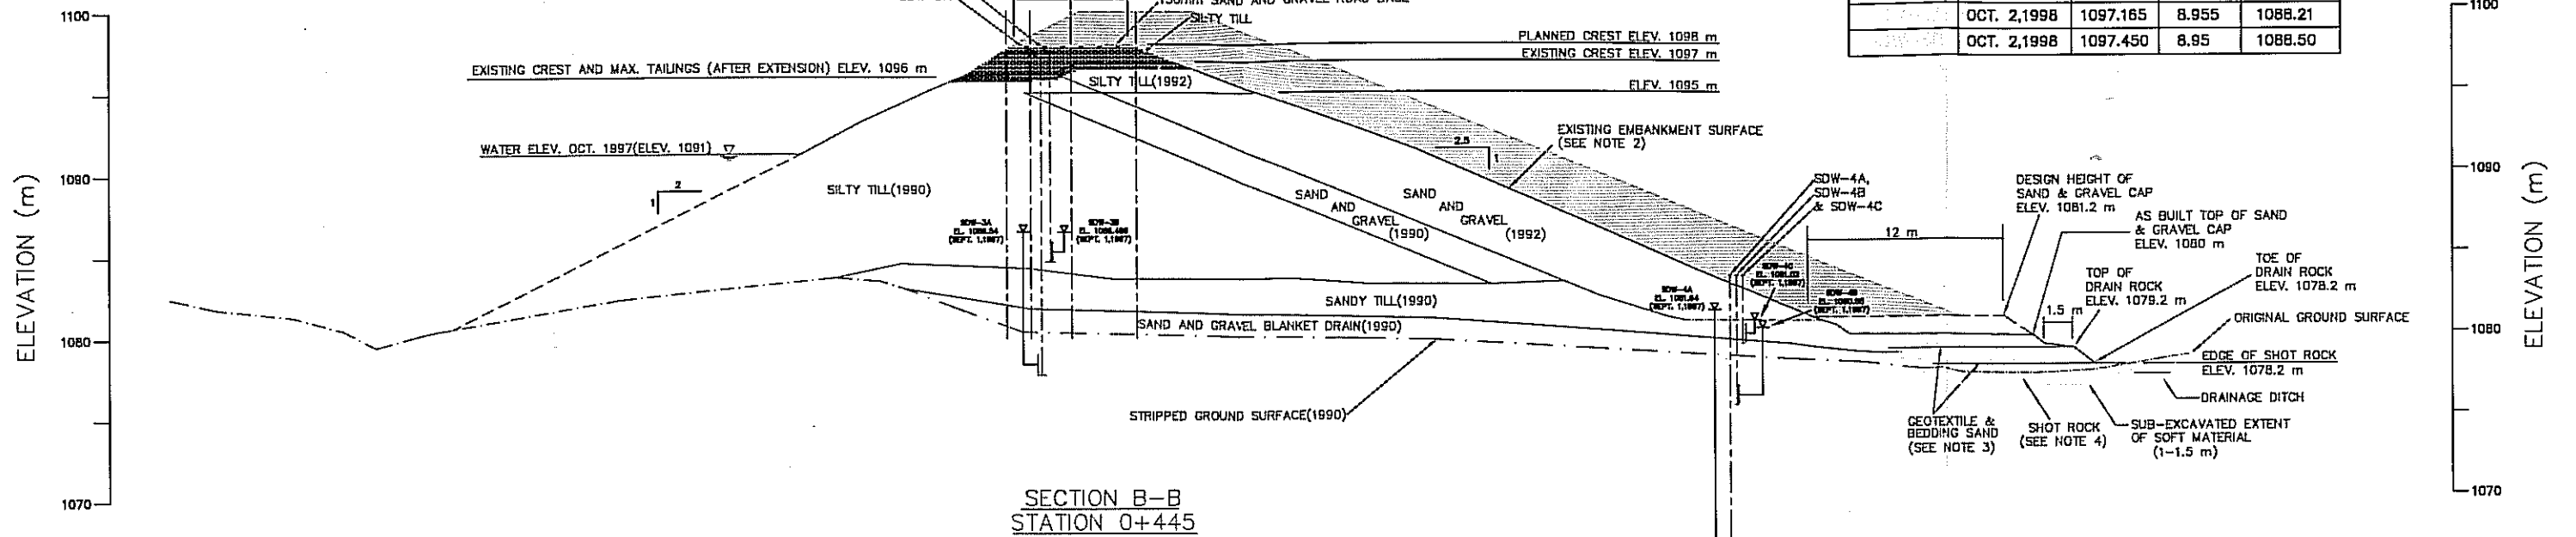
SECTION B-B  
STATION 0+445

SECTION 0+445 &  
0+495 SOUTH DAM

The South Dam has a current crest elevation of 1096 to 1097 m, which corresponds to a dam height between 17 and 18 m (Figure 10-6 and Figure 10-7). Further operation would require the dam be raised to elevation 1100 m or a height of 21 m. Its configuration is similar to the North Dam, with a 2H:1V upstream slope, and a 2.5H:1V downstream slope. However, unlike the North Dam, a small stabilizing rock buttress is present at the toe of the South Dam. Two zones grading from upstream silty till through a downstream sandy till make up the dam section, along with a sandy gravel blanket drain. The buttress is comprised of a 1m thick layer of drainrock capped with 2 metres of sand and gravel.

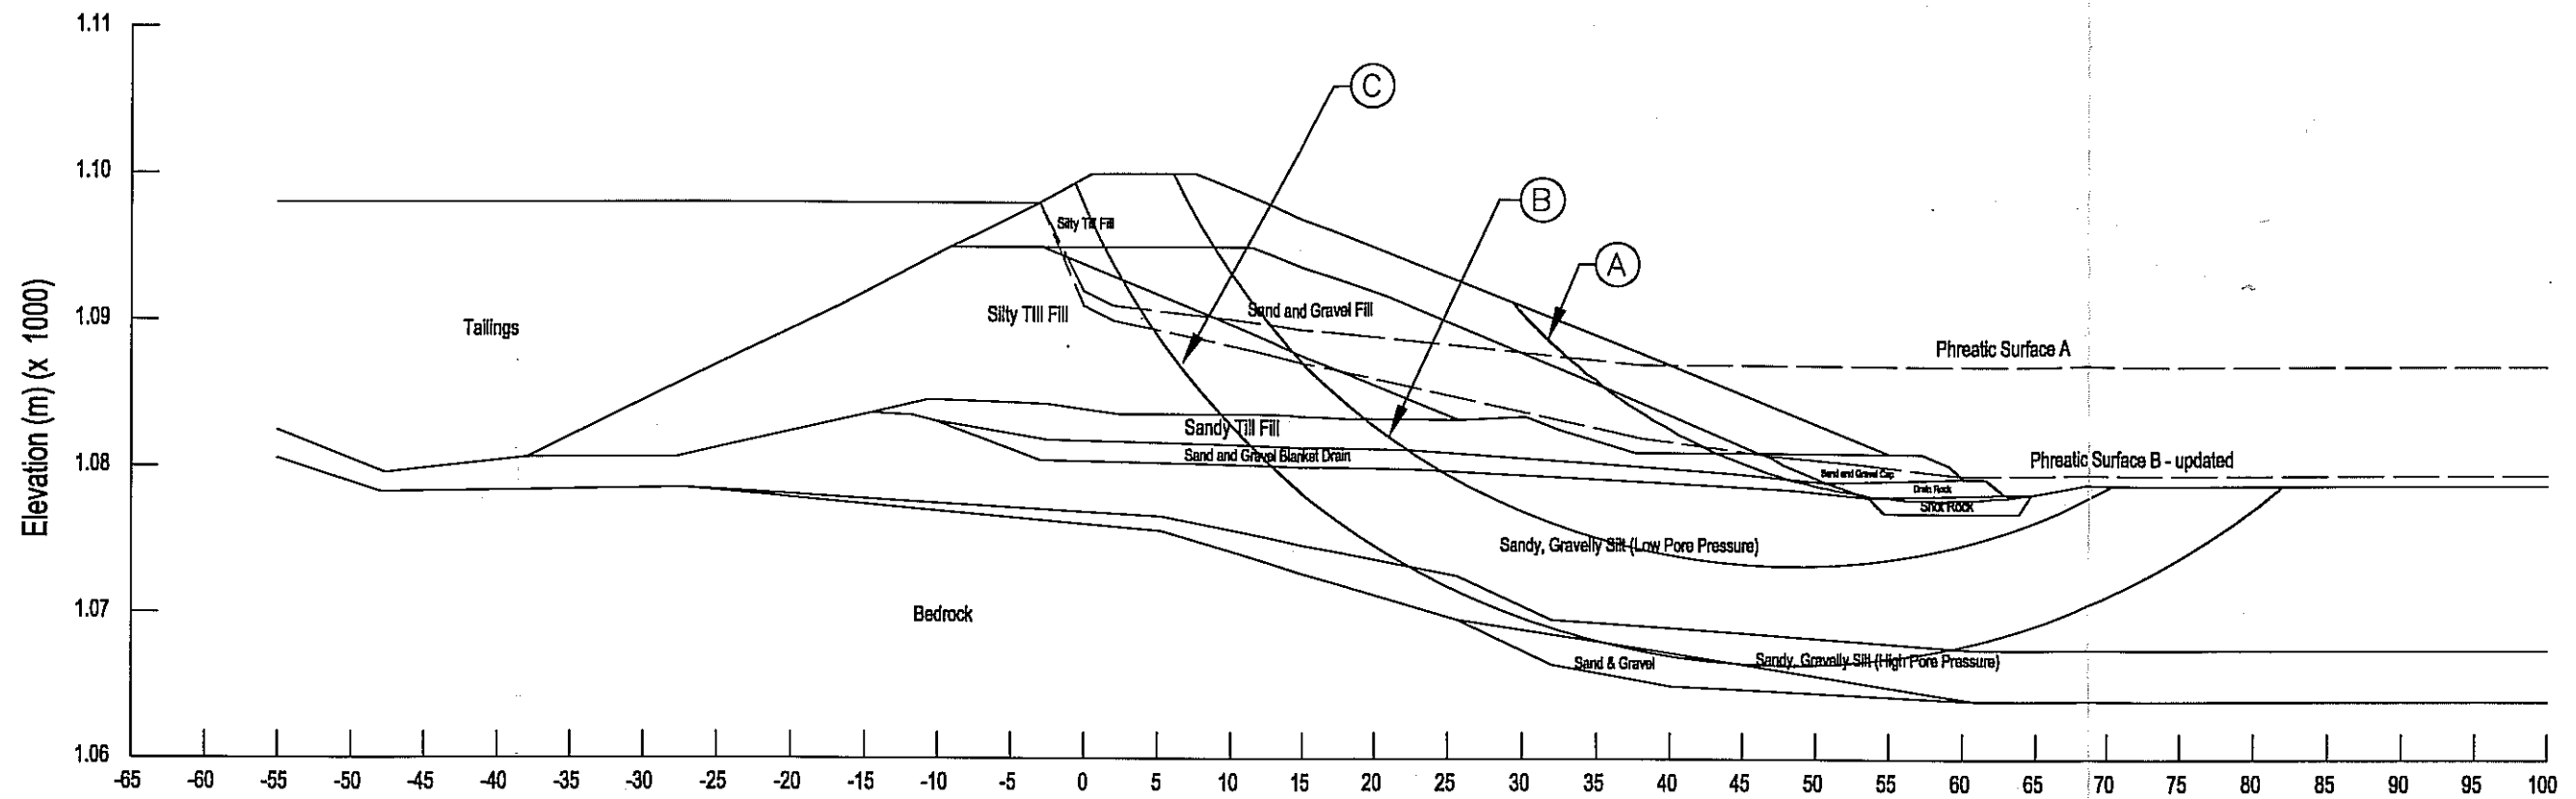
Material Properties Assumed in Stability Analysis					
Layer	Description	Unit Weight (kN/m <sup>3</sup> )	Effective Angle of Friction (?)	Effective Cohesion C' (kPa)	Phreatic Surface
A	Tailings	18.0	25	0	B
B	Silty Till	20.6	33	0	B
C	Sand & Gravel	20.6	33	0	B
D	Sandy Till	19.5	33	0	B
E	Sand & Gravel Blanket Drain	19.5	33	0	B
F	Sandy, Gravelly Silt (Low Pore Pressure)	22.0	35	0	B
G	Sandy, Gravelly Silt (High Pore Pressure)	22.0	35	0	A
H	Sand & Gravel	21.6	35	0	A
I	Bedrock	29.4	45	0	A
J	Sand & Gravel Cap	19.5	33	0	B
K	Drain Rock	19.5	35	0	B
L	Shot Rock	20.5	35	0	B

Failure Surface	Description	Factors of Safety	
		Static	Pseudo-Static (a <sub>max</sub> =0.089g)
1	Shallow	1.59	1.24
2	Intermediate	1.71	1.36
3	Deep	1.83	1.39

Failure Surface	Description	Factors of Safety ( 1 in 1000 yr seismic event)	
		Static	Pseudo-Static ( $a_{max}=0.089g$ )
1	Shallow	1.59	1.24
2	Intermediate	1.71	1.36
3	Deep	1.83	1.39

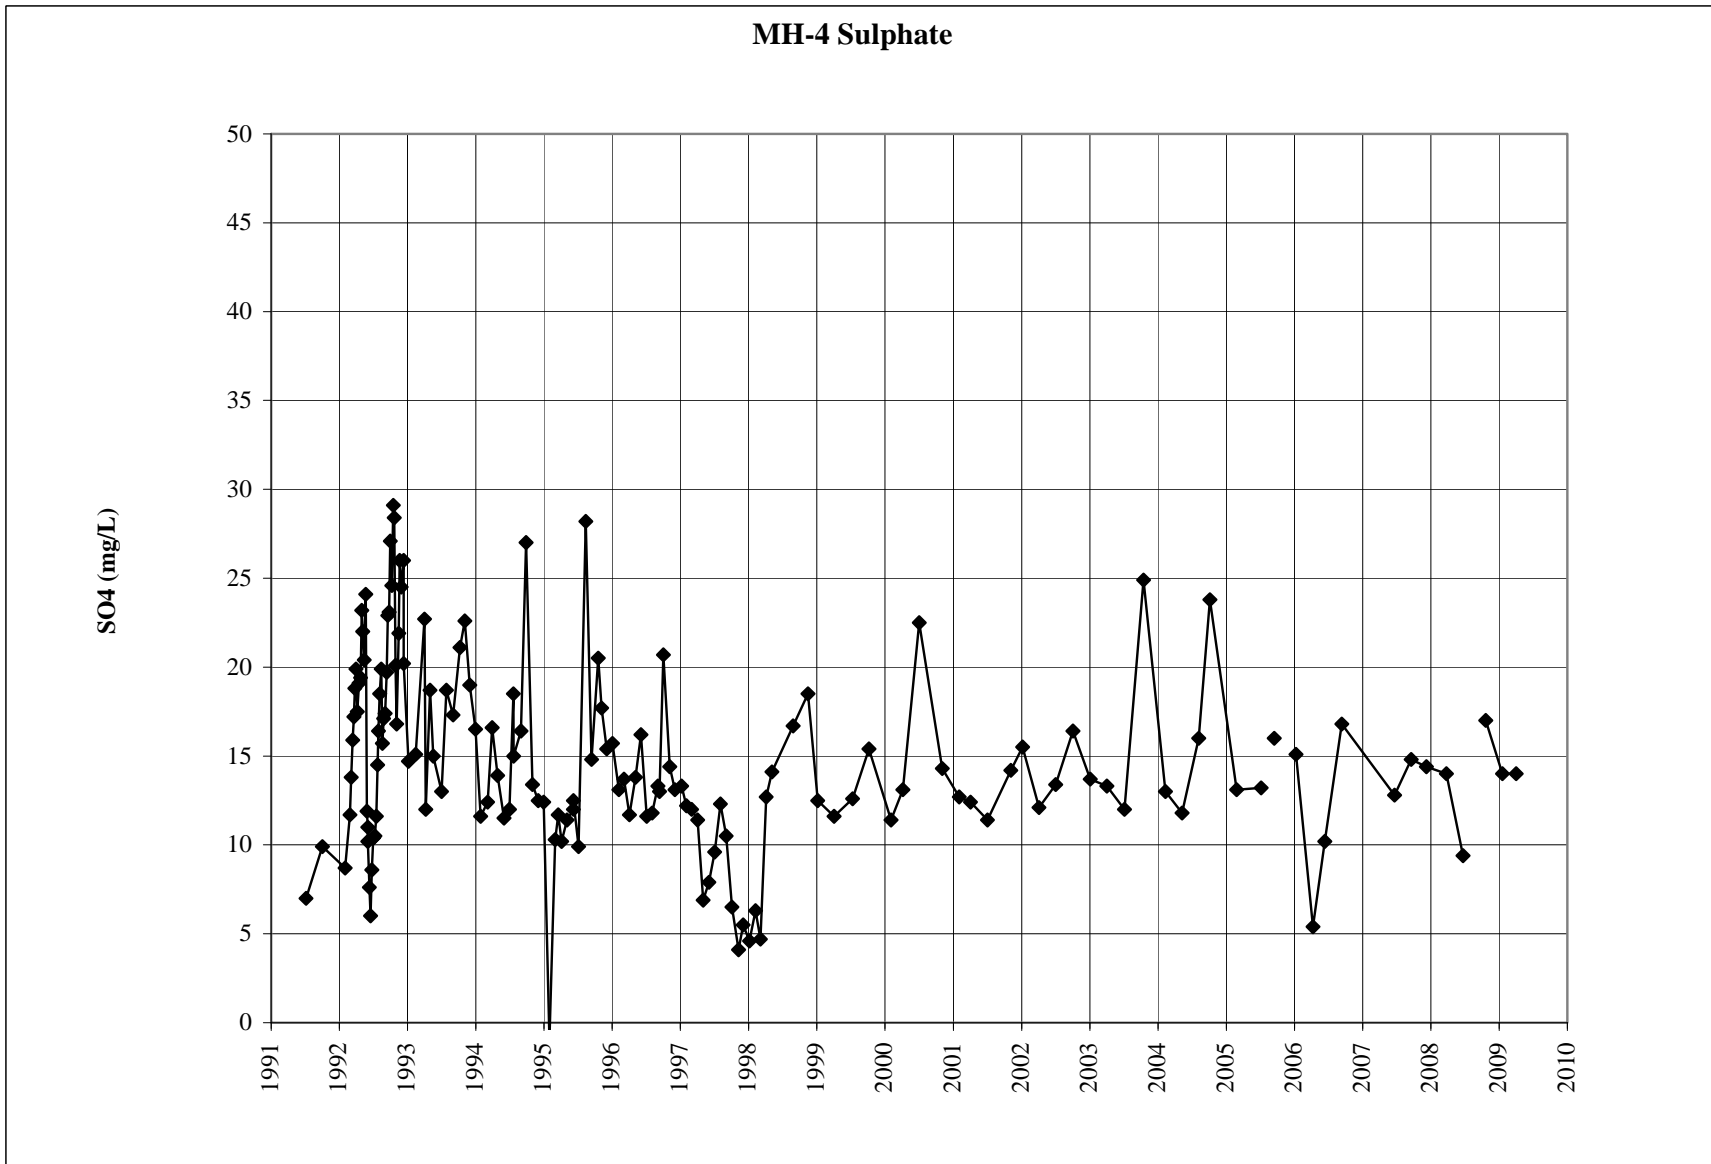
FIGURE D-1 MH-4 Sulphate

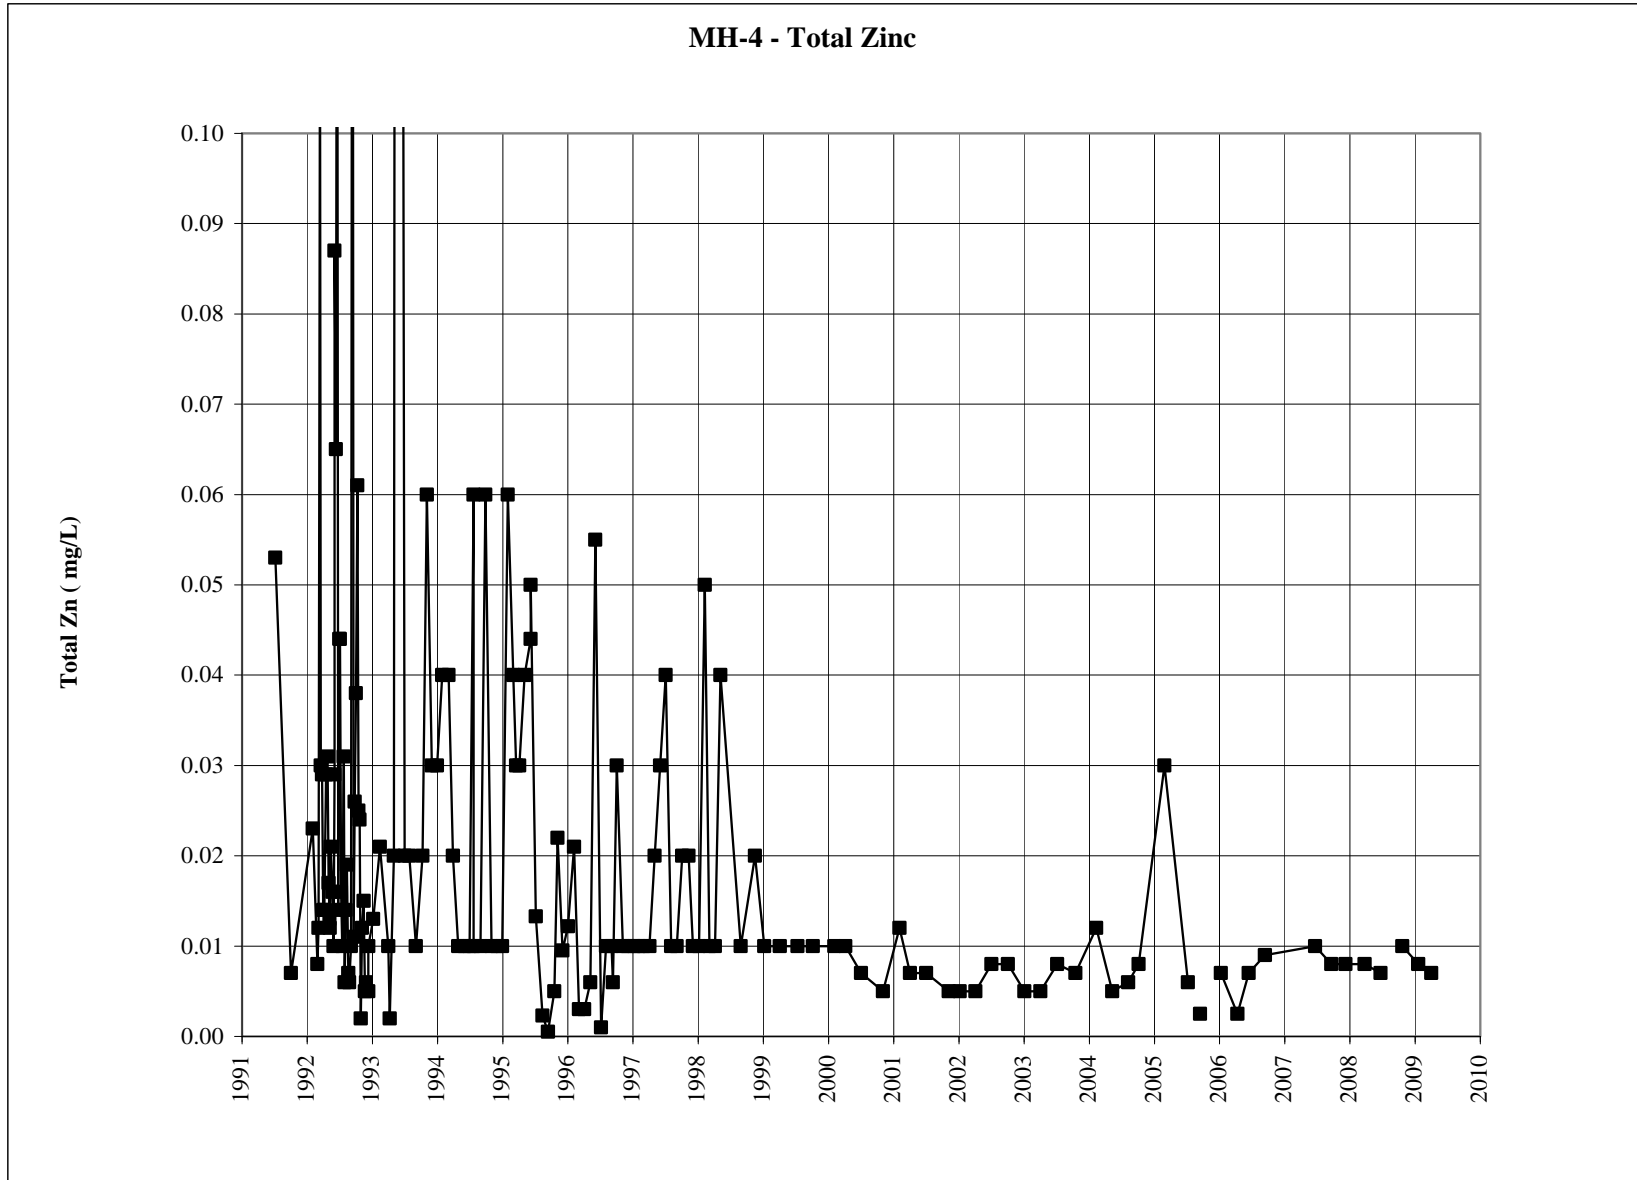
FIGURE D-2 MH-4 Total Zinc

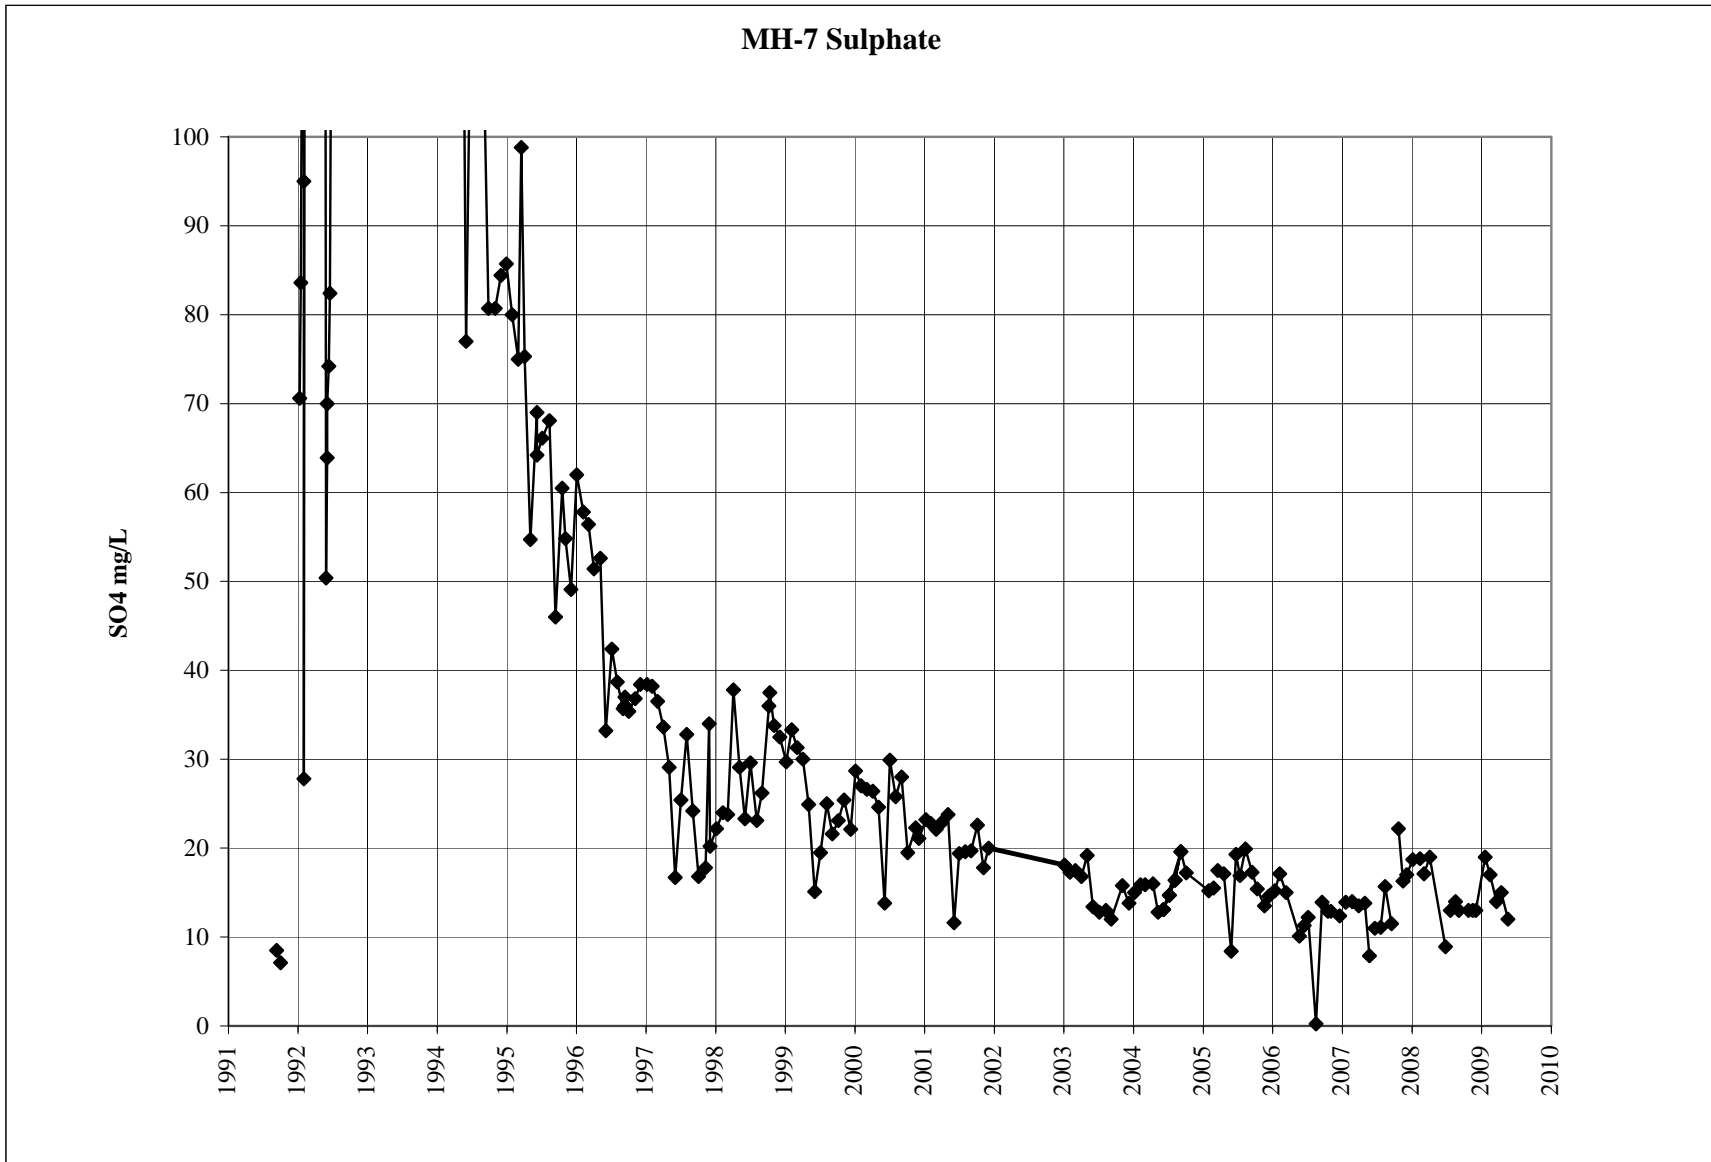
FIGURE D-3 MH-7 Sulphate

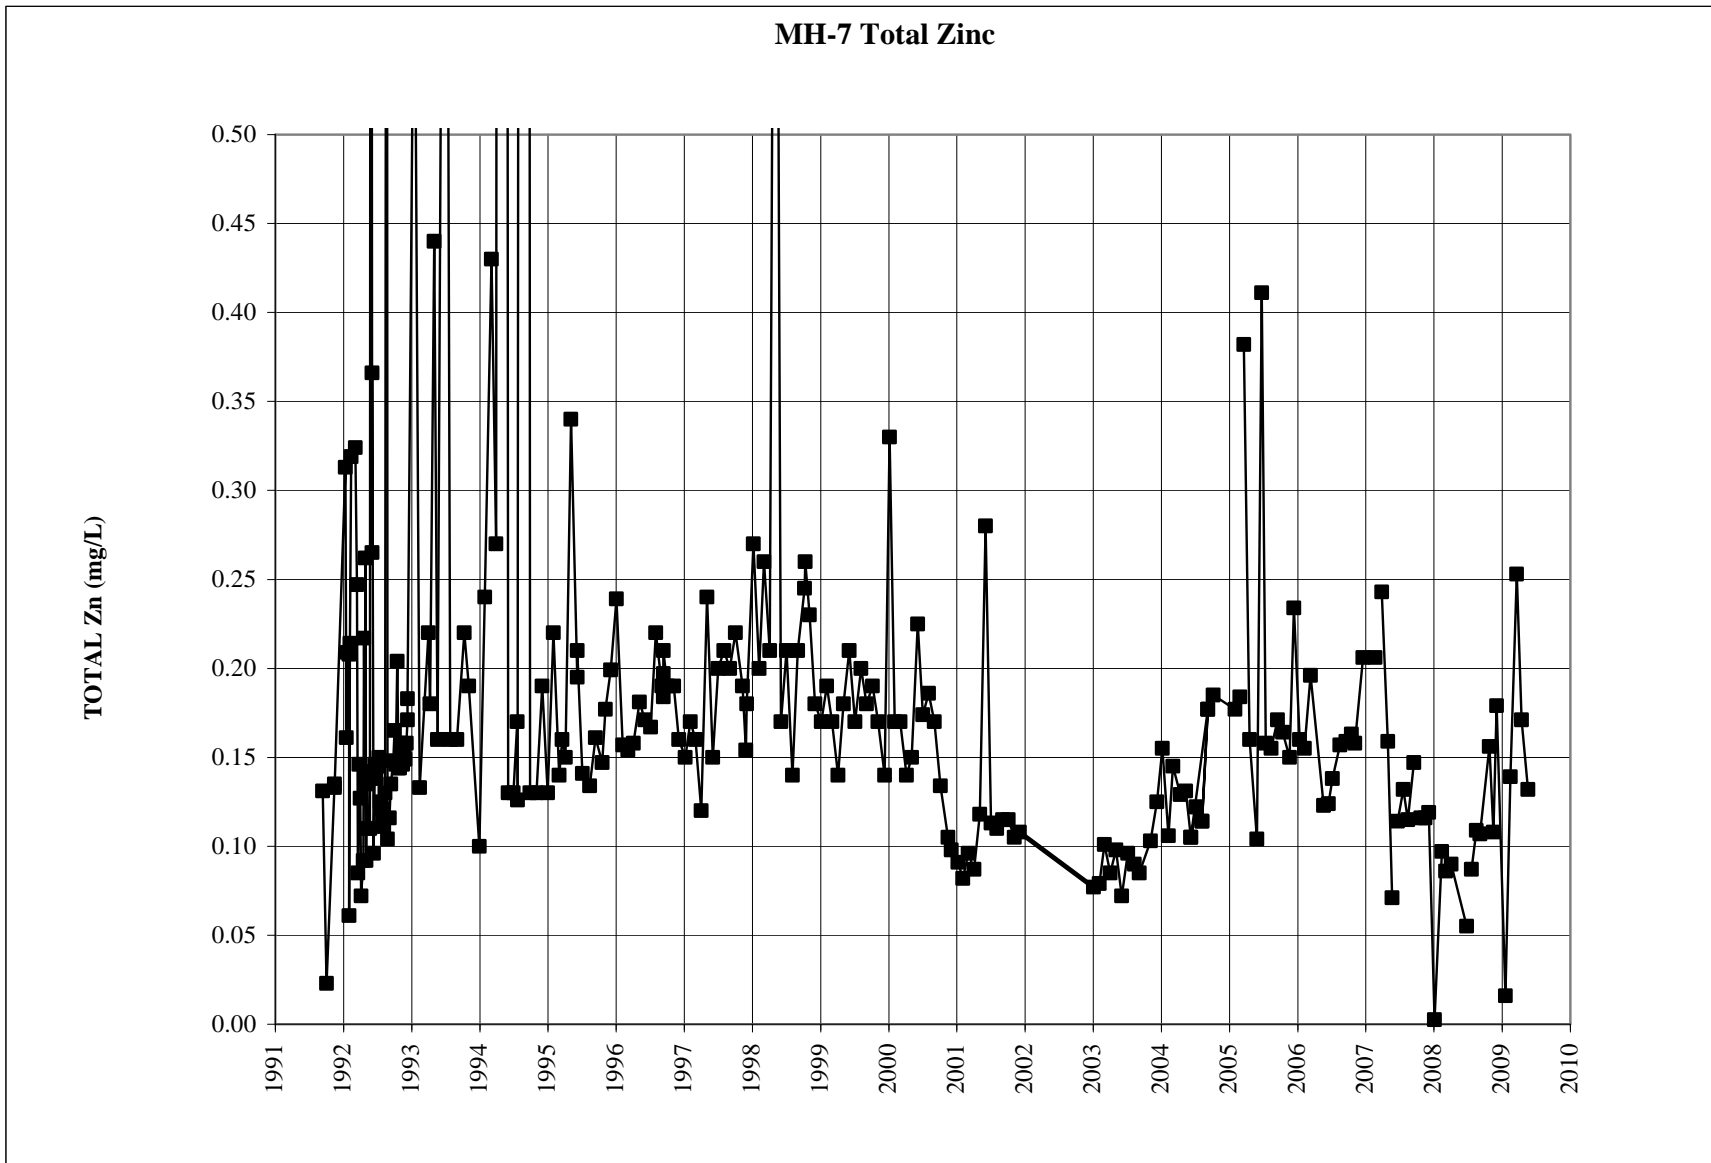
FIGURE D-4 MH-7 Total Zinc
