# SÄ DENA HES OPERATING CORPORATION

## SÄ DENA HES MINE

### DETAILED DECOMMISSIONING & RECLAMATION PLAN

### JANUARY 2010 UPDATE

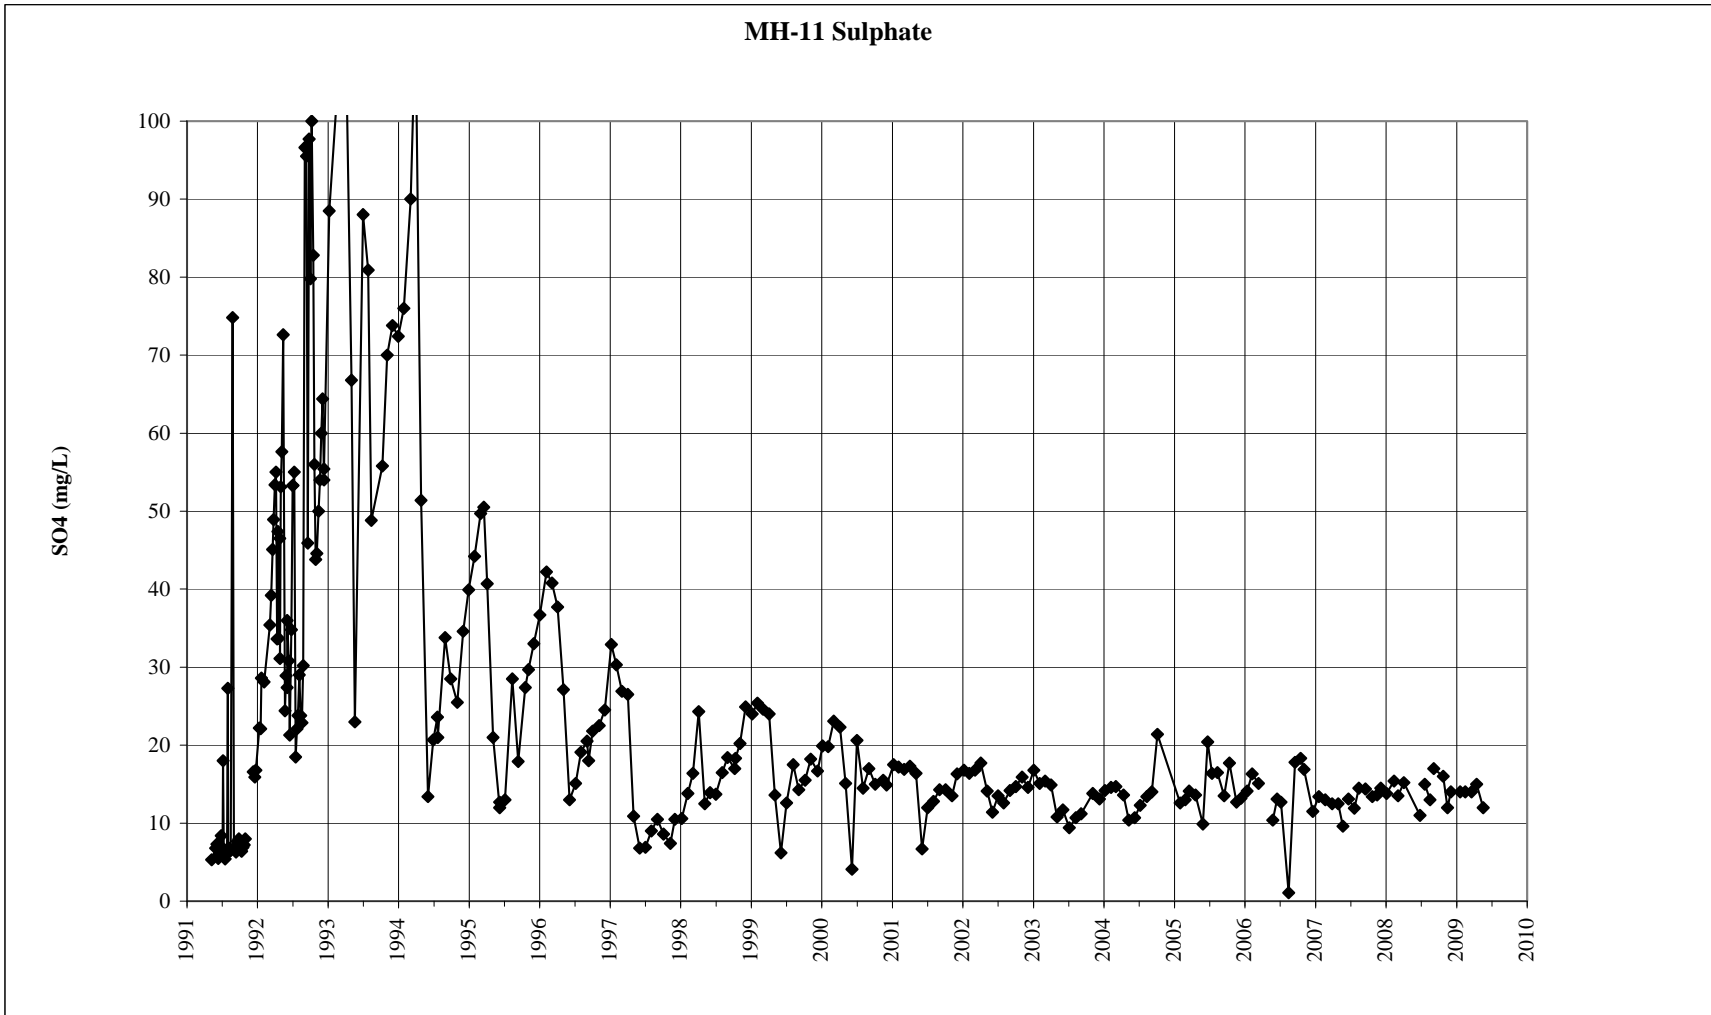
**FIGURE D-5 MH-11 Sulphate**

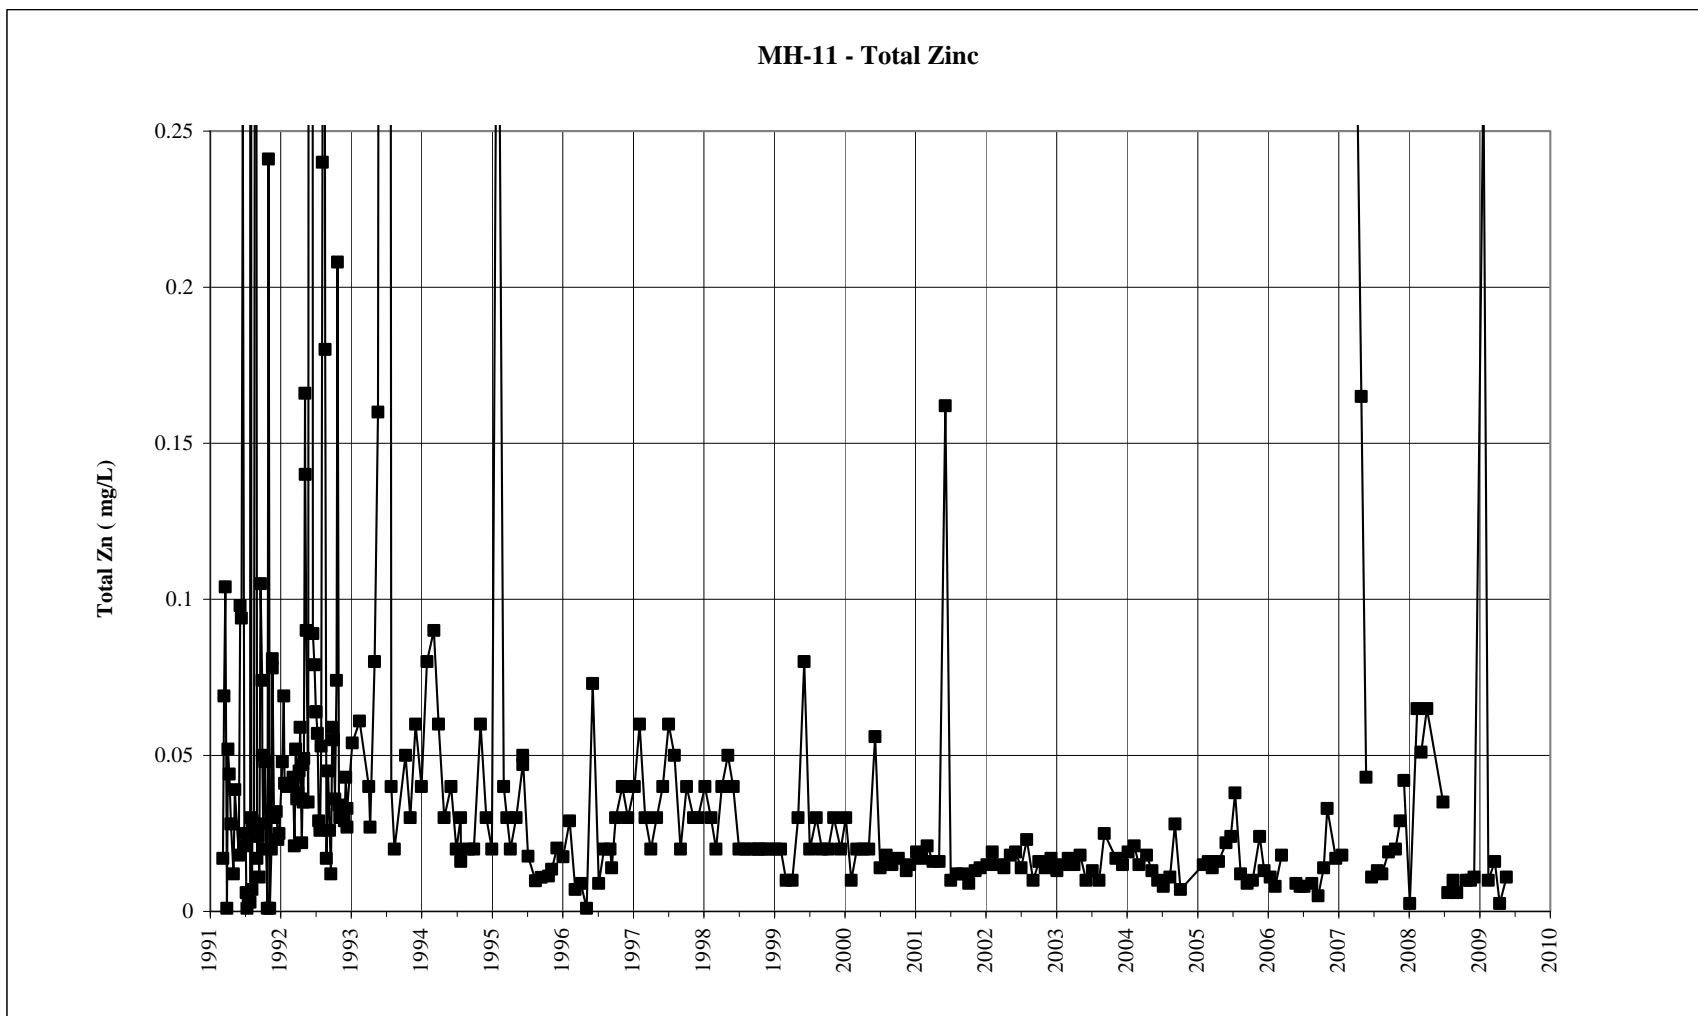
FIGURE D-6 MH-11 Total Zinc

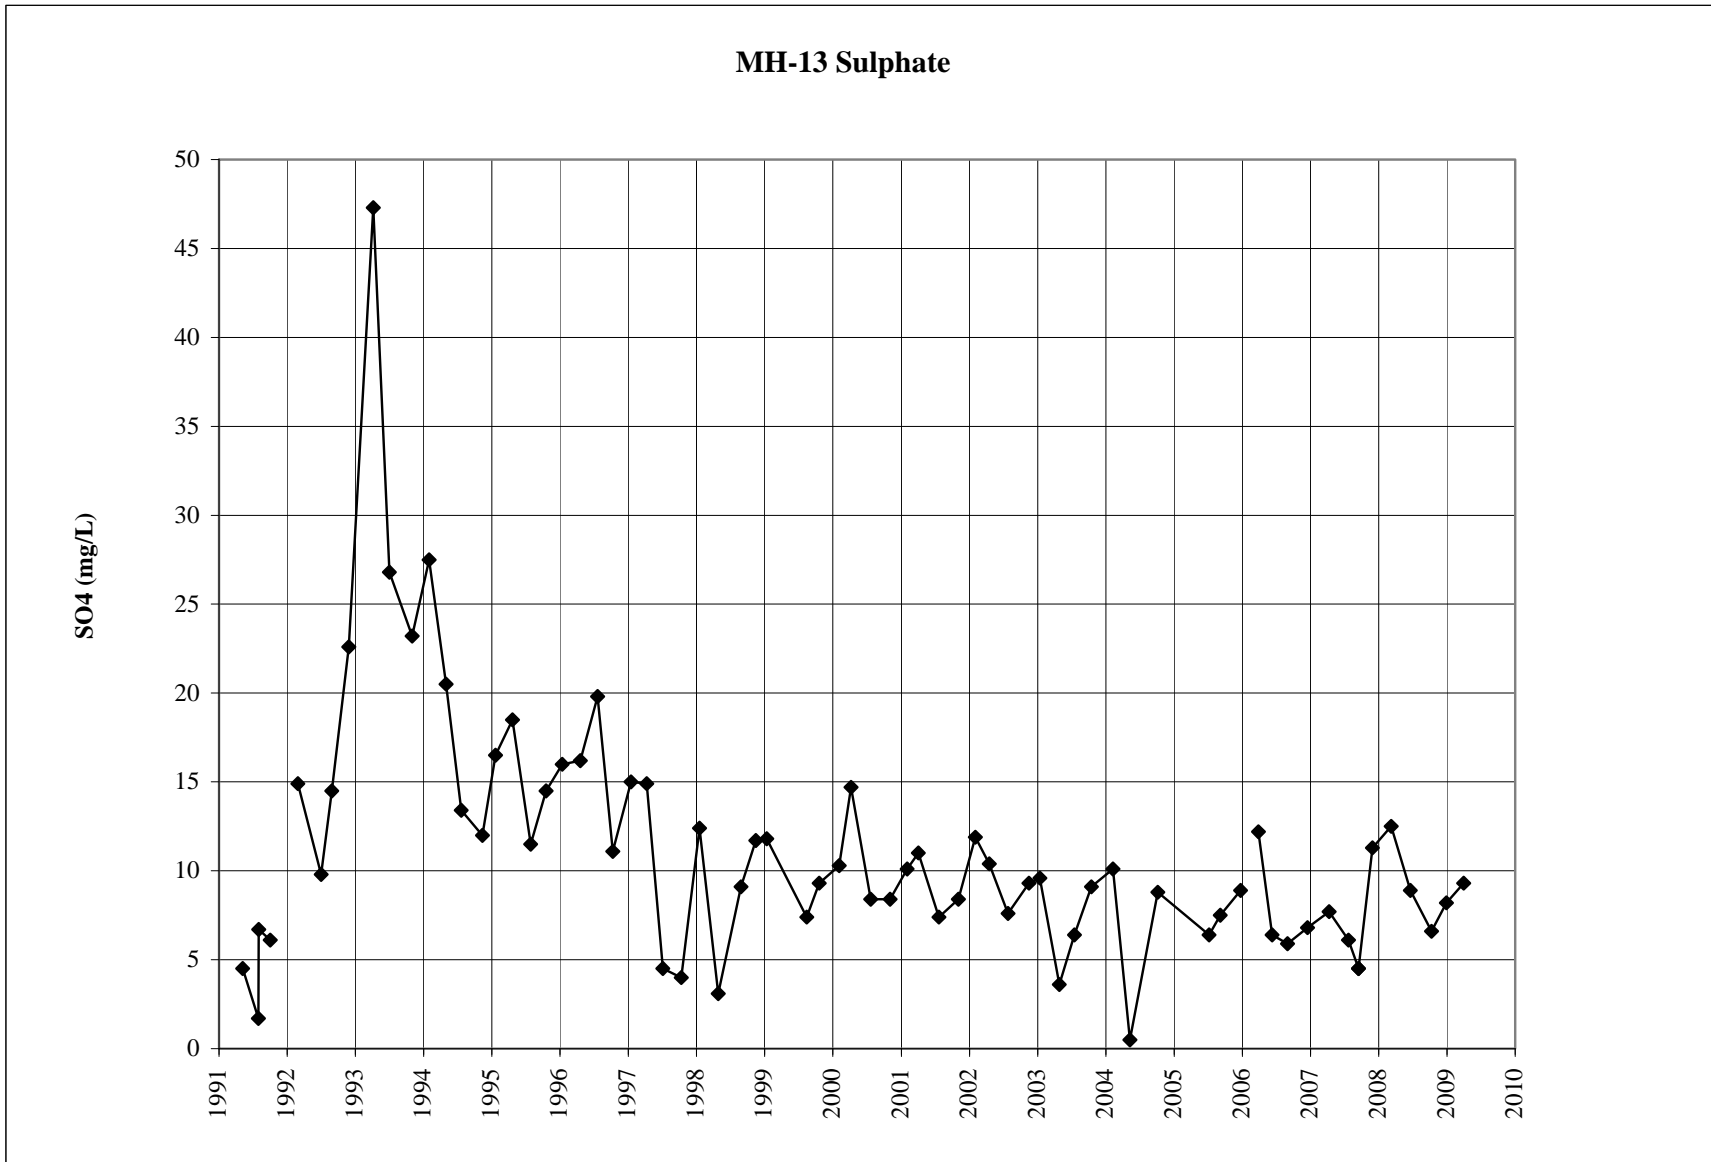
**FIGURE D-7 MH-13 Sulphate**

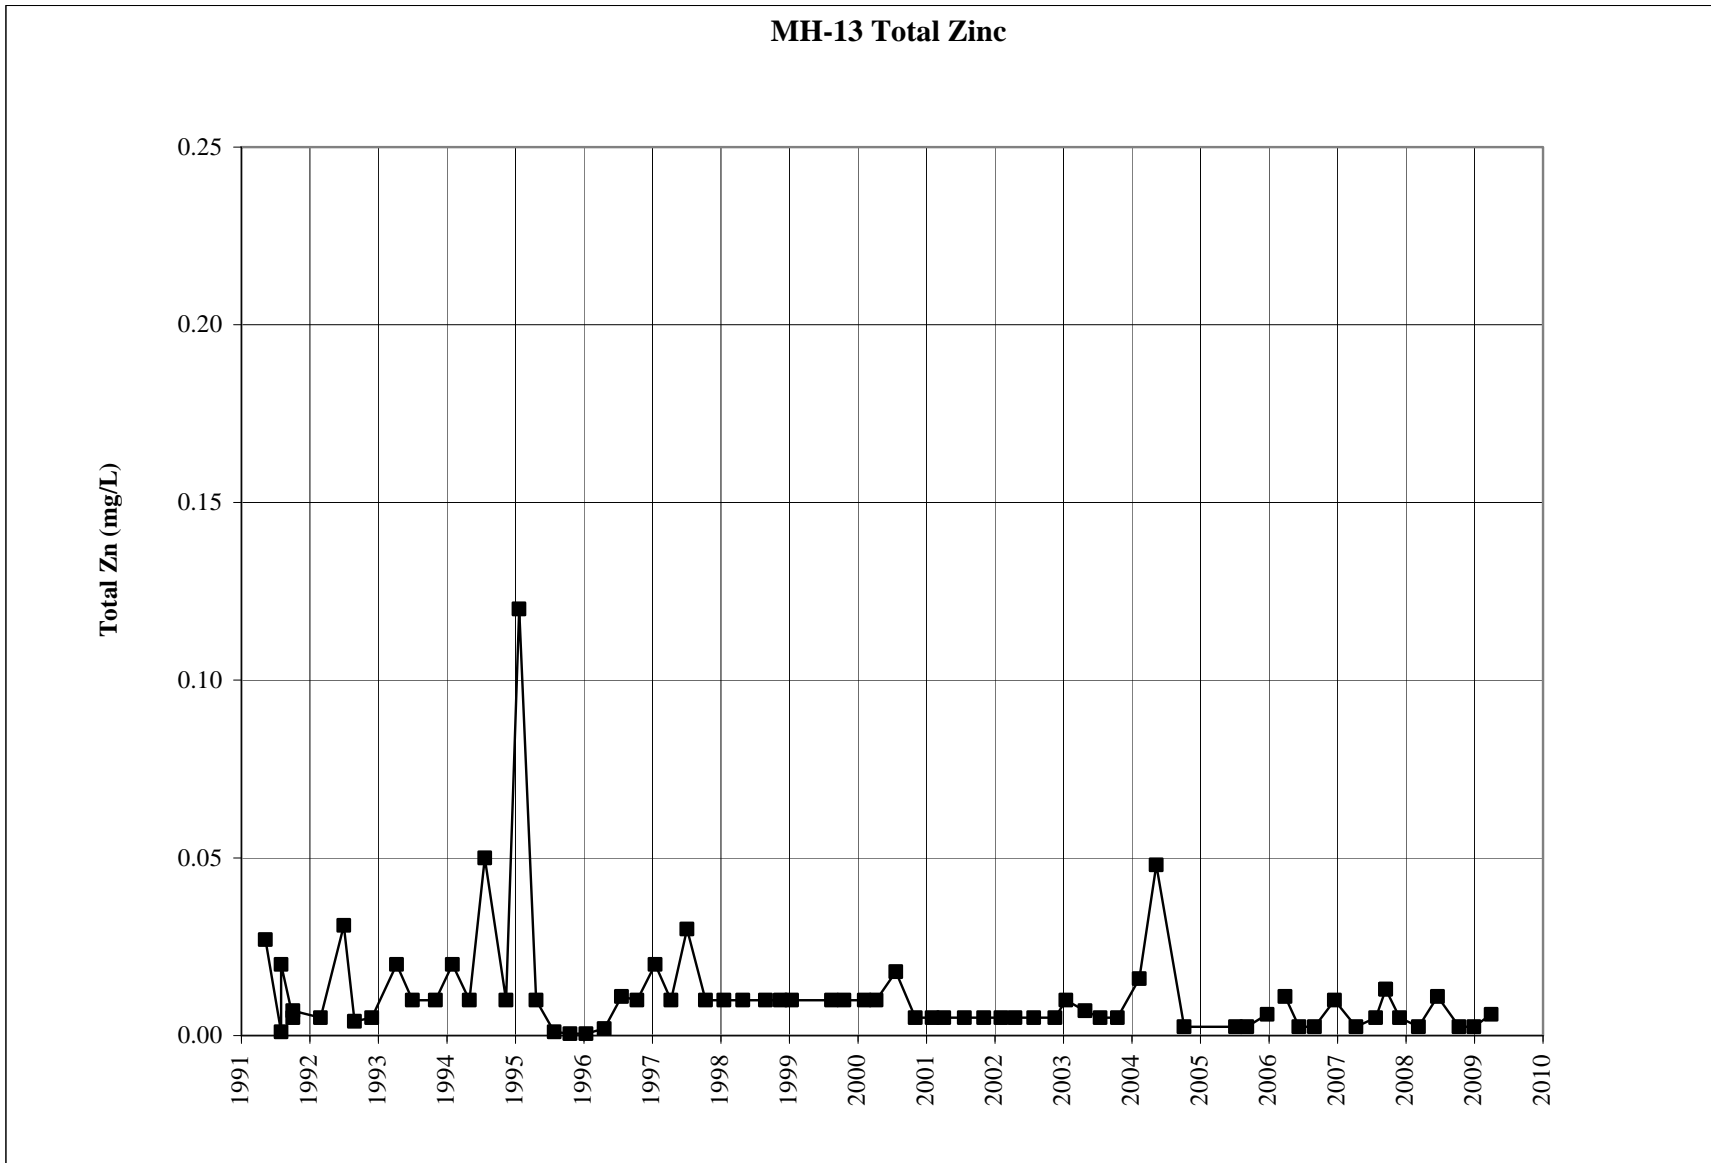
FIGURE D-8 MH-13 Total Zinc

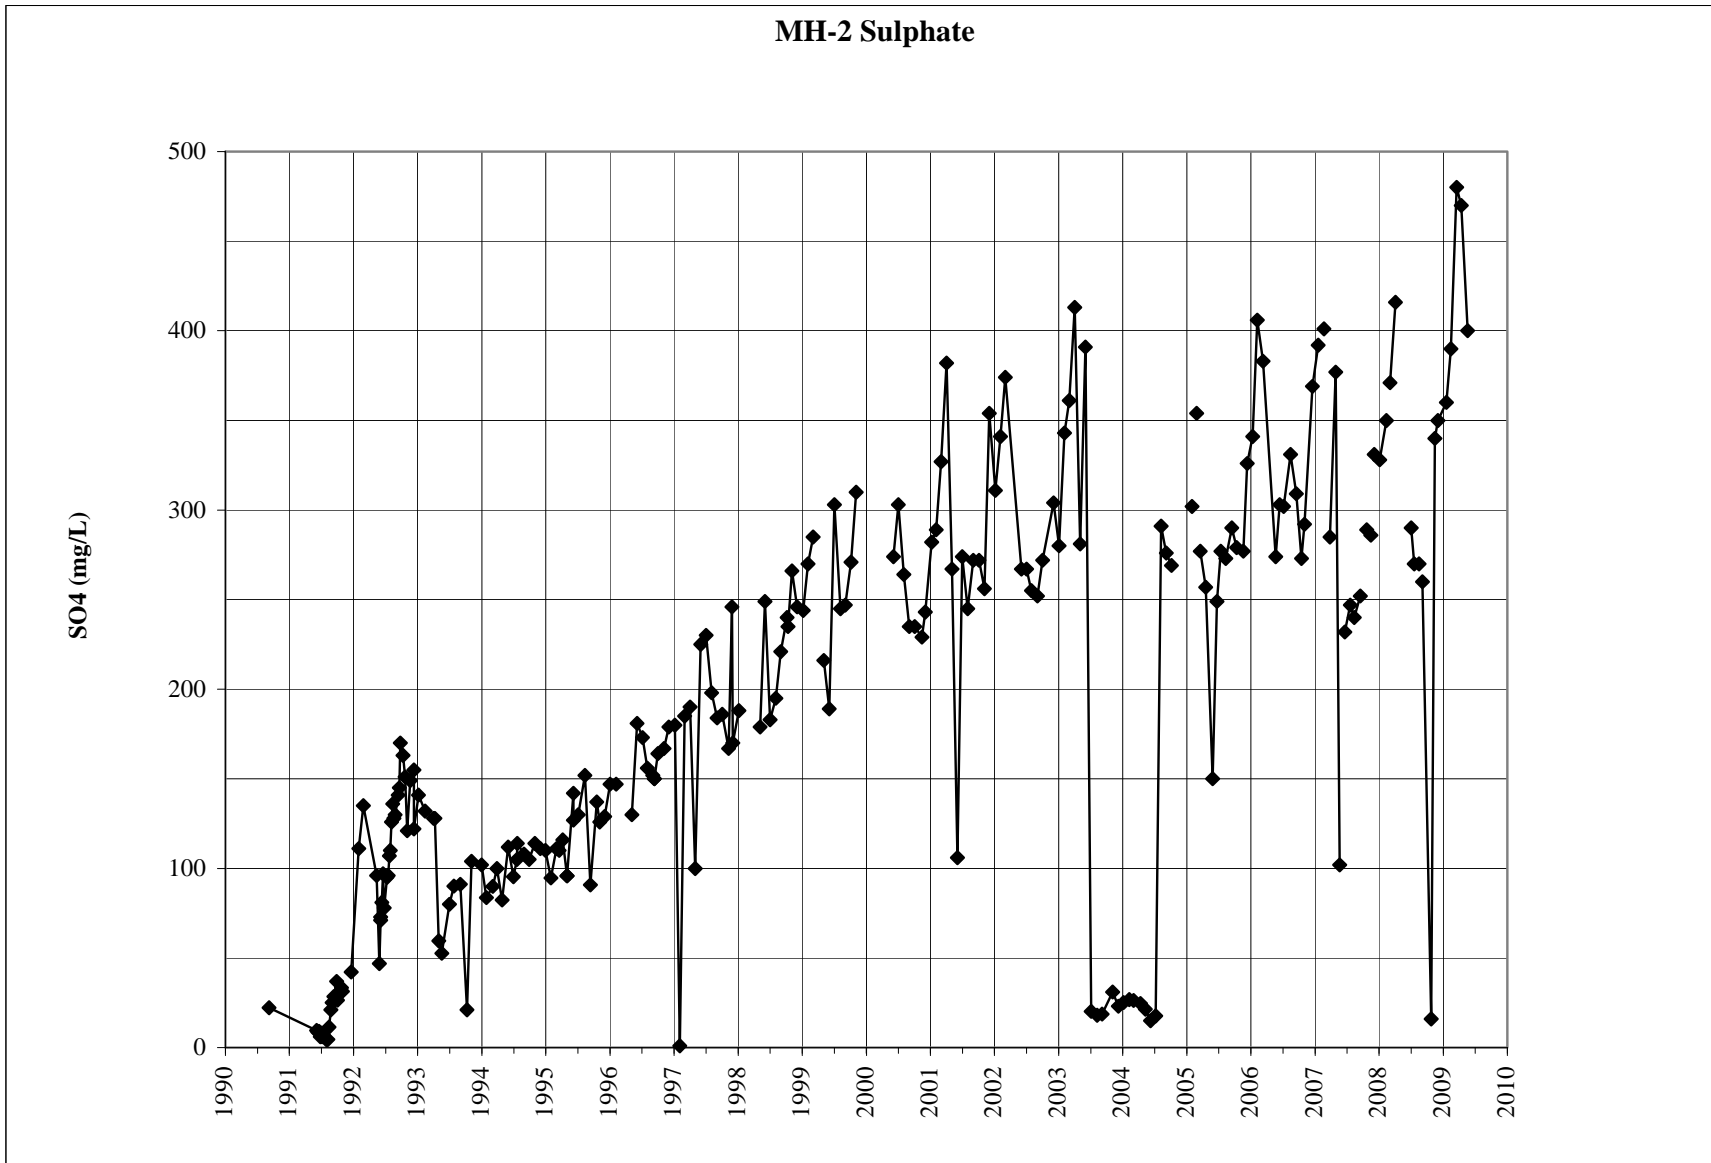
FIGURE D-9 MH-2 Sulphate

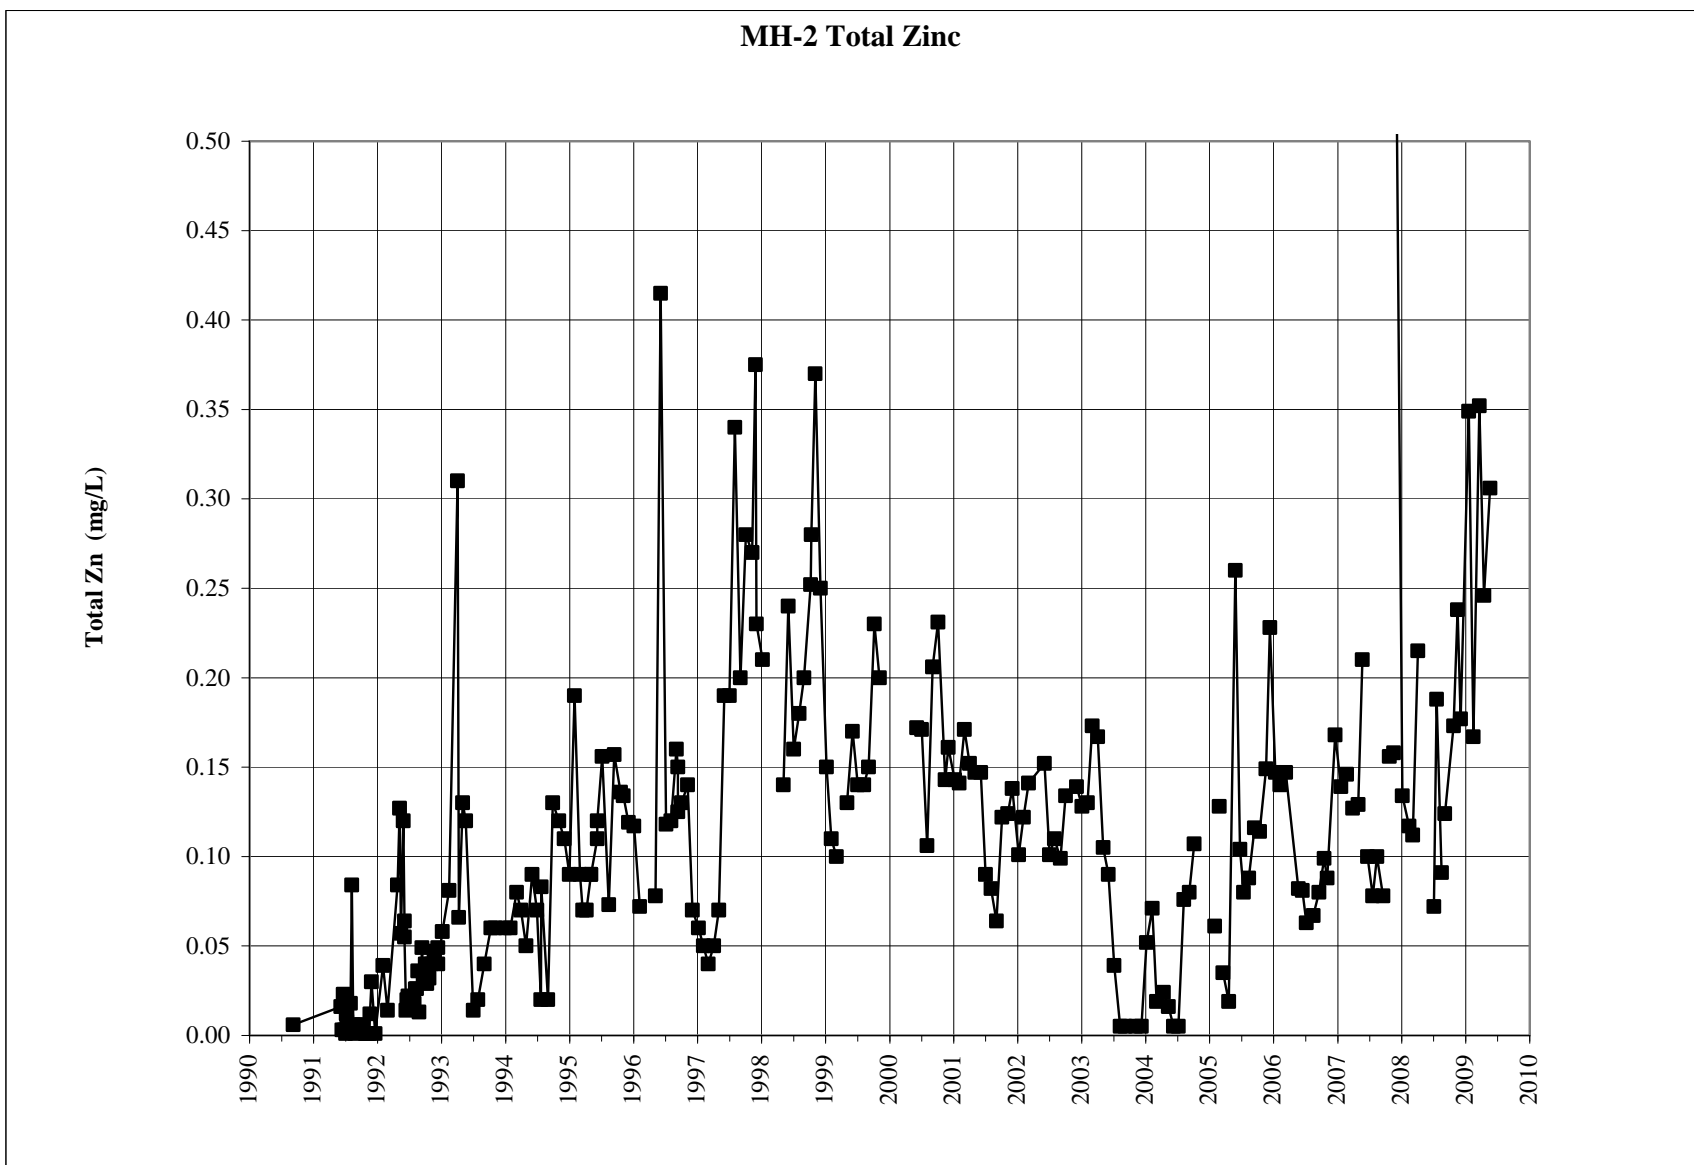
FIGURE D-10 MH-2 Total Zinc

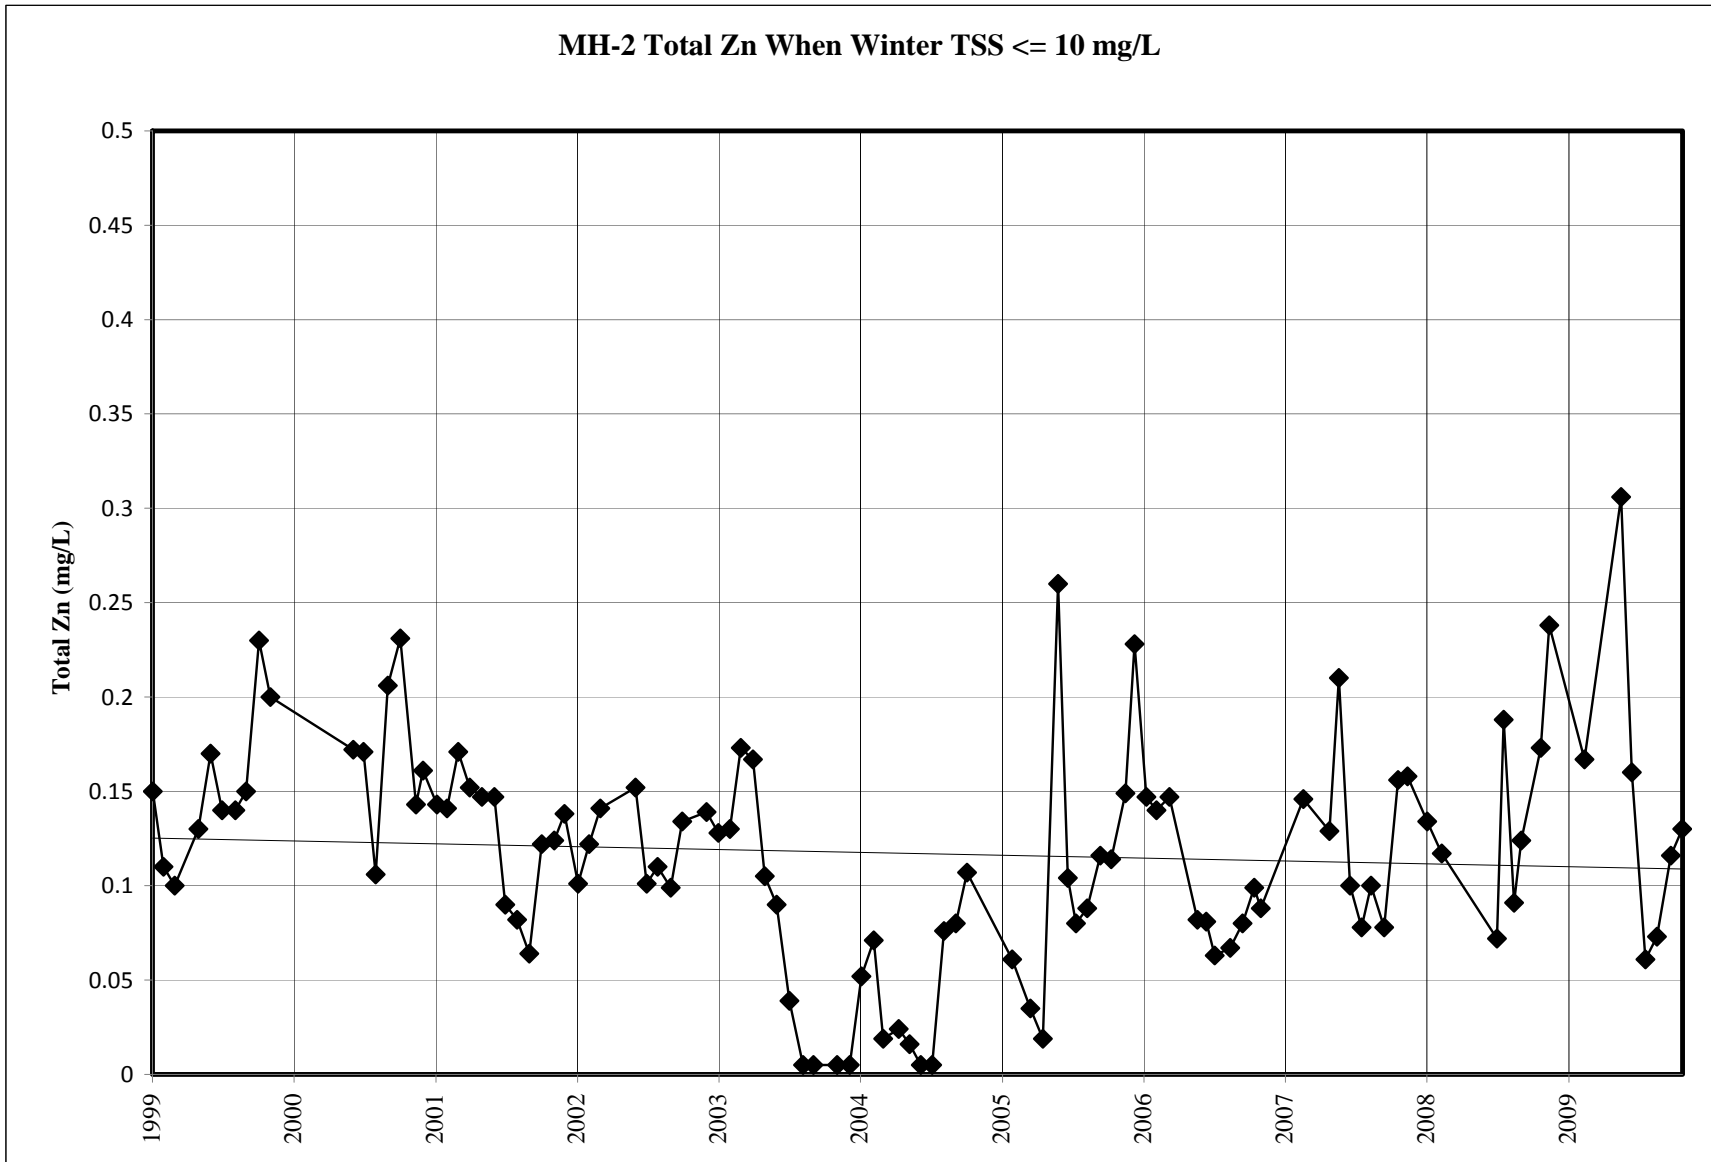
**FIGURE D-11 MH-2 Total Zinc When Winter TSS  $\leq 10$  mg/L**

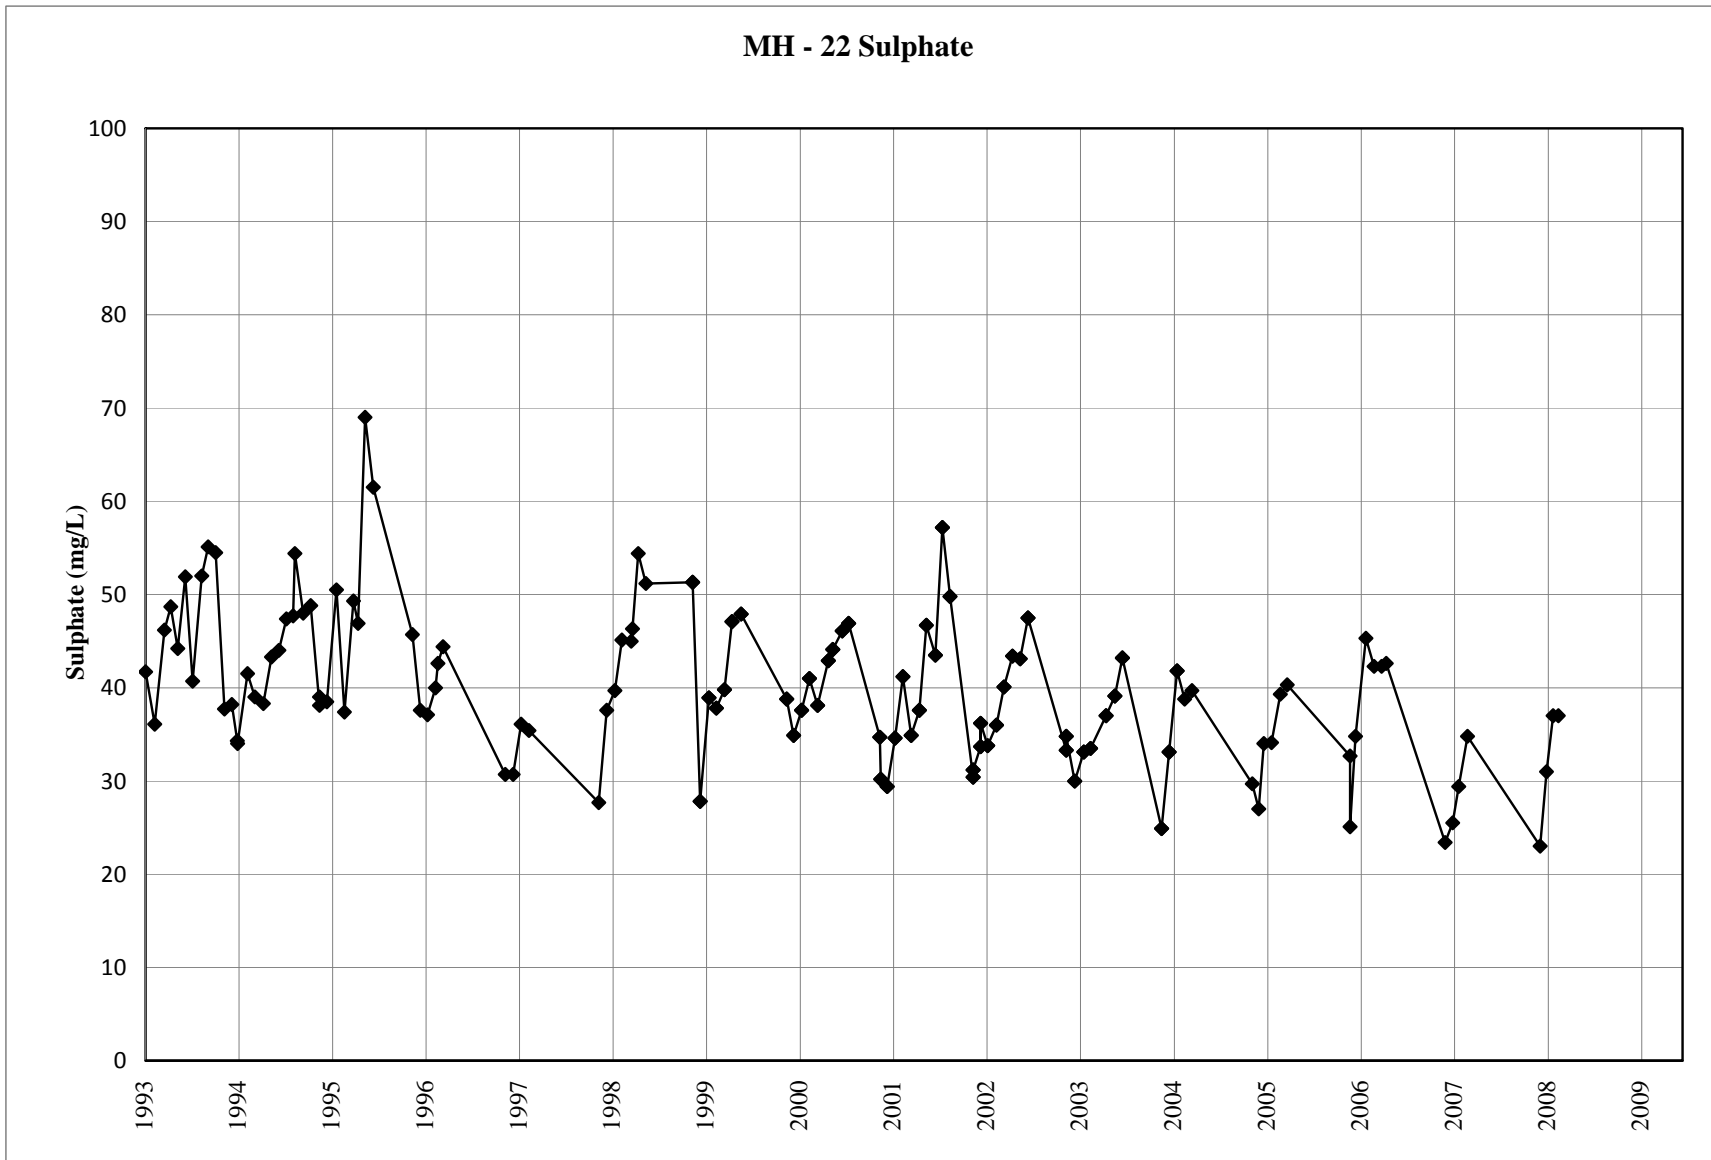
**FIGURE D-12 MH-22 Sulphate**

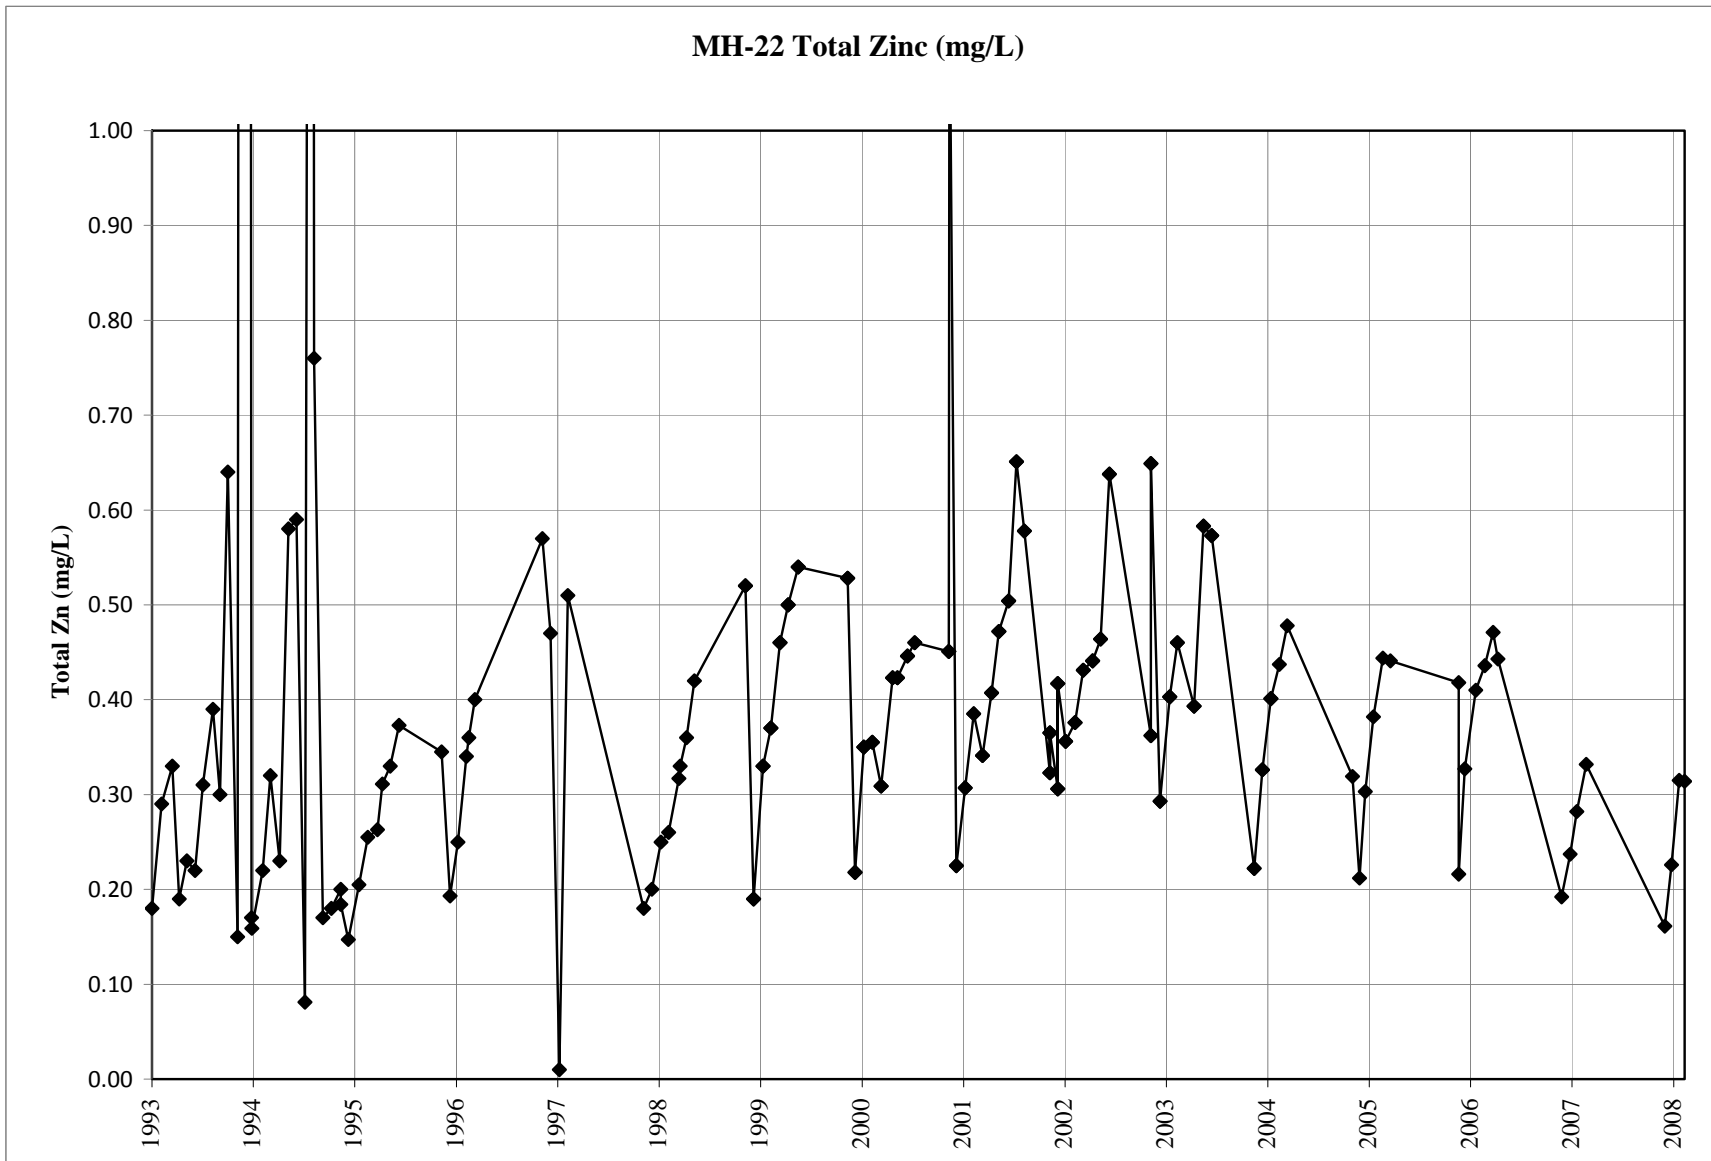
**FIGURE D-13 Mh-22 Total Zinc**

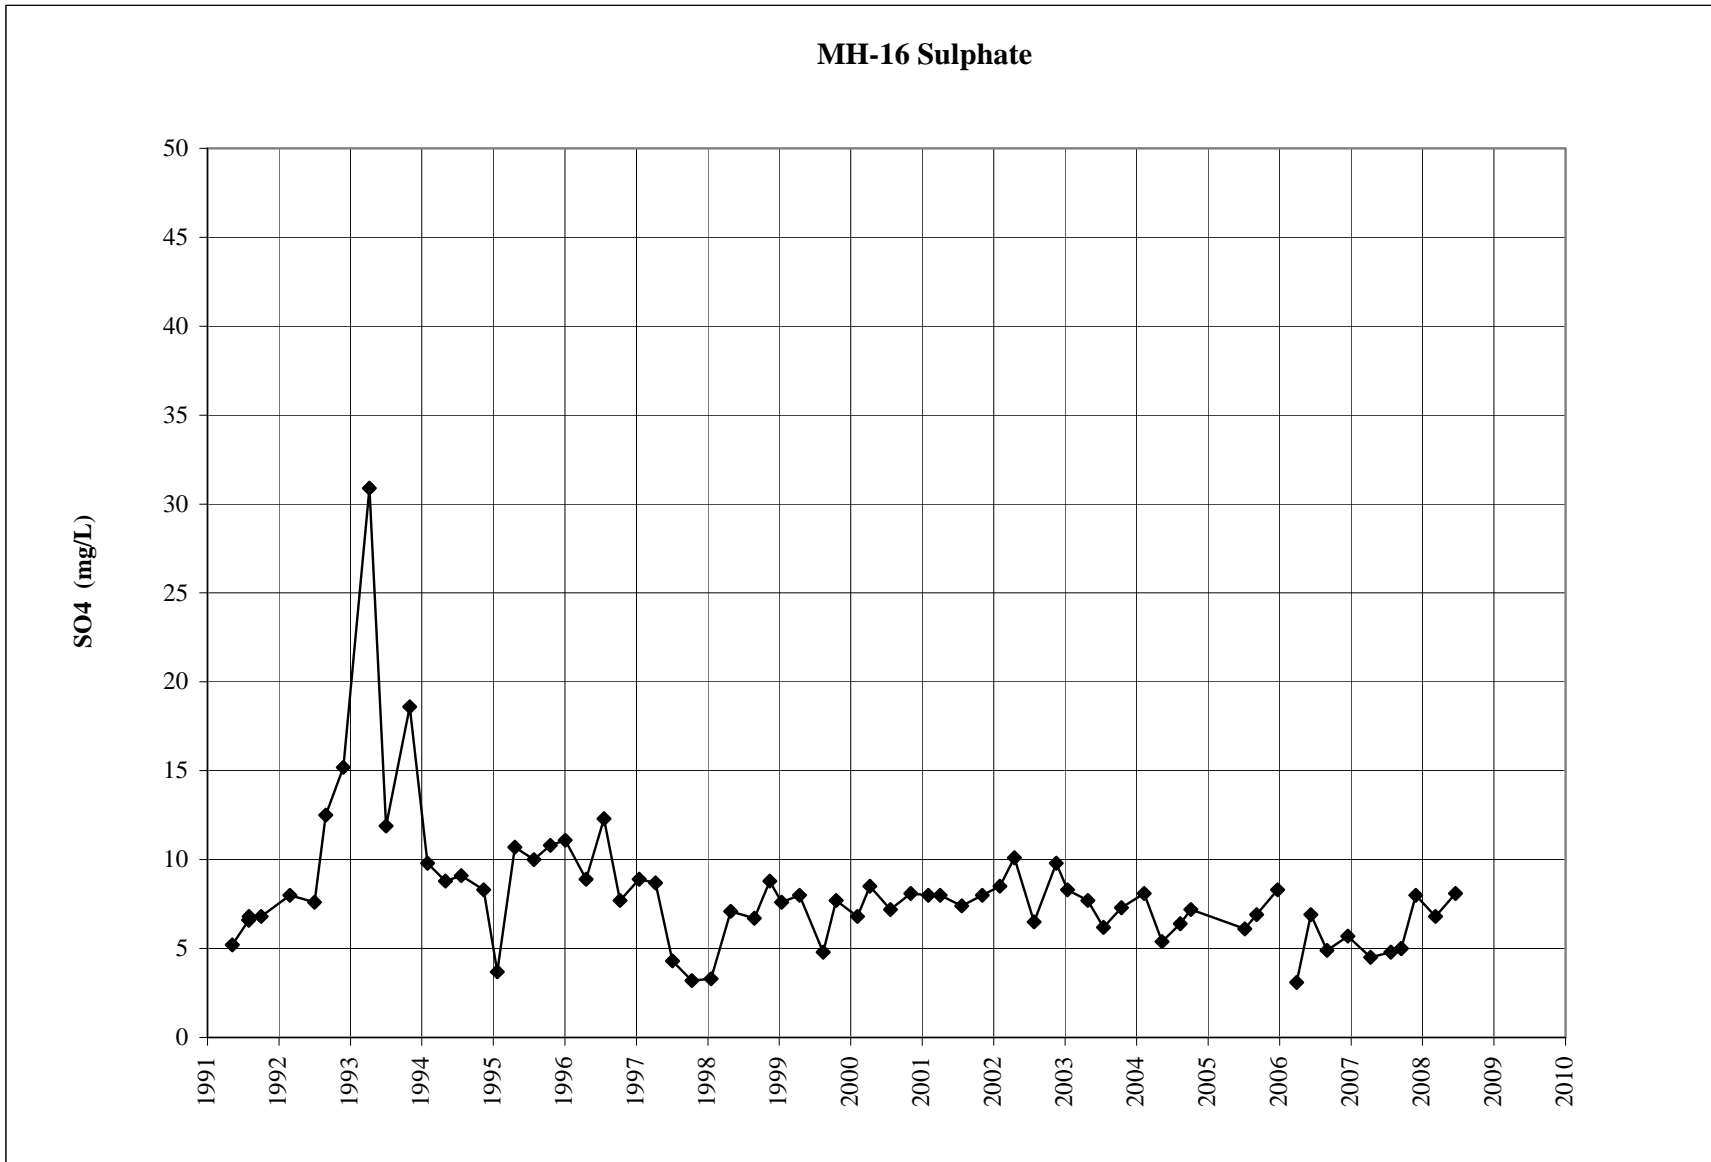
**FIGURE D-14 MH-16 Sulphate**

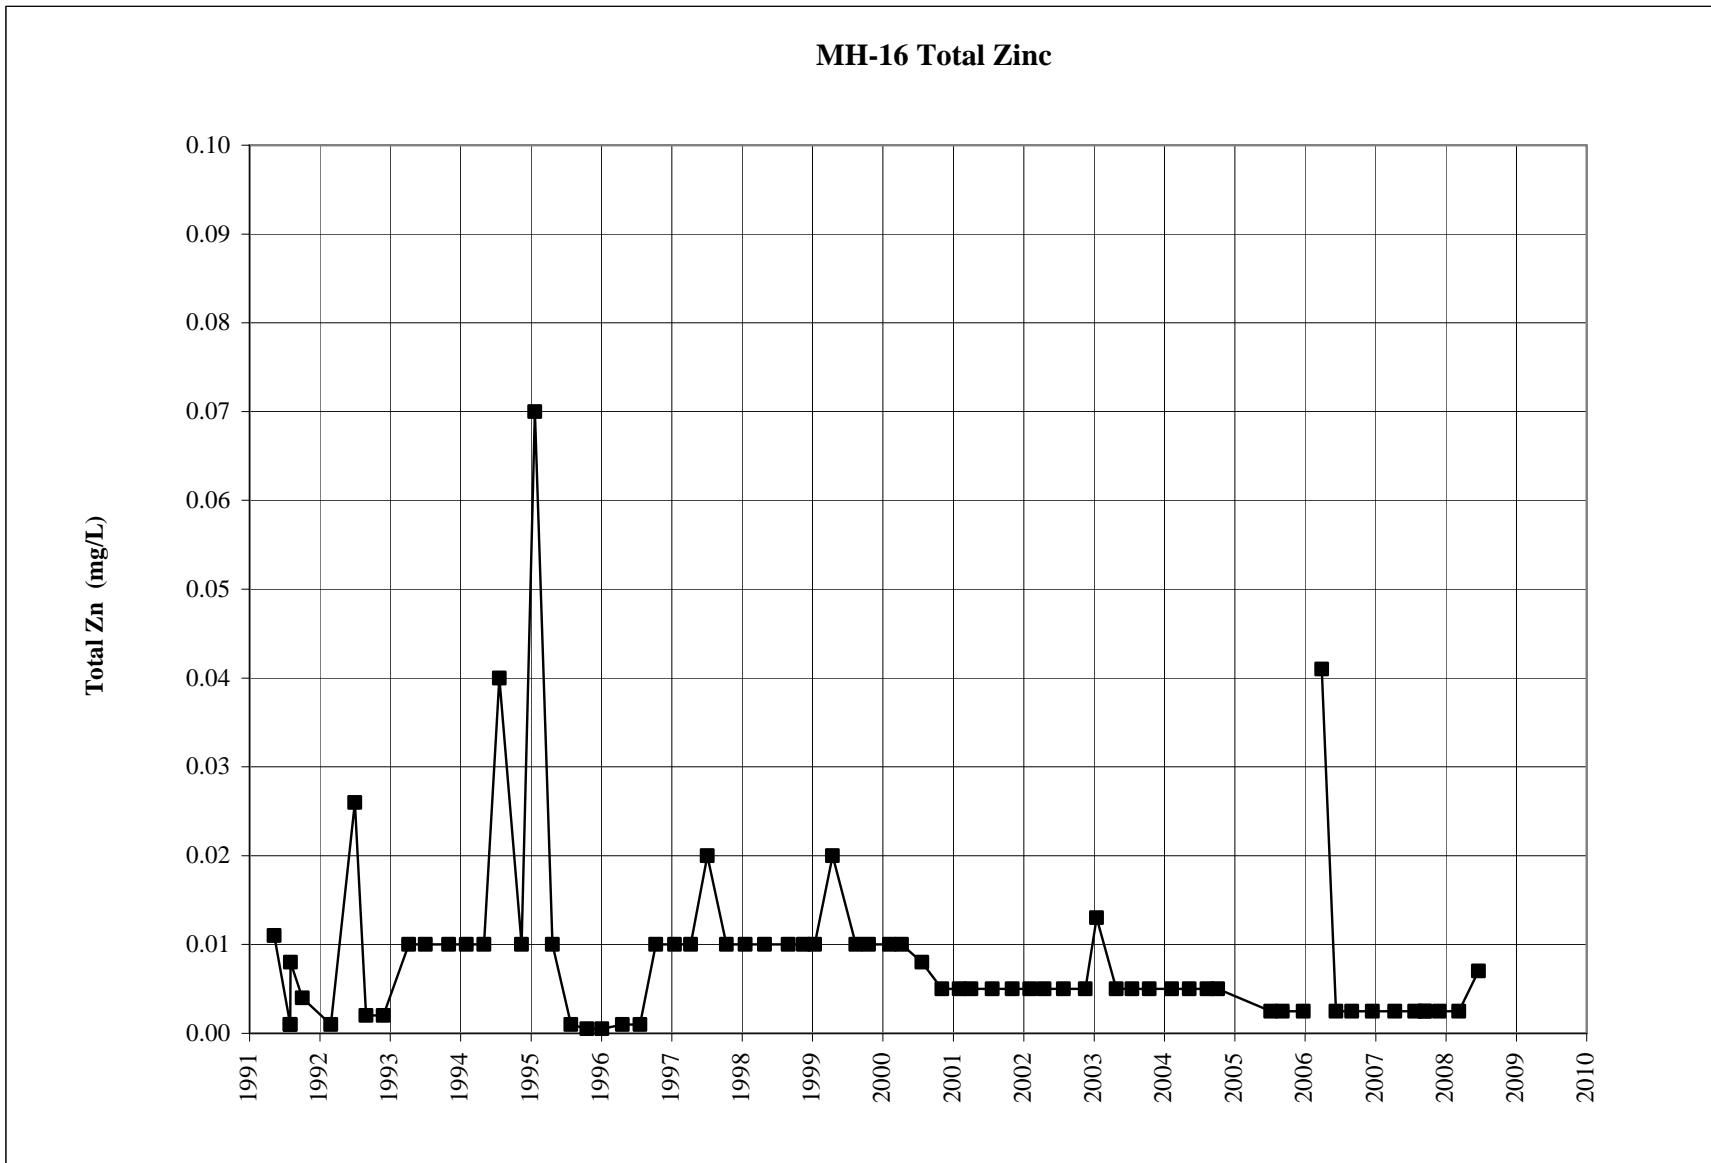
**FIGURE D-15 MH-16 Total Zinc**

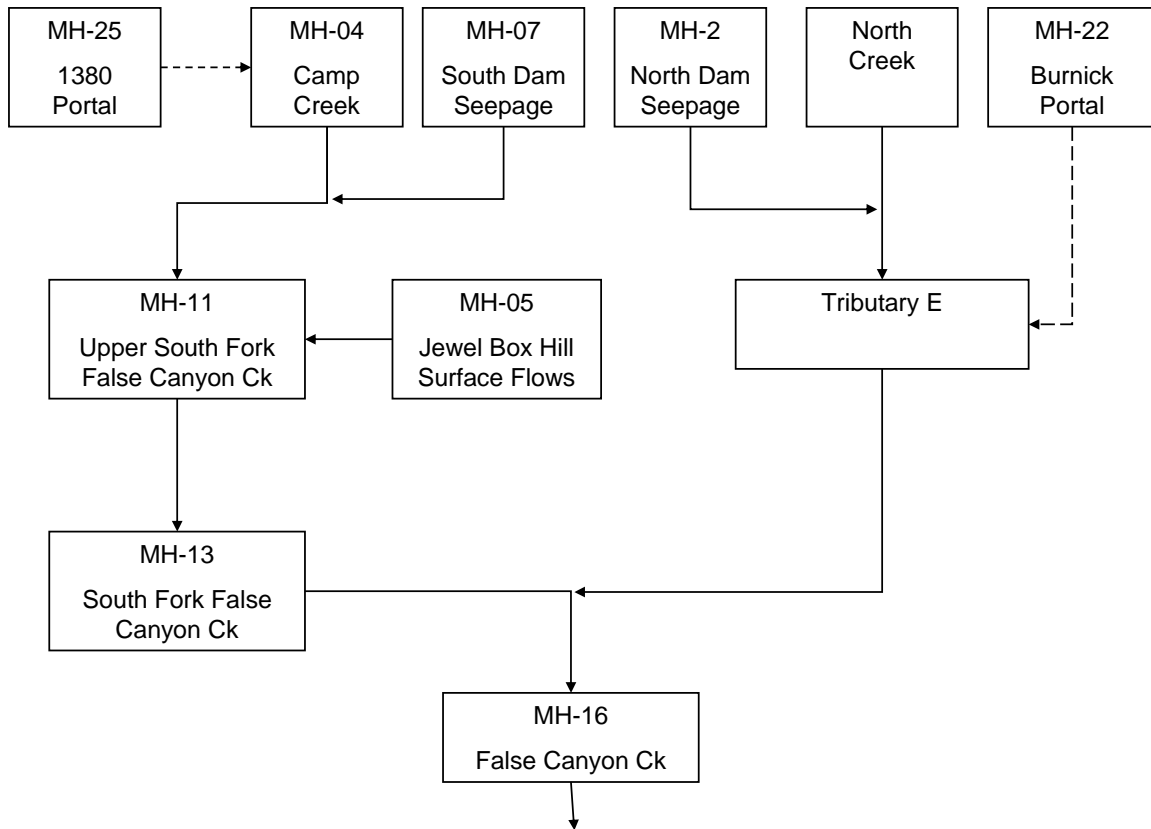
**Figure 1. Flow Network Used in Loading Calculations. Solid lines indicate surface flow connections. Dashed line indicates subsurface flow connection.**

The loading calculation approach was comparable to that used for the 2000 Detailed D&R Plan. The overall flow network considered in the loading calculation is shown in Figure 1. Monitoring locations are shown in Appendix A.

The flow network used in the 2000 Detailed D&R Plan considered MH-22 (North Hill Settlement Basin) as a direct surface flow connection to Tributary E. Subsequent work reported by SRK Consulting (2003) has demonstrated that MH-22 does not have a surface connection to Tributary E and that soils in the slopes below MH-22 significantly attenuate zinc concentrations to low levels (<0.001 mg/L). Sulphate is not attenuated and monitoring sulphate concentrations are used for calculation. The original loading balance has been re-calculated and the current loading balance calculated using attenuated zinc concentrations for MH-22 indicated by laboratory studies.
