# SÄ DENA HES OPERATING CORPORATION

## SÄ DENA HES MINE

### DETAILED DECOMMISSIONING & RECLAMATION PLAN

### JANUARY 2010 UPDATE

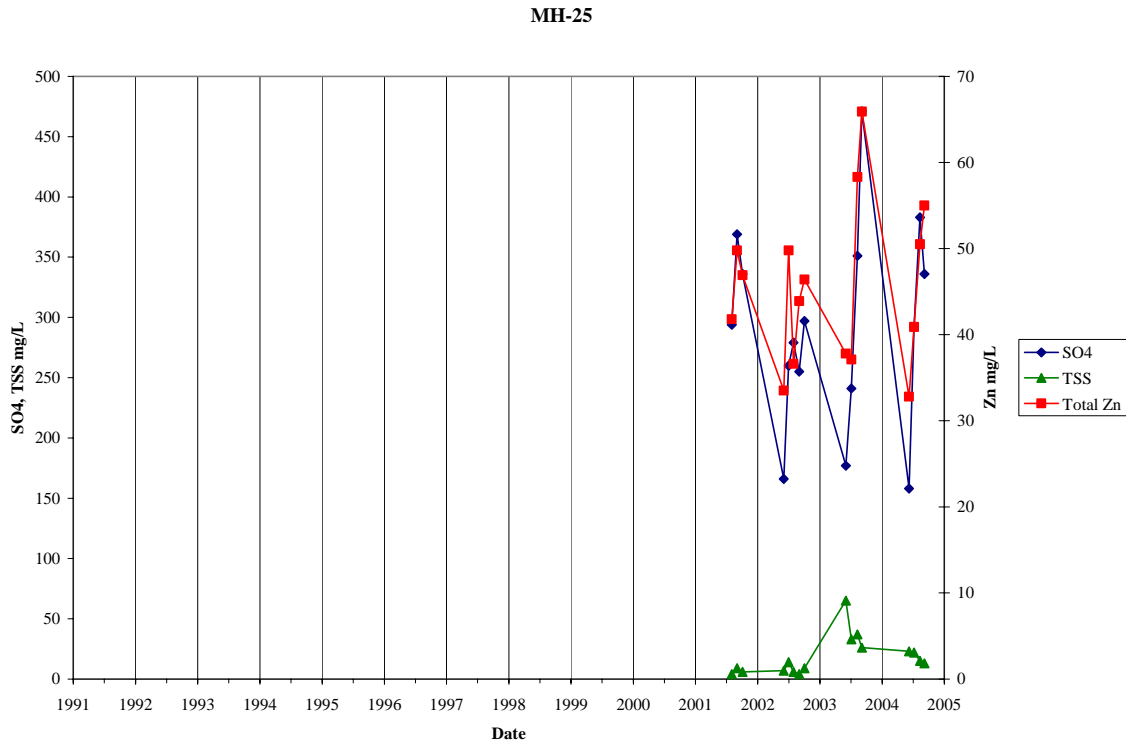
**Figure 2. Monitoring Results for 1380 Portal (MH-25).**

Camp Creek (MH-04) receives flow from the natural mineralized exposure on the north side of Jewelbox Hill as well as from the Main Zone Pit and 1380 Portal (MH-25) via subsurface flow. The 1380 Portal continues to be a source of elevated zinc concentrations and loads exceeding loads at MH-04 (Figure 2). Investigations subsequent to the 2000 Detailed D&R Plan (SRK Consulting 2003) indicated that this load reduction is probably occurring as a result of strong attenuation in waste rock and talus below the portal.

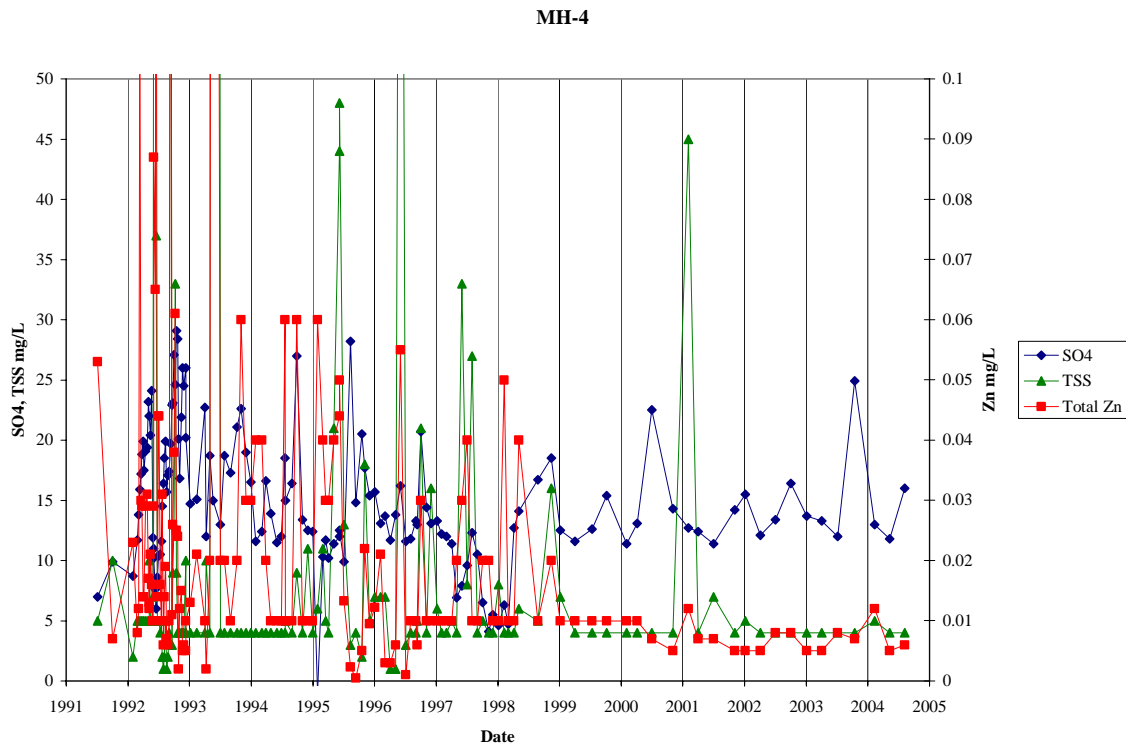
**Figure 3. Monitoring Results for Camp Creek at MH-4**

Monitoring results for MH-04 indicate that zinc concentrations have been low and decreasing slightly since 1998 (Figure 3). Sulphate concentrations have been relatively stable for at least ten years.

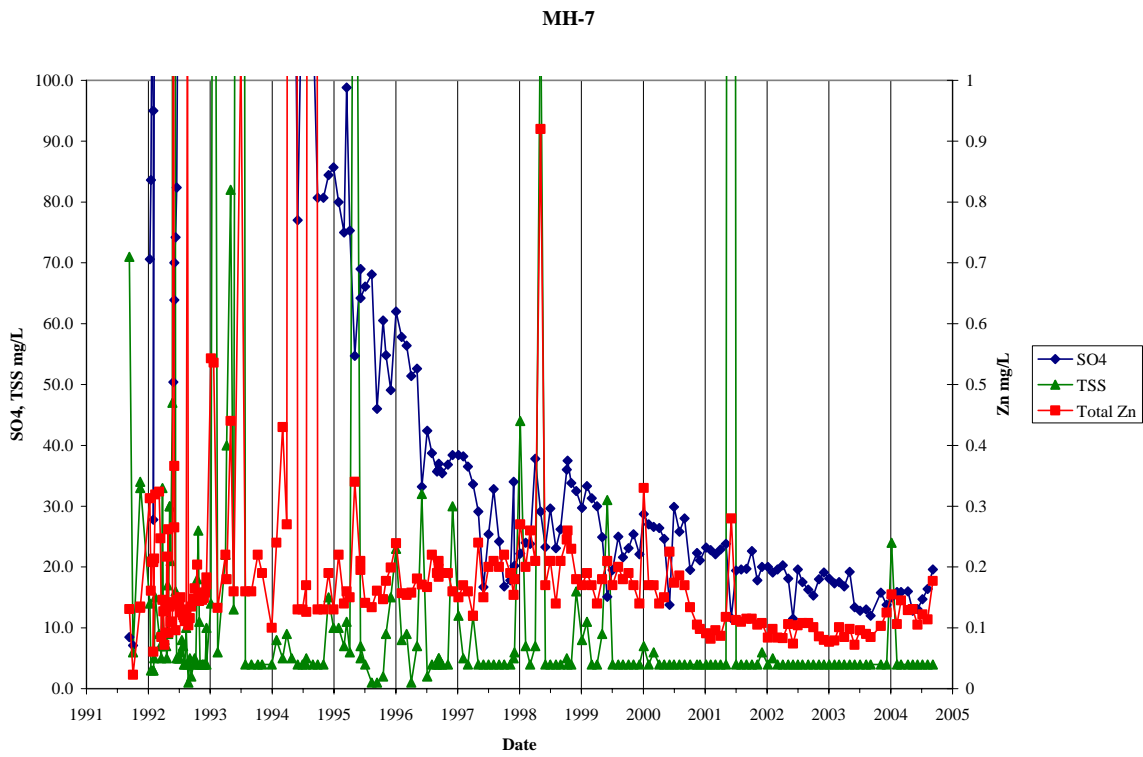
**Figure 4. Monitoring Results for South Dam Seepage (MH-07)**

Monitoring data for the South Dam seepage (MH-07) show a continuing long term decrease in sulphate concentrations which began when operations ceased. Zinc concentrations appeared to increase in the late 1990s reaching concentrations approaching 0.3 mg/L following a trend opposite to sulphate. Zinc concentrations decreased from 1998 to 2001. In 2003 and 2004, zinc concentrations increased from 0.07 mg/L to 0.18 mg/L (Figure 4).

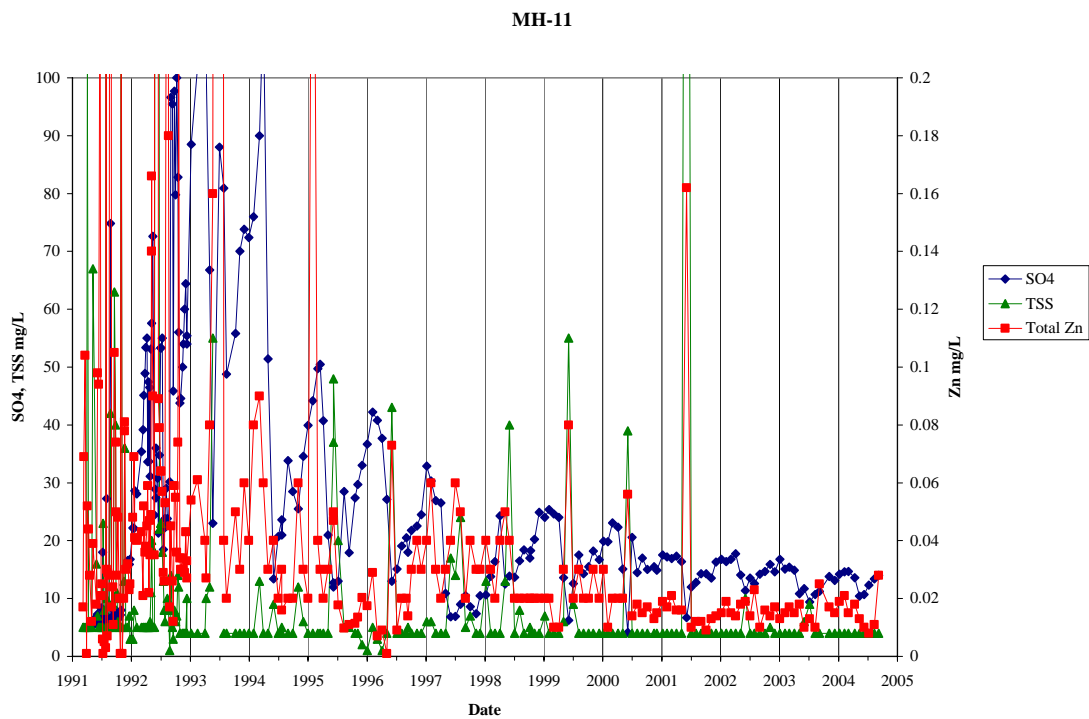
**Figure 5. Monitoring Results for MH-11**

MH-11 is roughly 3 km downstream of the South Dam. This site has shown a steady decrease in sulphate concentrations matching the decrease at MH-07 (Figure 5). Zinc has shown the same general trend though with a slight upward trend since 2001. The zinc concentration in September 2004 was 0.028 mg/L.

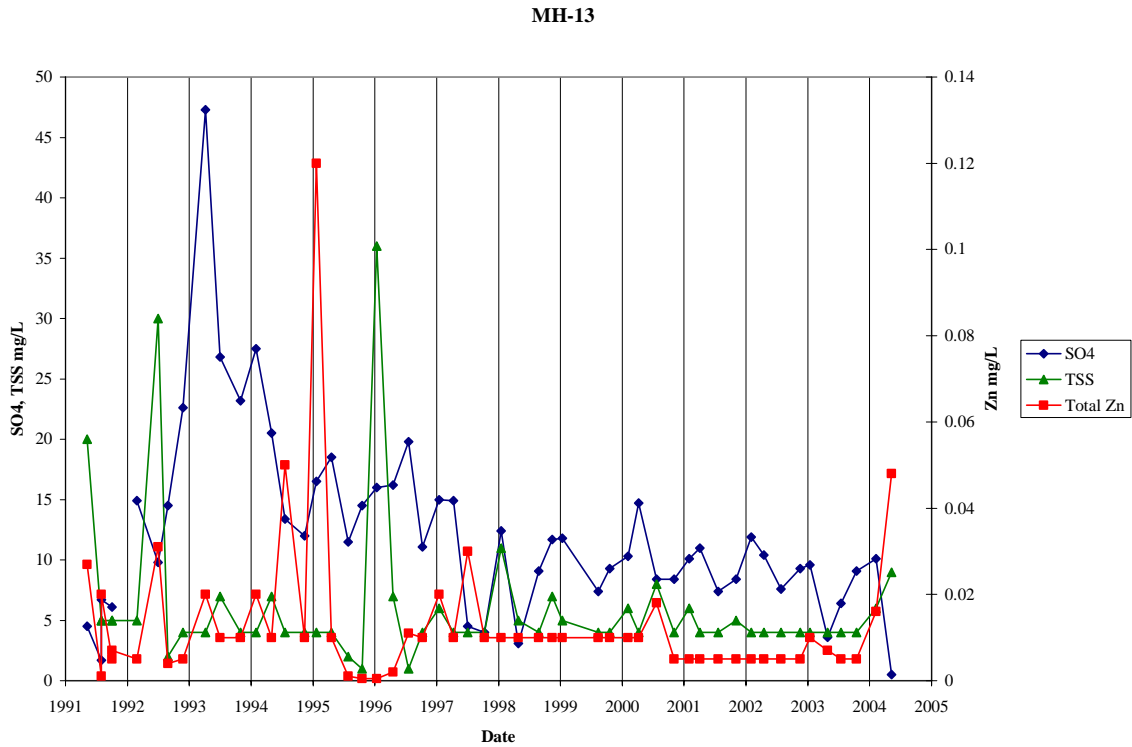
**Figure 6. Monitoring Results for MH-13.**

MH-13 is several kilometres downstream from MH-11 in False Canyon Creek. This site has also shown a steady decrease in sulphate concentrations. Zinc concentrations have remained low (Figure 6). The last two results in 2004 showed a slight increase to 0.048 mg/L, but this appears to be related to a corresponding increase in TSS to 9 mg/L.

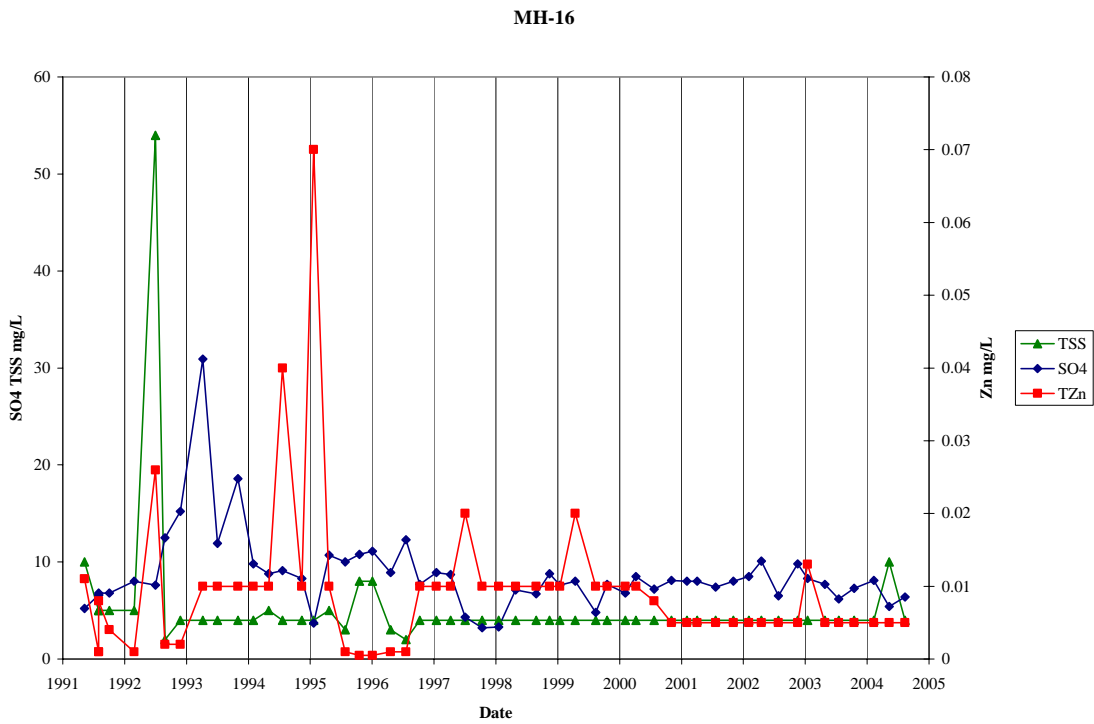
**Figure 9. Monitoring Results for False Canyon Creek Below Tributary E.**

MH-16 is in False Canyon Creek downstream of the confluence with Tributary E. Like MH-11 and MH-13, sulphate concentrations initially decreased but have remained stable since 1998 (Figure 9). Likewise, zinc concentrations have remained very low since 2001.
