WorkCentre 7220/7225 Service Documentation

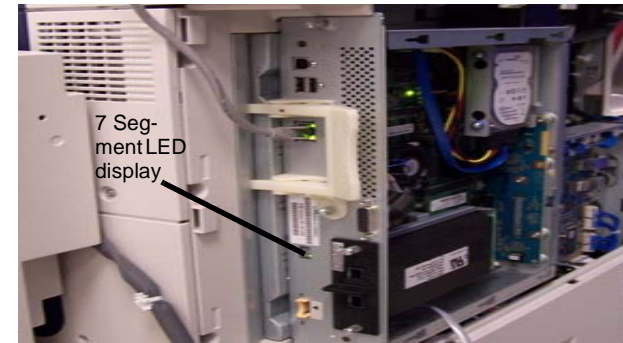
Figure 1 SBC 7-segment LED Location

1. Locate the SBC 7-segment display, [Figure 1](#), then cycle system power.

2. Observe activity on the 7-segment display. If a failure occurs during POST, one of the codes listed in [Table 1](#) remains to indicate the error. Follow the indicated service action.

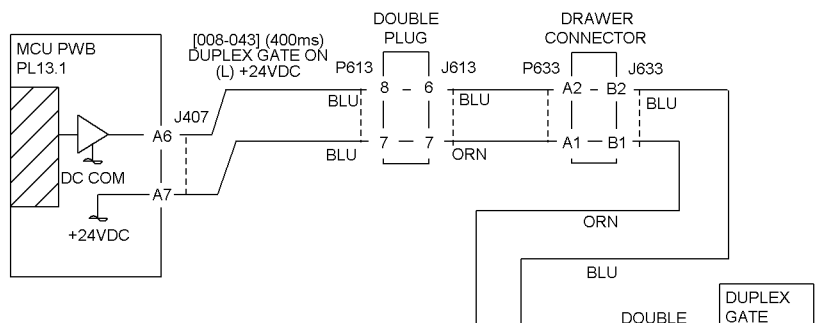
Figure 1 Typical Solenoid/Clutch Circuit Diagram

There is a short circuit on the switched leg (J407 pin A6 in the example) from the solenoid or clutch. Check the wire for a short circuit to GND. If the wire is OK, replace the solenoid. If the problem persists, replace the controlling PWB.

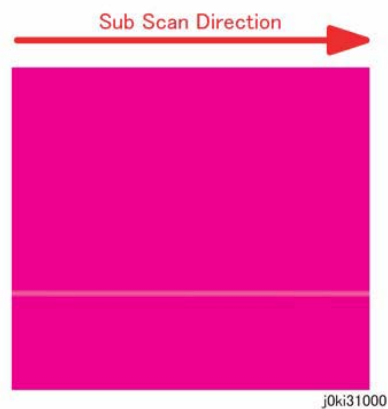
Figure 1 White Streaks

IQ 1 White Streaks/White Band (Dirt, Scratches) in SS Direction

approx. 1mm wide

This is caused by dirt or scratches.

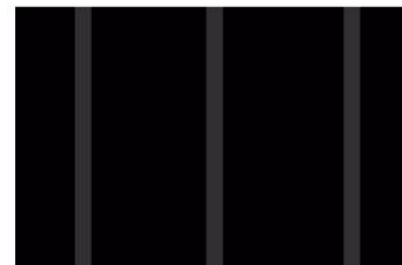
Figure 1 Charging Roll Pitch White Streaks

If BCR is deformed at the BCR-to-Photoreceptor NIP area, the trace may appear as thin white streaks in the FS direction on the highlight area at intervals of Charging Roll Pitch.

This problem may occur with a New Drum Cartridge that has been stored for a long period, or in a machine that has had a long rest in a high-temperature environment. (Halftone Image)

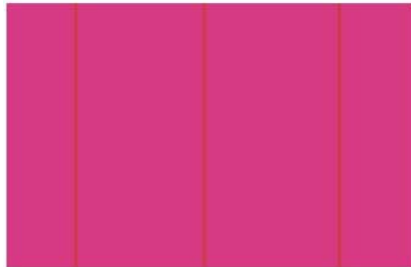
Figure 1 Photoreceptor Pitch Color Streaks

Vibrations during transportation of the Drum Cartridge cause the BCR or the Blade to rub against the photoreceptor, thereby causing electrostatic memory to be left on the photoreceptor. This may cause thin color streaks to appear in the FS direction on the highlight area at intervals of Photoreceptor Pitch (94mm).

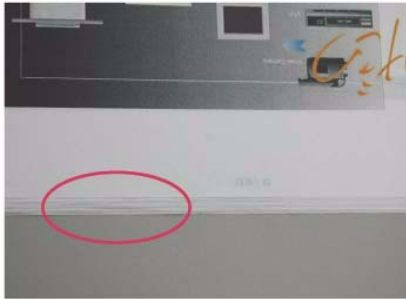
Figure 1 Toner Contamination at Lead/Trail Edge

Lead Edge: The lead edge of paper contacts the belt when it is transported from REGI to Transfer.

Trail Edge: When paper that looped between Transfer and Fusing is released from the 2nd-transfer nip, its trail edge moves in the reverse direction to the feed direction thereby contacting the surface of the 2nd BTR, or jumps up thereby contacting the Transfer Belt, thus causing toner contamination.

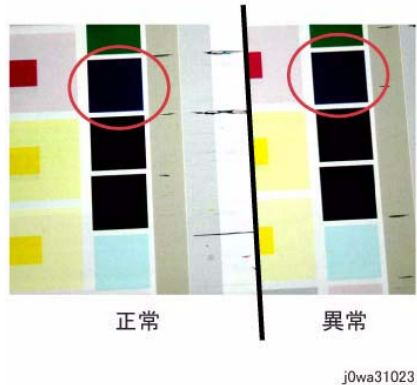
Figure 1 Micro White Spots

When the resistance of the 2nd-transfer area is high, e.g., at the 1st operation of the day in a low-humidity environment, the transfer latitude between the multicolor area and the one-color area is narrow and the set voltage is in favor of multicolor transfer. Therefore, the voltage is a little excessive for one-color transfer, causing the transfer-nip discharge phenomenon.

This occurs on Side 2 in a low-humidity environment.

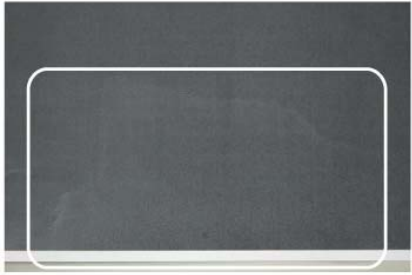
Figure 1 Wetting

Distorted image (resembles a water stain) may appear at one side or both sides of the paper trail edge when printing halftone fill.

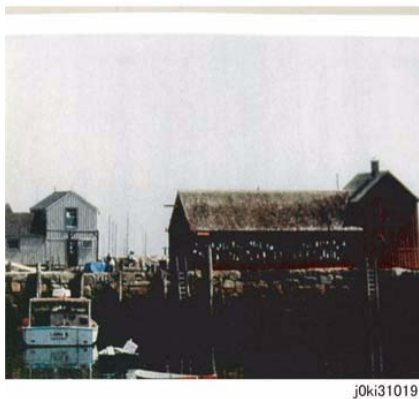
Figure 1 Background

The default background suppression function is unable to fully remove the background.

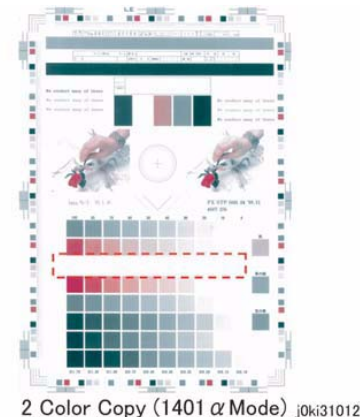
Figure 1 CVT Streaks

Dirt such as paper dust is generated at the DADF scan position. The streaks in the SS direction are created when that contamination is scanned.

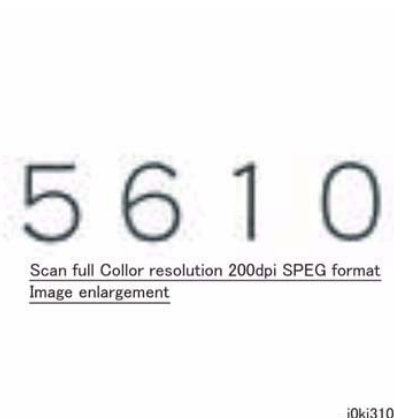
Figure 1 Mosquito Noise

Color texts are blurred and mosquito noise is generated around the texts due to JPEG compression.

As the JPEG compression technique is for images, not texts, noise is easy to crop up when it is used to compress texts.

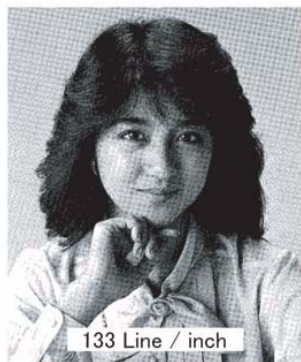
Figure 1 Moire

When a document with tint on the whole paper or a background image is scanned using Fax Text mode in High Quality (Fine), the file size or the Fax transmission time may increase drastically.

Fax fine 133 line half tone Screen Image
j0ki31015

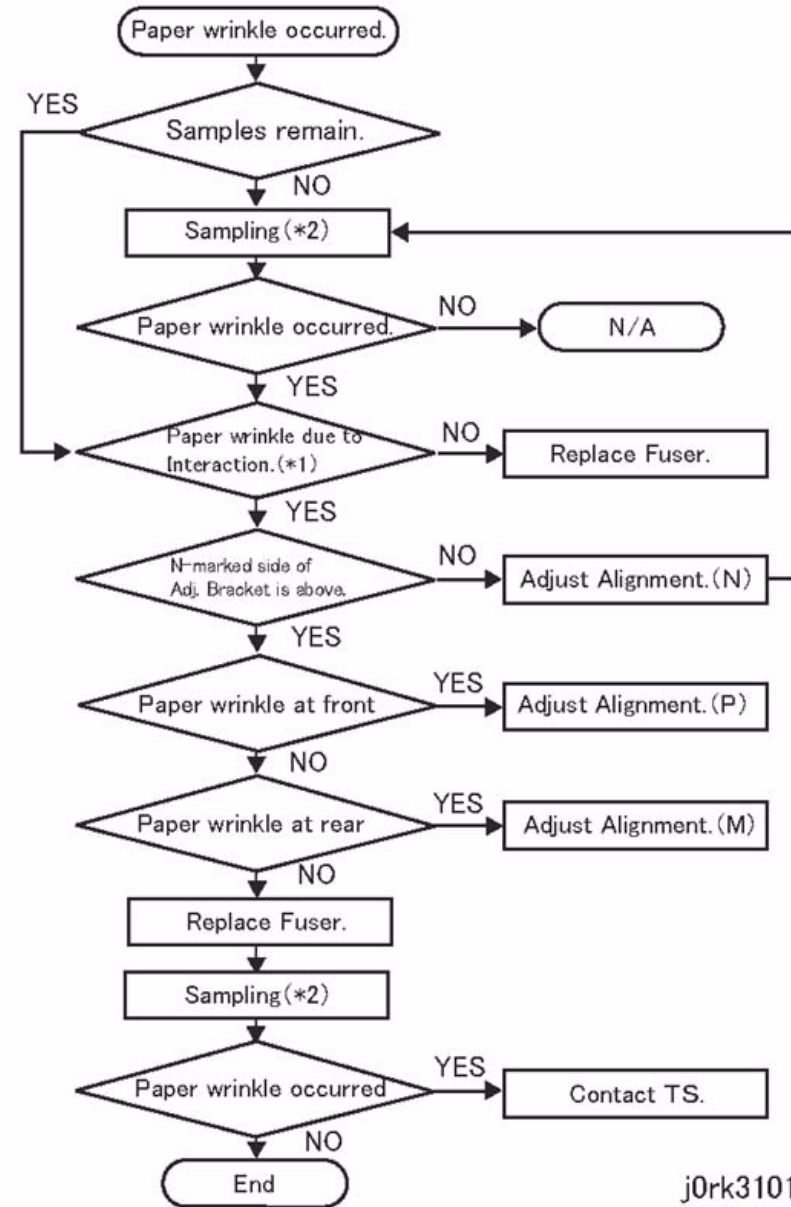
Figure 7 Wrinkle Flowchart

- Paper wrinkles due to the interaction between Fuser and Transfer and Regi.
- Cause: The positional relation of a roll at each sublevel with the Fuser is inappropriate, causing paper to skew. As a result, paper wrinkles at the Fuser.

- Paper: A3SEF
- Pattern: Half Tone K50%
- Paper Qty.: Simp 5 sheets

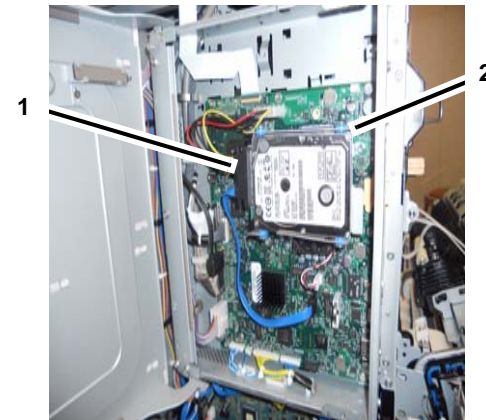
Figure 1 HDD Removal Preparation

1. Switch off the power and disconnect the power cord.
2. Remove the following parts:
 - Right Cover
 - Rear Lower Cover ([REP 14.4](#))
3. Open the SBC Chassis Cover.
4. Remove the HDD Assembly. ([Figure 1](#))
 - (1) Disconnect the connector.
 - (2) Remove the screws (x4) and remove the HDD and bracket.

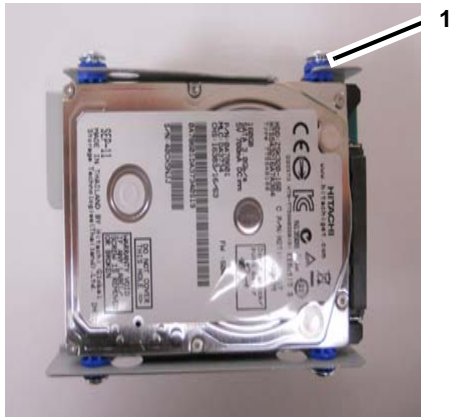
Figure 2 HDD Removal

5. Remove the HDD from the bracket ([Figure 2](#)).
 - (1) Remove the screws (x4) and remove the HDD from the bracket.

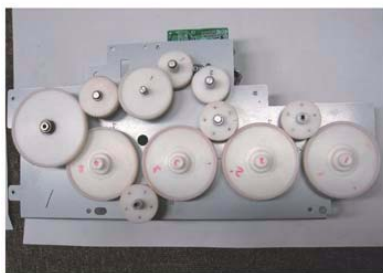
Figure 2 Gears

4. Remove the gears. (Figure 2)

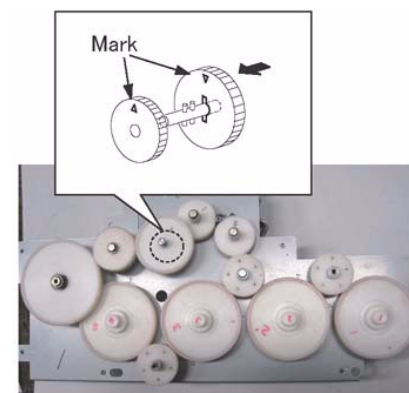
Figure 4 Triangular Marks Alignment

NOTE: When installing the gears (x2) shown in the figure, install them by aligning the triangular marks on the gears. (Figure 4)

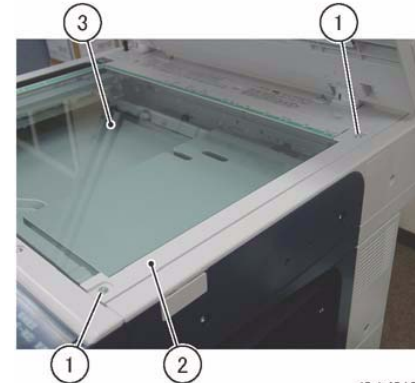
Figure 1 Platen Glass Removal

- Switch off the power and disconnect the power cord.
- Open the Platen Cover or DADF.
- Remove the Platen Glass. (Figure 1)
 - Remove the screws (x2).
 - Remove the Right Side Plate.
 - Remove the Platen Glass.

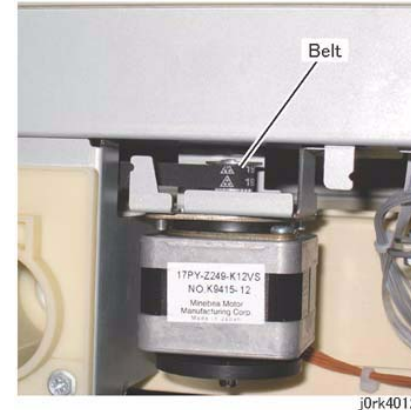
Figure 2 Belt Installation

1. To install, carry out the removal steps in reverse order.
2. Install the Belt to the Pulley of the Carriage Motor. (Figure 2)

3. Take note of the following points when installing the Carriage Motor.
 - (1) Attach the spring.
 - (2) Loosely affix the Carriage Motor that comes attached with a belt.
 - (3) Move the carriage to fit the belt.
 - (4) Secure the Carriage Motor to the Main Unit.
4. After installing the Carriage Motor, move the Full Rate Carriage back and forth and check that it is moving smoothly.

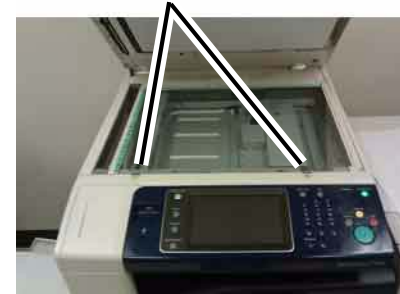
Figure 1 Control Panel Screws

1. Switch off the power and disconnect the power cord.
2. Open the Platen Cover or DADF.
3. Remove the screws that secure the Control Panel. ([Figure 1](#))
(1) Remove the screws (x2).

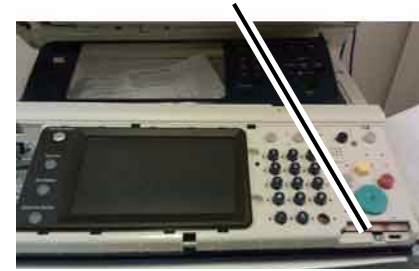
Figure 5 UI Lower Cover Removal

8. Turn the Control Panel so that the screen is face up.
9. Remove the self-tapping screw that secures the UI Lower Cover. (Figure 5)

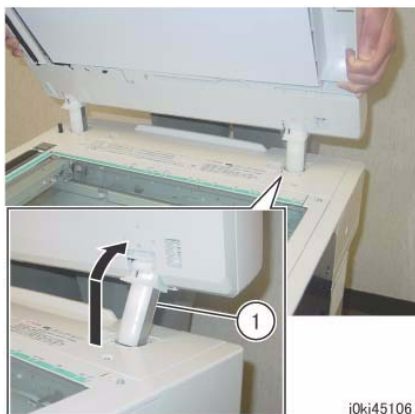
Figure 2 Tilt Counter Balance

3. Remove the DADF. (Figure 2)
 - (1) Tilt the Counter Balance in the direction of the arrow and remove it from the installation holes.

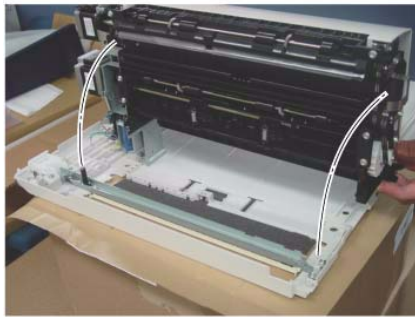
j0ki45115

1. To install, carry out the removal steps in reverse order.
2. Align the positioning pin of the Base Frame and the hole of the DADF Feeder Assembly. (Figure 3)

Figure 3 Align the Positioning Pin

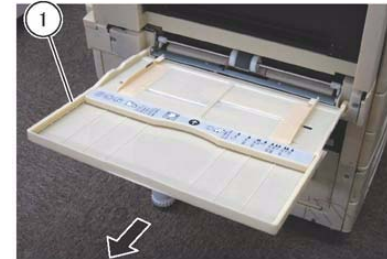
Figure 1 Extension Tray Removal

1. Switch off the power and disconnect the power cord.
2. Gently extend the Extension Tray and pull it out. (Figure 1)
 - (1) Remove the Extension Tray.

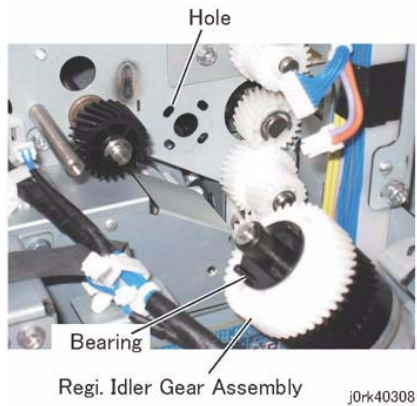
Figure 2 Reg Idler Gear Assy Alignment

NOTE: As it is difficult to align the tabs (x4) of the bearing at the rear of the Registration Idler Gear Assembly to the holes of the Frame, perform the following:

1. Remove the Main Drive Assembly. ([REP 4.2](#))
2. Align the tabs (x4) of the bearing of the Registration Idler Gear Assembly to the holes of the Frame and temporarily affix the Registration Idler Gear Assembly. ([Figure 2](#))

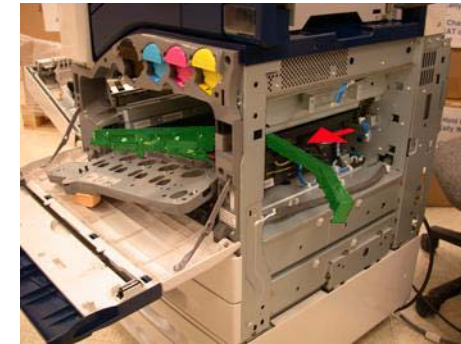
Figure 4 Repositioning the High Voltage Conductor Housing Assy

5. Shift the High Voltage Conductor Housing Assembly (Figure 3 and Figure 4).
 - (1) Remove the screw (1).
 - (2) Rotate the High Voltage Conductor Housing Assembly and move to the front. .

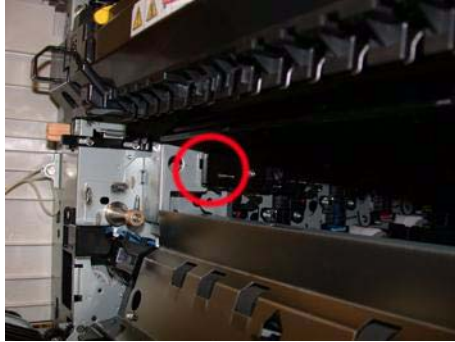
NOTE: When installing the High Voltage Conductor Housing Assembly, make sure that the tab at the left is inserted properly into the hole of the Frame (Figure 6).

Figure 6 High Voltage Conductor Housing Assembly Tab

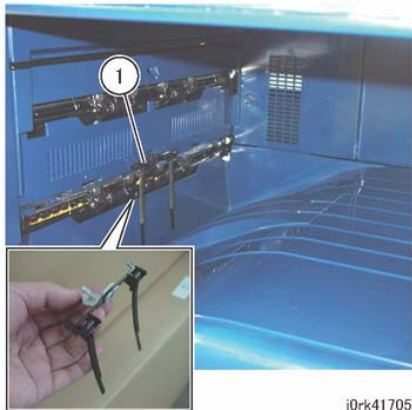
Figure 1 Paper Weight Removal

1. Switch off the power and disconnect the power cord.
2. Open the L/H Cover Unit.
3. Remove the following parts:
 - Front Left Cover (PL 19.2)
 - Left Upper Cover (PL 19.2)
 - Left Rear Upper Cover (PL 19.2)
4. Remove the Paper Weight. (Figure 1)
 - (1) Release the hook and remove the Paper Weight.

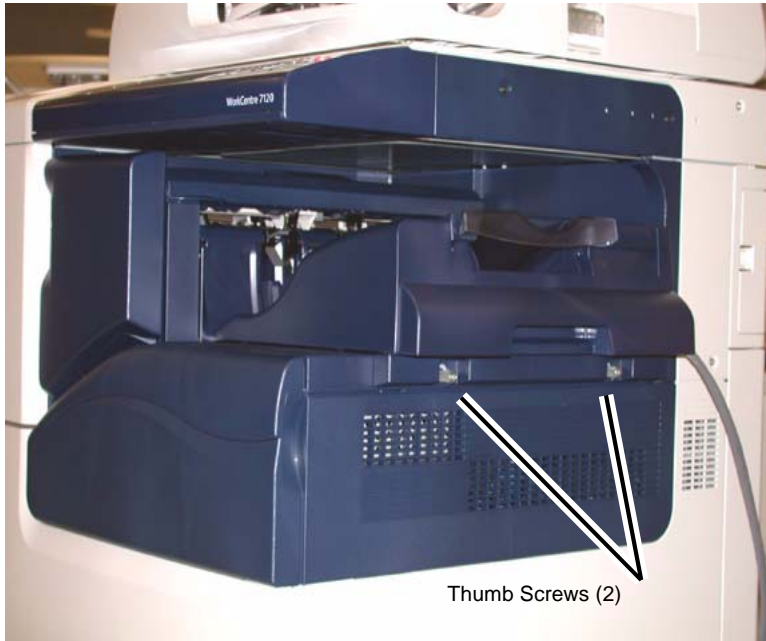
Figure 3 Loosen the Thumb Screws

3. Loosen the Thumb Screws (2) ([Figure 3](#)):

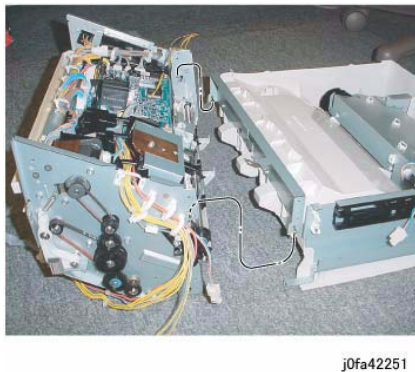
1. Reverse the removal procedure for replacement.
2. Install the Stacker Tray Assembly and Integrated Office Finisher as shown in [Figure 5](#).

Figure 5 Installing the Stacker Tray Assembly

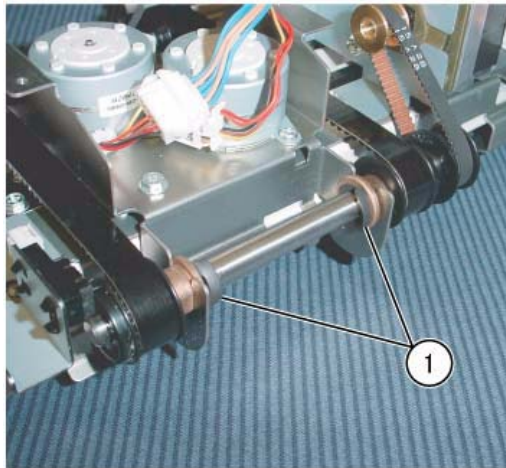
Figure 2 Removing the KL-Clips

5. Remove the KL-Clips from the Eject Shaft ([Figure 2](#)):
 - (1)Remove KL-Clips (2).

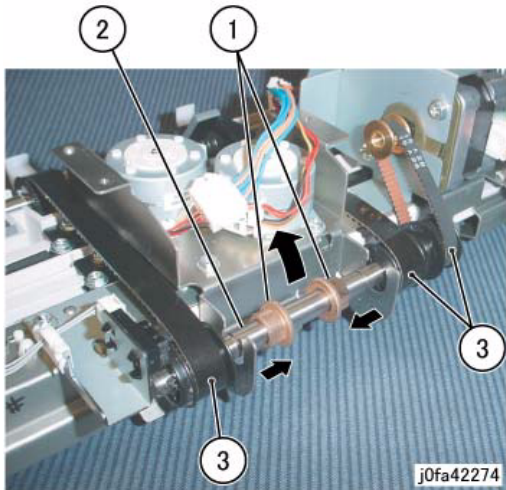
Figure 3 Removing the Eject Shaft

6. Remove the Eject Shaft from the Front/Rear Tamper Motor Assembly (Figure 3):
 - (1) Move Bearings (2) in the direction of the arrow.
 - (2) Remove Eject Shaft in the direction of the arrow.
 - (3) Remove Belt from Pulley.

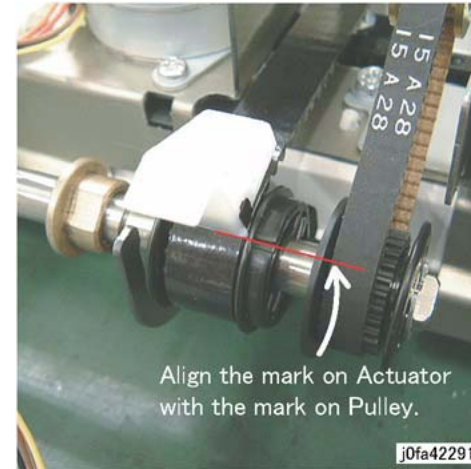
Figure 6 Align Eject Belt

1. Reverse the removal procedure for replacement.
2. Install and align the Eject Belt with marks on the Pulleys (Figure 5) (Figure 6):

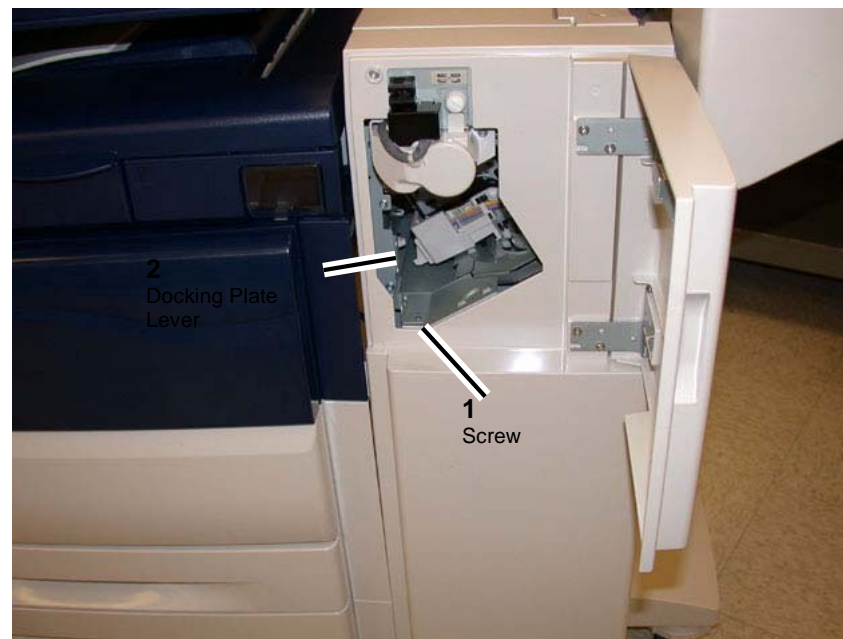
Figure 2 Finisher Lever

4. Open the Front Door of the Finisher.
5. Release the Screw that secures the Docking Plate and detach the Finisher.
 - (1) Remove the Screw.
 - (2) Pull the Docking Plate Lever towards you and detach the Finisher.(Figure 2)

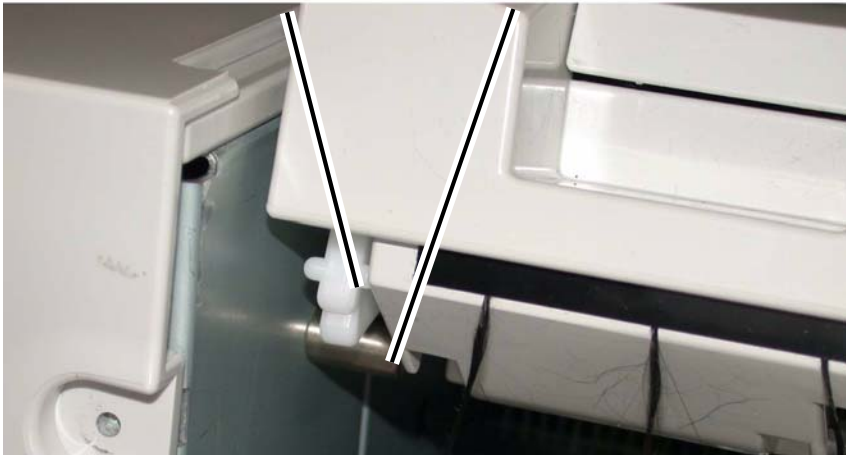
Figure 5 Positioning the Latch Hook and Latch Pin

4. Make sure the Latch Hook and Latch Pin are positioned as shown (Figure 5).

Latch Hook Latch Pin

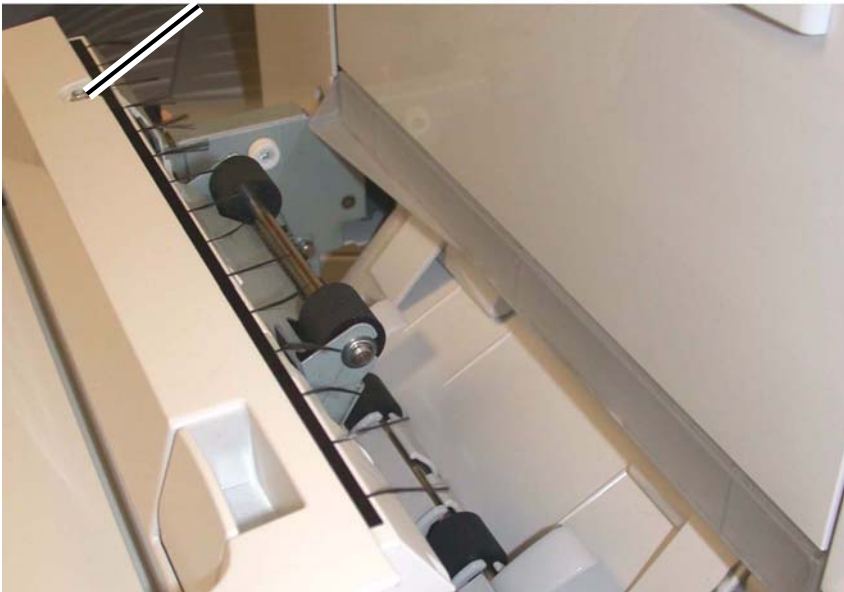
Figure 6 Installing the Retaining Screw

5. Install the Retaining Screw (1) (Figure 6).

Retaining Screw

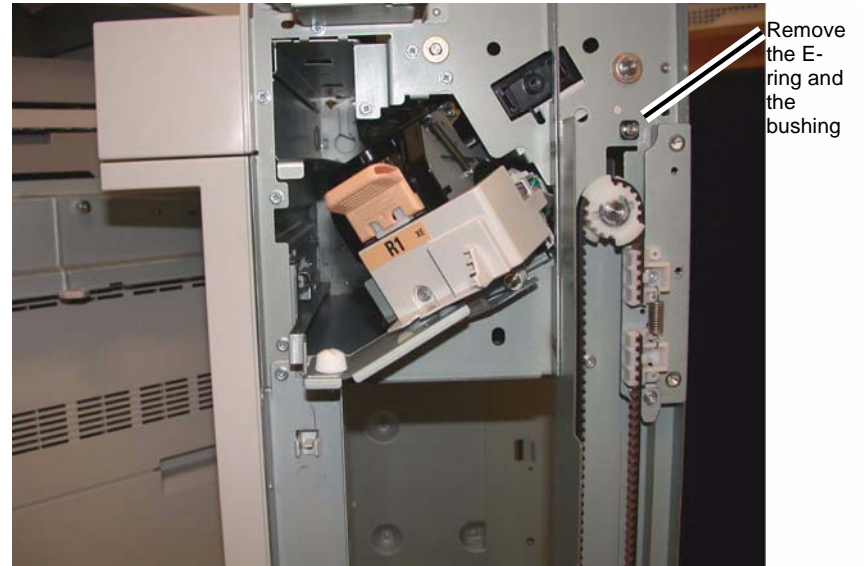
Figure 5 Removing the front E-ring from the Set Clamp Shaft

14. Remove the front E-ring and the bushing from the Set Clamp Shaft Assembly (Figure 5).

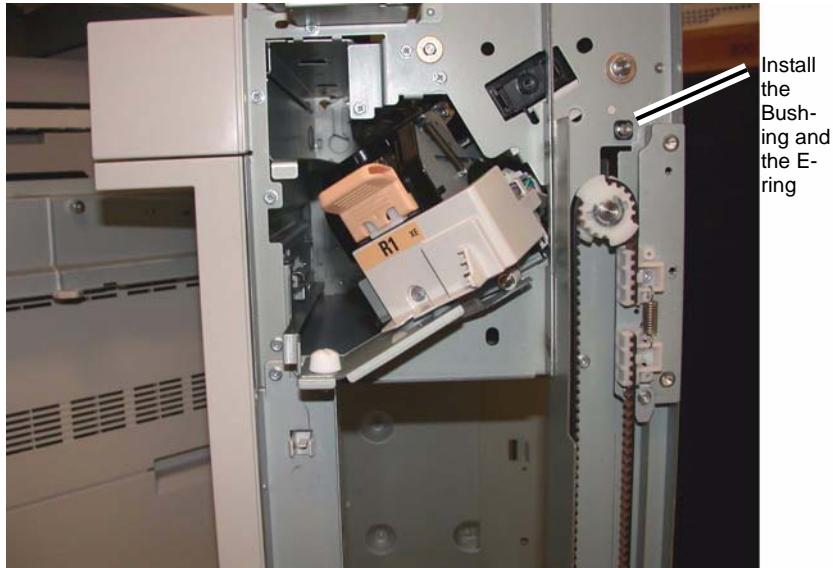
10. Install the Bushing onto the front end of the Set Clamp Shaft and install the E-ring (Figure 16).

Figure 16 Installing the Bushing and E-ring

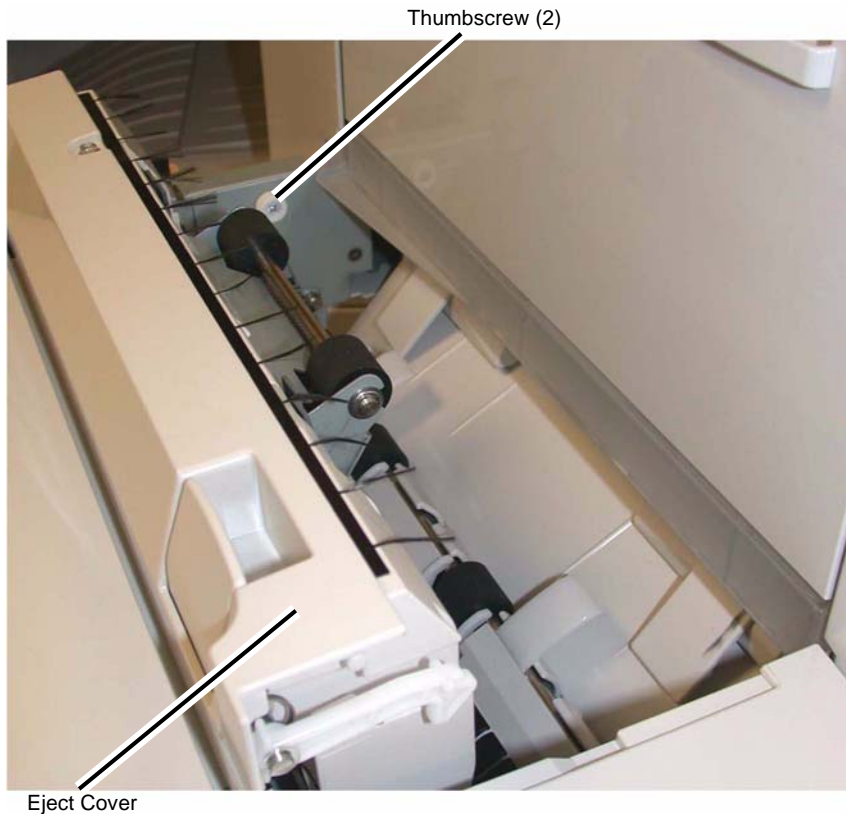
1. Switch off the power and disconnect the power cord.
2. Unlatch the Eject Cover, and move it all the way to the left ([Figure 1](#)).
3. Remove the Thumbscrews (2) ([Figure 1](#)).

Figure 1 Eject Cover and Thumbscrew

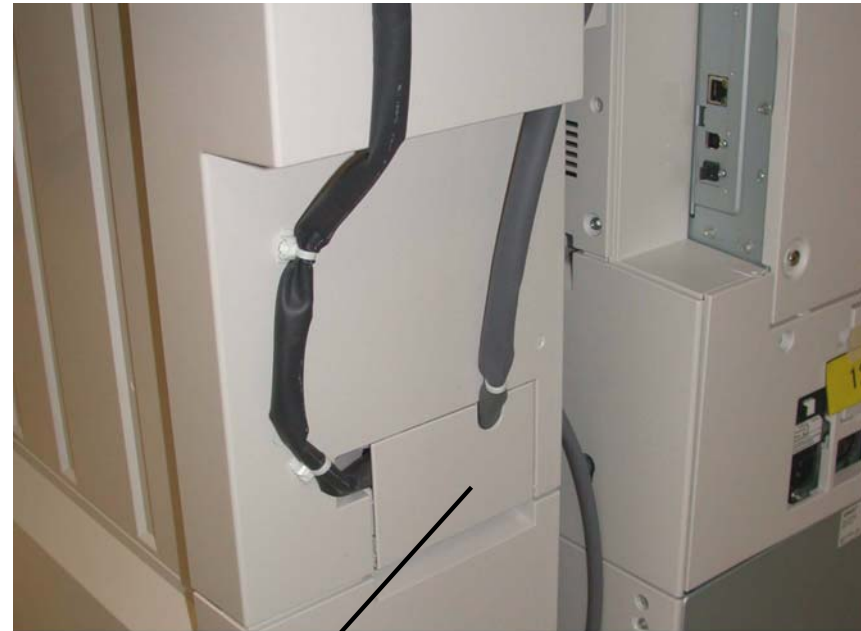
4. Disconnect the Booklet Maker Assembly from the Finisher.
 - (1) Remove the Connector Cover ([Figure 2](#)).

Figure 2 Connector Cover

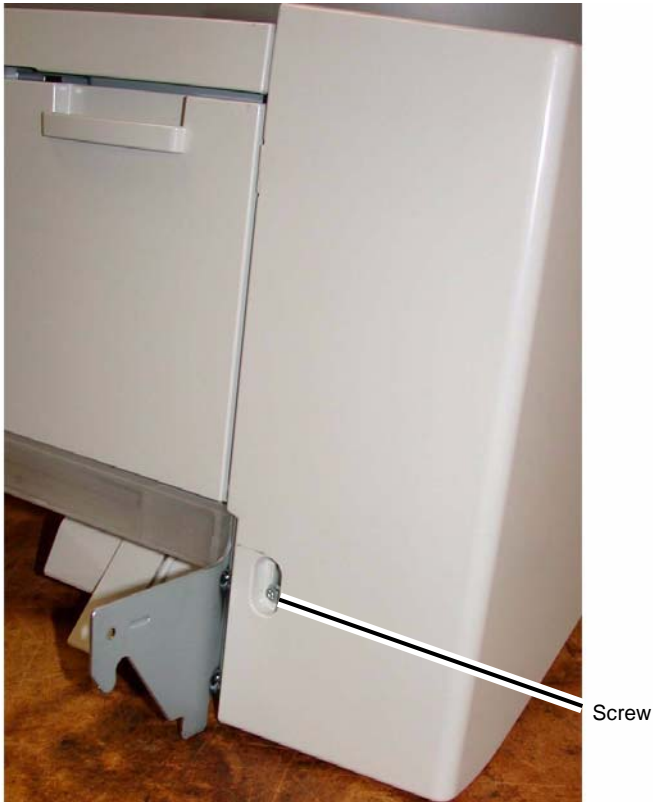
1. Switch off the power and disconnect the power cord.
2. Remove the Booklet Maker Assembly from the Finisher ([REP 13.31](#)).
3. Remove the Booklet Front Cover.
 - (1) Remove the Screw (1) ([Figure 1](#)).

Figure 1 Removing the Booklet Front Cover

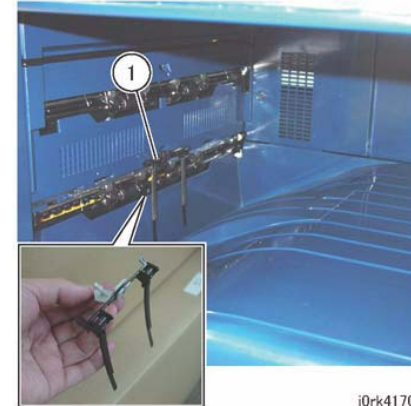
j0rk41705

5. Remove the Paper Weight. (Figure 3)
(1) Release the hook and remove the Paper Weight.

Figure 3 Paper Weight

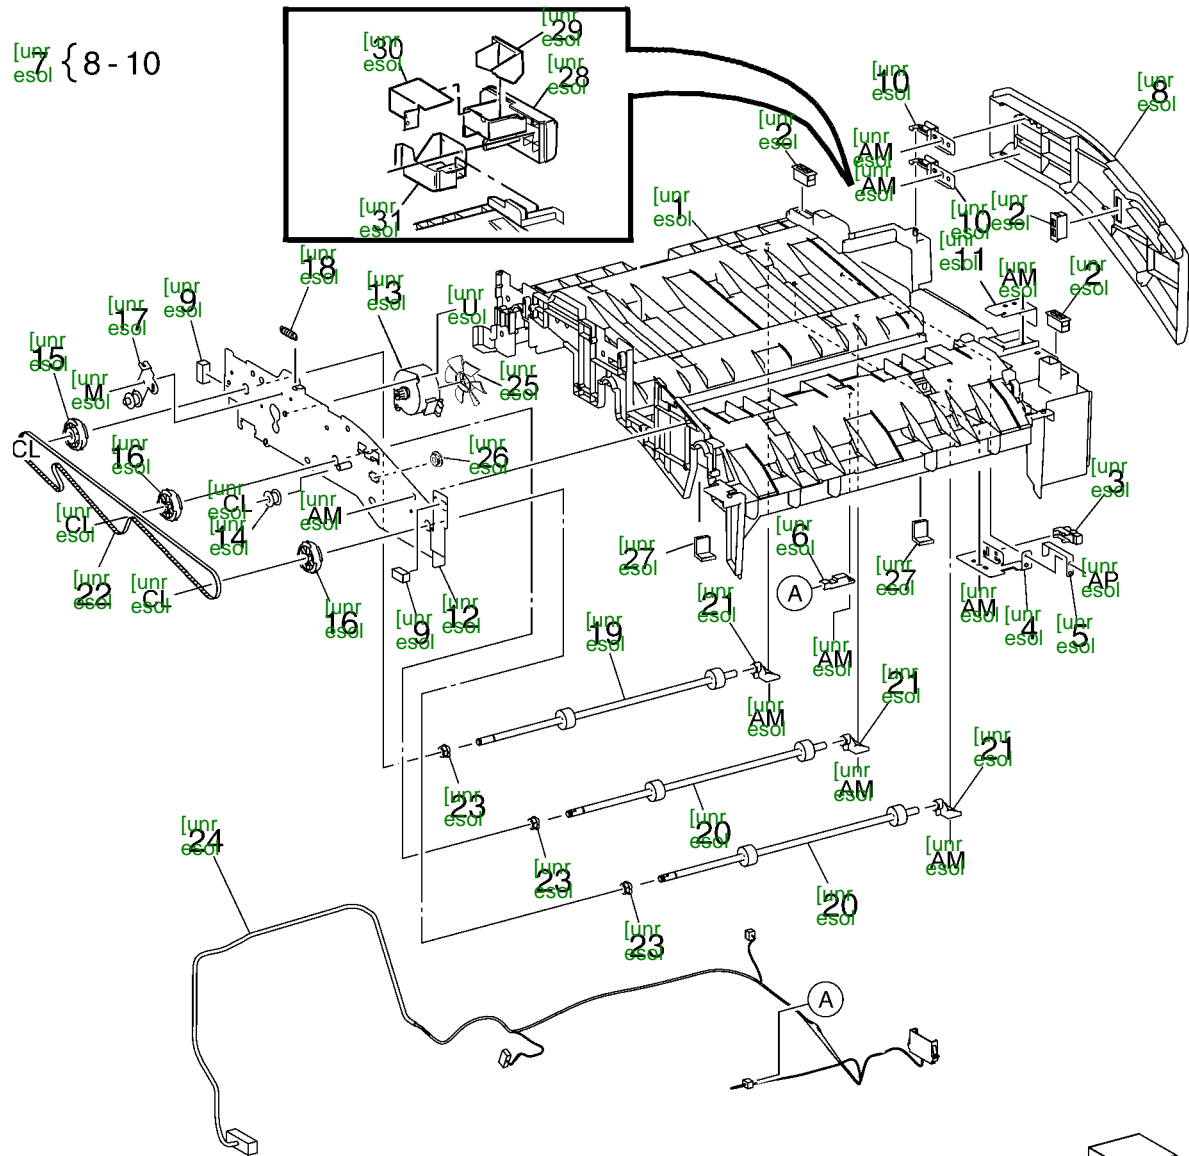
PL 23.4 H - Transport Assembly (4 of 5) (Office Finisher LX)

Item	Part	Description
1	-	Lower Chute (P/O PL 23.2 Item 6)
2	-	Magnet (P/O PL 23.1 Item 1)
4	-	Sensor Bracket (P/O PL 23.1 Item 1)
10	-	Hinge (P/O PL 23.4 Item 7)
11	-	Bracket (P/O PL 23.2 Item 6)
12	-	Rear Frame Assembly (P/O PL 23.2 Item 6)
13	-	H - Transport Motor (P/O PL 23.1 Item 1) (REP 13.4)
17	-	Tension Bracket (P/O PL 23.2 Item 6)
30	-	Cover (Not Spared)
31	-	Bracket (Not Spared)

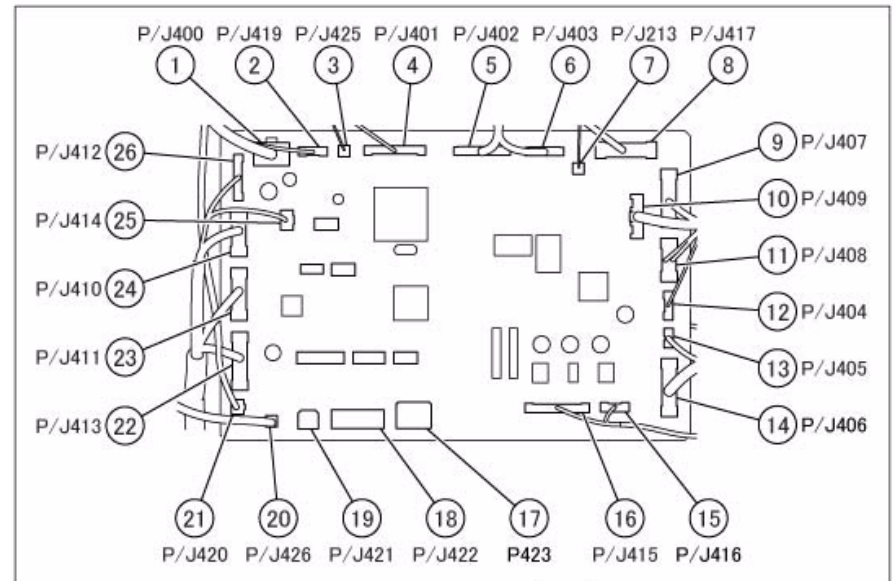
Figure 13 MCU PWB

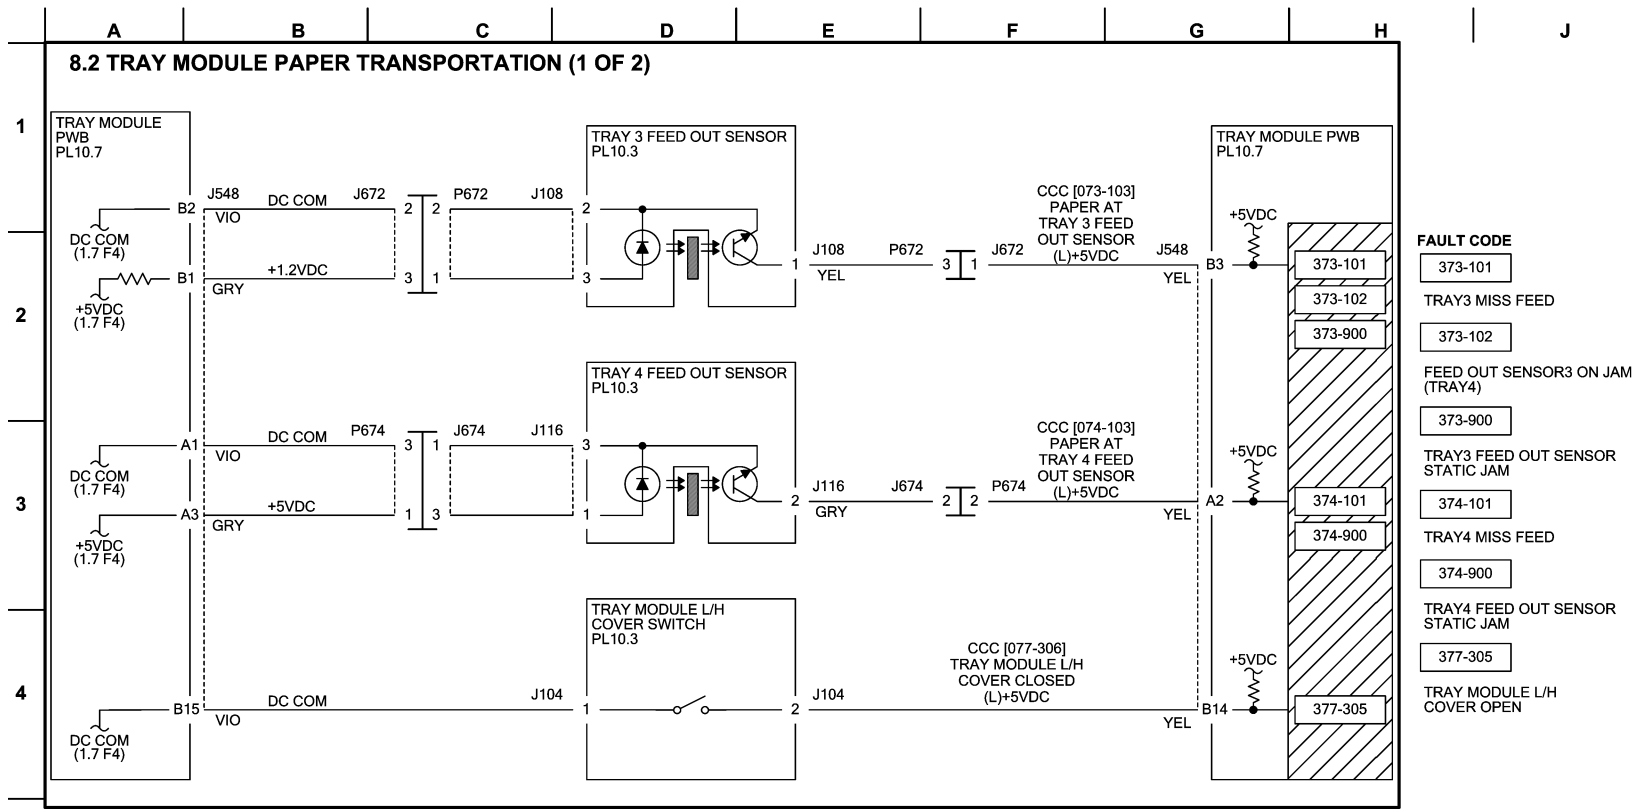
Figure 2 BSD 8.2 - Tray Module Paper Transportation (1 of 2)

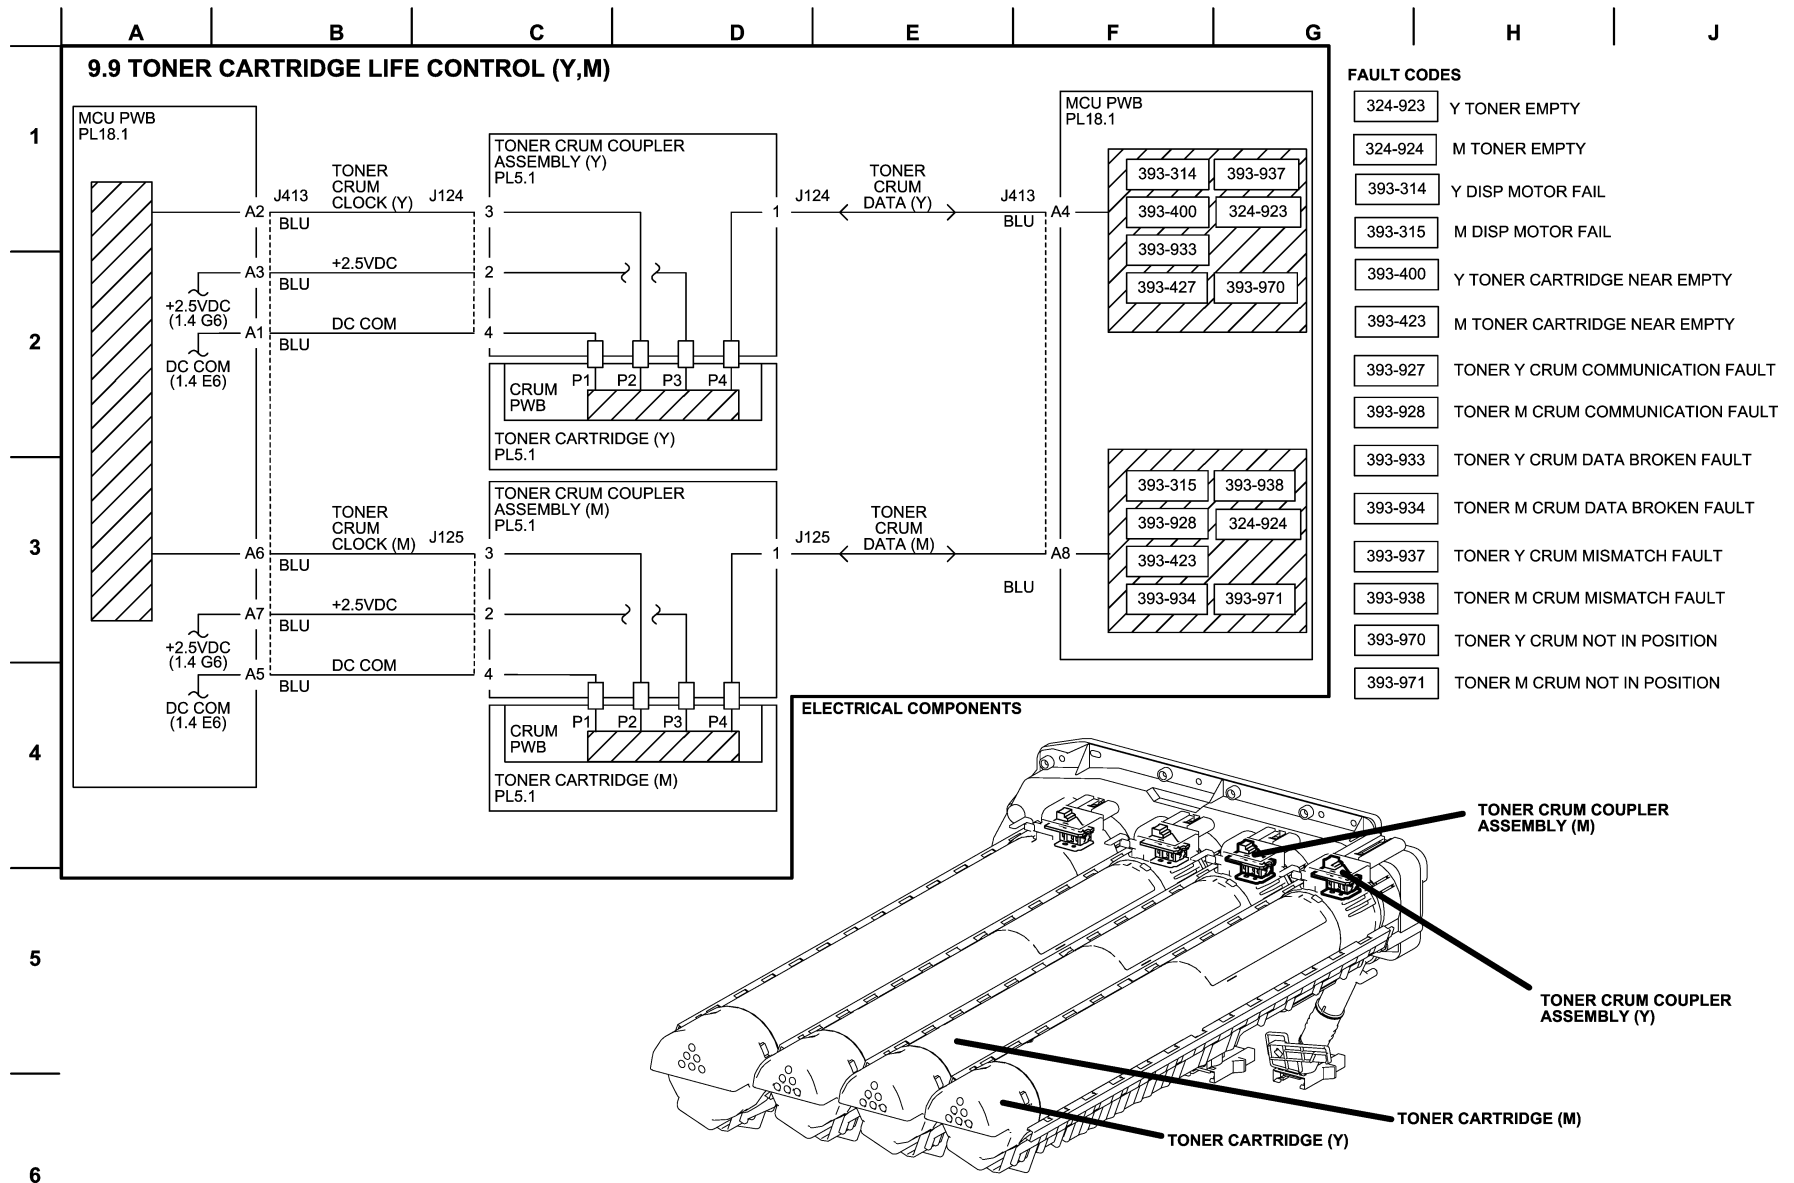
Figure 9 BSD 9.9 - Toner Cartridge Life Control (Y, M)

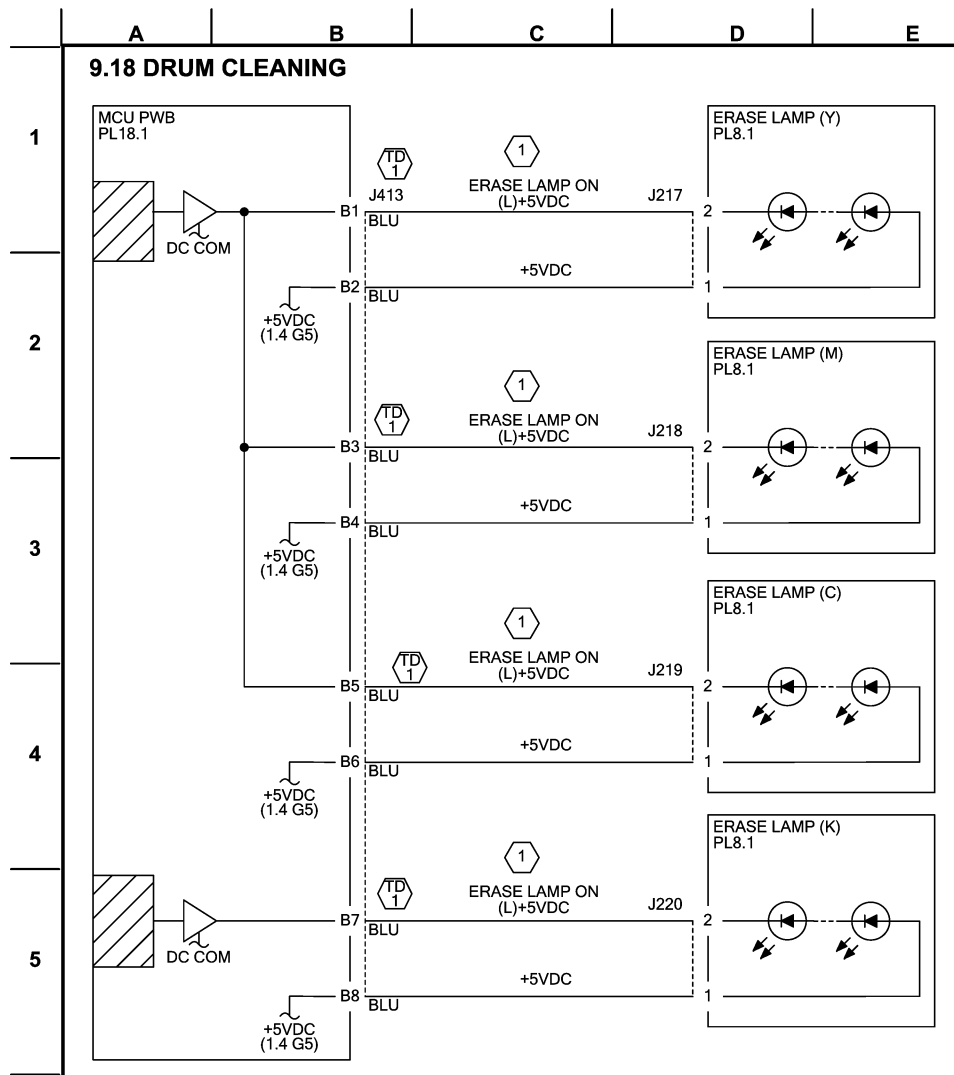
Figure 18 BSD 9.18 - Drum Cleaning

TEST POINT
 TD 1
 MCU PWB J413-B1 (+) TO GND (-)
 MCU PWB J413-B3 (+) TO GND (-)
 MCU PWB J413-B5 (+) TO GND (-)
 MCU PWB J413-B7 (+) TO GND (-)
 LED ON: APPROX. 0VDC
 LED OFF: APPROX. +3.5VDC

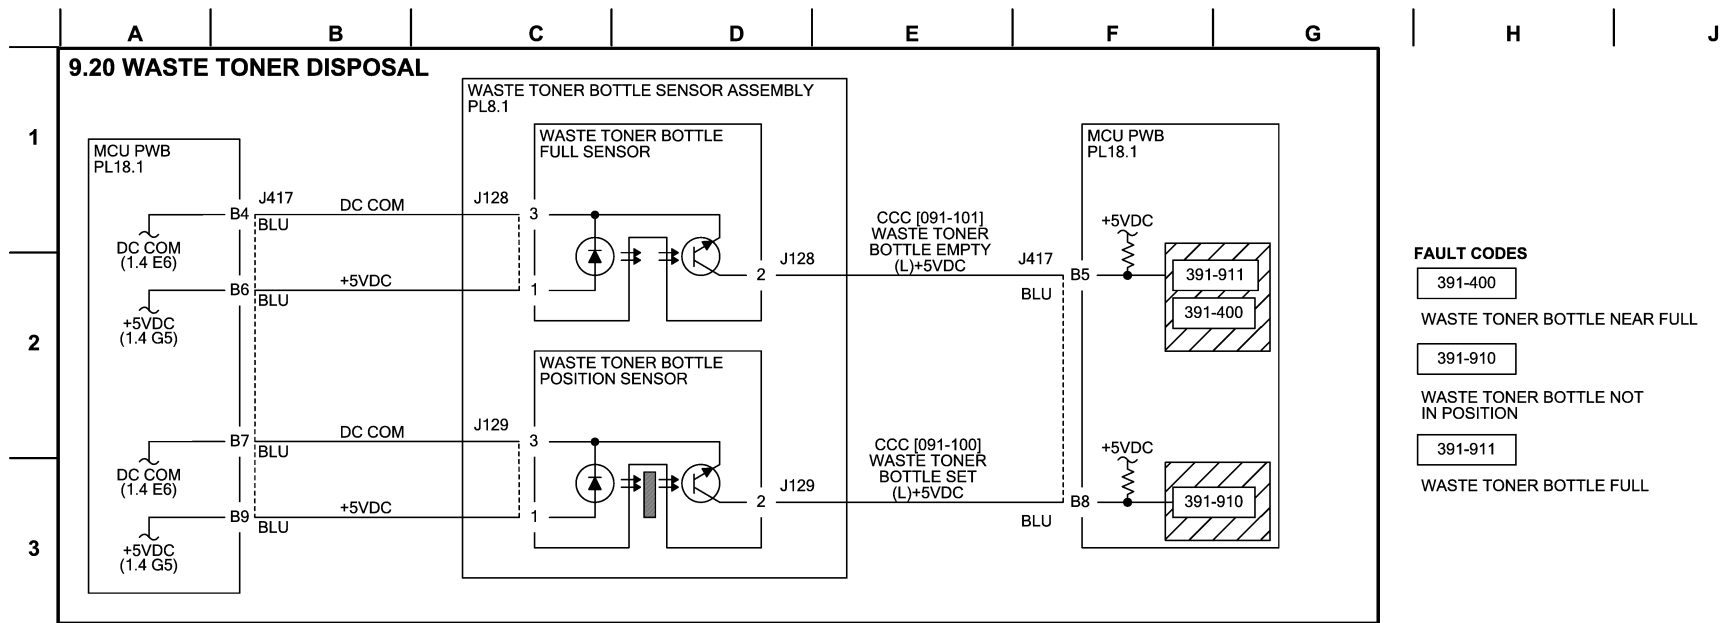
Figure 20 BSD 9.20 - Waste Toner Disposal

- FAULT CODES**
- 391-400
WASTE TONER BOTTLE NEAR FULL
 - 391-910
WASTE TONER BOTTLE NOT IN POSITION
 - 391-911
WASTE TONER BOTTLE FULL

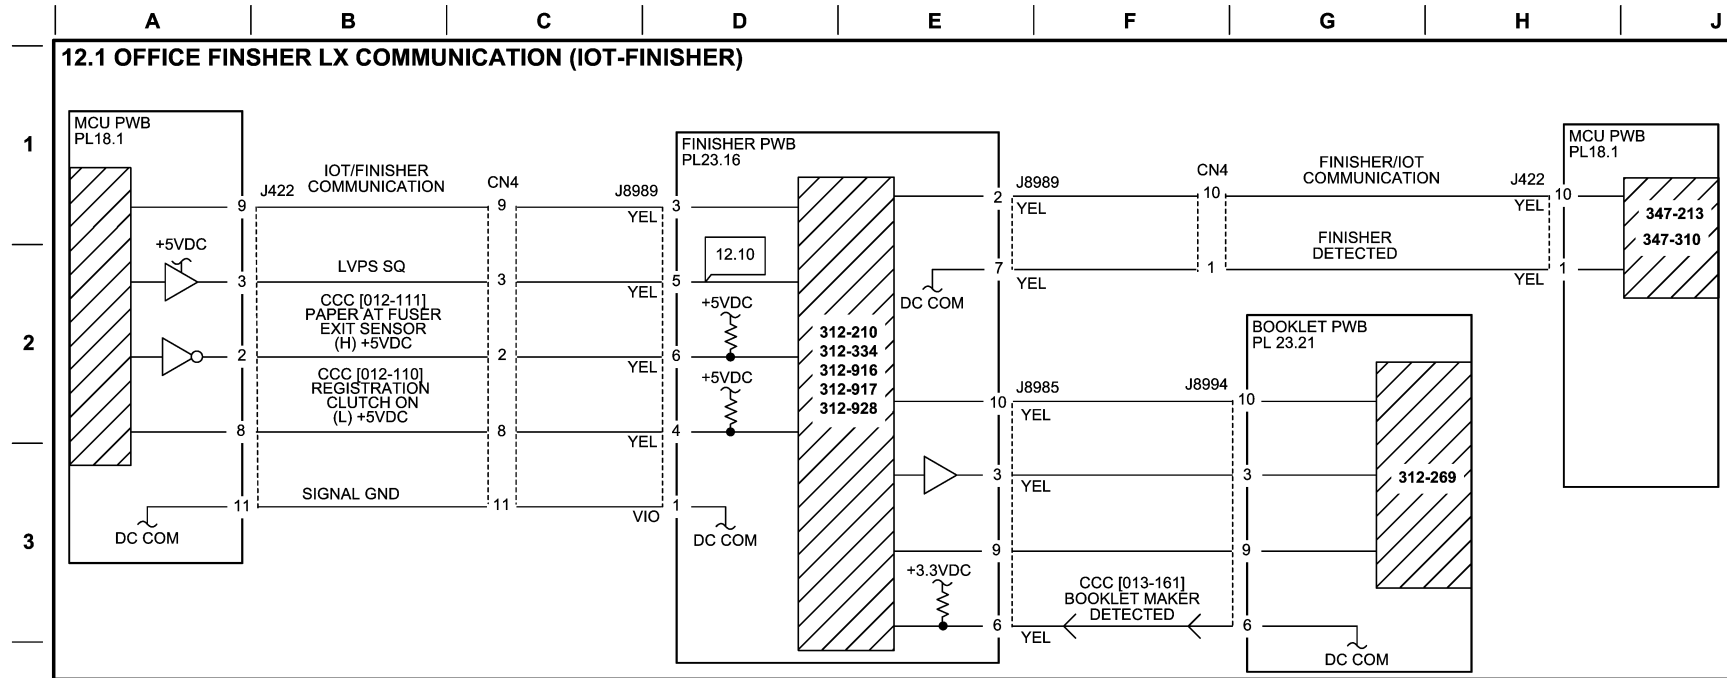
Figure 1 BSD 12.1 Office Finisher LX Communication (IOT-Finisher)

312-210 NVM ACCESS FAULT	312-917 STACKER TRAY STAPLE SET OVER COUNT
312-269 BOOKLET SUB-CPU COMMUNICATIONS FAILURE	312-928 SCRATCH SHEET COMPILE
312-334 DOWNLOAD FAILURE	347-213 FINISHER TYPE MISMATCH
312-916 STOCK MIXED SIZES DETECT	347-310 FINISHER COMMUNICATION FAULT
