Postfire Rehabilitation of the Hayman Fire

Peter Robichaud, Lee MacDonald, Jeff Freeouf, Dan Neary, Deborah Martin, Louise Ashmun

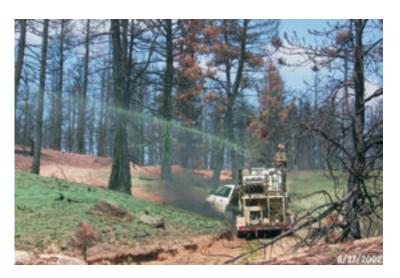
Figure 6—Ground-based application of hydromulch.

- *Ground-based hydromulching with seed* (fig. 6), for 1,500 acres (600 ha). Truck-mounted hydromulching was done from existing roads within high severity burn areas. Treatment occurred within 300 feet (90 m) either side of 25 miles (40 km) of road. Ground-cover amounts were 2000 lb per acre (2.24 Mg per ha). Seed mix and seed application rate were as described in table 8.

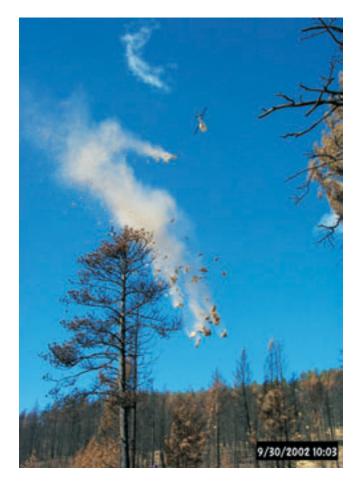
Figure 11-Aerial dry mulch being applied.

- *Aerial dry mulching with seed* (fig. 10, 11), for 7,700 acres (3,100 ha). Aerial dry mulching with

seed was applied to high severity fire areas above Cheesman dam that cannot be reached by existing roads. Focus was on ridge-tops and the upper one-third of the slopes. Application rate was 2,000 lb per acre (2.24 Mg per ha). Seed mix and seed application rate were as described in table 8. A total 4,000 acres of treatments originally intended for the more costly aerial hydromulching were changed to the dry mulching treatment. The cost savings provided for an additional 5,500 acres of dry mulch treatment on high severity burn areas. The contract was terminated for convenience to the government prior to the contract completion.

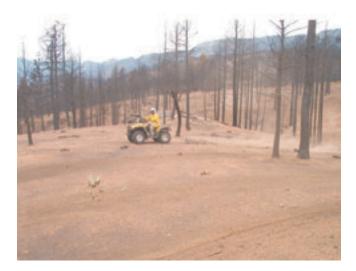
Figure 12—Mechanical scarification with an ATV pulling a chain harrow.

• Mechanical scarification by all terrain vehicles (ATV), with seed (fig. 12), for 9,200 acres (3,700 ha). Scarification and seeding occurred on selected high severity-burn areas on slopes less

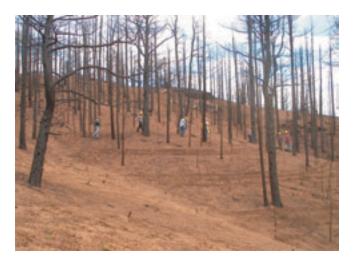
Figure 13—Volunteers using hand rakes and whirlybird seed spreaders to scarify and seed severely burned soils during the *Colorado Cares* event.

"Colorado Cares Day" scarification, seeding and mulching (fig. 13), for 125 acres (50 ha). On "Colorado Cares Day" (August 8, 2002) a variety of treatments were installed to utilize the services of 1,000 volunteers. These treatments included scari-

fication with McLeods, seeding with whirly-bird spreaders, and hand mulching.
