Appendix K – Marine Ecological Assessment

Message Ref: Marine Ecological Assessment – Moa Avenue Stormwater Upgrade

Project No: T18179

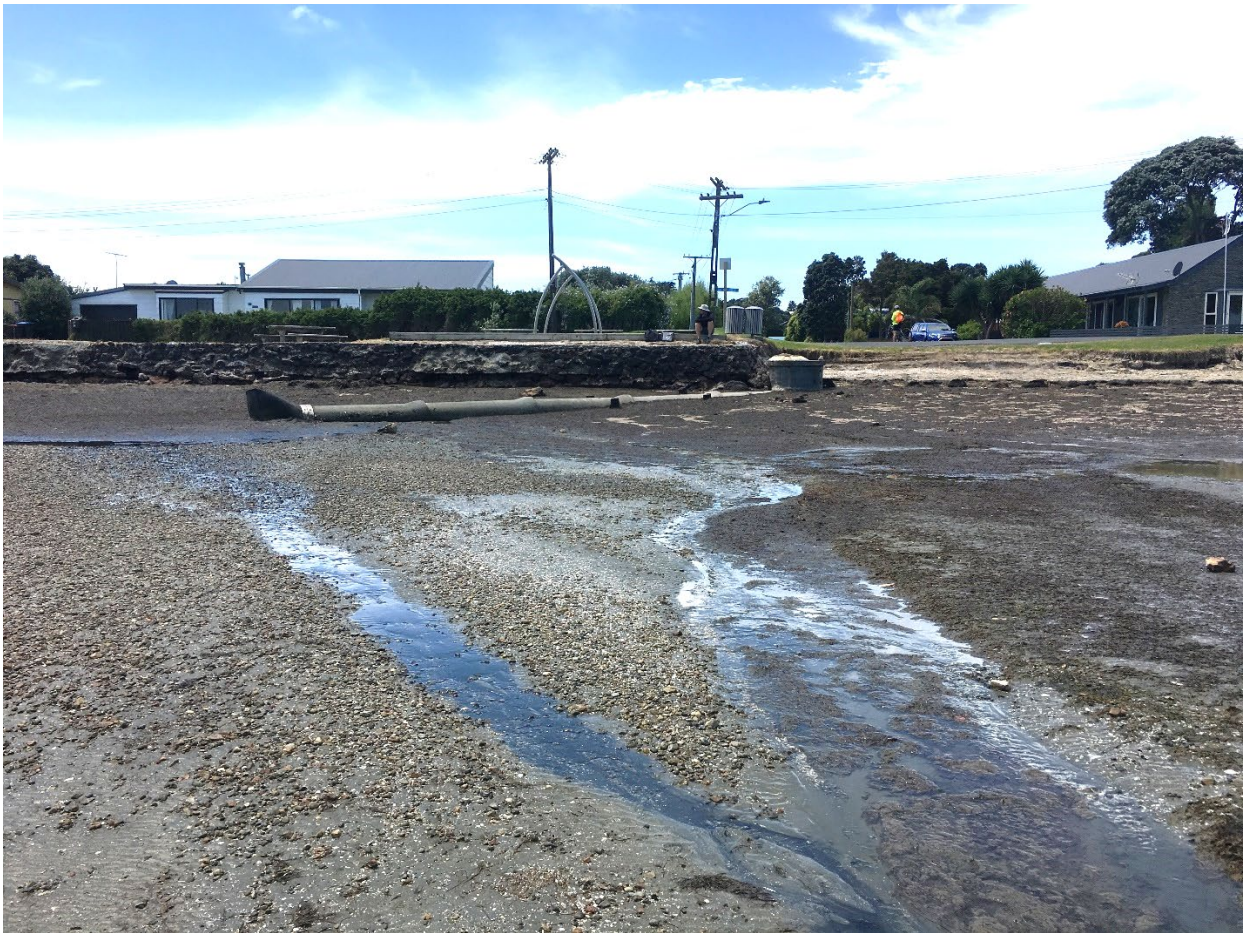
Figure 3: The site showing existing outfall and manhole, the proposed area of works and adjacent children's playground and adjacent properties.

Photographs of the habitats were taken (Figure 3; Figure 4; Figure 5).

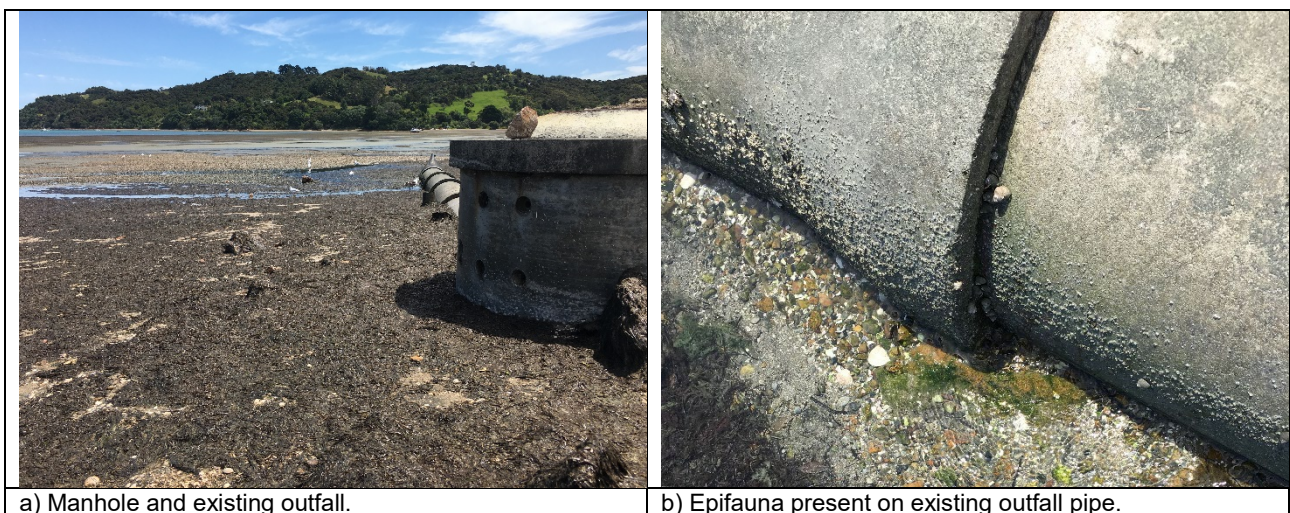
Figure 5: Hard shore epifauna present on existing structures.

The existing marine environment is within the proposed area of works consists of sandy soft sediment intertidal habitat. The existing outfall and manhole structures provide some habitat for hard shore marine species (Figure 5).

The existing structures are comprised of concrete and provide habitat for epifaunal species (Figure 5). A total of four species were identified inhabiting the structures; little black mussels (*Limnoperna pulex*), brown barnacles (*Octomeris brunnea*), dark top shells (*Diloma aethiops*), and an unidentified limpet.
