PROCEEDINGS OF THE MERCHANT MARINE COUNCIL UNITED STATES COAST GUARD

January 1955

The Ship You Save May Be Your Own.....	Page 3
Nautical Queries.....	5
International Load Line Convention, 1930.....	7

Blast Off!.....	8
Don't Learn the Hard Way.....	10

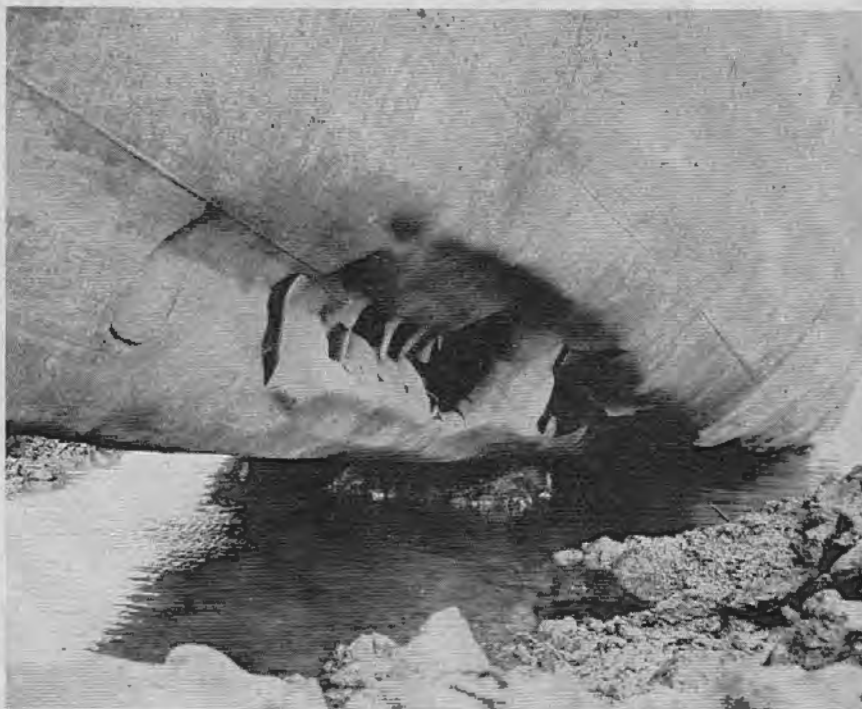
Figure 2.

task of refloating this strand. Salvage operations included the blasting of rock from under the forepart of the vessel (see cover and fig. 2), and in some instances the blasting off of rock protruding up through the vessel's bottom.
