PROCEEDINGS

OF THE MERCHANT MARINE COUNCIL

UNITED STATES COAST GUARD

Vol. 20, No. 12 • December 1963

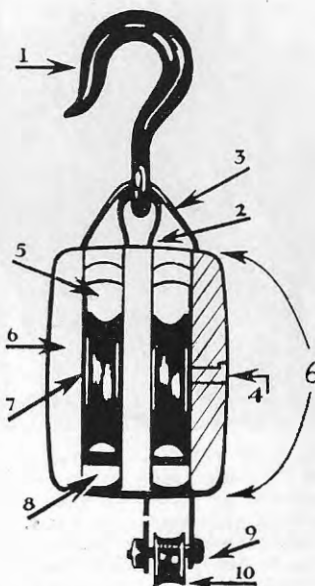
Q. Name seven of the ten parts of a block indicated on the diagram below:

| A. 1. Hook | 6. Cheeks or shell |

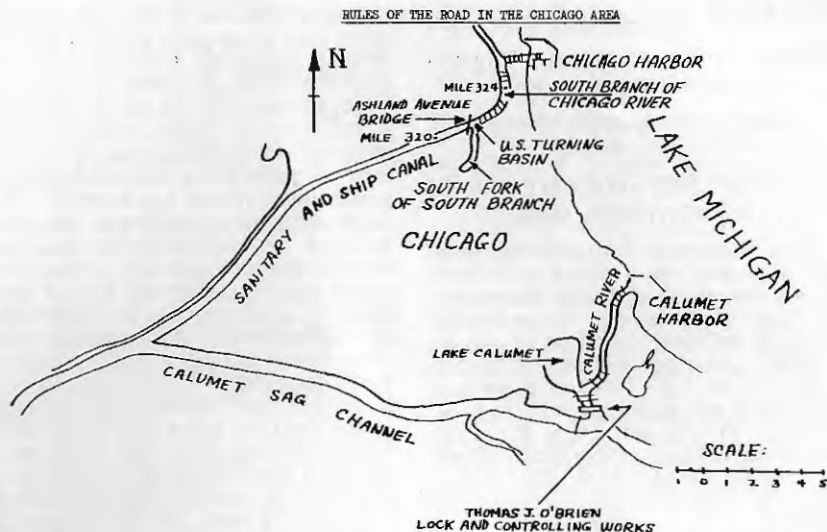
Demarcation Lines Between Rules of Road for Great Lakes and Western Rivers in Chicago Port Area

THE ABOVE SKETCH illustrates the new location of the Rules of the Road line of demarcation between the Great Lakes and the Western Rivers in the Chicago area. This line is now located at the east side of the Ashland Avenue Bridge on the Chicago River and on the Calumet River at the Thomas J. O'Brien Lock by authority of the Coast Guard administrative ruling published in Federal Register of October 15, 1963 (excerpted below).

The statutory definition of the waters subject to the Act of February 8, 1895, as amended (33 U.S.C. 241), states that the "Rules of the Road—Great Lakes" (CG-172) apply in part " * * * upon the Great Lakes and their connecting and tributary waters * * * ." The statutory definition of the waters subject to the provisions

of section 4233 of the Revised Statutes, as amended (33 U.S.C. 301), states that the "Rules of the Road—Western Rivers" (CG-184) apply in part " * * * upon the waters of the Mississippi River * * * and all of the tributaries emptying thereinto and their tributaries * * * ." Certain waters in the Chicago port area, by reason of these definitions, seemingly are subject to both sets of "Rules of the Road." The Coast Guard, in an effort to obtain uniform administration and compliance, since 1939 has treated the waters between Lockport, Illinois, and Lake Michigan as subject only to the "Rules of the Road—Great Lakes."
