STANDARD OPERATING PROCEDURE FOR Inspection of Pipes 23 February 2021

Note: The following guidance is from Chapter 6 of EM 1110-2-2902, "Conduits, Pipes, and Culverts Associated with Dams and Levee Systems", publication date on 31 December 2020. The complete manual can be found at <https://www.publications.usace.army.mil/Portals/76/Users/182/86/2486/EM%201110-2-%202902.pdf?ver=dWvkKGoSFozppG1qRnya4Q%3d%3d>. Refer to the full document for descriptions of all terminology and concepts.

Chapter 6 Inspections, Condition Assessments, and Prioritized Mitigation Plans

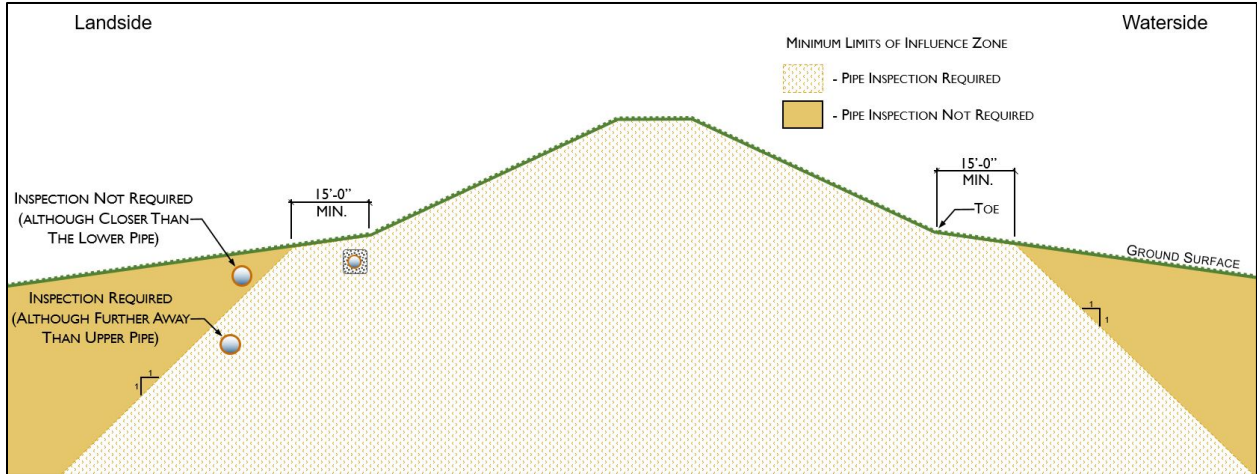
Figure 6-7. Gravity pipes adjacent to a levee.

6.4.6. Gravity Pipes that Do Not Cross a Levee Alignment. Pipes running adjacent to a levee embankment or floodwall that are within 15 feet horizontally of the levee toe or floodwall (I-wall) face, within eight feet of the floodwall (T-wall) foundation or toe drain, or below a 1H:1V slope from that point, require inspection. Examples of these types of pipes include toe drains, collector systems, and third-party pipes Figure 6-7 and Figure 6-8).

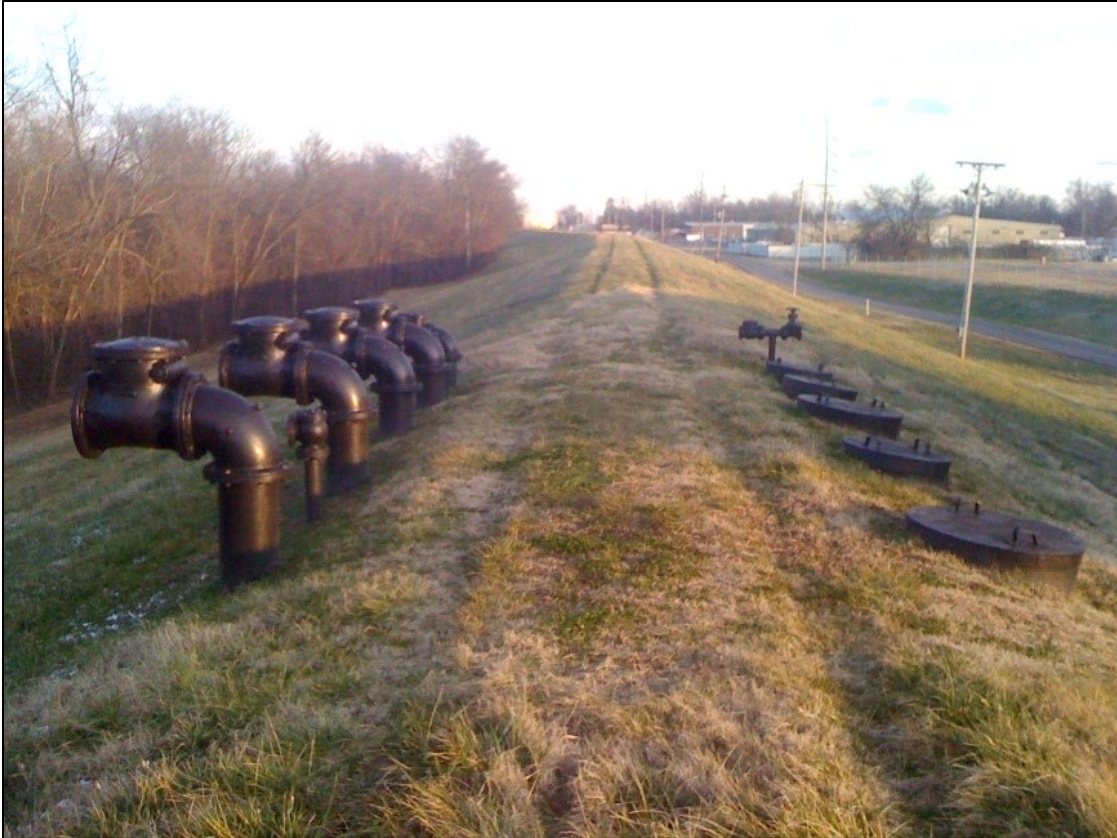
Figure 6-11. Potential inspection access points for pump station discharge pipes.

6.4.7. Discharge Pipes from Pump Stations (Through or Profile). Discharge pipes from pump stations are inspected from inside the pump station starting at the flange connection and ending at the end of the discharge line at the headwall/gatewell (Figure 6-9 and Figure 6-10). Pipe access is possible through outlet headwalls, gatewell discharge locations, and sometimes air vents/siphon breakers (Figure 6-11, reference Section 9.4.4.1.). The discharge pipes must be inspected from the pump station all the way to the outlet structure, regardless of whether they are interrupted by a gatewell. This applies to the entire waterside pipe length, even for the portion beyond the 15-foot limit/distance from the levee toe.

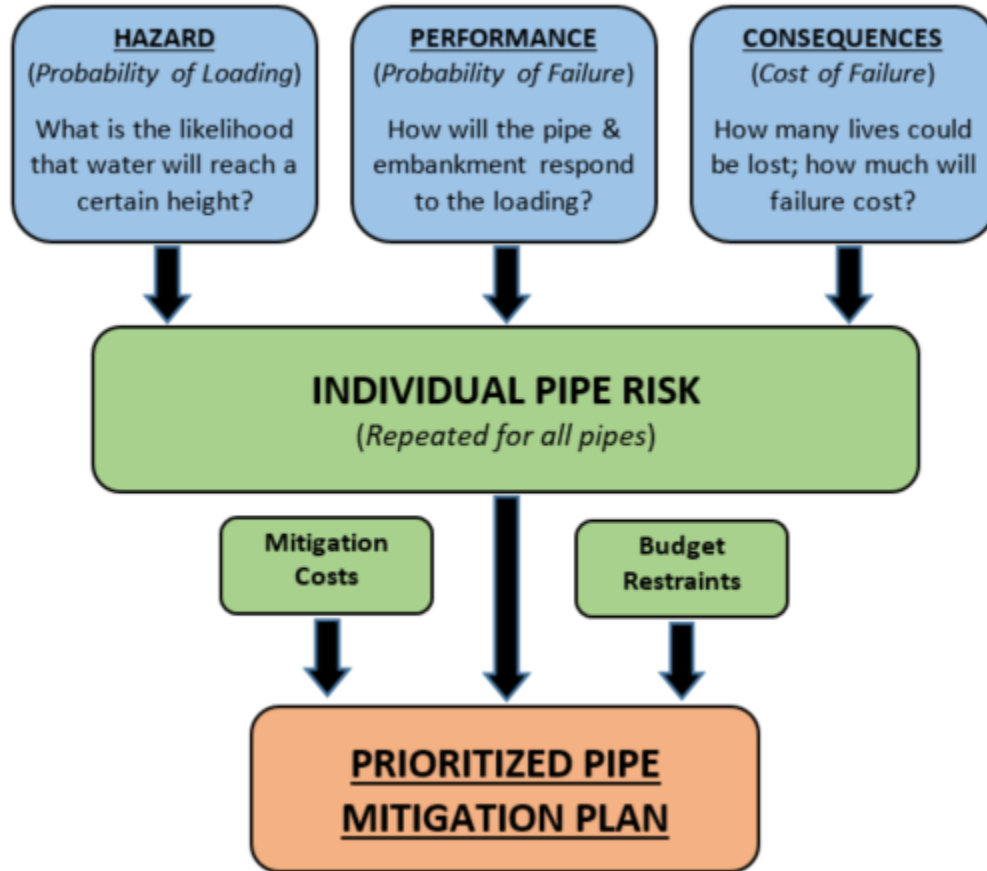
Figure 6-16. Example risk management approach to a prioritized mitigation plan.

6.9.2.2.7. Cost. Once developed, the preliminary prioritized pipe mitigation plan must then be balanced with the cost of addressing each pipe and the levee sponsor's budget constraints. Depending on the cost disparities associated with properly addressing each pipe, it is possible that the pipe presenting the most risk will not be addressed first. A simplified pipe-focused prioritized mitigation plan is shown in Figure 6-16.
