SUPPLEMENTAL ENVIRONMENTAL IMPACT ASSESSMENT

ROYAL BEACH CLUB AT PARADISE ISLAND NASSAU, THE BAHAMAS

JUNE 2023

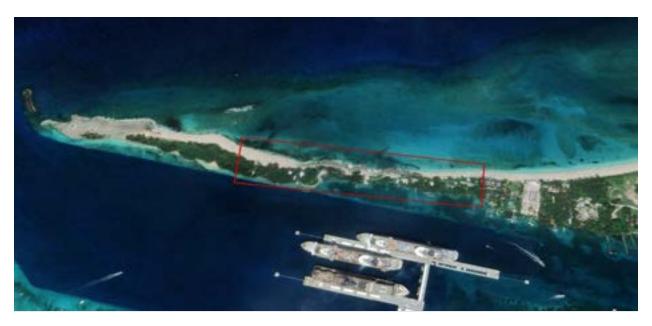
Figure 1-1: Royal Beach Club at Paradise Island Survey area

In October 2019 a botanical assessment was conducted for the western end of paradise island to document the baseline conditions within the proposed project limits and surrounding areas of Royal Beach Club at Paradise Island. In 2023 the size of the development was reduced to 17 acres within the area outlined in figure 1-1. On the 27th of April 2023 a botanical assessment was conducted for the 17 acres encompassing the Royal Beach Club at Paradise Island site. The purpose of the botanical study was to document the baseline conditions within the project limits. More specifically, the focus was to map vegetation types, determine floristic diversity, record protected species abundance, and identify the presence of invasive species.

The findings of this survey speak to the observations within the 17 acres outlined in figure 1-1. These findings are similar to the 2019. Variations noted are due to the reduced scope of the report.

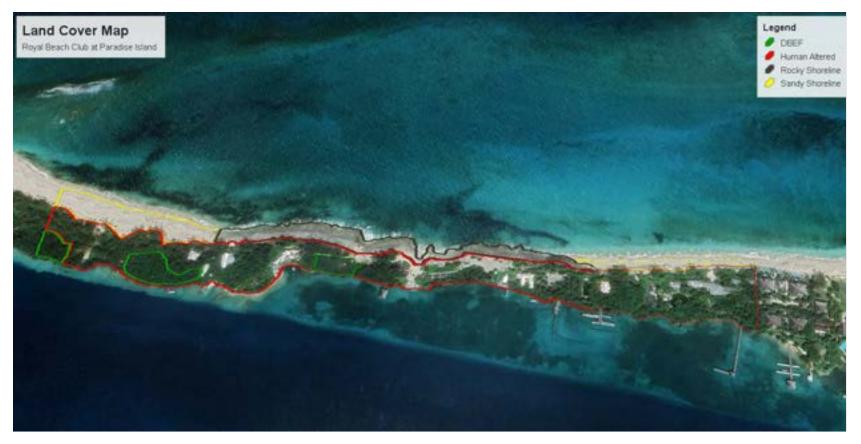
Figure 3-1: Land Cover Map – Royal Beach Cub at Paradise Island

There are three general vegetation land cover types in The Bahamas – coastal, interior upland and wetland. The site consisted of coastal (Rocky shore, Sandy Shore) and interior upland (Dry broadleaf evergreen formation and Human Altered) land cover types. There were no wetlands within the project limits. Land cover type distribution is outlined in Table 3-1 and illustrated in Figure 3-1.

Land cover distribution	Square Feet	Acres	Percentage of total acres (17)
Sandy shoreline	95,086	2.18	12.82%
Rocky shore	92,162	2.12	12.47%
Dry Broadleaf Evergreen Formation	54,198	1.24	7.29%
Human Altered	499,198	11.46	67.41%
Total	740,644	17	100%

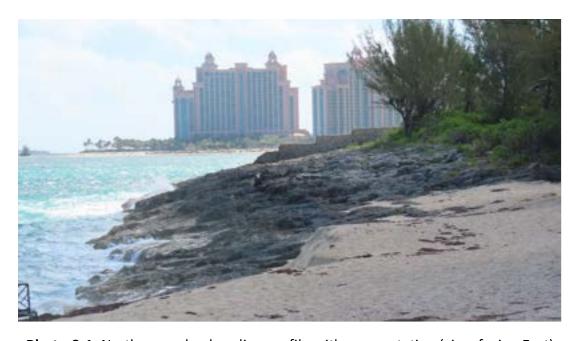
Photo 3-1: Northern rocky shoreline profile with no vegetation (view facing East)

An extensive area of iron shore with no vegetation is present along the northern coastline. For the most part, bare iron shore abuts humann altered vegetation in upland sections of the site.

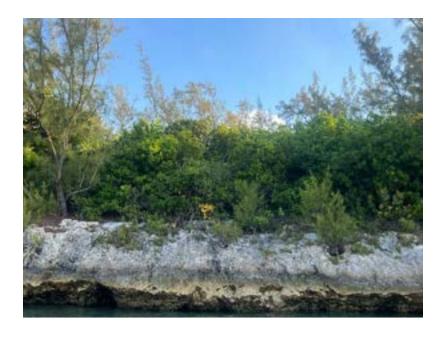
Photo 3-3: Rocky shore with *Rhachicallis americana* (Sandfly Bush) herbland vegetation on Southern shore (view facing North)

Along the southern shore, the rocky shore profile occurs as a band less than three (3) meters wide between shoreline and the upland vegetation. Iron shore rock with no vegetation is present along wave cut platforms and there is small strip of *Rhachicallis americana* (Sandfly Bush) herbland vegetation along the edge of the upland vegetation in some areas. Invasive species such as *Casuarina equisetifolia* (Australian Pine) are also present.

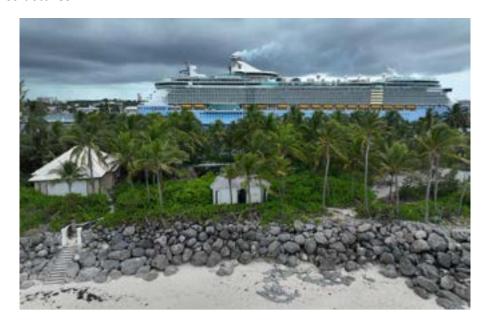
Photo 3-4: Rock revetment along Northern shoreline

Boulder rock revetments are present in the Eastern section of the site on both the Northern and Southern coastlines. These structures are in the heavily human altered areas near existing residential structures.

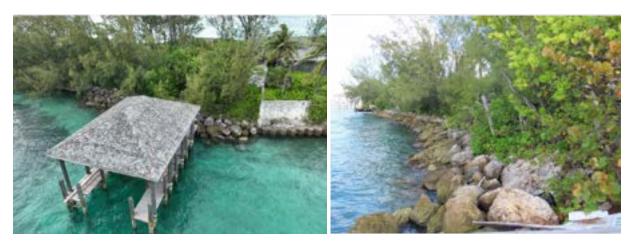
Photo 3-5: Rock revetment along Southern shoreline

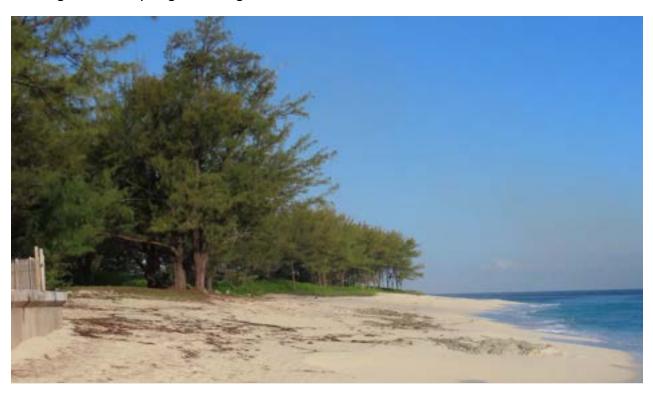
Photo 3-6: Western sandy shoreline profile with *Scaevola taccada* (White Inkberry) and *Casuarina equisetifolia* (Australian Pine) (view facing East)

Sandy Shoreline is present along the Northern coast interspersed with Rocky shore. These areas are predominantly human impacted. The Western sandy shoreline has large sections of *Scaevola taccada* (White Inkberry) and *Casuarina equisetifolia* (Australian Pine) with a thick leaf litter layer on the ground or zoysia grass as a ground cover.

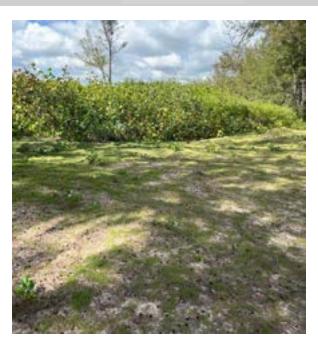
Photo 3-7: Western sandy shoreline profile with *Zoysia* sp. grass as ground cover under *Casuarina* equisetifolia (Australian Pine)

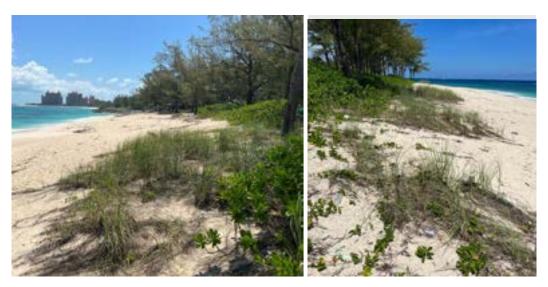
Photo 3-8: Western sandy shoreline with pocket of native dune vegetation (left – view facing East, right – view facing West)

There is a small section that has a patch of vegetation that is typical in native dune systems along the sandy shorelines in The Bahamas. The vegetation present includes *Uniola paniculata* (Sea oats) and *Ipomea pes-caprae* (Railroad vine).

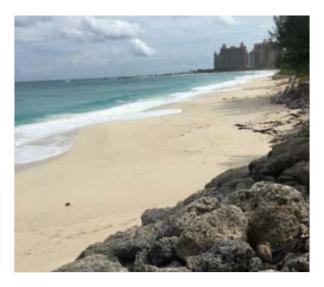
Photo 3-9: Eastern sandy shoreline profile with no vegetation and rock revetment (view facing East)

The Easternmost sandy shore is predominantly sand with no vegetation and is separated from uplands by a series of concrete retaining walls and rock revetment. The amount of exposed sand below retention structures varies due to periodic tidal and seasonal inundation which at times completely covers this area.

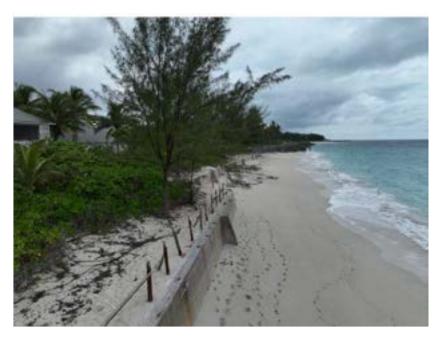
Photo 3-10: Eastern sandy shoreline profile with no vegetation and retaining wall (view facing West)

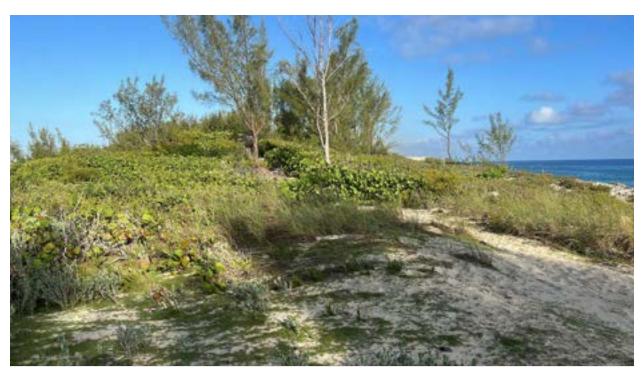
Photo 3-12: Uniola paniculata (Sea Oats) in sandy area near Northern Rocky Shore

At one of the narrowest points on the site, there is an area of sand deposit immediately South of the Rocky iron shore on the Northern coast. Vegetation in this area include patches of *Uniola paniculata* (Sea Oats), *Rhachicallis americana* (Sandfly Bush), *Borrichia frutescens* (Bay Marigold) and *Sporobulus virginicus* (Seashore rush grass).

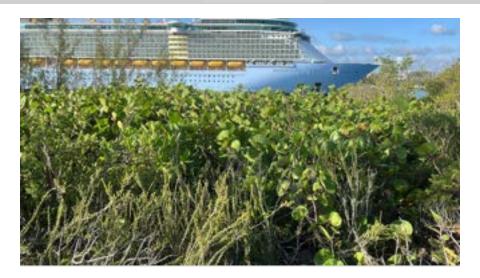
Photos 3-13: DBEF shrubland 4-5 feet in height (view facing South)

Several patches of dry broadleaf evergreen formation (DBEF) are present along the Southern side of the site which is more protected from wind and salt spray. This vegetation type consists of shrubland and forest. Shrubland, at a height of 4-5 feet, is present in one of the narrowest sections of the site. This area is exposed to coastal conditions from both the Northern and Southern shore thus the vegetation is dwarf and wind pruned. Plant species present is predominantly *Coccoloba uvifera* (Sea grape), with *Conocarpus erectus* (Buttonwood) along the Southern shore. Other species present include *Croton linearis* (Granny bush) and *Casasia clusifolia* (Seven-year apple).

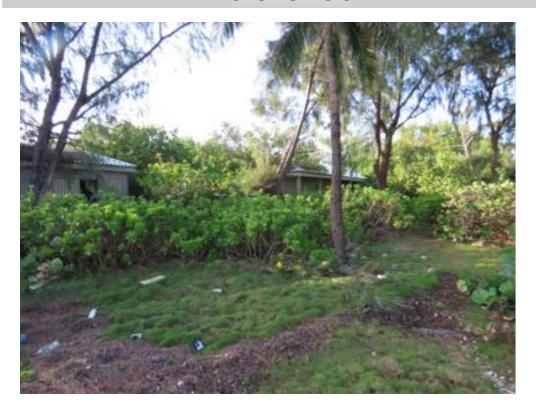
Photos 3-14: Human altered area with abandon structures

The Easternmost interior upland areas on site are almost exclusively human altered. The area consists of a series of residences with partial or complete clearing of native vegetation. Existing vegetation is a combination of native vegetation left in place such as large stands of *Coccoloba uvifera* (Sea grape), predominantly invasive species such as *Scaevola taccada* (White Inkberry), Casuarina *equisetifolia* (Australian Pine) and *Thespesia populnea* (Cork Tree); and landscape species including grass, palms and ornamentals such as *Cocos nucifera* (Coconut Palm), *Stenotaphrum secundatum* (St. Augustine grass), *Archontophoenix alexandrae* (Alexander Palm), *Ixora coccinea* (Jungle Flame), *Ficus microcarpa* (Green Island Ficus) and *Plumeria sp.* (Frangipani).

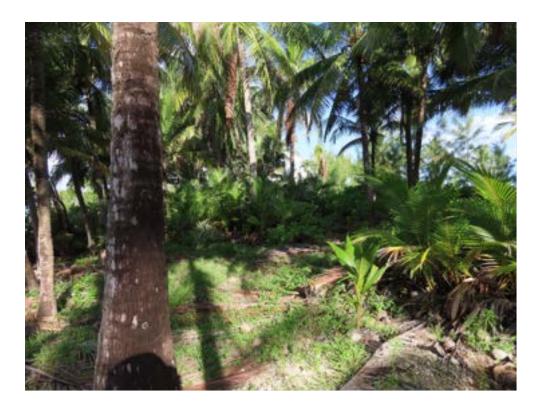
Photos 3-15: Human altered area with concentration of Coconut Palms

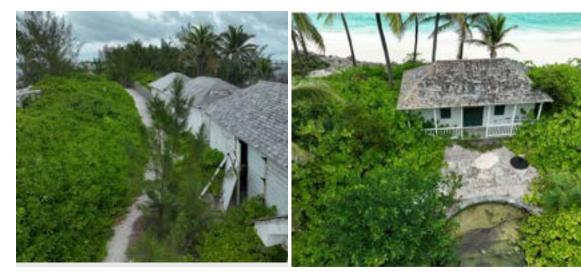
Photo 3-16: Large stands of *Scaevola taccada* (White Inkberry) in human altered area in Eastern section of site

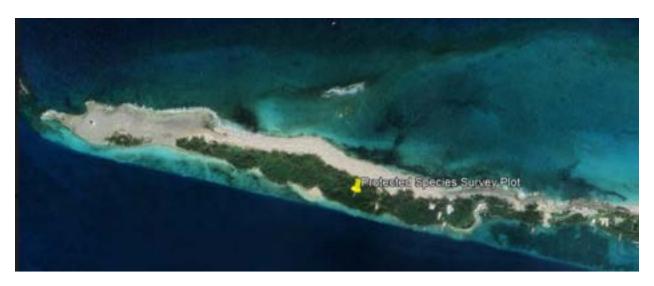
Figure 3-2: Location of Protected Species survey plot

Native DBEF vegetation on the site totalled 1.24 acres thus one (1) temporary survey plot was established within DBEF to assess protected species (See Figure 3-2 for survey plot location).

The plot was sized (66 feet X 66 feet) using a measuring tape and the area outlined with orange flag tape. Once the plots were established, the amount of each protected species within the area was counted. To avoid double counting or missing a plant, tags were placed on individual plants when counted. The results of the surveys are detailed in the sections that follow.

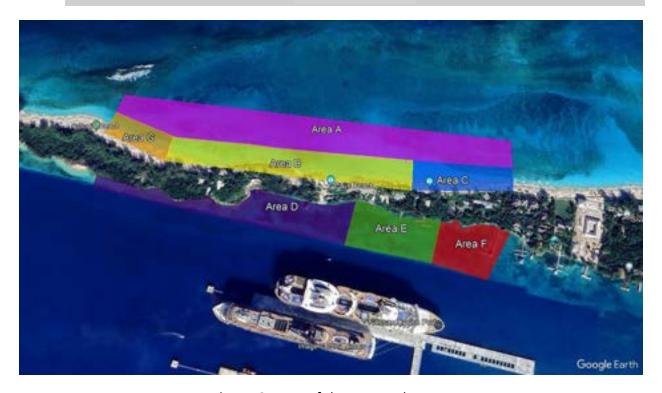
Figure 2: Map of the assessed areas.

Map Key: Area A= Offshore, Area B, Area C, Area D, Area E, Area F, Area G

On March 29-30th, 2023, field studies were conducted on the RBCPI site within the surveyed areas below (See Figure 2). A five (5) person team consisting of four (4) JSS Consulting team members and a boat captain conducted the assessments. The area encompasses shallow water between one and fifteen feet (1ft-15ft) on the Northern side of the project site and one to ten feet (1-10 ft) on the southern side of the project site.

On April 14^{th} , 2023 a second attempt was made to survey the rocky shoreline of Caves Beach (Area B) on the northern side of the property; however, due to swells and poor visibility, assessment of the area was not possible. A final attempt was made on April 22^{nd} and 23^{rd} , 2023, where the team was able to successfully assess the area.

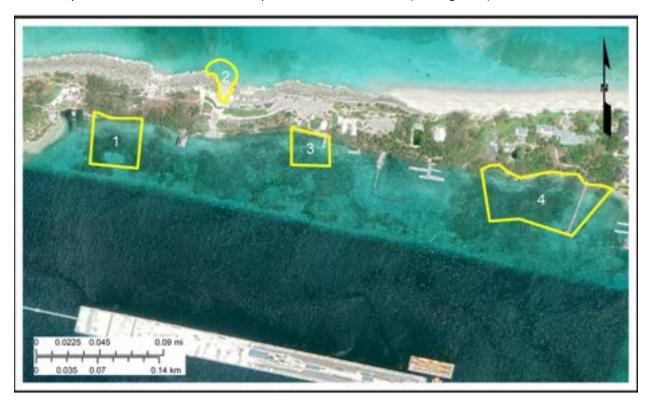
Figure 3: Key assessment areas in 2021.

Drones were used to assess the benthic habitat of the project site. Drones were navigated perpendicular to the shoreline and photos and GPS data points were taken. Special attention was placed on areas noted in the respective EIA and the Benthic Map and Coral Assessment (see Figure 3).

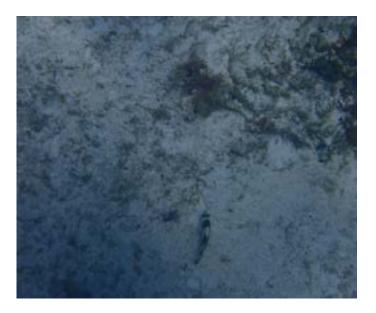
Photo 9: Algal dominated hardbottom with Banded Butterflyfish (*Chaetodon striatus*).

Fish abundance and diversity was overall low on the northern side of the property; however, the majority of fish species in the area were observed in this benthic habitat. Species include, Bar Jacks (Carangoides

ruber), Slippery Dicks (Halichoeres bivittatus), Banded Butterflyfish (Chaetodon striatus), and Blue Tangs (Acanthurus coeruleus).

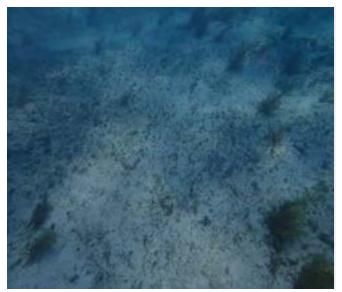
Photo 12: Algal dominated sandy bottom

Algal sandy bottom with low to medium density of seagrass was observed in patches amongst the hardbottom. The dominant algae observed in this benthic habitat was Sargassum (*Sargassum fluitans*). No epifauna was observed in this benthic habitat.

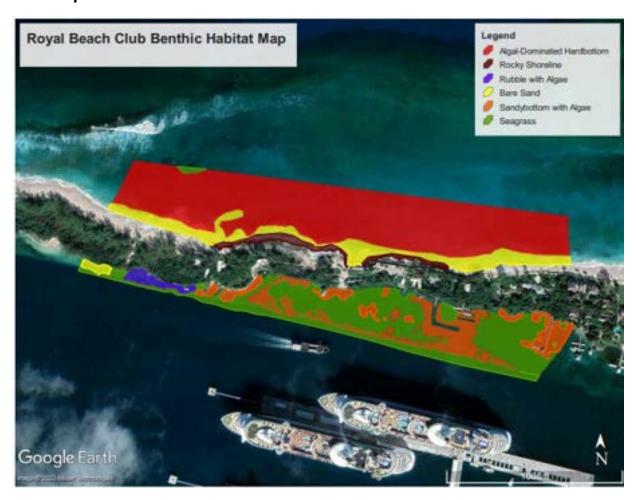
3.4 Benthic Habitat Map

Figure 4: Royal Beach Club Benthic Habitat Map

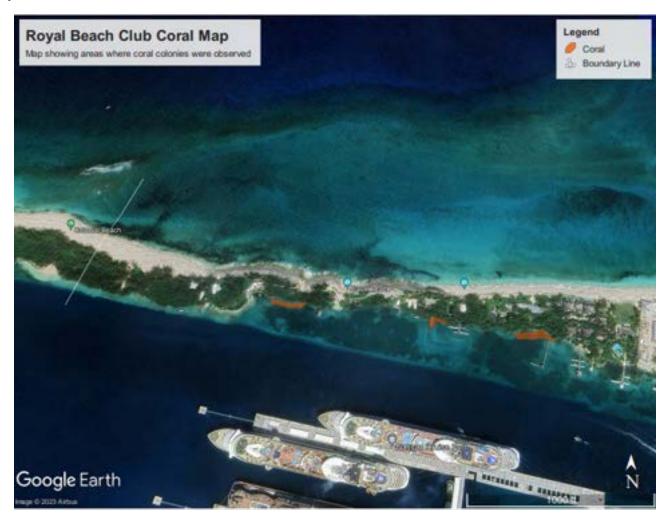
3.5 Coral Map

Figure 5: Royal Beach Club Coral Map.

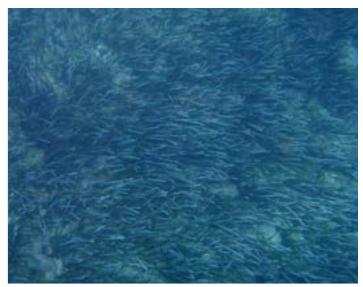
Photo 33: Turtle Grass (*Thalassia testudinum*)

Seagrass beds were observed on both the northern and southern side of the property. There were small patches of dense seagrass (predominantly Turtle Grass (Thalassia testudinum)) with sparse algae offshore on the northern side of the property. Cavities of bare sand and reef rubble were observed within the seagrass.

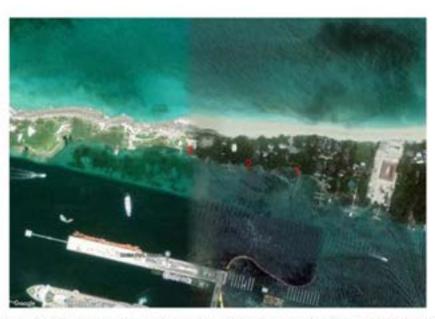
Figure 1. Satellite image indicating project site, measurement locations and notable noise sources.

Generally, daytime noise levels are within the 55 dBA range and can approach 60 dBA with the entry of ships into port. Overnight noise levels decrease to 44-46 dBA at meter location 3 which again does not include significant palm tree noise. Please refer to Figure 1 above for Measurement Locations.

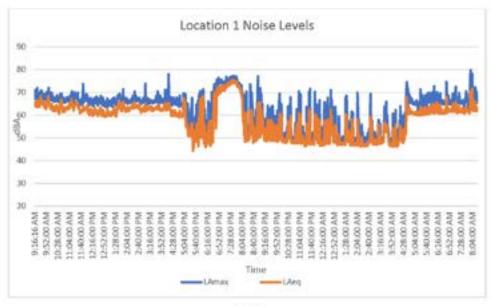
Chart I

Detailed measurement results are shown in the charts below. For each measurement location, the chart includes both the maximum noise level along with the equivalent noise level for the one minute measurement period. In many instances, particularly in location 3, noise levels regularly exceed 80 dBA.

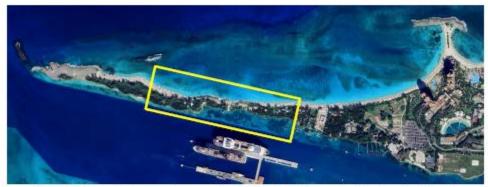
Figure 2: Approximate area of proposed project works (yellow rectangle), shown in Figure 1.

Per the masterplan, the proposed project development area comprises approximately 3000 feet of shoreline (along each of the north & south shores) near the western end of Paradise Island commencing west of Paradise Beach Villas. No works or improvements are indicated along the westernmost 2400± feet of the island. See Figures 1 and 2, below.

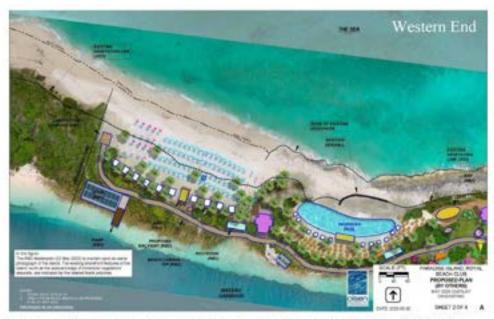
Figure 5a: RBC masterplan with annotation of existing island features (black polylines). Western third.

Attachment A, and Figures 5a & 5b below, depict the 5/23/2023 masterplan overlain upon an aerial photograph of the island. The principal existing shorefront features – traced from March 2018 and December 2022 aerial photographs – are illustrated by <u>black polylines</u> and labelled as <u>Existing</u>. These black lines include the existing seawalls, boulder revetment, seaward edge of vegetation and ironshore, harborside docks, and typical location(s) of the mean high water line. The proposed RBC development is shown by the color illustration, in which the principal shorefront features are outlined by <u>blue polylines</u> and labelled as (RBC). These blue lines include the proposed seaward edge of development, beach cabanas, promenades, docks, pools, etc.

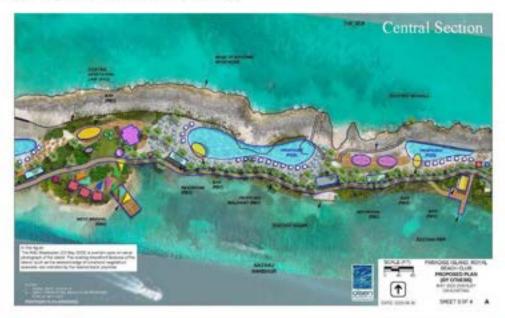
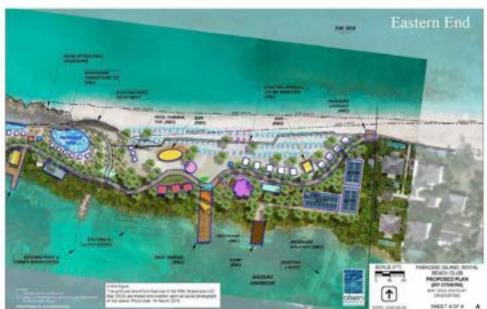
Figure 5b: RBC masterplan with annotation of existing island features (black polylines).

Central and Eastern thirds.

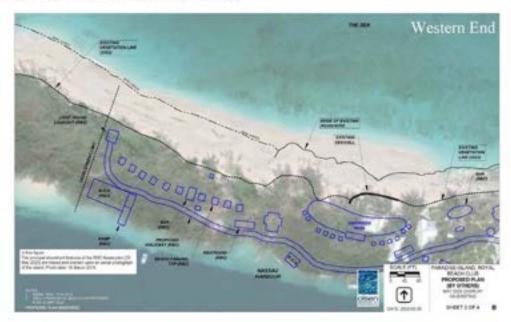
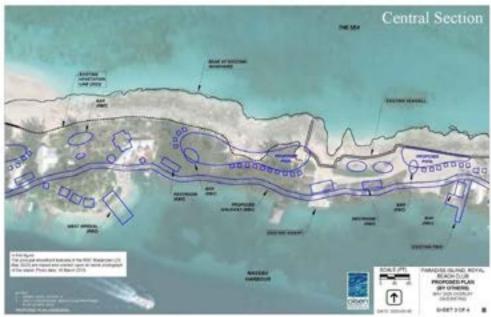
Figure 6a: Principal features of RBC masterplan (blue polylines) illustrated atop existing island conditions. Existing island features annotated by black lines. Western & Central thirds.

Attachment B, and Figures 6a & 6b, likewise depict the principal shorefront features of the masterplan (blue polylines) overlaid on the existing island photograph. As described above, the island's principal existing features (seawalls, vegetation line, etc) are highlighted in black.

In the figures, the indicated location of the MHWL is nominal (recognizing that it fluctuates along the beach). It illustrates typical locations from prior observations and aerial photographs.
