**NORTH WEST WALES DENDROCHRONOLOGY PROJECT 2009-2012**  
**PROSIECT DENDROCRONOLEG GOGLEDD ORLLEWIN CYMRU**

**DATING OLD WELSH HOUSES / DYDDIO HEN DAI CYMREIG**

**Bron Y Foel Isaf, Dyffryn Ardudwy, Gwynedd, LL44 2ZH**

**ARCHITECTURAL RECORD /COFNOD PENSARNIOL**

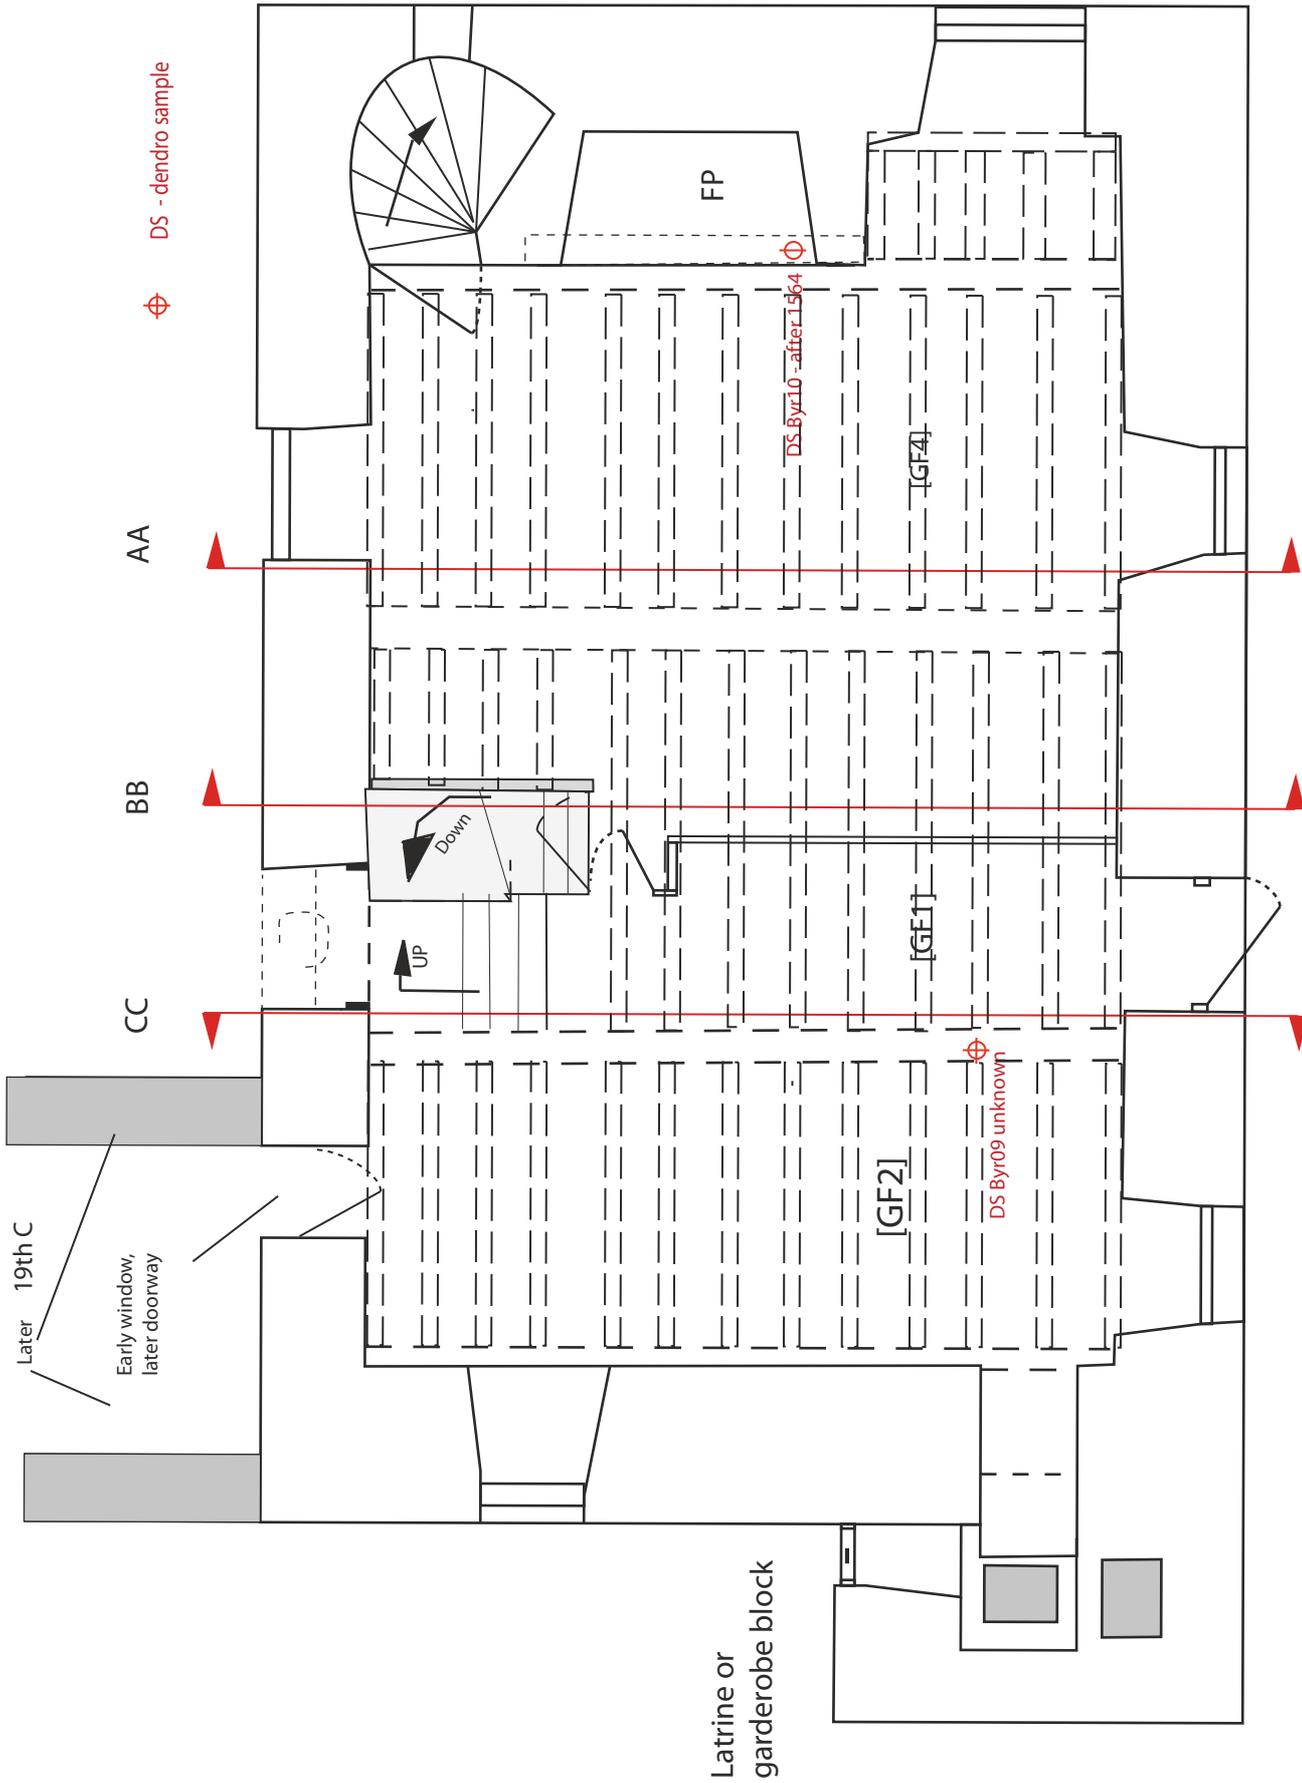
Figure 4: Ground floor plan  
Bron Y Foel Isaf, Dyffryn Ardudwy, Gwynedd, LL44 2HZ

Scale 1:50 >A4

4.2.2 Passing through the W door we enter the cross passage. **[GF1]** The screen partition to the right (S) has been re-constructed and plastered. The doorway to this screen may not be in its original position and has been altered to facilitate the enclosure of the entrance to the basement. The right door jamb, incomplete, with scratch moulding, (plate13) may be an original fragment with the rest being later. The staircase then occupies the position of this portion of screen, re-using planking from the former screen and fixed to later studwork. A dogleg staircase with half landing stair winds behind this enclosure **(Plate 14)**.

4.2.3 The room **[GF2]** was a service or store room. It is lit by a small sash window (W), an enlarged window in the gable and a doorway (E) has replaced a possible former window in the E elevation. This leads to a small room off formed within a connecting link to other buildings constructed in the 19<sup>th</sup> century. The ceiling is a single run of joists located on the

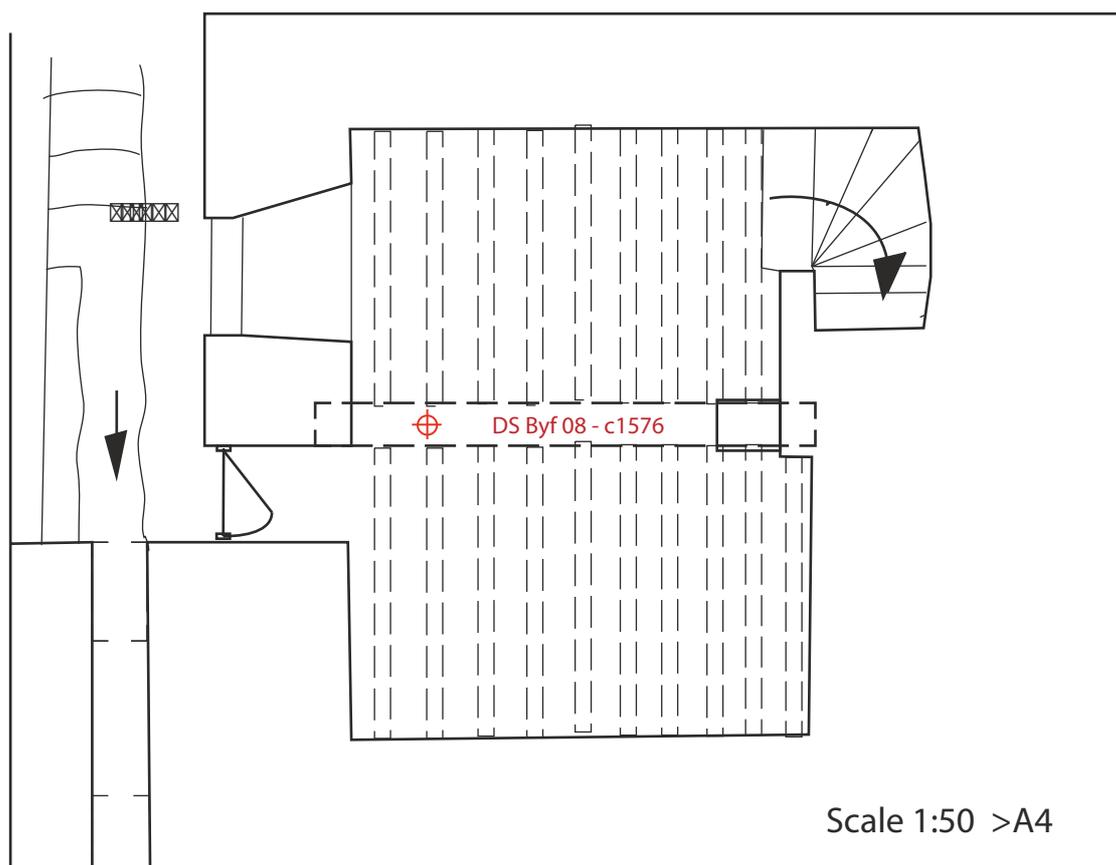
Figure 5: Basement

DS - Dendro Sample

4.2.4 The basement **[GF3]** is interesting in its apparent development. A primary construction seems established with an exterior doorway and window in the north gable. Internally, the doorway is of poor construction with no quoins immediately obvious. However, this doorway has been added to at some stage with further masonry and the small stones used on the inner reveals may be some form of repair or addition to support a lintel as the earlier stonework is visible beneath on closer inspection. This lintel in turns supports the main beam in a less than ideal manner and the masonry on this wall generally displays adjustment **(Plate 20)**. The proximity of this doorway to falling waste from the latrine is an interesting design concept! There is no sign of what the room might have been used for but was possibly a dairy. The large timber beam supporting the floor is, in common with the other principal beams in the house, of 300mm and also displays a 70mm chamfer and stop as elsewhere in the building. The southern end of this beam, while built into the masonry appear to have had further support added in the form of a pillar **(Plate 21)**. Chamfered joists with stops display a superior reference to detail in such a room. The date of c1576, obtained for the main beam is earlier than the rest of the building and has led to the suggestion (Bridge, 2011) that the basement possibly predates the building above. This is a possibility and there is disturbance of masonry on the internal north wall and additional support provided for the main beam on the south wall in the form of a pillar so this idea may warrant further investigation if the opportunity arises. A cobble floor under varying levels of water made inspection of this room interesting.

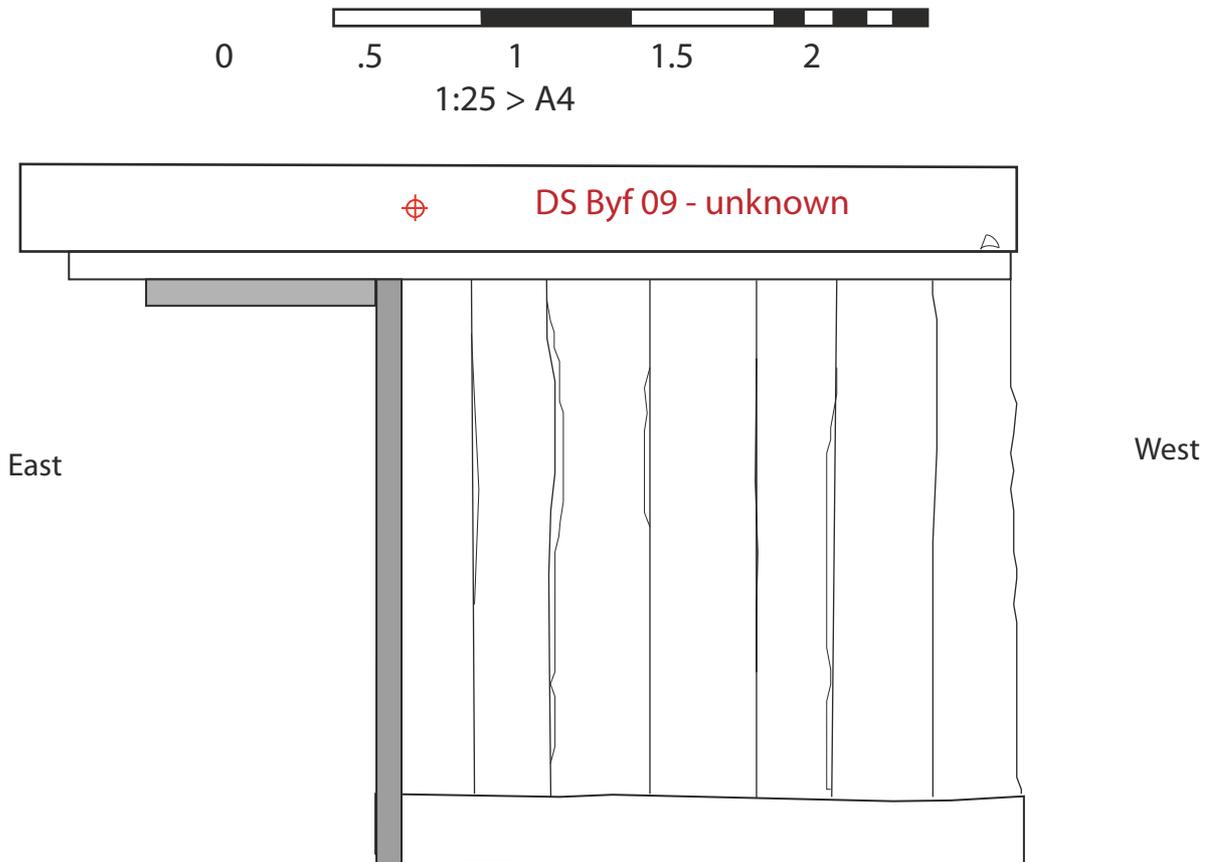
Figure 6: Ground Floor Screen - part.

Facing south.  
Screen in service room. Floor level raised so this screen may be re-fitted but likely primary. Timber is of inferior work compared to re-used part of screen elsewhere e.g. enclosure for basement entry.

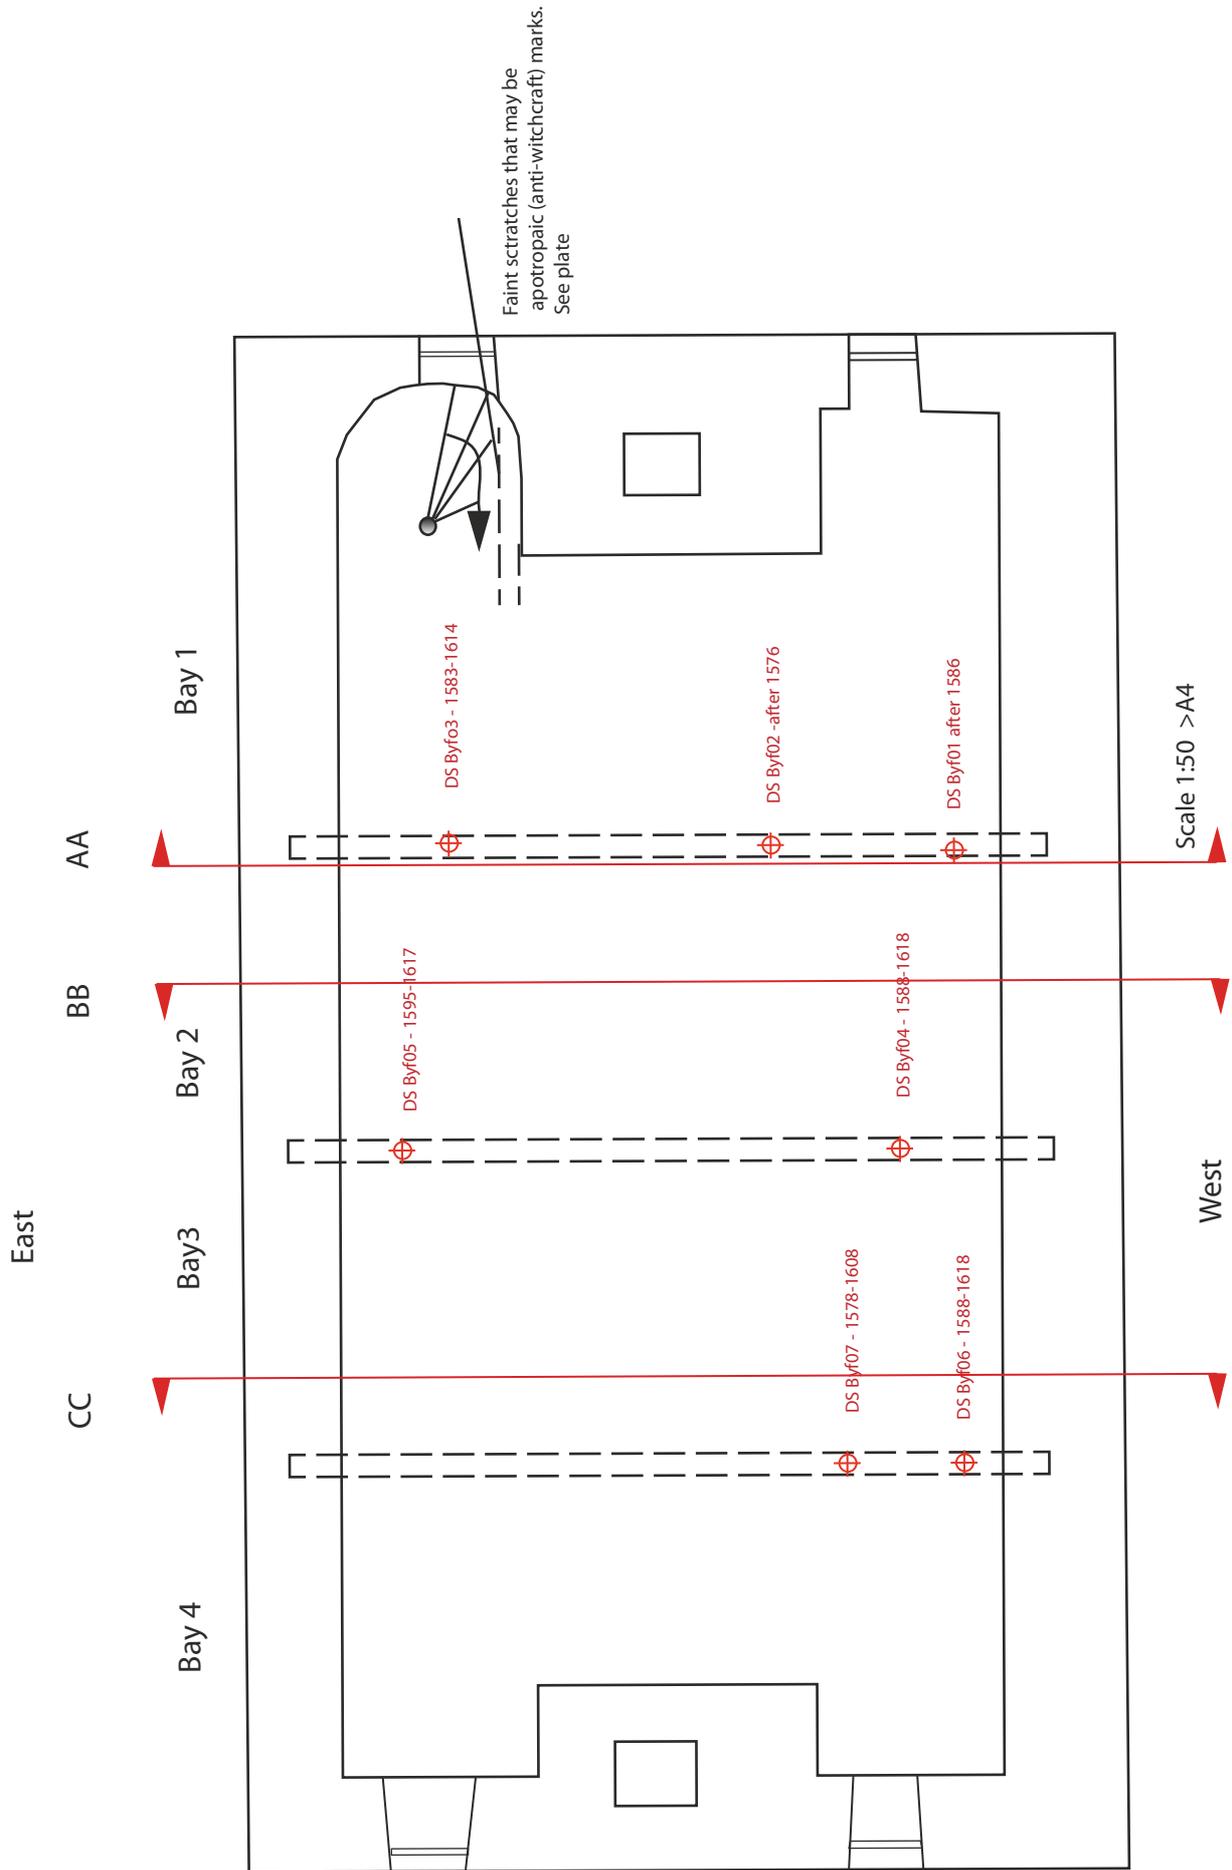
Figure 8 : Loft  
Bron y Foel Isaf , Dyffryn Ardudwy, Gwynedd, LL44 2HZ

Truss 1 viewing southwards. Principal rafters set on wall plates braced by raking struts

DS - Dendro samples

6.1.4 The construction of the roof was of principal rafters bearing on wall plates which sat on mass walls of rubble stone. Two tiers of trenched purlins and a squared ridge beam supported common rafters. The roof – slates and battens- has been replaced on at least one occasion.

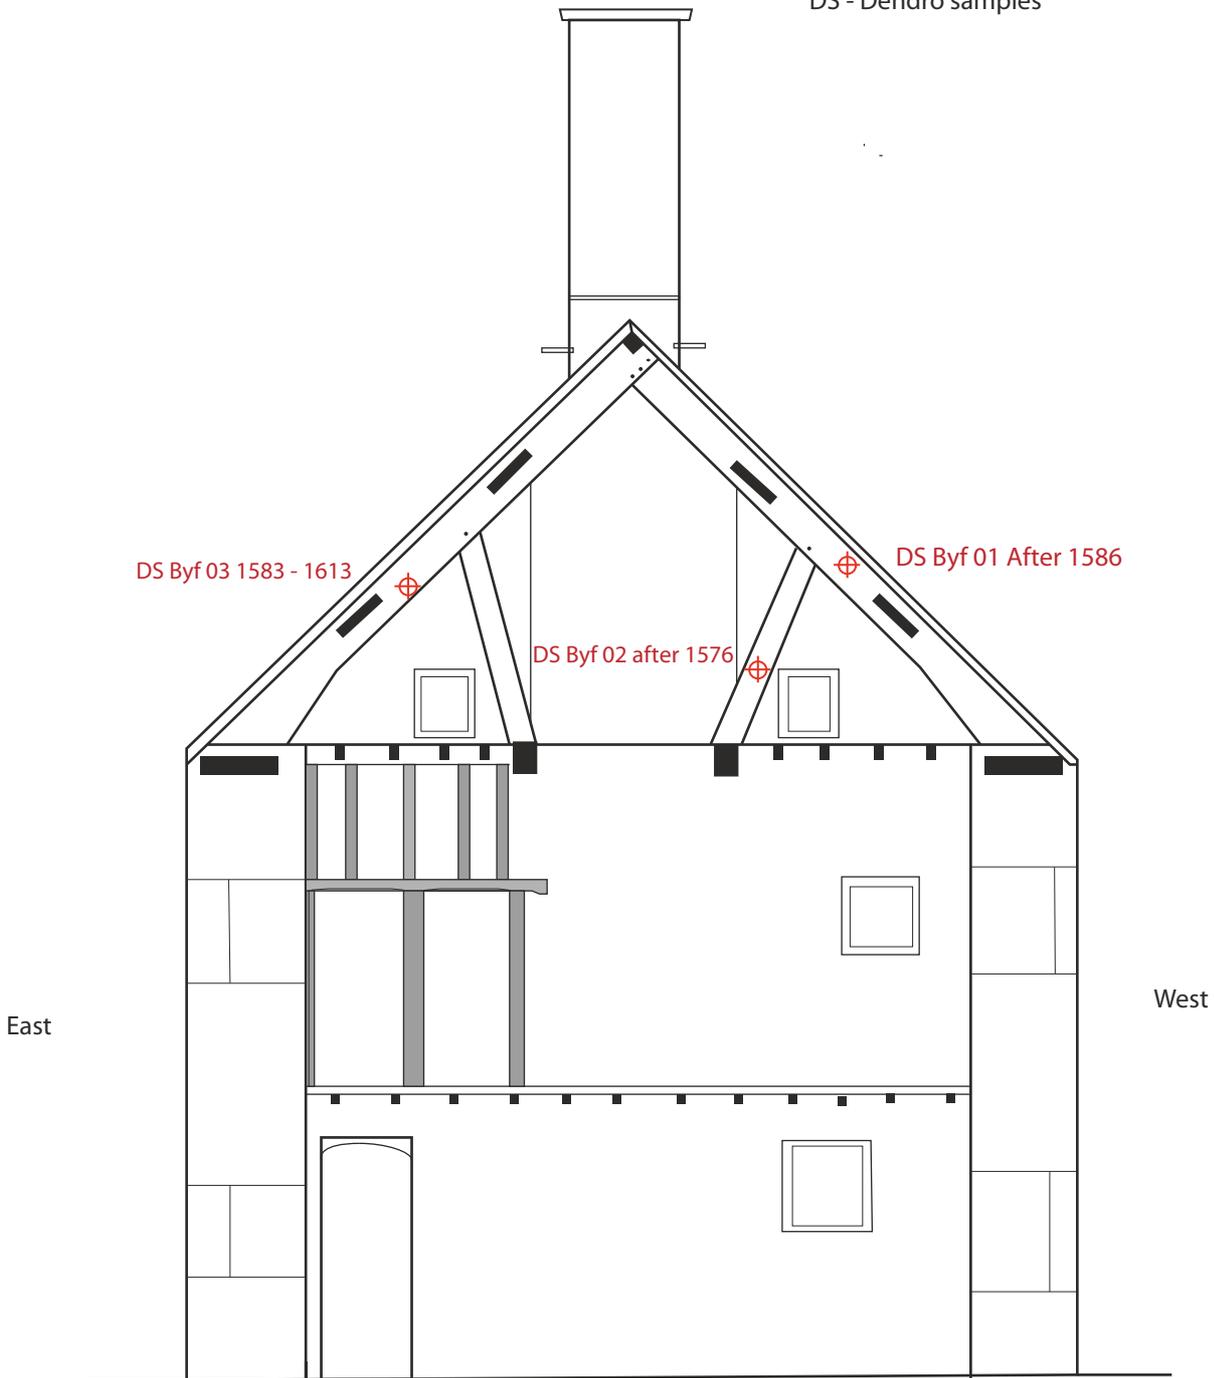
Figure 9 : Section AA - Truss 1 looking south.

Scale 1:50 > A4

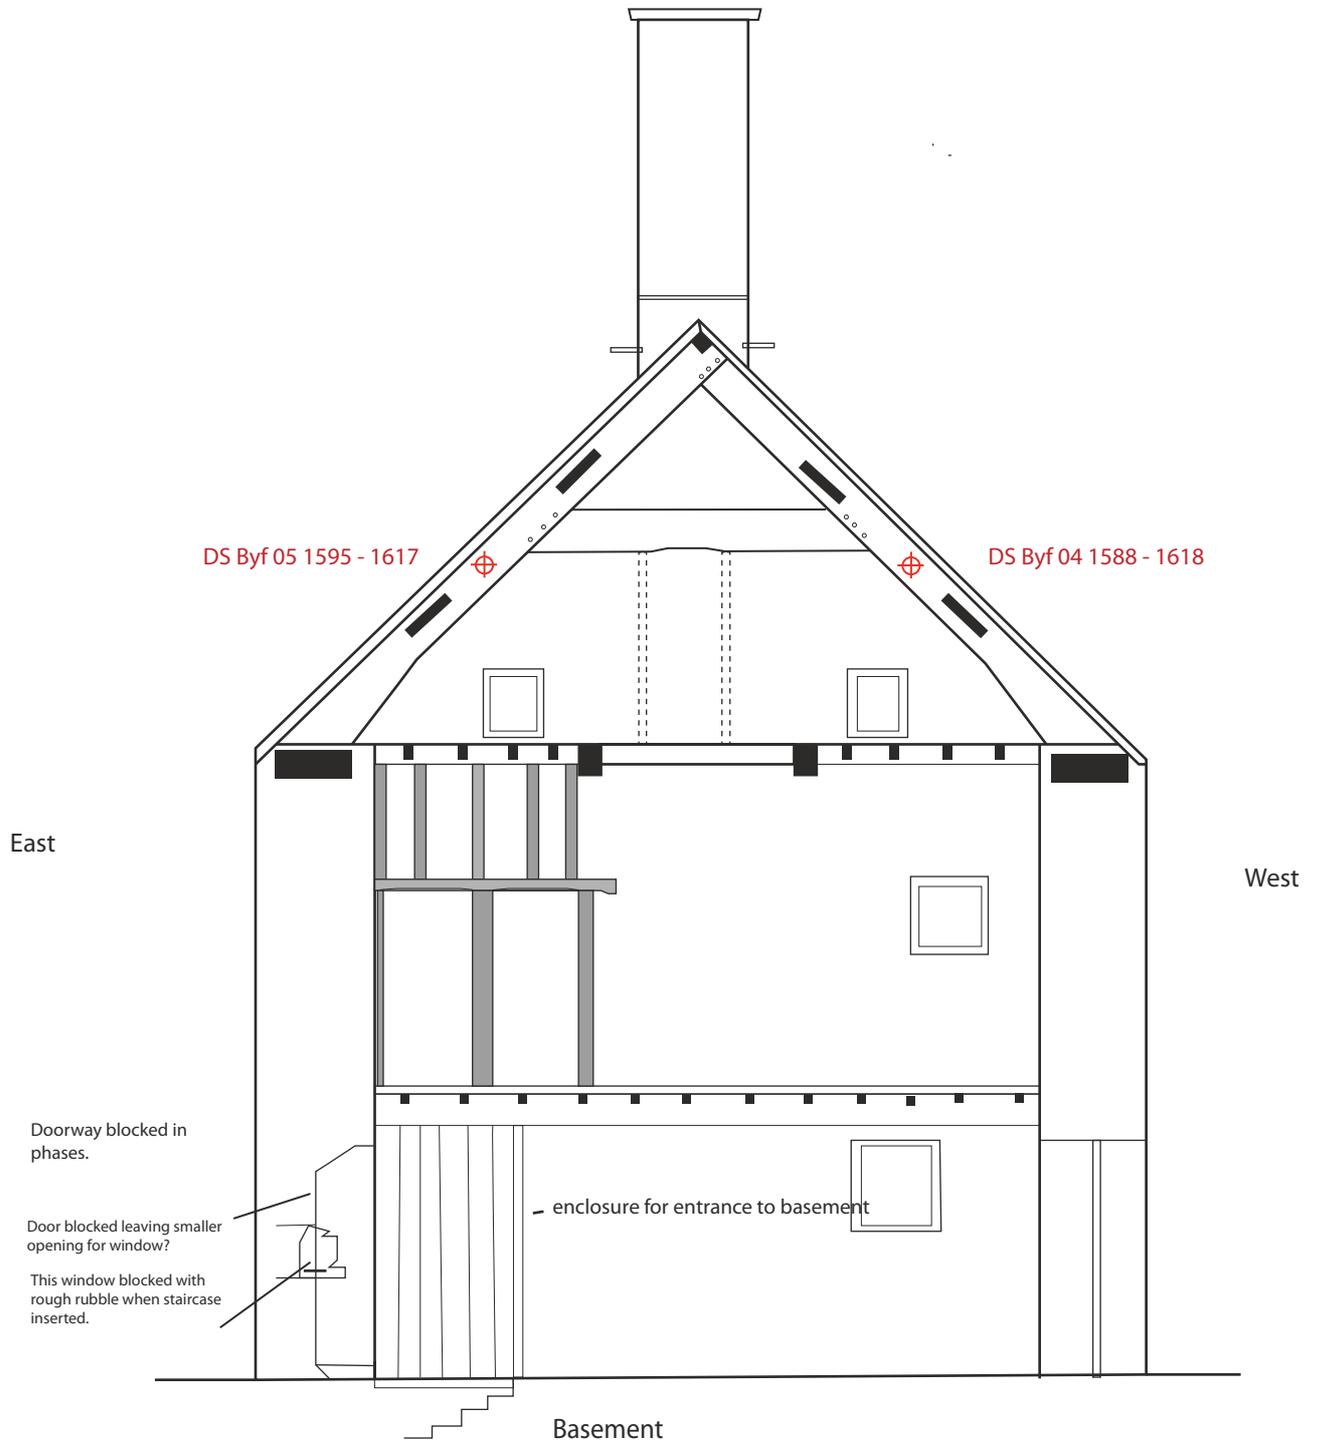
Figure 10: Section BB looking south. Truss 2 - principal rafters with collar

Truss 2. Principal rafters with collar.  
Mortised for partition

DS - Dendro sample

Scale 1:50 >A4

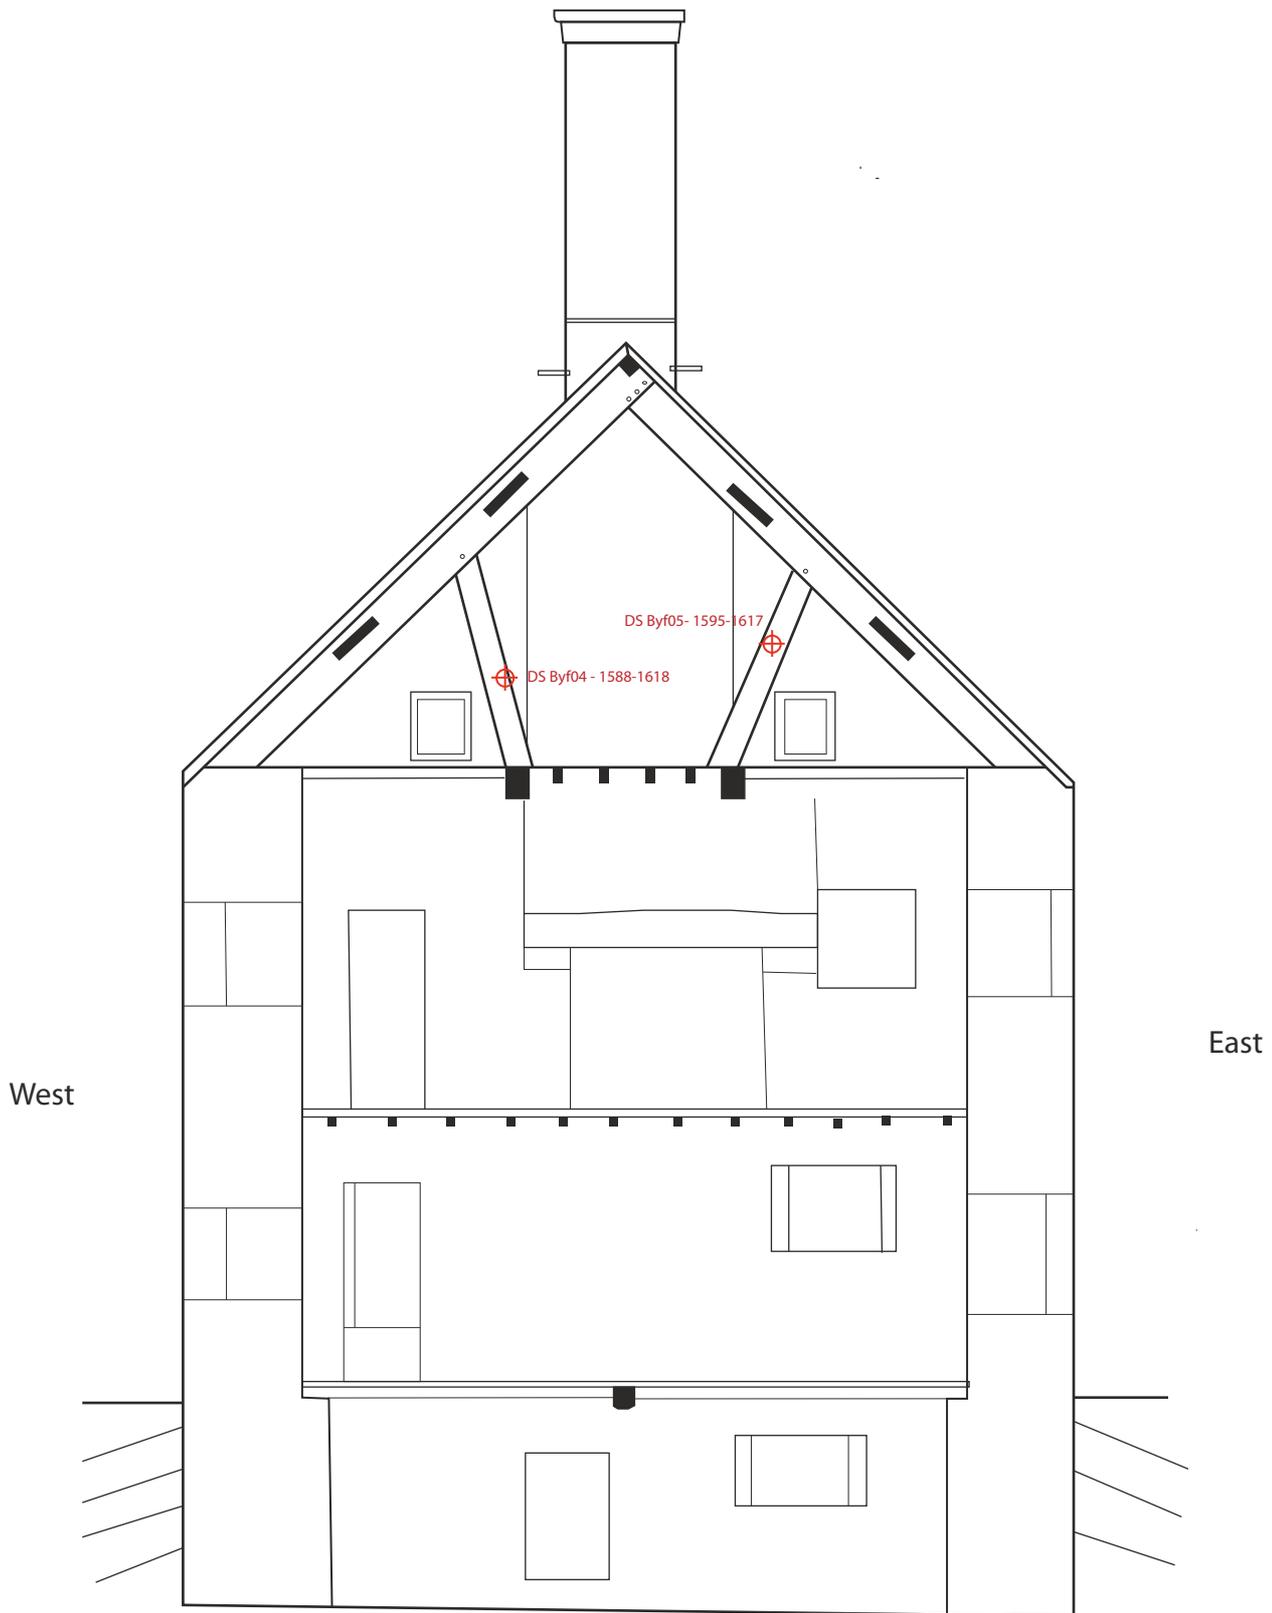
Figure 6: Bron Y Foel Isaf , Llanenddwyn, Dyffryn Ardudwy, Gwynedd, LL442HZ

Section CC looking north - Truss 3 - principal rafters with raking struts

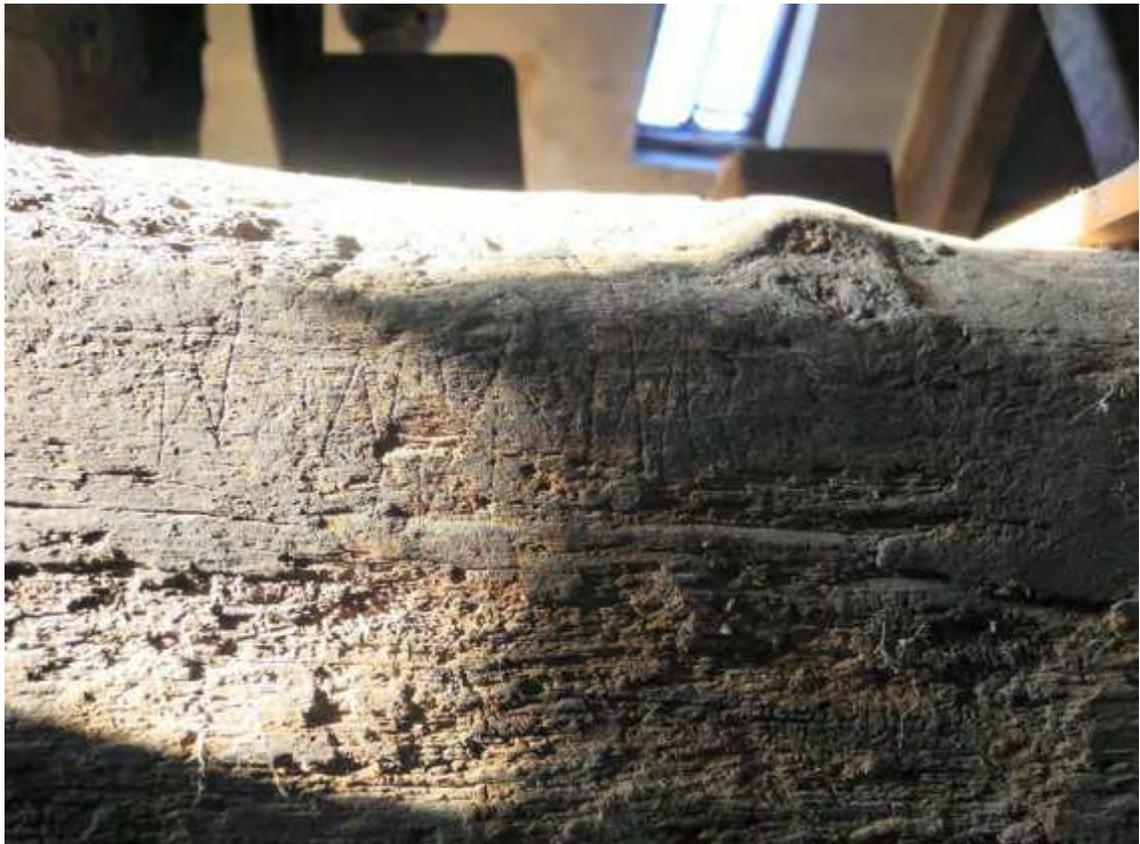
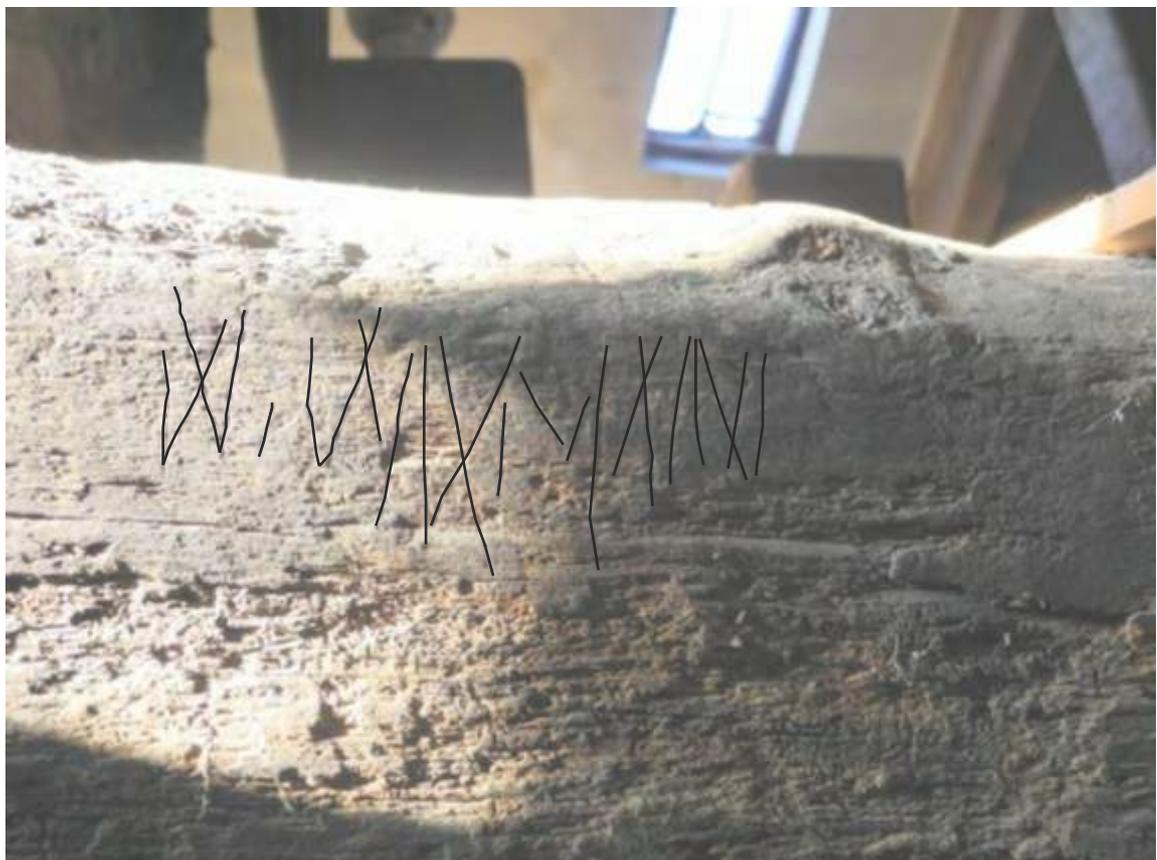
Figure 12 : Apotropaic scratch marks

Large beam protruding from first floor ceiling faced from top of staircase (south gable). Scratch marks discerned that have distinct similarities with apotropaic, ritual marks, used to avert witches. (Hall, 2005)

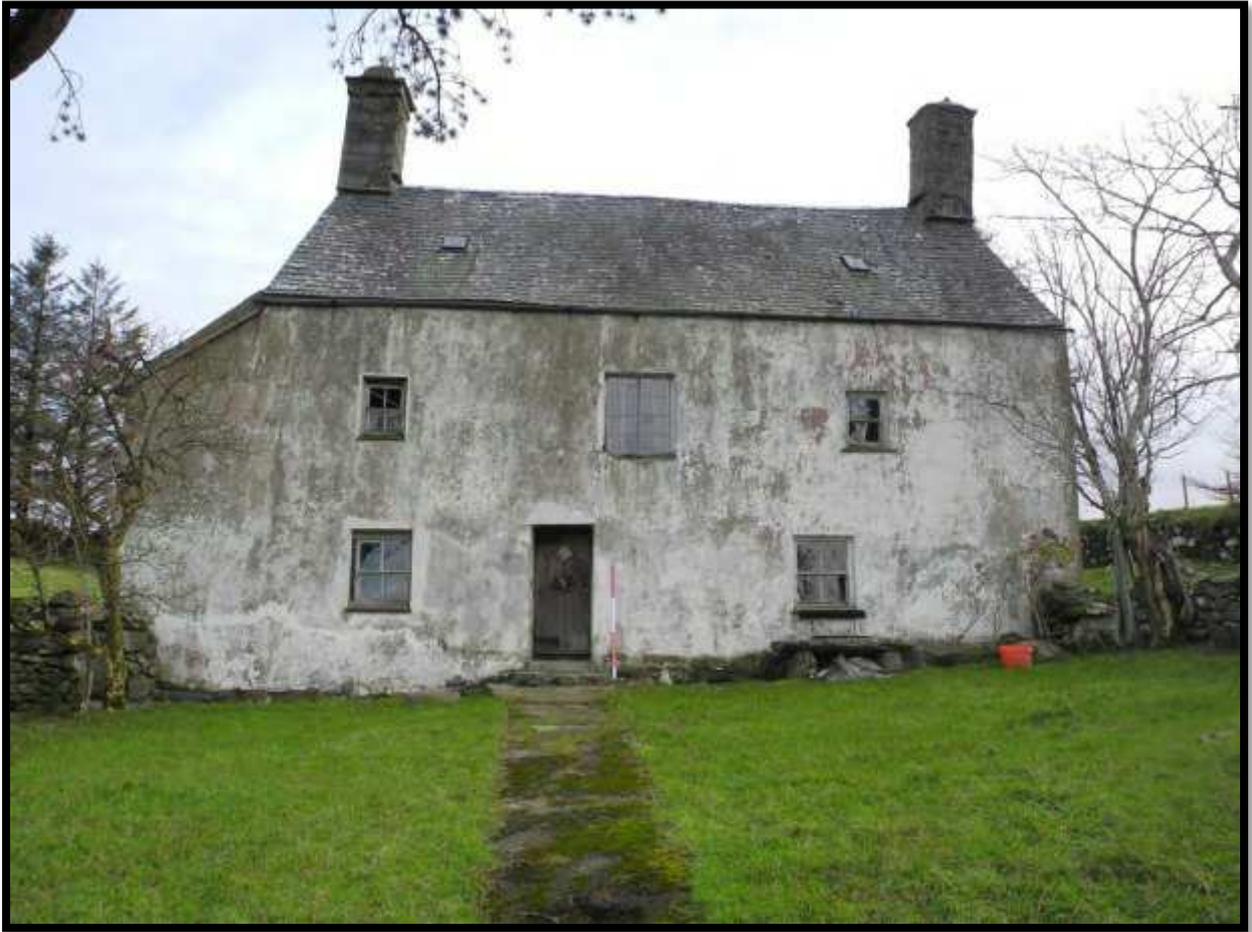
Plate 1 - Front elevation Bron Y foel

4.1.2 The (W) elevation (**Plate 1**) has been rendered and it is not now possible to discern alterations. However, the walling sits on top of a level plinth of larger, rougher boulders that run to the south of the doorway but not so discernible to the left and width of the building. The elevation nevertheless reveals its origin as a sub-medieval building of standard type. The front door opposes a blocked doorway in the rear (E) elevation to form the typical cross passage, situated between the service end to the left and the hall to right. The doorway was blocked, first to form a window which was in turn completely blocked when the later stairway was inserted. It is stated in the NMR that the doorways had cyclopean door heads (shaped arch from one piece of stone) but the front doorway is now re-rendered, covering the lintel, and the rear, east, blocked doorway actually displays a flat lintel.

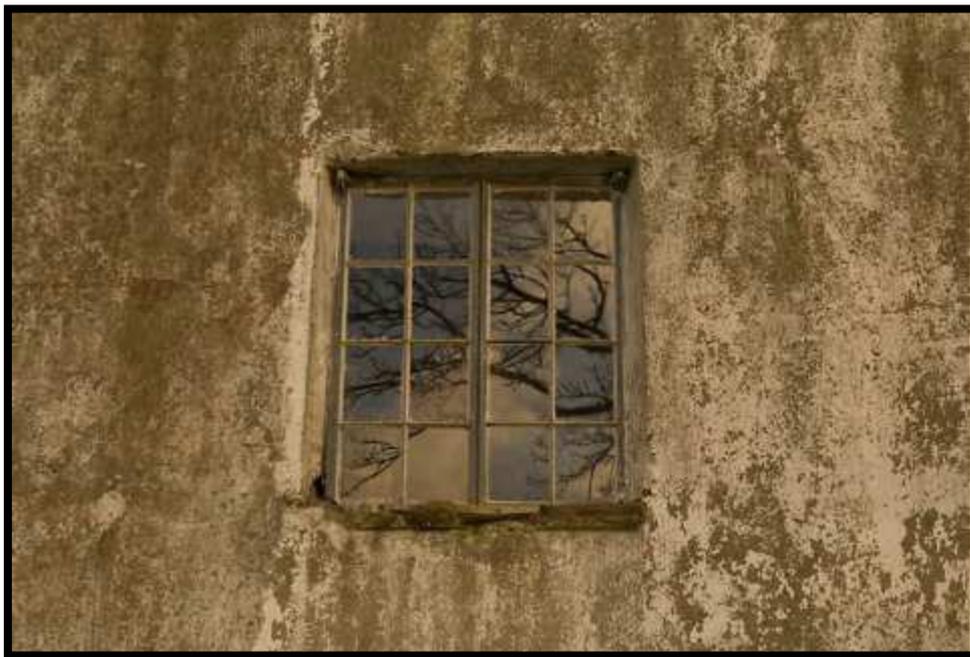
Plate 2 - metal casement, front elevation.

The front façade has been altered with the insertion of later sash windows, the central first floor window now being slightly enlarged, with a metal casement window (**Plate 2**) replacing a sash window according to photographs in the possession of the owner. It is possible that the first floor window was a later insertion but this is conjectural. The positions suggests the windows replaced earlier mullion windows. Windows may have been introduced to light the rooms once the partitioning was inserted in the first floor.

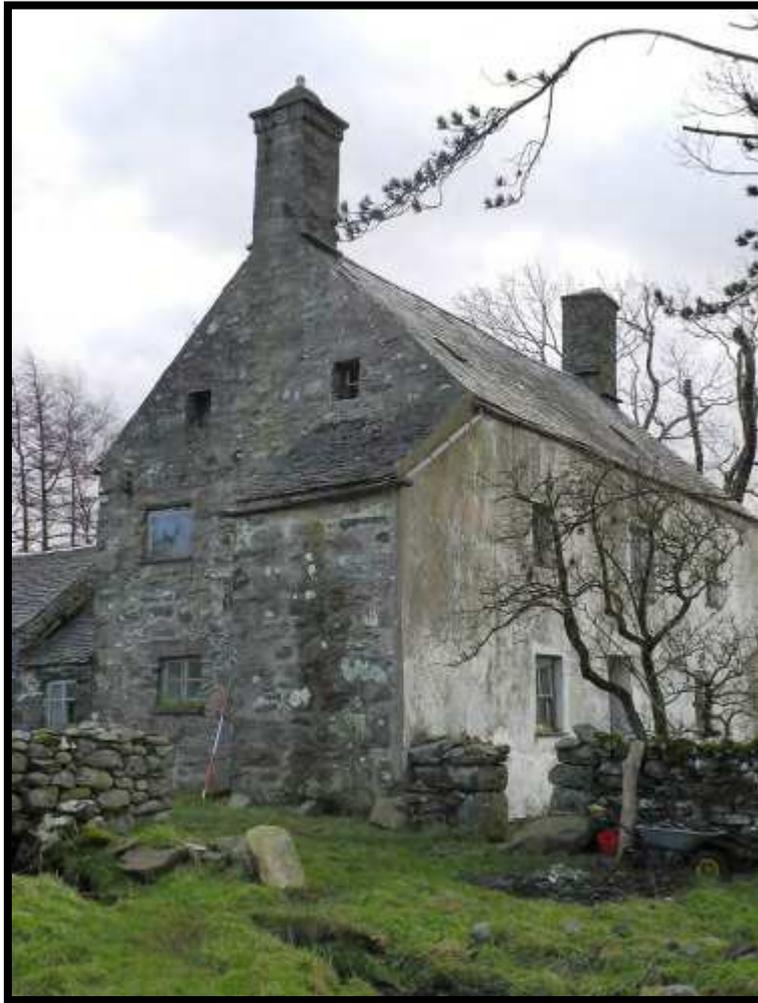
Plate 3 - Gable from NE showing latrine block

A window lights the hall and service room at GF level and three windows light first floor level. To the extreme left (N) a two storey latrine block with a pitched slate roof falling from front eave height. (**Plates 3,4,5,6**) The block abuts the gable and is lit on both floors by a small oak mullion window with frame still *in situ* but the mullions themselves have gone, leaving only the frame and mortises. The remainder of the north gable is pierced by a number of openings which leave a notable impression. Two simple openings light the loft either side of the chimney. A window at first floor and a further window at ground floor level, both probably enlarged. To light and access the basement there is a further window and a door, all with later timber. The shallow stream that runs under the latrine block still flows and stone steps, now overgrown and rough, lead down to the basement entrance and the latrine chutes are clear and unblocked to their respective floors.

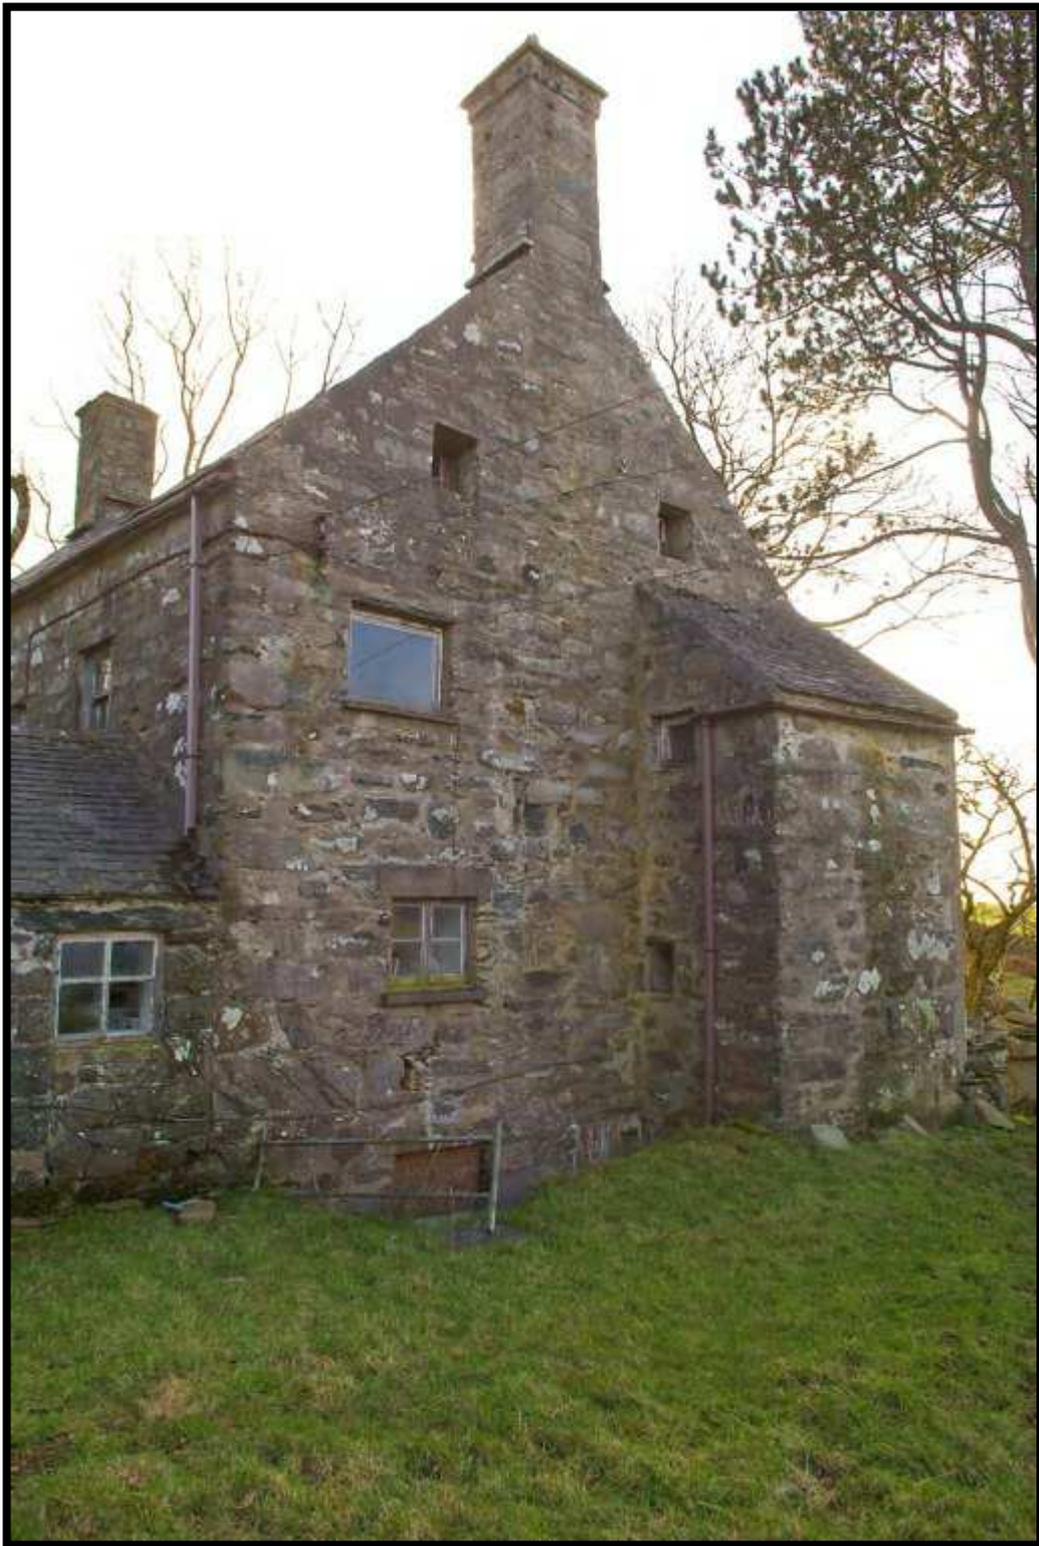
**Plate 4 - North gable revealing fenestration and the latrine block.**

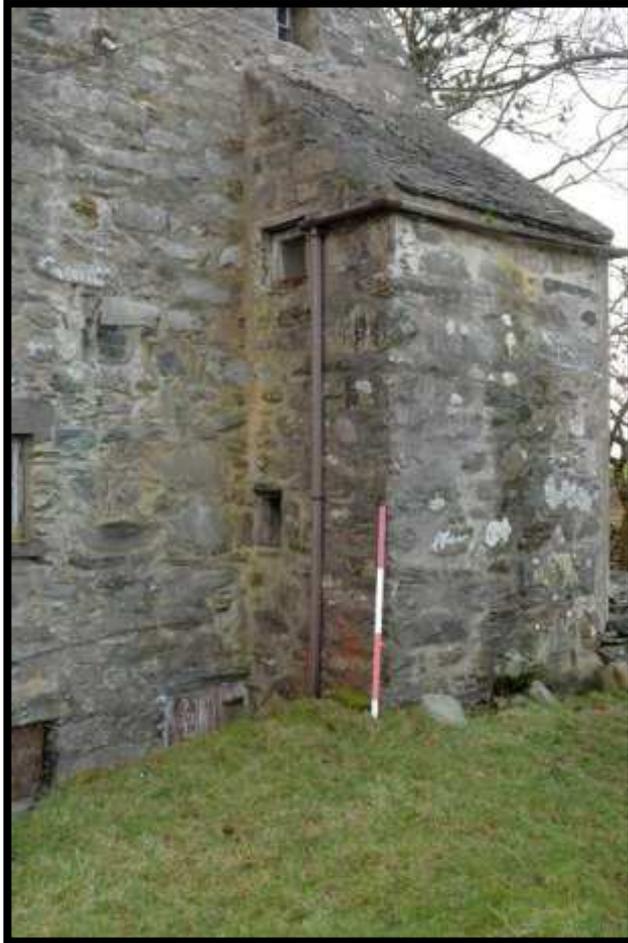
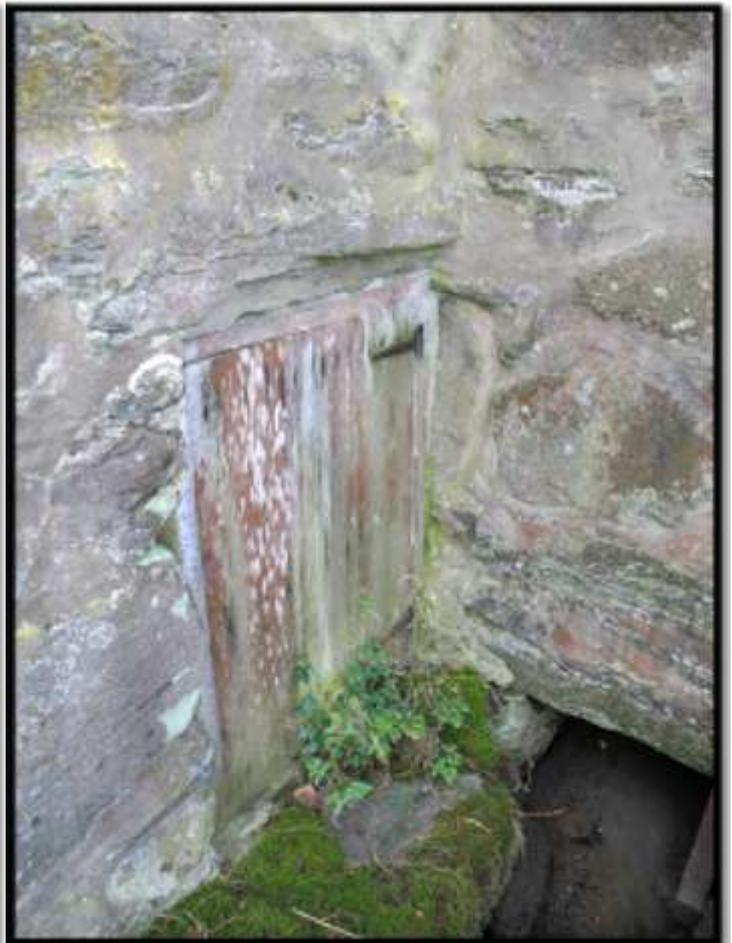
Plate 5 - Latrine block and basement with later door

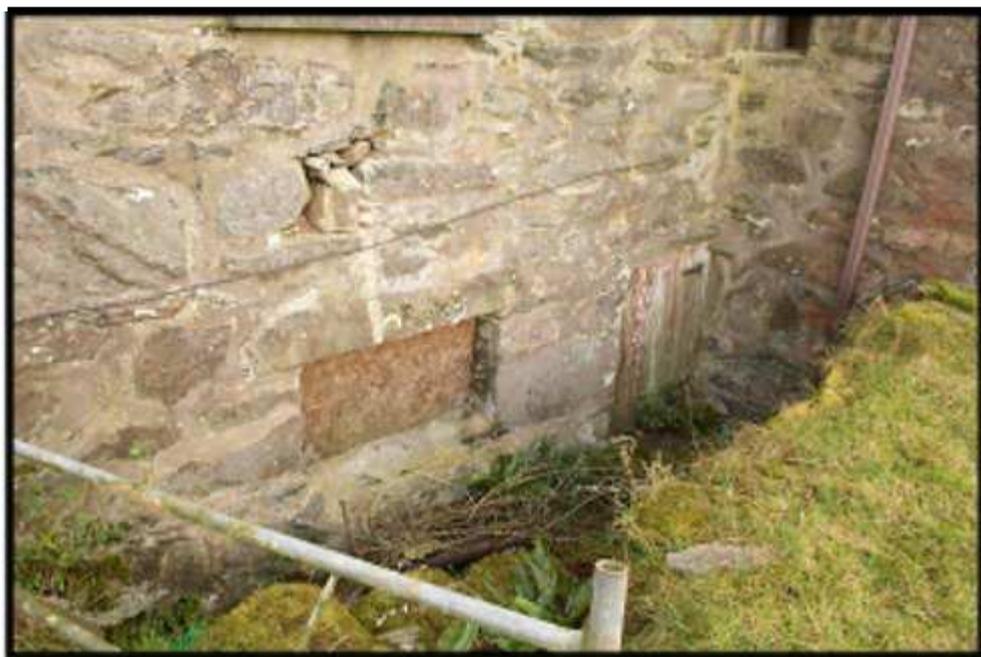
Plate 6 - basement window and door

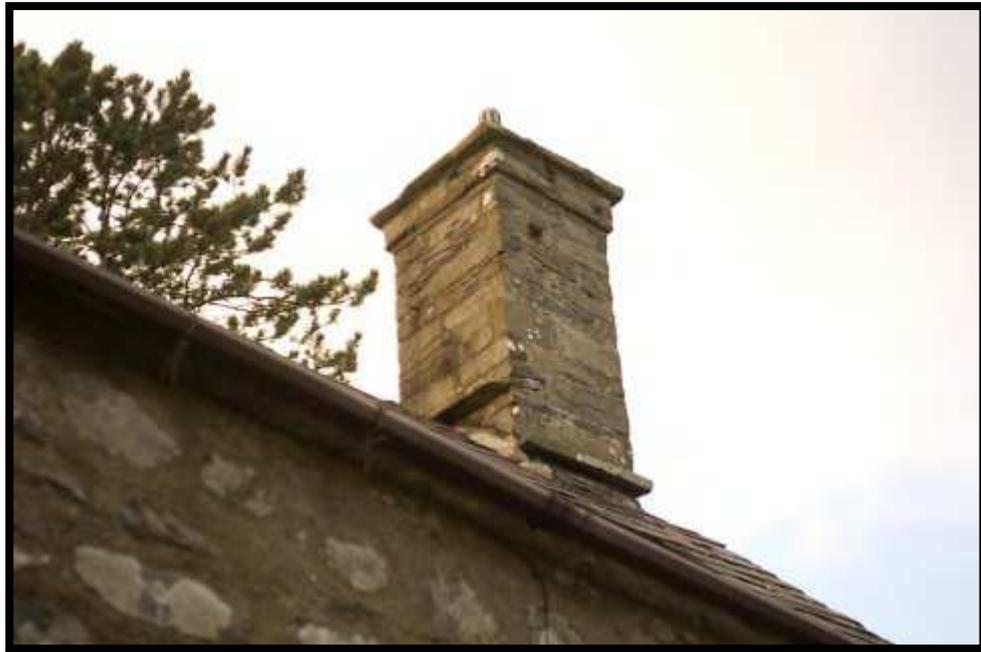
Plate 7 - North chimney

4.1.3 The roof has two gable end chimneys. To the left, N gable, a large square stack of dressed masonry rises from the gable and has simple bands to produce a decorative moulding at the top. (**Plate7**) This chimney serves a fireplace in the first floor chamber. The
