**NORTH WEST WALES DENDROCHRONOLOGY PROJECT 2009-2012**  
**PROSIECT DENDROCRONOLEG GOGLEDD ORLLEWIN CYMRU**

**DATING OLD WELSH HOUSES / DYDDIO HEN DAI CYMREIG**

**Bron Y Foel Isaf, Dyffryn Ardudwy, Gwynedd, LL44 2ZH**

**ARCHITECTURAL RECORD /COFNOD PENSARNIOL**

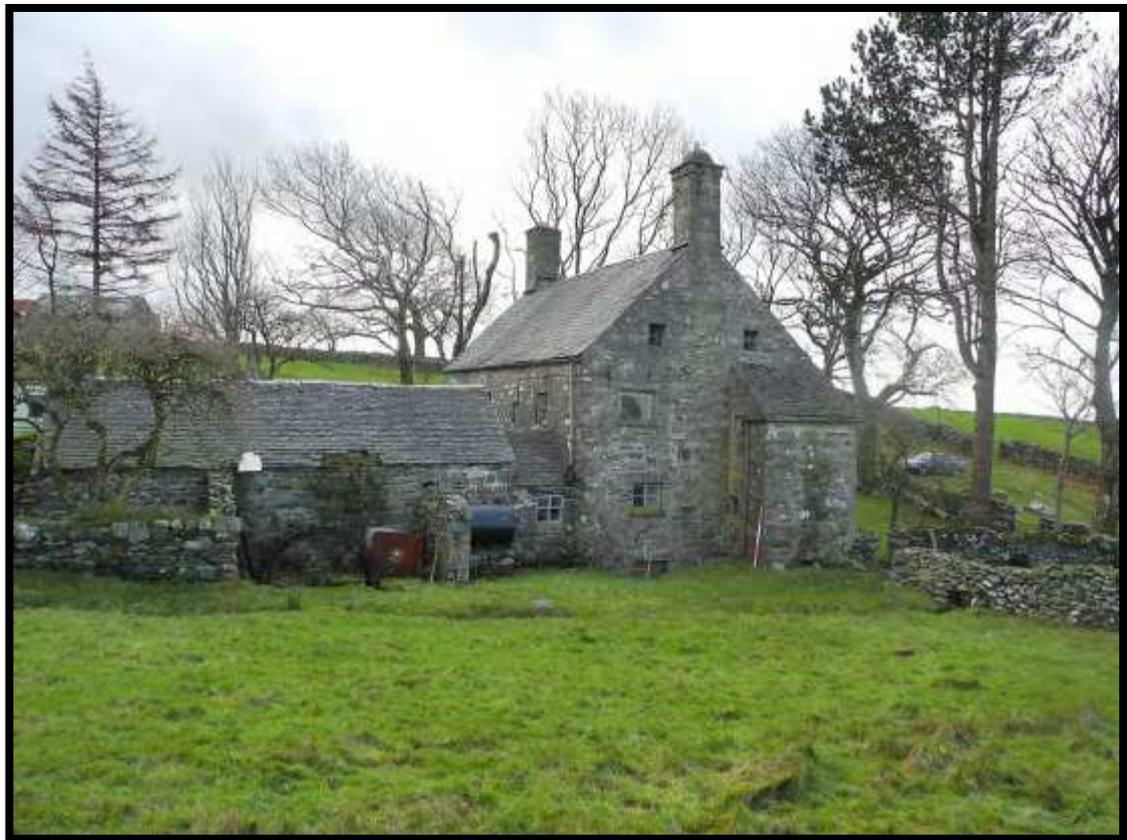
Plate 8 - House and 19th century range of outbuildings

4.1.4 The N gable is joined to the east by a small masonry link that extends to a single storey range constructed probably in the 19th century. **(Plate 8)**

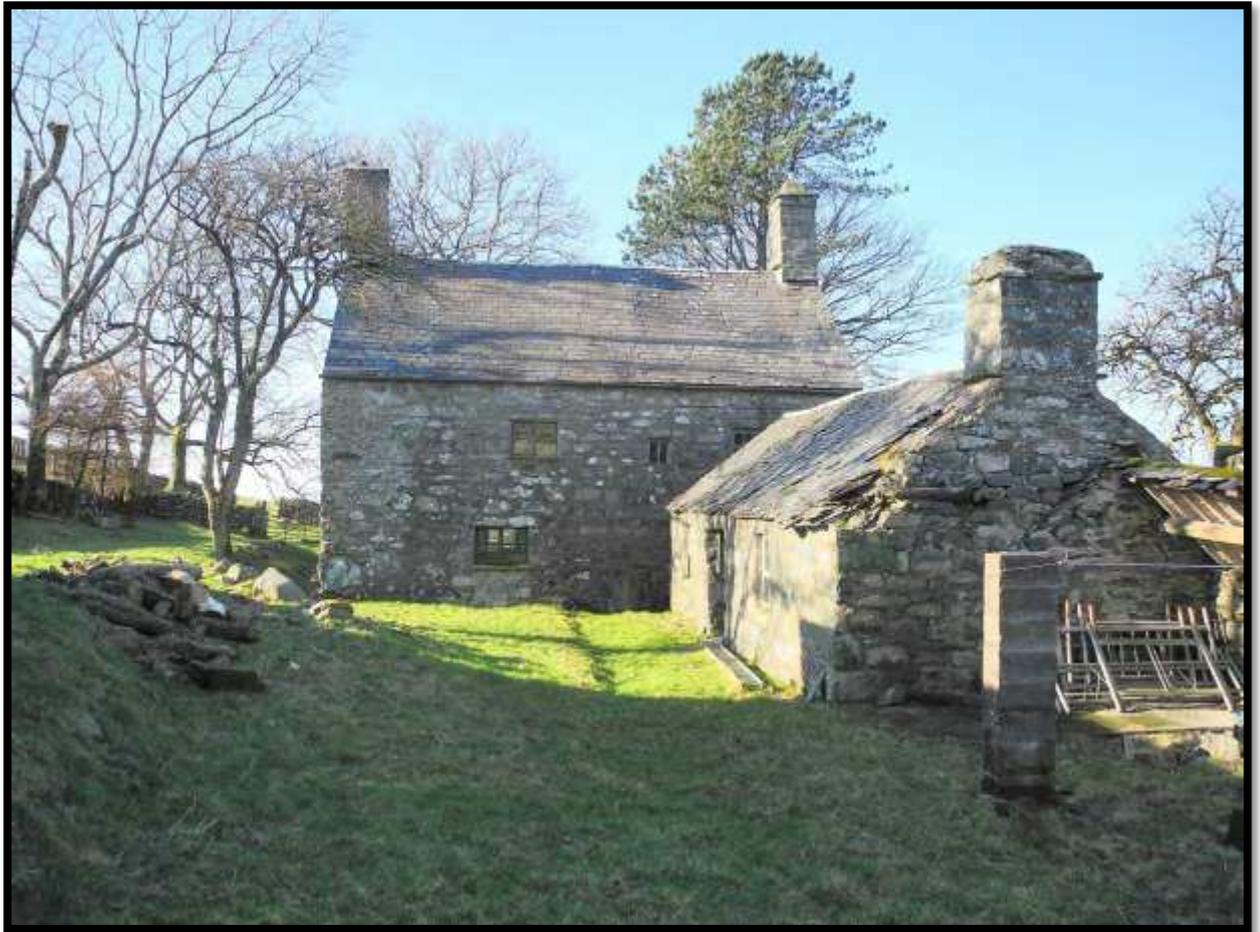
Plate 9 - East elevation with 19th C range to right.

4.1.5 The eastern elevation, continuing south from the link forms the rear of the building and the stonework is exposed and pointed with relatively modern cement mortar **(Plate 9)**. The opening for the blocked opposing cross passage doorway is evident from the flat lintel and shadow of the former doorway **(Plate 10)**. There are three windows of varying sizes lighting the first floor with the smallest lighting the later stairs. A further window, with modern timber casement lights the hall on the ground floor **(Plate 11)**.

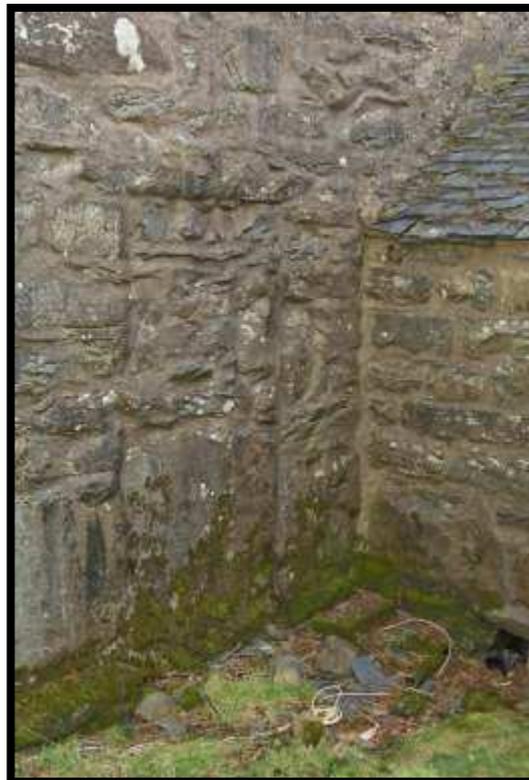
Plate 10 - Cross passage blocked doorway

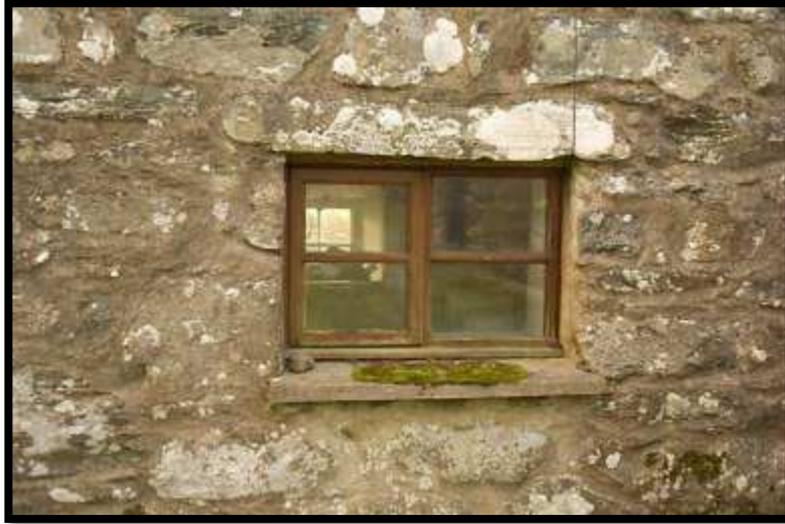
Plate 11 - Hall window with modern casement.

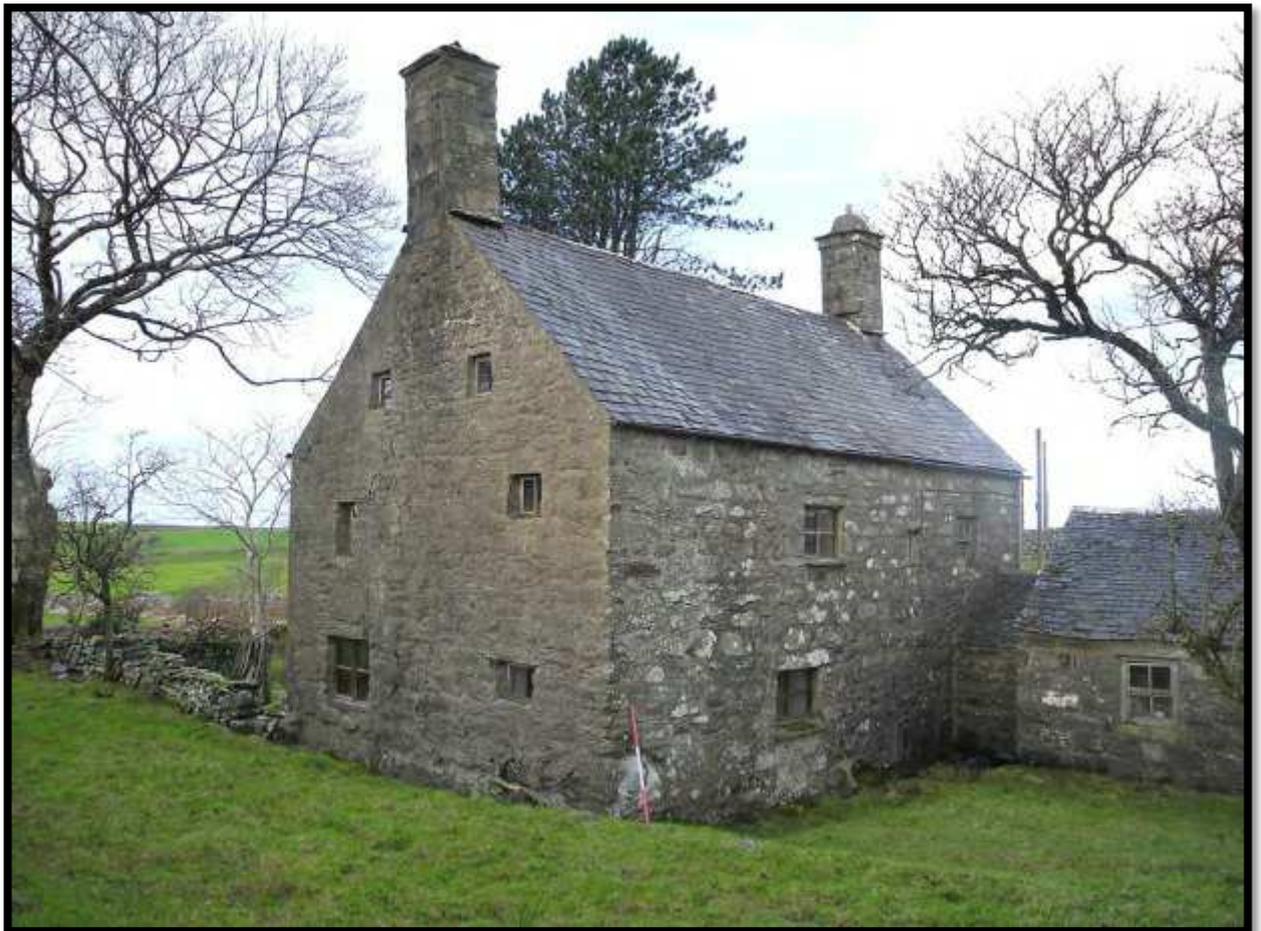
Plate 12 - South gable

4.1.6 The plain south gable is pierced with six windows. Two light the loft area in the same fashion as the north gable and there are two windows that light the stone (and timber) staircase to the right. The two windows to the ground and first floor (W) appear to be insertions or enlargements of earlier windows. All have later, modern casements or fixed glazing **(Plate 12)**.

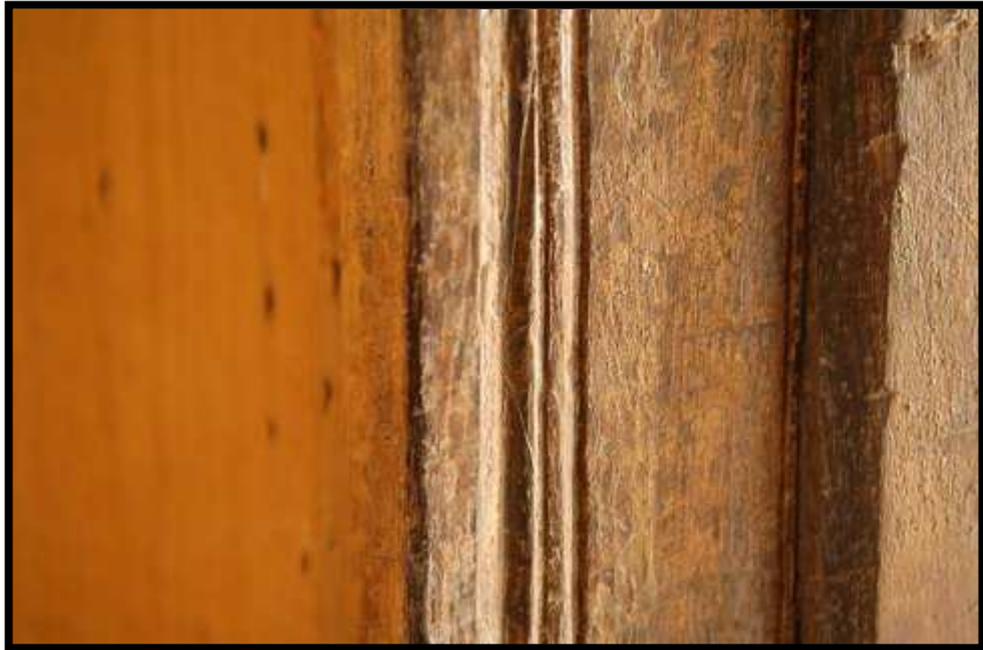
Plate 13 - door post south screen remnant. Moulding typical of 16th C

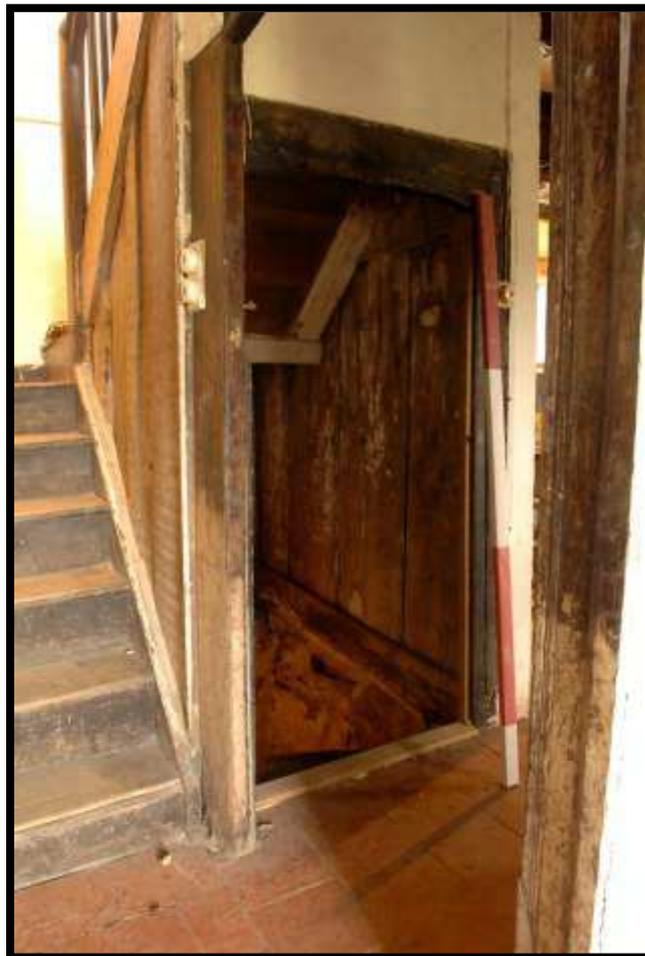
Plate 14 - later staircase and entrance to basement

4.2.2 Passing through the W door we enter the cross passage. **[GF1]** The screen partition to the right (S) has been re-constructed and plastered. The doorway to this screen may not be in its original position and has been altered to facilitate the enclosure of the entrance to the basement. The right door jamb, incomplete, with scratch moulding, (plate13) may be an original fragment with the rest being later. The staircase then occupies the position of this portion of screen, re-using planking from the former screen and fixed to later studwork. A dogleg staircase with half landing stair winds behind this enclosure **(Plate 14)**.

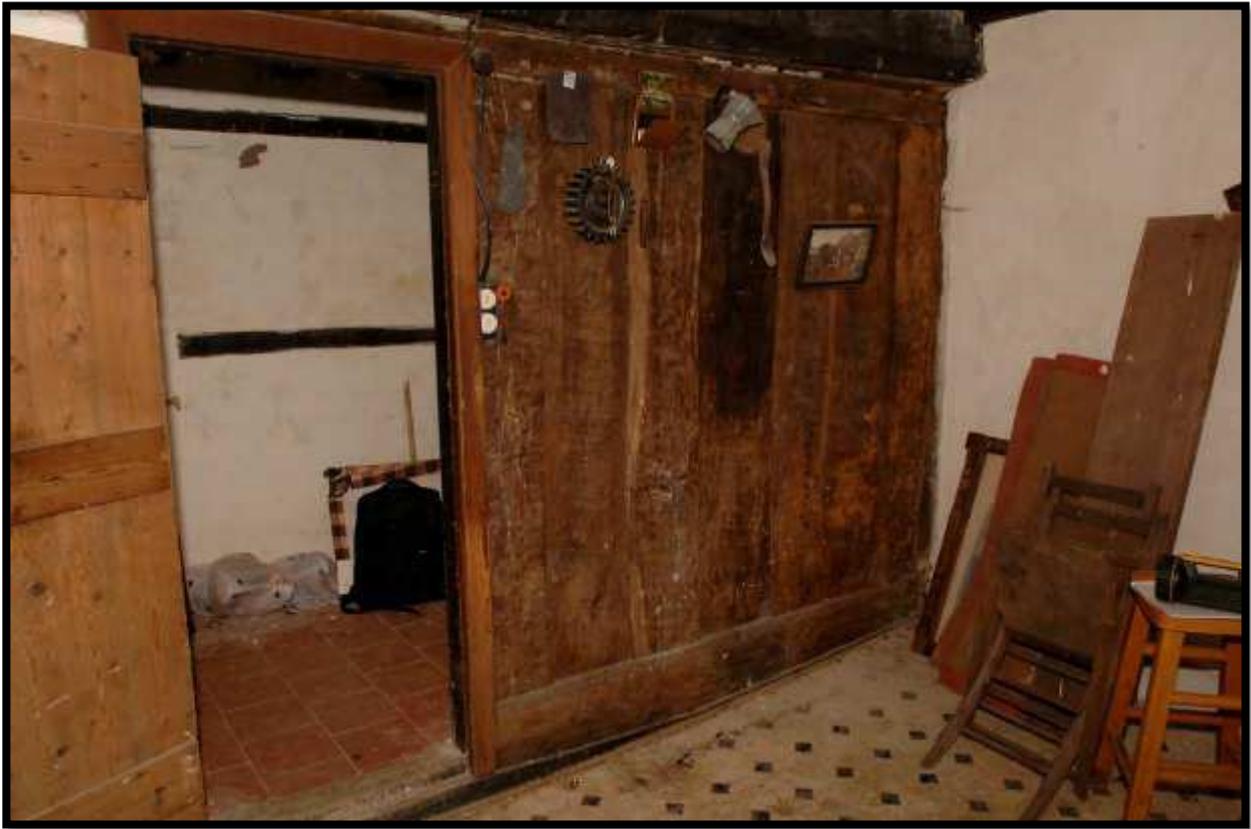
Plate 15 - Part of passage screen. Service room.

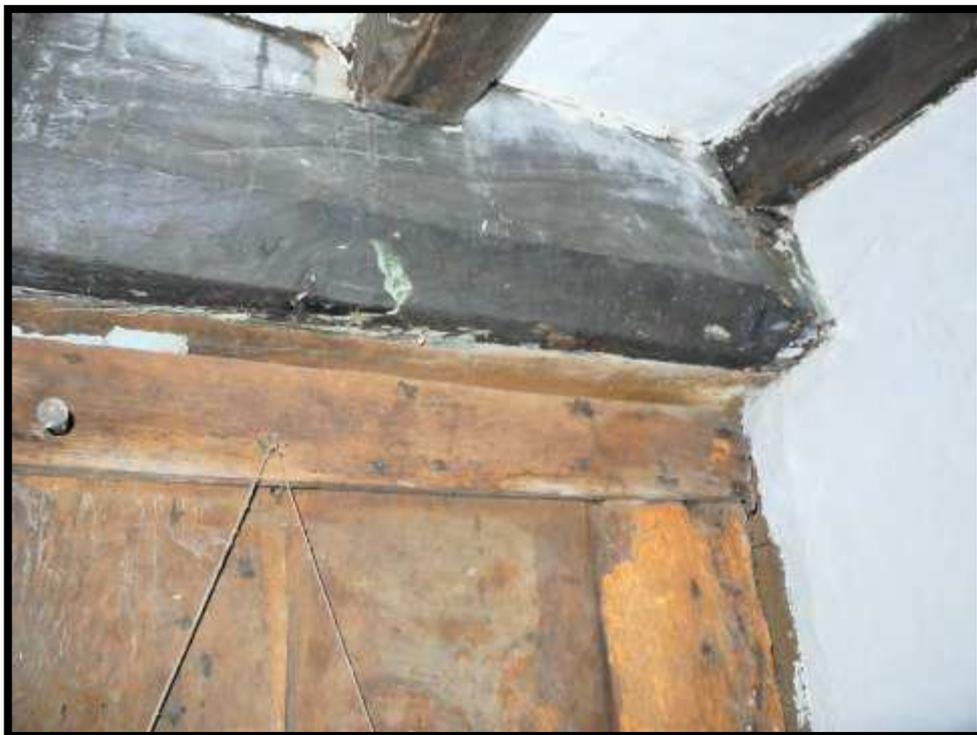
Plate 16 - Main beam over screen, chamfer & stop. No Mortise.

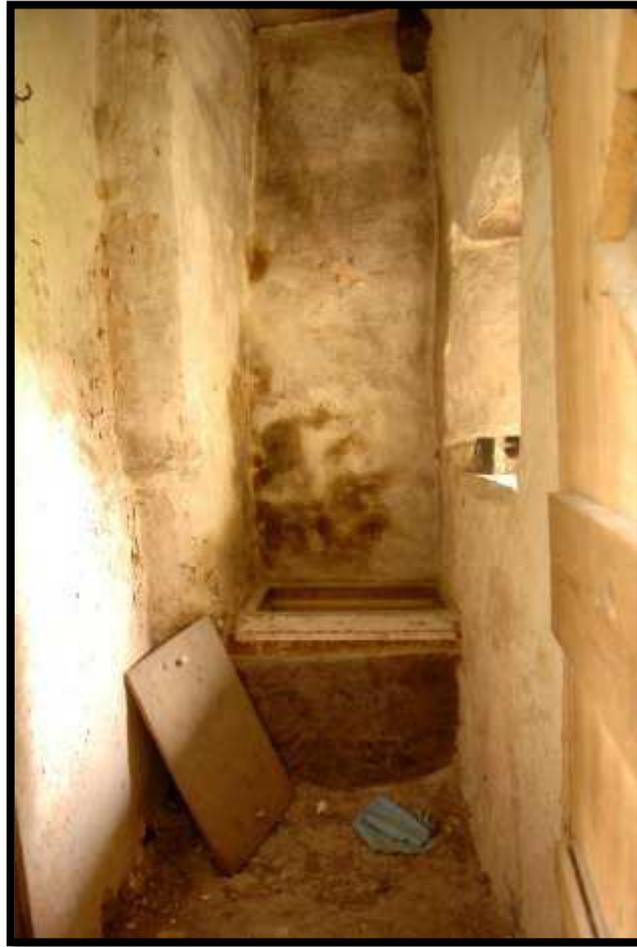
Plate 17 - Latrine or garderobe

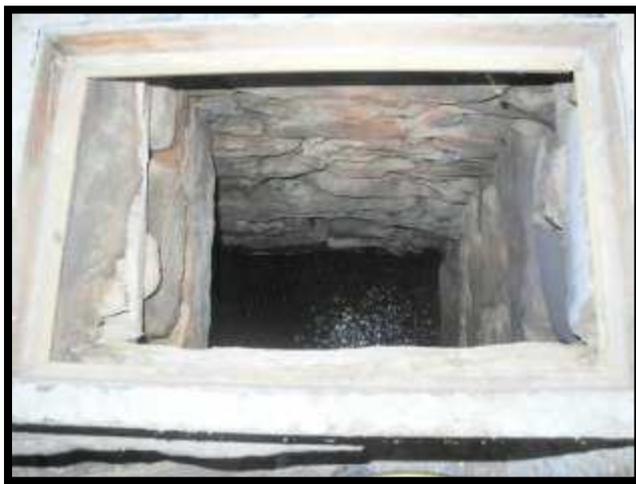
Plate 19 - Latrine chute directly over stream.

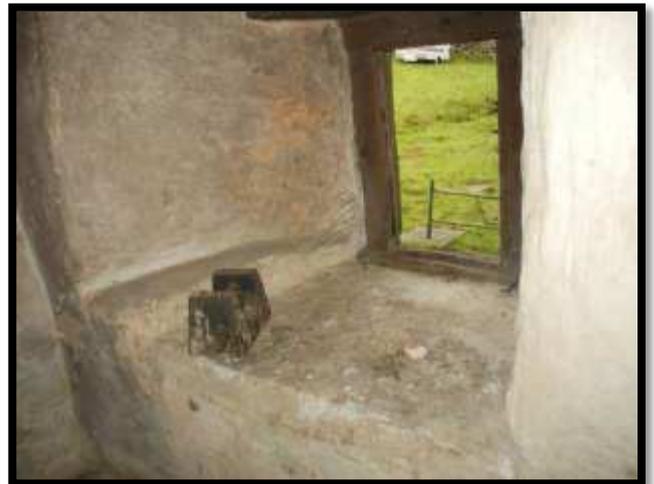
Plate 18 - Latrine - light and ventilation

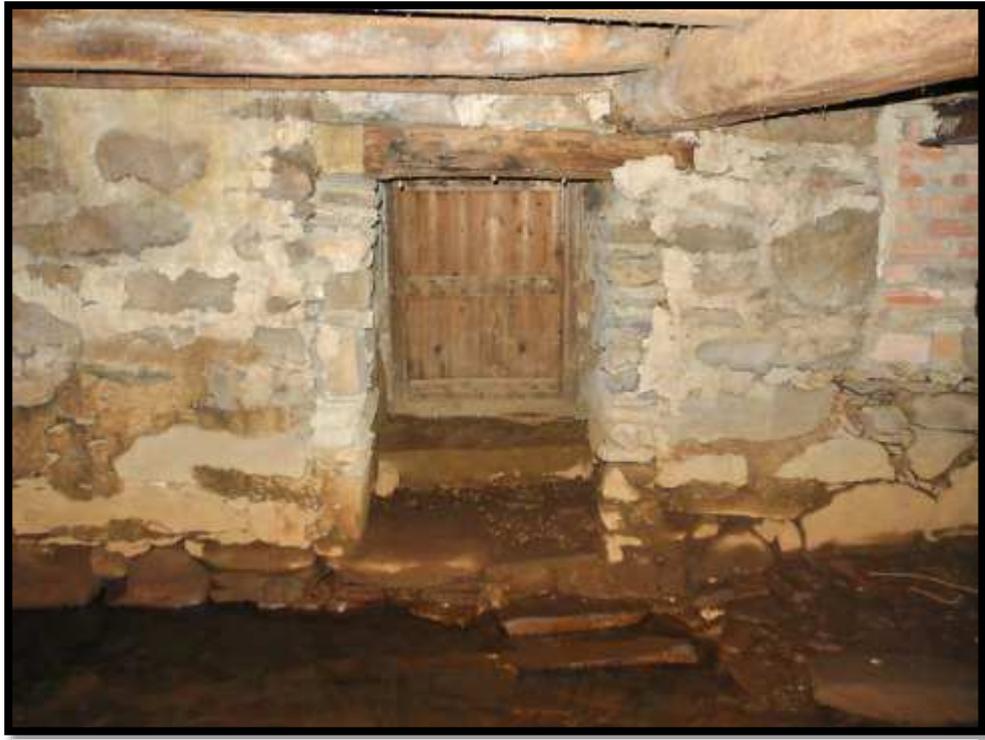
Plate 20 - Basement - external door, remodelled doorway south gable

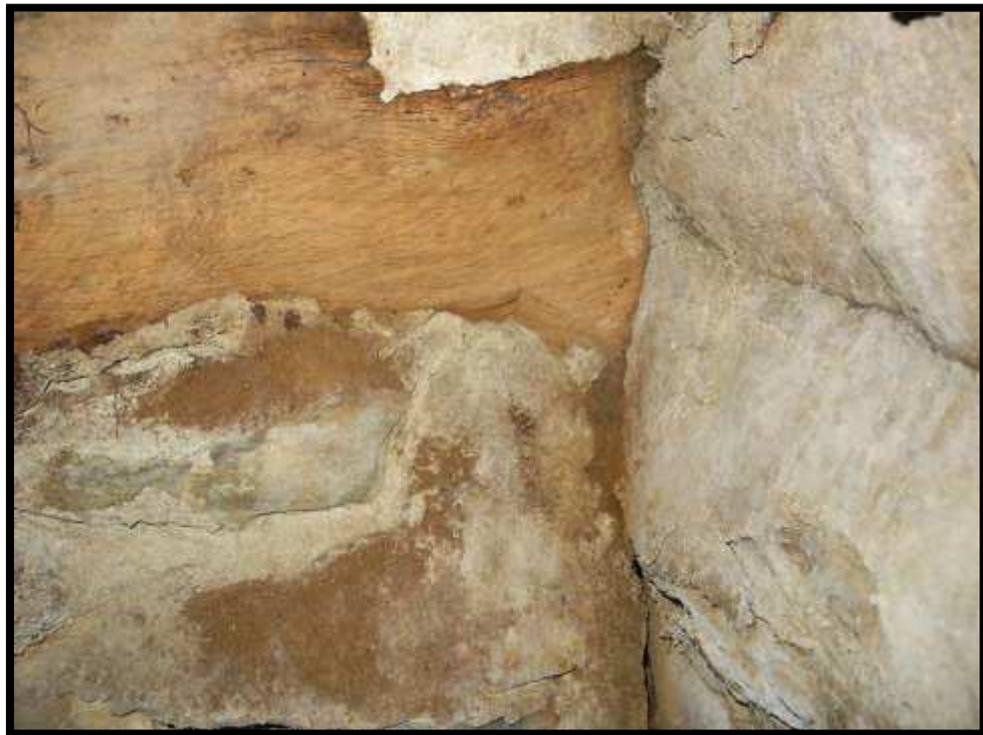
Plate 21 Basement -south end of main beam. Chamfer & stop just visible and fully located in wall with later supporting pillar underneath to the left.

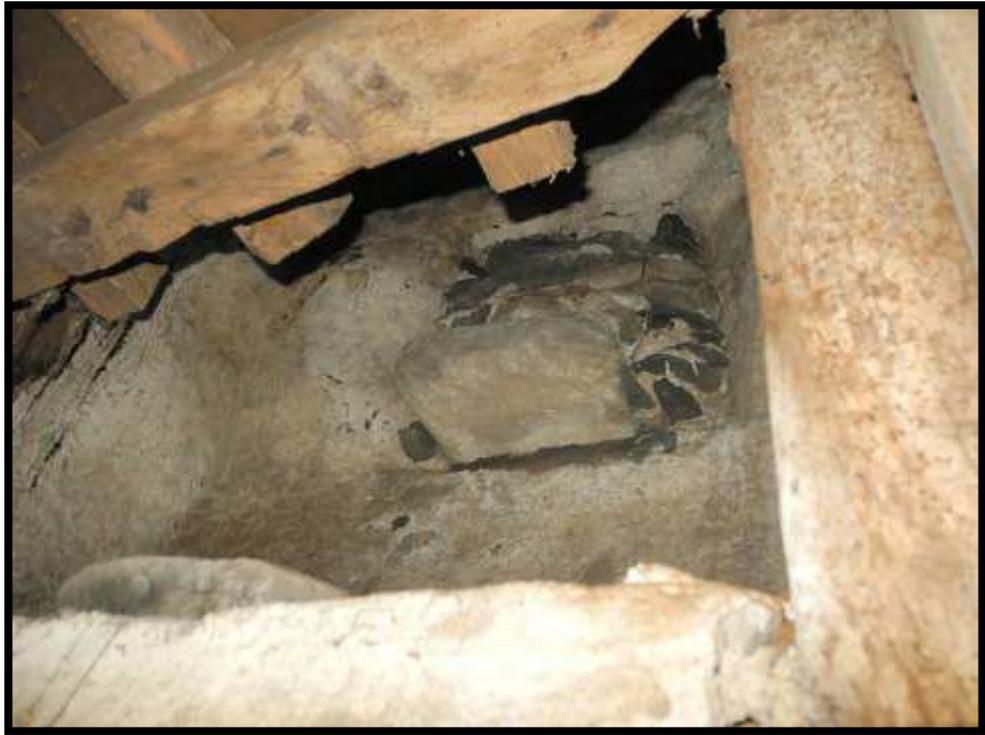
Plate 22 - Blocked cross passage door. This doorway appears to have been reduced in size leaving a small window, which can be see has been filled in roughly with stones.

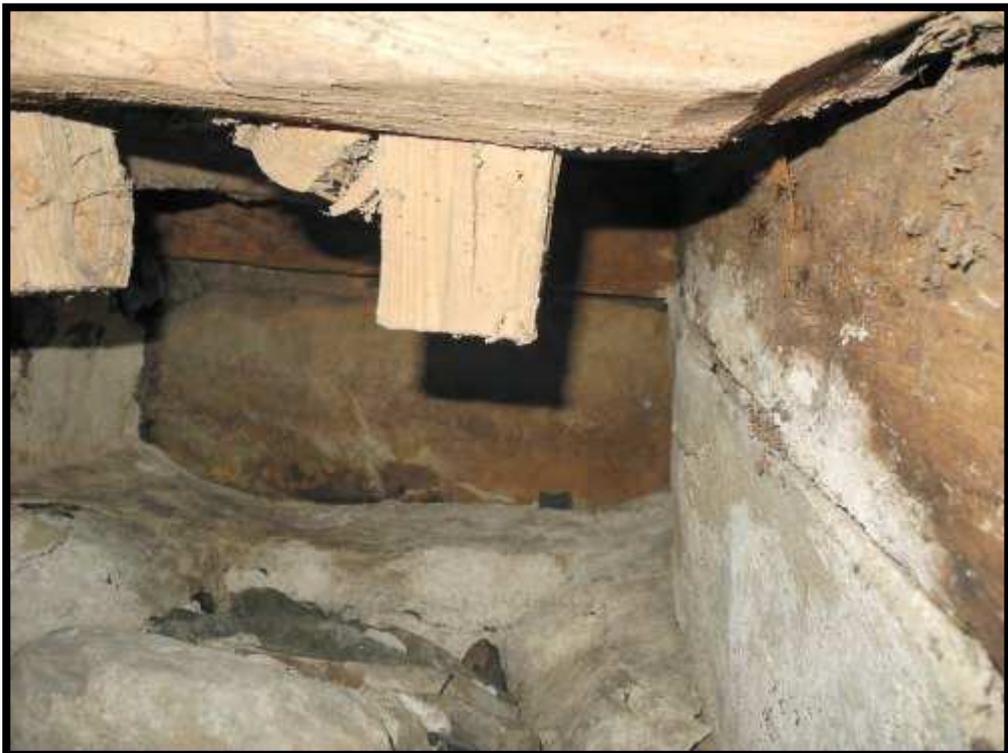
Plate 23 - In this image an oak frame is clearly seen, including head and the plaster can be seen applied to the reduced doorway.

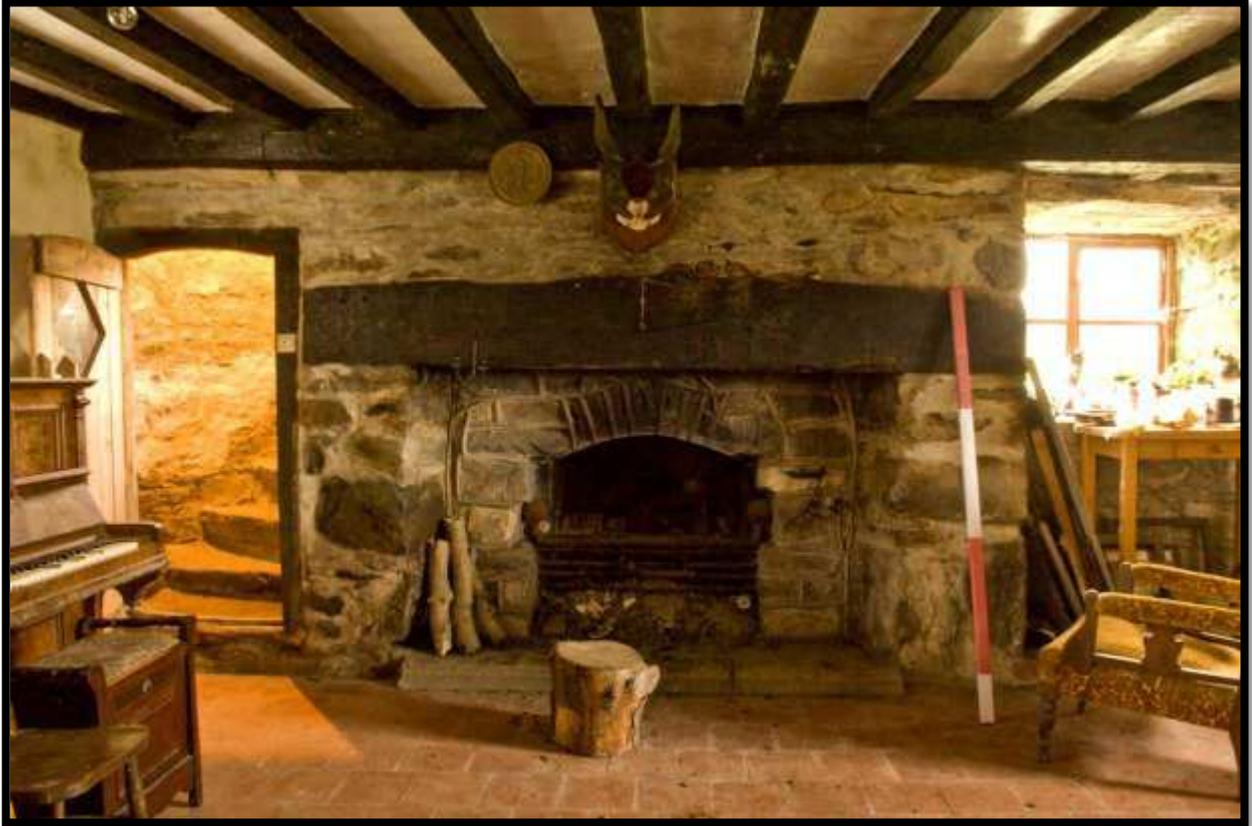
Plate 24 - Hall, fireplace and stair

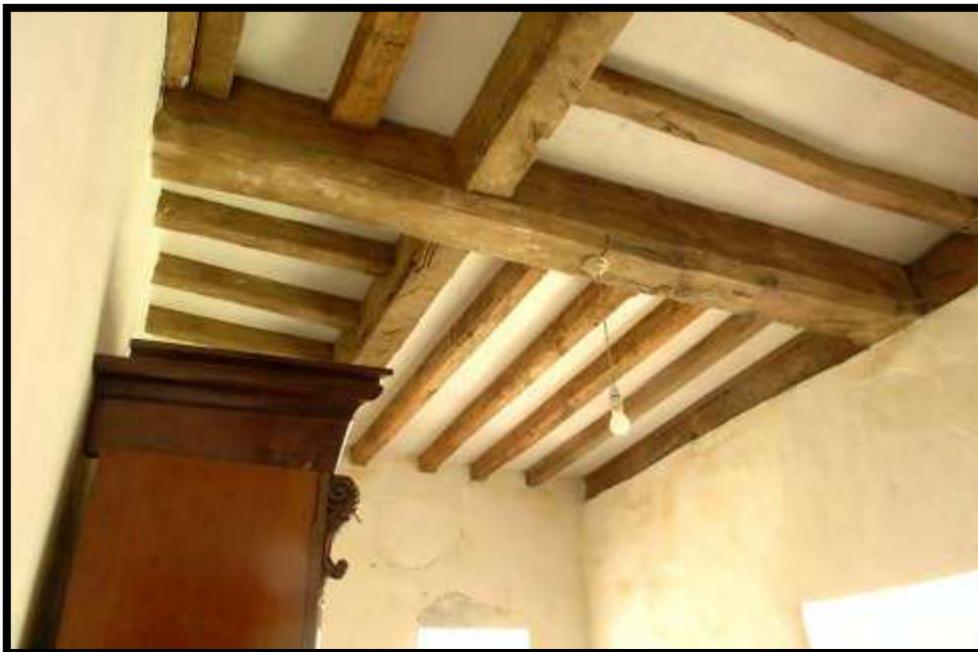
Plate 25 - Portion of the of the first floor ceiling

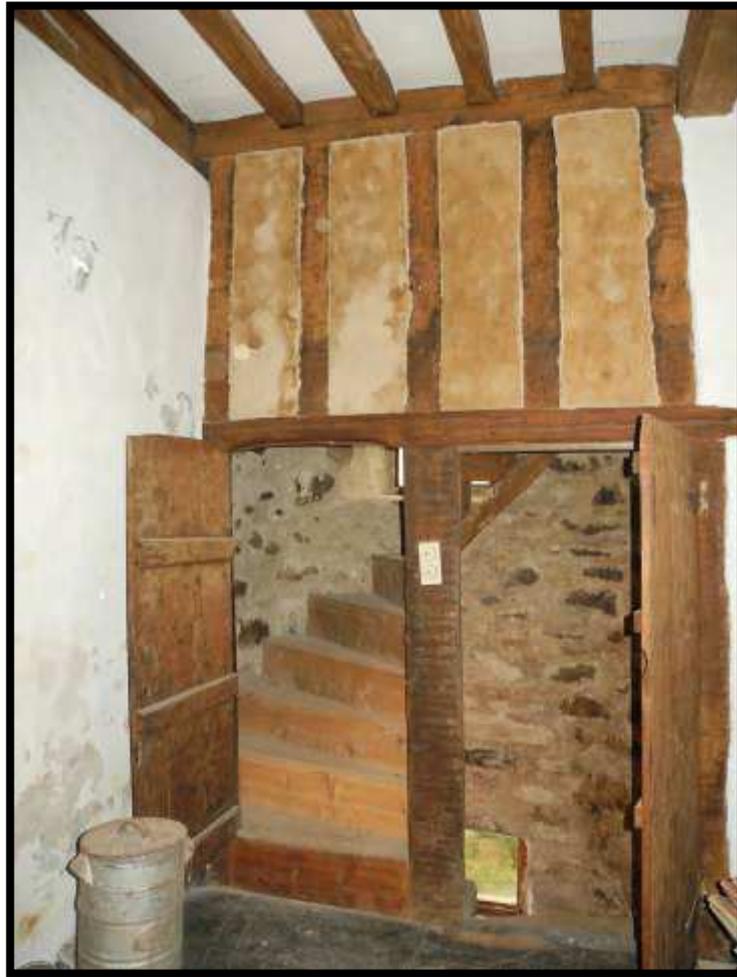
Plate 26 - Timber framed partition with doors to stairs.

4.3.4 The remainder of the floor is divided by partitioning into two further rooms. Room to south west is lit by two windows. The ceiling in this room has been repaired extensively, but rather well, by the use of timber from a monkey puzzle tree that grew nearby. The remaining room (SE) is lit by a window with modern light similar to hall (E) and a timber framed screen that accommodates two doors **(Figure 9) (Plate 26)**. One stair leading to GF and the other to attic

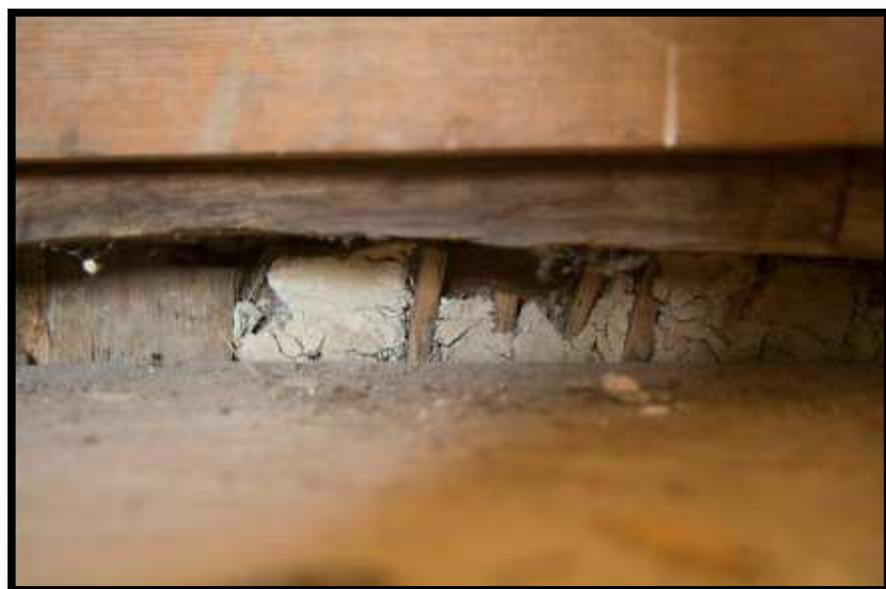
Plate 27 - Wattle and daub screen.

4.3.5 A timber staircase winds from first floor to loft or attic. There is an oak newel post, notched for an earlier stair. This stair allows an examination of the wattle screen that covers the stairway above the doorway. The main panel has been repaired in places between the oak posts but at the top of the stairs a section of original hazel staves, lime and horsehair plaster can be seen between the treads of the stair (Plate 27). Entry into the loft is by the side of the chimney breast but the visible four feet of one of the principal floor beams extends by the side of this breast into the stairwell. It is possible to discern what seem be **apotropaic marks** on the side of this timber **(figure 12)**. The discovery of this set of marks is interesting but difficult to date however. The pattern is similar to marks found elsewhere. These marks are thought to have been applied to parts of a building to ward off the entry of spirits – namely witches and are found in many forms. This particular type are termed multi-marks (Hall, 2005).

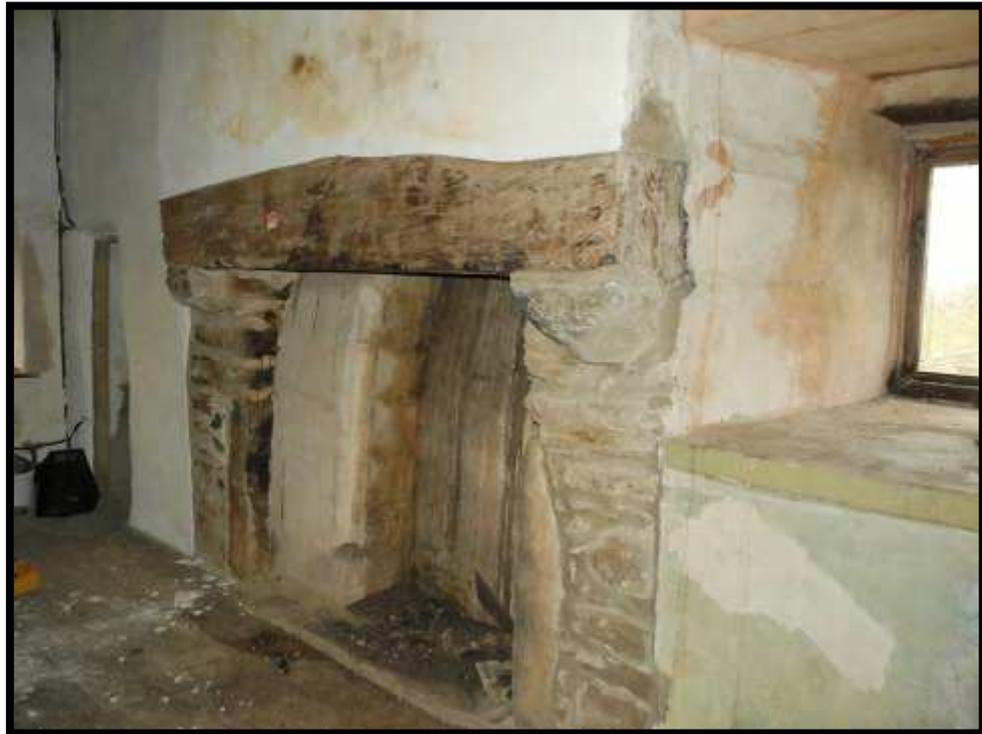
Plate 28 - First floor fireplace, latrine door

4.3.2 The northern end of this chamber **[FF1]** is lit by sash windows on each elevation (E,W) and a further window is positioned in the gable, next to the fireplace **(Plate 28)**. To the left of the fireplace is the entrance to the latrine **[FF1]** which is similar in dimension to the ground floor latrine. The position of the shaft is to the left but now sits under a water immersion tank and could not be examined. Lit by small mullion window with early frame *in situ* but without central mullion.

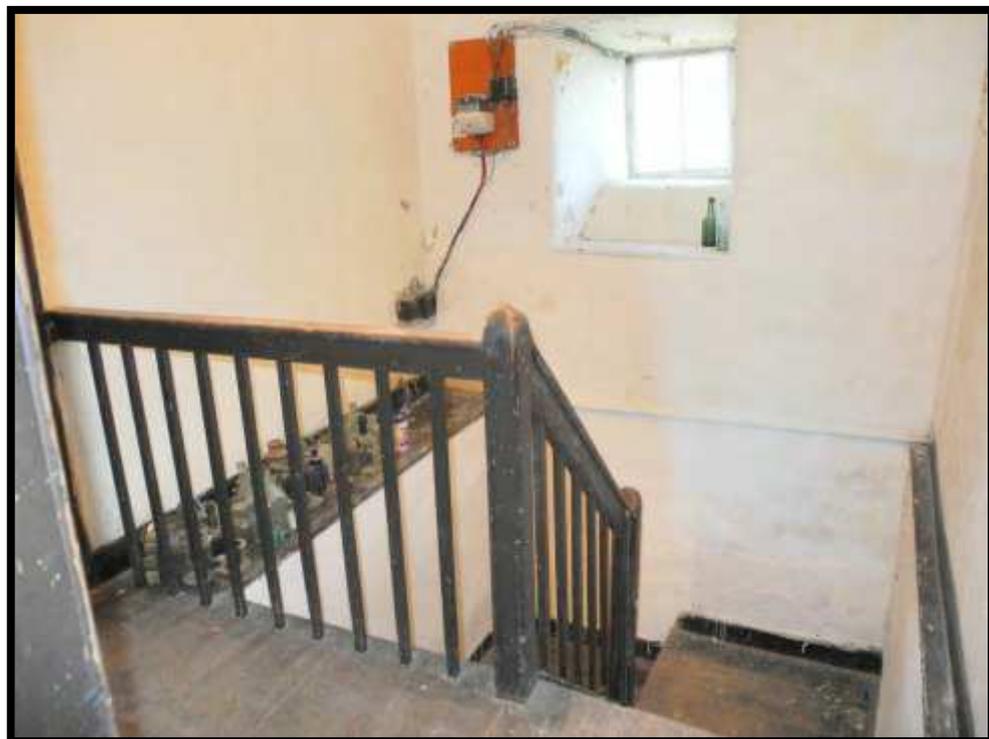
Plate 29 - 18th - early 19th C inserted staircase

4.3.3 A door leads through to the central section of the later modernised chamber onto a landing to the rear staircase **(Plate 29)**, and central room to the front of the building lit with an enlarged window with metal casement. The detail of the staircase, with plain, square balusters suggests an early 19<sup>th</sup> century date which is supported by the partitioning of sawn timber, lath and plaster. The stairway is lit by a small window with sash light, set low.

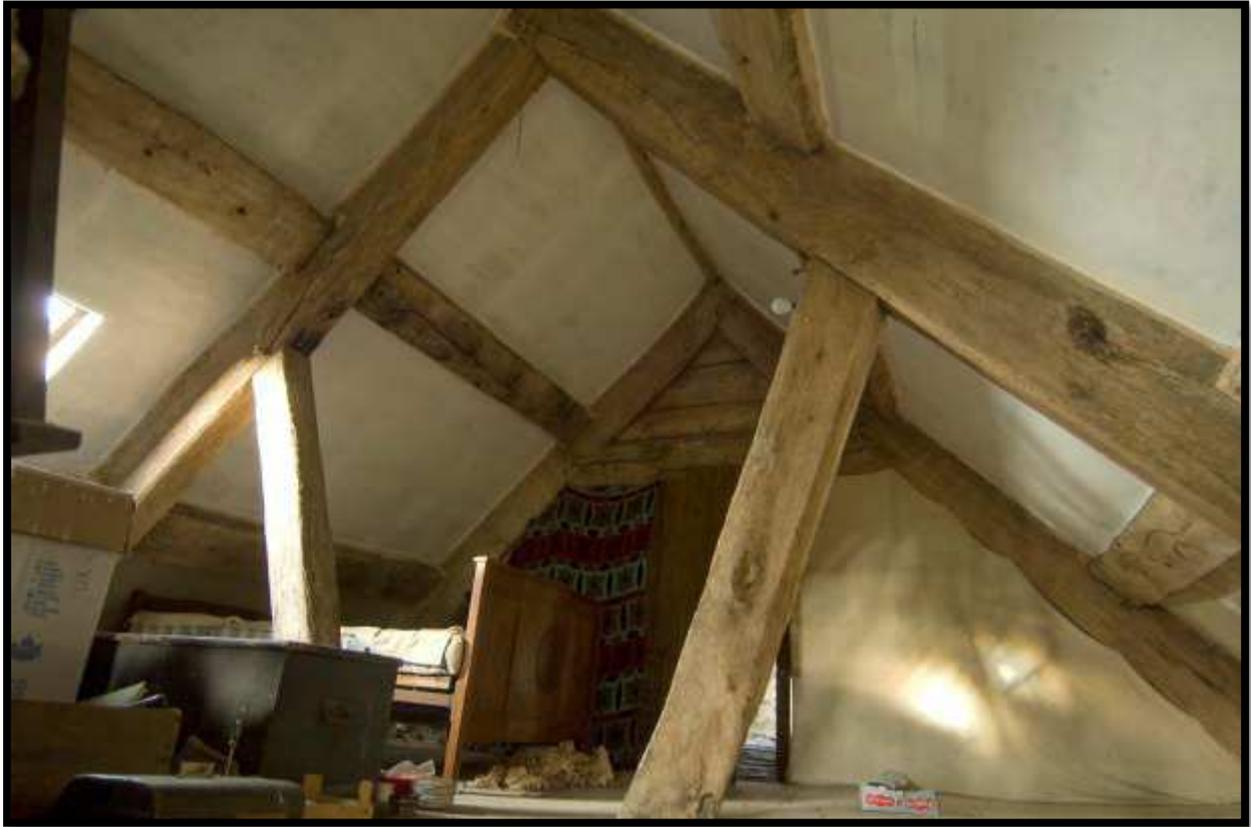
Plate 30 - Truss 1 with truss 2 beyond looking from the south

The loft itself has four bays divided by three trusses. All have principal rafters with the outer trusses **[T1, T3]** being braced by raking struts while the central truss **[T2]** has a collar (**Figures 9,10,11**). Two tiers of trenched purlins rest on the principal rafters. From S gable to truss **[T1]** (**Plates 30, 34**) the purlins are scarfed with two pegs (**Plate 31**) to purlins that run the entire length of the rest of the loft.

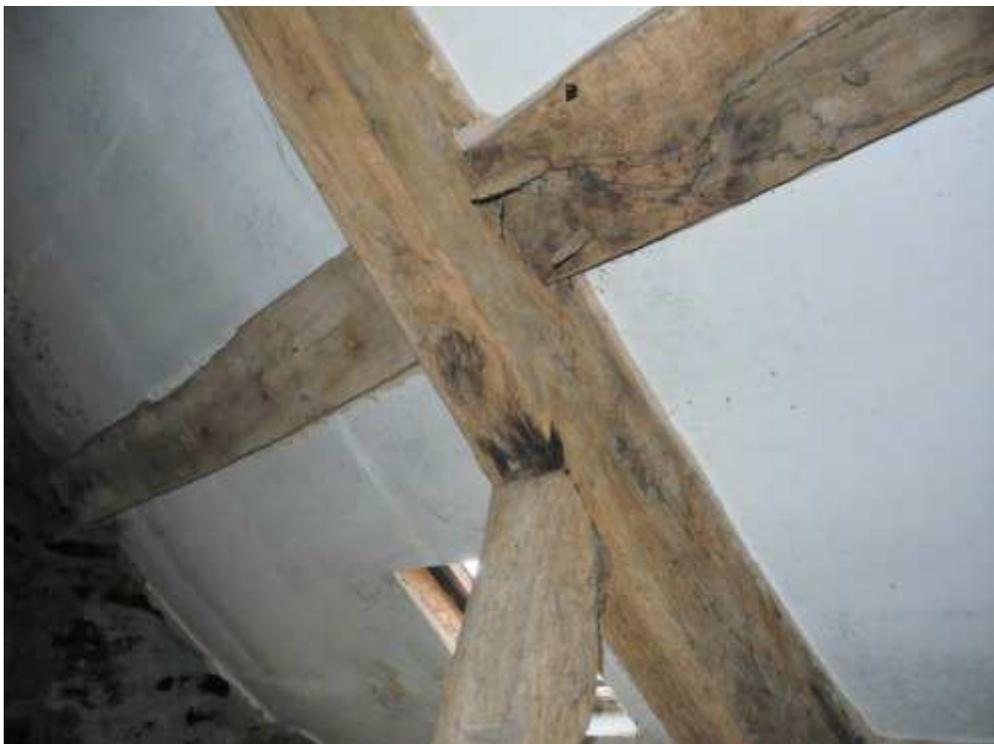
Plate 31 - Purlins scarf jointed with raking strut support below. Note scorch marks.

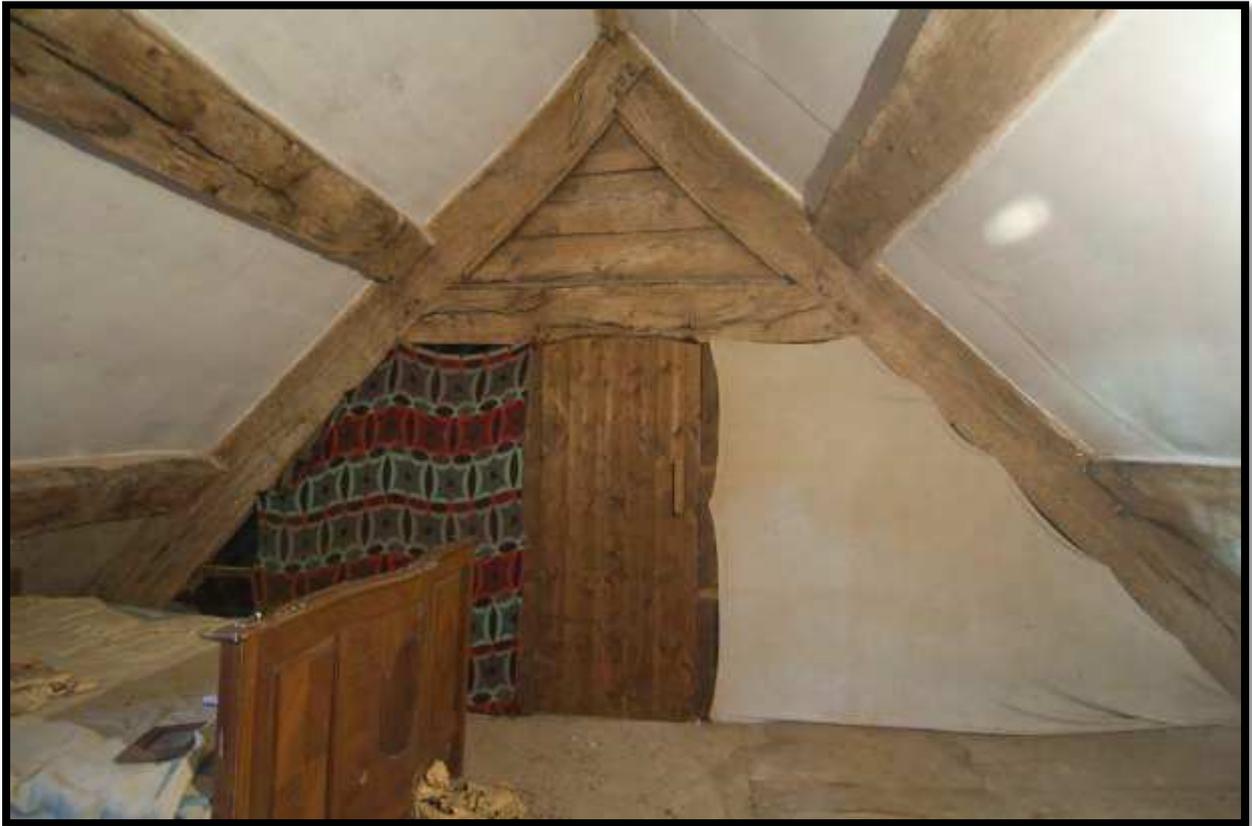
Plate 32 - Truss 2 from the south.

The central truss is mortised on all inner visible faces (**Plates 32, 35**) to house a boarded partition. This has now gone but simple, undecorated boards are placed horizontally above the collar, now with a batten nailed to hold them in place. A simple shallow arch has been cut from the bottom of the collar, centrally, to decorate a doorway, now gone (**Plate 36**).

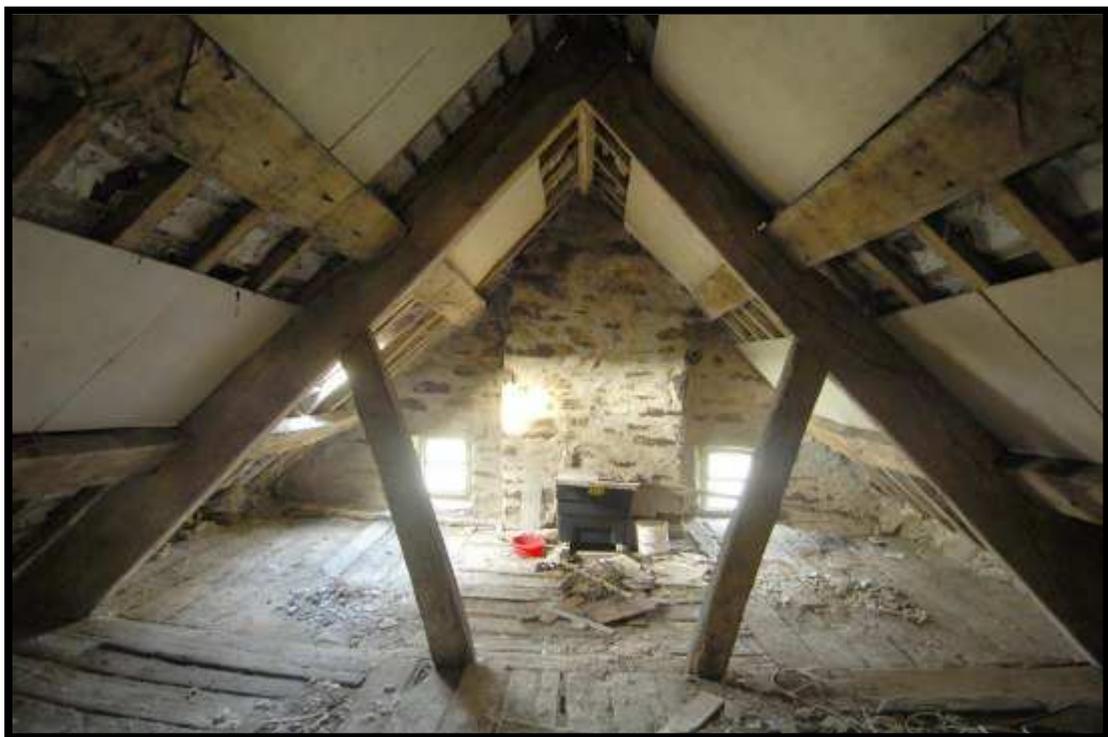
Plate 33 - Truss 3 from the south

4.3.6 The trusses are housed at apex and clasped by three pegs in each joint and a square ridge piece and the bottom of principal rafters are set in wall plates. The raking struts **[T1, T3]** are pegged with one peg only. All the trusses have a simple stopped chamfer. Raking struts to **[T3]** (**Plate 33**) are dimensionally smaller than **[T1]**. Northernmost two bays 3 & 4 retain early or original floor boards although considerably worn and distorted (**Plate 34**). The layout of these short floorboards reflect the joist pattern beneath. The loft is lit at either end by two single paned lights.

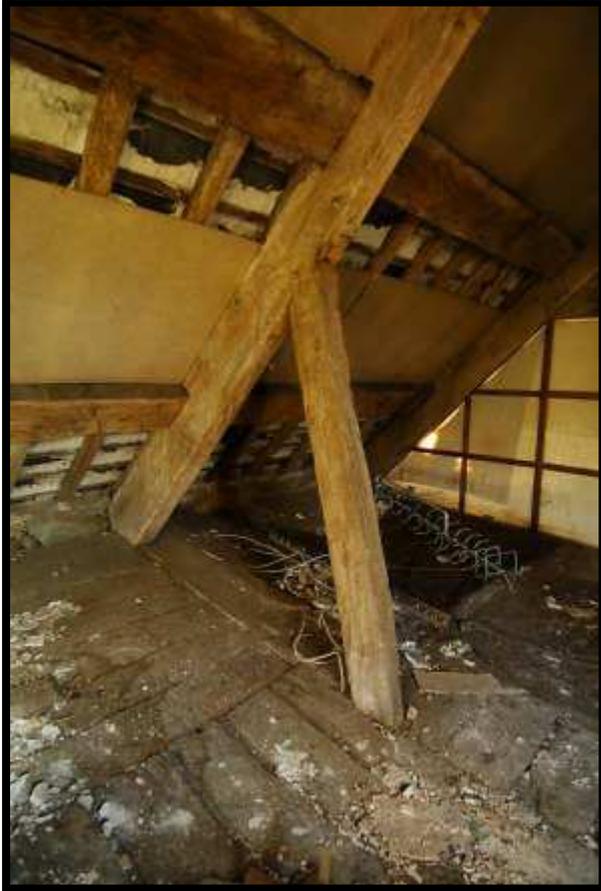
Plate 34 - Truss 3 east from the north

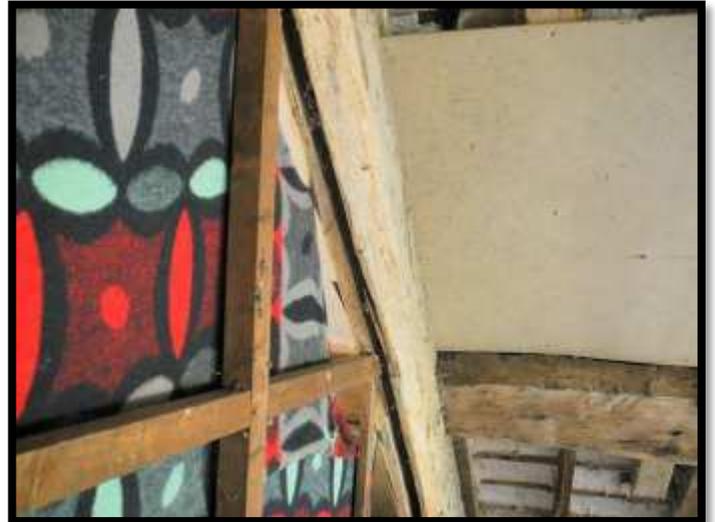
Plate 35 - mortise on principal rafter truss 2
