**NORTH WEST WALES DENDROCHRONOLOGY PROJECT 2009-2012**  
**PROSIECT DENDROCRONOLEG GOGLEDD ORLLEWIN CYMRU**

**DATING OLD WELSH HOUSES / DYDDIO HEN DAI CYMREIG**

**Bron Y Foel Isaf, Dyffryn Ardudwy, Gwynedd, LL44 2ZH**

**ARCHITECTURAL RECORD /COFNOD PENSARNIOL**

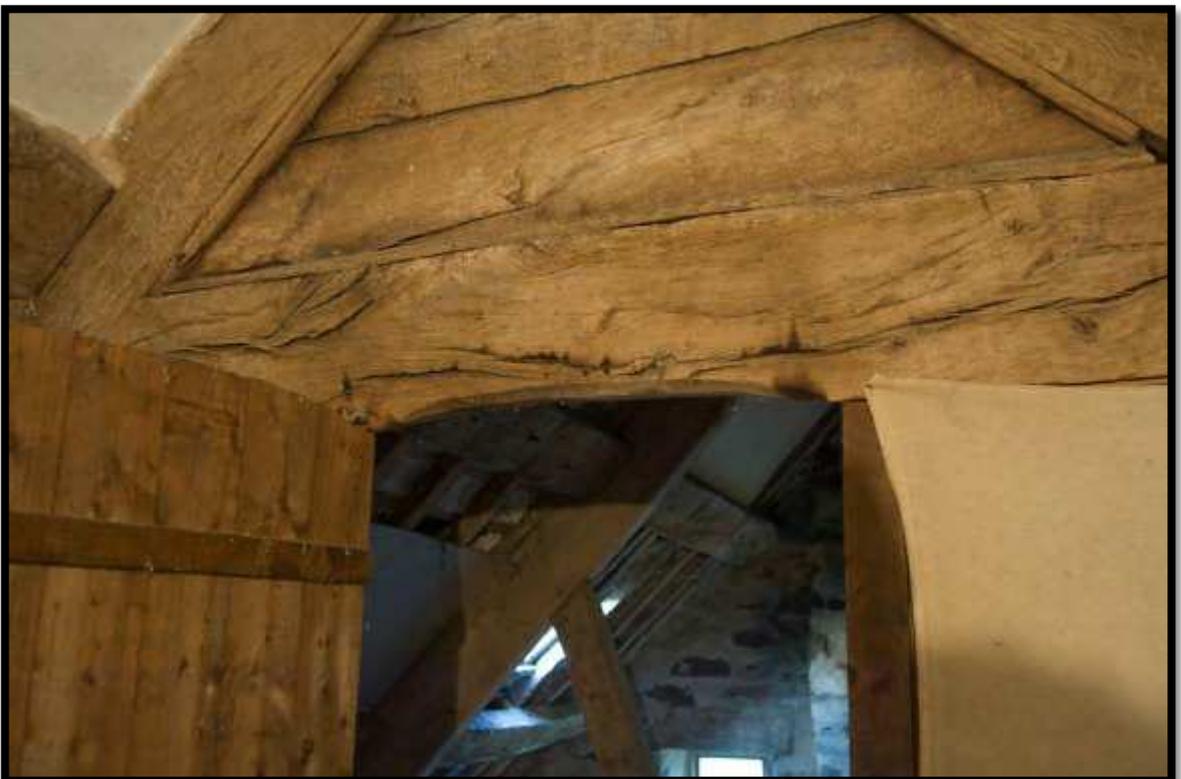
Plate 36 - Truss 2 collar door head

The central truss is mortised on all inner visible faces (**Plates 32, 35**) to house a boarded partition. This has now gone but simple, undecorated boards are placed horizontally above the collar, now with a batten nailed to hold them in place. A simple shallow arch has been cut from the bottom of the collar, centrally, to decorate a doorway, now gone (**Plate 36**).
