**SUPERSONIC TRANSPORT PROGRAM
PHASE II-C**

**BI-MONTHLY TECHNICAL
PROGRESS REPORT**

**CONTRACT FA-SS-66-5
NOVEMBER 1966**

D6-18110-8

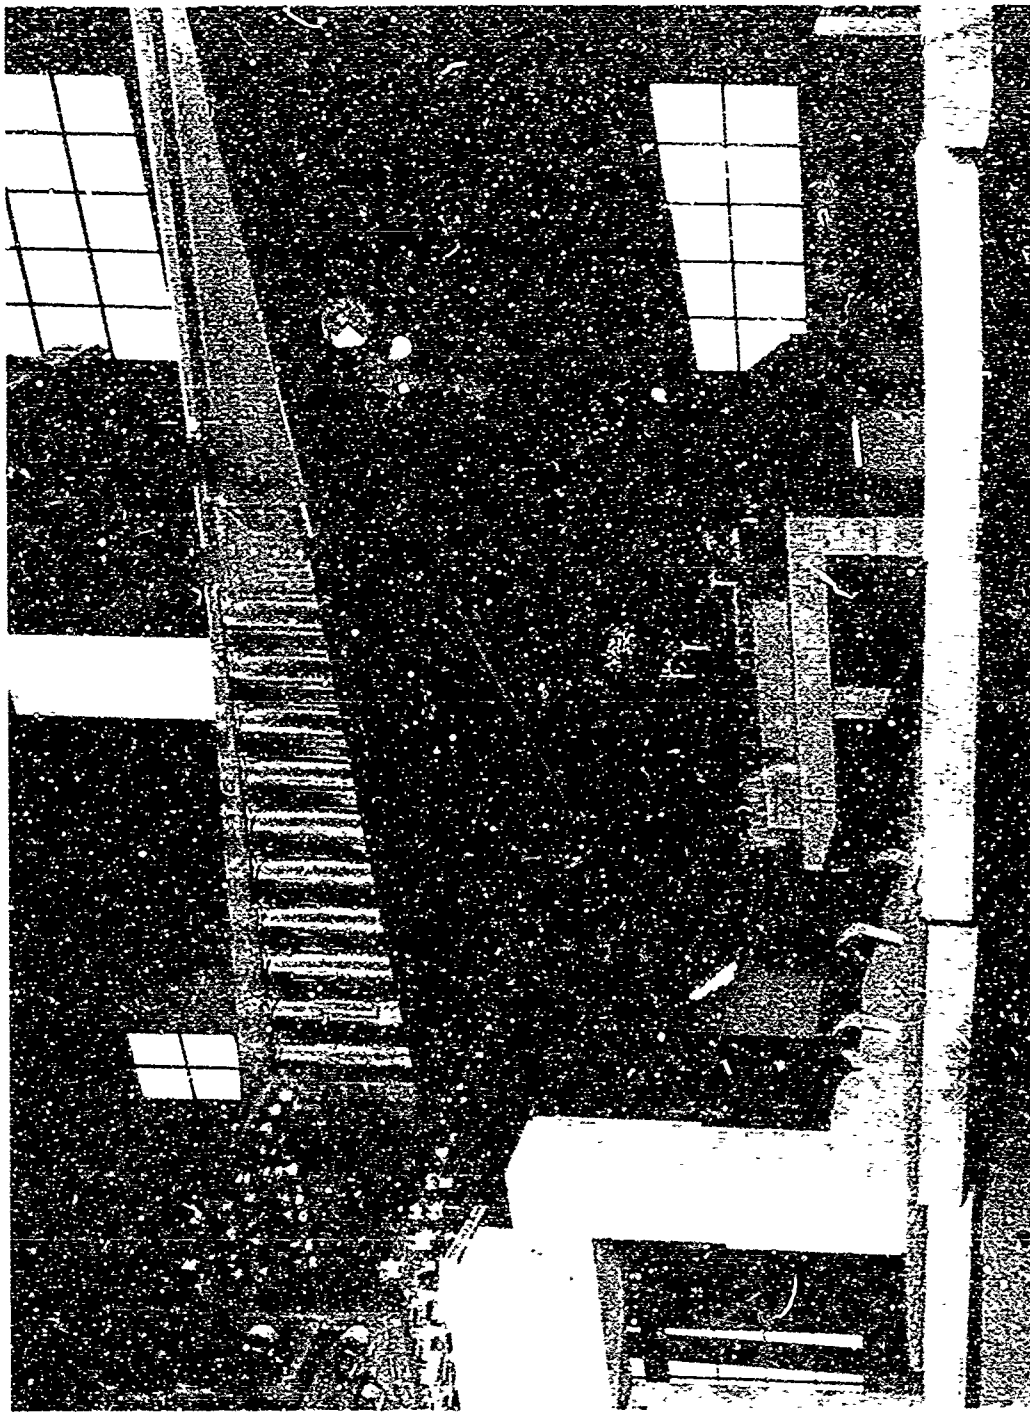
Figure 25. Stabilizer Test Structure

Assembly of the empennage test structure has been completed and mounted in the test fixture. The Evener System for applying loads has been installed. Strain gages and thermocouples have been installed and these are now being connected to the data recording system. Room temperature testing will commence early in December. Figure 25 shows the empennage test structure in the test fixture prior to installation of the Evener System.
