PLANNING PLANNING PLANNING
REPORT AND TECHNICAL APPENDIX

PREPARED FOR ERIE COUNTY
 WITH COORDINATION OF
 STATE OF NEW YORK WATER RESOURCES COMMISSION
 AND DEPARTMENT OF PUBLIC WORKS

FLOOD PLAIN INFORMATION

BUFFALO CREEK, NEW YORK

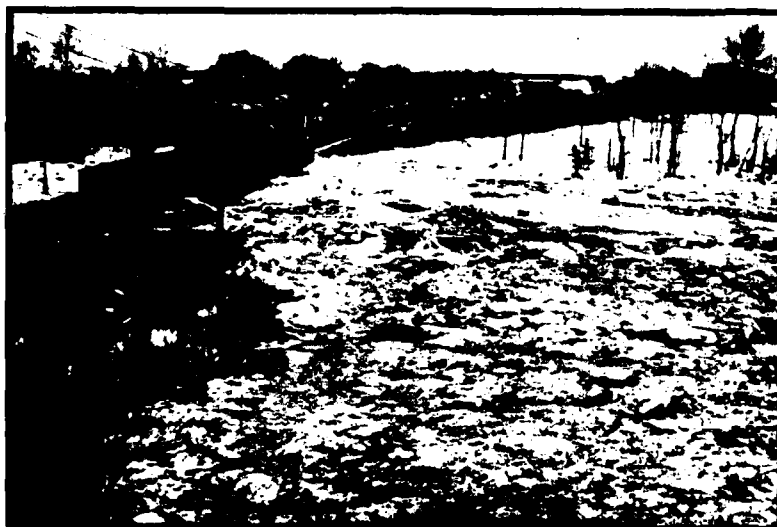
Photo No. 2. Looking north across creek from Indian Church Road toward the N.Y.C. R.R. bridge during the March 1942 flood.

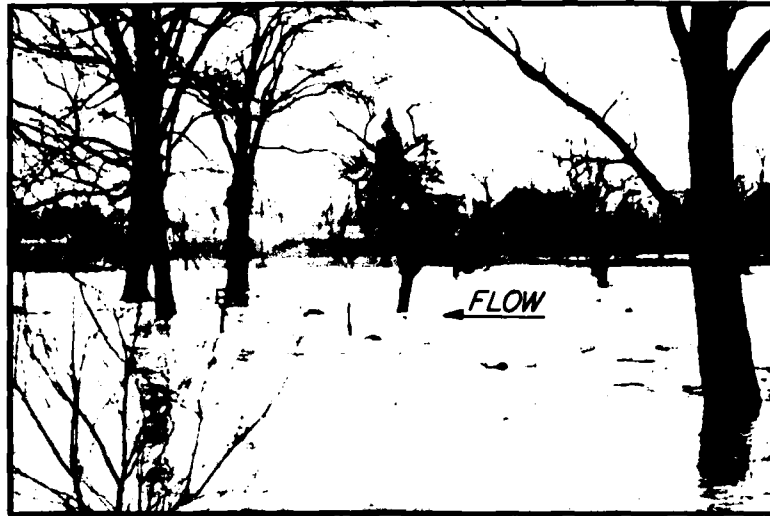
Photo No. 3. Looking north toward Clinton Street from Island Park at Gardenville, during the March 1942 flood.

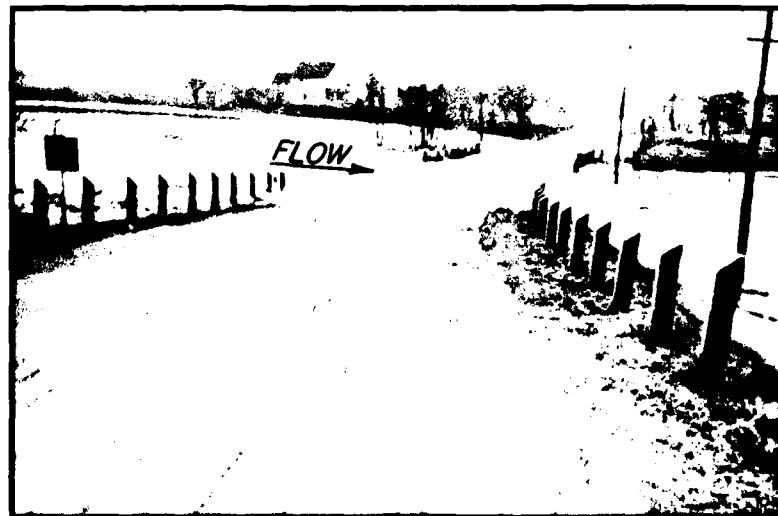
Photo No. 4. Looking south along Borden Road from bridge during the March 1942 flood.

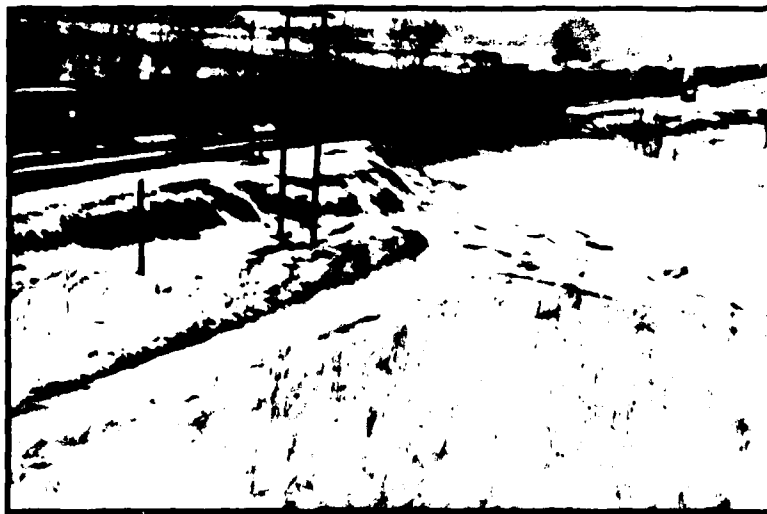
Photo No. 8. Looking at upstream side of the N.Y.C. R.R. bridge from Indian Church Road. This flood took place during the 1950's.

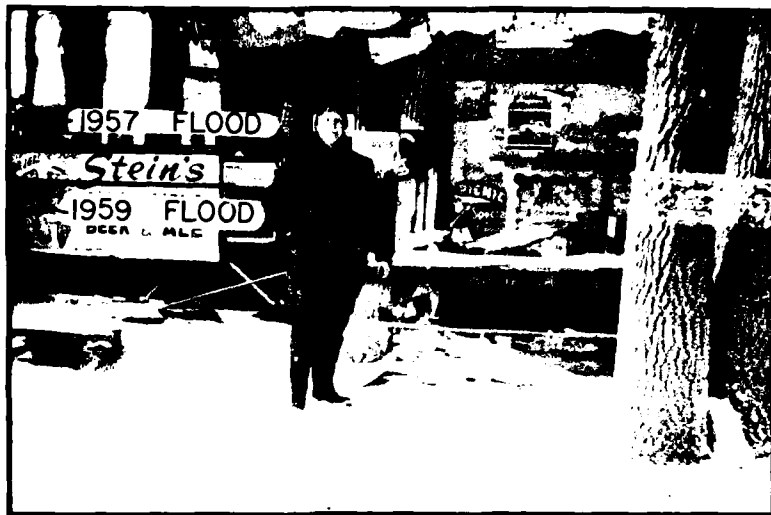
Photo No. 9. Ice lines indicate January 1959 flood elevation at Huppertz Grove, Collins Avenue. Near mile 0.15.

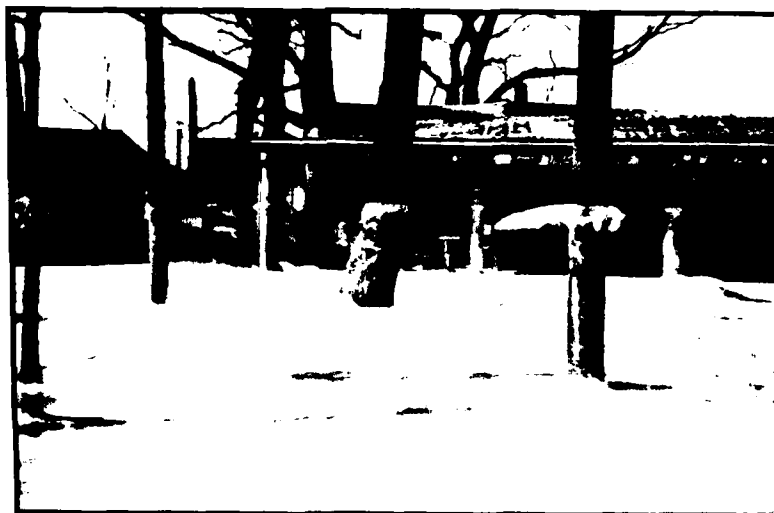
Photo No. 10. Same as photo no. 9. The January 1957 flood was 1.3' higher than the 1959 flood at this location.

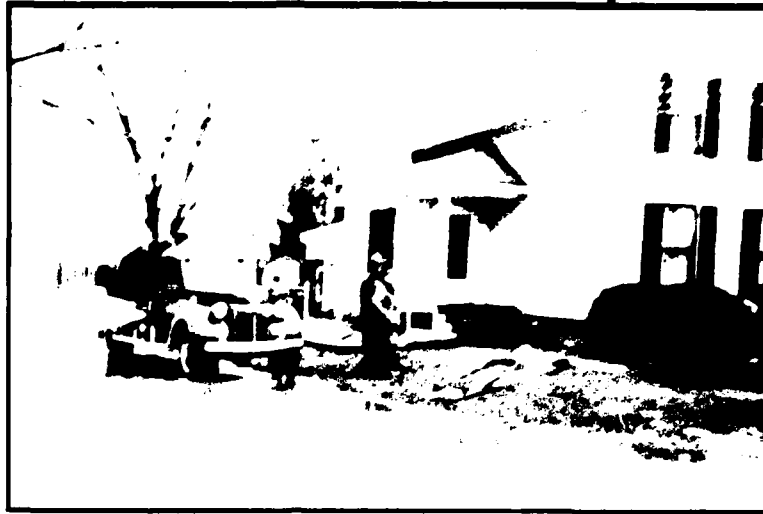
Photo No. 11. Firemen shown pumping overland flood water out of basement at residence on Borden Road after water receded, during the March 1962 flood.

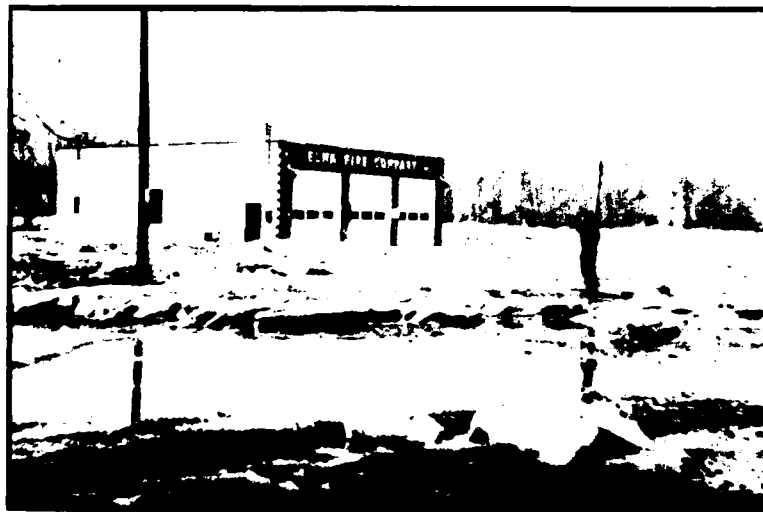
Photo No. 12. The new Elma Fire Hall during the March 1962 flood. The floor was covered by 8 inches of water.

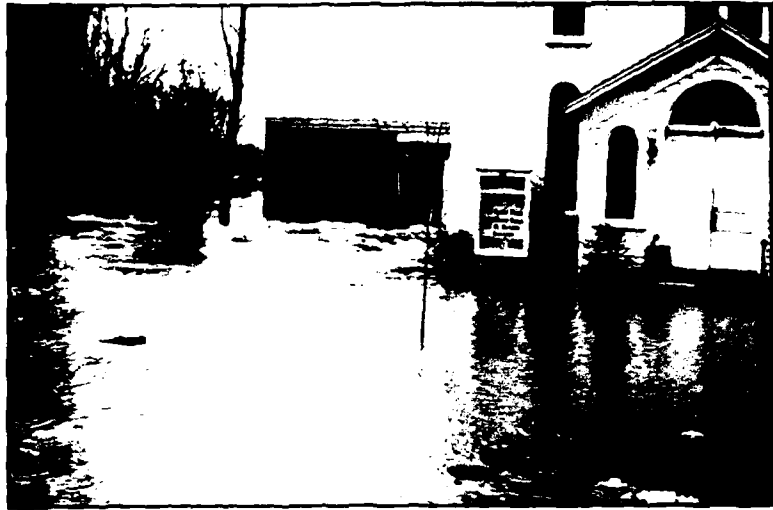
Photo No. 13. Elma Methodist Church and Sunday School addition on Bowen Road, during the March 1962 flood.

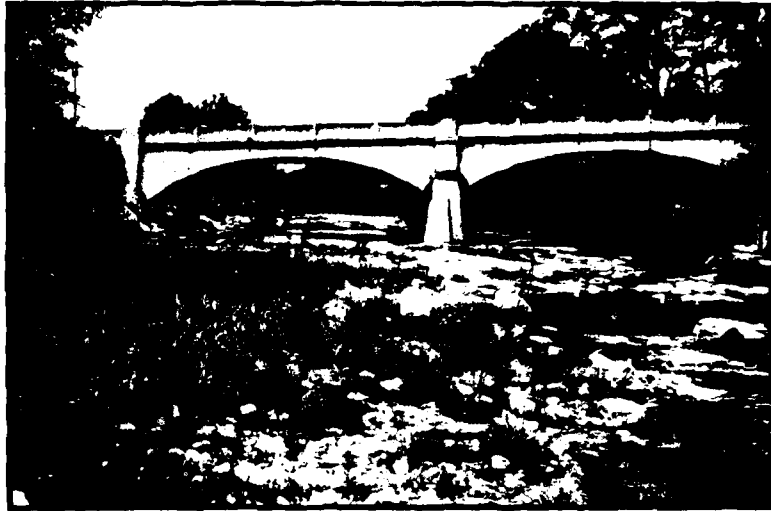
Photo No. 19. Looking downstream at Borden Road bridge showing rock channel bottom and shoals.

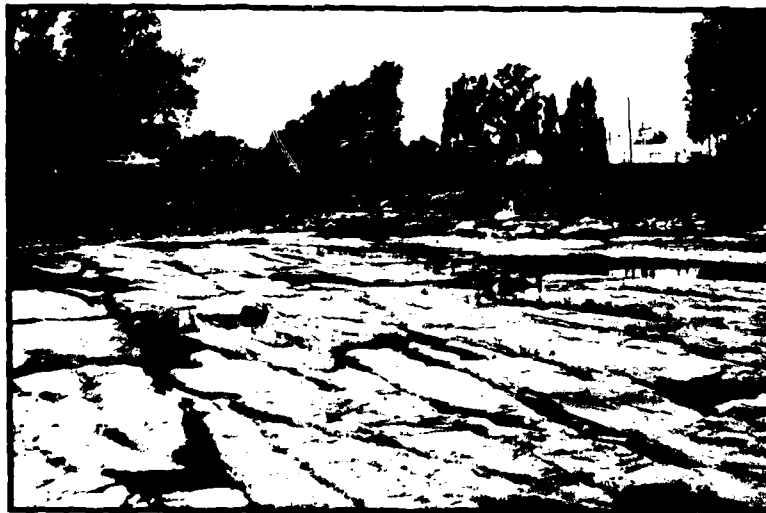
Photo No. 20. Looking downstream at Transit Road bridge showing the rock channel bottom.

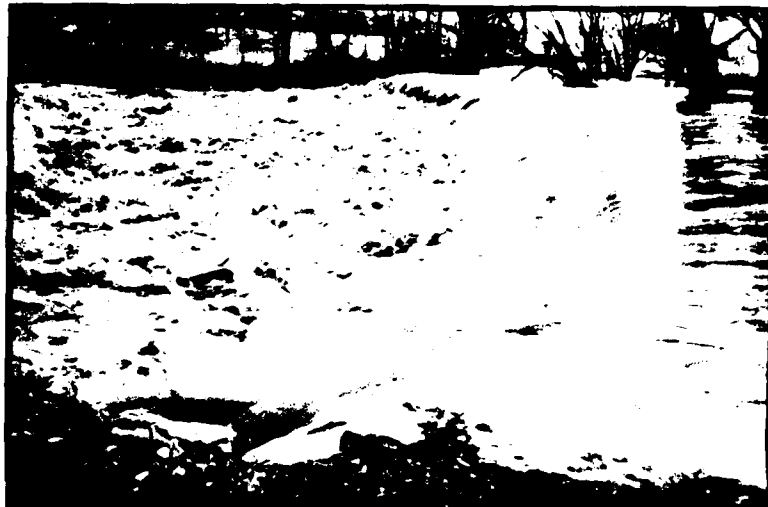
Photo No. 21. Blossom Dam near mile 5.95. Photo shows increase in water surface at the dam during the moderate runoff of April 1959.

44. At the present time there are dams at Blossom and Elma which are no longer in use and which project 3 to 4 feet above the natural creek bottom. Shoal areas have formed at the upstream end of the pools and ice floes and debris are easily grounded. If these dams are not serving any useful purpose removing them would reduce high water elevations in the immediate area. Pictures of the Blossom and Elma dams are shown on exhibits 11 and 12. Picture 21 shows the increase in water surface at the Blossom dam during a moderate runoff. Picture 22 shows that equipment has been engaged in removing shoal material from upstream of the Blossom dam.

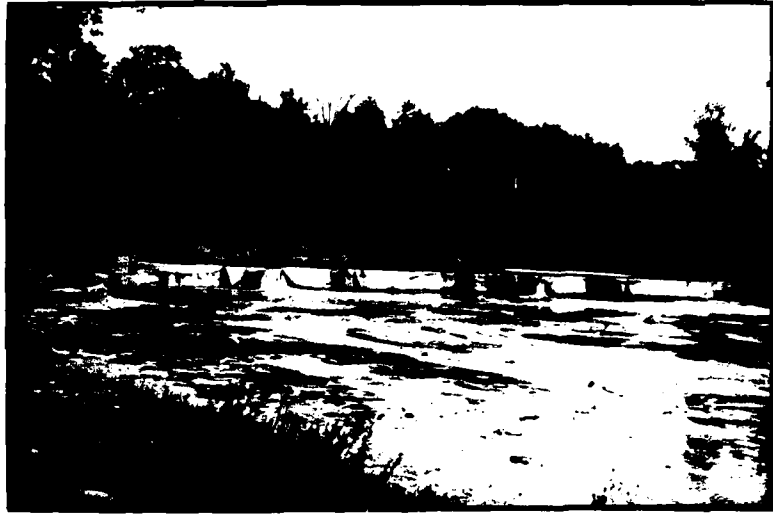
Photo No. 23. Elma Dam upstream of Bowen Road near mile 10.2. Note shale on right bank upstream of the dam.

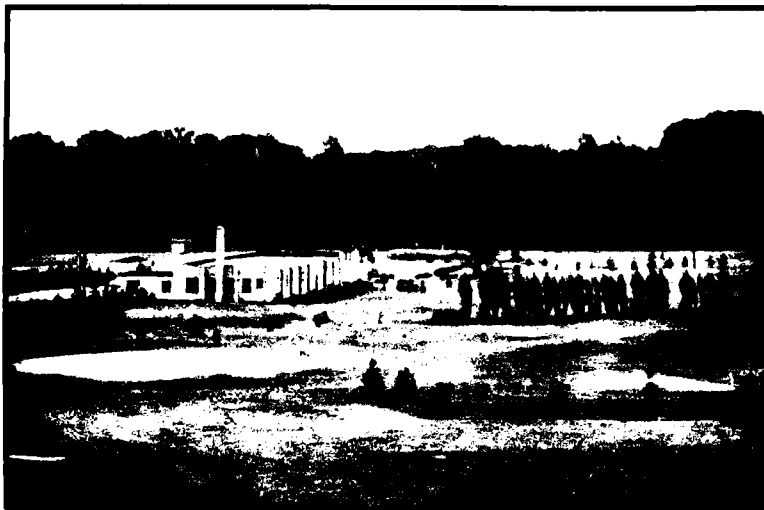
Photo No. 33. Elma Meadows County Park near mile 14.3. The building is above flood levels but lower portions of the golf course are flooded.
