### **DENNY ISLAND – SITE LOCATION AND PHOTOS**

# **DENNY ISLAND – GEOTECHNICAL REPORT**

**Re: Proposed Denny Island, Antenna Tower and Equipment Building, Report of Geotechnical Assessment**

# **SAFETY MOUNTAIN – SITE LOCATION AND PHOTOS**

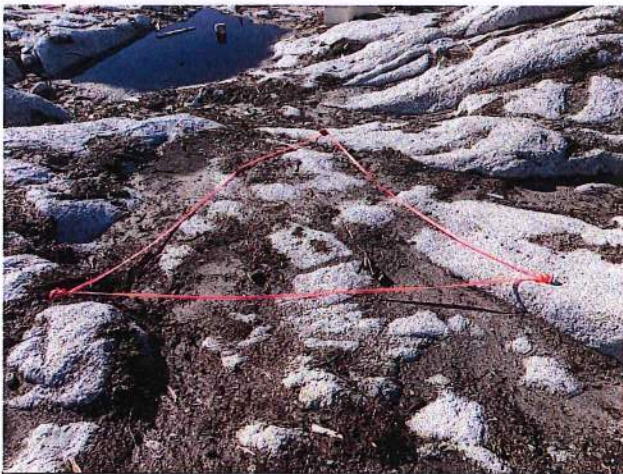
Photo 3 – Proposed antenna tower location 1 area looking southwest

The bedrock discontinuities had a blocky to very blocky structure with predominantly widely spaced discontinuities, although local areas of close to moderately close discontinuities were observed. Release surface discontinuities tended to be near vertical, while sliding planes were near horizontal or gently sloped down to the north. Photographs of the proposed tower and building areas are provided in Photos 3 through 5.

The foundations for tower location option 1 should not encroach within 4m of the crest of the low rock “step” to the southeast without specific geotechnical review. The tower location option 1 shown on Drawing G-1 meets that recommendation. No slope stability considerations are warranted for the other proposed tower and building location options shown on Drawing G-1.

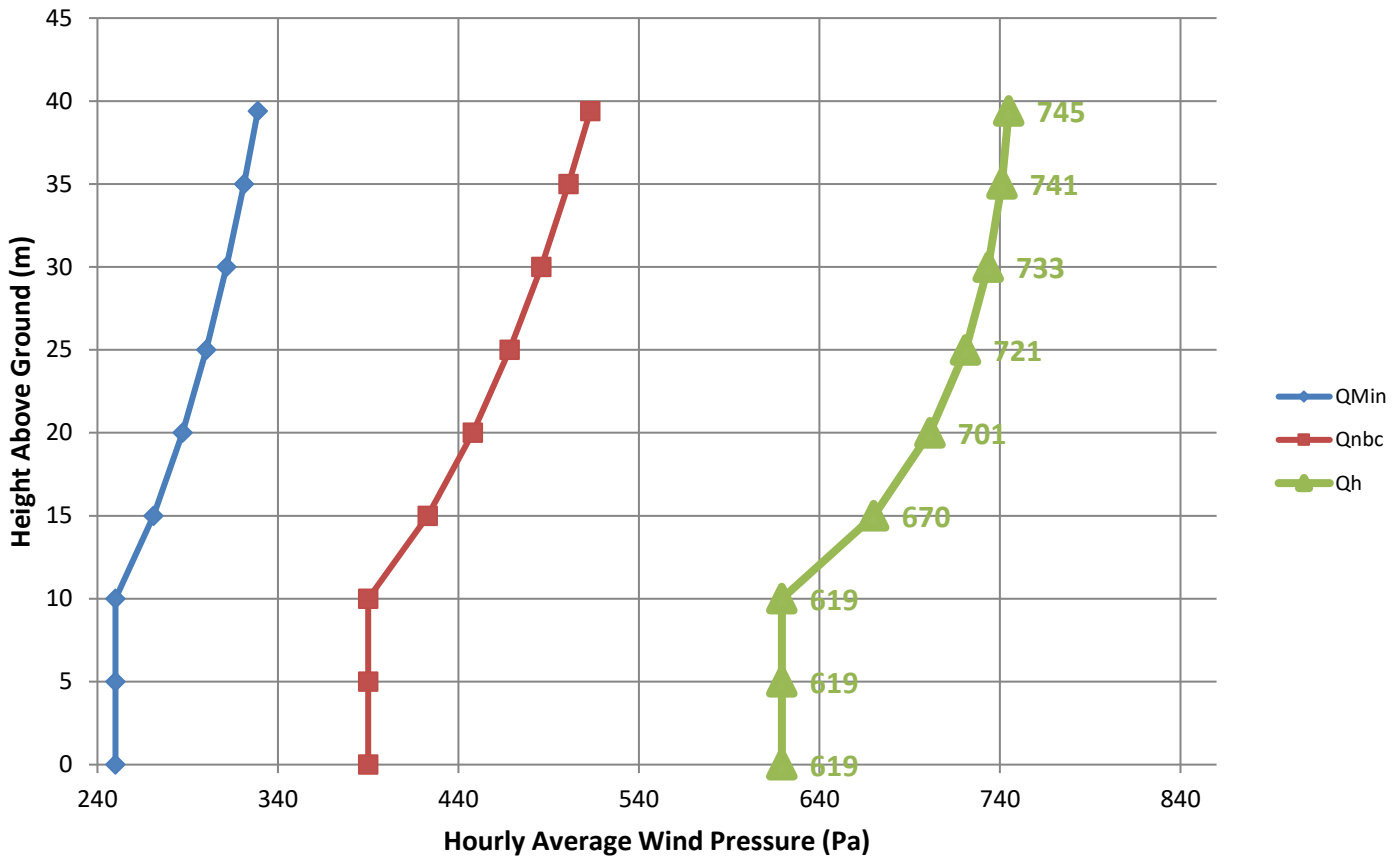
10-yr. Wind Pressure Profile Graph for WM637 Denny Island, BC 39.4m Tower

- Tower Height:** Height of the tower from ground level at the base of the tower to the top of the structure.
- Q<sub>nbc</sub>:** Regionally representative reference wind pressure at 10 m in the format of the National Building Code of Canada and the Q<sub>nbc</sub> value is profiled with the <sup>2</sup>/<sub>10</sub> power law.
- Q<sub>Min</sub>:** Minimum reference wind pressure (320 Pa, 300 Pa, and 250 Pa for the 50-year, 30-year, and 10-year return periods respectively) profiled with the <sup>2</sup>/<sub>10</sub> power law as per Section 5.4.1 of S37-18.

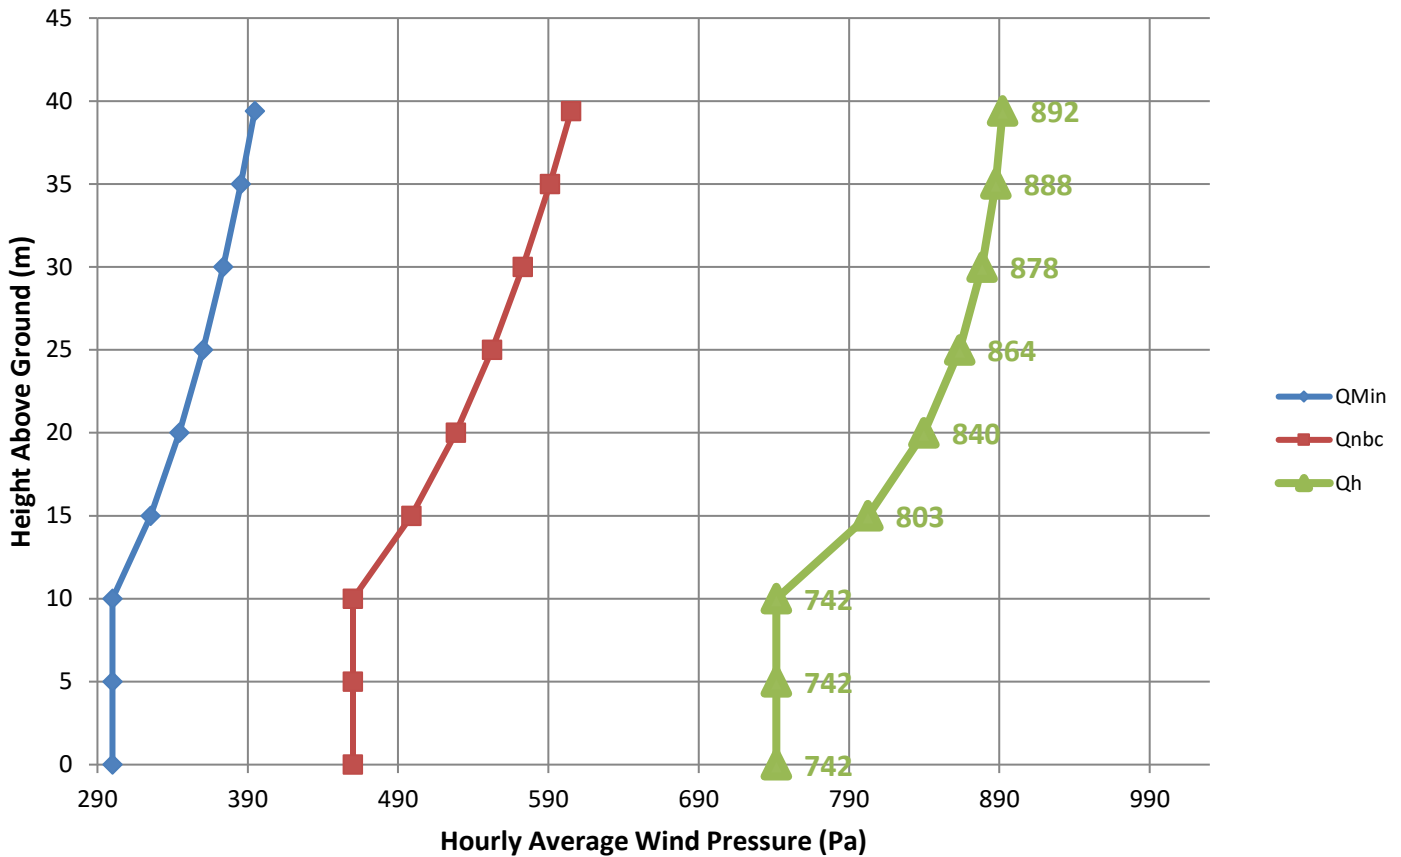
30-yr. Wind Pressure Profile Graph for WM637 Denny Island, BC 39.4m Tower

**Tower Height:** Height of the tower from ground level at the base of the tower to the top of the structure.

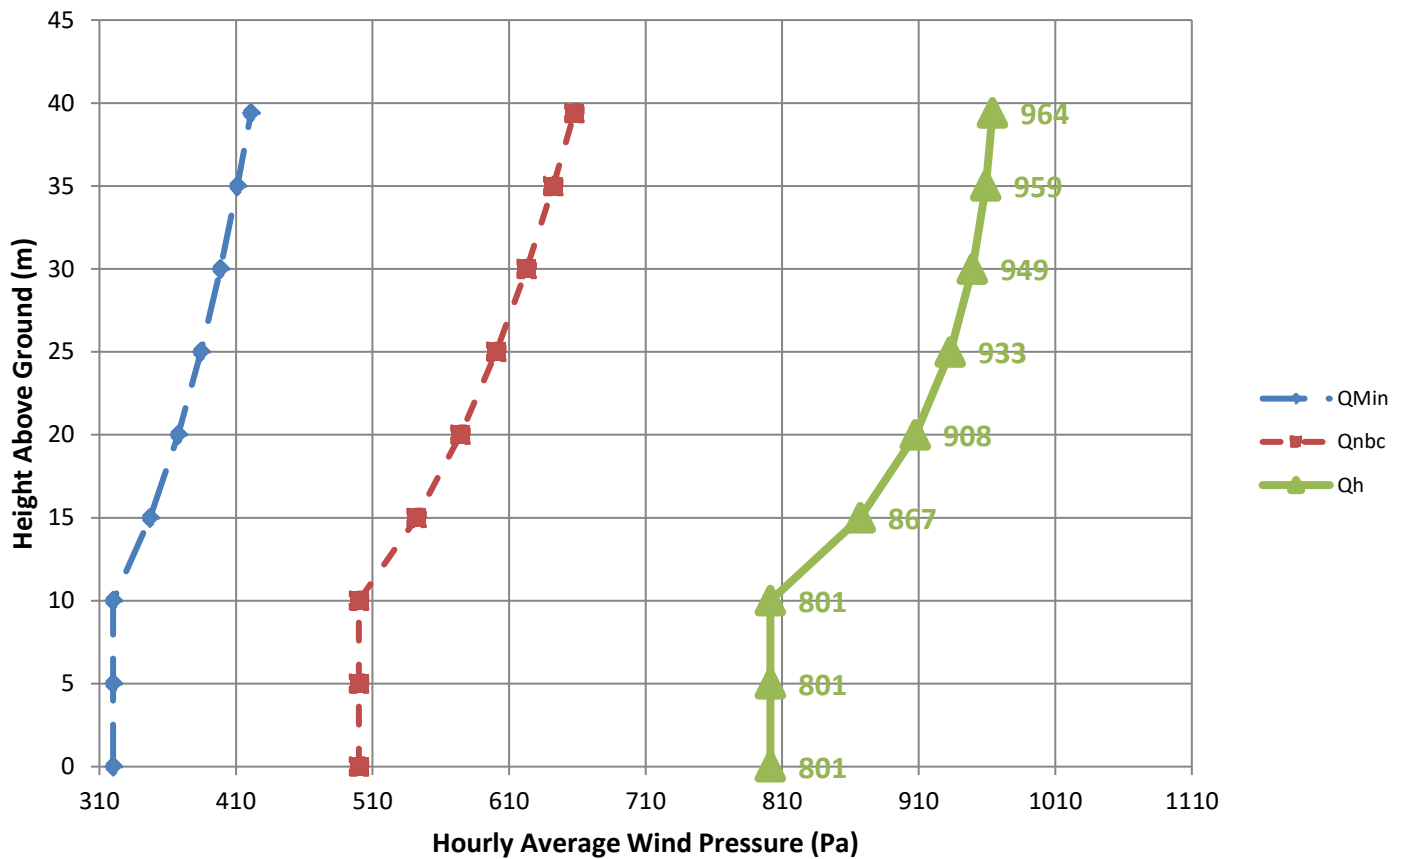
50-yr. Wind Pressure Profile Graph for WM637 Denny Island, BC 39.4m Tower

**Tower Height:** Height of the tower from ground level at the base of the tower to the top of the structure.

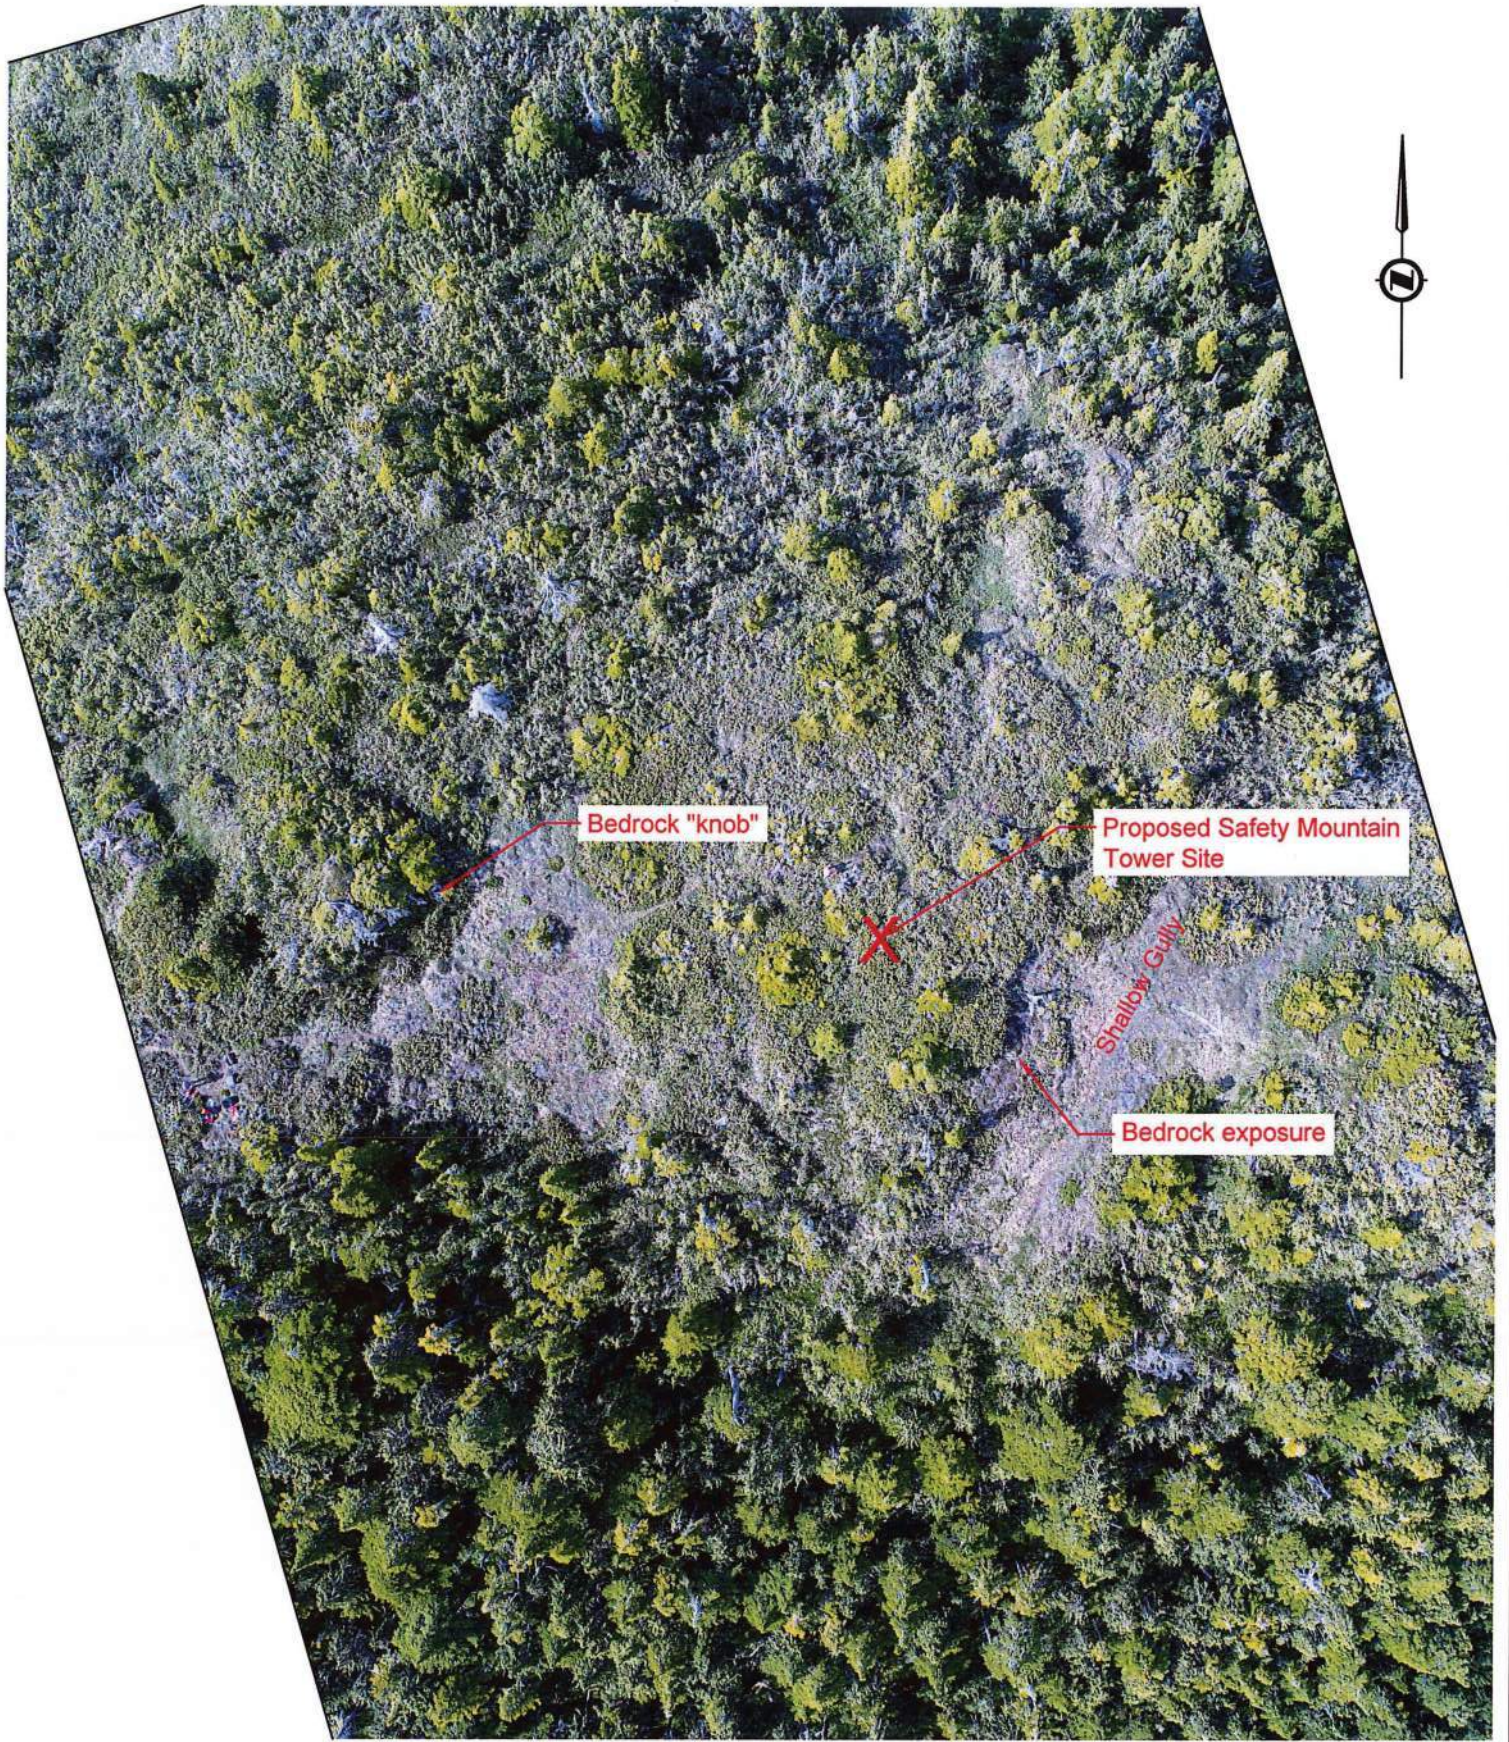
Dwg. No.: Figure 1

Project: Proposed Communications Tower, Safety Mountain, Calvert Island, BC

Title: Site Plan

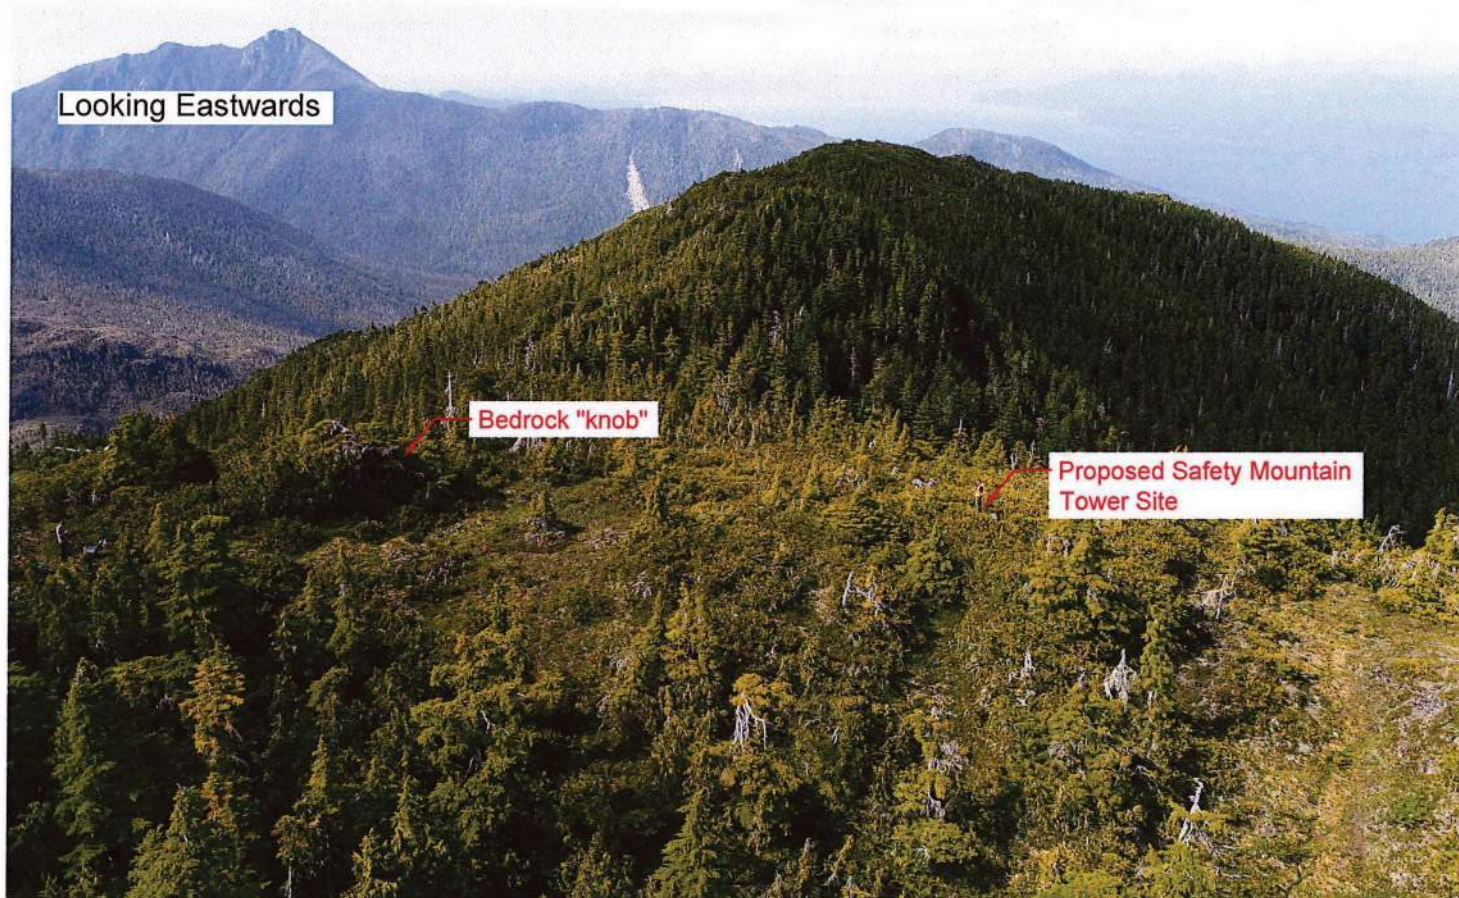
Looking Eastwards

Bedrock "knob"

Proposed Safety Mountain Tower Site

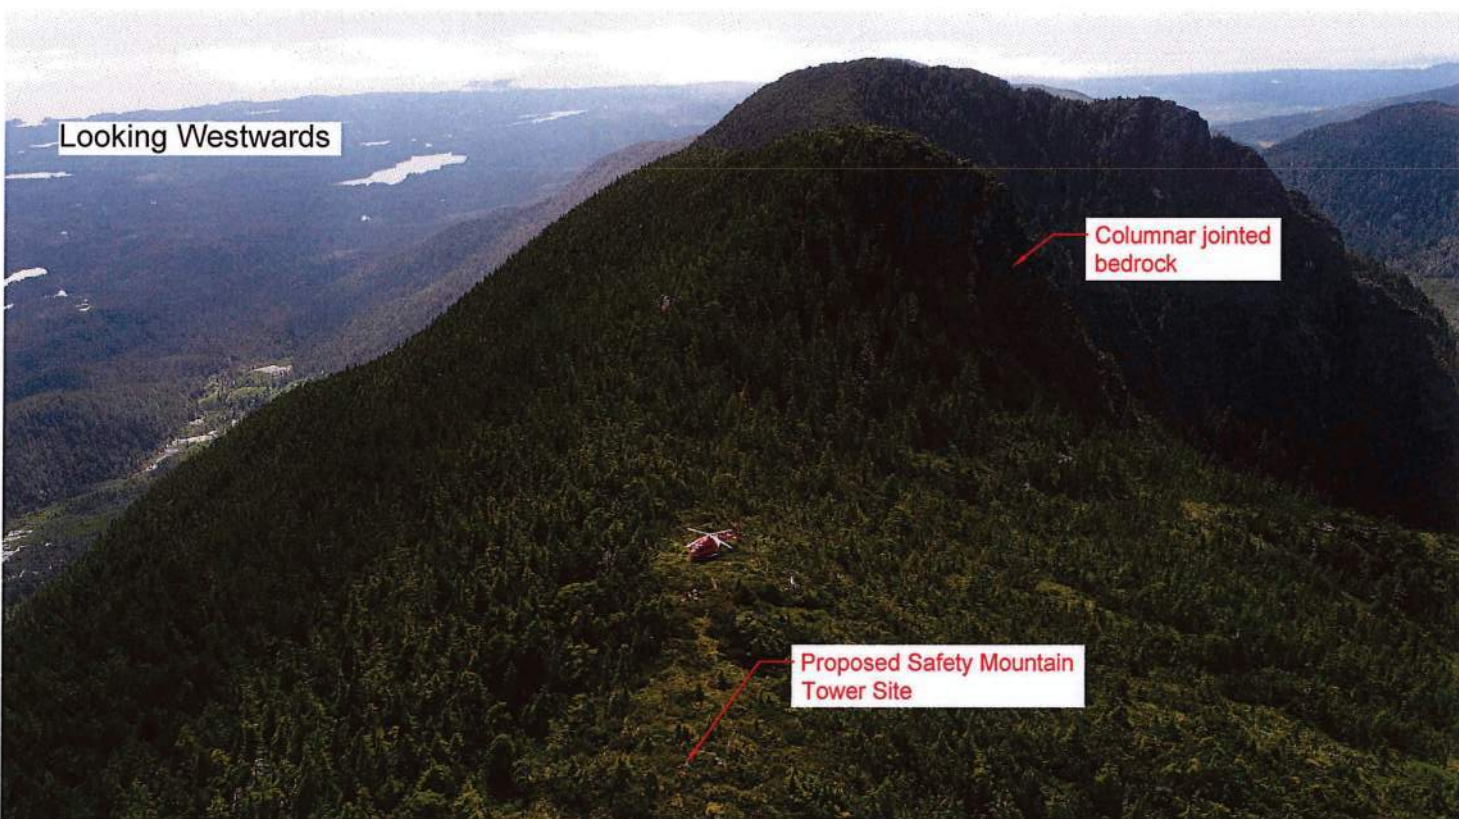
Looking Westwards

Columnar jointed bedrock

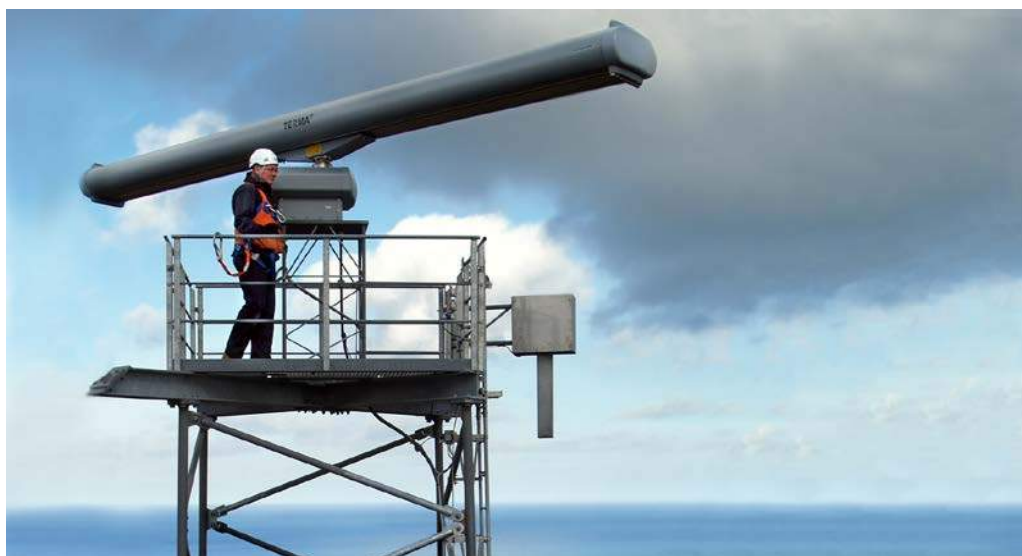
**Wind Pressure Formula:** Formula for the design wind pressure as a function of height. (Ref.: S37-18, 5.3.1)

The antennas are of the linear array type, with fan beam,  $\text{Cosec}^2$  (Cosecant squared) beam or inverse  $\text{Cosec}^2$  beam elevation shape and are available with horizontal or circular polarization.

The antennas are designed to have narrow horizontal beam width, low side lobes, and no back lobes.

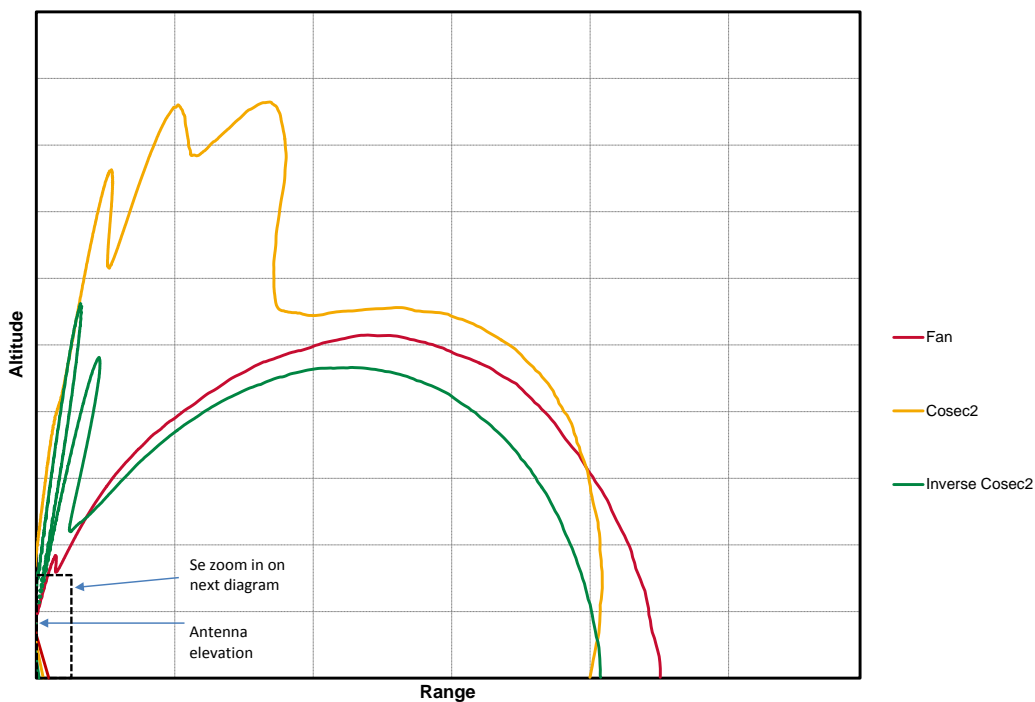
Note: The following diagrams are for illustration purposes only, and shows coverage as a function of range of the 3 different beam shapes. The vertical and horizontal scales are not identical formatted.

Figure 3.1 Long-range coverage diagram

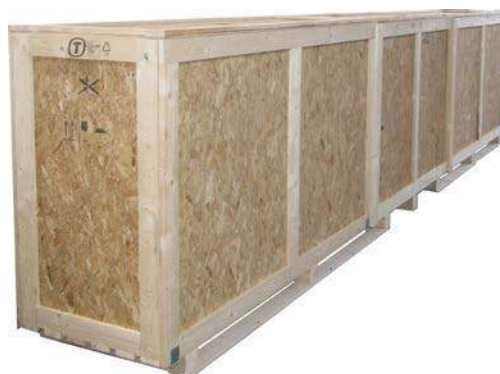
Figure 4.2 Wooden transport crate

<b>Mechanical construction</b>	
Color	Silver grey RAL 7001 / White RAL 9010 (opt.) / Orange RAL 2009 (opt.)
Weight	Approx 400 kg
H x L x W x D (Height x Length x Width x Depth)	1110 x 6560 x 712 x 1000 mm
Swing radius	3300 mm
<b>Packed for transport</b>	
Weight incl. wooden crate	Approx 850 kg
H x L x D (Height x Length x Depth)	Approx 1560 x 6820 x 880 mm

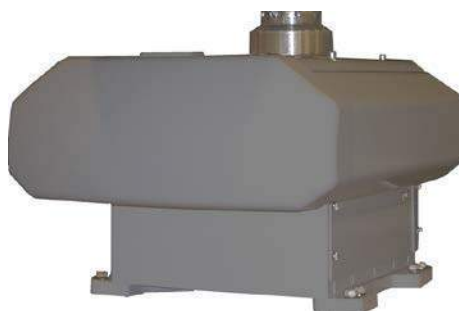
Figure 4.6 Turning unit

The *Turning unit* includes the asynchronous motor, the gearbox, the encoder assembly and the terminal box. The encoder assembly consists of a rotary joint and up to two azimuth encoders (2nd redundant encoder is optional). Two encoders are standard on SMR antennas.

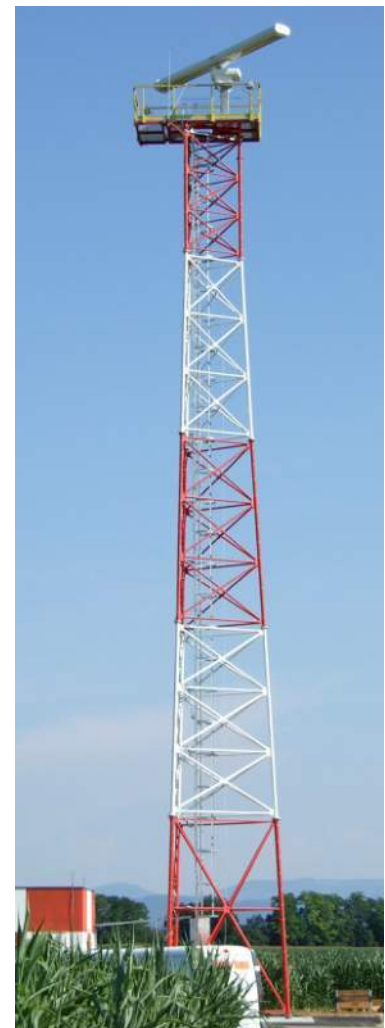
Figure 7.1 Three-legged lattice tower

The picture shows a self-supporting conically shaped three-leg steel lattice tubular tower, which is excellent for radar antennas.

The antenna base plate may be mounted on a steel pedestal or directly on the tower construction.

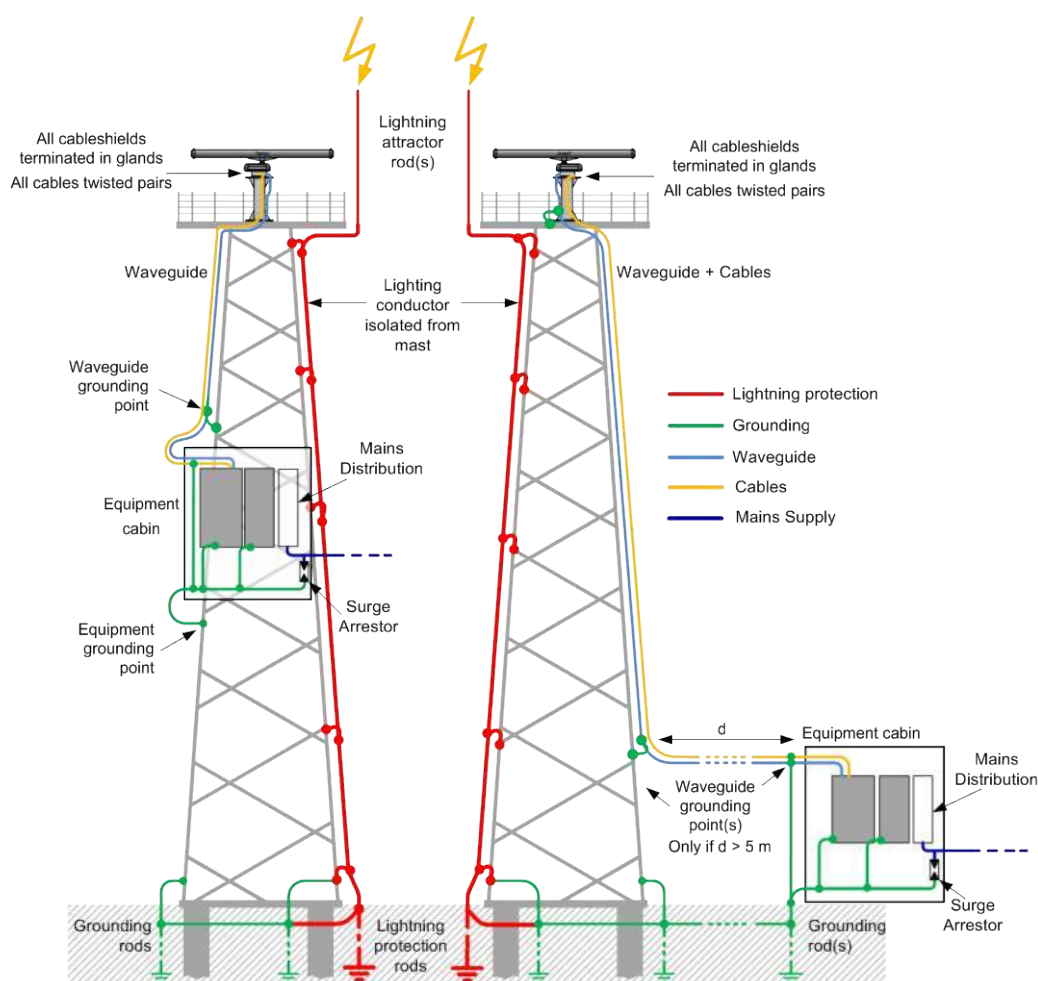
In summary, the idea is to connect the system as effectively as possible to ensure that all components have the same potential in the event that lightning strikes and a Faraday’s cage must be established around the equipment cabin.

Figure 7.2 Lightning protection and grounding solution

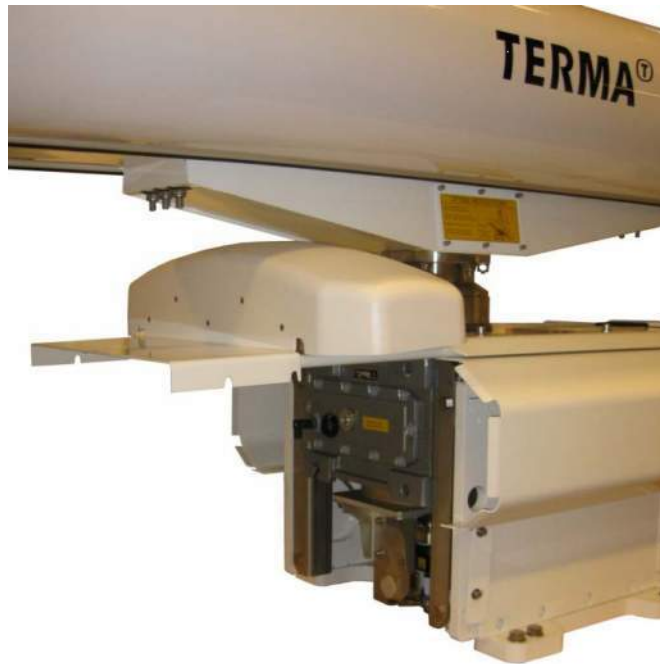
Preventive maintenance should be performed with fixed intervals.  
The procedures and recommended intervals are based on long-term experience.  
Refer to doc. no. 255548-HT for maintenance intervals.

Figure 0.1 Turning unit maintenance access

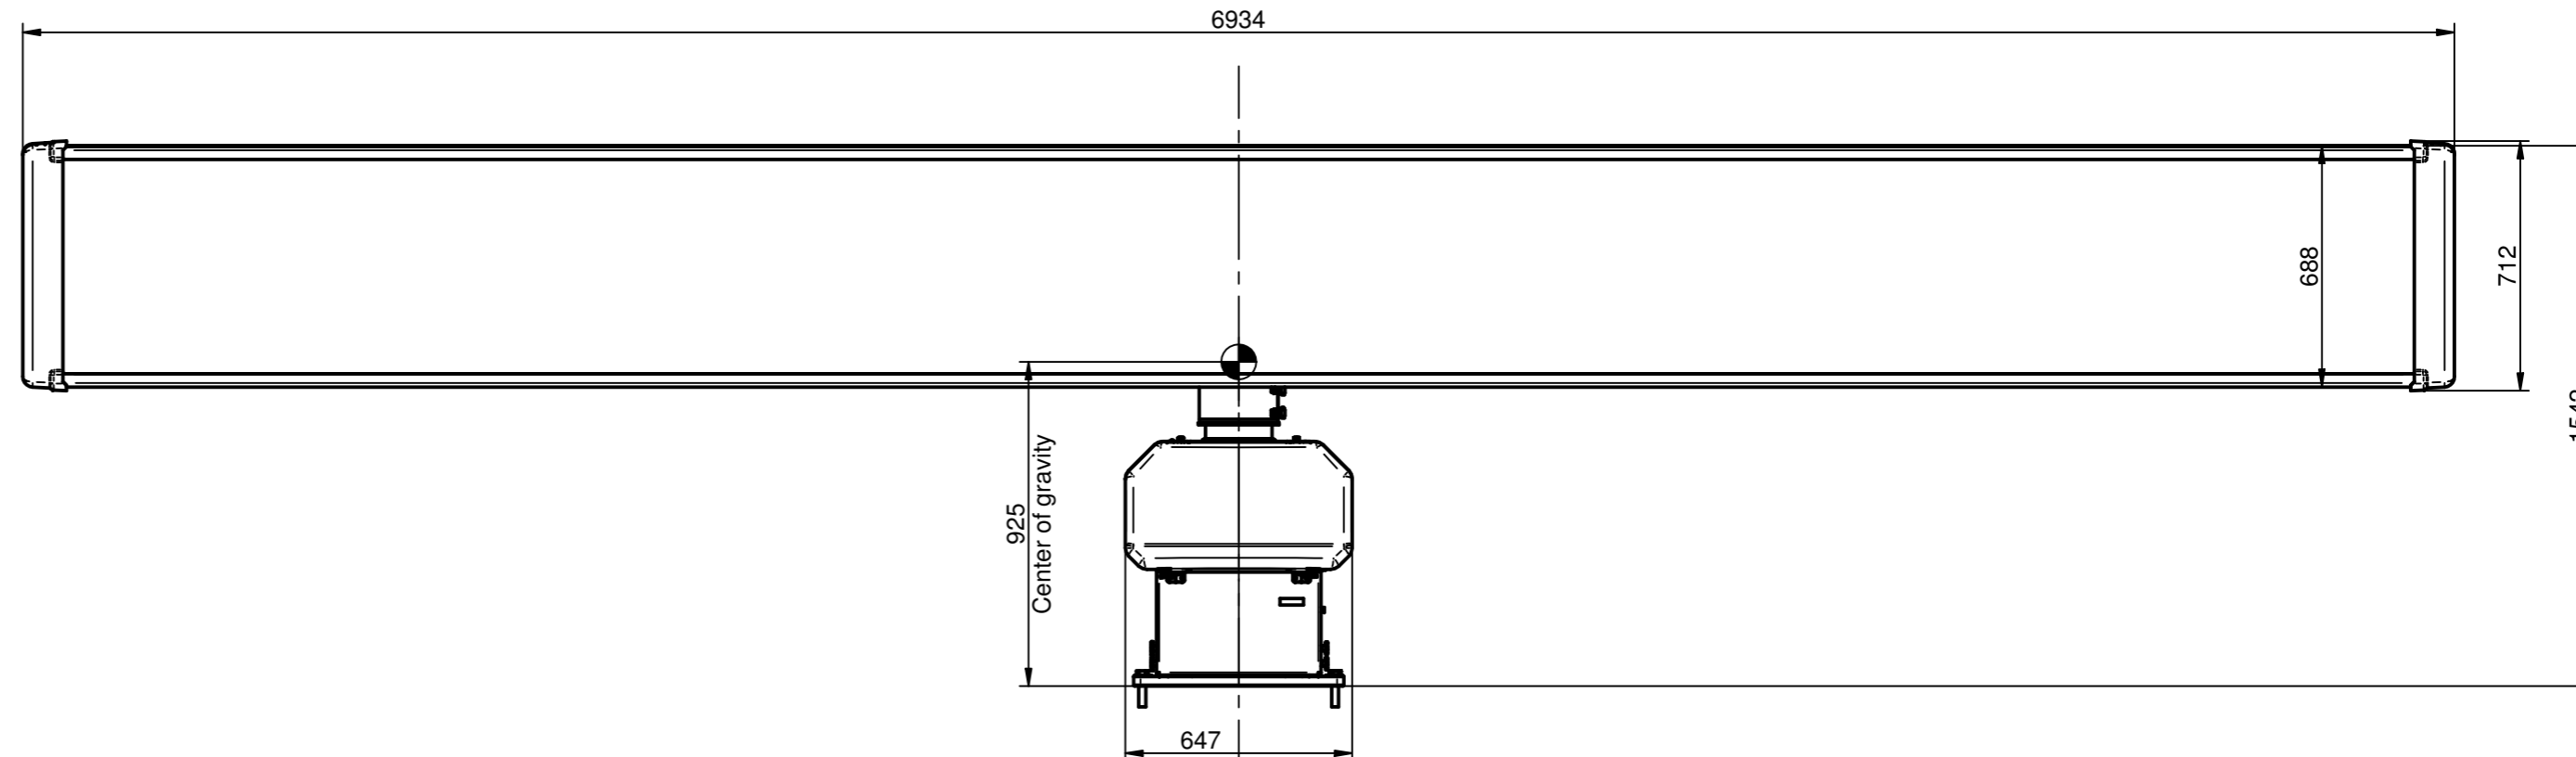
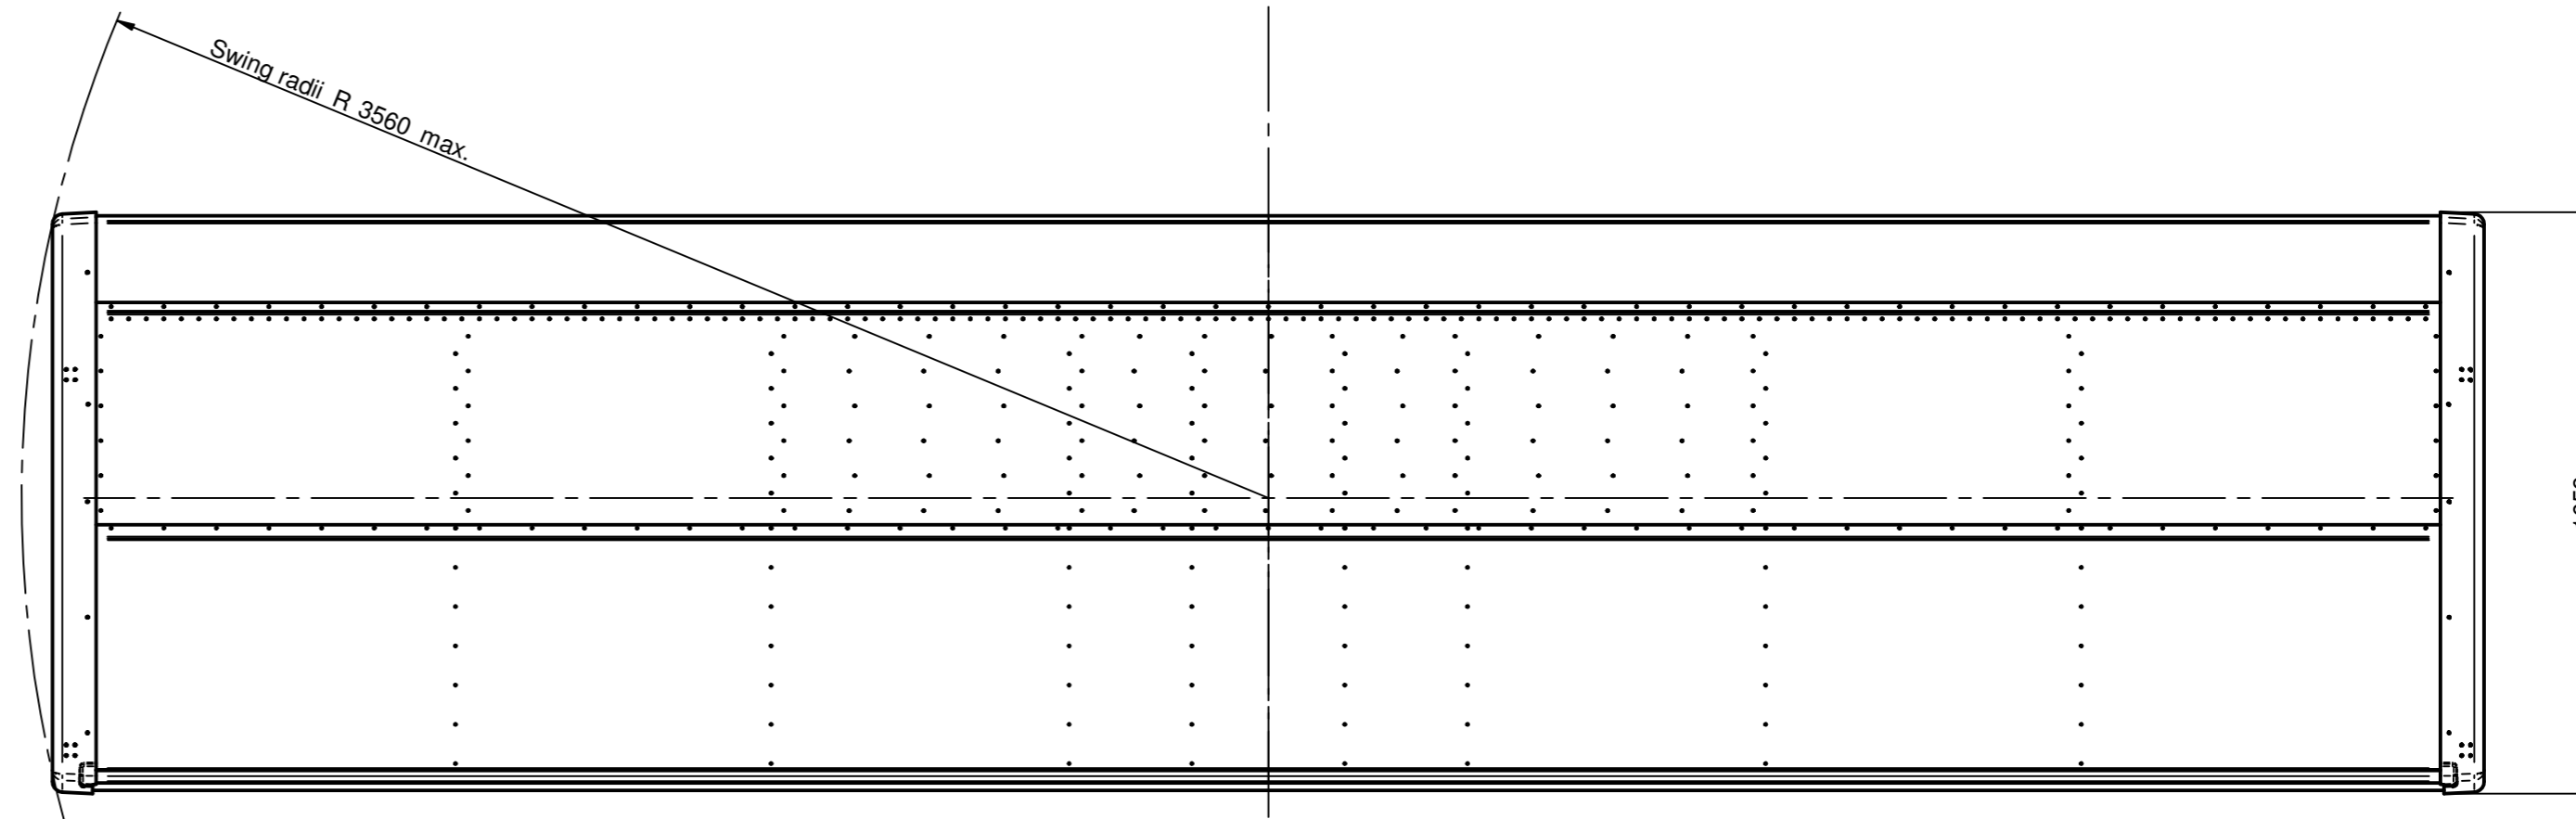
LA 21'				
Start torque [Nm]	Min	Max	Frequency [Hz]	Wind [m/s]
Cyclic torque 15 RPM [Nm]	82	1274	0,5	30 m/s
Cyclic torque 10 RPM [Nm]	37	1274	0,33	45 m/s
Cyclic torque 4 RPM [Nm]	6	567	0,133	50 m/s
	Min	Max	Frequency [Hz]	Wind [m/s]
Lateral force 15 RPM [N]	1386	6368	0,5	30 m/s
Lateral force 10 RPM [N]	3119	14328	0,33	45 m/s
Lateral force 4 RPM [N]	3850	17689	0,133	50 m/s
Lateral force non operating [N]	7547	34670	-	70 m/s
	Min	Max	Frequency [Hz]	Wind [m/s]
Overturning moment 15 RPM [Nm]	609	7576	0,5	30 m/s
Overturning moment 10 RPM [Nm]	1370	17046	0,33	45 m/s
Overturning moment 4 RPM [Nm]	1691	21045	0,133	50 m/s
Overturning moment non operating [Nm]	3315	41248	-	70 m/s
Motor output power : 4,0 kW				
Rated Current (In) : 9,0 A @ 400V				
Locked Rotor Current (Is) : 42,3 A				
Is/In = 4,7

Variant Table									
Part no.	Color	Type	Azimuth Output [ACP]	Max Speed RPM	Mains [V]	Weight approx. Kg	Oil Sensor	Encoder Supply	Motor Output Power kW
304262-002	Grey	21' LAHP-F-42	1*8192	15	3x230/400	1000	Optional	± 10%, max. 120mA	4,0
304262-022	Grey	21' LAHP-C-40	1*8192	15	3x230/400	1000	Optional	± 10%, max. 120mA	4,0
304262-031	Grey	21' LACP-F-42	1*8192	15	3x230/400	1000	Optional	± 10%, max. 120mA	4,0

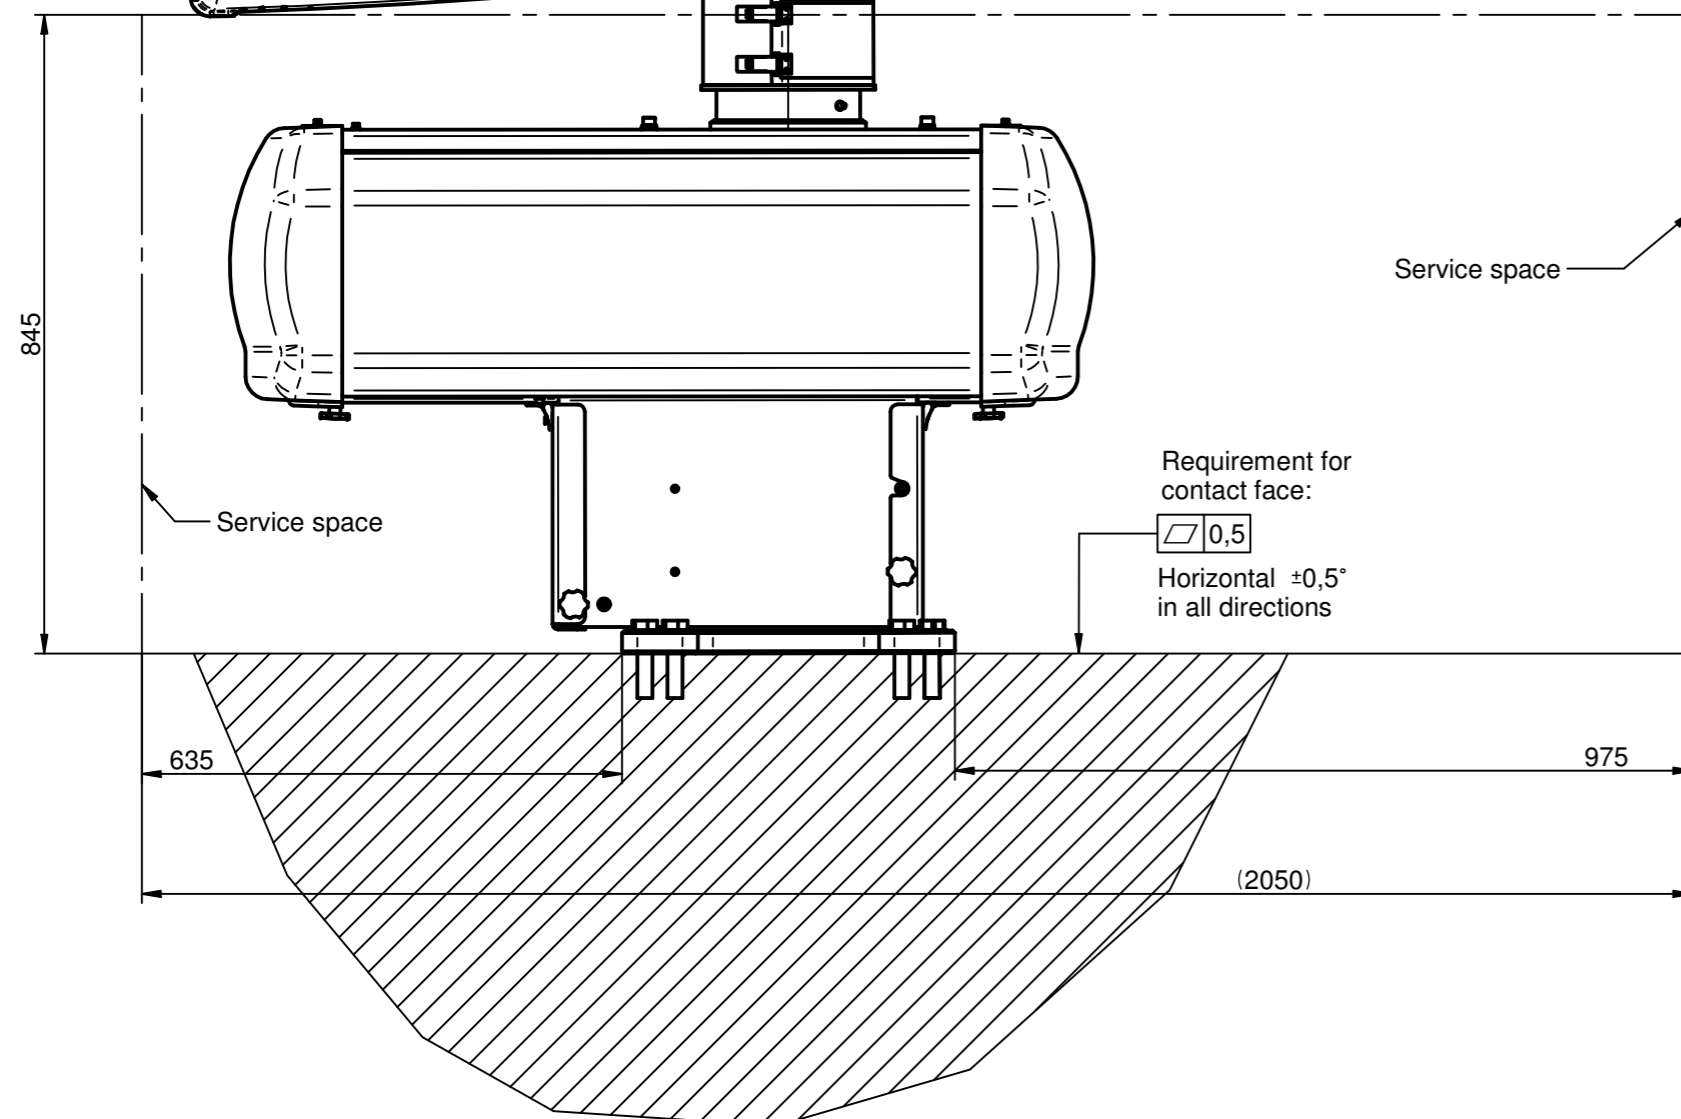
For installation use:

- 8 bolts DIN933, M20x90, A4, CL. 70
- 16 washers, flat DIN 125A, A4
- 8 washers, lock DIN 127B, A4
- 8 nut DIN 934, M20, A4

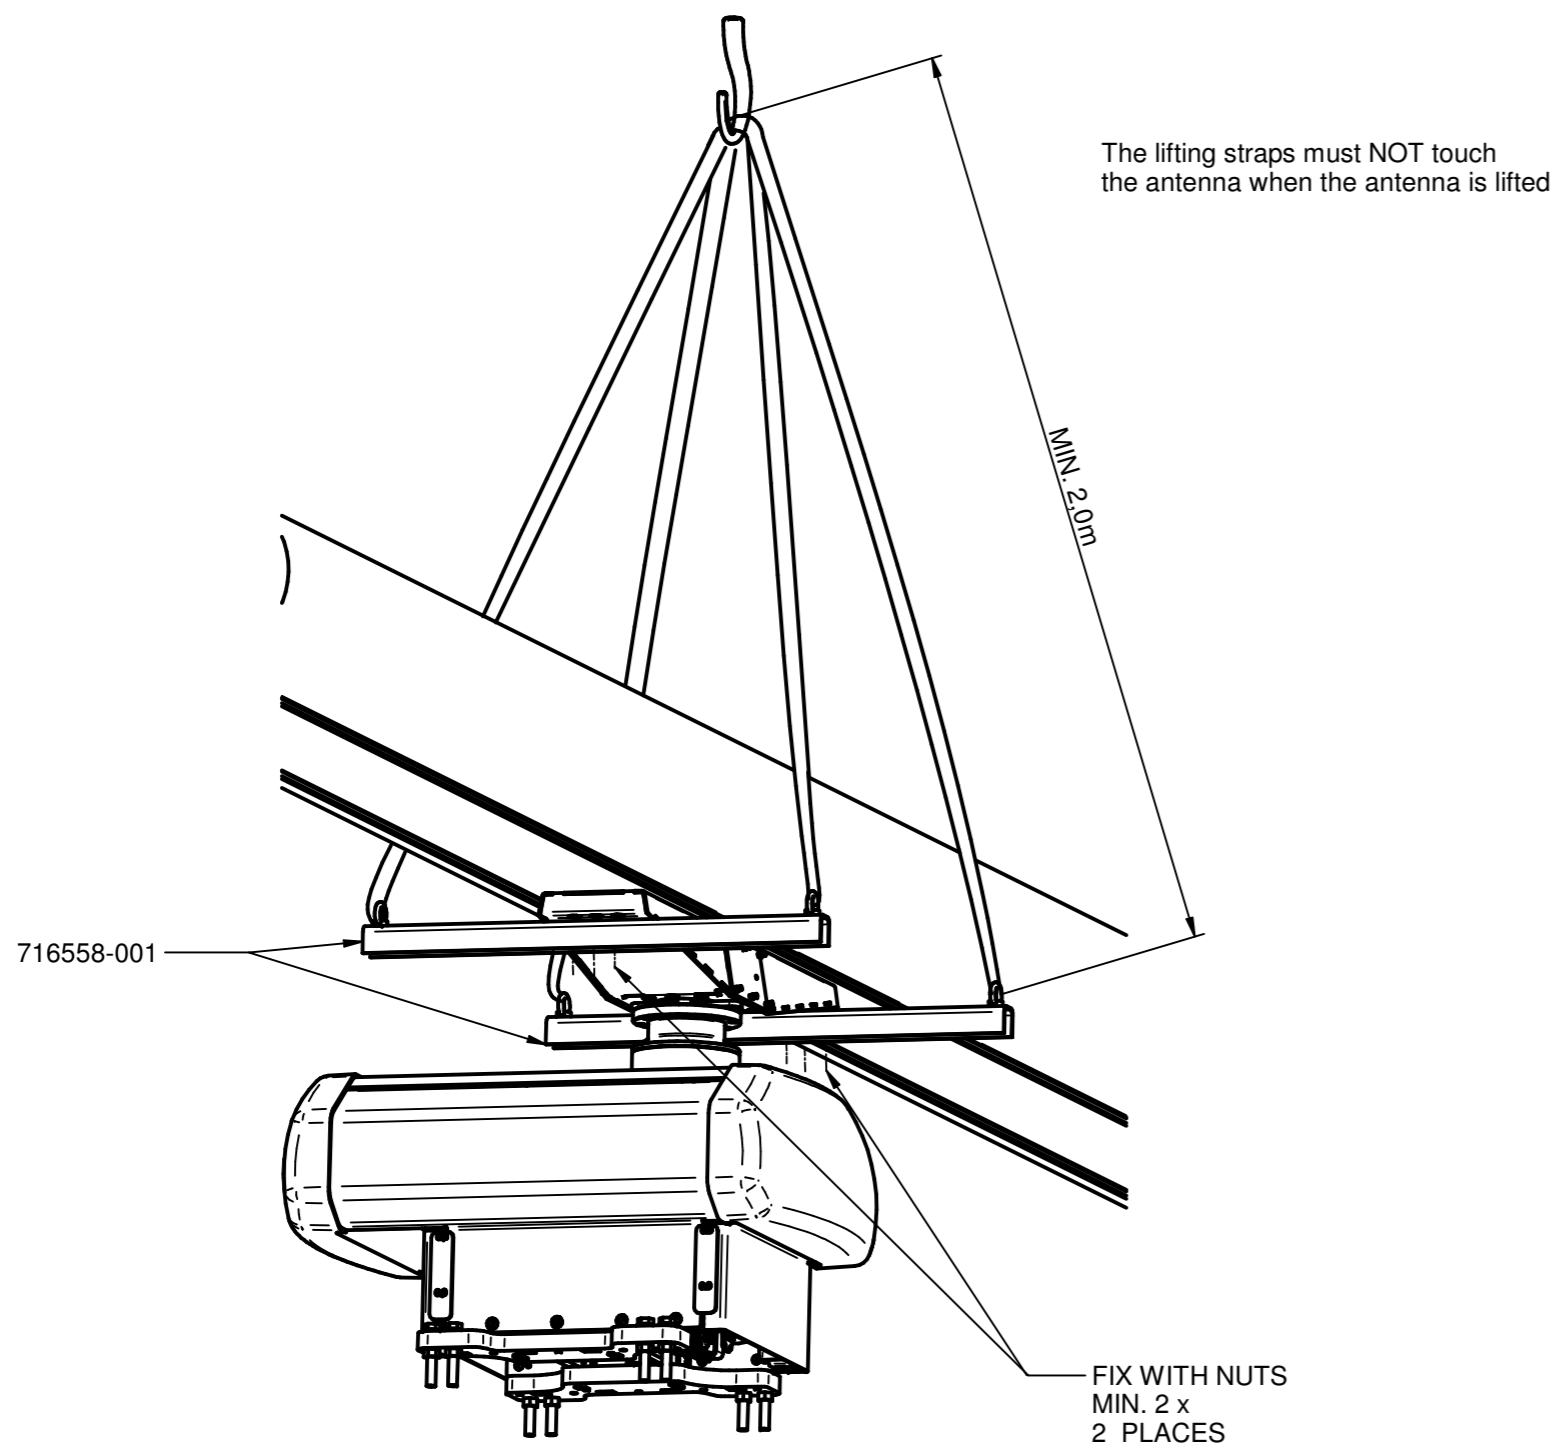
- USE LIFTING YOKES  
TERMA PART NO.:716558-001
- MOUNT LIFTING YOKES AS SHOWN, AND FASTEN WITH NUTS
- MINIMUM SLING LENGTH: 2,0m
- REMOVE LIFTING YOKES AFTER MOUNTING ANTENNA
- HANDBOOK DOC. 716558-HC
