# BRAKLAAGTE SOLAR PV FACILITY DEVELOPMENT RE-VEGETATION AND REHABILITATION MANAGEMENT PLAN

**Braklaagte Solar PV Facility**

SLR Project No.: 720.13101.00004  
Report No.: 2.6  
Revision No.: 03  
November 2022

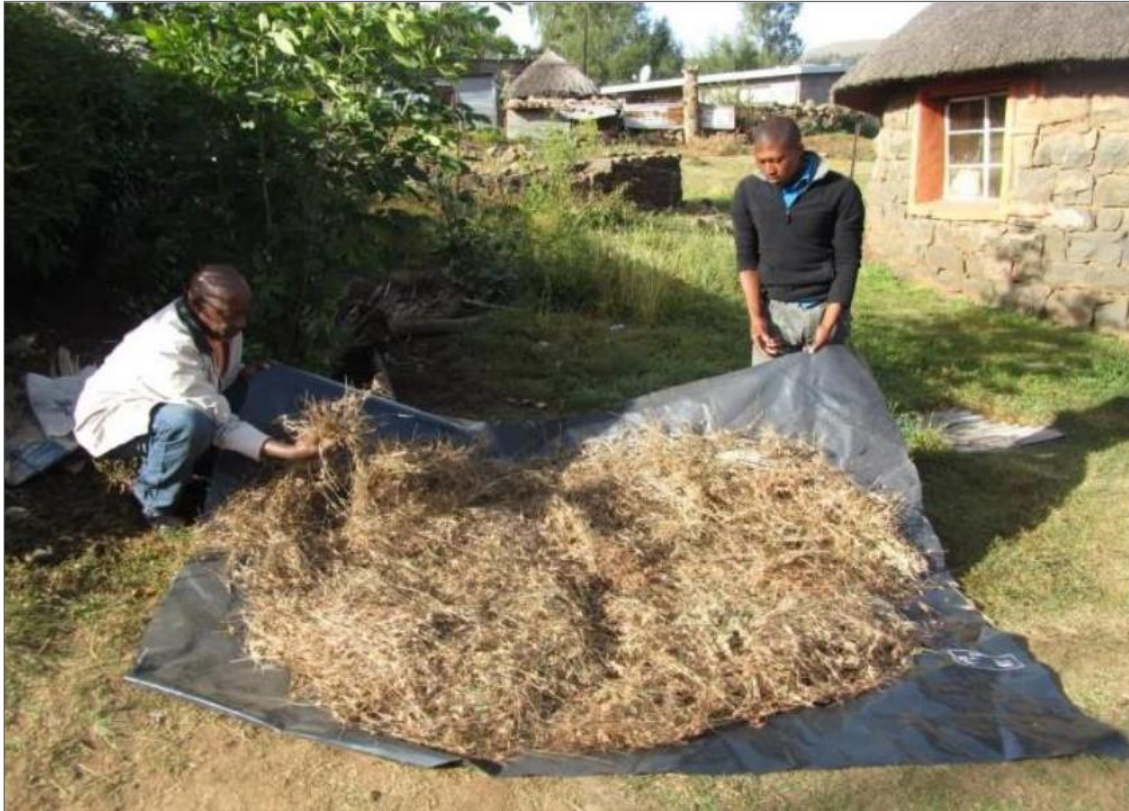
**Figure 4. 1: Recently harvested indigenous grass seeds being aerated during the drying process (photo credit: Kevin Kirkman)**

Once the seed has been harvested it must be dried as soon as possible to prevent it from rotting (**Figure 4.1**). The most suitable way of drying the seed is to lay it out on a sheet in a suitably ventilated room. The seed should be turned over several times a day until it is dry. Then it can be placed in suitable bags for storage until the next growing season. The seed can be sown by hand at the beginning of the growing season using established techniques. Germination is usually slow and erratic compared to

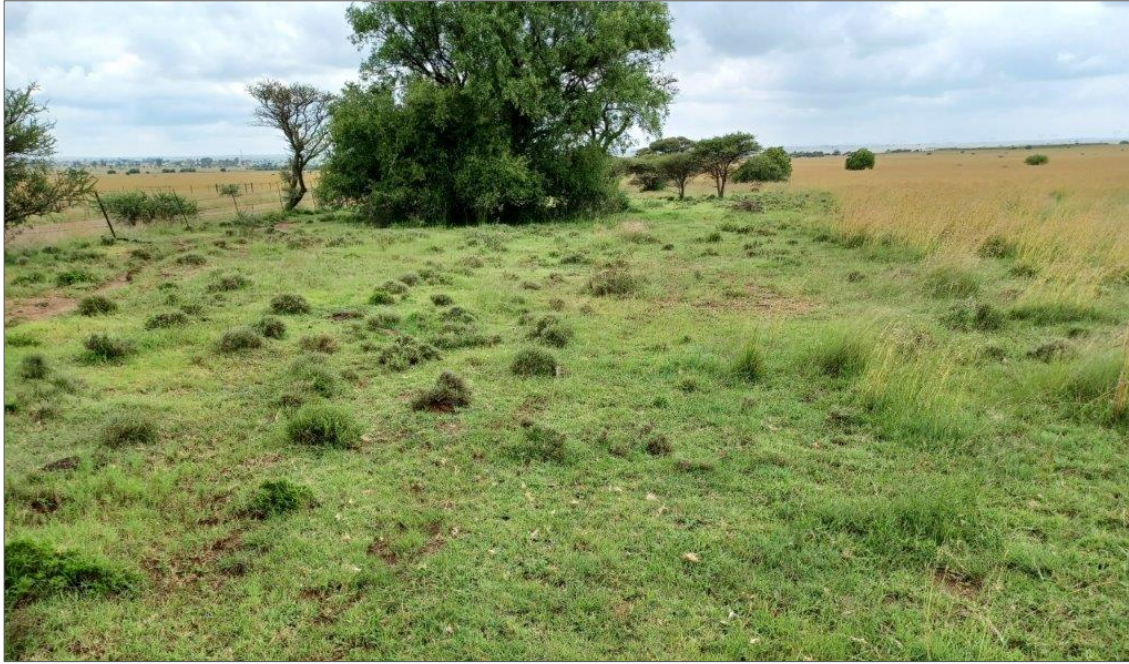
**Figure 4. 2: *Cynodon dactylon*, showing dense, creeping growth habit (photo credit: Doug McCulloch). This is ideal for protecting the soil surface and binding the topsoil. It also able to withstand heavy grazing and trampling. Ideal for vegetating slopes and drainage swales.**

*Cynodon dactylon* occurs naturally within localised patches in the area (**Figure 4.2**). This is a rhizomatous grass species that forms a dense mat, is drought resistant, can withstand heavy grazing and has a dense adventitious root system that binds surface soil effectively. This species would be the ideal cover for areas where water runoff is anticipated, such as on roadsides or on the sides and bottoms of drainage swales.

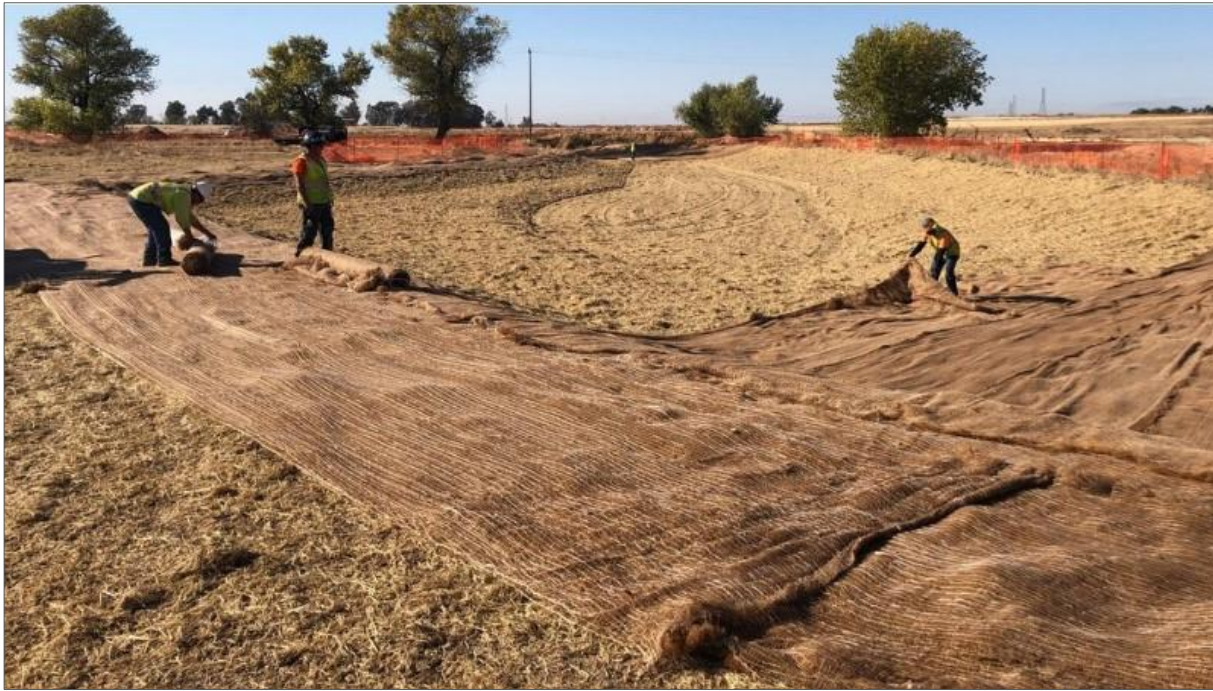
**Figure 4. 3: Straw mulching together with an example of a biodegradable erosion control soil saver (photo credit: Tully Consulting Group)**

- In dry areas where seed, moisture and organic matter retention is low it is recommended that soil savers are used to stabilize the soil surface. The site has variable rainfall with dry winter months. Soil desiccation and wind erosion are substantial threats to successful rehabilitation. Soil savers are loose mats constructed of biodegradable materials such as hemp or jute that are placed over the bare soils surface and pegged down (**Figure 4.3**).
- Soil savers may be seeded directly as the holes in the material catch seeds and provide suitable micro-sites for germination. Alternatively fresh mulch containing seeds can be applied to the soil saver. Soil savers may only be necessary if rehabilitation is occurring during a particularly dry period within the rainfall months, or at the temporal edges of the rainfall season.
