ECOSYSTEM RESTORATION

17100 LARGE RECREATIONAL PONDS

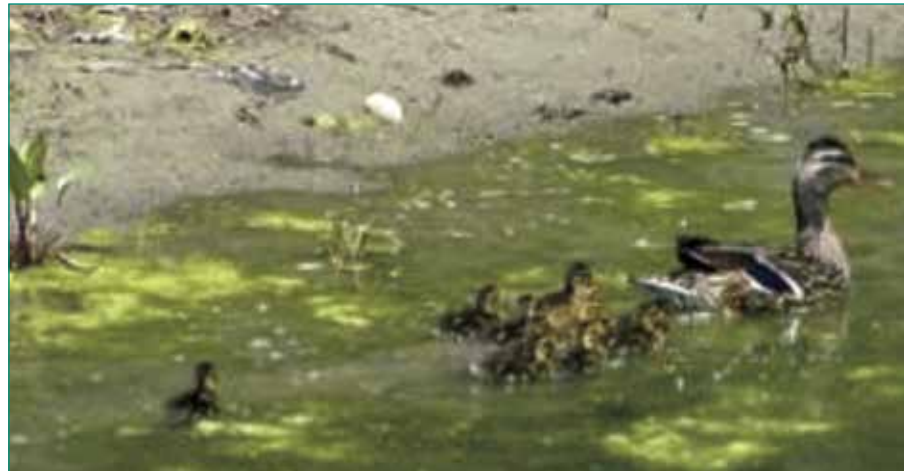
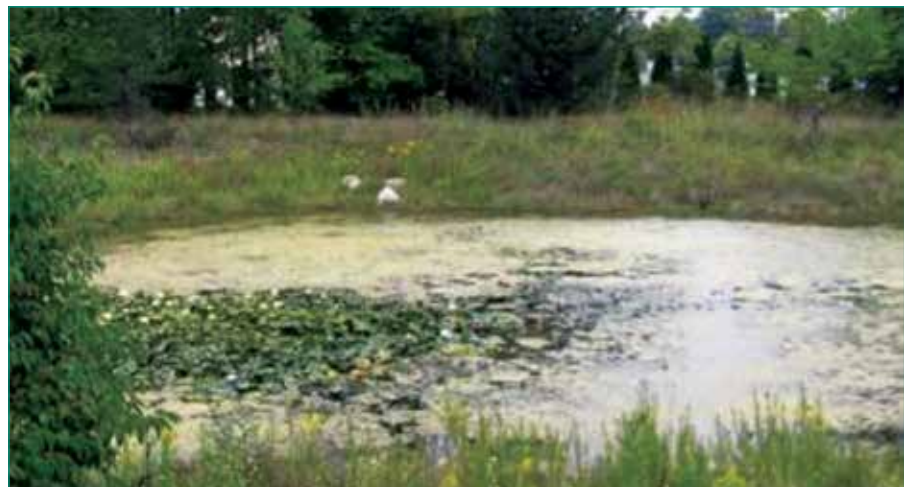
Fig. 1 & 2: In the pictures, the ducks are living in an unhealthy environment. The picture below shows the surface scum, a condition that is not only unsightly but interferes with natural cycles that provide a healthy environment for wildlife.

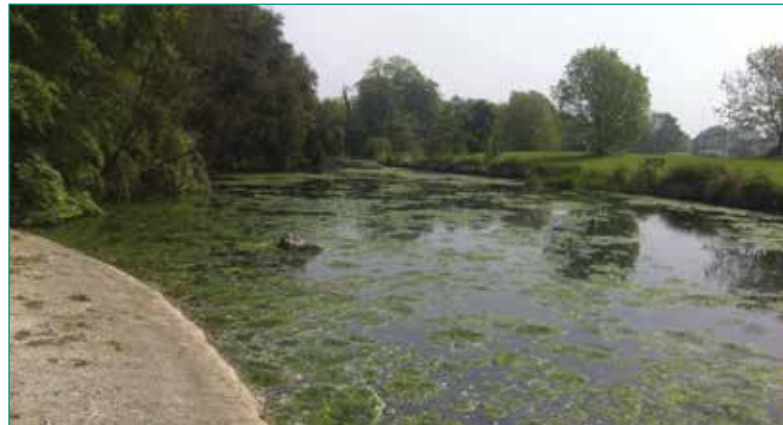
Fig. 2: This picture shows the massive amount of algae and surface solids accumulated on the lake surface.

For many years a combination of natural organic decay, surface water pollution, and nutrient run-off from adjacent playing fields has produced a build-up of organic sludge and inorganic silt in the pond. The resultant nutrient imbalance led to cloudy water, pungent malodors, and regular algae blooms across the entire lake.

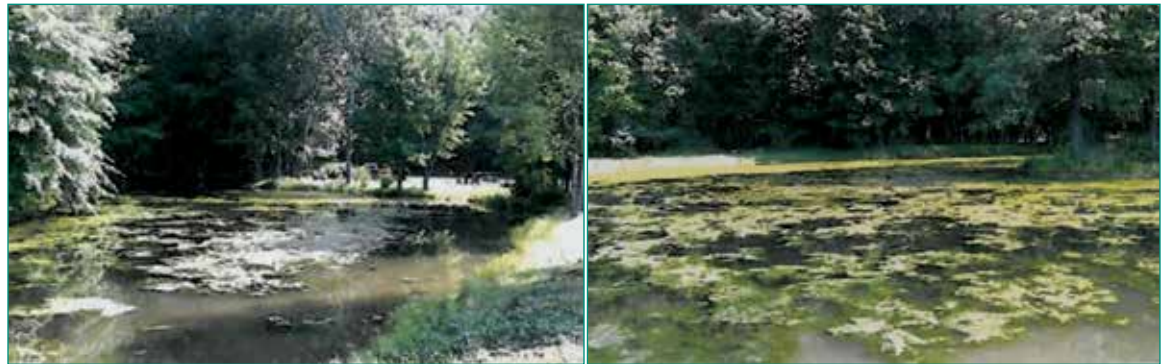
Fig 1: Severe string and mat algal blooms destroy the beauty of this preserve. Turbidity and solids accumulating on shore detract further from this potential retreat. (pictures taken 4/21/2004)

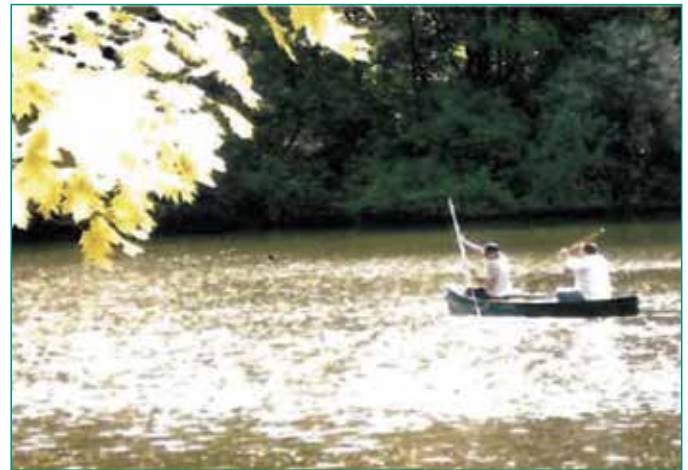
Fig. 1: This picture taken May 15, 2006 shows the turbidity of the water.

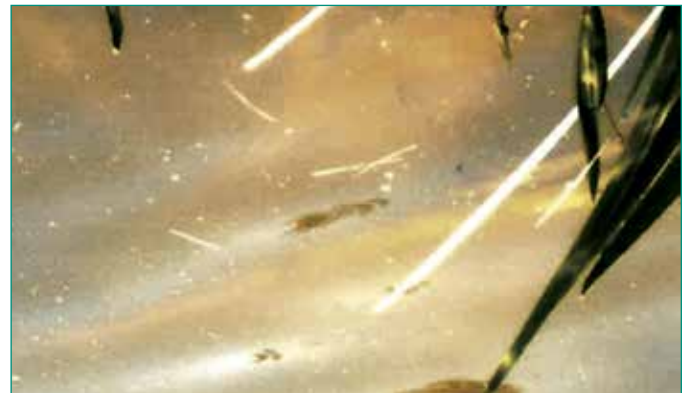
Fig. 2: Also taken of the pond surface on May 15, 2006 this picture is a close up showing turbidity and surface scum.

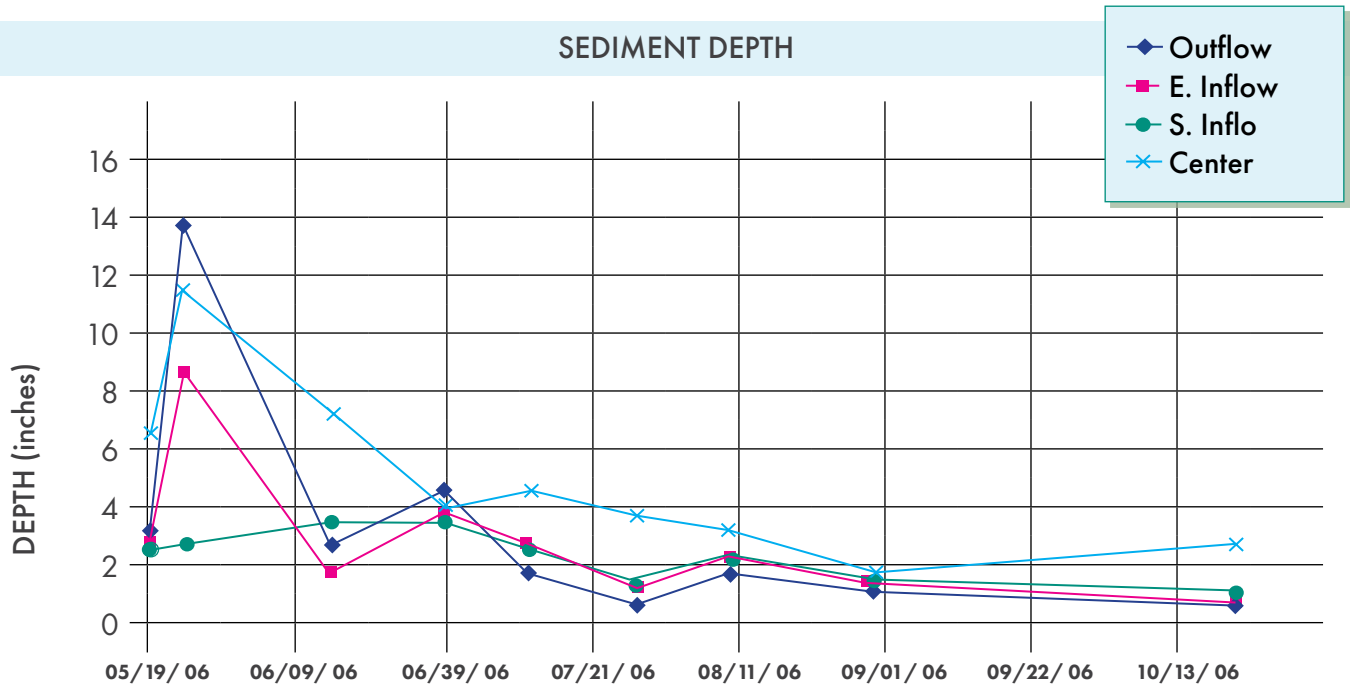
Chart 1: This graph shows the reduction in sediment in bi-monthly recordings throughout the treatment program. The first data point was incorrect due to improper use of the sludge judge, making the second data point the true baseline.

Microbial metabolism will continue to breakdown organic solids until mineralization is achieved, leaving only the inorganic portion of the sludge. The percentage of organic solids in the sludge determines the potential for biological removal. The data below indicates the organic portion of Occum Pond sediment is high, thus, the potential for a successful biological removal of sludge is high. **EL** estimates that it is reasonable to expect up to 6 to 12 inches of removal per year depending on temperature and other environmental factors.

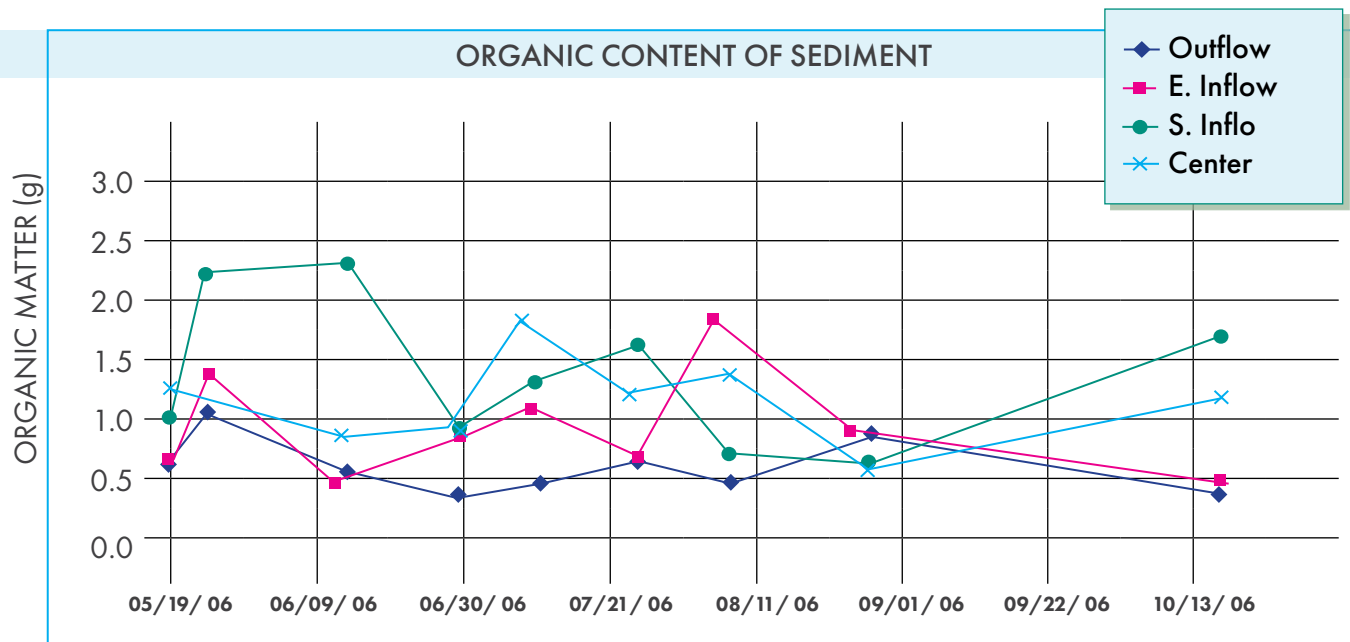
Chart 2: Sediment is high, thus, the potential for a successful biological removal of sludge is high.

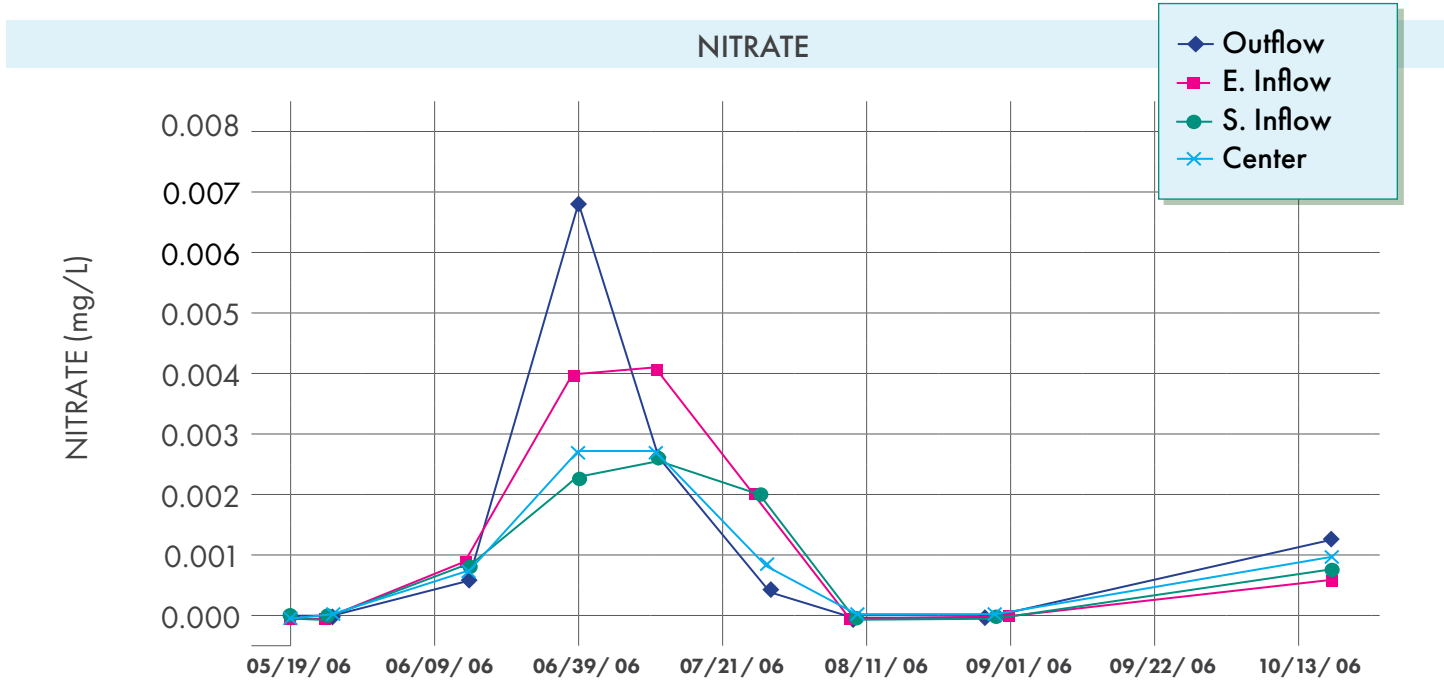
Chart 4: Initial stages of high rainfall concentrates the nitrate contamination.

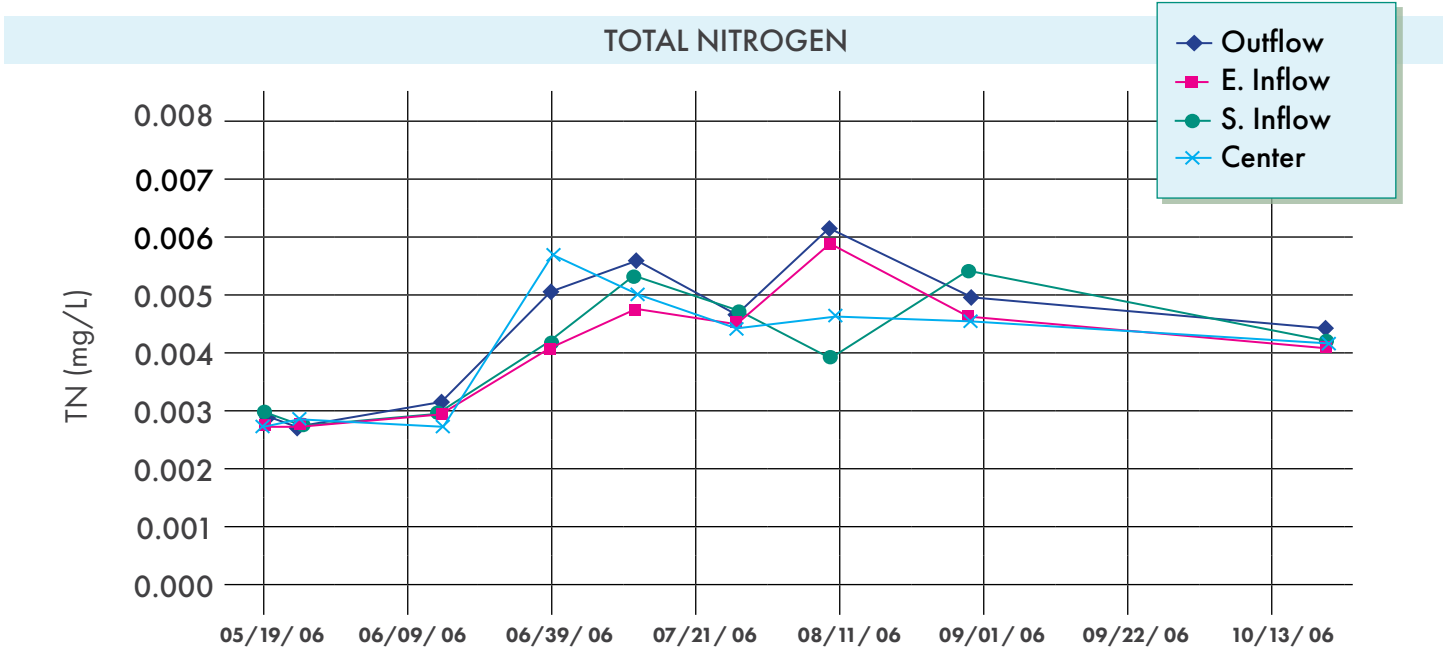
Chart 6: Total nitrogen includes all forms of nitrogen: ammonia, nitrite, and nitrate plus the nitrogen in organic compounds. This curve shows the influence of the peaks in both nitrate and ammonia

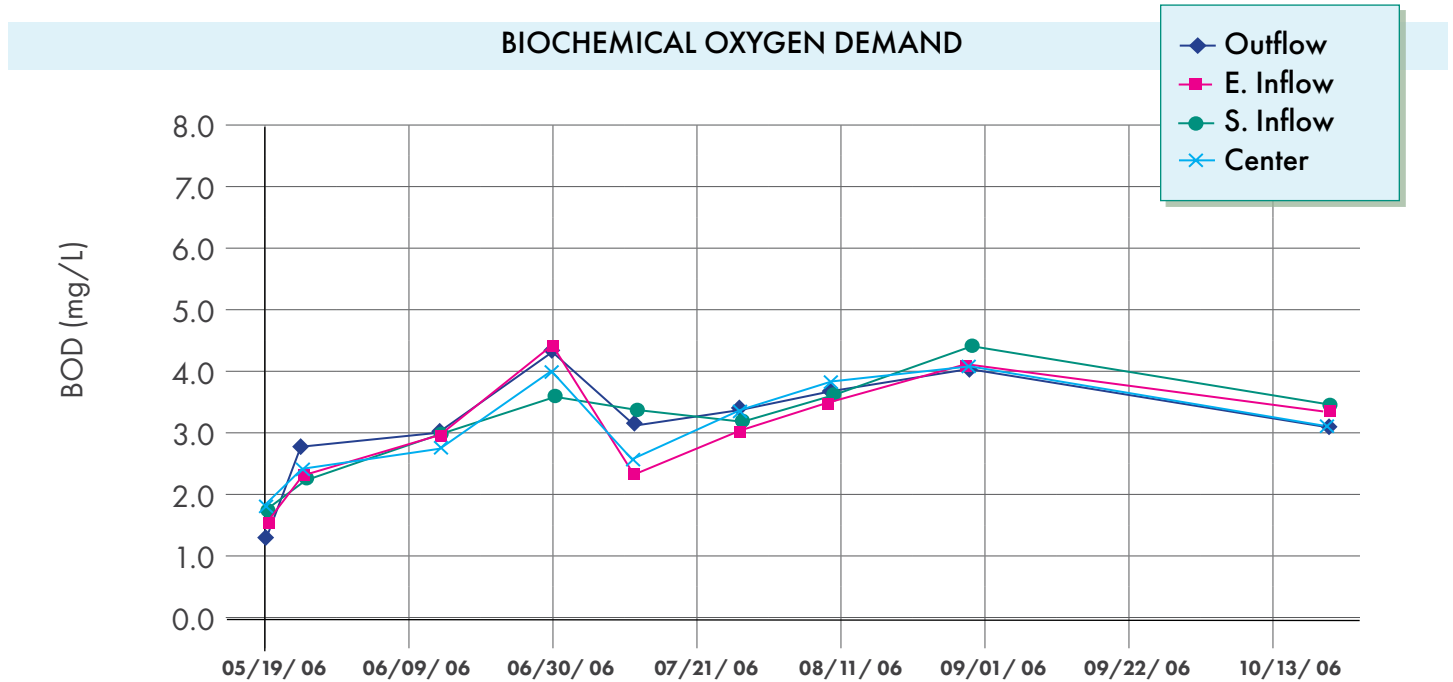
Chart 8: Biochemical Oxygen Demand (BOD) shows increased deposit of organic matter with heavy rainfall peaking on June 30th.

Biochemical Oxygen Demand (BOD) or organic contamination of water results from a number of factors: a) soluble organic matter released from bottom solids, b) conversion of some COD or slow to degrade material to degradable material based on capabilities of selected microbes, and c) organic matter coming into the system in the influent waters or other natural sources such as animal waste. This chart shows increased deposit of organic matter with heavy rainfall peaking on June 30th.

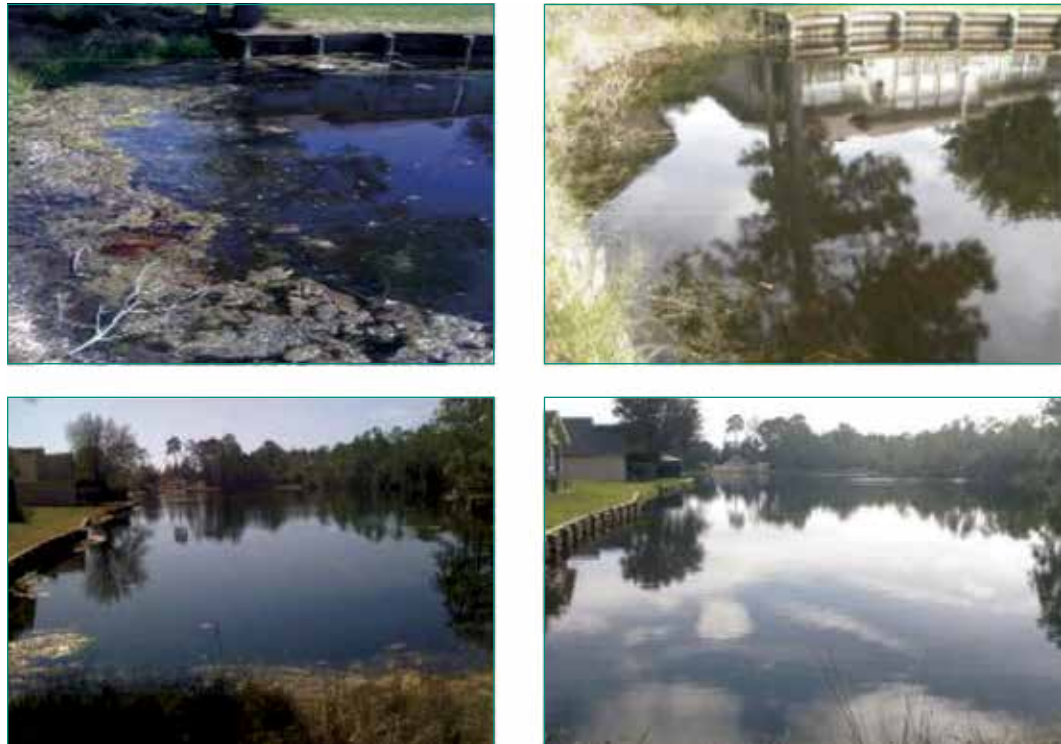
Fig. 4: These are pictures of before treatment (left) and after treatment (right). These are views of the north side of lake #1. Algae scum on the left has been completely removed.

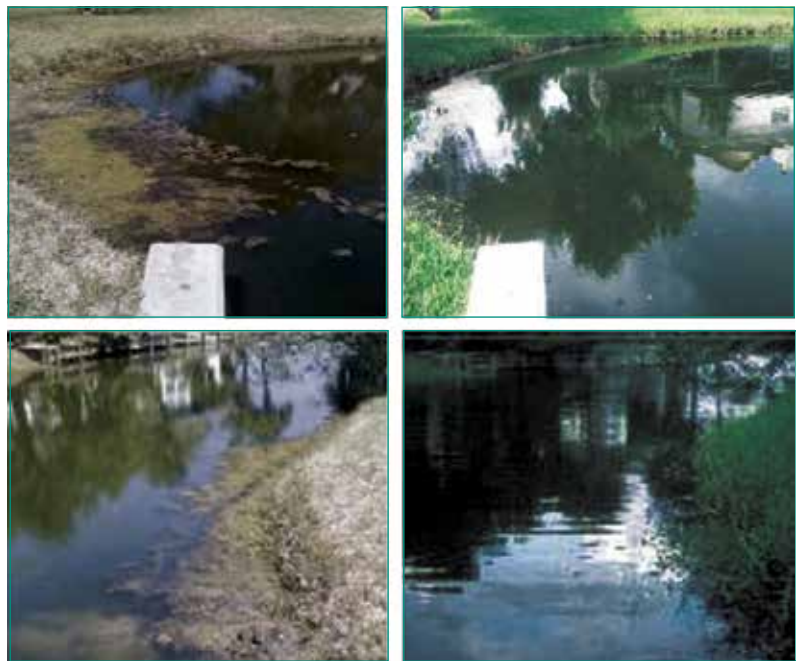
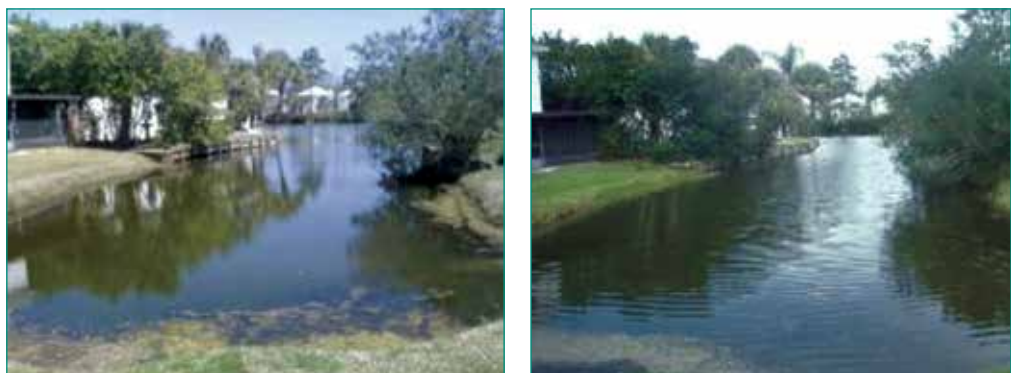
Fig. 8: Additional “before” (left) and “after” (right) pictures of lake #2.

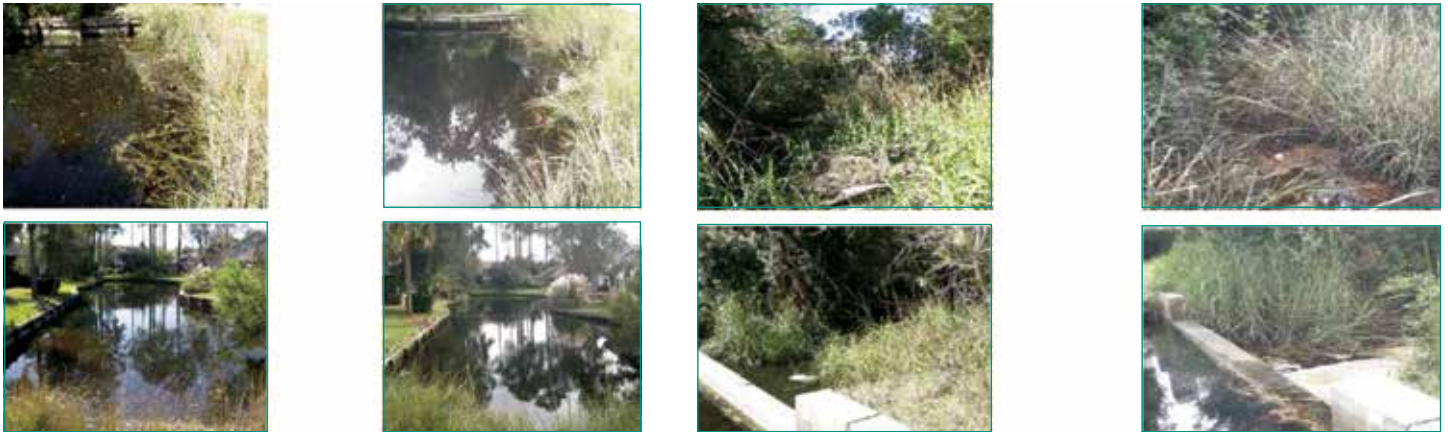
Fig.17: Before (left) and after (right) pictures of the creek.

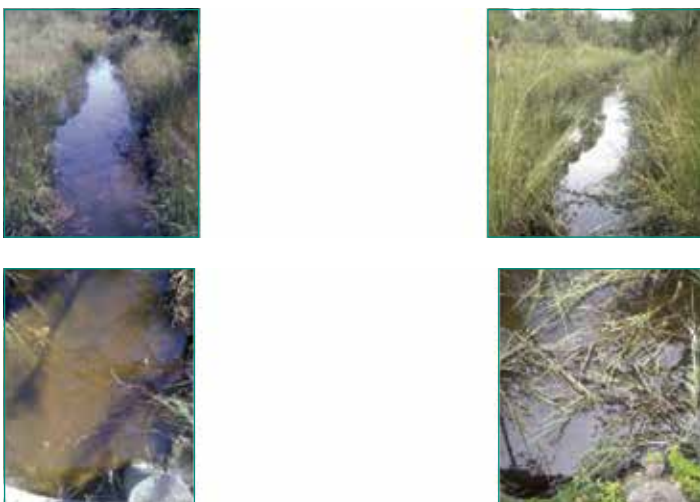
Fig. 18: Additional pictures of the creek associated with Lake 5 show the increased clarity of water after treatment (right) as opposed to those taken prior to treatment (left). The major benefit was reduction in bottom solids, which provides additional turbidity to be degraded.

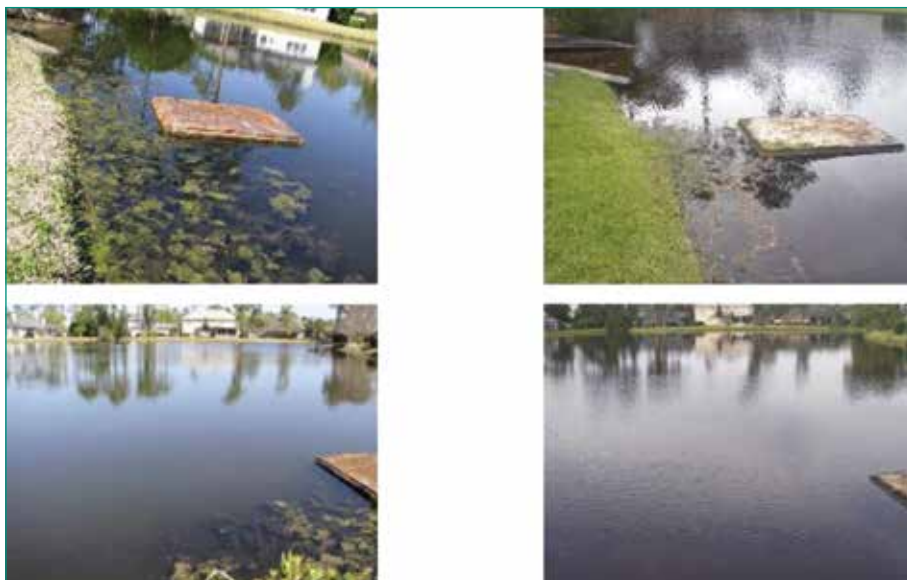
Fig. 19: Note the scum in pictures of untreated lake (left), which are dramatically reduced or eliminated with treatment (right).

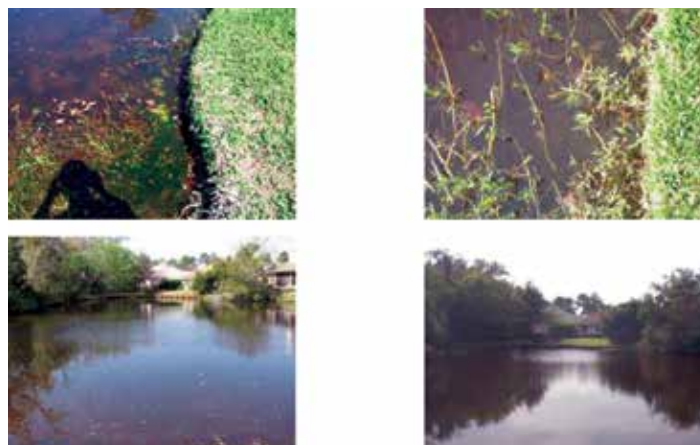
Fig. 20: Pictures demonstrate improved surface cleanliness and improved water clarity.

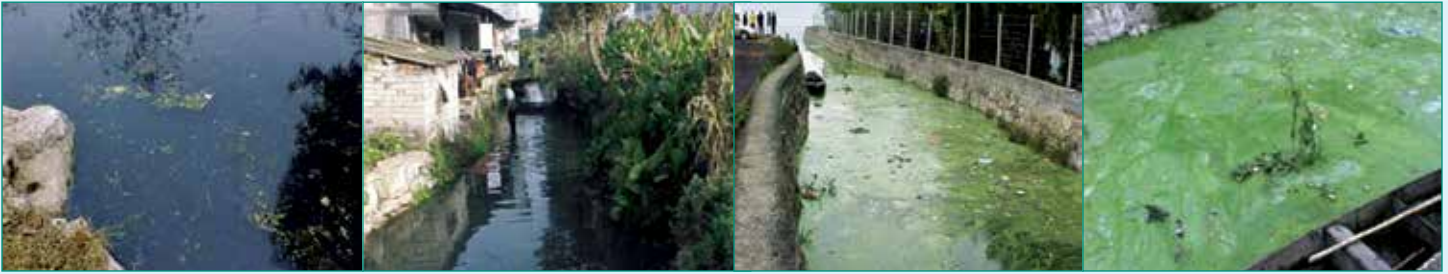
Figure 2: Condition of Xiba River before Trial Treatment on 21st November 2004

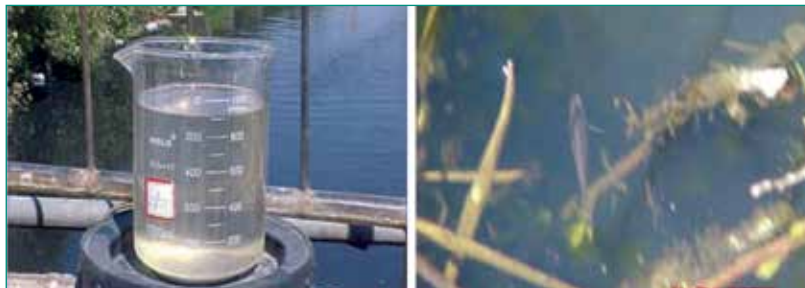
Fig.6: D water sampling from Fig. 5

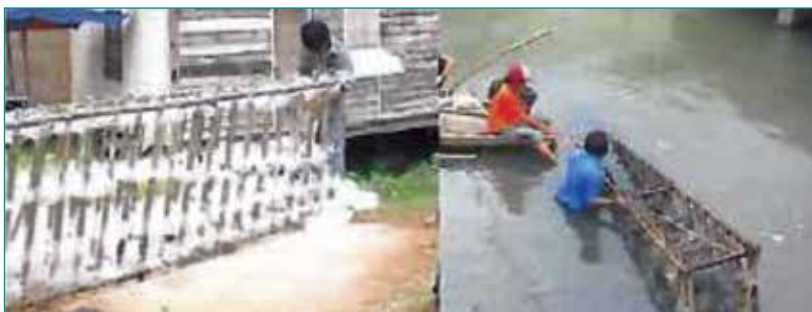
Fig.4: Shows the installation of the biomedica cages in the river.

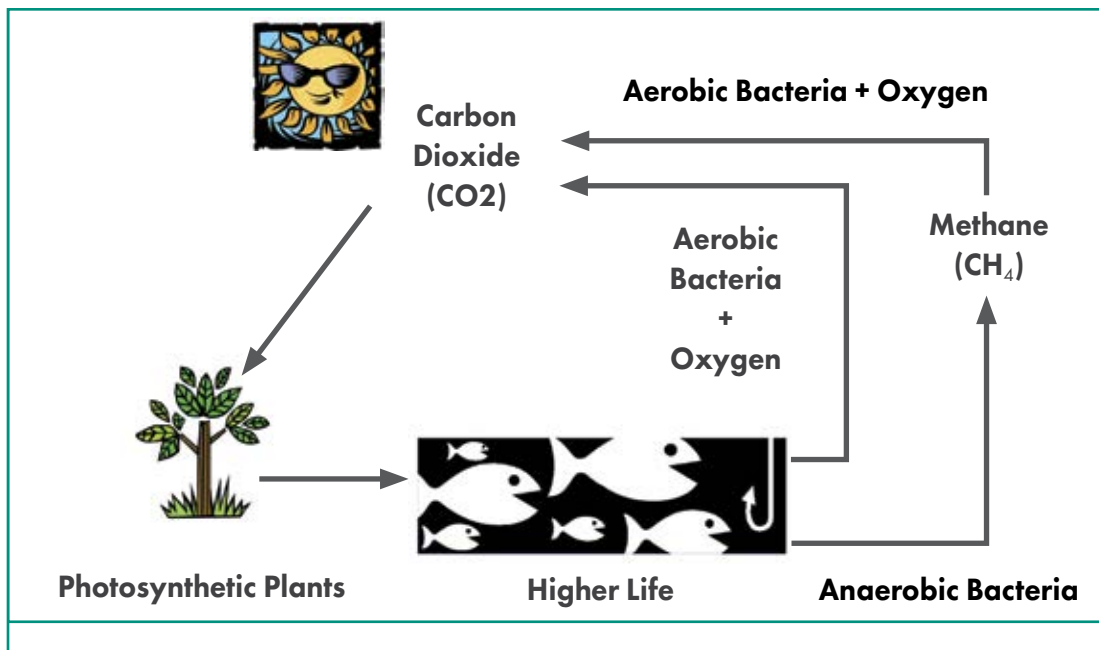
Fig 1: The Carbon Life Cycle

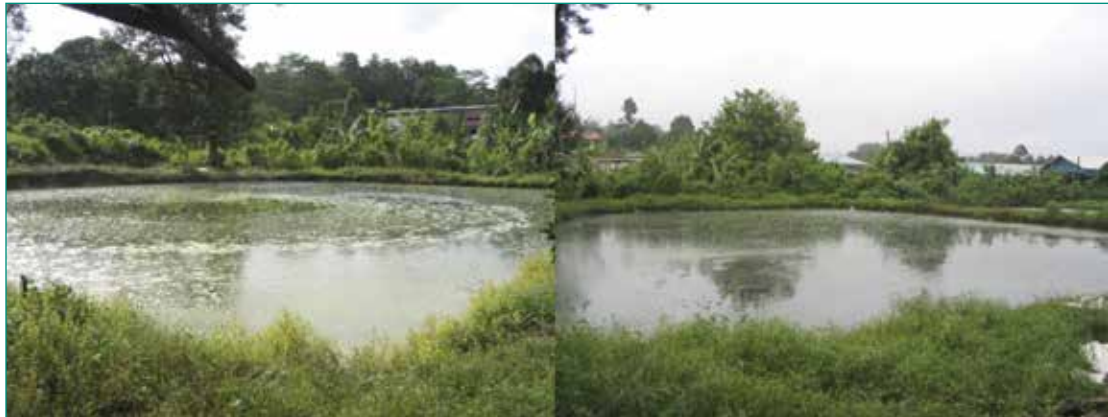
Fig 5: Pond Condition Before and After Treatment at Poh Huat Piggery Waste Treatment
