# ESTCP Cost and Performance Report

(CU-9519)

In Situ Remediation of a TCE-Contaminated Aquifer Using a Short Rotation Woody Crop Groudwater Treatment System

May 2006

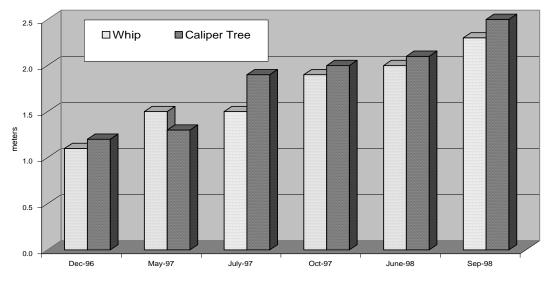
Figure 4. Canopy Diameter over Time.

Both the whips and caliper tree canopy diameter increased over time, with minor observable differences between the plantations. Whips were planted approximately 1.25 m apart. The average canopy diameter for whips at the end of September 1998 (end of the third growing season) was 2.32 m. The whip plantation was approaching canopy closure at this time. Caliper trees were planted approximately 2.50 m apart. The average canopy diameter for caliper trees in September of 1998 was 2.52 m. The caliper tree plantation was not approaching canopy closure at this time. The observed differences between whips and calipers over time were reported to be due as much to inherent genotype differences as to their different modes of establishment.
