Appendix D. Biological Setting Analysis: Caltech Submillimeter Observatory Decommissioning

Biological Setting Analysis: Caltech Submillimeter Observatory Decommissioning

**Final Report
November 2019**

Biological Inventory and Assessment Report, Fall 2018 Caltech Submillimeter Observatory, Maunakea, Hawai‘i

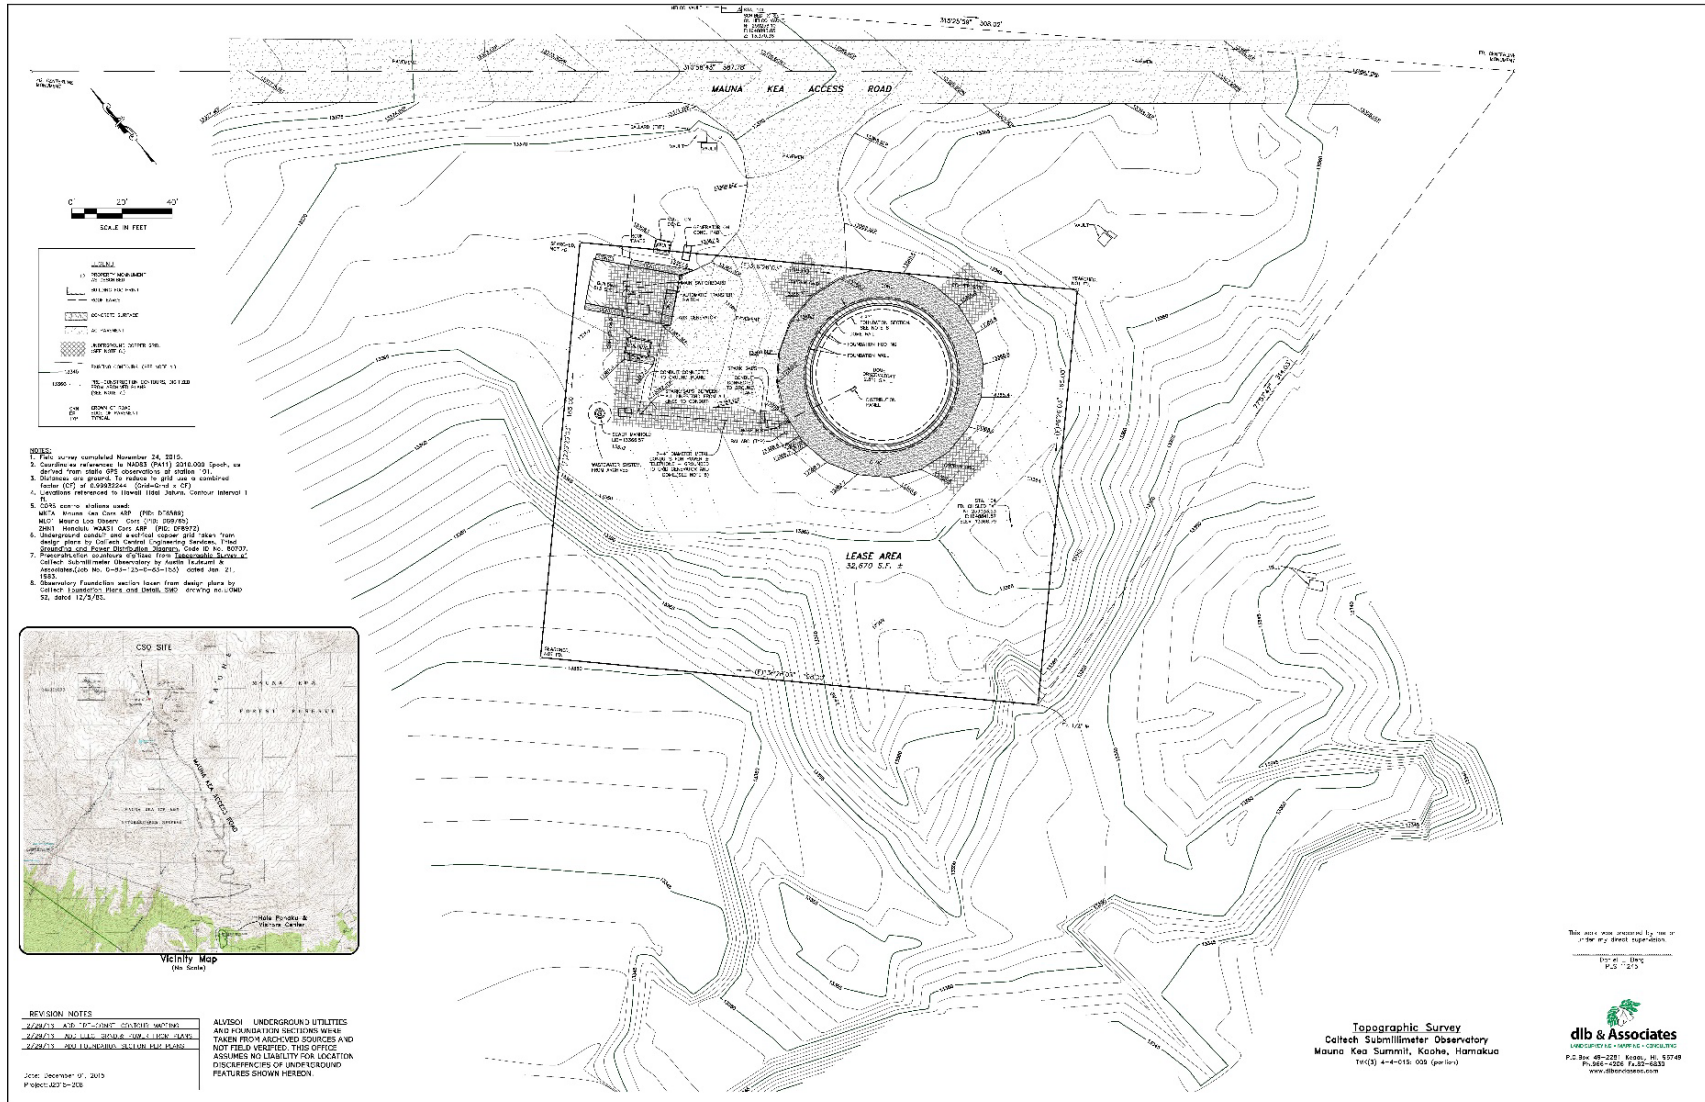
Survey area as depicted by dlb & Associates, December 2015 (Berg 2015). Note existing contours (solid) vs. pre-construction contours (dotted). Subsequent maps in this report are taken from the center section of this map.

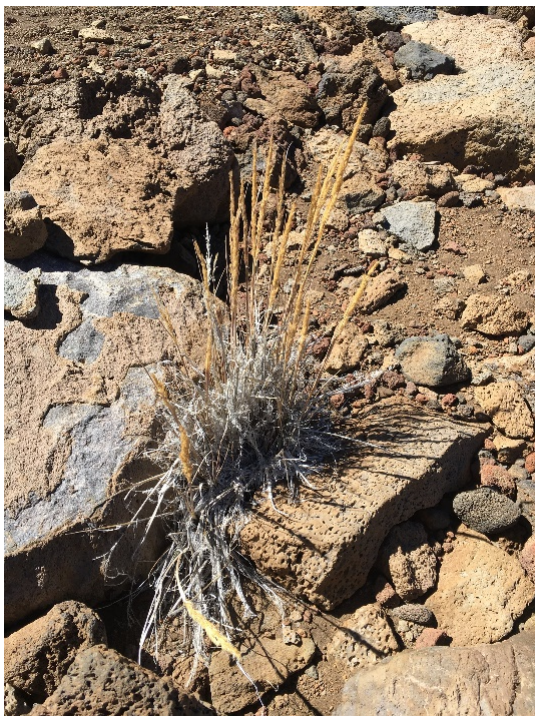
Photograph 3. Pili uka (*Trisetum glomeratum*) growing in artificially leveled substrate, from the survey site.

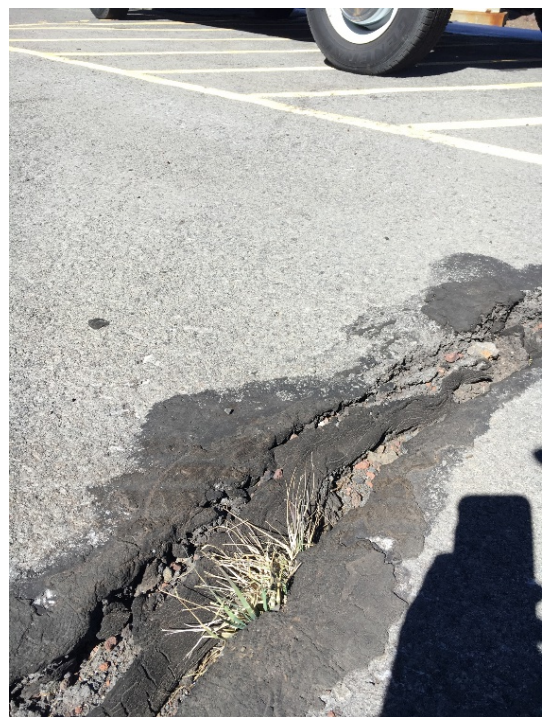
Photograph 4. Pili uka (*Trisetum glomeratum*) growing in a crack on the asphalt, from the survey site.

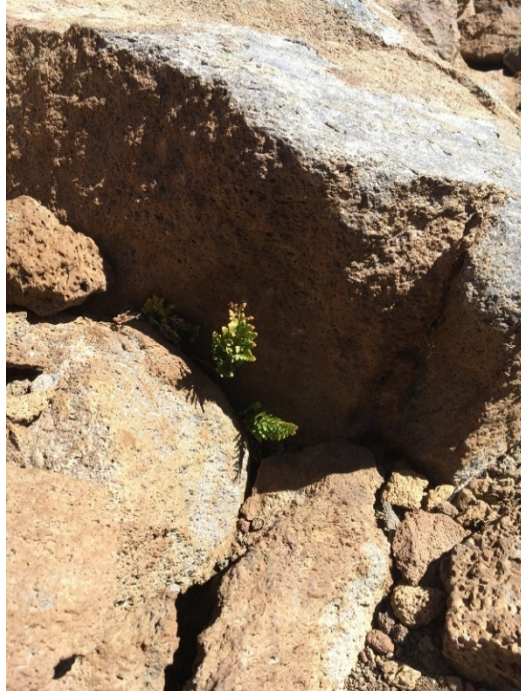
Photograph 5. 'Iwa'iwa spleenwort (*Asplenium adiantum-nigrum*) just outside the survey area.

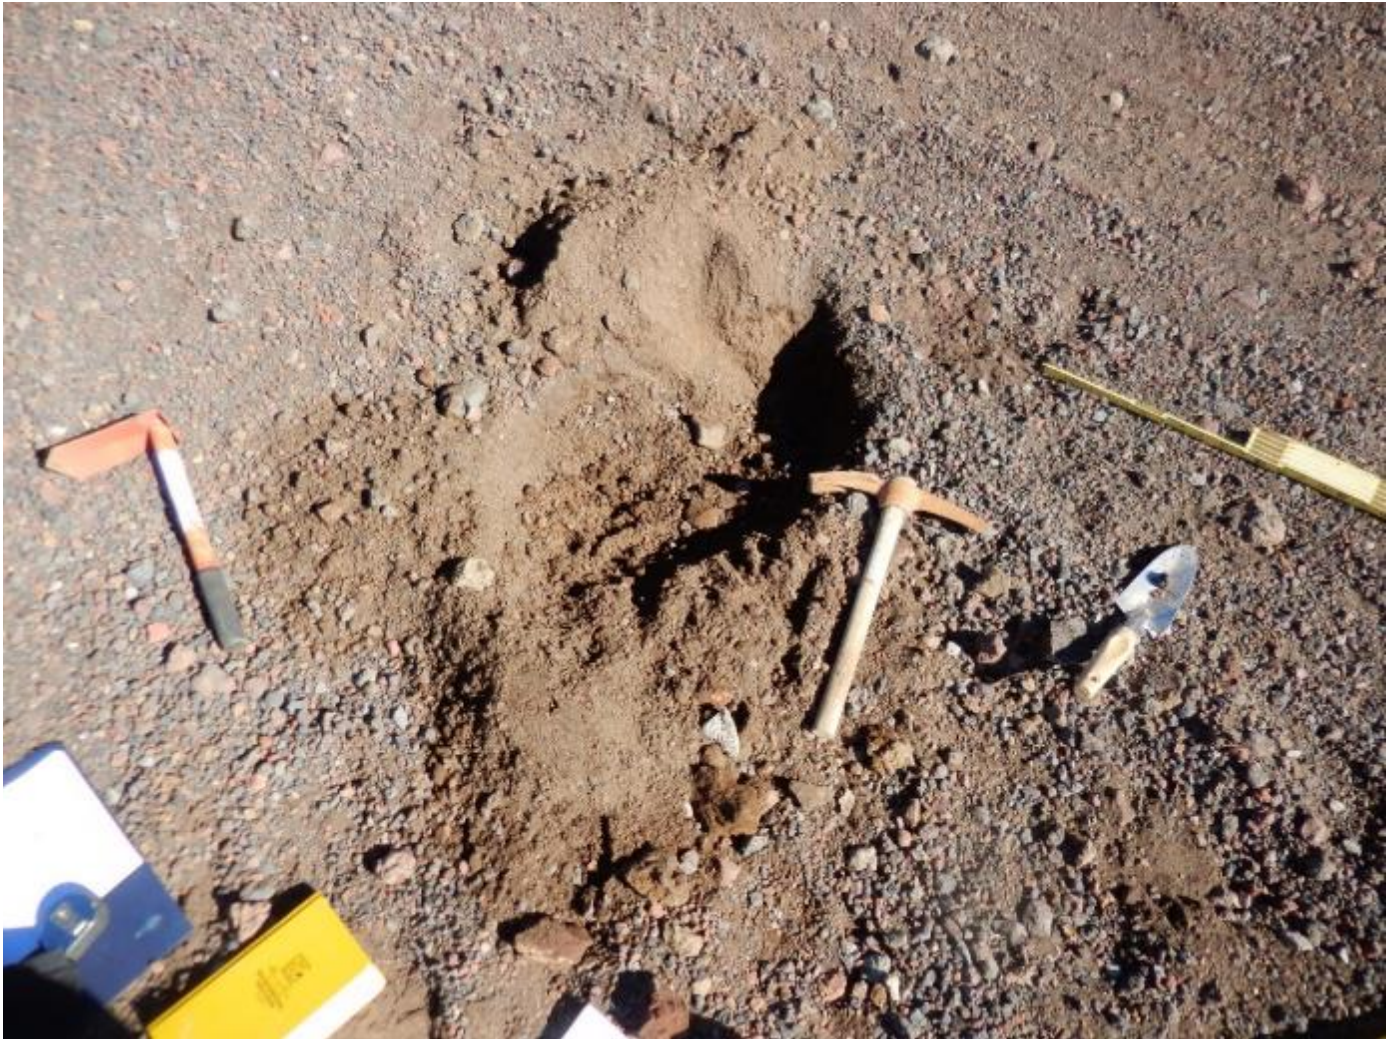
Figure 38. CSO-F-1 Sampling Hole.
Hydrogeological and Geological Evaluation
Decommissioning of the Caltech Submillimeter Observatory

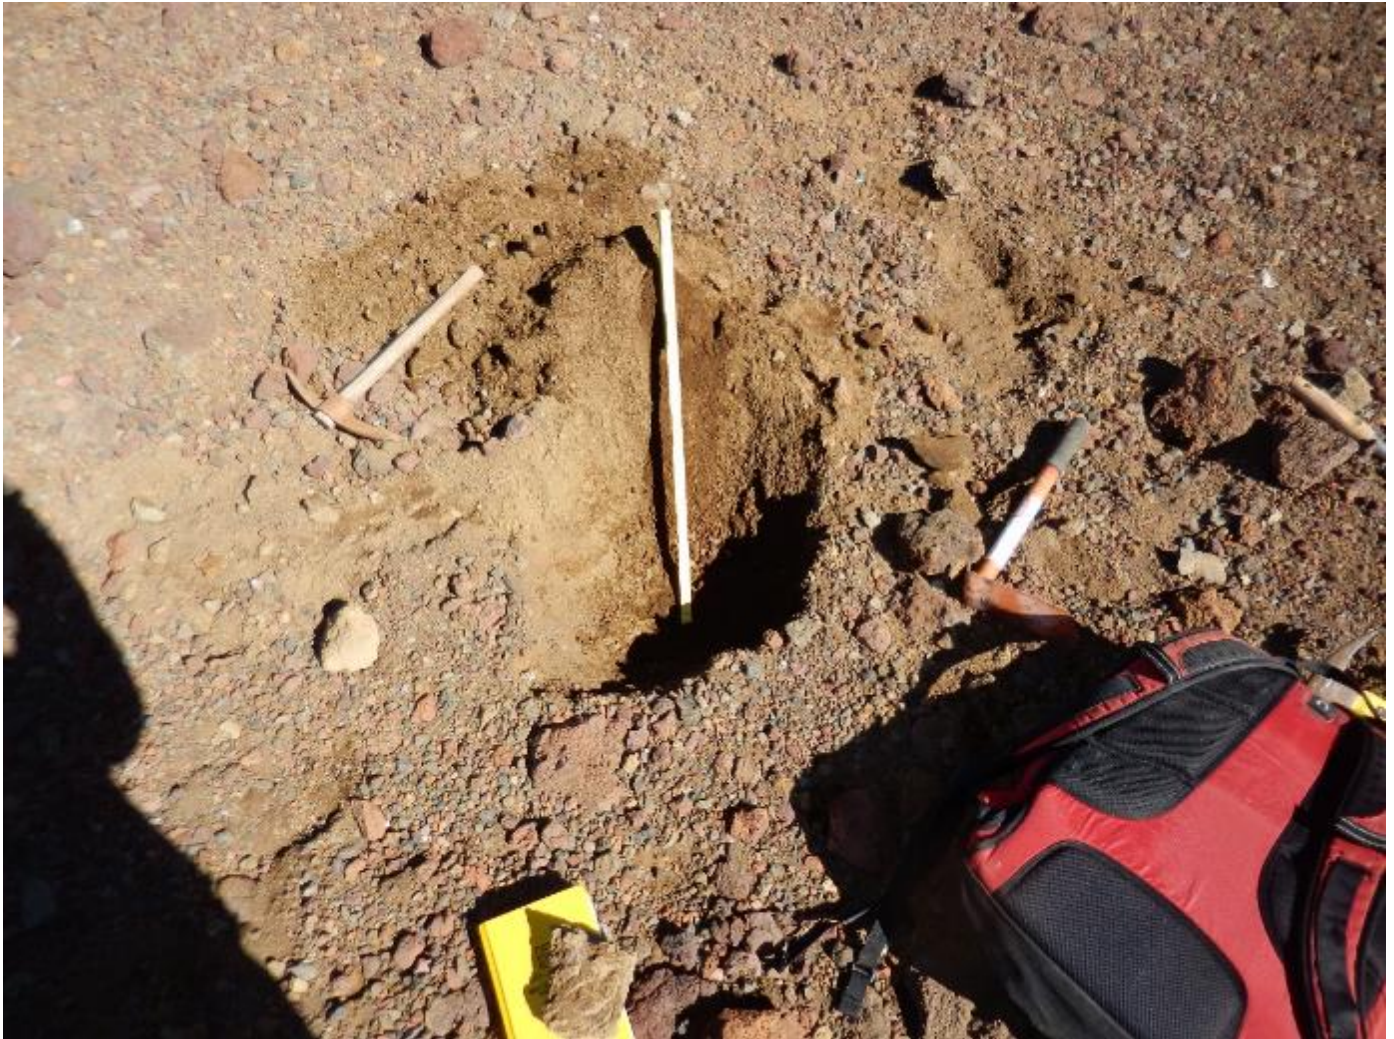
Figure 40. CSO-F-2 Sample Hole.
Hydrogeological and Geological Evaluation
Decommissioning of the Caltech Submillimeter Observatory

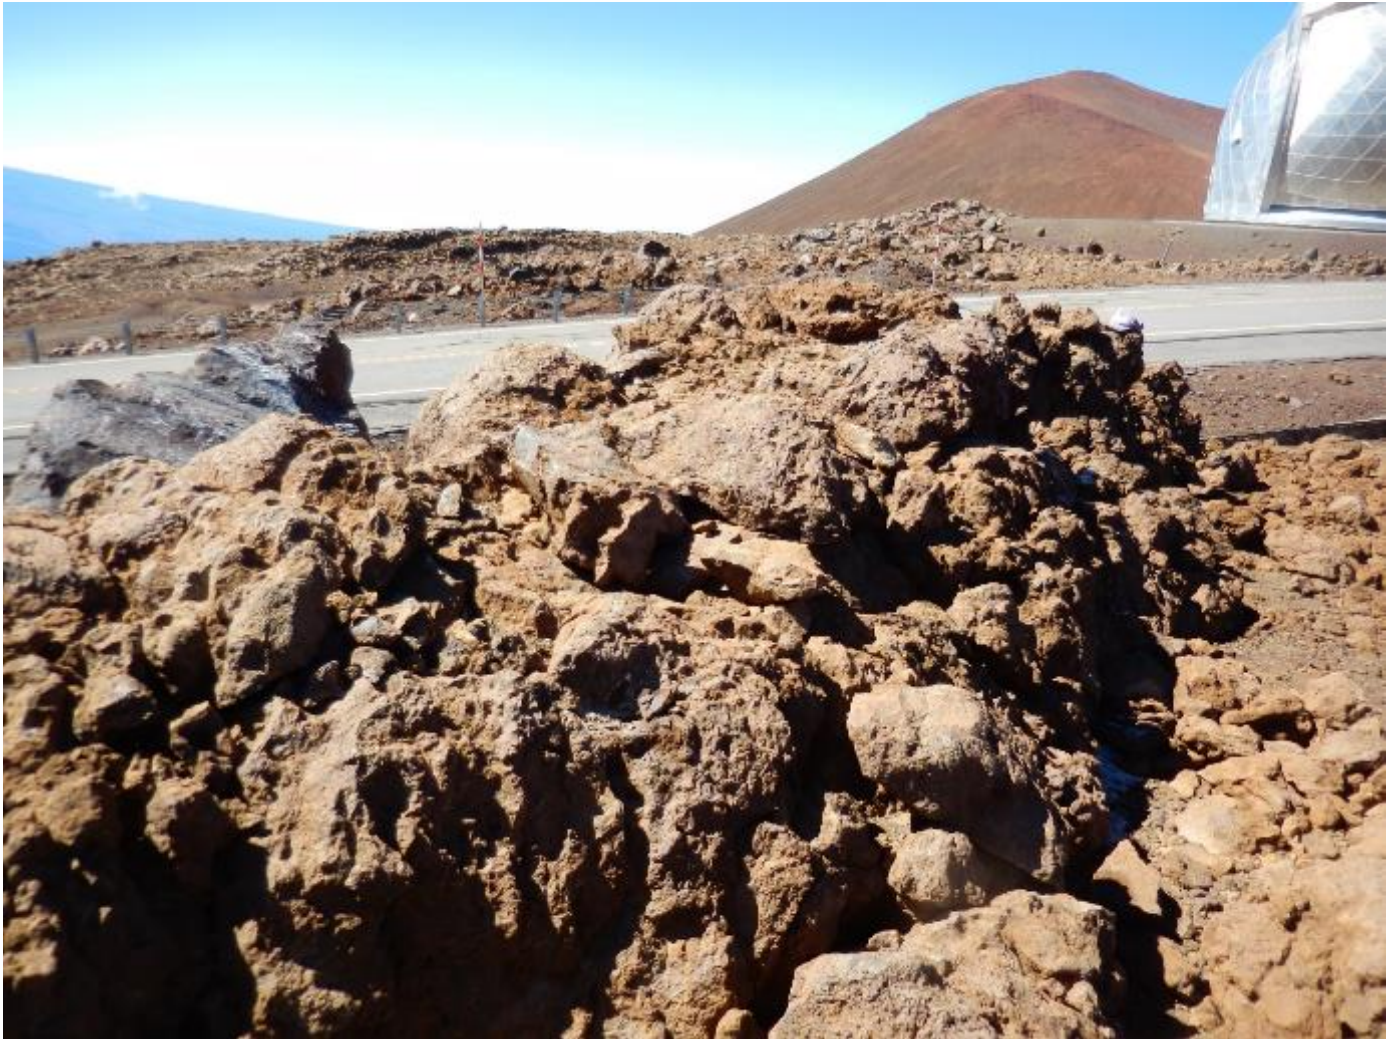
Figure 43. Volcanic Flow in Relationship to CSO from which CSO-N-1 Sample was Collected from the Left-Back Area Shown in this Photo.

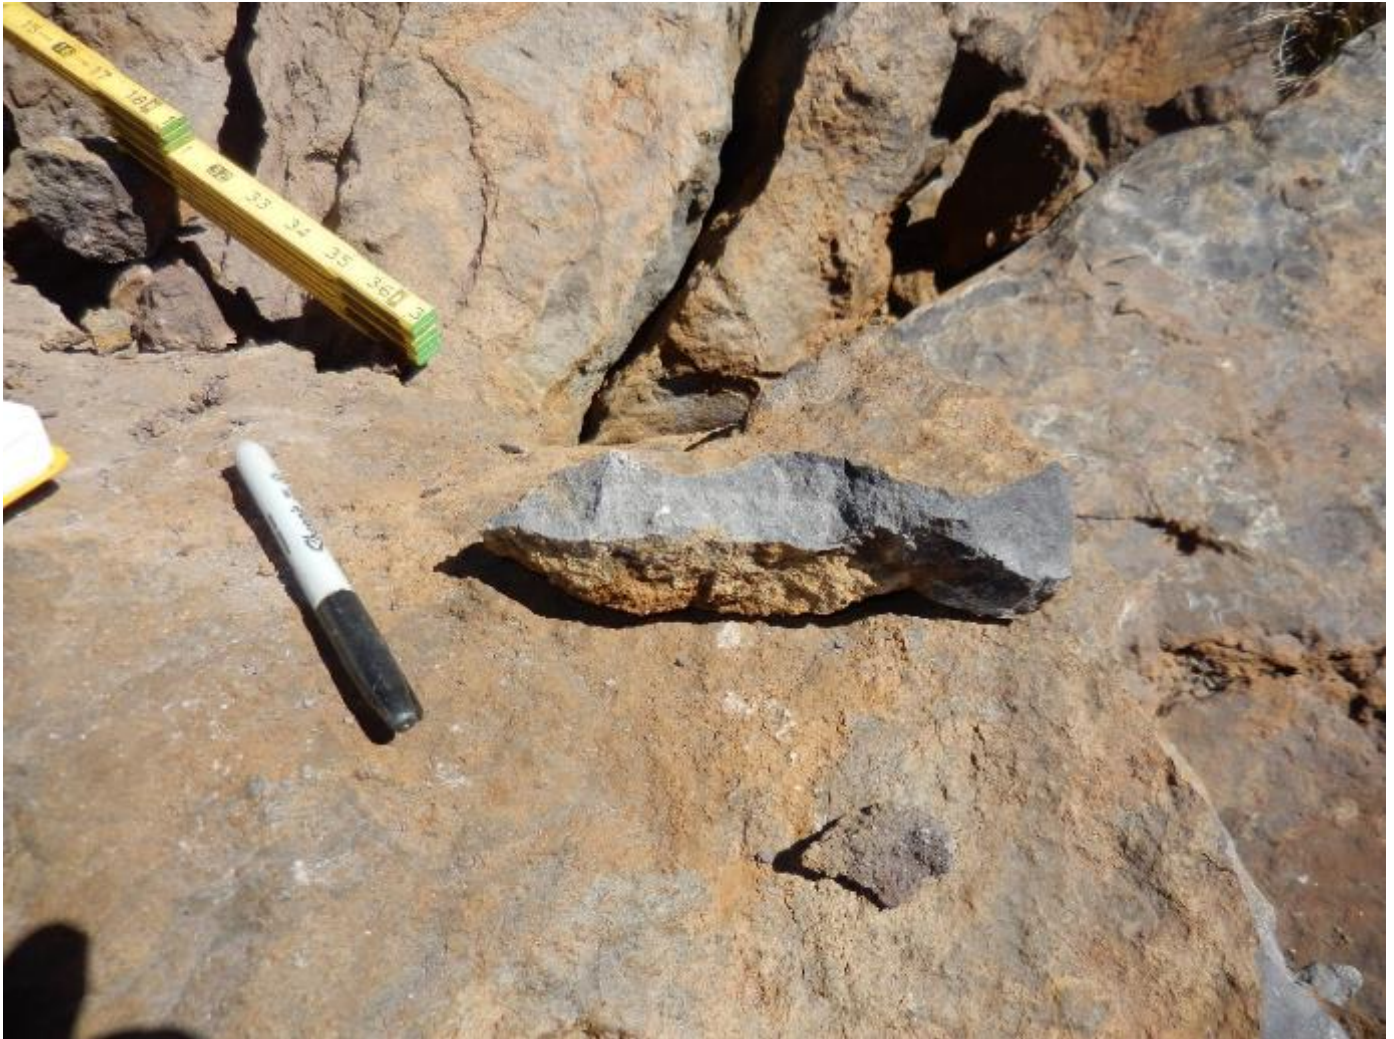
Figure 44. CSO-N-1 Sample.
Hydrogeological and Geological Evaluation
Decommissioning of the Caltech Submillimeter Observatory

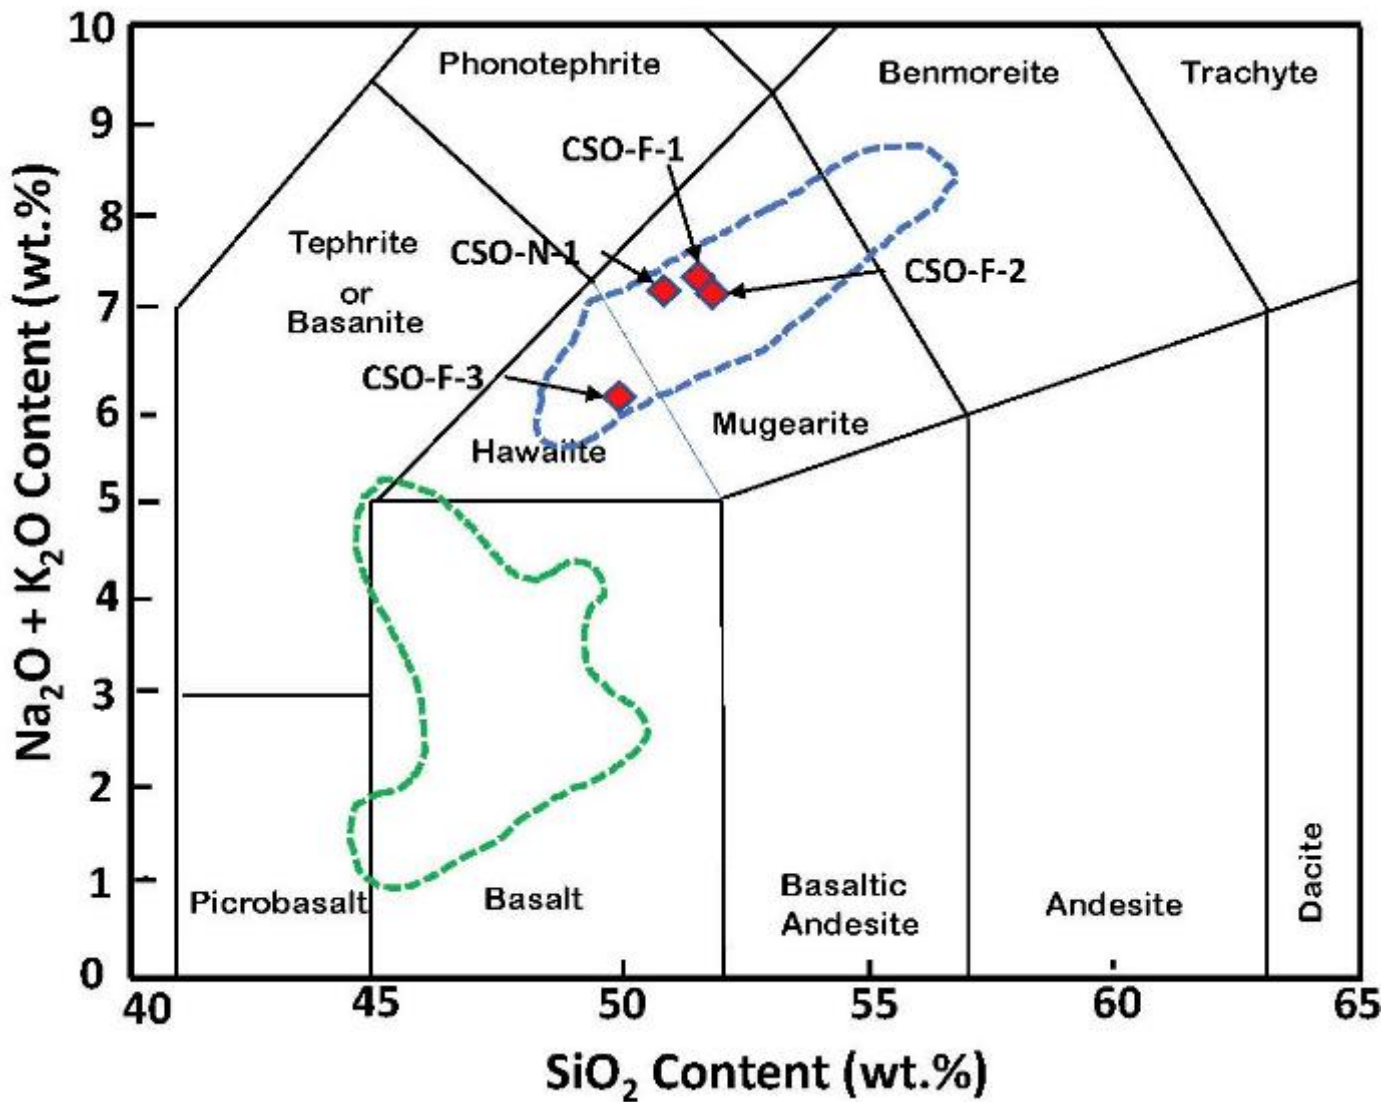
Diagram was used by Wolfe et al. (1997) to compositionally classify Mauna Kea lavas. The green dashed line denotes the approximately extent and range of geochemically analyzed older Hāmākua Volcanics and the blue dashed line denotes the approximately extent and range of geochemically analyzed younger Laupāhoehoe Volcanics as reported by Wolfe et al. (1997, p. 17, Figure 5). The 4 samples collected and analyzed for this investigation (red diamonds) all fall within the Laupāhoehoe Volcanics extent.

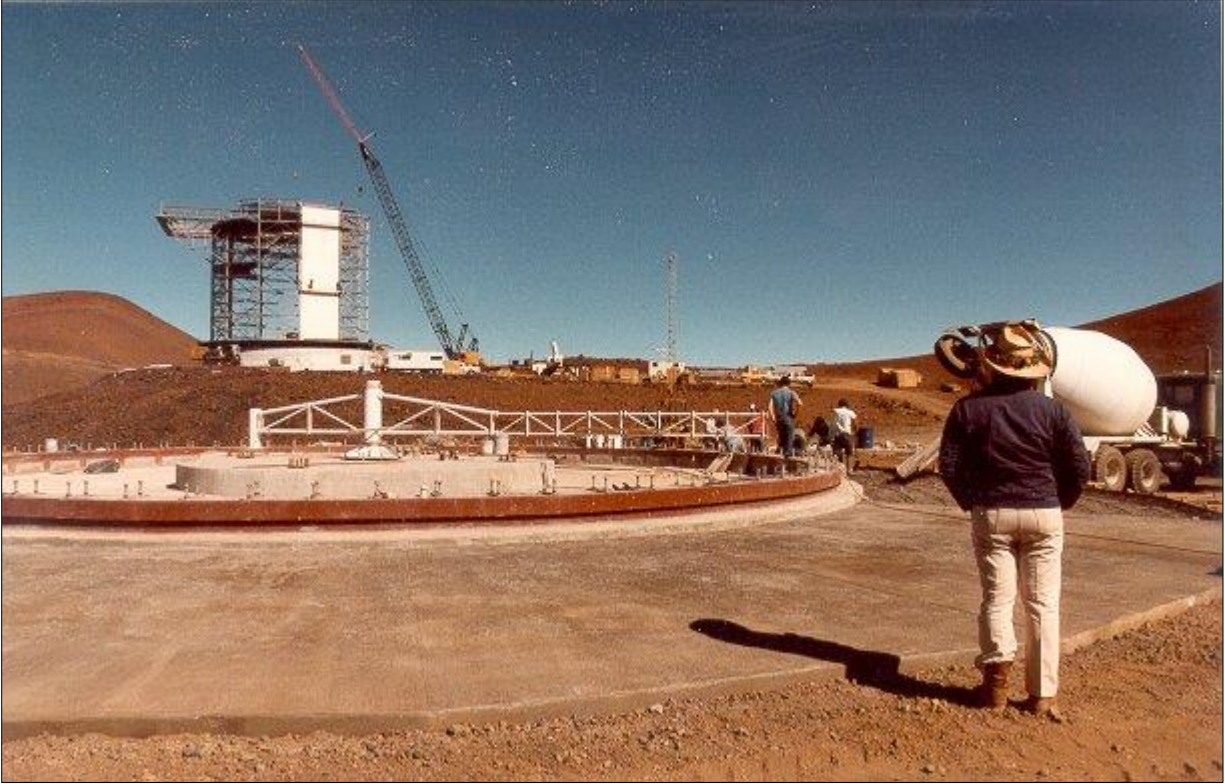
Figure 12. CSO under construction, view to the northwest (Steiger 2009).
