**The Northern Delta Transport Development
Project (NDTDP)**

Environmental Assessment Corridor 1
Phase 1

Waterways Improvement

Ministry of Transport, Vietnam Inland Waterway
Administration (VIWA), Project Management Unit of
Waterways (PMU-W)
8 April 2008

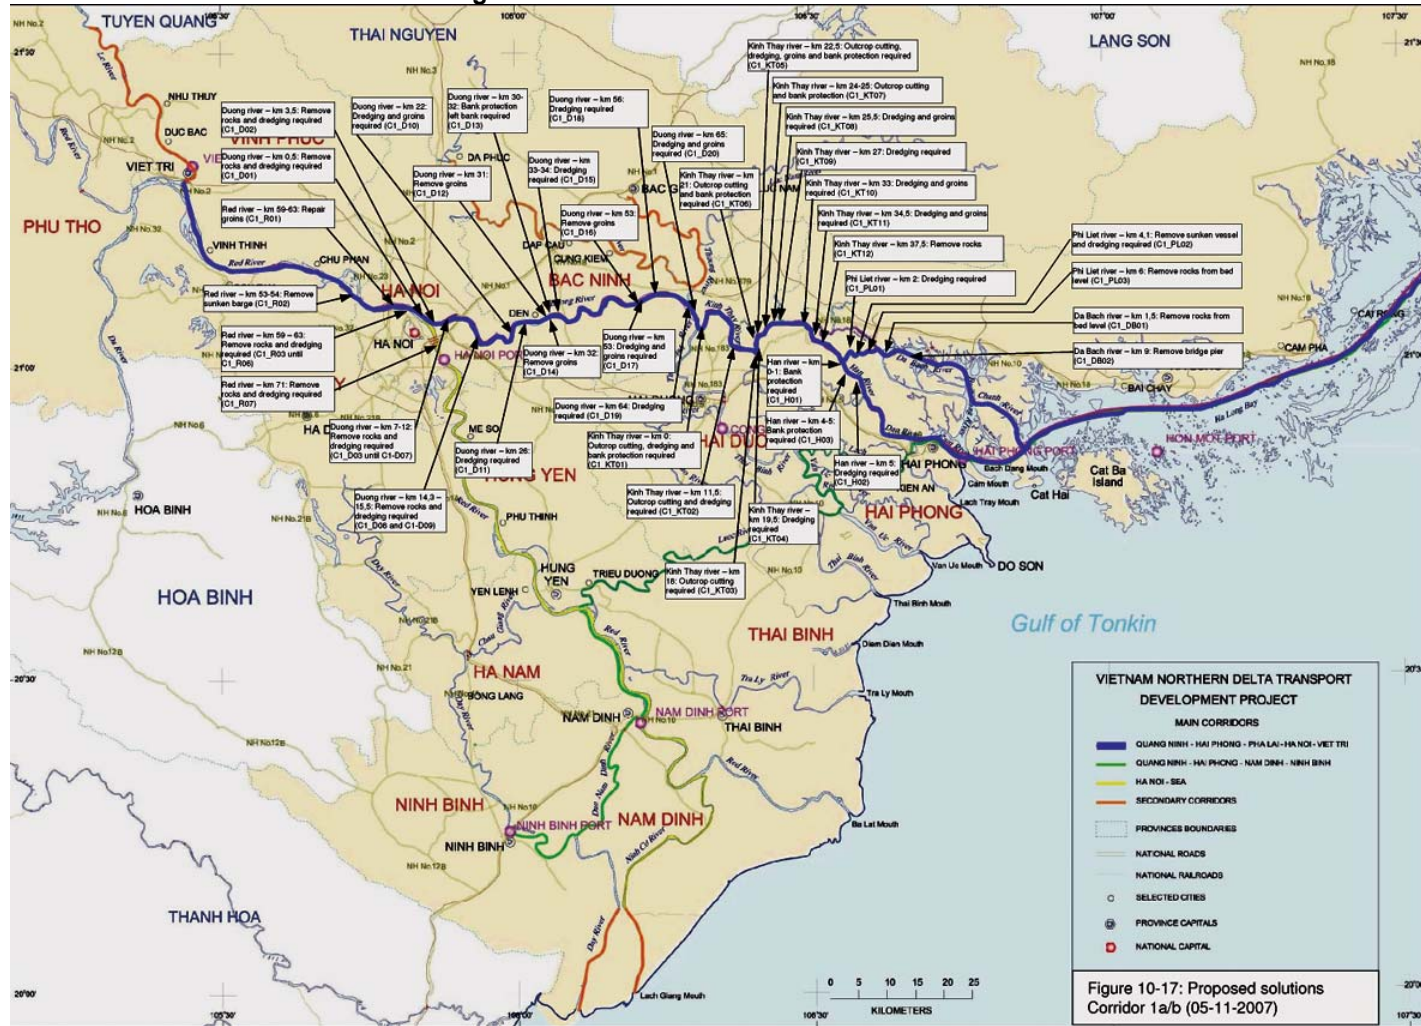
Figure 3-2. Location of constraints in Corridor

Severely eroded banks in some parts of the Red River delta have been installed with dikes for bank protection. However, the dikes are now in worst conditions and additional bank protection has to be installed. Particular areas in need of upgrading and/or additional bank protection system are sections of the Red River, Duong River, Han River and Phi Liet River. These concerns have been recommended by the NDTDP waterway improvement project for investment.

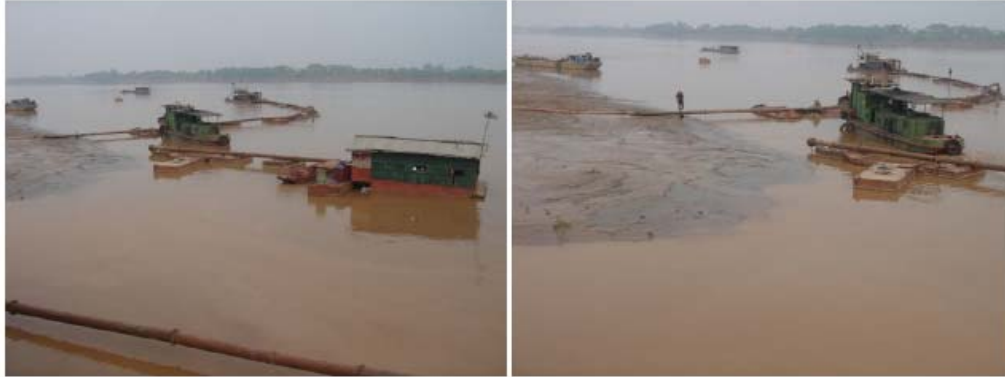
Figure 3-3. Dredging works at Khuyen Luong Port

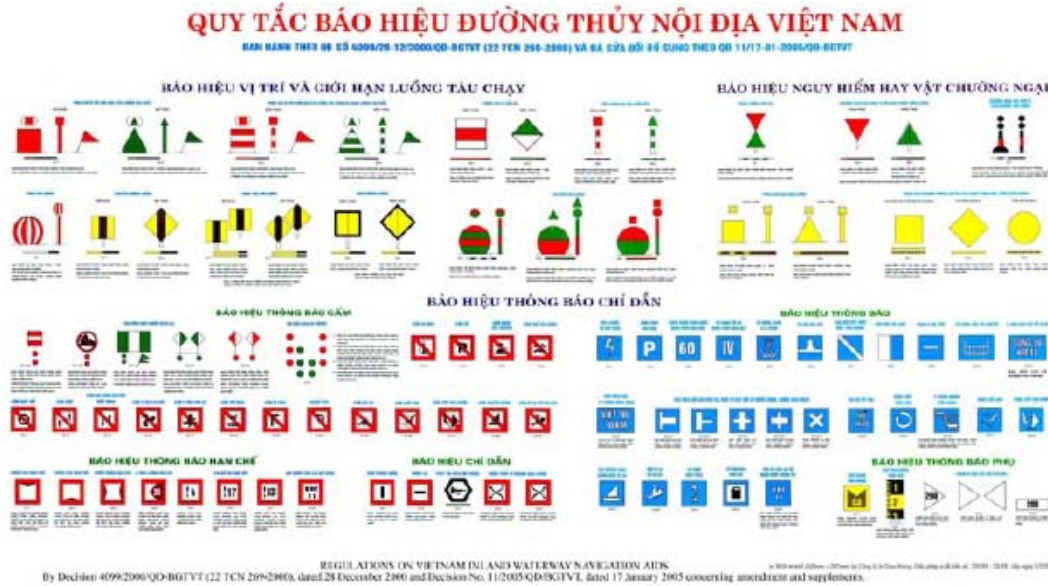
Figure 3-4. Vietnam's navigational aid markers /signs

REGULATIONS ON VIETNAM INLAND WATERWAY NAVIGATION AIDS
By Decision 4099/QĐ-BQTVT (22 TCN 269-280), dated 28 December 2000 and Decision No. 11/2005/QĐ-BQTVT, dated 17 January 2005 covering amendments and supplements.

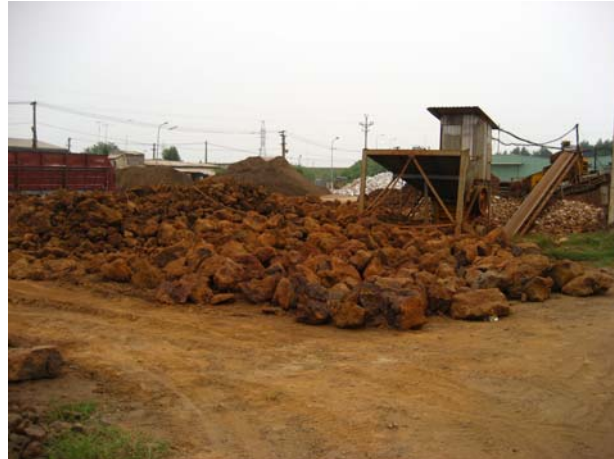
Photo 4-2. Ore Crusher and stockpile of iron ore in Viet Tri Port

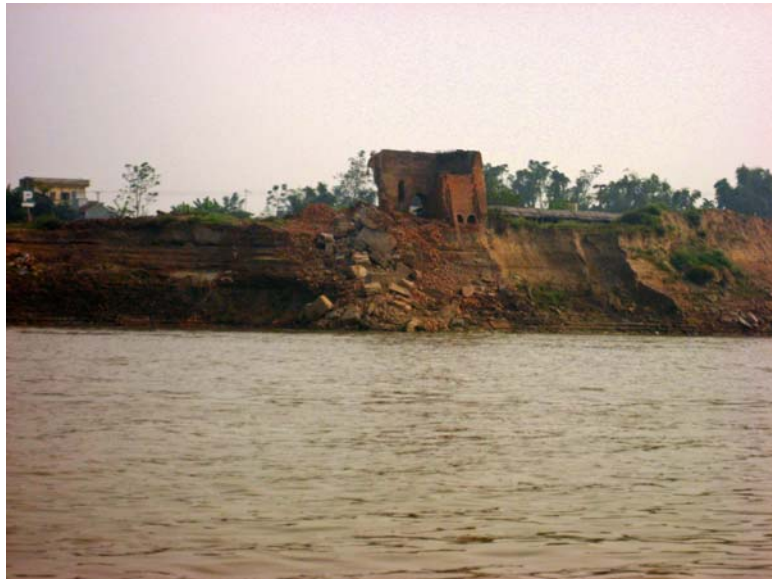
Photo 4-5. Active bank erosion Red River (7389)

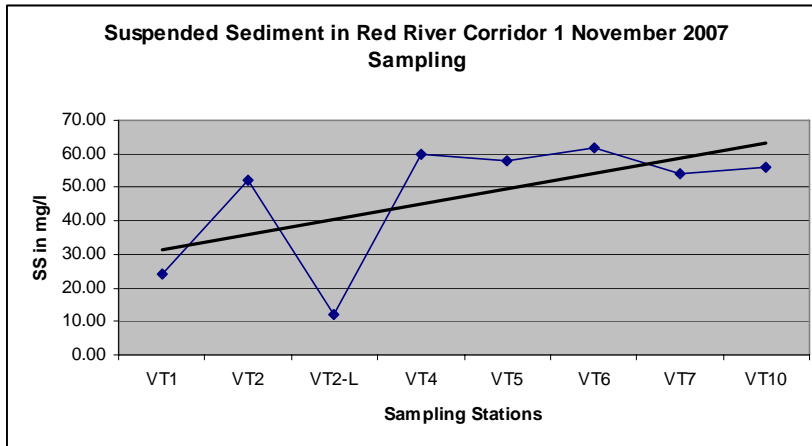
Figure 4-12. Spatial Variation of Suspended Sediment in Corridor 1

The trend of suspended sediments in the Red River from the headwater (Nhu Thuy Port, Phu Tho) to the downstream segment in Kenh Vang Port shows increasing concentration of suspended sediment. This condition is inferred to be due to the combined effects of rampant dredging in Duong River and active bank erosion. Note that concentration of suspended sediment in VT2-Viet Tri lake is considerably lower than the river. The identical spatial trend exhibited by suspended sediments (**Figure 4-12**) and turbidity measurements (**Figure 4-13**) below shows that the turbid condition of Red River in this segment is mainly due to the sediment load.

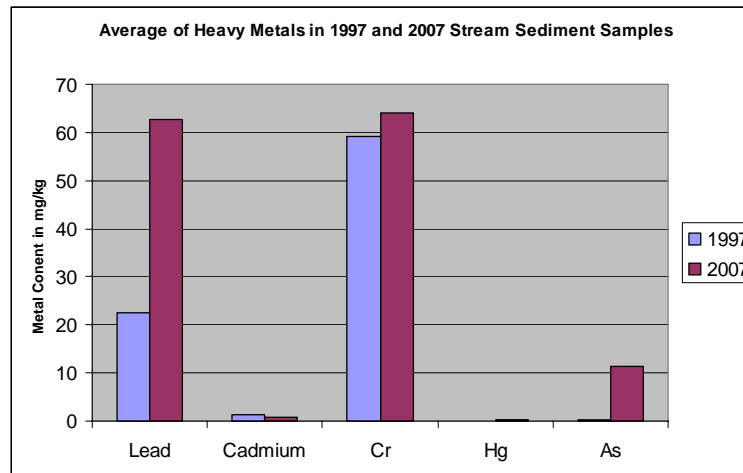
Figure 4-20. Comparison of Average Concentrations of Heavy Metals in 1997 & 2007 Stream Sediments

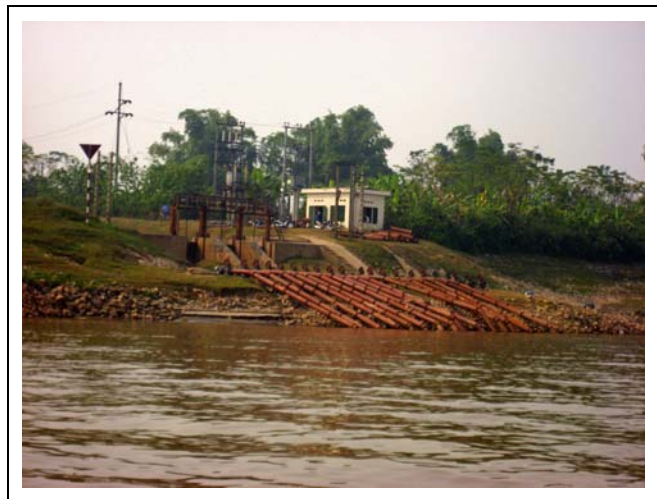
Photo 4-22. One of the pumping stations upstream of the Red River

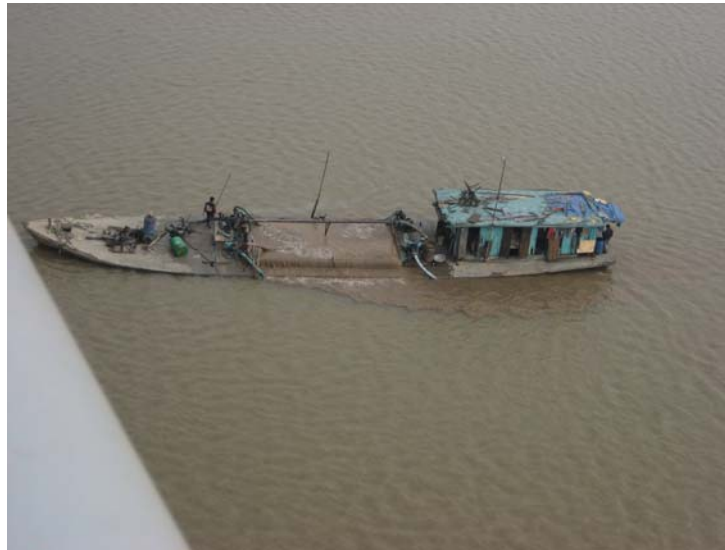
Photo 5-1. Dredging in Red River

Duration of the dredging of Corridor 1 will depend on the capacity of the cutter suction dredge that will be used. Assuming a weekly dredging rate of 75,000 cu meters, dredging of the entire length of Corridor can be completed with 36 weeks.

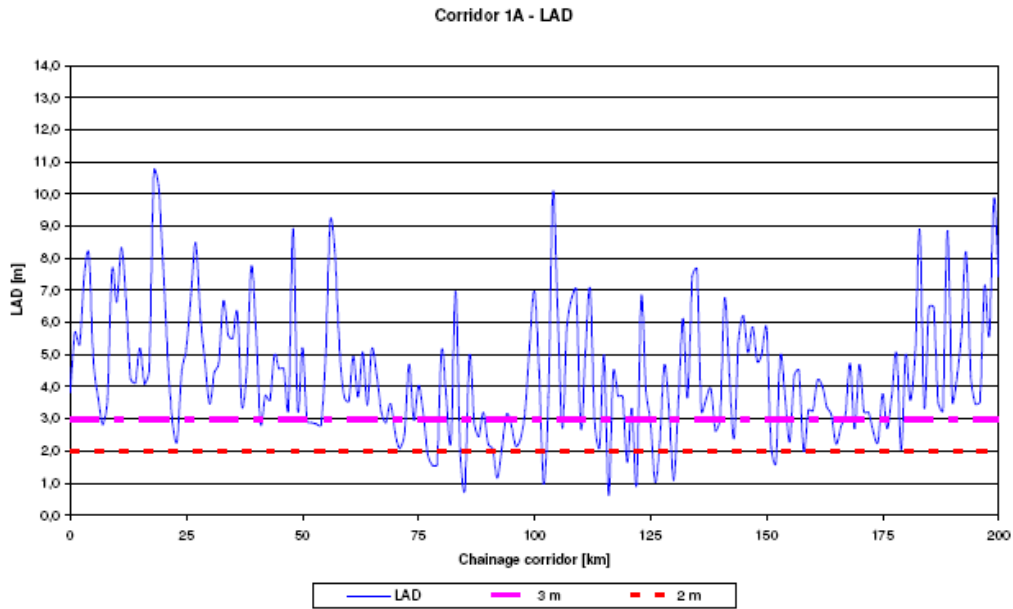
Figure 5-1. Chart of Least Available Depth in a Segment of Corridor 1

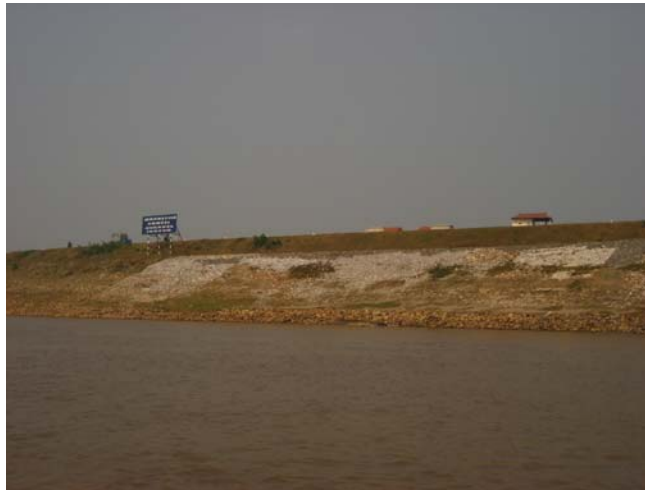
Photo 5-2 Bank Protection in Duong River at About Km 0.

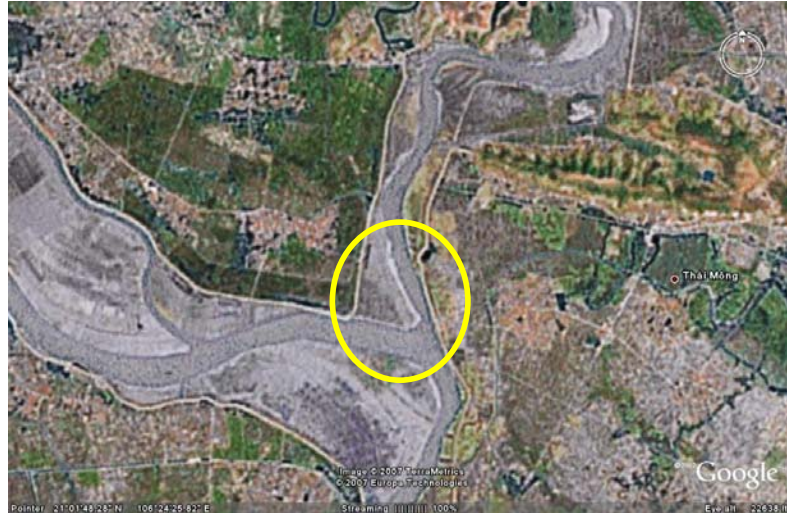
The following Google Earth imagery shows the bend cutting site in Km 18, Kinh Thay River.

Figure 5-3. Imagery of the Proposed Outcrop Cutting Area in Km 18 Kinh Thay

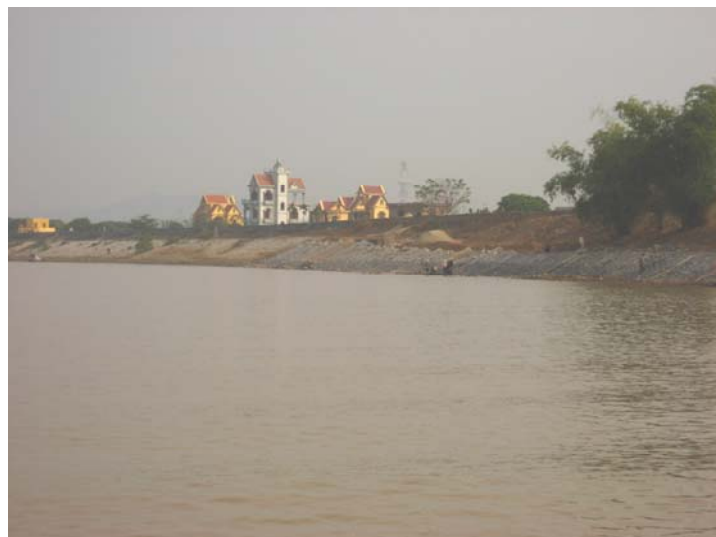
Photo 5-5. Bank Protection Construction in a Segment of Corridor 1.

The photo above is from Kinh Thay River, Chi Linh, Province of Hai Duong. The photo shows the on-going construction of the bank protection. The construction is basically manual labor intensive and is land-based.
