Voluntary Investigation and Remediation Plan

Former Macon 2 MGP Facility Macon, Georgia HSI #10692

Geotechnical & Environmental Consultants, Inc. 514 Hillcrest Industrial Boulevard Macon, Georgia 31204-3472 (478) 757-1606

February 11, 2015

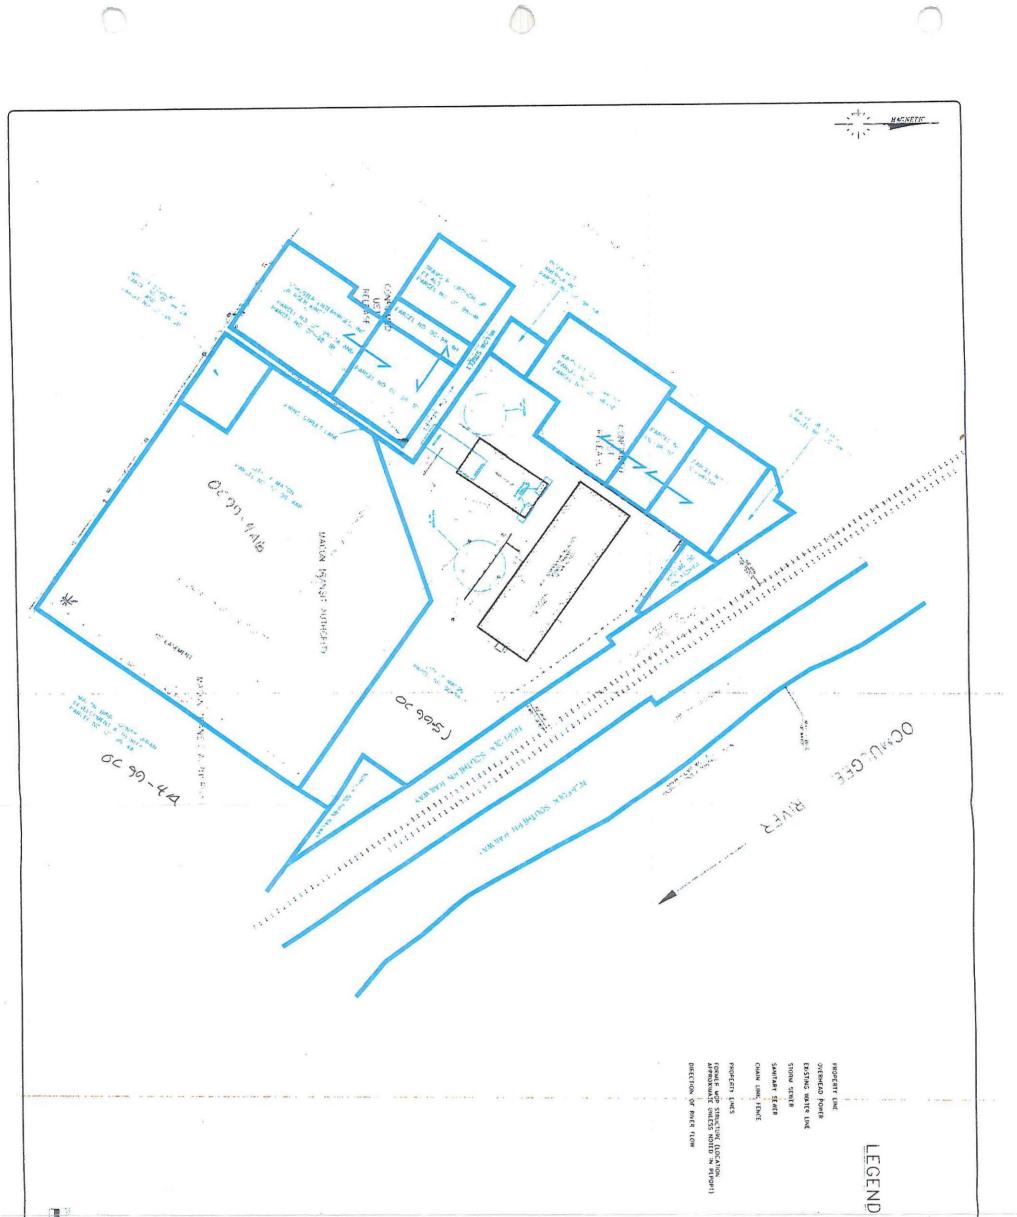
PROPERTY BOUNDARY MAP	Prepared By:	· · · · · · · · · · · · · · · · · · ·
FORMER MACON 2 MGP FACILITY MACON, GEORGIA	Williams Environmental Services, Inc. A Subsidiary of Williams Group Internationai, Inc. 500 Chase Park South, Suite 150, Birmingham, Alabama 35244 205-988-8305 Fax: 205-988-5249

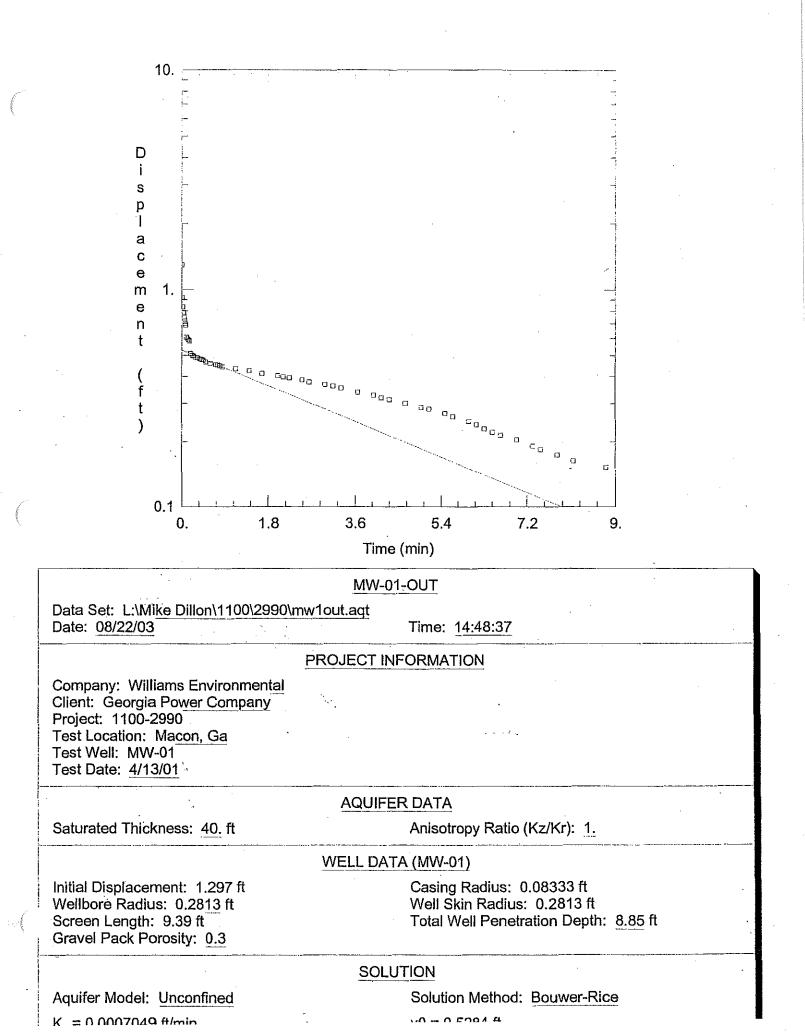
Data Set: L:\Mike Dillon\1100\2990\mw1out.aqt Title: MW-01-OUT Date: 08/22/03 Time: 14:48:43

The following methods were utilized during slug tests performed during the CSI. Slug-in tests were performed by lowering a weighted, five-foot long PVC pipe into the water column in each of the tested wells to cause an instantaneous water level change in the well. Slug-out tests were performed by withdrawing the PVC slug and recording head changes versus time. The changes in head with respect to time were recorded with a pressure transducer and data logger. The data from all of the slug tests were analyzed using the Bouwer and Rice (1976) analytical method for estimating

hydraulic conductivity of unconfined aquifers or leaky confined aquifers. The computer program AQTESOLV (Geraghty and Miller, 1991) was used to calculate the hydraulic conductivity and prepare graphs of the data.

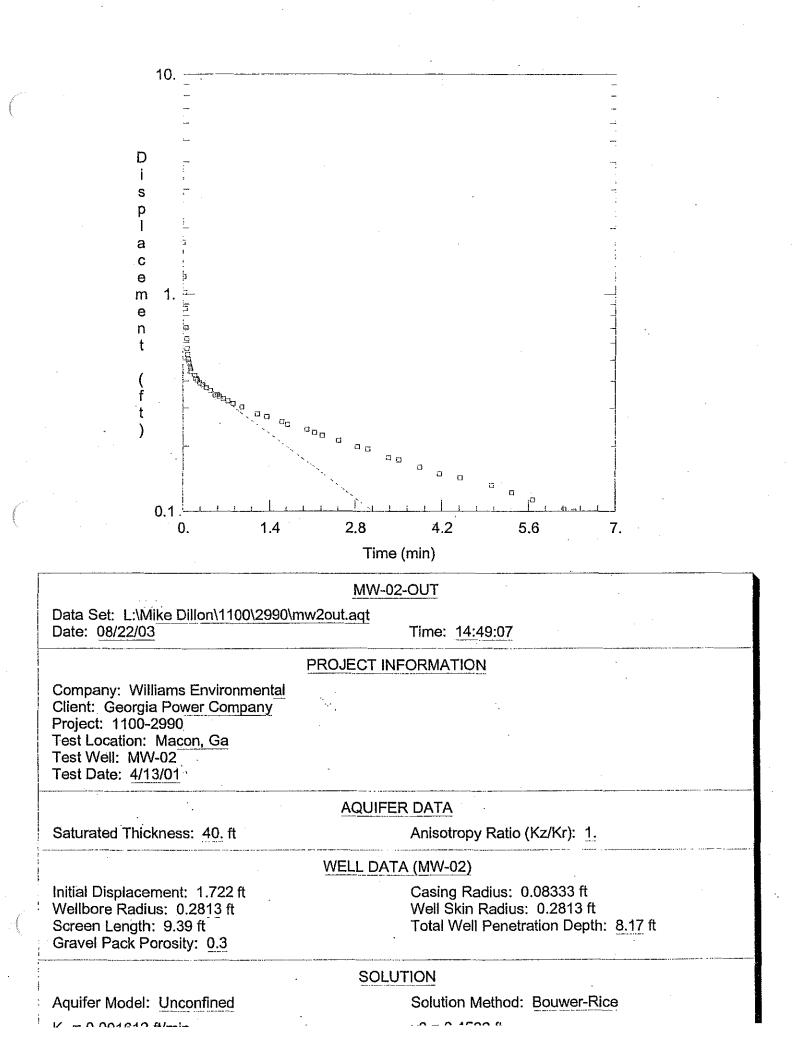
Data Set: L:\Mike Dillon\1100\2990\mw2out.aqt Title: MW-02-OUT Date: 08/22/03 Time: 14:49:12

Parameter	Estimate	
K	0.001612	ft/min
v0	0.4533	ft

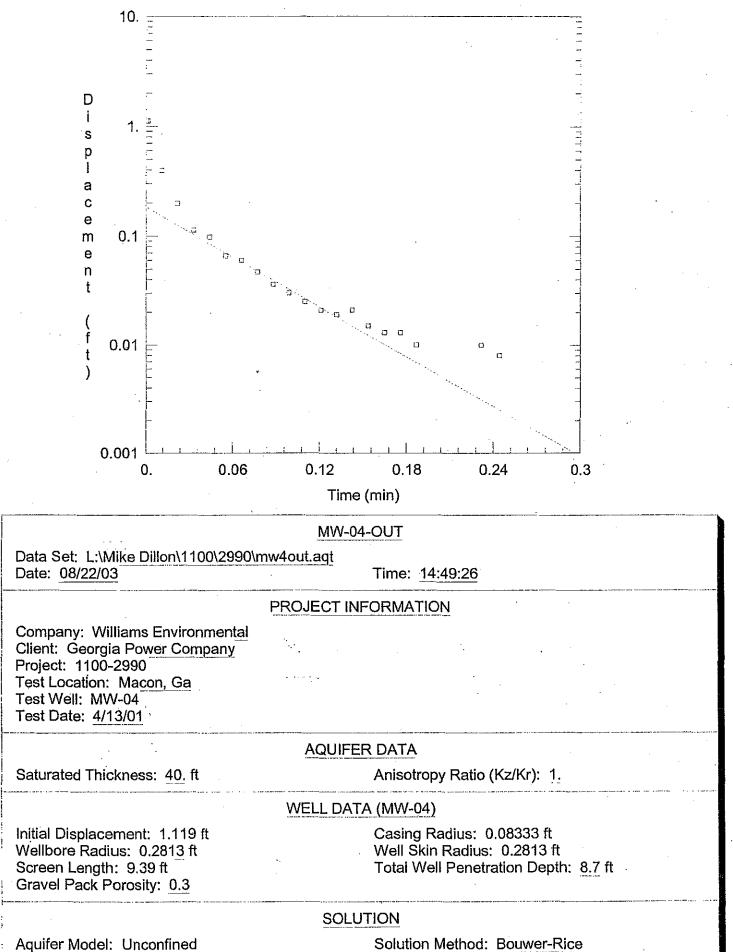
Data Set: L:\Mike Dillon\1100\2990\mw4out.aqt Title: MW-04-OUT Date: 08/22/03 Time: 14:49:31

Parameter	Estimate	
K .	0.05886	ft/min
v0 ·	0.1847	ft

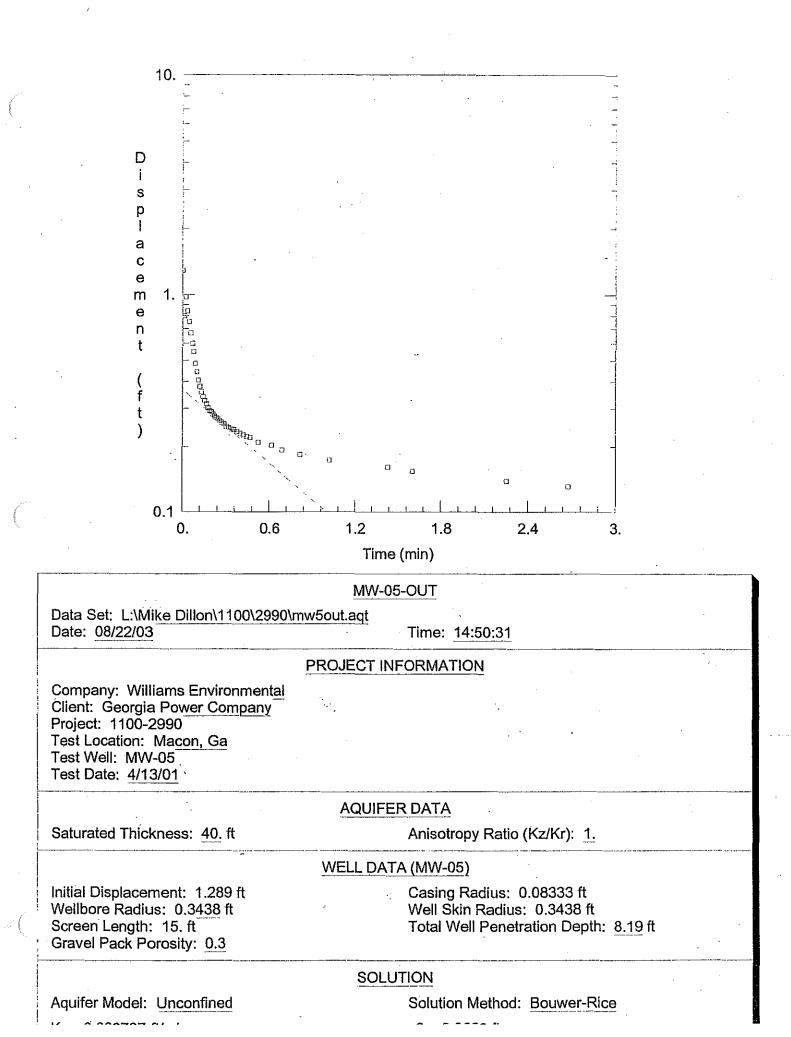
Data Set: L:\Mike Dillon\1100\2990\mw5out.aqt Title: MW-05-OUT Date: 08/22/03 Time: 14:50:37

Parameter	Estimate	
K	0.003787	ft/min
y0	0.3663	ft

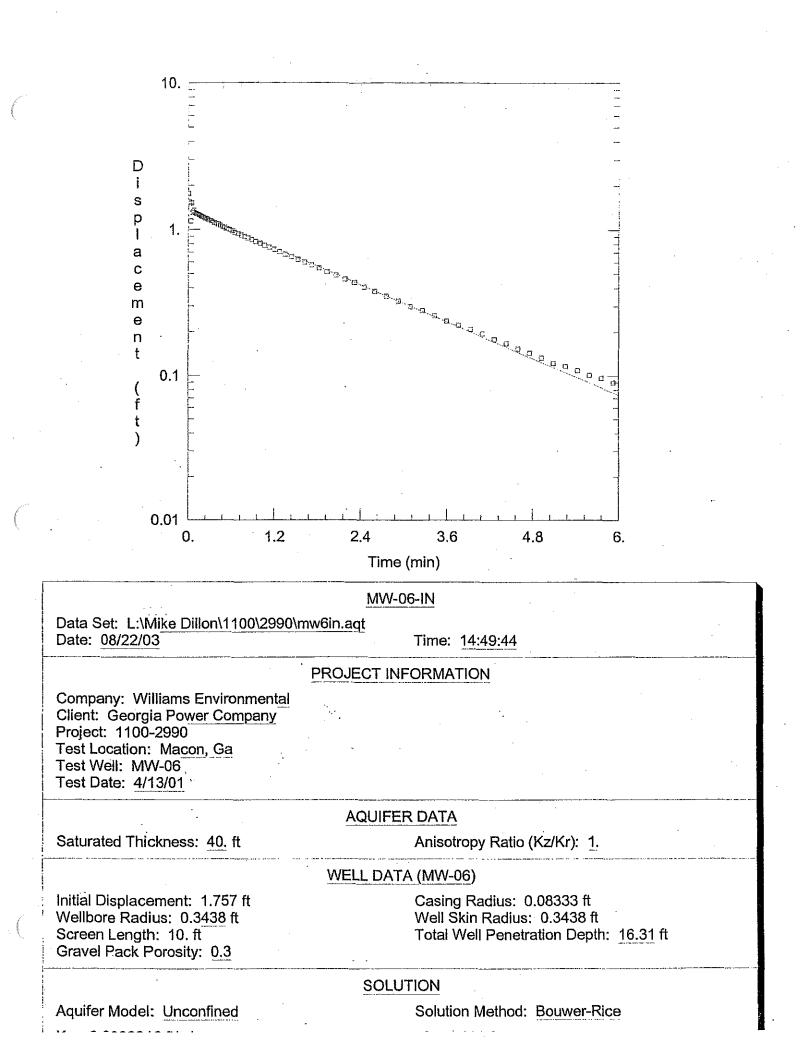
Data Set: L:\Mike Dillon\1100\2990\mw6in.aqt Title: MW-06-IN Date: 08/22/03 Time: 14:49:50

Parameter K y0 Estimate 0.0003948 1.339 ft/min ft
