Appendix D. Biological Setting Analysis: Caltech Submillimeter Observatory Decommissioning

Biological Setting Analysis: Caltech Submillimeter Observatory Decommissioning

**Final Report
November 2019**

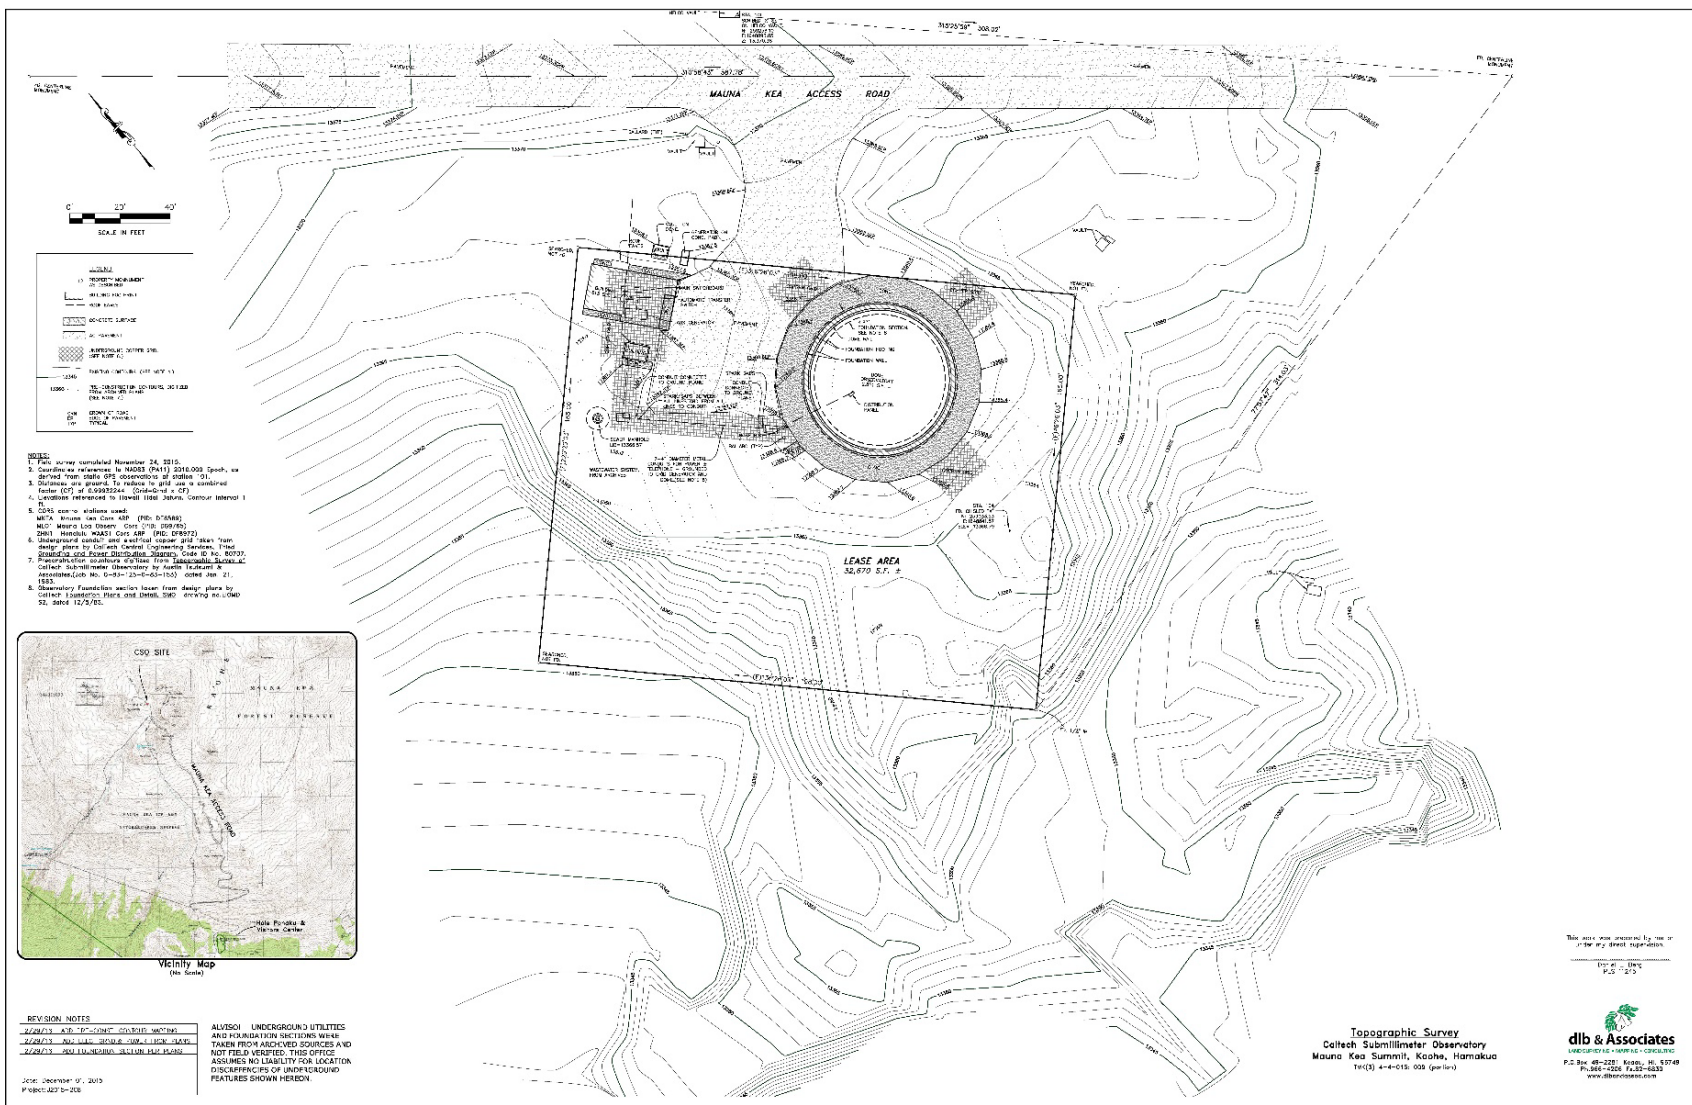
Survey area as depicted by dlb & Associates, December 2015 (Berg 2015). Note existing contours (solid) vs. pre-construction contours (dotted). Subsequent maps in this report are taken from the center section of this map.

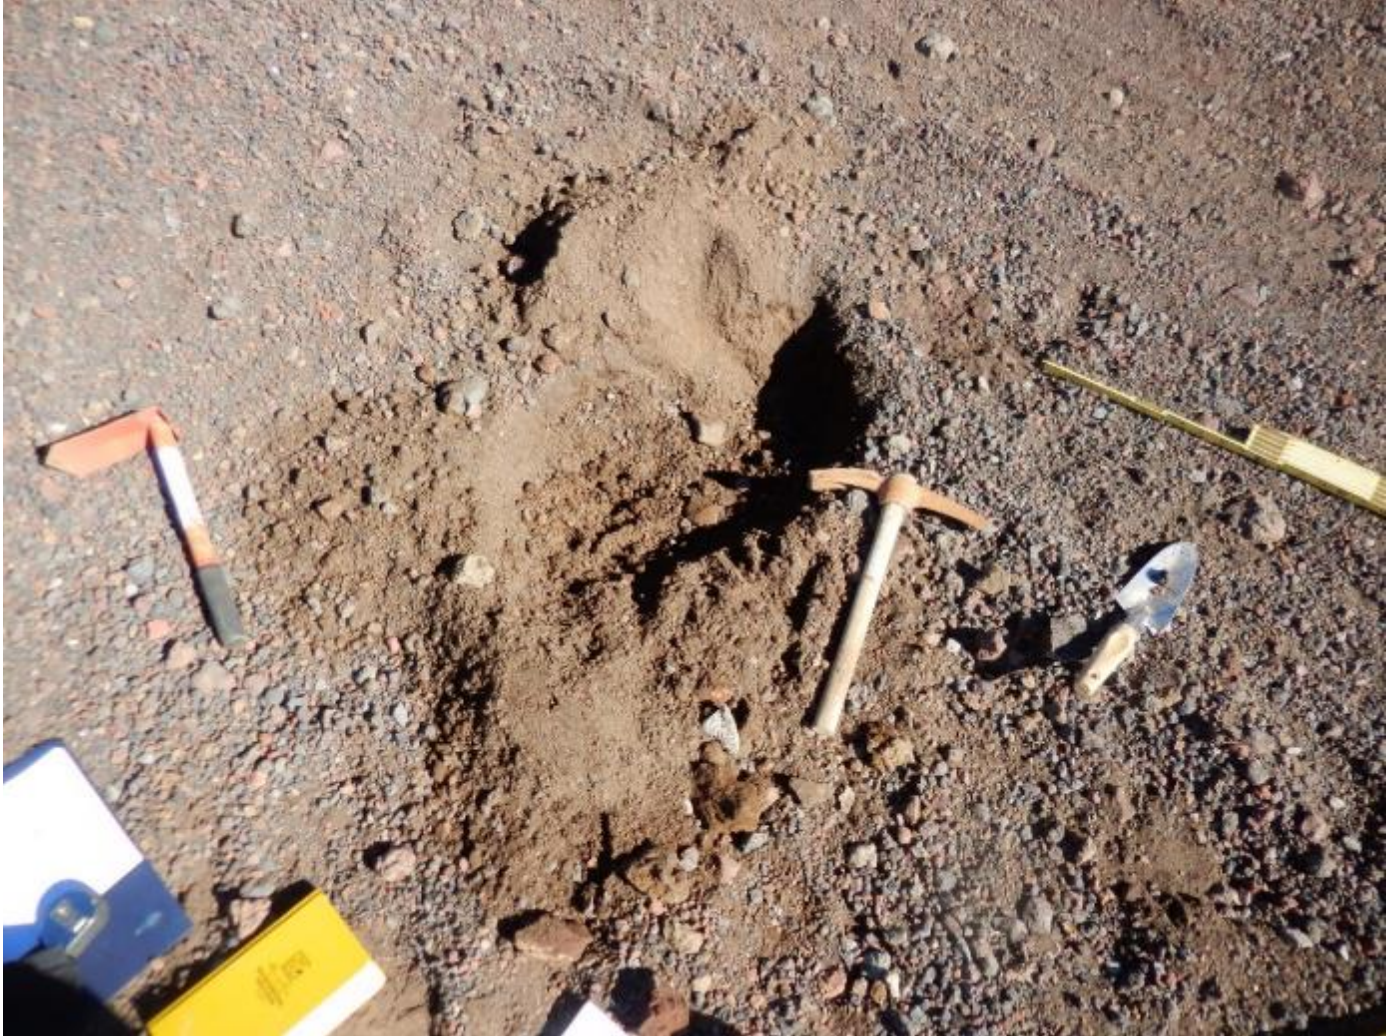
Figure 38. CSO-F-1 Sampling Hole.
Hydrogeological and Geological Evaluation
Decommissioning of the Caltech Submillimeter Observatory

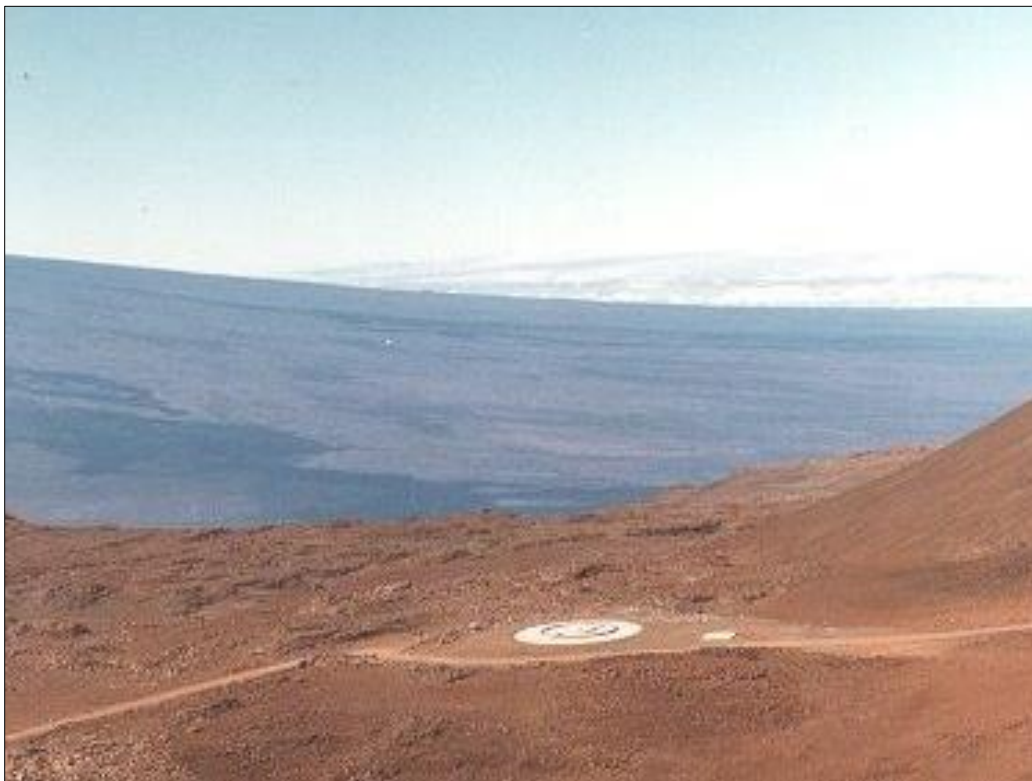
Figure 11. Observatory and outbuilding foundations in 1985, view to the southwest (Steiger 2009).
