**NATIONAL REGISTER OF HISTORIC PLACES**

**Clough H. Rice House**

Hendersonville, Henderson County, HN0244, Listed 12/27/2011

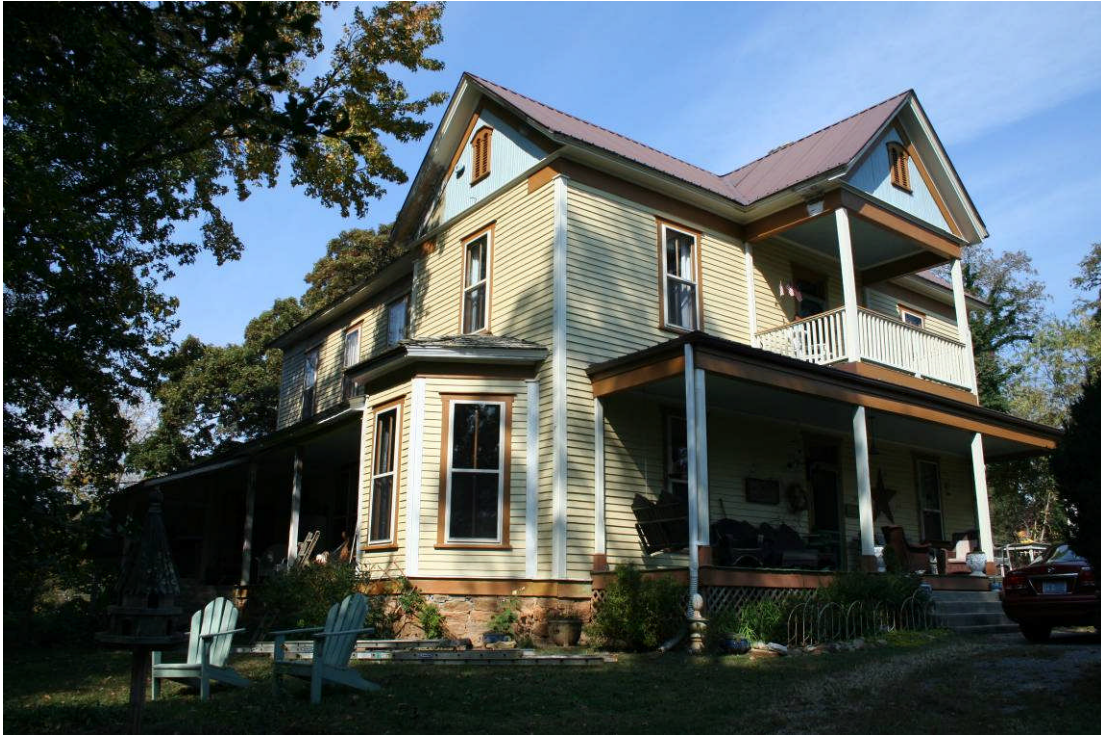
Overall view

The balanced three-bay façade faces east and is dominated by a full-façade single-story hipped-roof porch with a central single-bay front-gabled second-story porch. The roof of the single-story porch is supported by square wood columns on square wood bases with molding. While these columns are modern replacements, the original chamfered pilasters remain. The porch is finished in tongue-and-groove wood flooring and a bead-board wood ceiling. Under the protection of the porch is a center single-leaf paneled and glazed wood entry door with rectangular transom and a single window to each side of the door. Between the square columns of the second-story porch is a simple railing with square balusters. The gable is finished in vertical bead-board siding with a centered louvered gable vent consisting of two narrow round-arched vents protected by a drip mold. As below, the porch roof protects a paneled and glazed door with transom leading from the second-floor hall to the porch. A tall flat cornice board runs below the façade's eave and returns on the gable ends of the main block. The side (north and south) elevations of the main block are identical with a bay window on the first story, a centered window in the second floor and a gable finished in vertical bead-board siding with a centered gable vent.

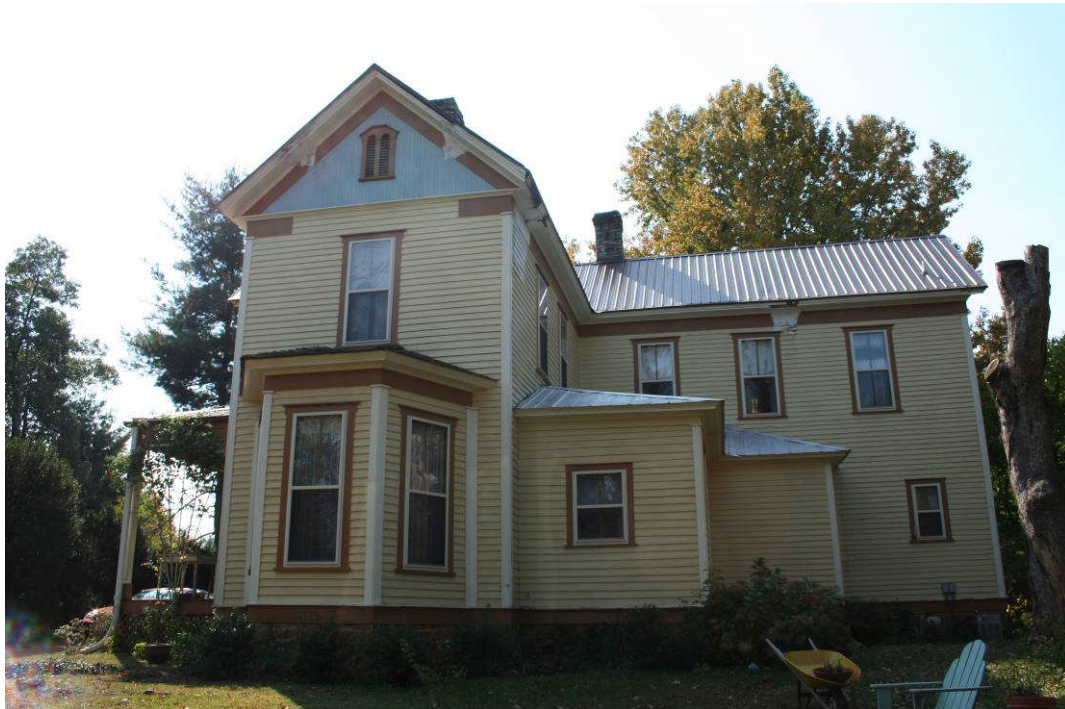
Side elevation and rear wing

The two-story ell projects off the southwest corner of the main block. A single-story L-shaped porch (enclosed in the 1920s) fills the inside corner created by the main block and the ell. This hipped-roof enclosed porch repeats the corner board details found on the main block. On its north elevation is a smaller two-over-two double-hung window, believed to be added when the porch was enclosed. The enclosed porch's west elevation has one two-over-two double-hung window in its north/south leg. This window was most likely originally on the first story on the rear (west) elevation of the house and moved to the outside wall when the porch was enclosed. On the west elevation of the east/west leg is a smaller, fixed window with recently installed stained glass. On the rear (west) elevation of the main block the tall cornice board is repeated under the eave and above the single-story enclosed porch are two-over-two double-hung windows. These details are carried around to the north elevation of the ell, where a small two-over-two double hung window is on the first story and three two-over-two double-hung windows
