**GMA Mining Australia**  
**Mining Tenement M70/204**  
**Supporting Documentation for**  
**a Native Vegetation Clearing**  
**Permit Application**

# M70/204 Supporting Information

## GMA Mining Australia

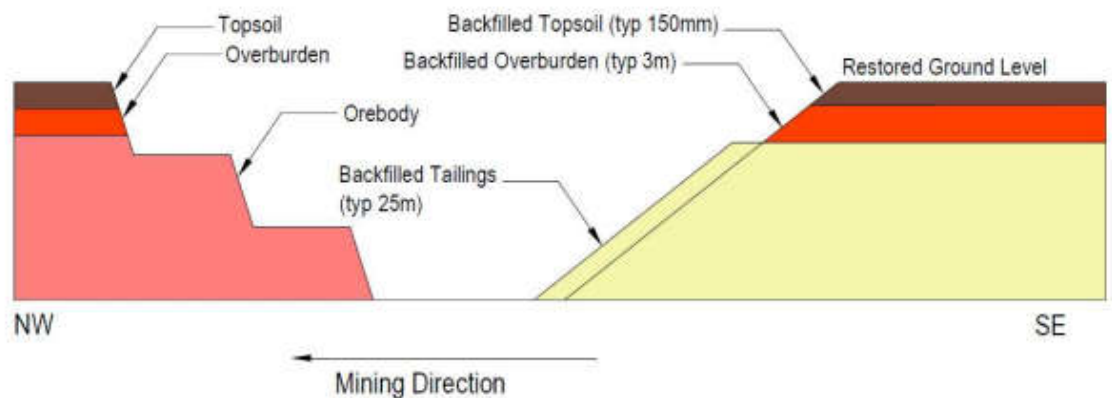
**Plate 1 Pit Backfilling/Landform Construction**

Stage	Task	Action	Objective
			New landform does not restrict the existing hydrological regime present in the area.
9	Topsoil return	Topsoil is placed over subsoil (overburden, tails) to a minimum depth of 150 mm.	Construction of post-mining landform to match pre-mining landform.
10	Soil treatment (as required)	Addition of fertilisers suitable for native plant growth (as required).	Create conditions suitable for native plant growth, but minimising weed growth (stage may not be required).
11	Integration of topsoil and landform	Deep ripping of constructed landform to ensure integration of topsoil and subsoil.	Minimise the risk of erosion by wind and water.
12	Return of larger vegetative material	Spreading across landscape of stockpiled logs, branches, and other vegetative material pushed up into windrows.	Increase rainfall penetration of soil profile.
13	Seeding	Direct seeding of reconstructed landform with seeds collected from the Site.	Minimise the risk of erosion by wind and water.

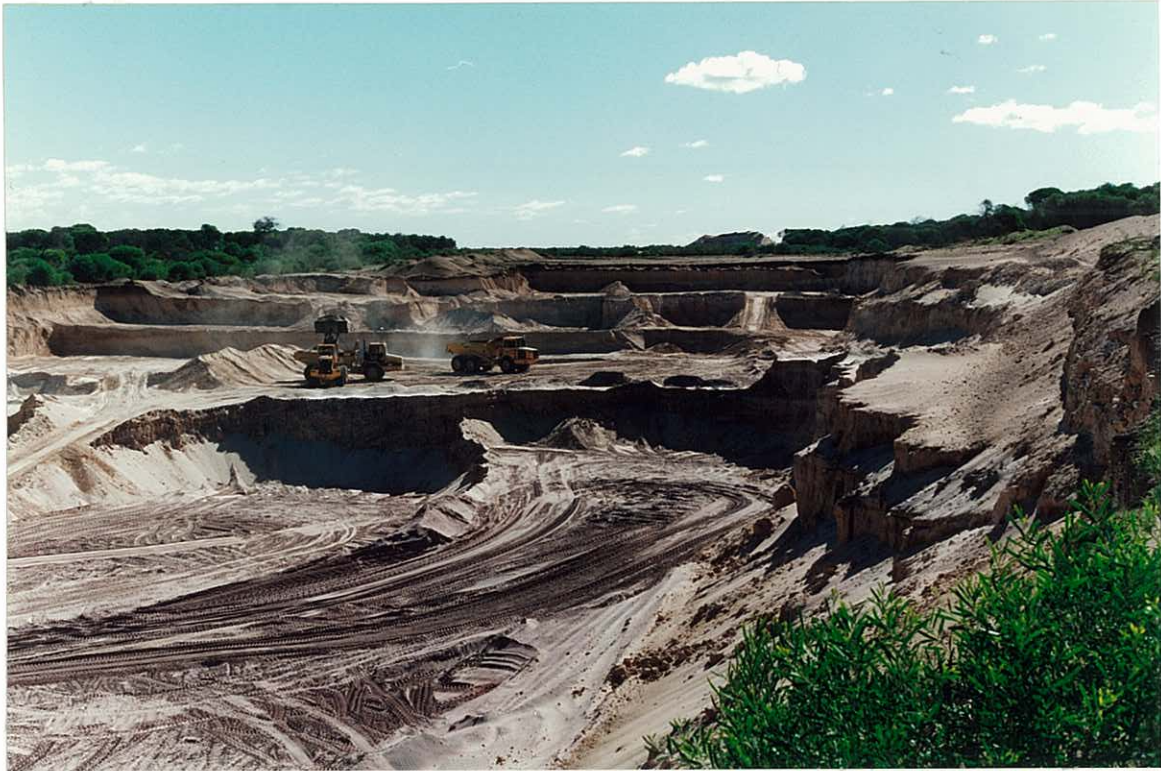
View looking North - West along mining direction showing ore face and overburden benches in the main pit.

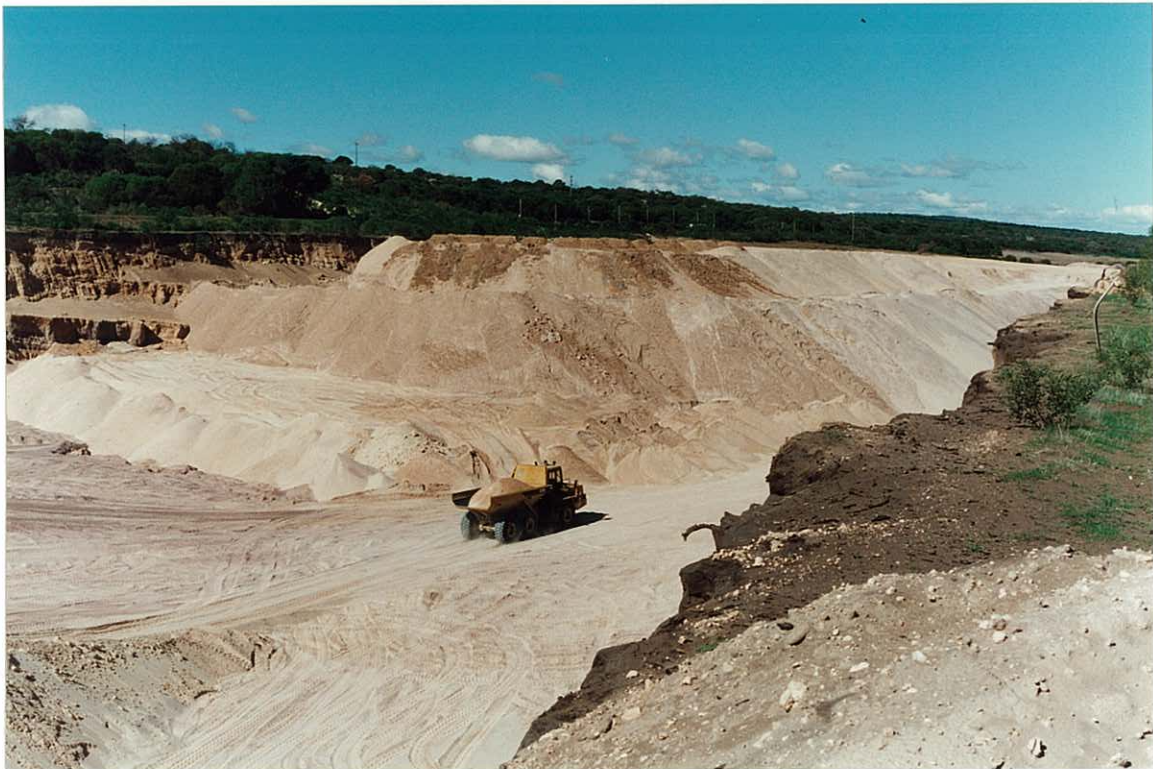
View looking South - East over the backfill dump. Overburden and tailings are used to backfill the pit as it moves northward, recreating a natural looking topography.

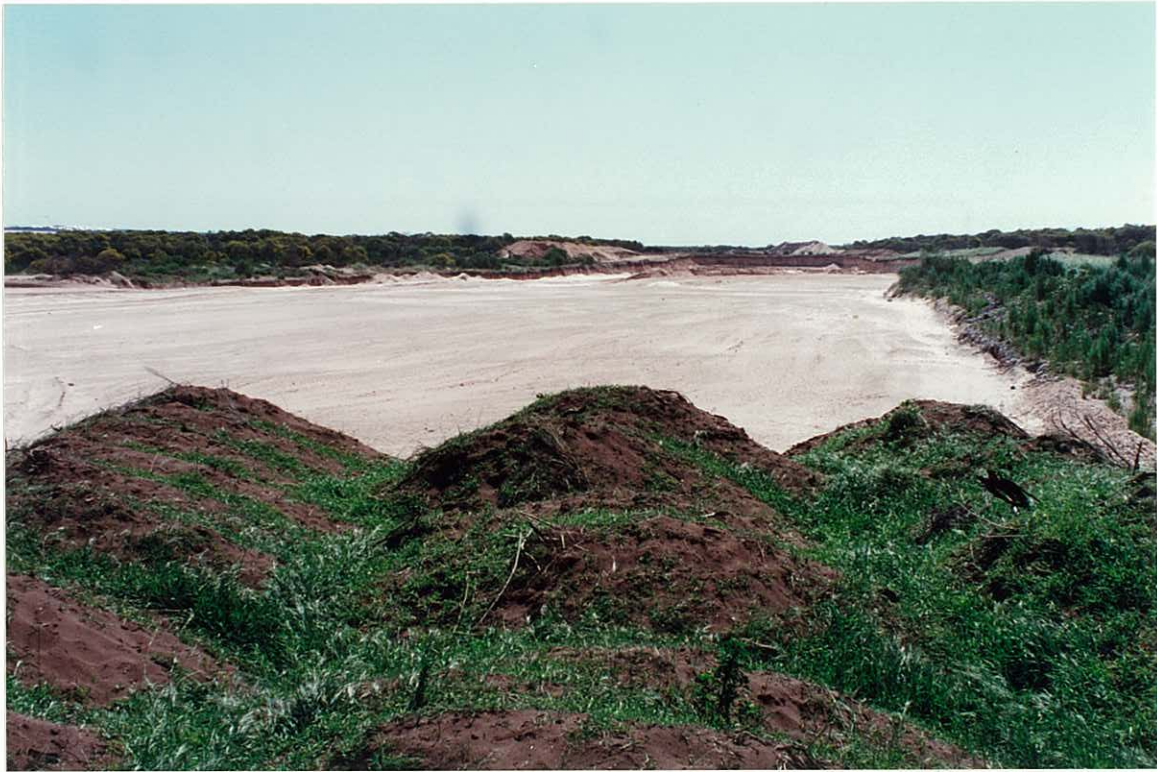
View to the North - West along the mining direction. In the foreground is stockpiled topsoil ready to be spread over the backfilled area in the middle of the photograph. The mine pit is in the middle distance.

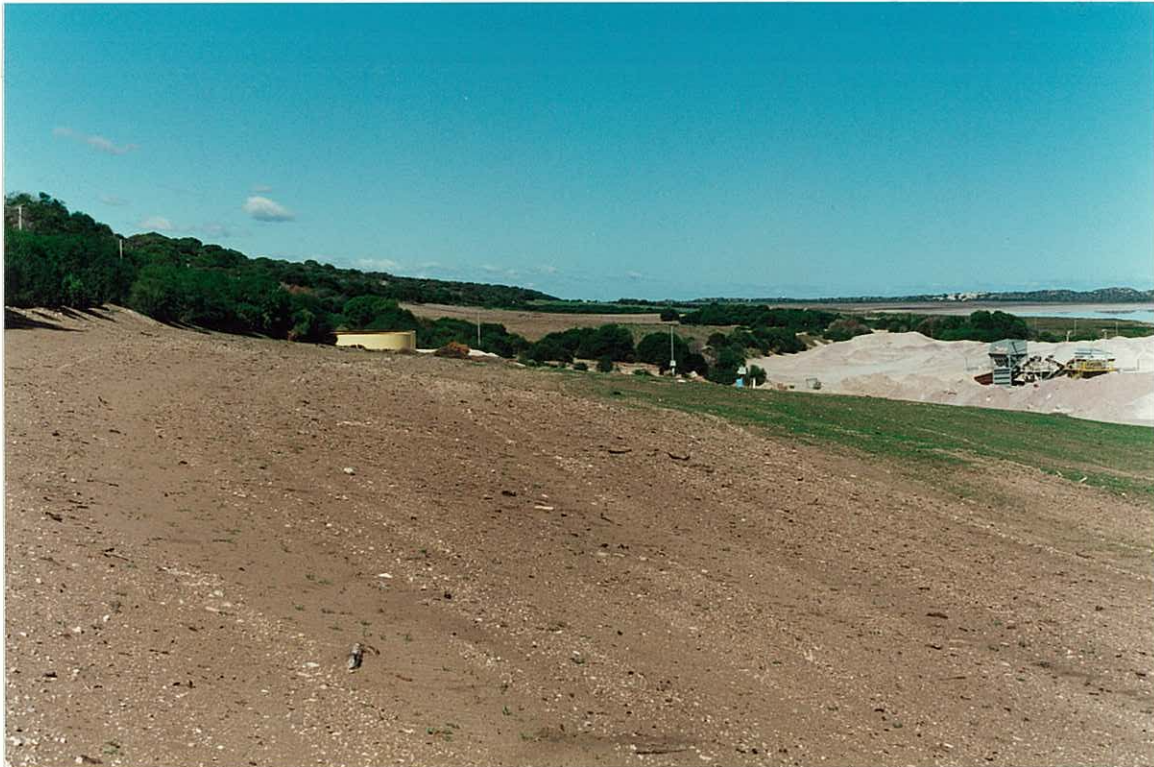
View looking South - East over mined out areas to east of the plant buildings and feed stockpiles. Areas in the foreground and middle distance have recently had the topsoil replaced.

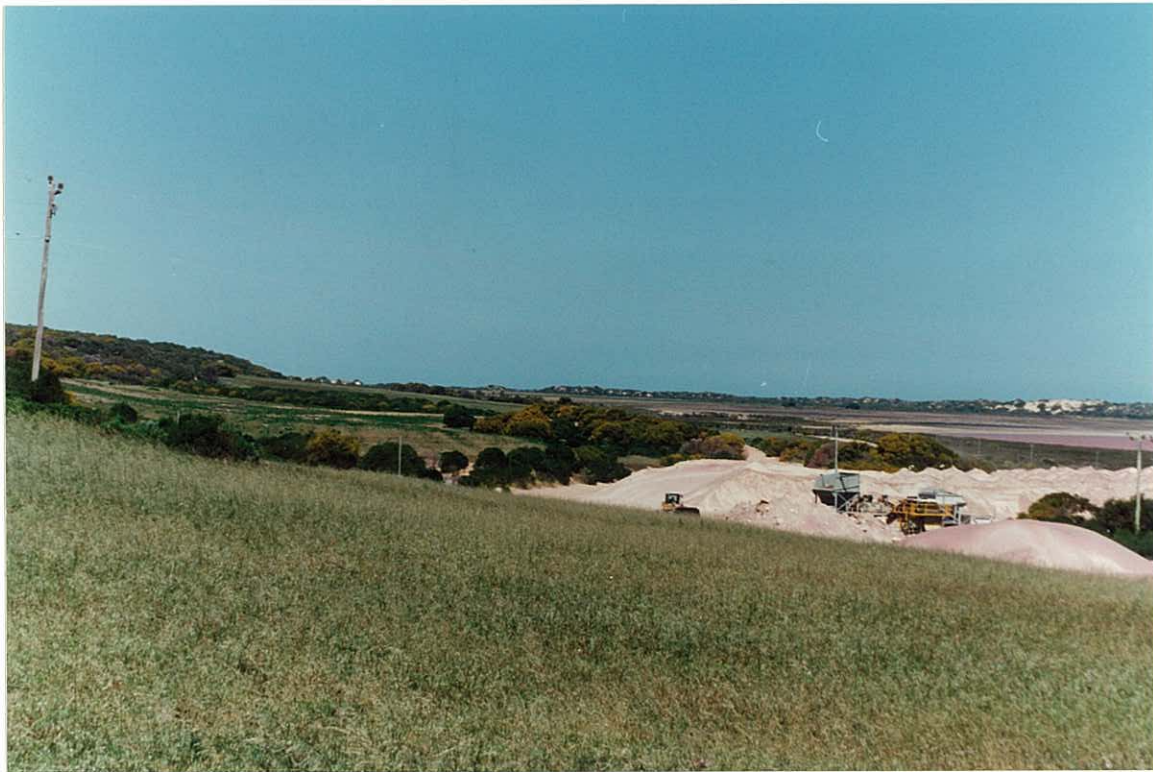
The previous photograph re-taken 4 months later. Grasses cover the topsoil and prevent wind erosion until the Acacia regrowth is established. The thick wattle in the left centre distance is the product of 3 year's regrowth.

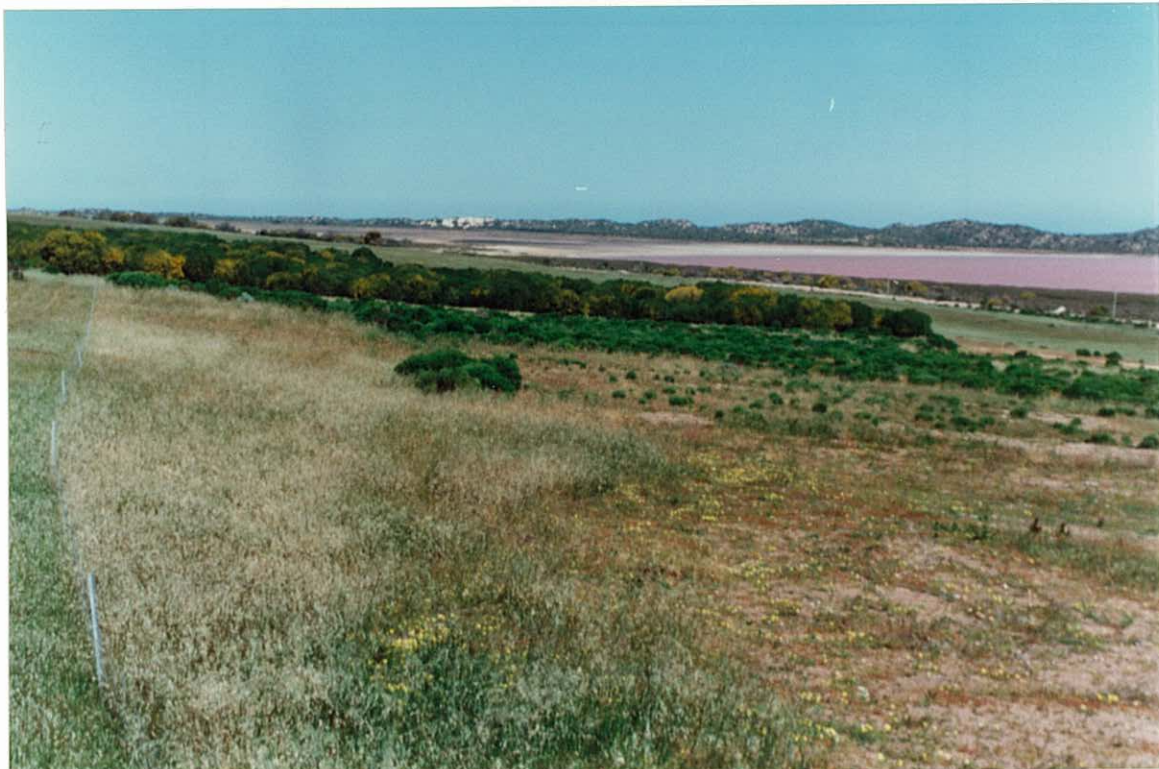
This view shows three stages of regrowth. The foreground has had one year of growth, while the centre (low scrub) has had two years of growth. The Acacia thicket in the middle distance is three seasons old.

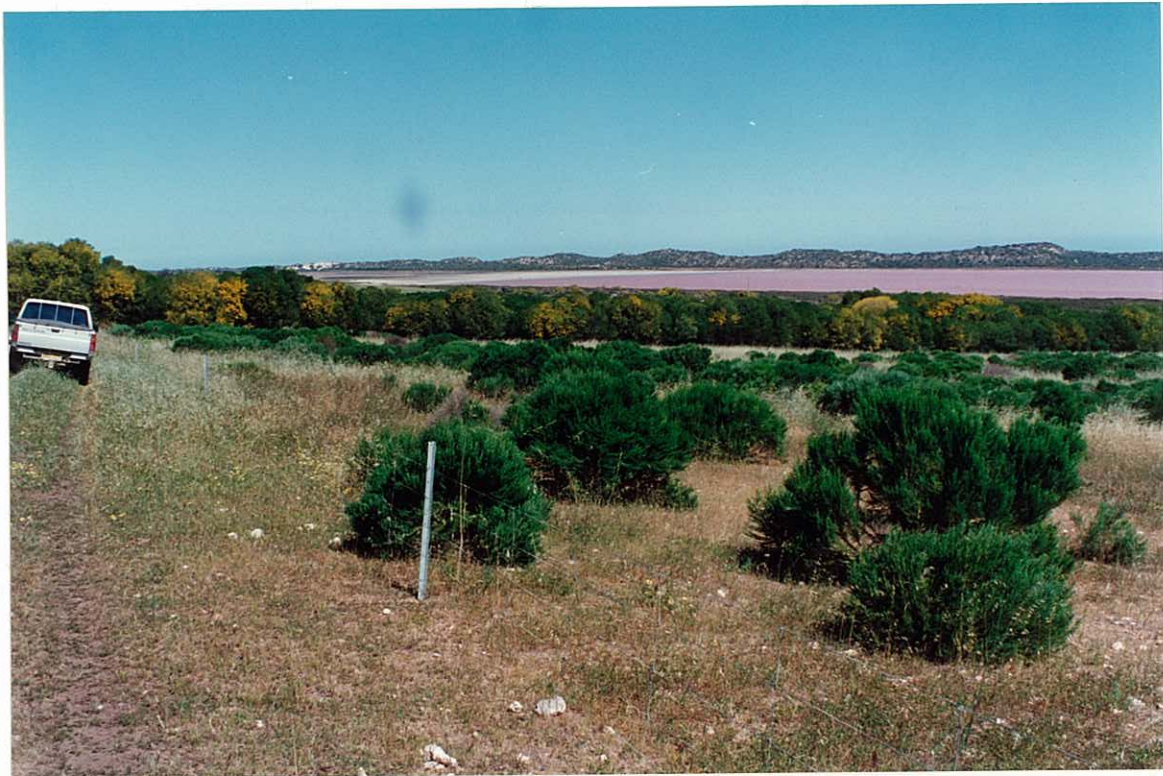
A view of the two year old regrowth in the foreground with the three year old growth behind. The fence in the foreground is to keep out sheep until the wattle is large enough to survive grazing.

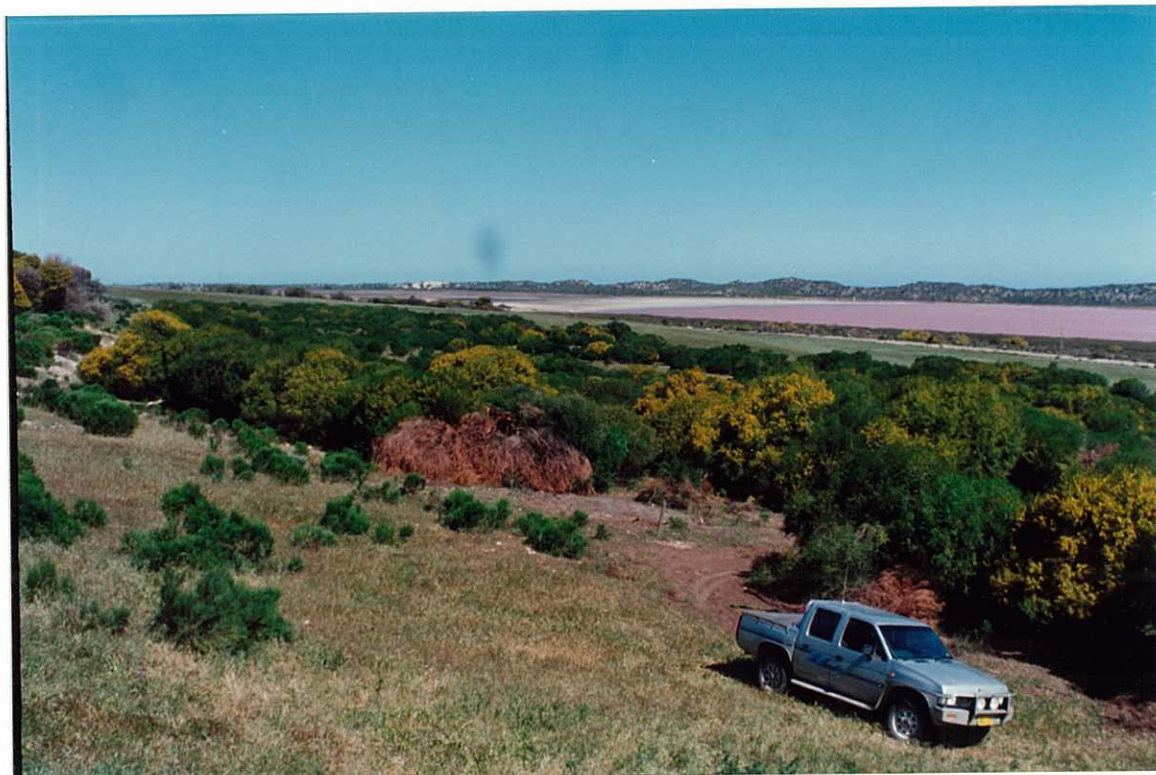
The three year old Acacia regrowth behind the vehicle is now large enough and thick enough to prevent grazing by sheep, and the fence has been removed.

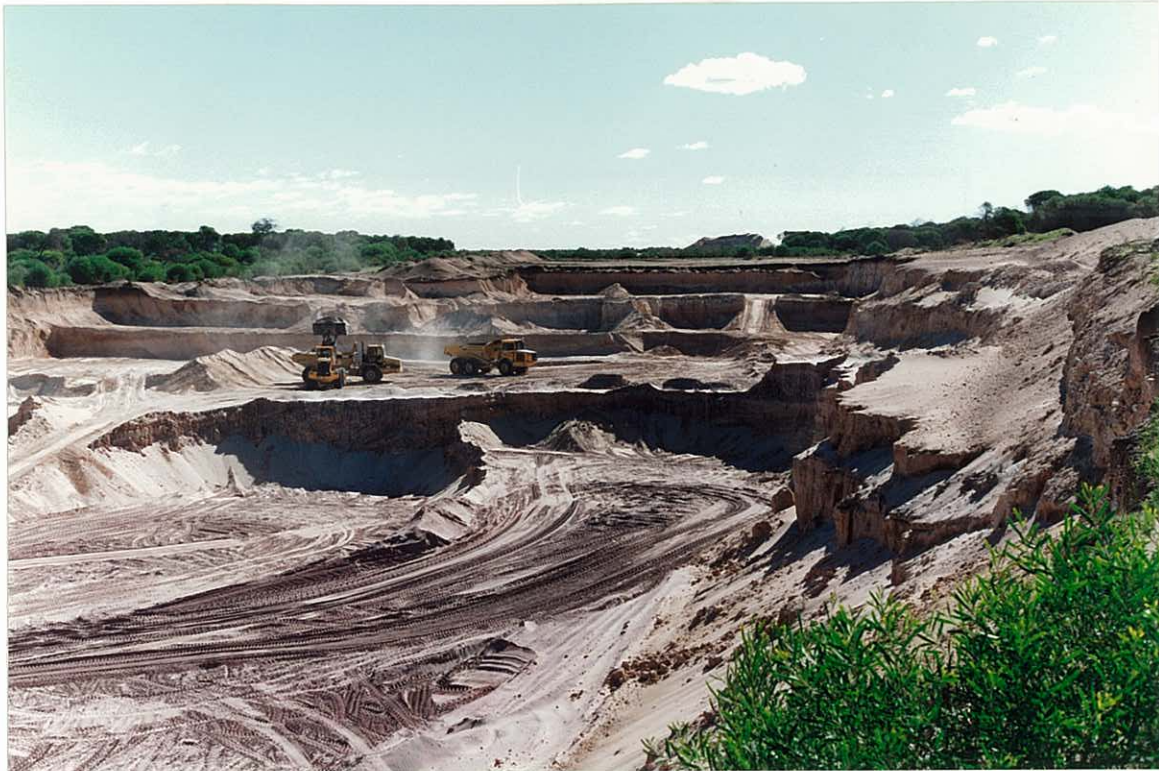
View looking North - West along mining direction showing ore face and overburden benches in the main pit.

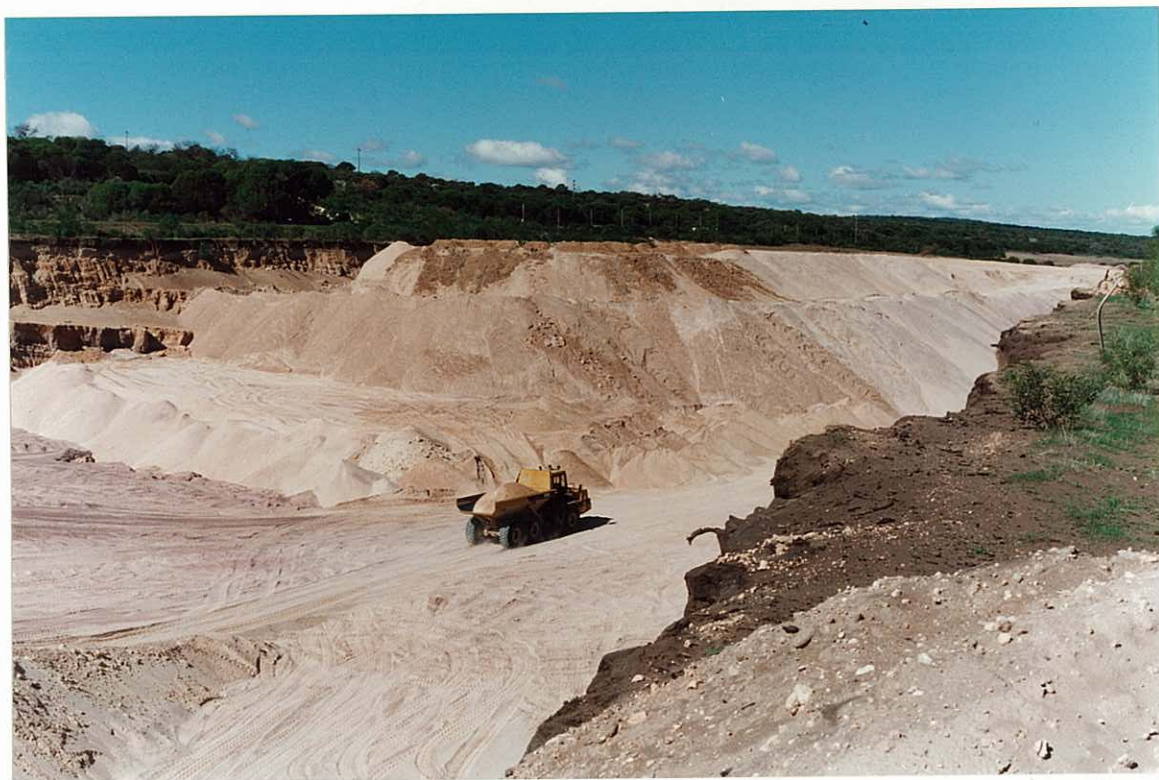
View looking South - East over the backfill dump. Overburden and tailings are used to backfill the pit as it moves northward, recreating a natural looking topography.

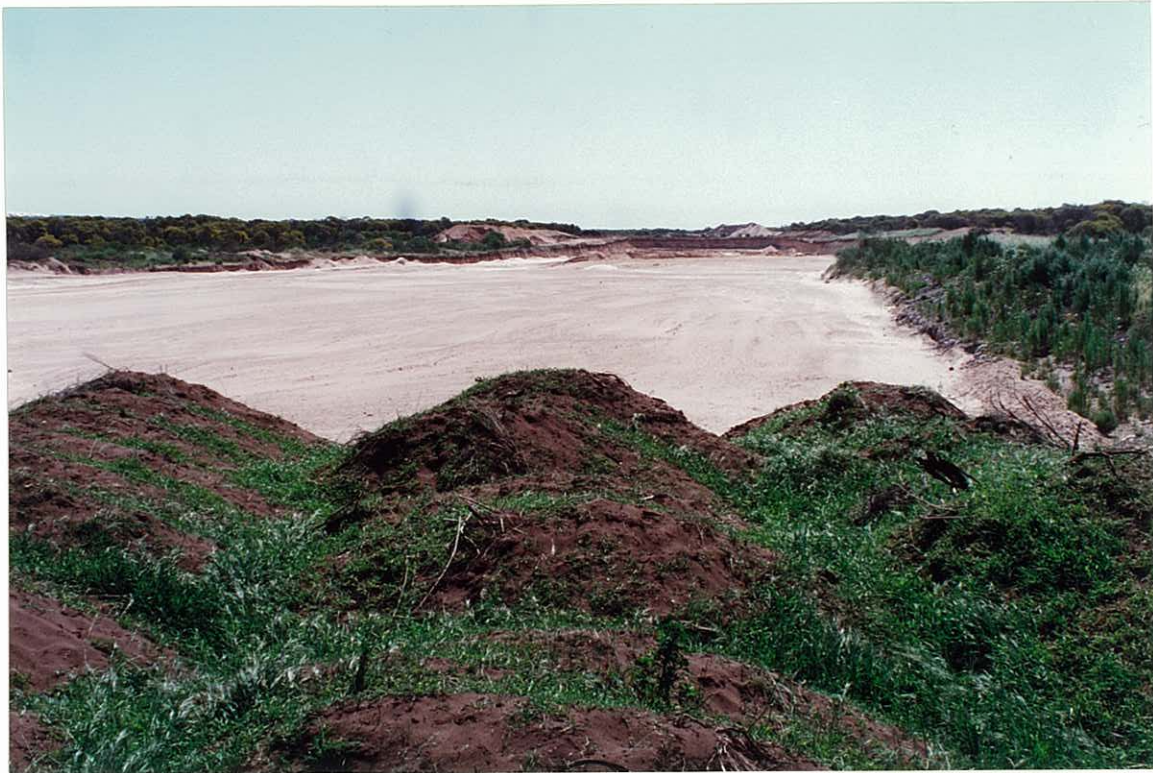
View to the North - West along the mining direction. In the foreground is stockpiled topsoil ready to be spread over the backfilled area in the middle of the photograph. The mine pit is in the middle distance.

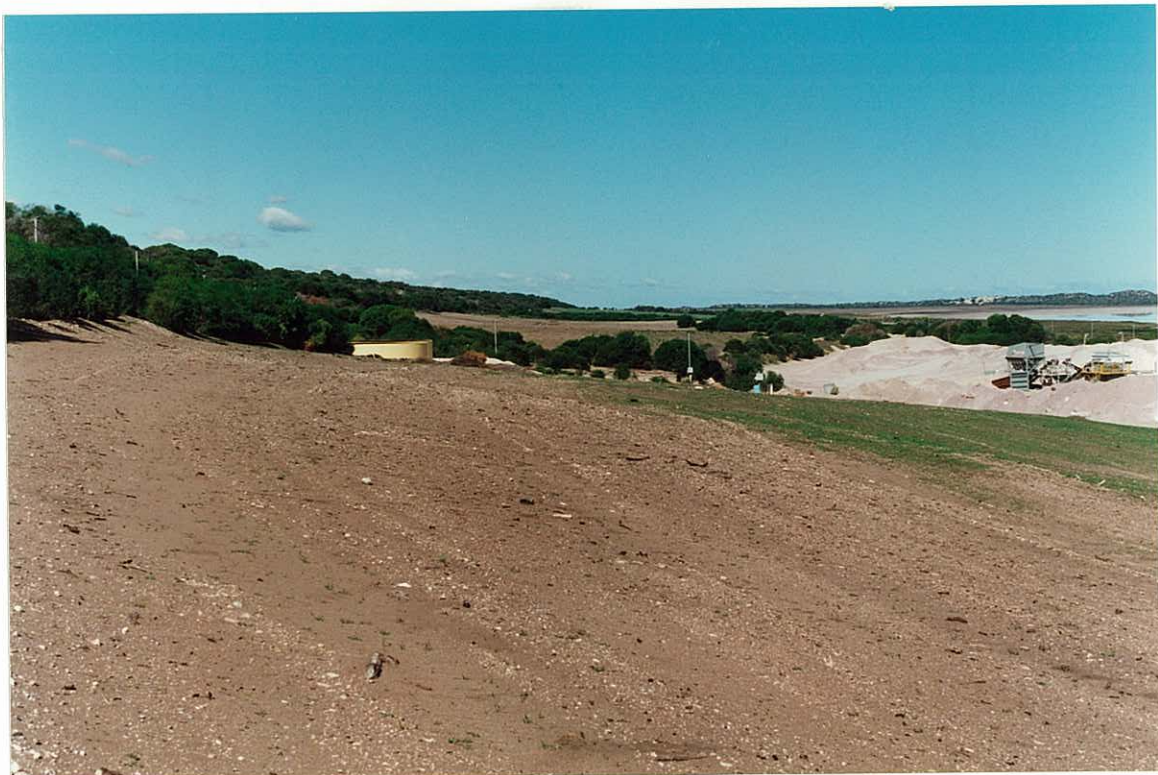
View looking South - East over mined out areas to east of the plant buildings and feed stockpiles. Areas in the foreground and middle distance have recently had the topsoil replaced.

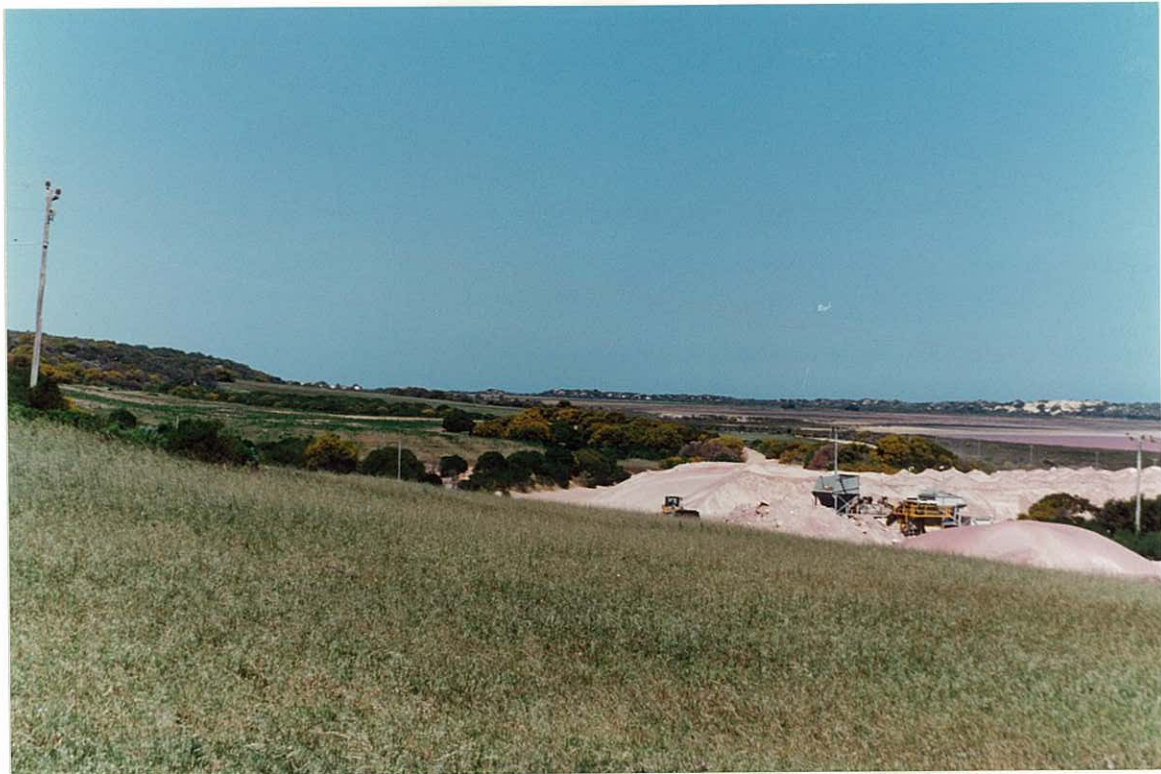
The previous photograph re-taken 4 months later. Grasses cover the topsoil and prevent wind erosion until the Acacia regrowth is established. The thick wattle in the left centre distance is the product of 3 year's regrowth.

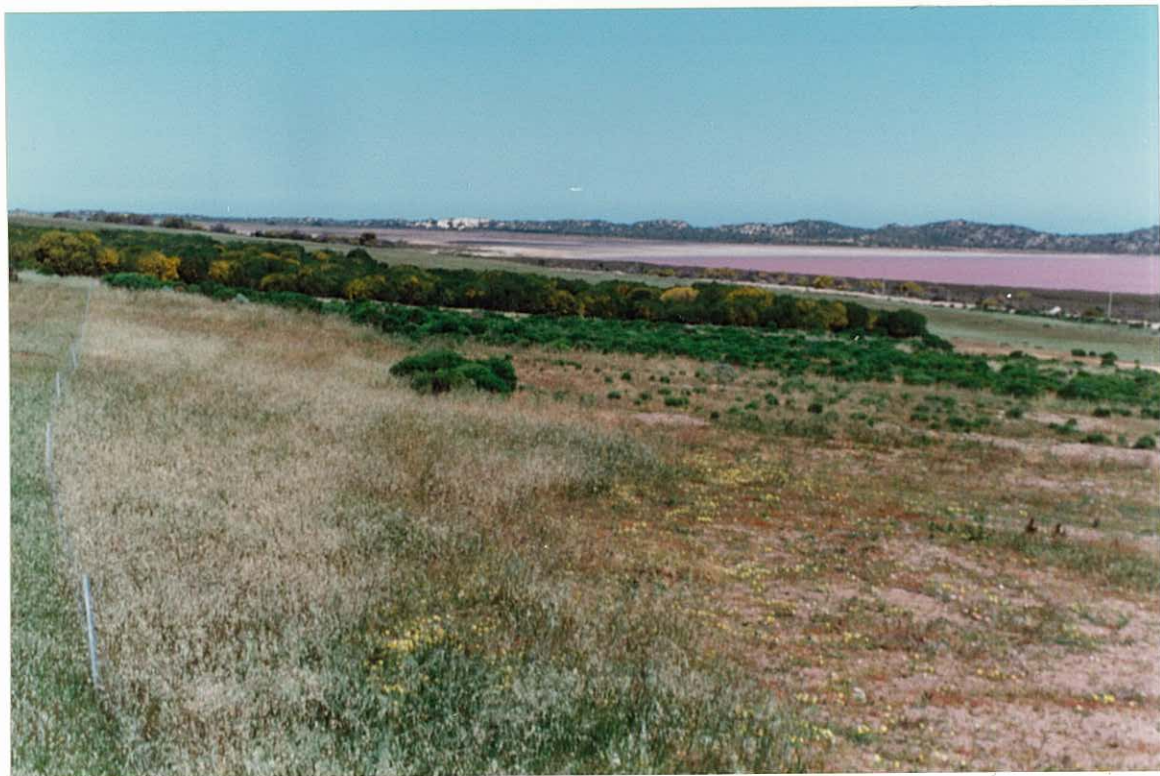
This view shows three stages of regrowth. The foreground has had one year of growth, while the centre (low scrub) has had two years of growth. The Acacia thicket in the middle distance is three seasons old.

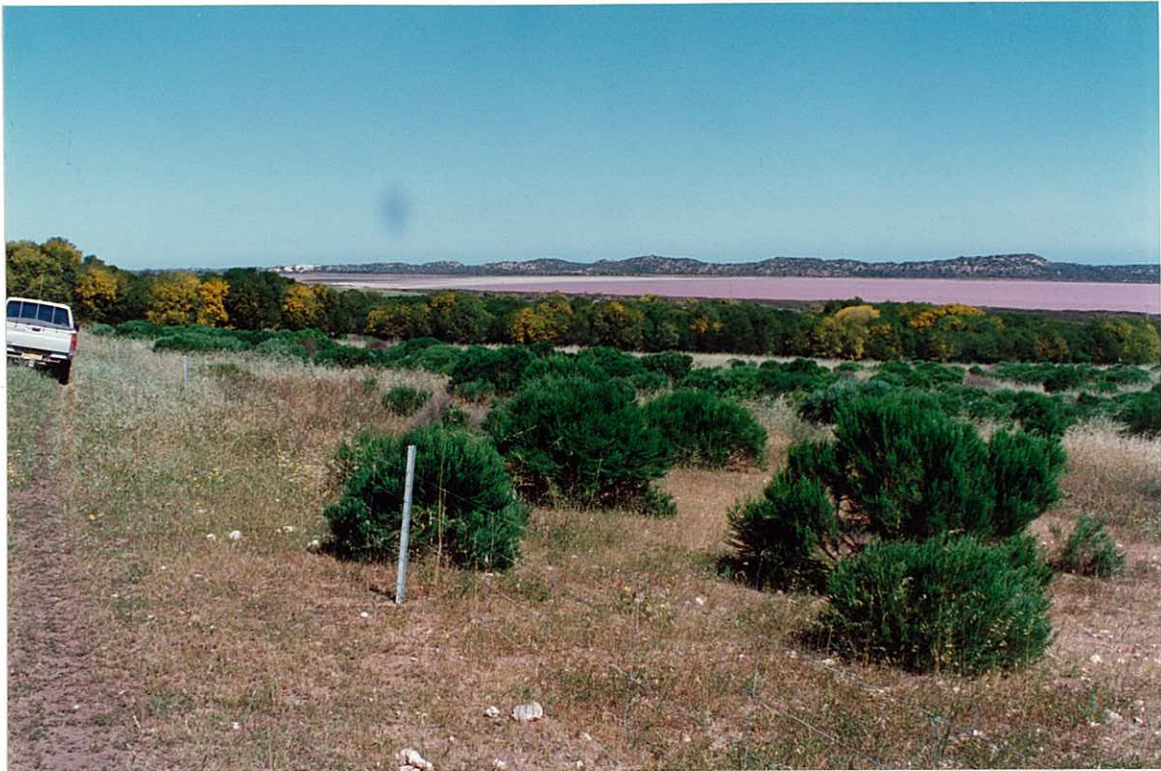
A view of the two year old regrowth in the foreground with the three year old growth behind. The fence in the foreground is to keep out sheep until the wattle is large enough to survive grazing.

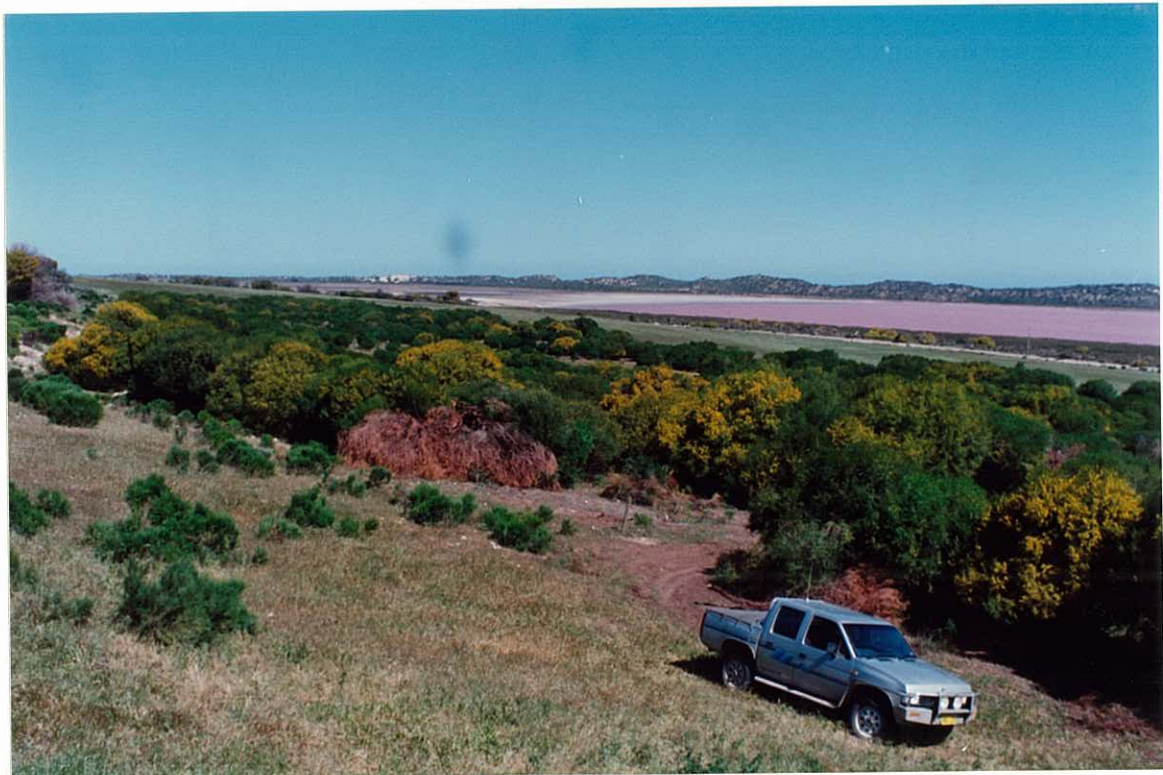
The three year old Acacia regrowth behind the vehicle is now large enough and thick enough to prevent grazing by sheep, and the fence has been removed.

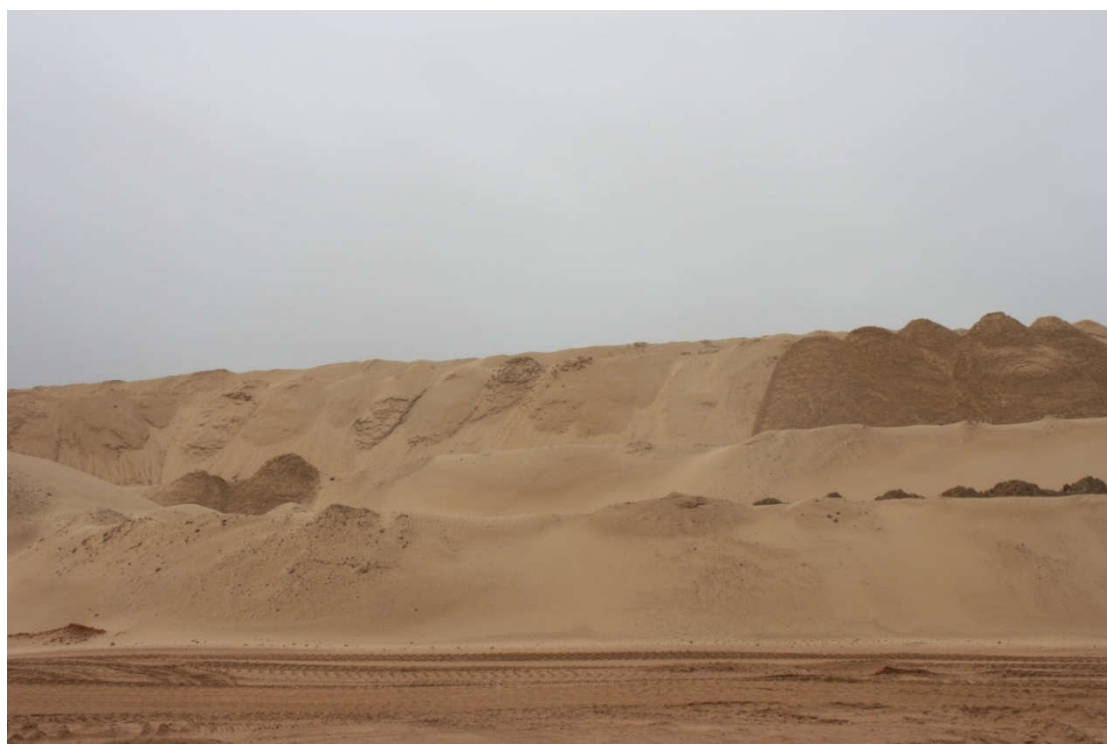
Subsidence has occurred in one previously rehabilitated area on the project site due to the consolidation of material. To achieve ground level, the removal of topsoil, further deposition of tailings and overburden, and reapplication of topsoil was required. Since this event, tailings and overburden are heaped to above ground level while backfilling, tailings are deposited when wet where possible and benched to enable some vehicle compaction. Since these measures have been implemented, no problems associated with subsidence have been identified.

Closure works are ongoing. Backfilling would be expected to be completed within 12 months of completing mining activities (the year 2034), based upon the current projected life of the project.

**Plate 1 Mine Pit Undergoing Backfilling (Hose Mine)**

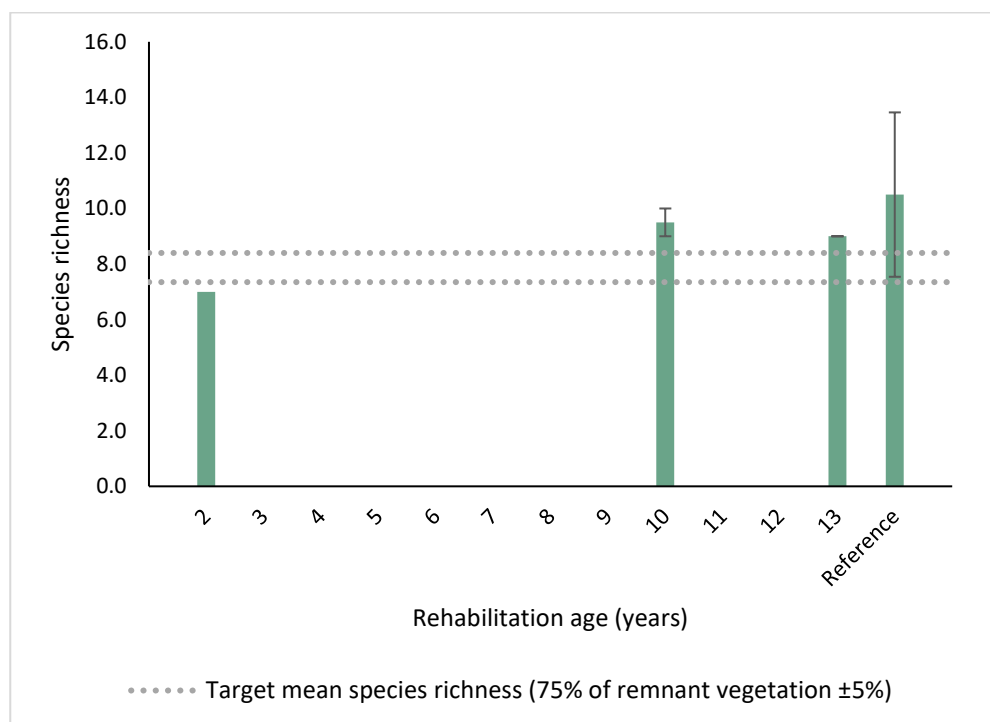
Plate 1: Mean species richness ( $\pm$  standard errors) for 2023 monitoring of quadrats in *Acacia rostellifera* rehabilitation areas and reference sites presented against completion criteria (native vegetation)
