# SIKA AT WORK Pool waterproofing at a private residence, Greece

WATERPROOFING: Sikalastic®-841 ST

# POOL WATERPROOFING, PRIVATE RESIDENCE

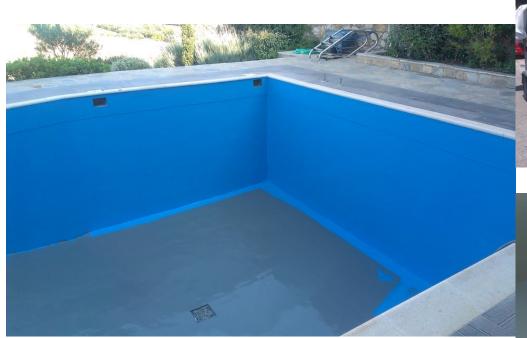
The waterprooring of a pool in a private residence, which was actually performed with cementitious mortar coated with epoxy paint, failed. The pool, measuring 15 m x 5m with a total surface of 225 m<sup>2</sup> excibited major water leak and the need for immediate restoration was necessary.

Initially, the substrate was cleaned using mechanical means (diamond wheel) in order to remove the existing coating. Local failures, gap sealing, penetrations, edge shaping, e.t.c were treated using the 2-component epoxy resin **Sikadur®-31EF**.

Afterwards, the 2-component, epoxy primer **Sikafloor®-161** in 2 layers was applied (the first layer was followed by a second one broadcasted with quartz sand 0.4-0.7mm in order to improve the mechanical adhesion and increase the roughness of the substrate). The main waterproofing layer was sprayed using the 2-component, liquid, polyurea membrane **Sikalastic®-841ST** with 100% solid content. The application of the membrane **Sikalastic®-841ST** offered at the same time waterproofing, protection crack bridging and was performed using the 2-component, heated, high pressure spray equipment GRACO REACTOR HXP 3.

On the waterproofing layer, the 2-component, acrylate-polyurethane final coating **SikaCor® EG-5** was applied, which offered high aesthetical results and is weather proof. At the walls of the pool the colour shade RAL 5012 was used, while on the bottom the colour shade RAL 5013 was used.
