Deskstudy

Lower Suck Priority Area for Action

(AFA0169)

Lower Suck PAA Desktop Assessment

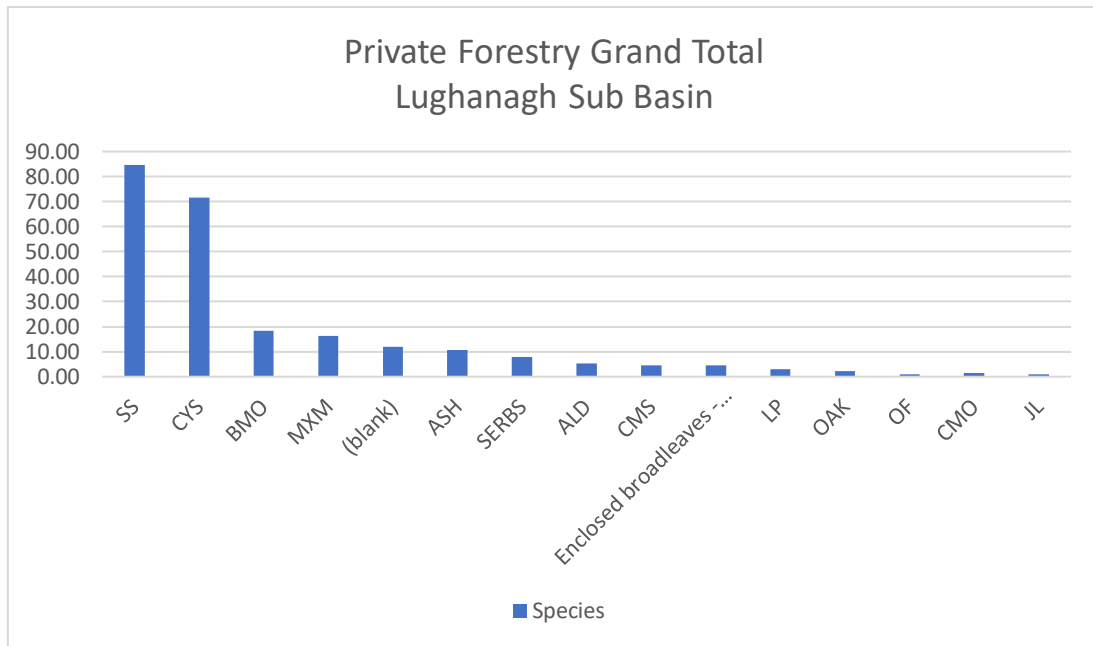
Figure 13 Species type by area (hectare) within private forestry in the Lughanagh_010 Sub Basin

Within private plantations, the main species planted within the sub basin is Sitka Spruce as illustrated in [Figure 13](#) below. The second most common species is Conifer young spruce. For Sitka Spruce and Conifer young spruce (CYS) the majority of planting took place in the 1990's ([Table 12](#)) and therefore would have been subject to new Forest Service guidelines regarding buffer zone management along watercourses e.g. within the buffer zone, ground preparation and other forest operations curtailed in order to protect water quality. In addition, drainage channels leading from the site must taper out before entering the buffer zone.
