Generalized Geologic Map for Land-Use Planning: Knott County, Kentucky

Daniel I. Carey, Steven E. Webb, Bart Davidson

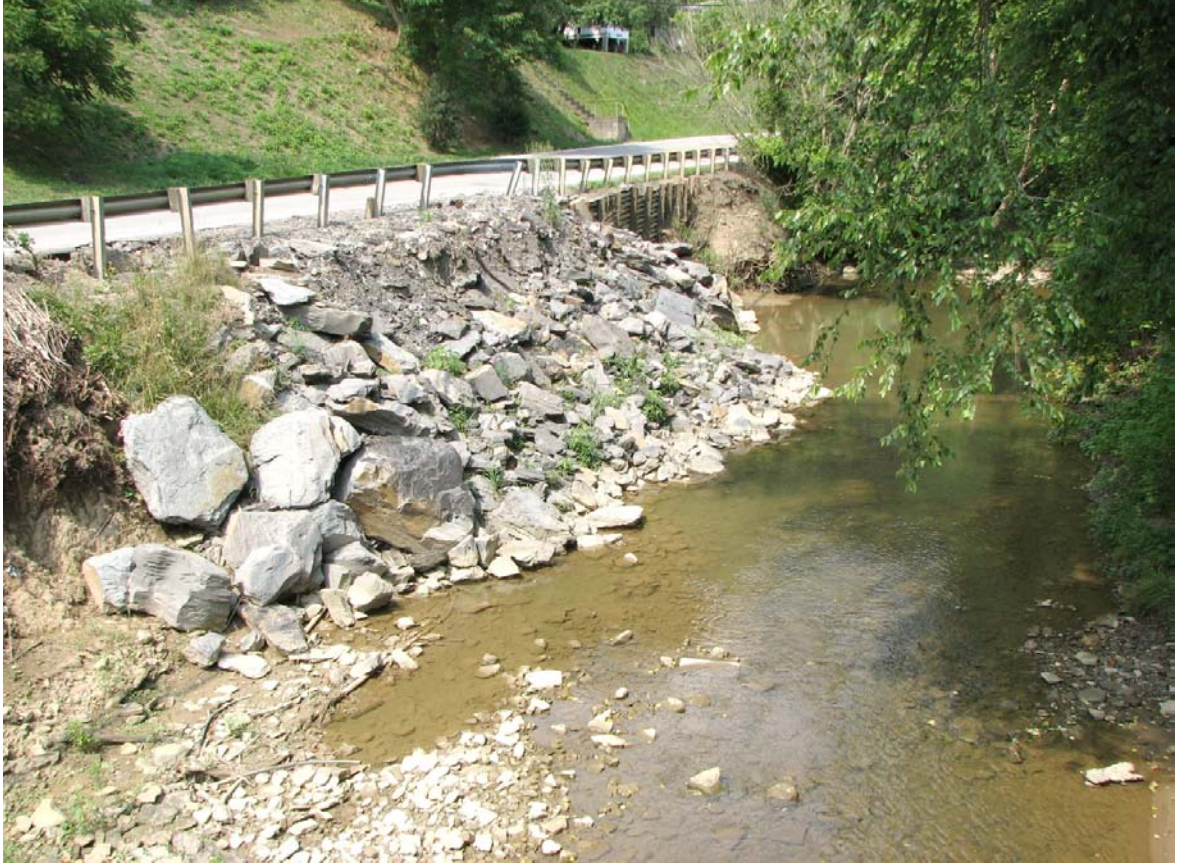
Slope Stability

Streambank and pavement support for roadbeds cut into slopes underlain by shale along streams. Photo by Dan Carey, Kentucky Geological Survey.

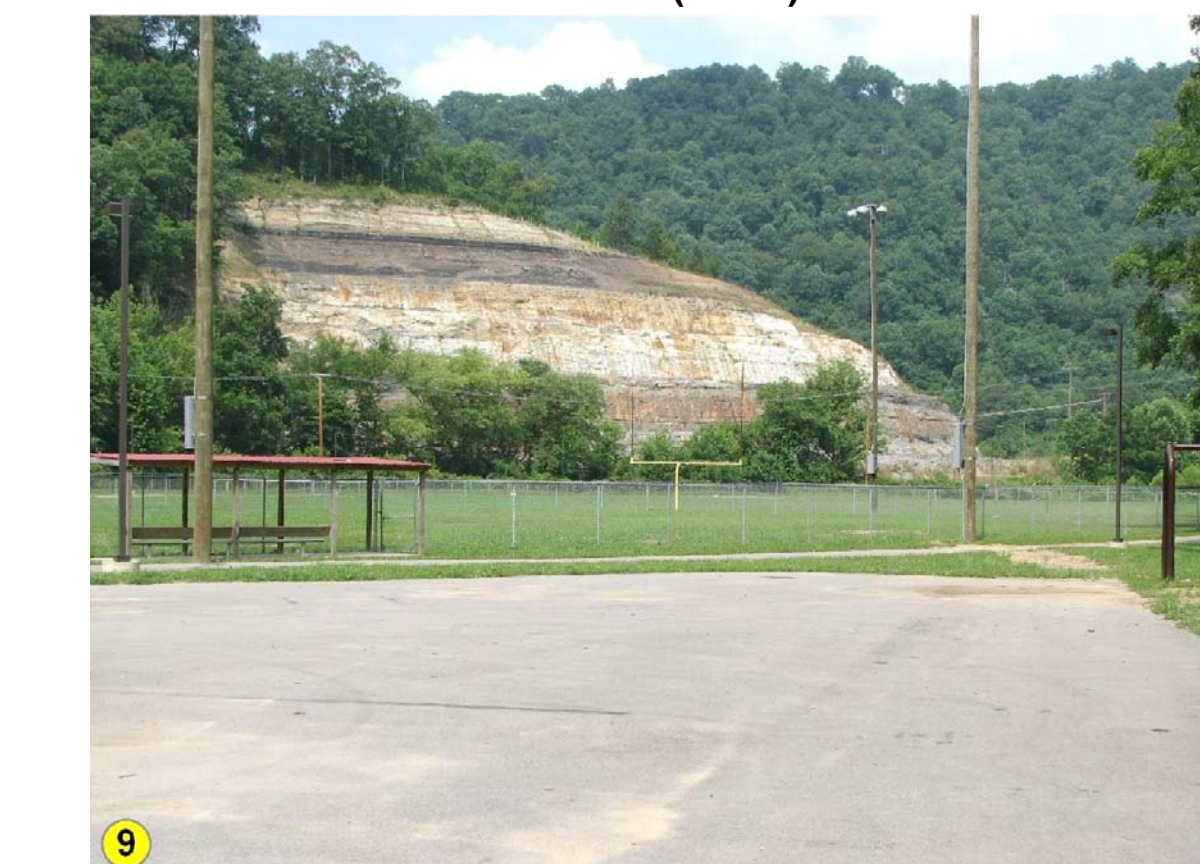
Alluvium (Unit 1) provides level land suitable for recreation and other uses if drainage and potential flooding are properly considered. Siltstone, sandstone, clay shale, and coal of unit 4 are exposed in the roadcut on Ky. 7 in the background. Photo by Dan Carey, Kentucky Geological Survey.

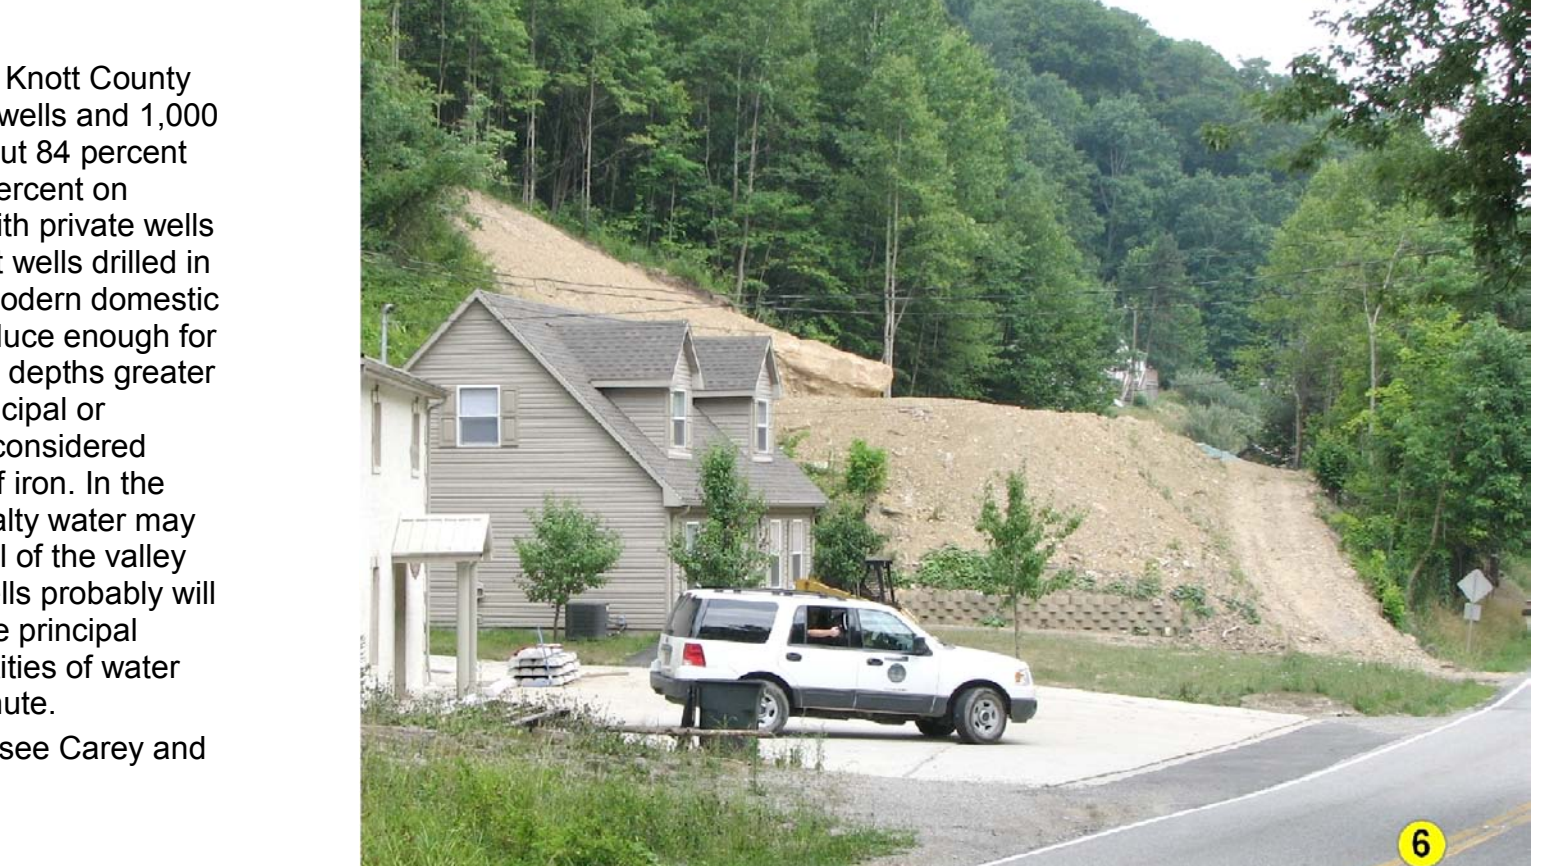
Site Preparation

Cut-and-fill foundation preparation is common in steep-sloping areas. Slope stability is maintained by retaining walls and other permanent vegetative covers. See diagram above. Photo by Dan Carey, Kentucky Geological Survey.
