Environmental Impact Assessment Registration

Development of the North Tributary Tailings Pond (NTTP) at the Caribou Mine, New Brunswick

July 17, 2018

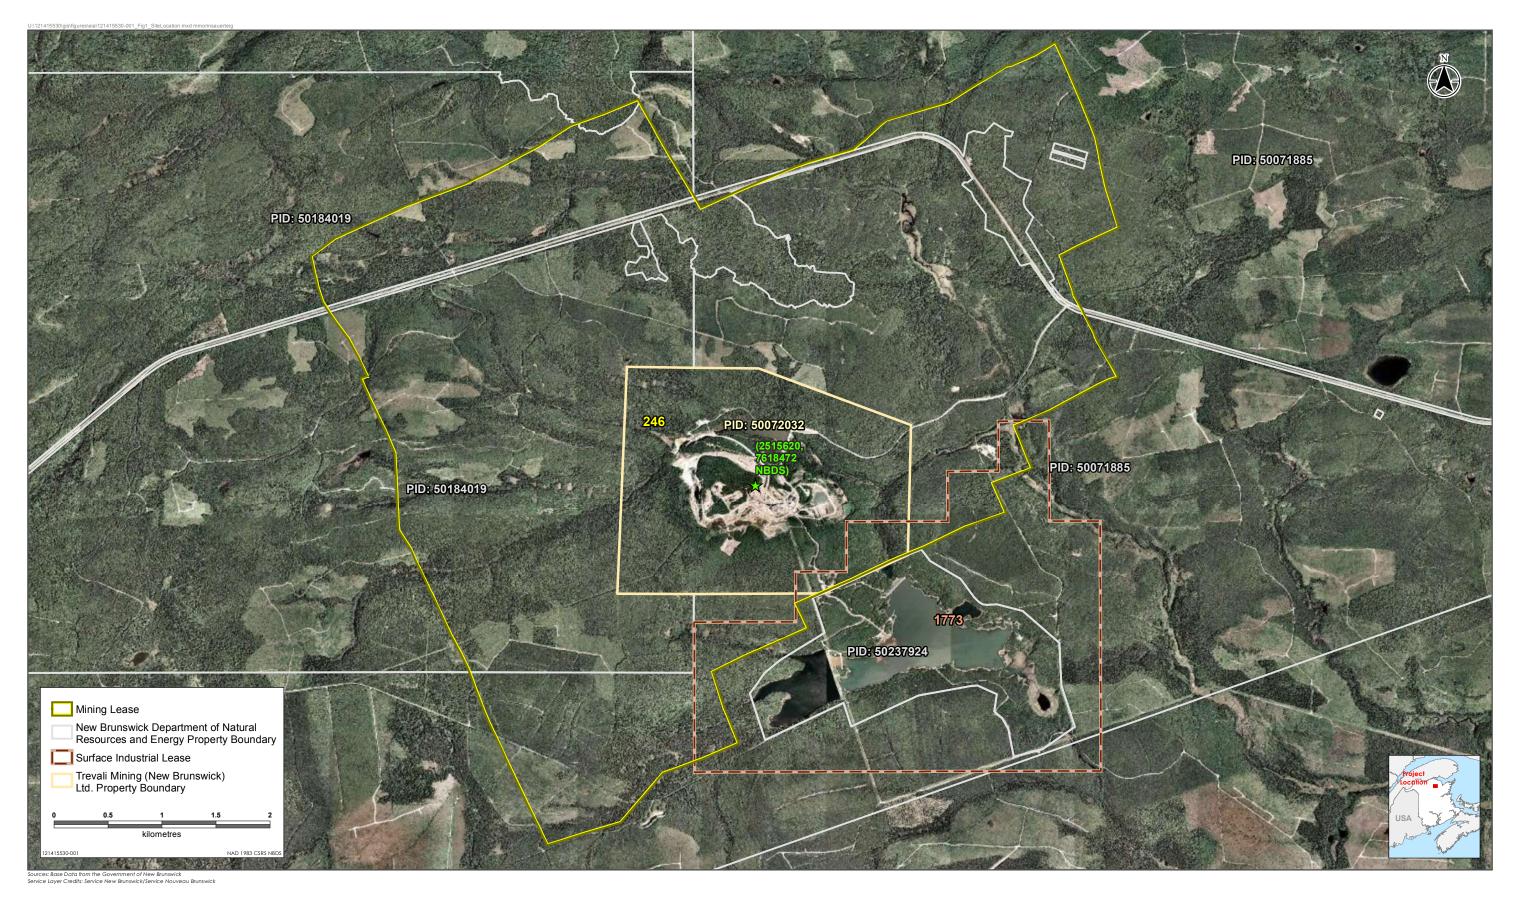
Figure 1.2

Project Location and Property Boundaries

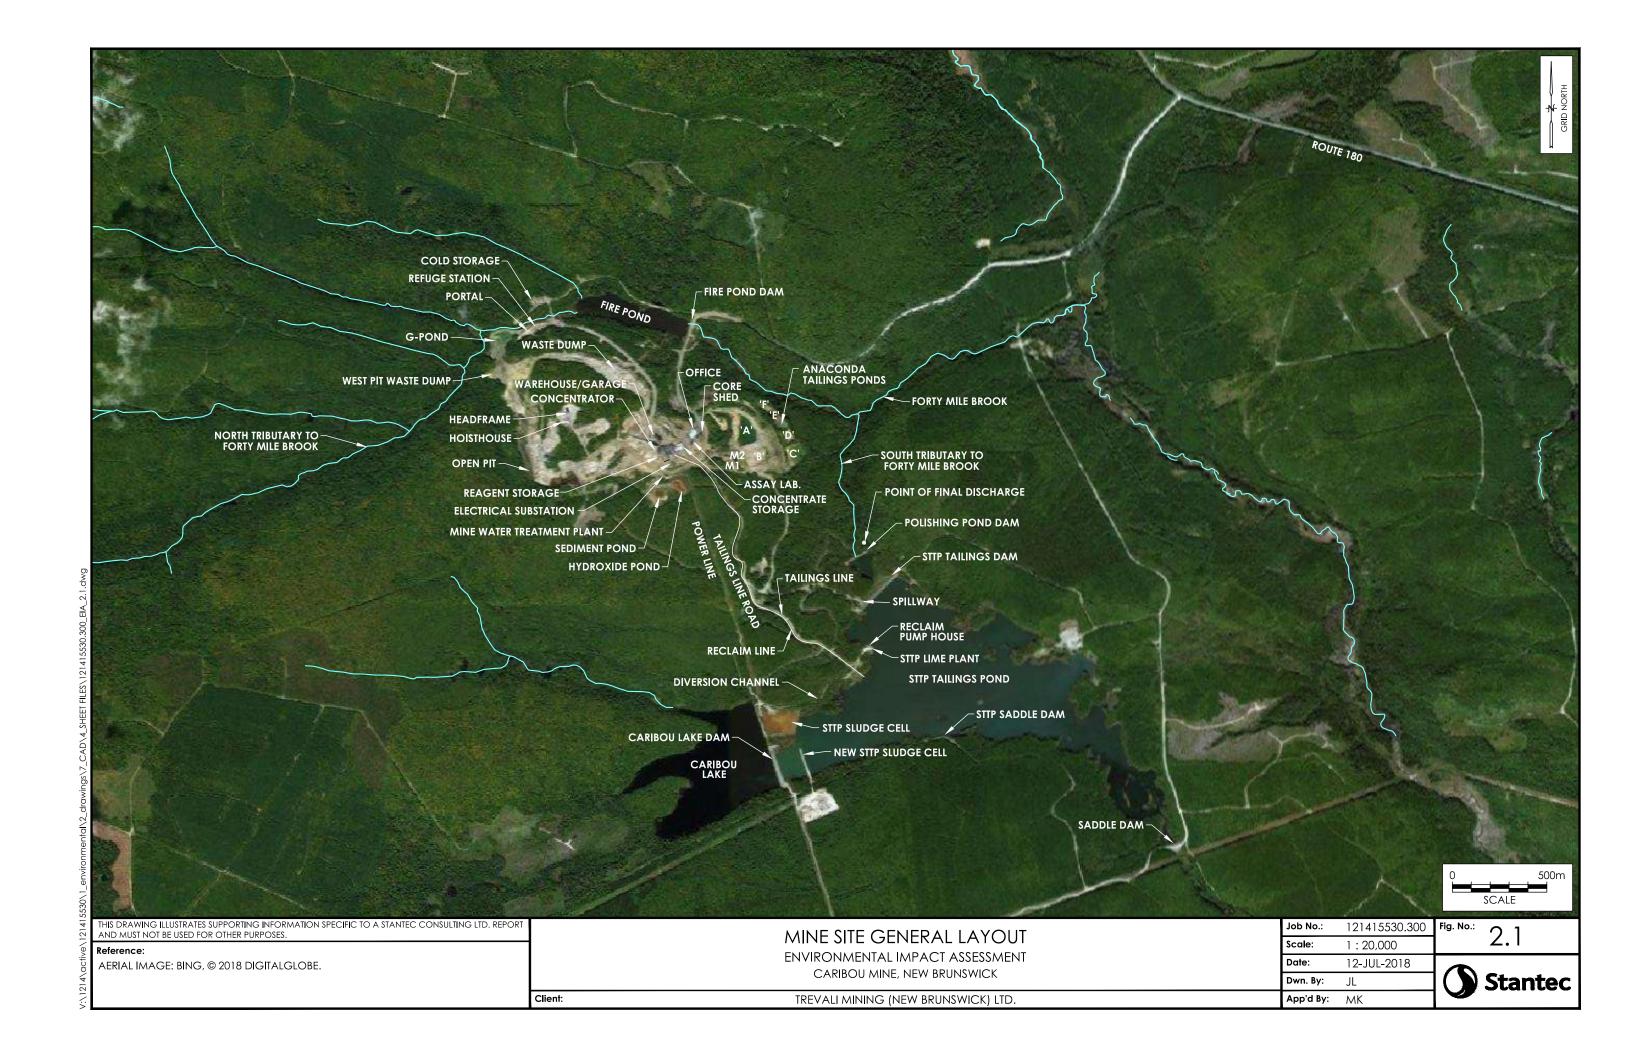
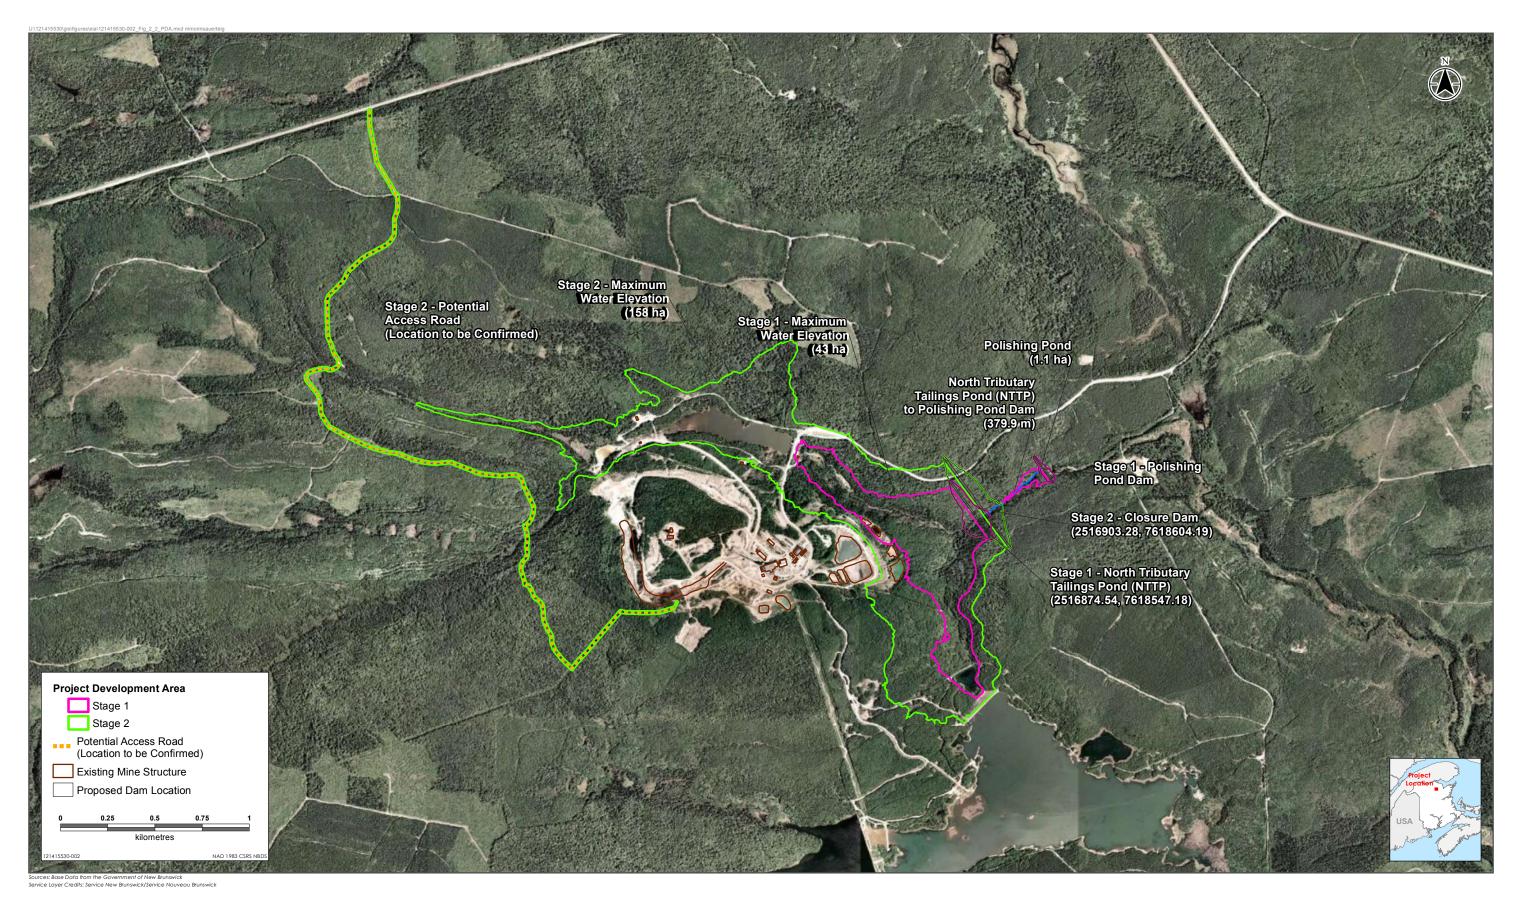
Project Development Area

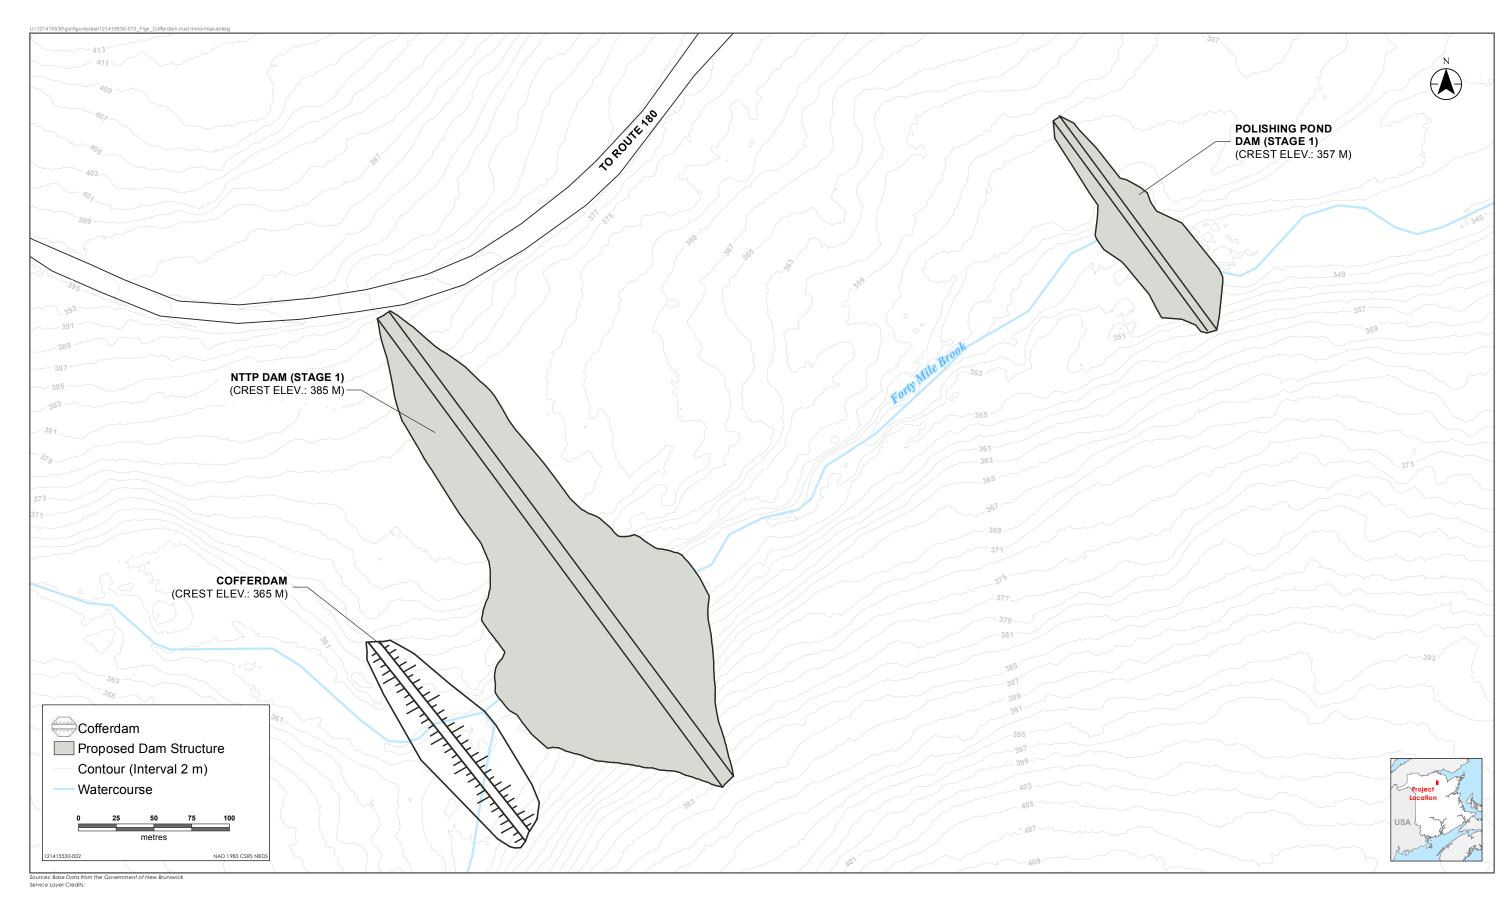
Cofferdam Location

To complete the work, it will be necessary to isolate the work site from the watercourse so that work can be carried out under dry conditions. A cofferdam will be installed below the confluence of the north and south tributaries to Forty Mile Brook above the NTTP dam location (Figure 2.6). The cofferdam will be built using a similar methodology as the main dam to maintain the work area in the dry. Any seapage below the cofferdam will be pumped back upstream to maintain dry condition. Prior to installing the cofferdam, the Fire Pond and STTP water levels will be lowered to their lowest operating level so that each basin can be used to maximize water storage during the construction period. These areas will serve as "surge" basins for any flood conditions arising during construction. A combination of

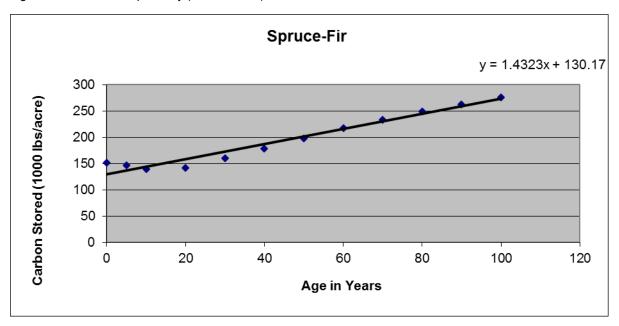
Figure 5.2 Carbon Storage for Coniferous Tree Species

In addition to direct emissions from construction activities for the Project, the Project will result in the loss of carbon sinks as the vegetation that currently exists where the TMF will be located is removed to make way for the Project. The forested area occupied by the Project and related GHGs were assessed. Based on the Forest Inventory, Region A.3 (Gray 1995), which includes New Brunswick, tree species are approximately 50% coniferous (i.e., spruce, pine, fir), with the remainder composed of broad-leaved species (e.g., maple, beech, birch) and other unclassified species. For this assessment, it is assumed that coniferous and broad-leaved species in the area of the Project have a 50:50 ratio. The increases in carbon storage with age for both coniferous and broad-leaved trees species are shown in Figures 5.2 and 5.3, respectively (US EIA 2000).

Based on this information, coniferous species have an average rate of carbon storage of 1,430 lb carbon/acre/year (or 5,248 lb CO₂/acre/year). Further, broad-leaved species have an average rate of carbon storage of 1,830 lb carbon/acre/year (or 6,716 lb CO₂/acre/year).

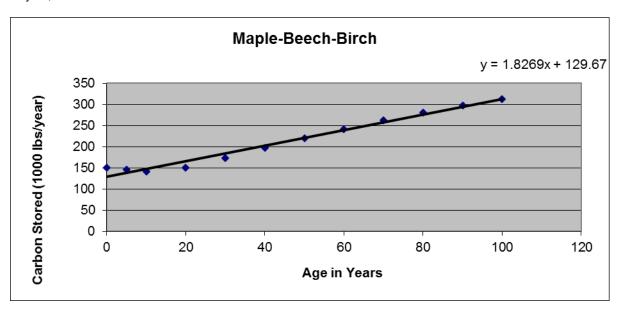
Figure 5.3 Carbon Storage for Broad-Leaved Tree Species

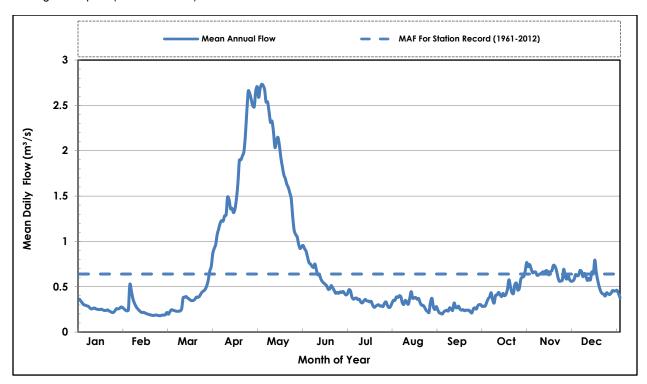
Figure 5.8 Estimated Mean Daily Flow of Forty Mile Brook at North Tributary Tailings Pond

annual flow rate is consistent with the mean annual climate normal runoff volume calculated in the NTTP water management plan (Stantec 2018c).

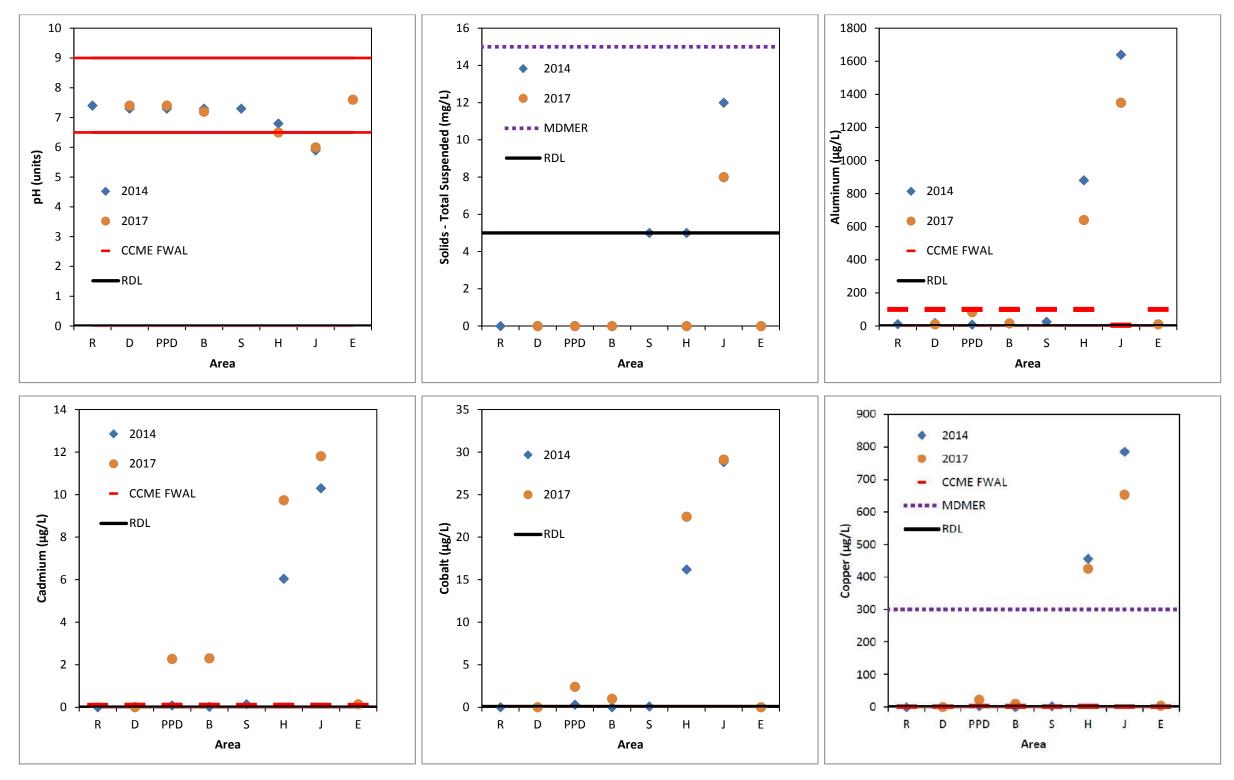
Figure 5.10 Summary of Water Quality Results for pH, Solids, Aluminum, Cadmium, Cobalt and Copper

Based on a review of the water quality data presented in the 2015 and 2018 EEM reports (Stantec 2015a; Stantec 2018b), water quality at Area PPD meets provincial and federal discharge requirements. Trace metals, TSS, nutrients and *in-situ* water quality results have been recorded at various locations throughout the Forty Mile Brook and Nepisiguit River watersheds and compared to the MDMER Schedule 4 requirements as well as to the CCME FAL guidelines (where applicable), as shown on Figure 5.10.

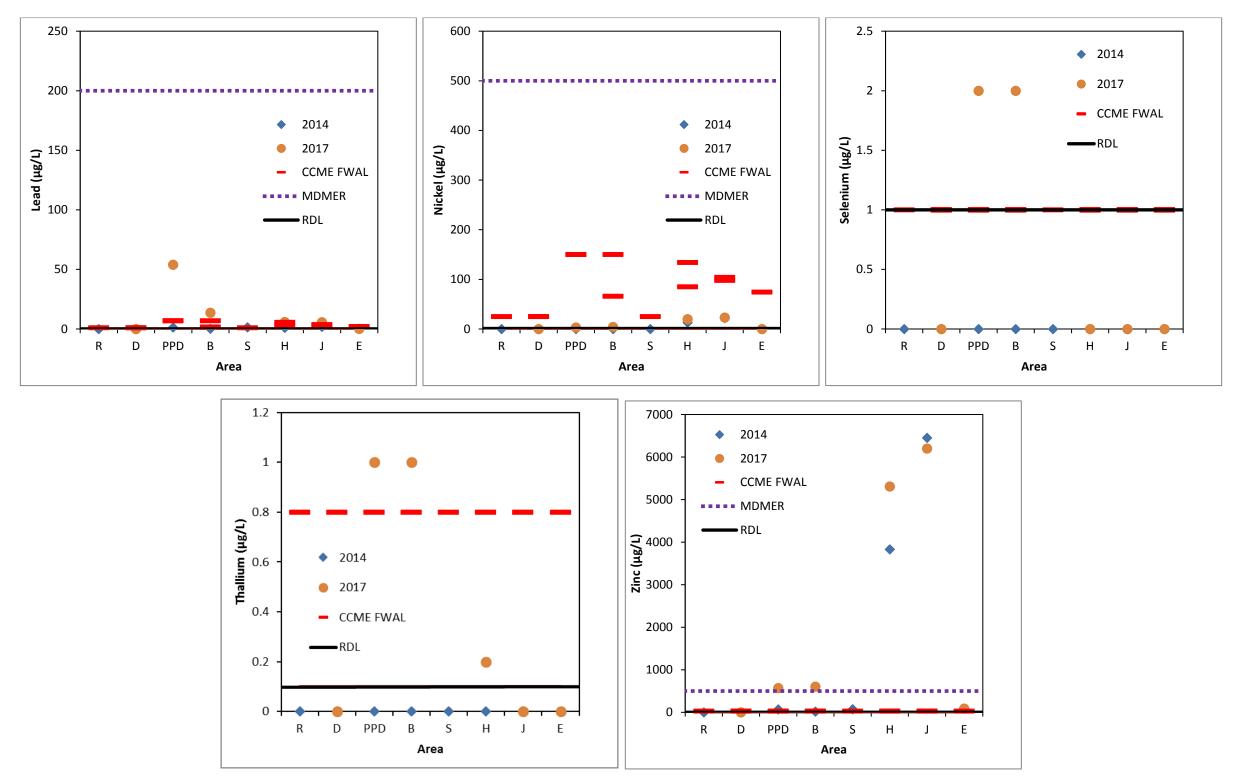
Figure 5.11 Summary of Water Quality Results for Lead, Nickel, Selenium, Thallium and Zinc

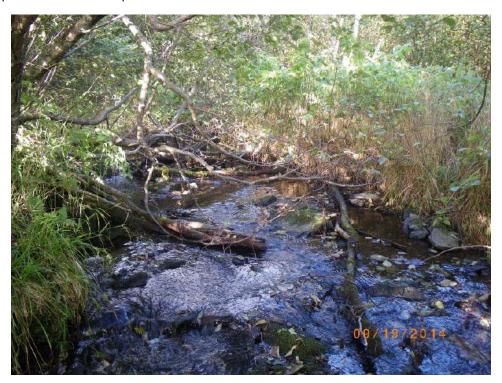
watercourse, and instream cover was provided by boulders, water clarity (e.g., turbulence, colour, turbidity), and small amounts of instream vegetation. Stream side vegetation is dominated by shrubs, grasses and conifers (Stantec 2015a). Representative habitat is provided in Photo 1.

Photo 1 Representative Habitat in the Headwaters of South Tributary to Forty Mile Brook (Area R, Facing Upstream)

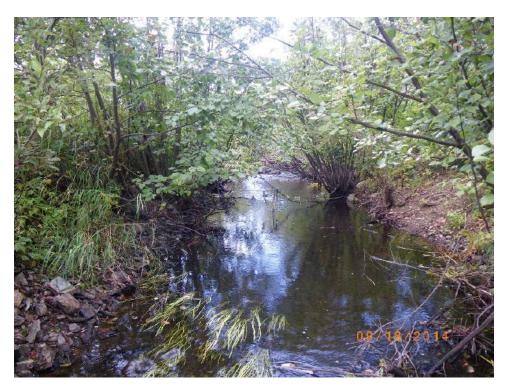
The existing Caribou Lake diversion channel runs west of the STTP and forms the outlet of Caribou Lake. It is located outside of the influence of the Caribou mine effluent discharge and the historic mining legacies at the site (Stantec 2015a). The Caribou Lake diversion channel is a manmade channel which serves to divert Caribou Lake waters around the existing STTP and provides upstream fish passage into Caribou Lake. Gradient within the sampling area (Area D) for the channel is relatively low (1%) in its upstream portion, increasing downstream to between 5-7%. The habitat types within the diversion channel are flat and shallow run at Area D. Water depths are generally shallow ranging from 0.2 to 0.4 m during low flow conditions. Stream widths ranged from 4 to 8 m with substrates dominated by organics and fines, with small amounts of gravel and cobble. There are small amounts (10%) of woody debris throughout the watercourse and instream cover was provided by aquatic plants (submergent macrophytes). Stream side vegetation is dominated by shrubs and grasses (Stantec 2015a). Representative habitat is provided in Photo 2.

Photo 2 Representative Habitat in the Caribou Lake Diversion Channel (Area D, Facing Upstream)

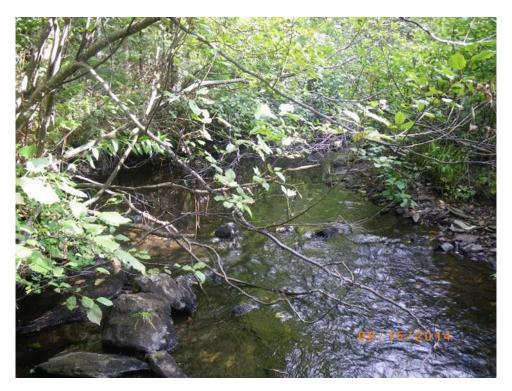
An unnamed tributary to the south tributary to Forty Mile Brook is located directly downstream of the existing polishing pond (Area PPD) and is directly exposed to 100% mine effluent from the Caribou mine (Stantec 2015a). Its flow is regulated primarily by the STTP discharge, although natural seepage/precipitation as well as dam seepage waters provide flow. Area PPD consists of riffle, run, glide and debris jams habitats. Water depths ranged from 0.15 to 0.25 m. Stream widths ranged from 2.5 to 5.5 m with mixed substrate dominated by organic matter and also composed of small gravel, cobble, and boulder. There were large amounts of instream woody debris in the channel which provide habitat for fish. Stream side vegetation is dominated by shrubs and grasses, with a small number of conifers and deciduous trees (Stantec 2015a). Representative habitat is provided in Photo 3.

Photo 3 Representative Habitat Downstream of the Polishing Pond (Area PPD, Facing Downstream)

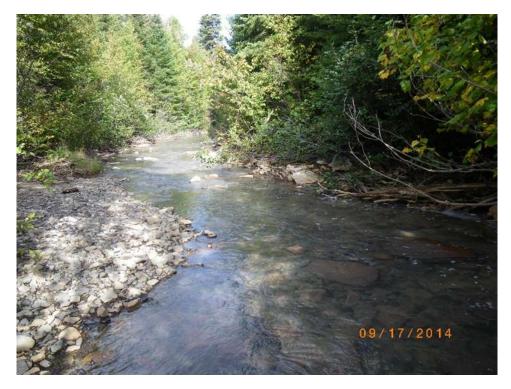
The lower portion of the south tributary to Forty Mile Brook (Area B and S) drains the diversion channel (Area D) and the unnamed tributary to Forty Mile brook (Area PPD) (Figure 5.9). The lower portion of the south tributary to Forty Mile Brook (Area B and S) is generally low gradient (1-2%) with a mix of riffle, flat, and run habitat (Stantec 2015a). Water depths range from 0.2 to 0.5 m at Area B. Stream widths ranged from 3 to 5.5 m with mixed substrate containing boulders, cobble, gravel, and sand. Stream side vegetation is dominated by shrubs and conifers (Stantec 2015a). Representative habitat for Area B is provided in Photo 4, and for Area S is provided in Photo 5.

Photo 4 Representative Habitat in the Lower Reach of the South Tributary to Forty Mile Brook (Area B, Facing Downstream)

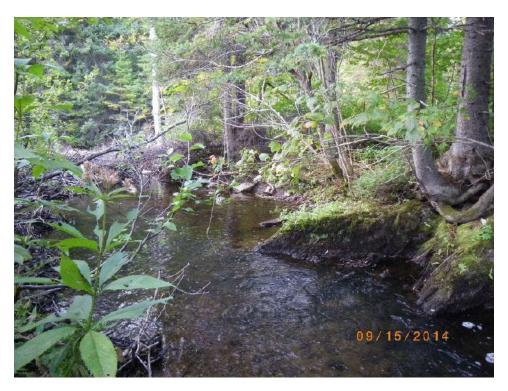
Photo 5 Representative Habitat in the Lower Reach of South Tributary to Forty Mile Brook (Area S, Facing Upstream)

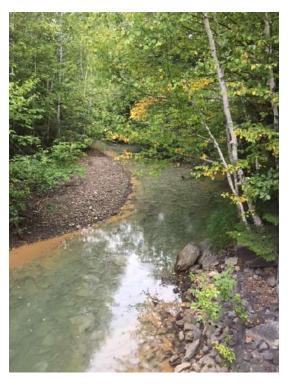
The habitat in the main branch of Forty Mile Brook approximately 1.5 km downstream of the confluence of the south and north tributaries (Area H) is relatively low gradient (2-3%). Fish habitat consists of riffle, pool, flat, and run habitat types. Water depth ranged from 0.2 to 0.7 m. Stream widths ranged from 5 to 9 m with mixed substrate composed of boulders, cobble, gravel, and sand. This habitat is characterized by the absence of aquatic vegetation, fish species, and benthic communities. Typically, the bottom at this location is covered with a "red and grey sludge precipitate" and has been deemed unproductive (R.A. Currie Ltd. 1988 in Jacques Whitford 2008). Representative habitat is provided in Photo 7.

Photo 7 Representative Habitat in the Main Branch of Forty Mile Brook Upstream of the Confluence with Caribou Brook (Area H, Facing Upstream)

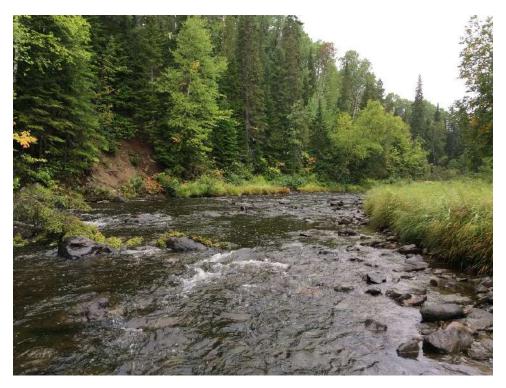
The habitat in the lower reach of the main branch of Forty Mile Brook approximately 300 m upstream of the confluence with the Nepisiguit River (Area E) is characterized by riffle habitat (Stantec 2018b). Stream width ranged from 7 to 8 m with water depths averaging 0.3 m and a maximum of 0.75 m. Riparian vegetation was dominated by trees (predominantly conifers), with some shrubs and grass. The majority of substrate was cobble, with smaller quantities of gravel and boulder. Banks were generally stable (Stantec 2018b). Representative habitat is provided in Photo 8.

Photo 8 Representative Habitat in the Main Branch of Forty Mile Brook Downstream of the Confluence with Caribou Brook (Area E Facing Downstream)

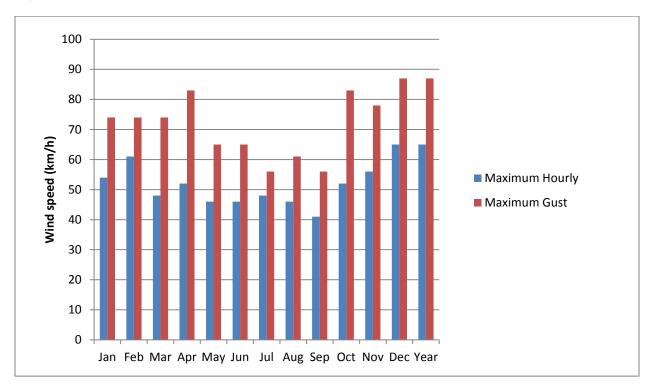
Figure 5.15 Maximum Hourly and Maximum Gust Wind Speeds (1981 to 2010) at Bathurst, New Brunswick Station

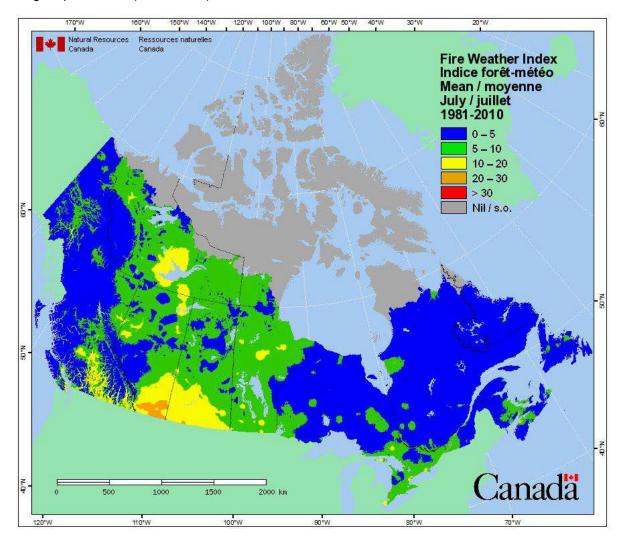
Figure 5.16 Average Fire Weather Index for the Month of July (1981-2010) (from NRCan 2018)

The mean Fire Weather Index for the Restigouche County for years 1981 to 2010 for July (i.e., normally the driest month of the year, when risk of forest fire is typically the greatest) is rated from 0 to 5 (Figure 5.16); this is in the lower range of possible risk (NRCan 2018).

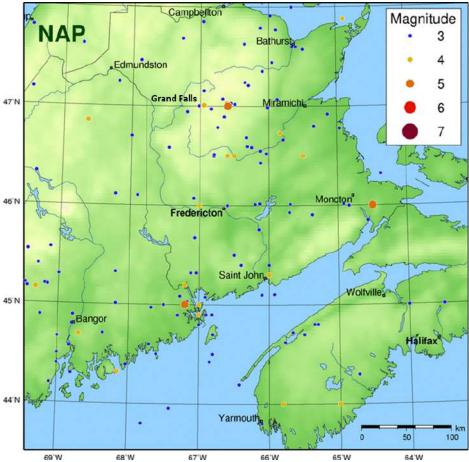
Figure 5.17 Northern Appalachians Seismic Zone (from NRCan 2016)

The Caribou mine property is located within the Northern Appalachians seismic zone (Figure 5.17) (NRCan 2016), which includes most of New Brunswick and extends southward into New England. It is one of five seismic zones in southeastern Canada, where the level of historical seismic activity is low. Historical seismic data recorded throughout eastern Canada has identified clusters of earthquake activity. Earthquakes in New Brunswick generally cluster in three regions: the Passamaquoddy Bay region, the Central Highlands (Miramichi) region, and the Moncton region (Burke 2011).
