*Completion of Work
Report for Building 68
Removal Action*

General Electric Company
Pittsfield, Massachusetts

February 2000

**Re: Building 68 Area Removal Action
EPA Region I CERCLA Docket #I-97-1033/DEP File #1-0147P
Final Completion of Work Report**

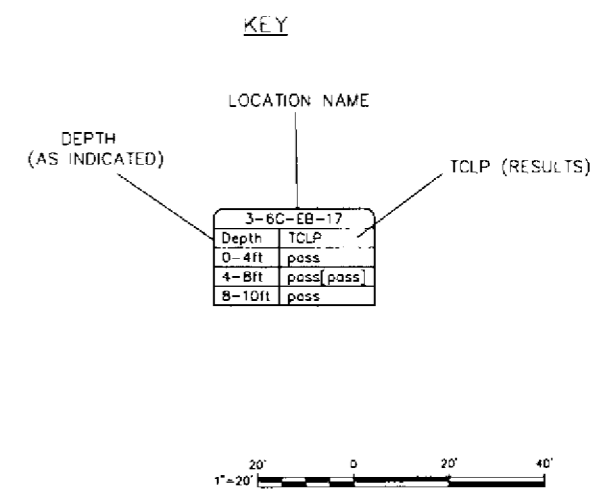
FIGURE
2-1

5. TOXICITY CHARACTERISTIC LEACHATE PROCEDURE (TCLP) RESULTS ARE INDICATED AS PASS/FAIL WITH RESPECT TO REGULATORY LEVELS. REFER TO TABLE 2-1 FOR A MORE DETAILED SUMMARY OF THE RESULTS. ALL EXCEEDENCES (HIGHLIGHTED ON FIGURE) ARE RELATED TO LEAD ONLY.

**DISPOSAL CLASSIFICATION AND BANK
TCLP SOIL SAMPLING LOCATIONS
AND RESULTS**

To better assess the extent to which unclassified bank soils constituted a RCRA hazardous waste, additional samples were collected on August 7, 1997 from two temporary stockpiles located east of Building 68. These soils were generated from bank soils south of Building 68 that were removed to provide access for sheetpile installation. Five discrete-grab samples were collected from each stockpile and submitted to NEA for TCLP analysis for lead only. The results of the TCLP analyses of these samples for lead (Table 2-1) indicated that these materials constituted a RCRA hazardous waste and warranted TSCA/RCRA disposal.

analytical results (Table 2-1) indicated that 68-CL-1 and 68-CL-3 contained lead at levels that exceeded the TCLP regulatory levels; therefore, the entire soil stockpile was considered RCRA hazardous waste, and was subject to TSCA/RCRA disposal.

On December 5, 1997, to characterize unclassified bank soils prior to disposition, temporarily stockpiled materials were sampled from three locations (68-QM-1, 68-QM-2, 68-QM-3). These stockpiled soils were generated during completion of the removal action along the river bank south of Building 68. These samples were submitted to NEA for TCLP analysis for lead only. The analytical results (Table 2-1) indicated that these samples did not exceed the TCLP regulatory levels for lead. Thus, based on the available data, the stockpiled soils did not constitute a RCRA hazardous waste, and subsequently were disposed of as TSCA materials.
