EXTENSIVE GREEN ROOF STUDY ON A RETROFIT BUILDING IN BERLIN, GERMANY: REPORT AFTER 34 YEARS OF MONITORING

Manfred Koehler

Green Roof Center, University of Applied Sciences Neubrandenburg, Germany

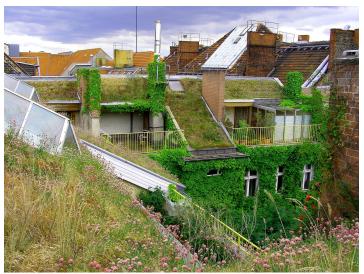
Figure 5 The PLU (Paul-Lincke-Ufer) roofs today: the green roofs are well developed, and the climber has covered all the facades. All areas are in good condition and will thrive for years to come.
